## Expertise

Protocol number: 46359267  
Order No. / Reference: 26547160  
Inspection date: 3 Jun 2026

Manufacturer: Peugeot

Model: 5008 BlueHDi 130 EAT8 GT

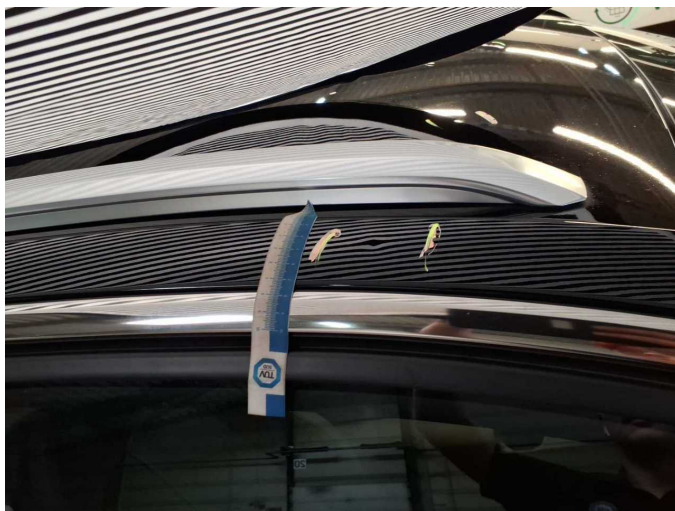
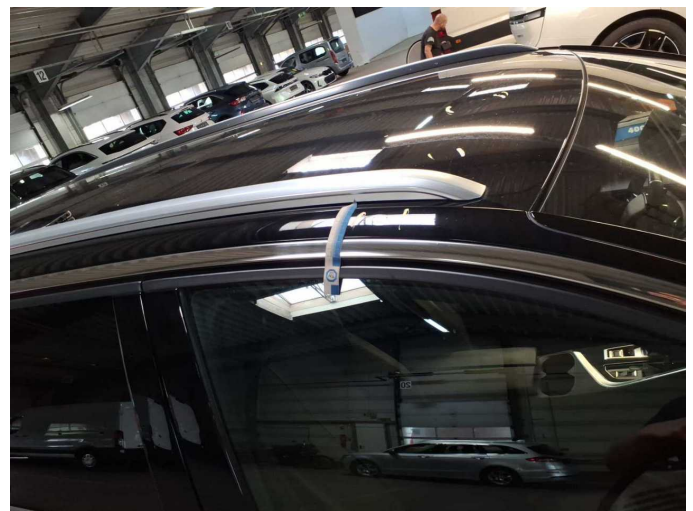
Damage 1: Roof: Roof rail - right side - dent(s) - Smooth repair work

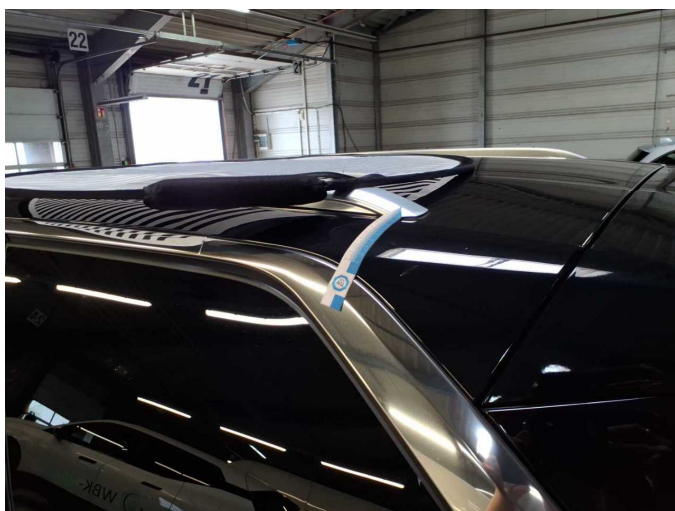
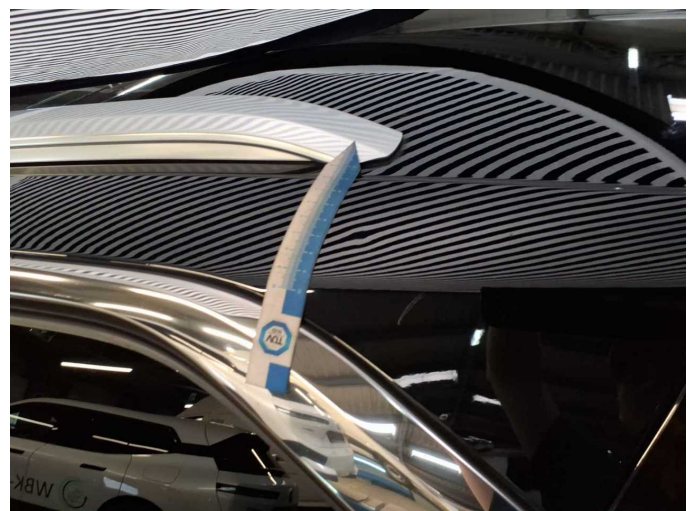
Damage 2: Roof: Roof rail - left side - dent(s) - Smooth repair work

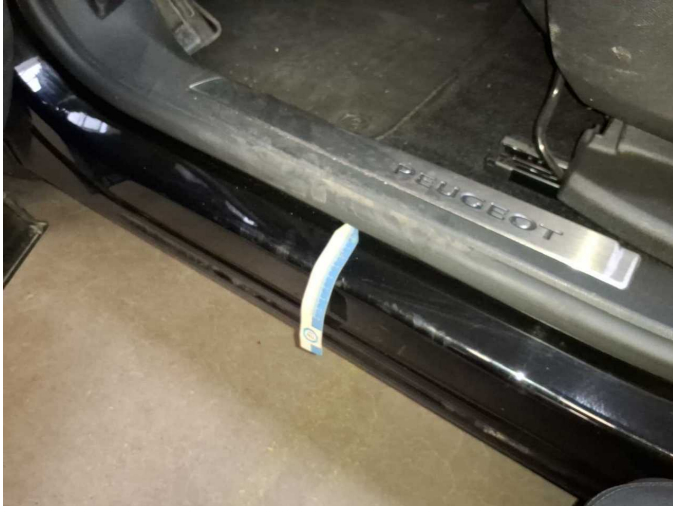
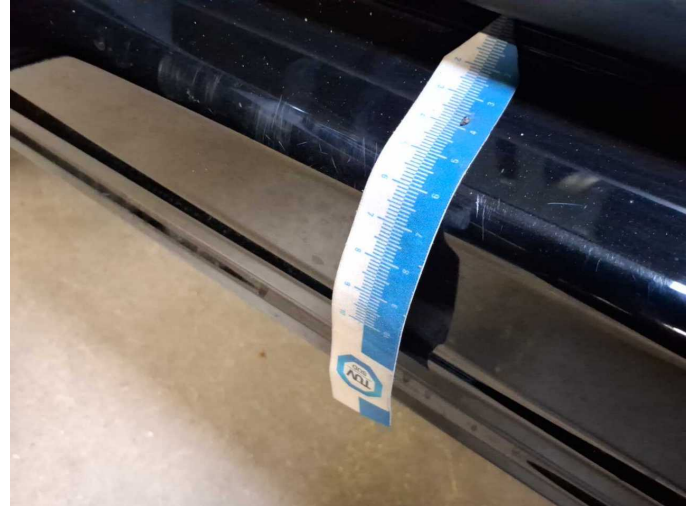
**Damage 3:** Sill - left side: Sill - Scratch(es) - Smart repair

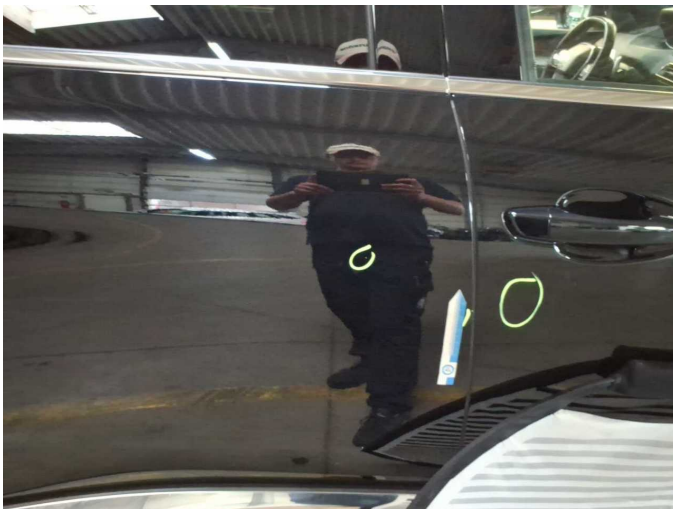
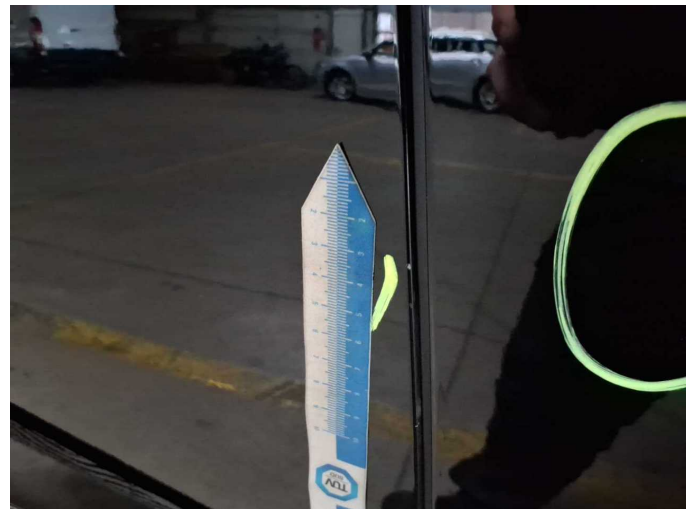
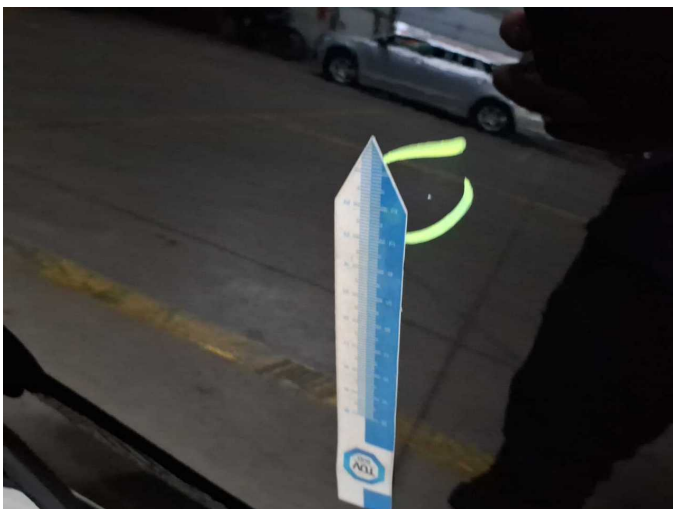
**Damage 4:** Door - rear right side: Door (Außen) - Scratch(es) - Smart repair

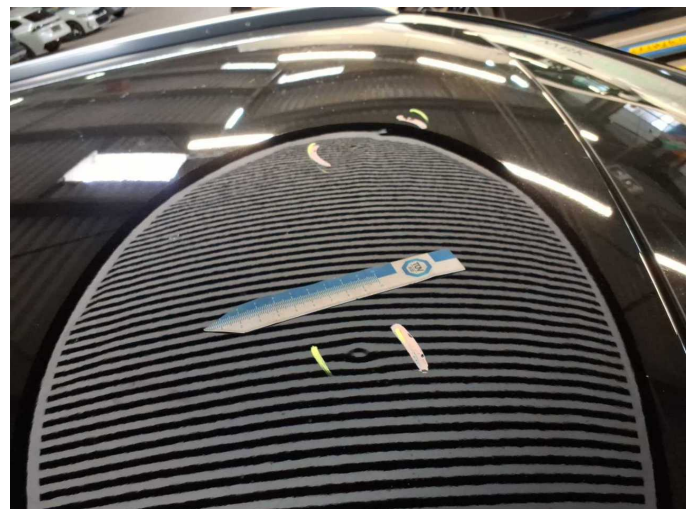
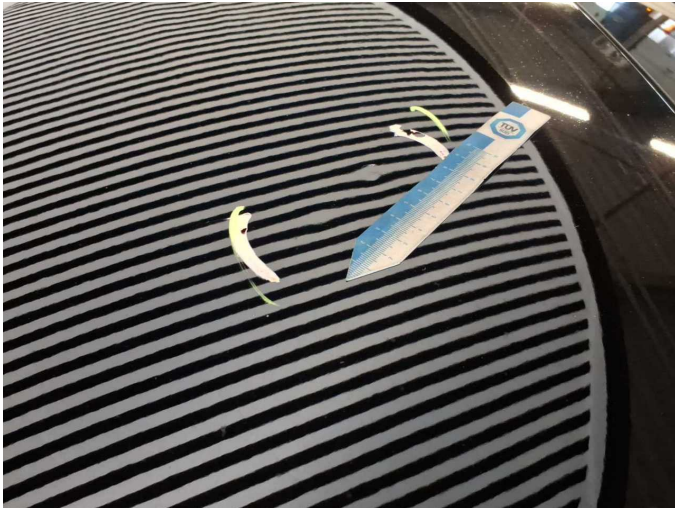
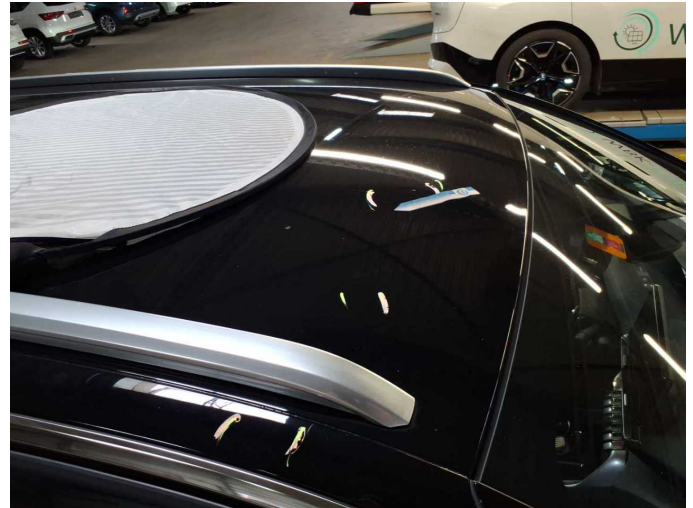
**Damage 5:** Roof: Roof - dent(s) - Smooth repair work

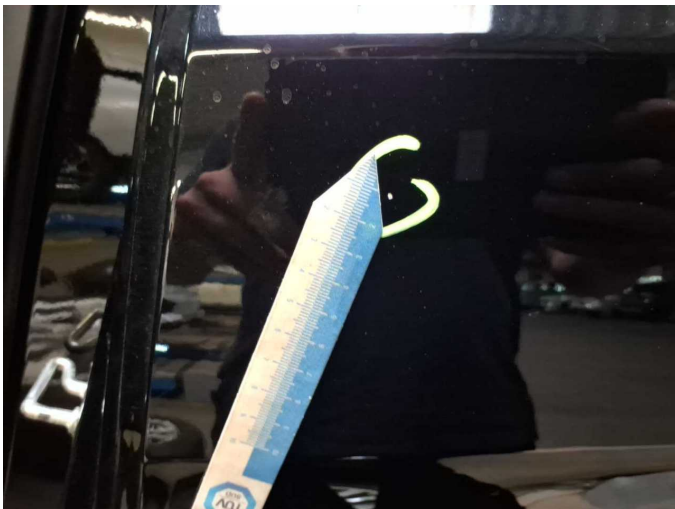
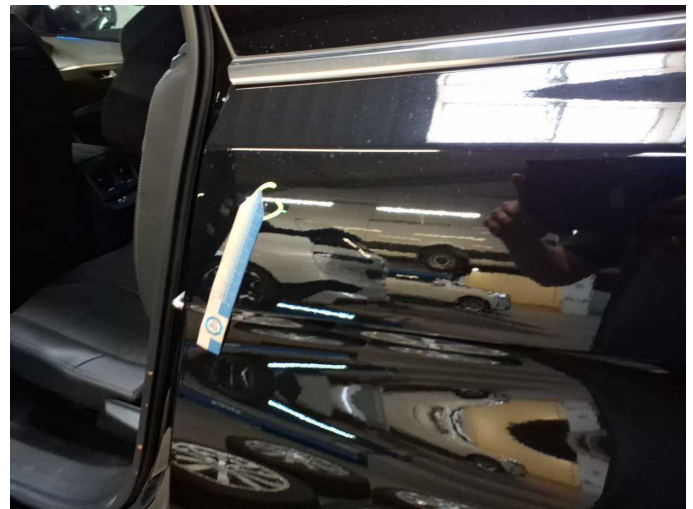
**Damage 6:** Side panel - rear right side: Side panel - Scratch(es) - Smart repair

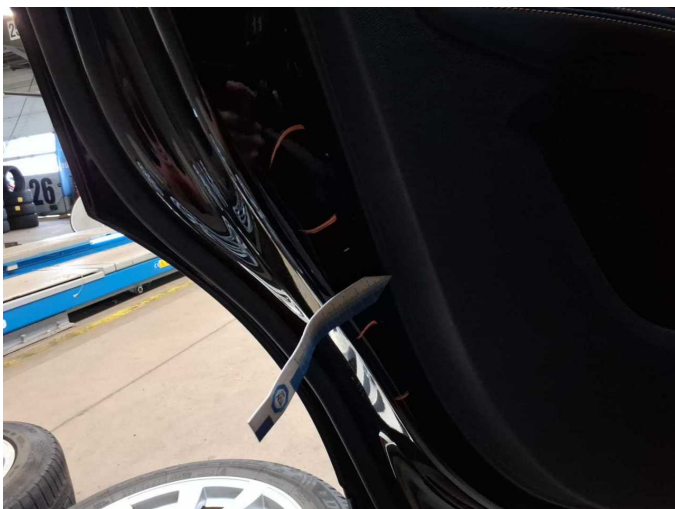
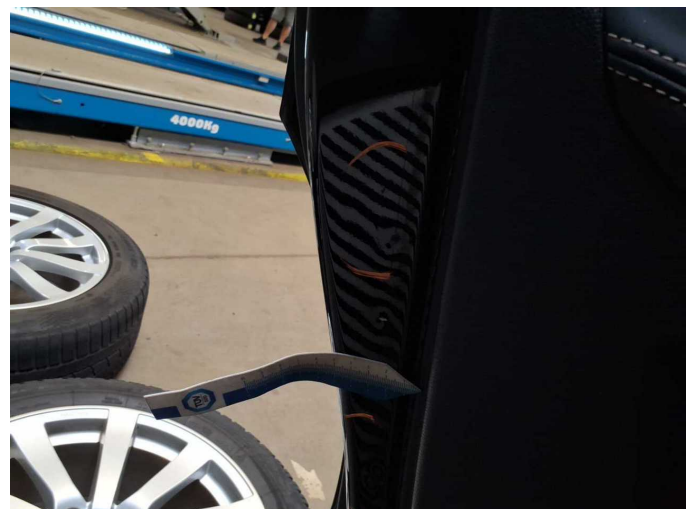
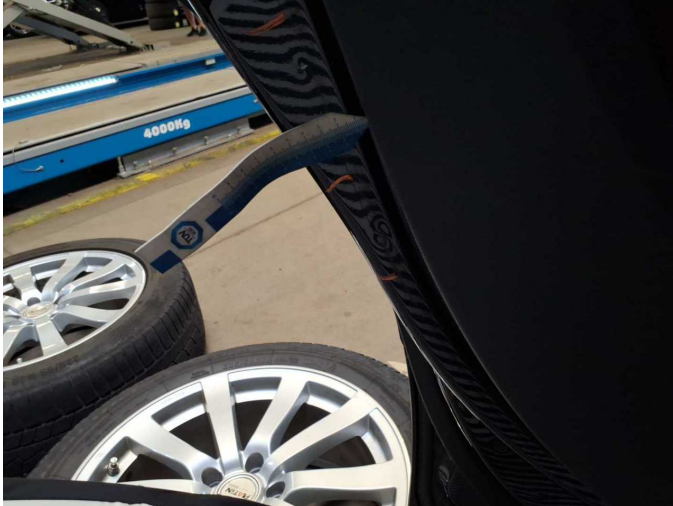
**Damage 7:** Door - rear left side: Door (Innenseite) - dent(s) - Smooth repair work

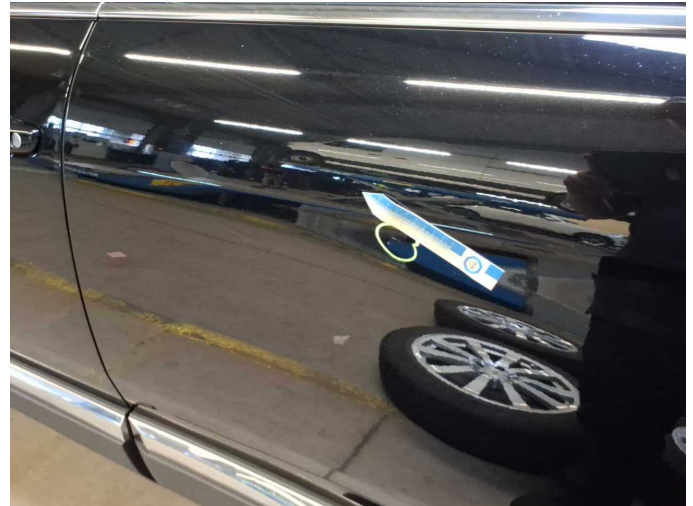
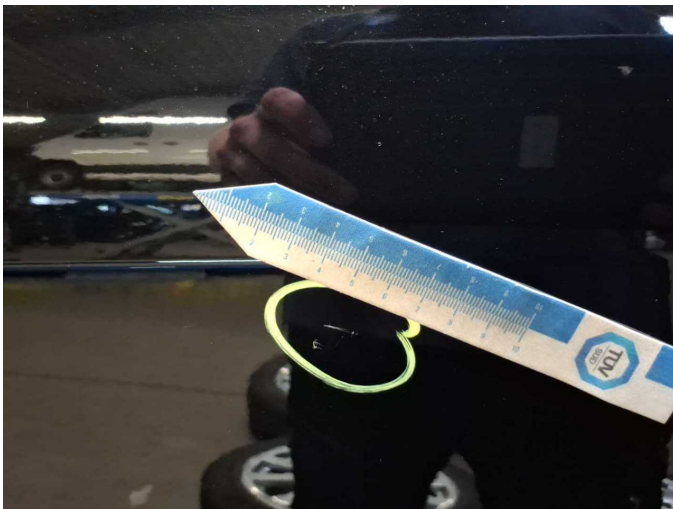
**Damage 8:** Door - rear left side: Door - Scratch(es) - Smart repair

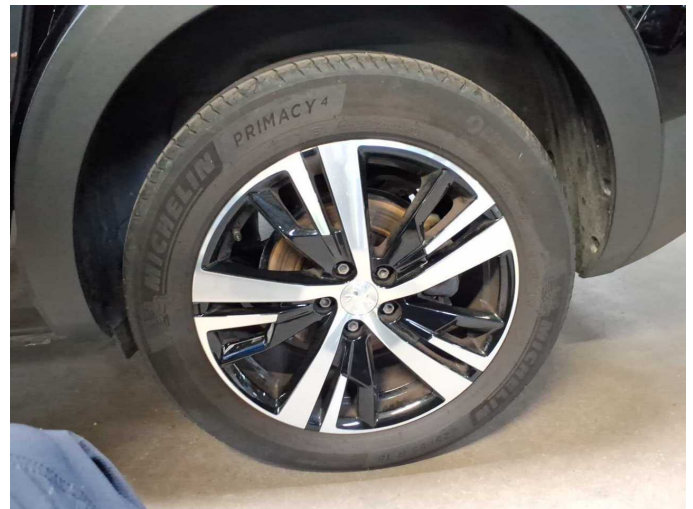
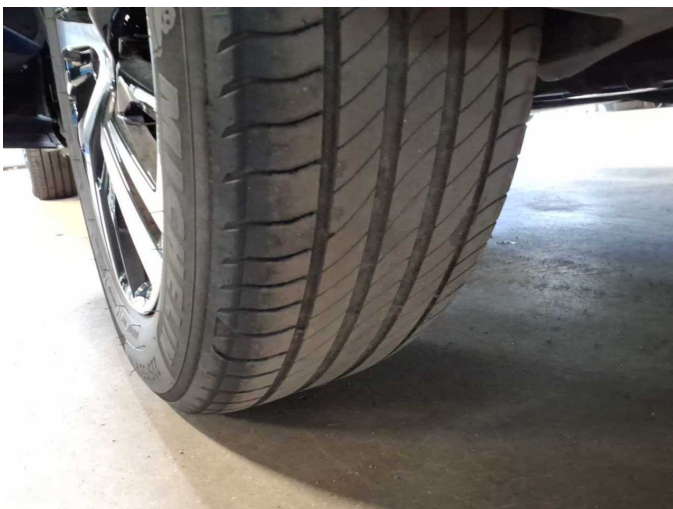
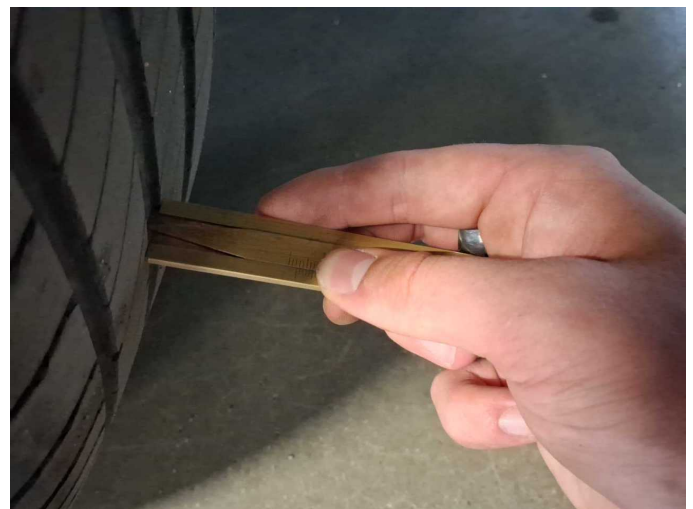
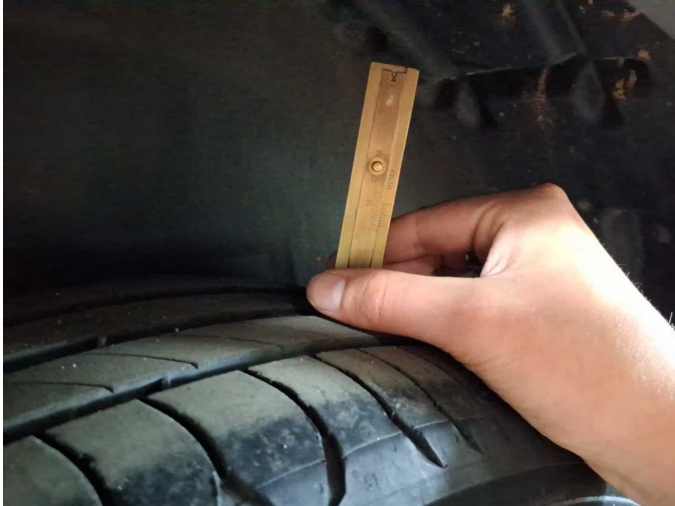
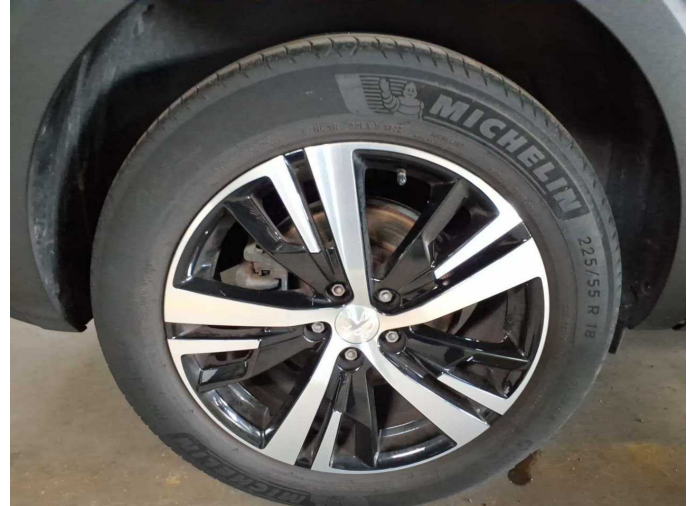
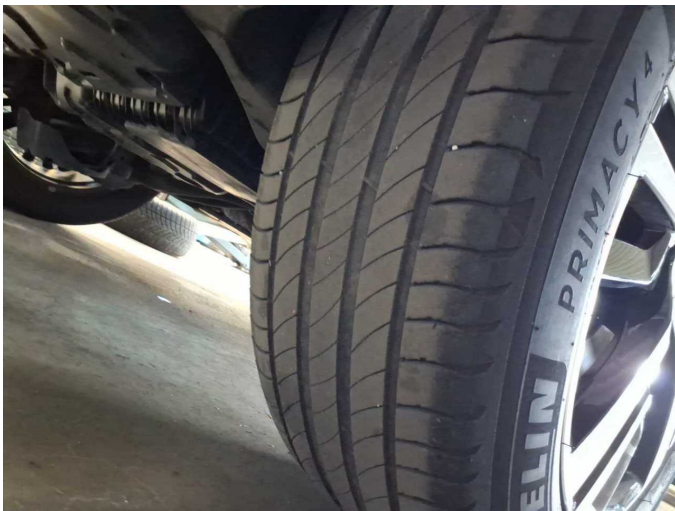
**Damage 10:** Wheel / tyres: Tyre - right - Worn - Replace

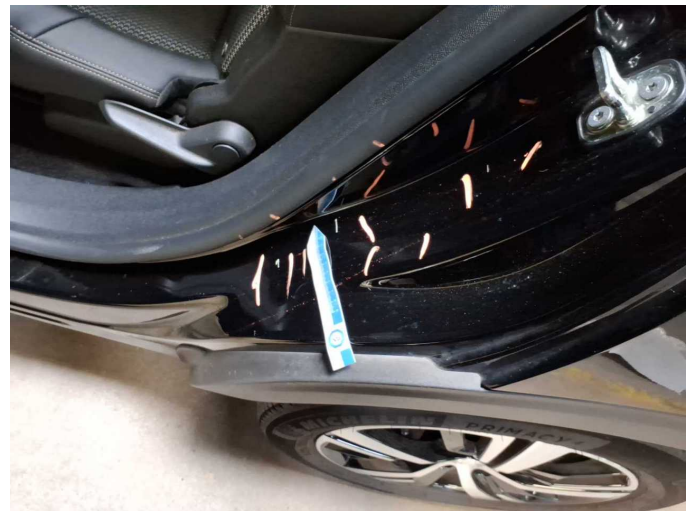
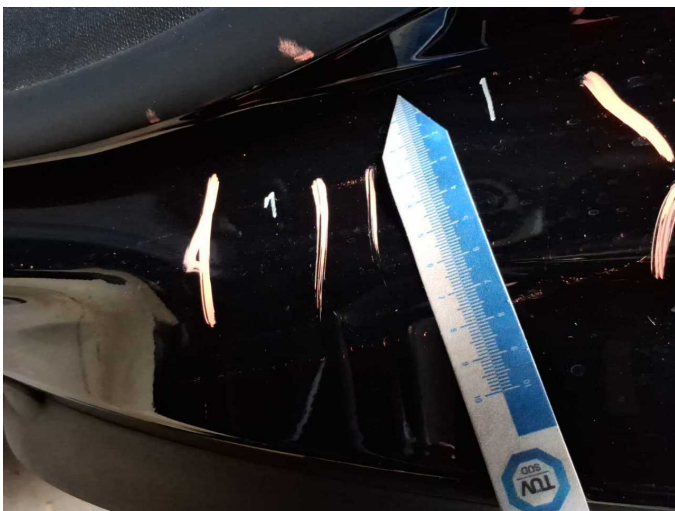
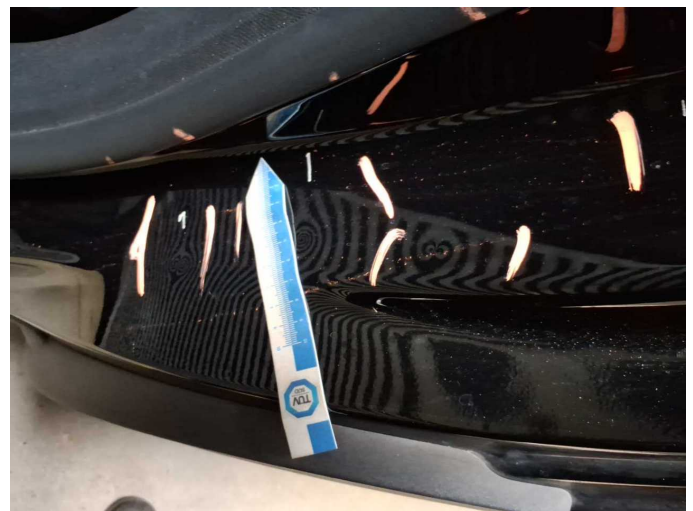
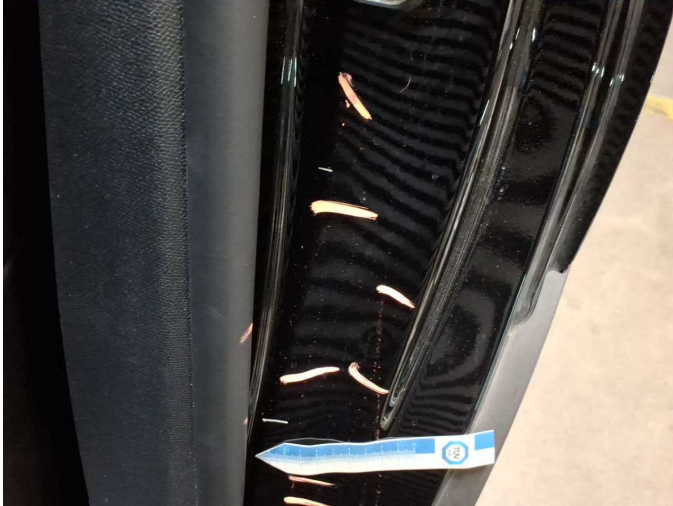
**Damage 11:** Side panel - rear left side: Sill - Dent / paintcoat damage - Repair and paint

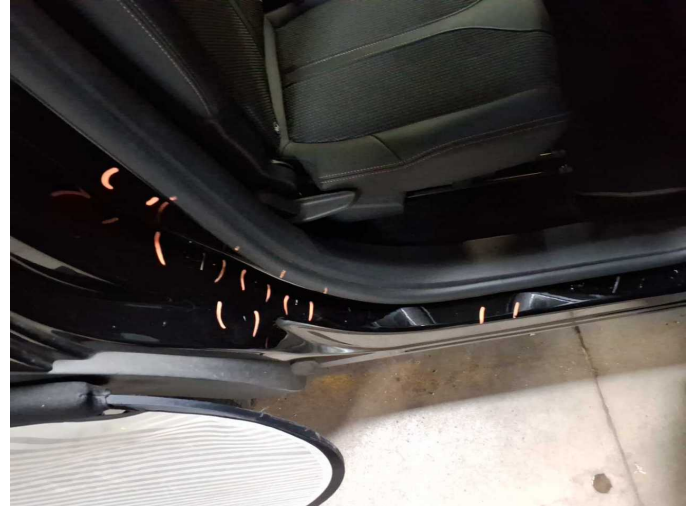
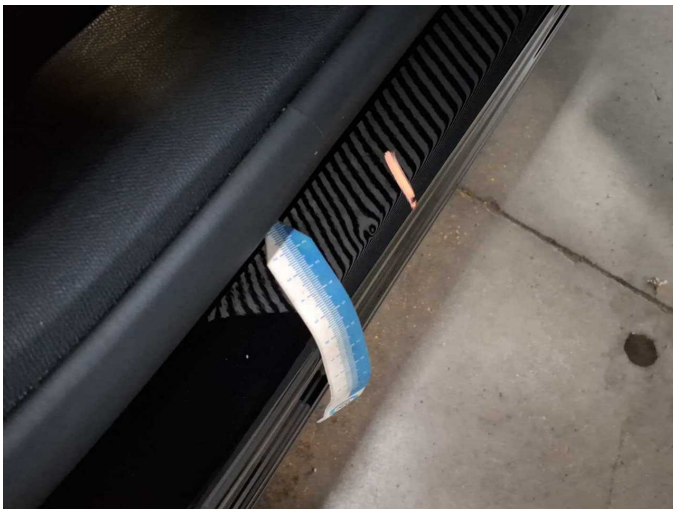
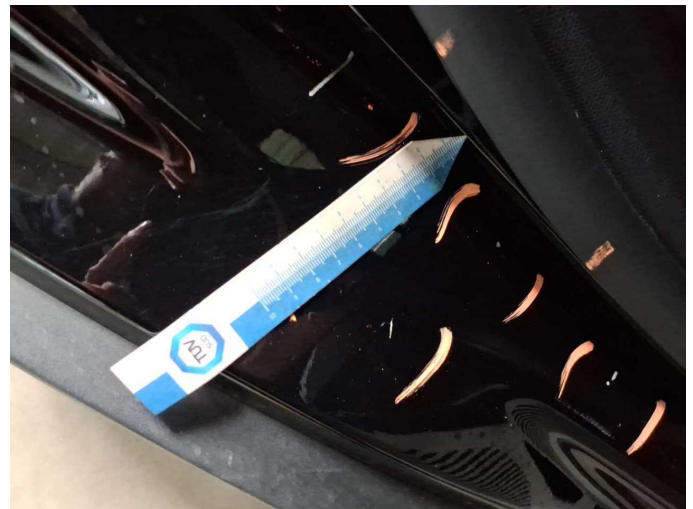
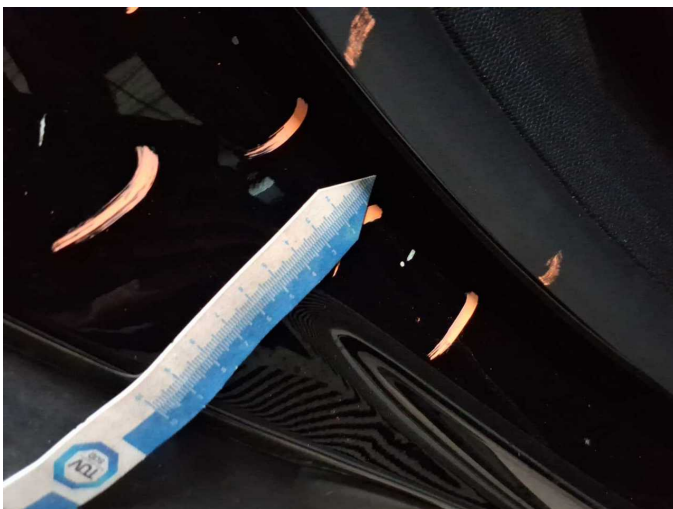
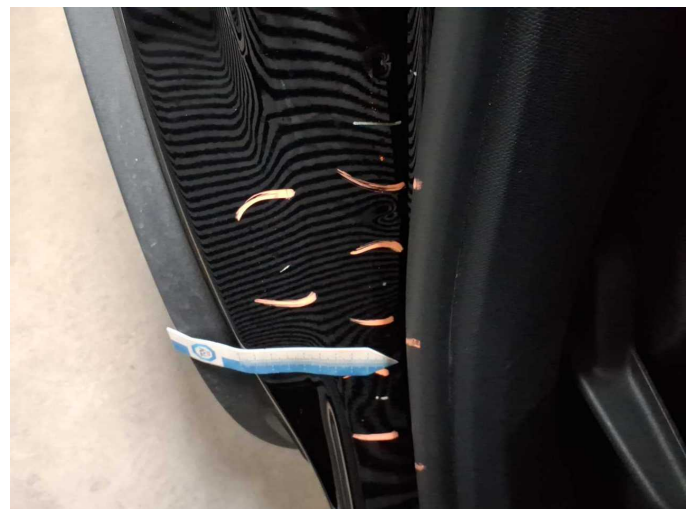
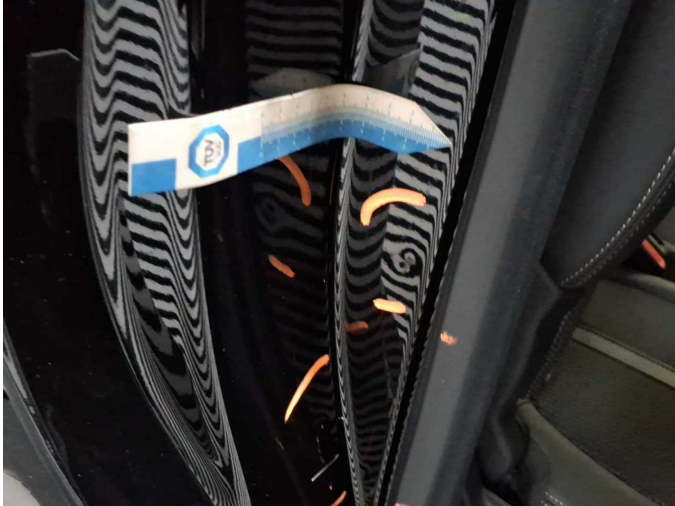
**Damage 12:** Side panel - rear right side: Sill - Dent / paintcoat damage - Repair and paint

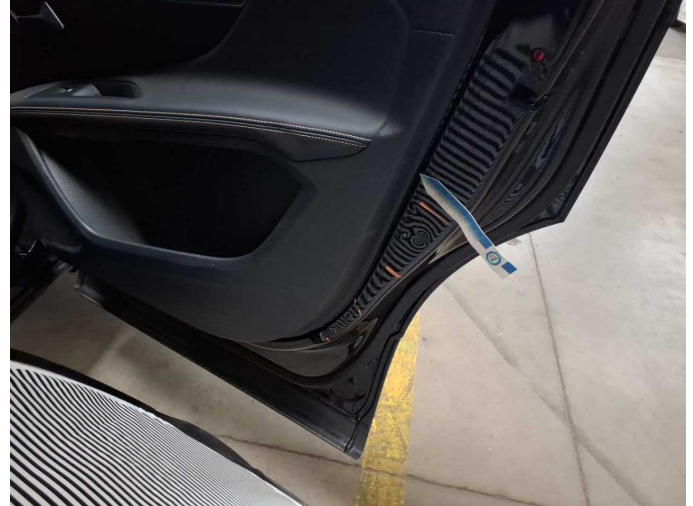
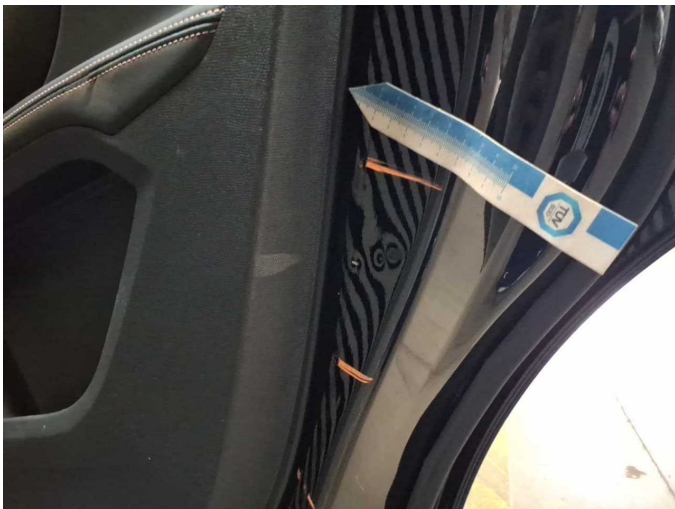
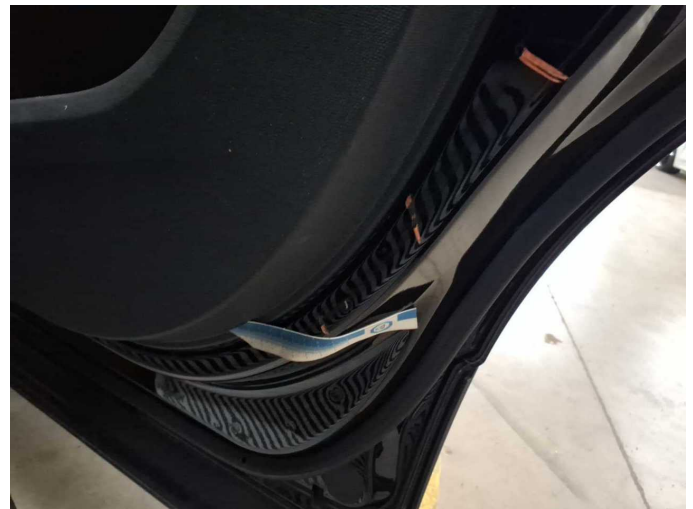
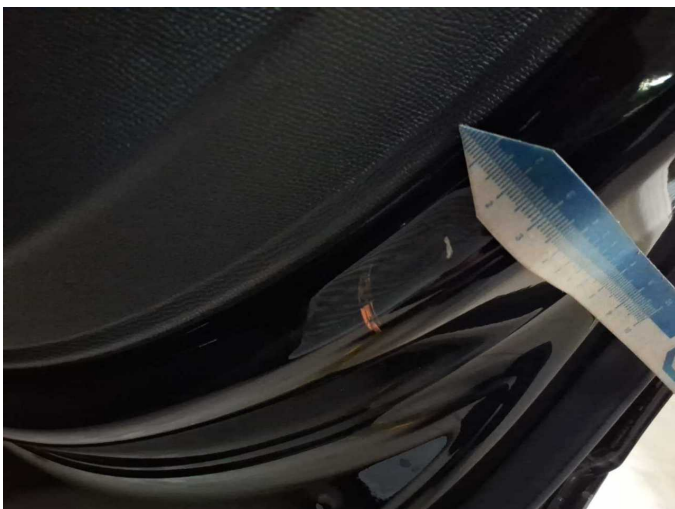
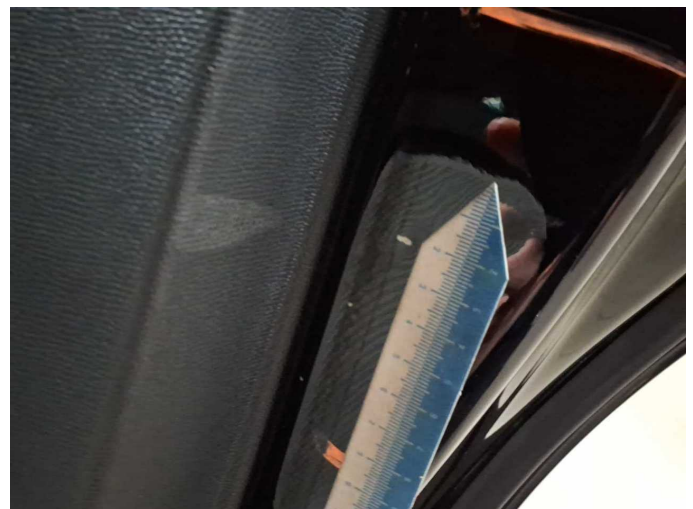
**Damage 13:** Door - rear right side: Door (Innenseite) - Dent / paintcoat damage - Repair and paint

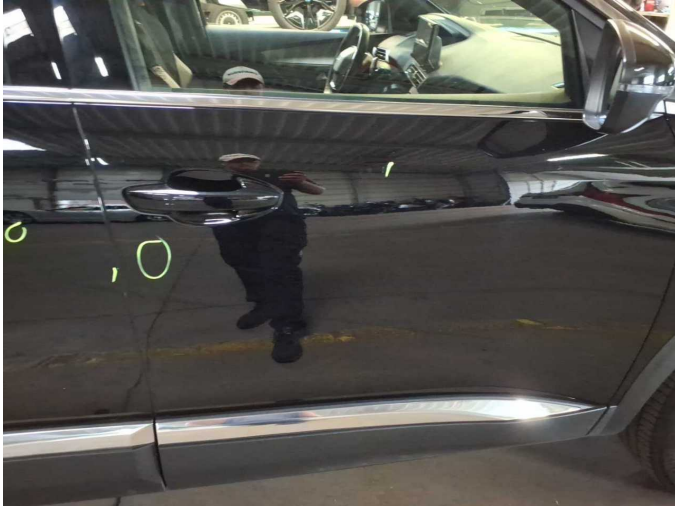
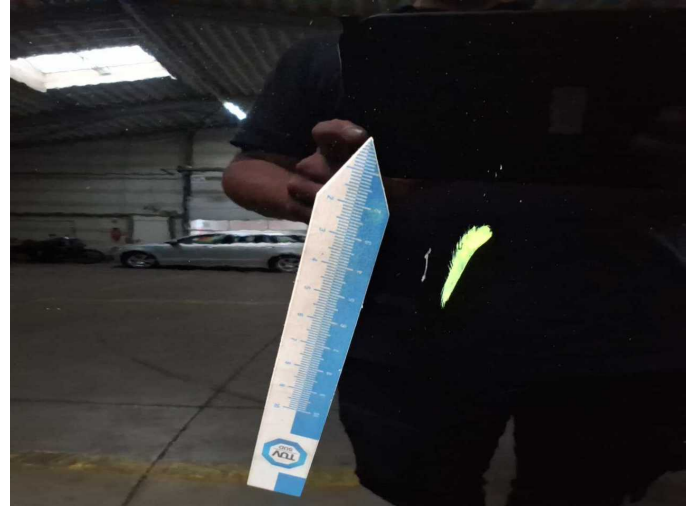
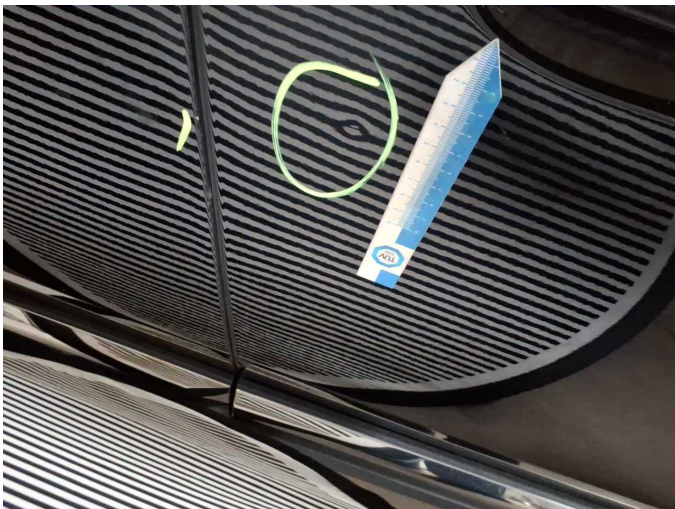
**Damage 14:** Door - front right side: Door - Dent / paintcoat damage - Repair and paint

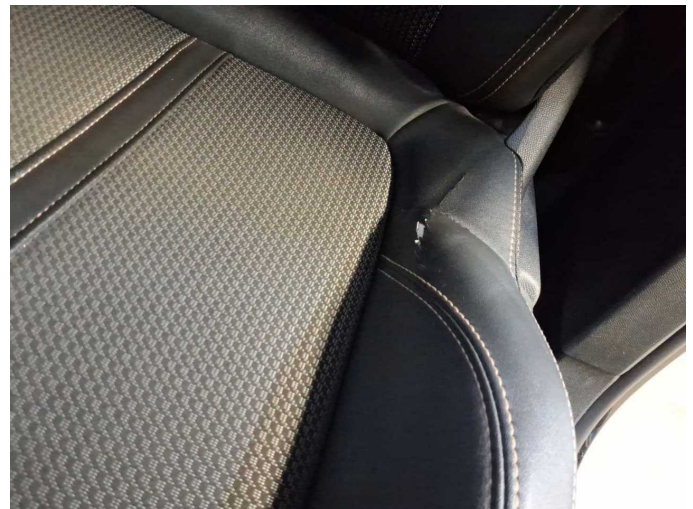
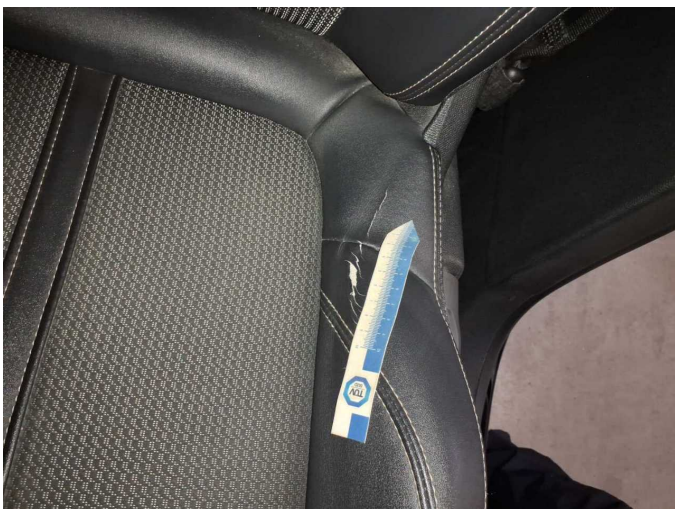
**Damage 15:** Seat - front: Seat cover - left side - Broken / torn - Replace

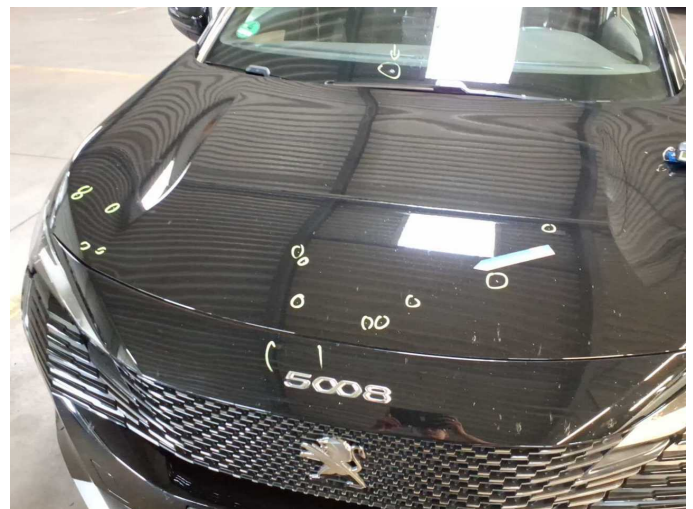
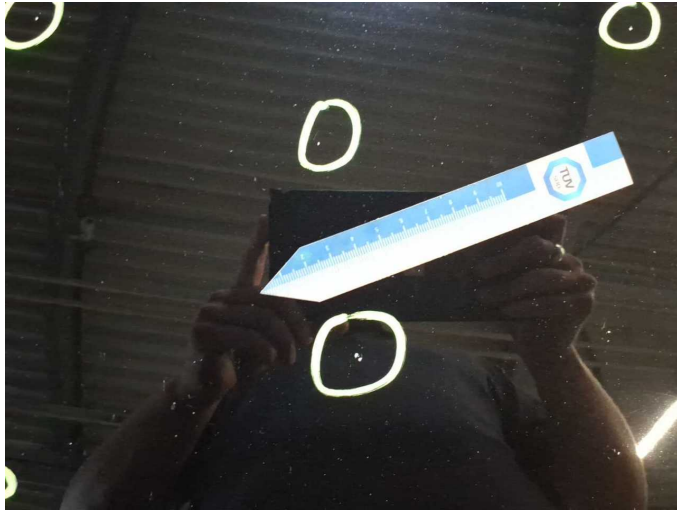
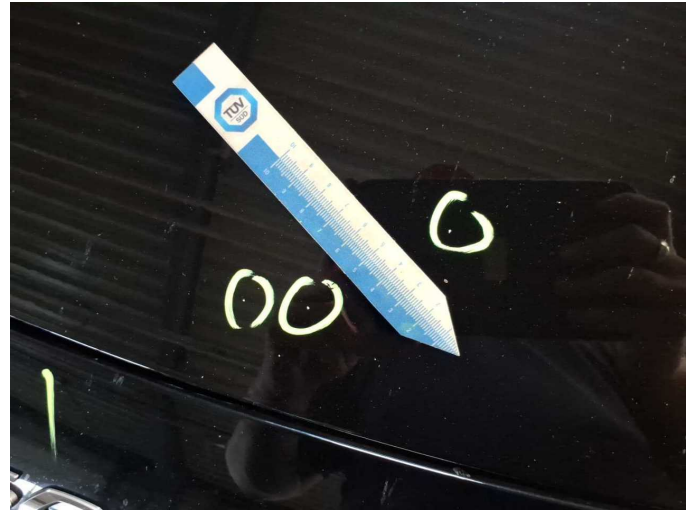
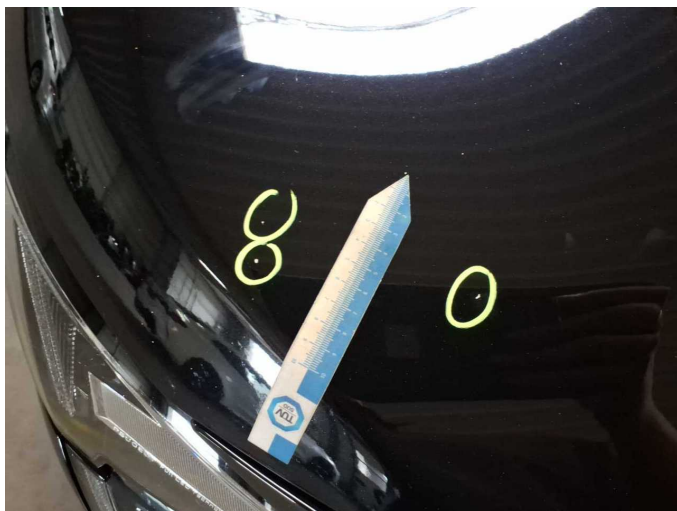
**Damage 16:** Bonnet: Bonnet - Stone chips - Paint

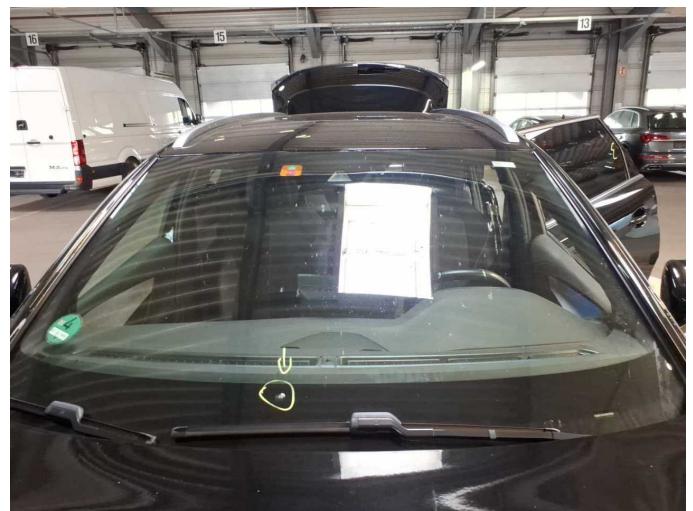
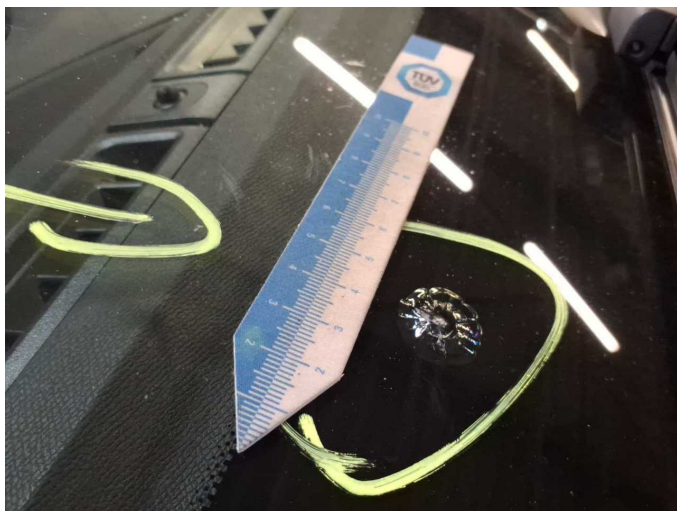
**Damage 17:** Vehicle glazing: Windscreen - Stone chips - Replace

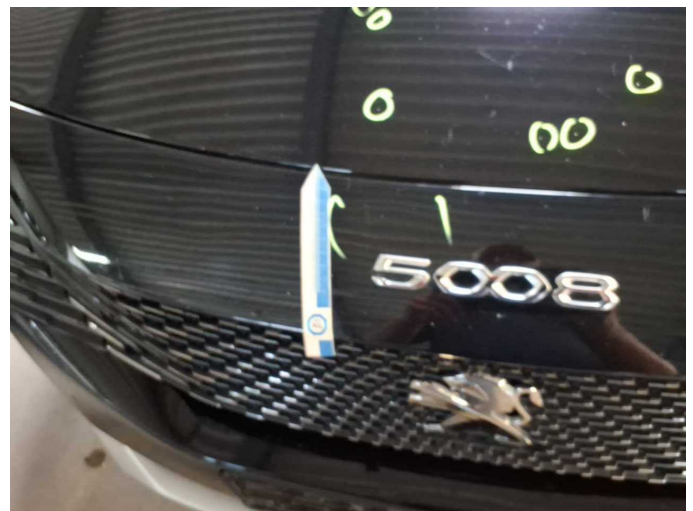
**Wear and tear 1:** Front bumper: Front bumper - dent(s) - No deduction

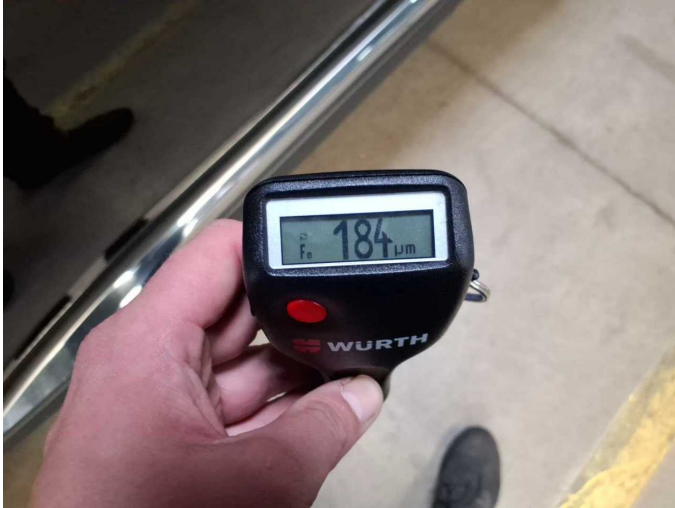
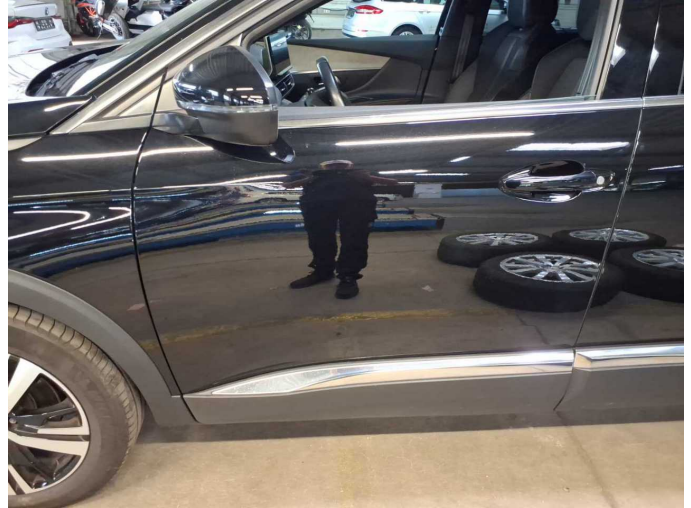
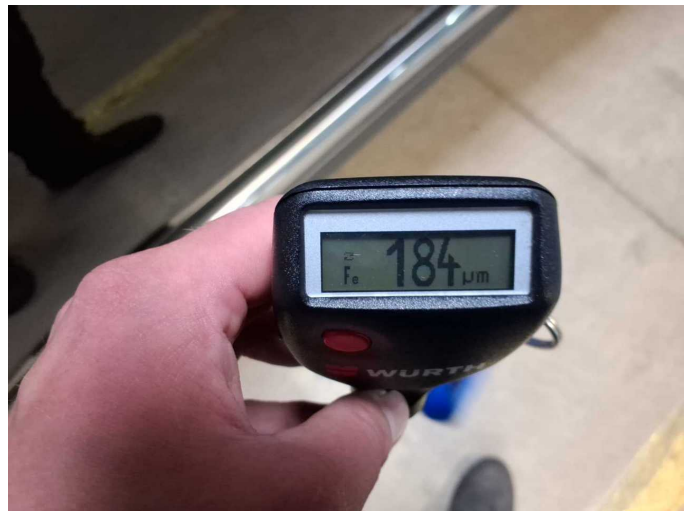
No.	Repainting
1	Door - front left side, Professionally carried out, Invoice of repair done Non-existent

Repainting 1: Door - front left side

Door - front left side: 184 µm
