Expertise

Protocol number: 46187784  
Order No. / Reference: 26479328  
Inspection date: 19 Jun 2026

Manufacturer: Opel

Model: Astra 1.5 D Automatik Business Elegance

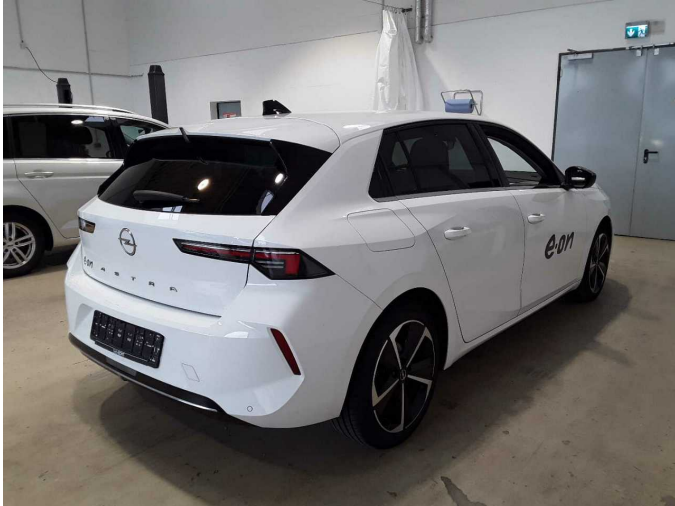
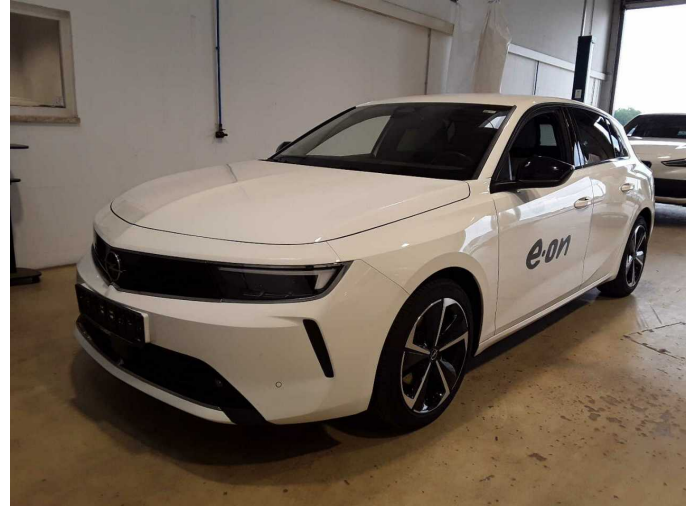
| No. | Component group | Description |
|---|---|---|
| 1 | Body | Body - Glued / labelled - De-glue / neutralise |

**Damage 1:** Body: Body - Glued / labelled - De-glue / neutralise

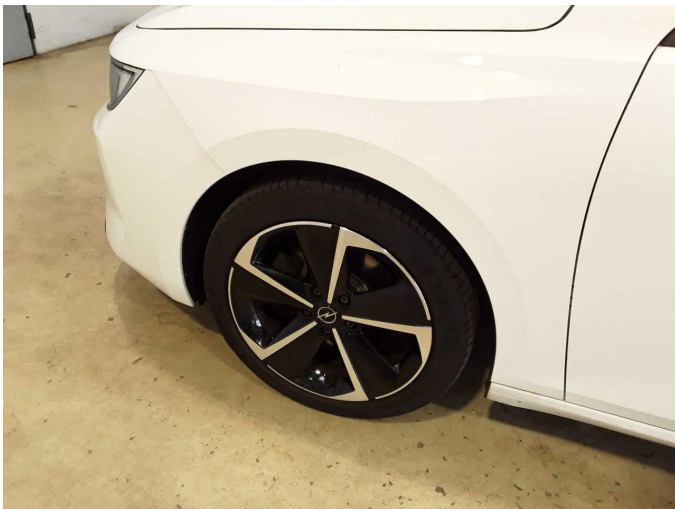
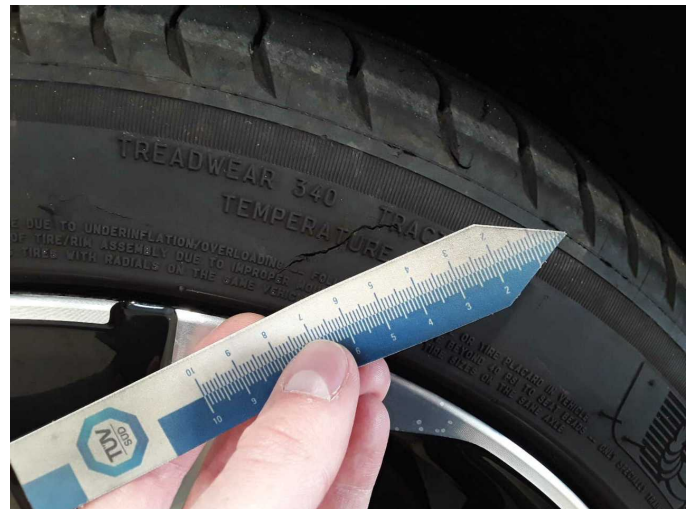
| No. | Component group | Description |
|---|---|---|
| 2 | Wheel / tyres | Tyre - front left side - Broken / torn - Replace |

**Damage 2:** Wheel / tyres: Tyre - front left side - Broken / torn - Replace

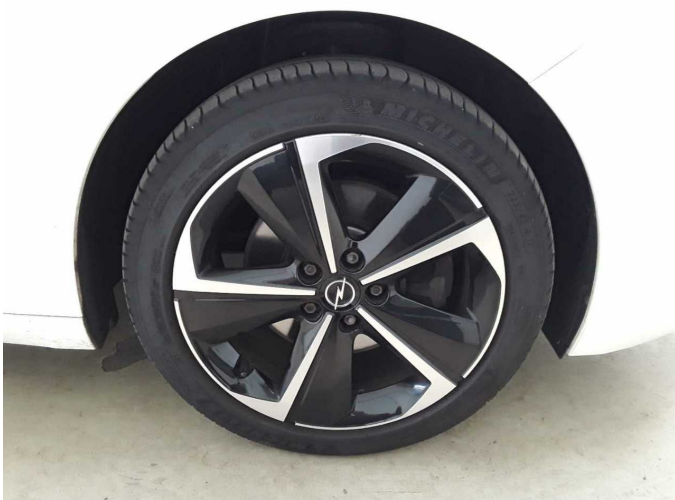
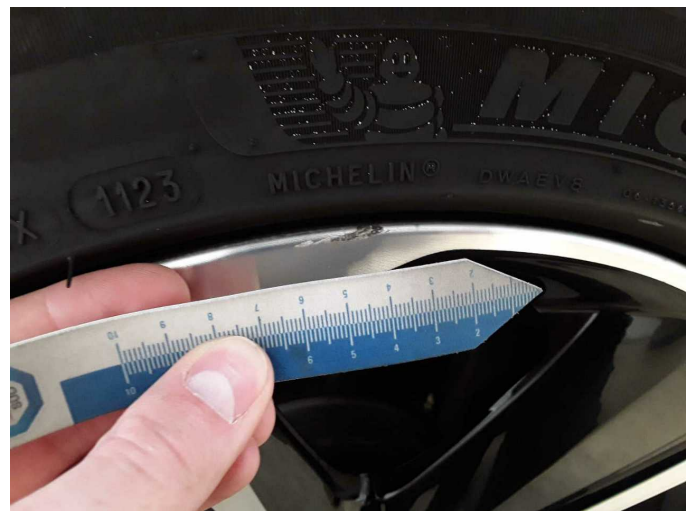
| No. | Component group | Description |
|---|---|---|
| 3 | Wheel / tyres | Alloy rim - front right side - Scratch(es) - Loss in value |

**Damage 3:** Wheel / tyres: Alloy rim - front right side - Scratch(es) - Loss in value

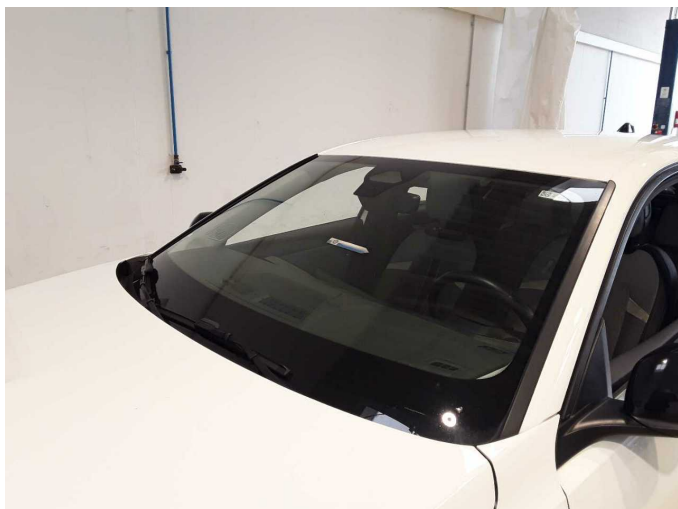
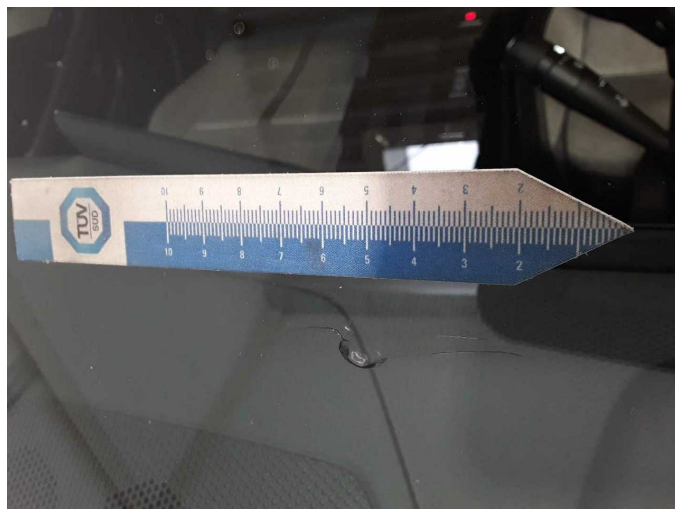
| No. | Component group | Description |
|---|---|---|
| 4 | Vehicle glazing | Windscreen - Broken / torn - Replace |

**Damage 4:** Vehicle glazing: Windscreen - Broken / torn - Replace

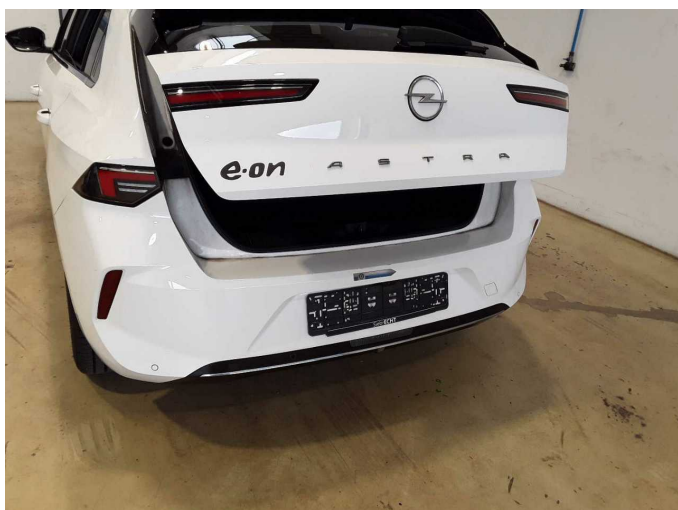
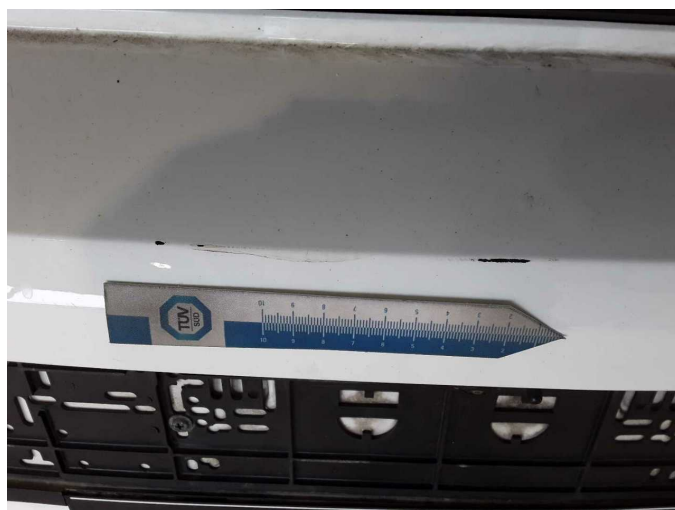
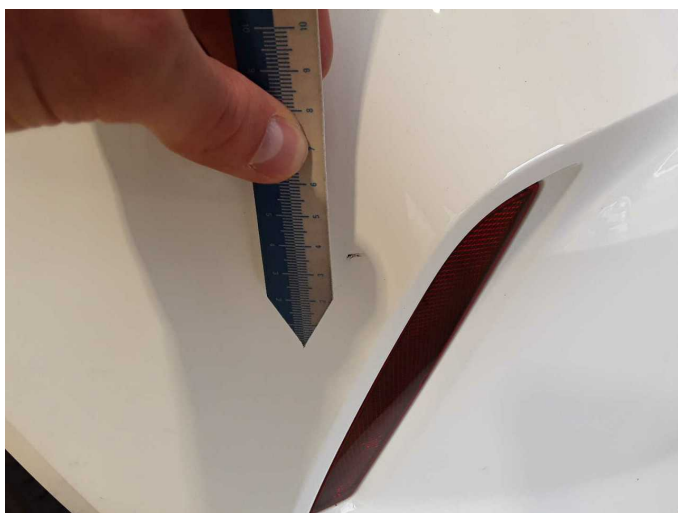
| No. | Component group | Description |
|---|---|---|
| 5 | Rear bumper | Rear bumper - Scratch(es) - Paint |

**Damage 5:** Rear bumper: Rear bumper - Scratch(es) - Paint

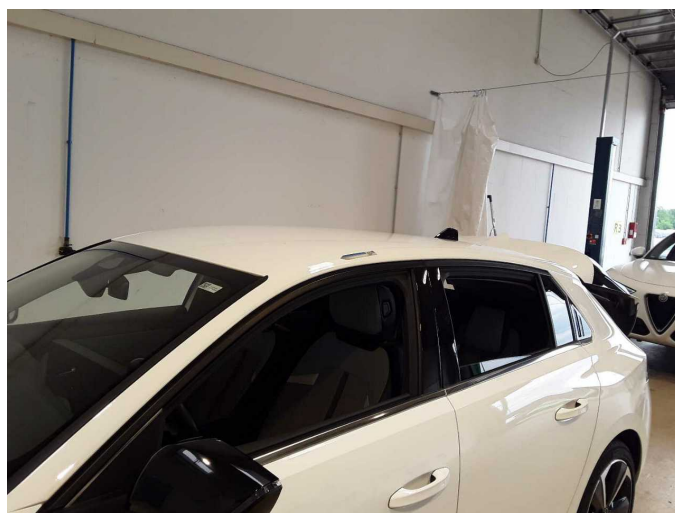
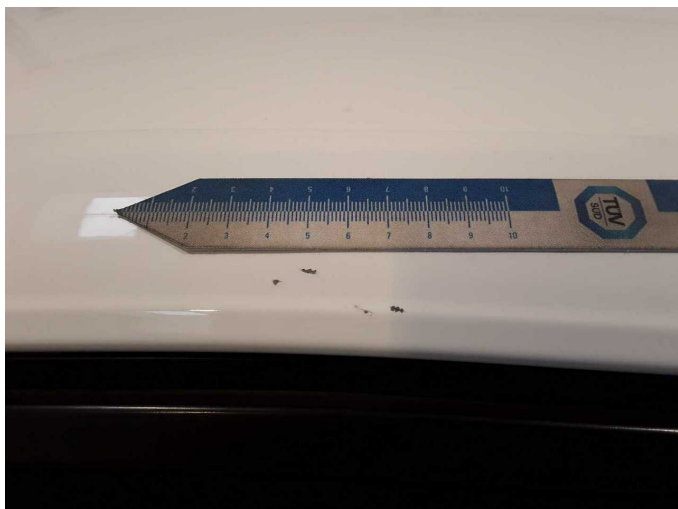
| No. | Component group | Description |
|---|---|---|
| 6 | Roof | Roof rail - left side - Scratch(es) - Paint |

**Damage 6:** Roof: Roof rail - left side - Scratch(es) - Paint
