# MACADAM

**Peugeot 3008**

**Limited Technical Inspection**

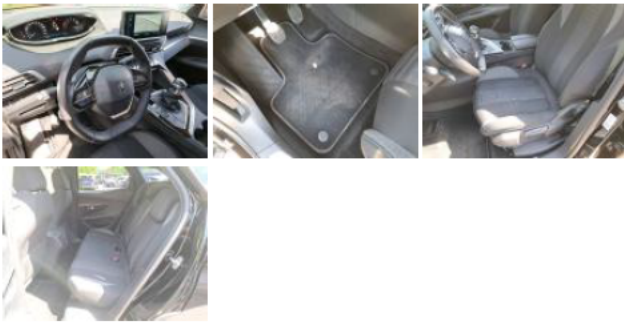
Total cost ex VAT:	<b>923,98</b>
Interior, Worn, Acceptable:	<b>0,00</b>

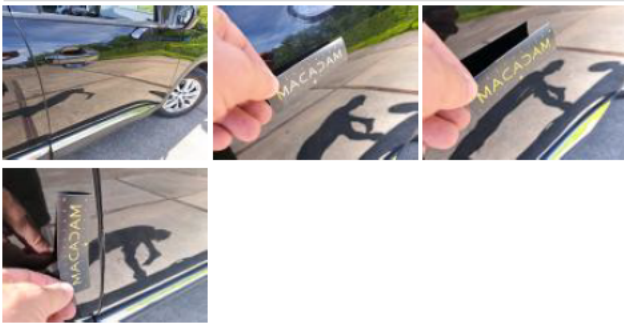
Door FR, Scratch(es), Acceptable 0,00
