Expertise

Protocol number: 45125600
Order No. / Reference: 26292985
Inspection date: 24 Apr 2026

Model: 317 CDI Sprinter Standard HA 9G-TRONIC PRO

VIN: W1V3KBFZ1TP863645

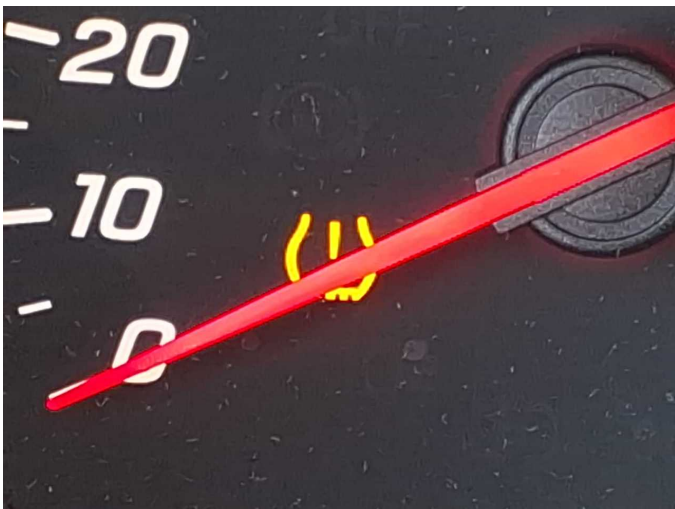
No.	Component group	Description
1	Instrument panel	Indicator light (Reifendruckkontrolle) - on - Perform diagnosis
2	Side panel - rear left side	Side panel - Dent / paintcoat damage - Smart repair
3	Sliding door, right	Sliding door - Deformed - Smart repair

Damage 1: Instrument panel: Indicator light (Reifendruckkontrolle) - on - Perform diagnosis

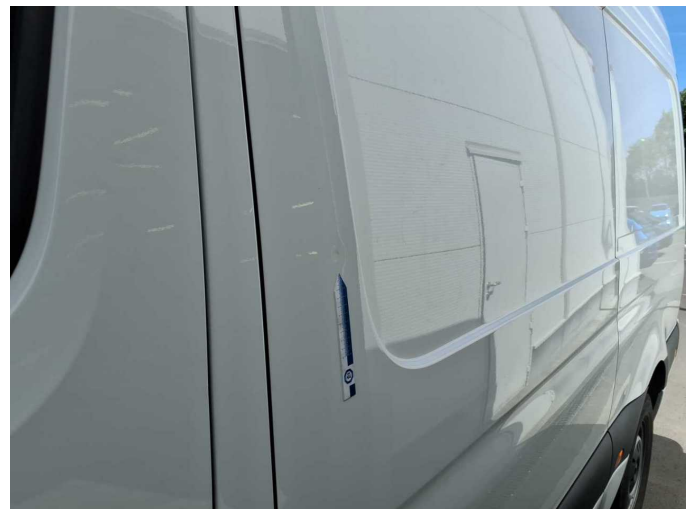
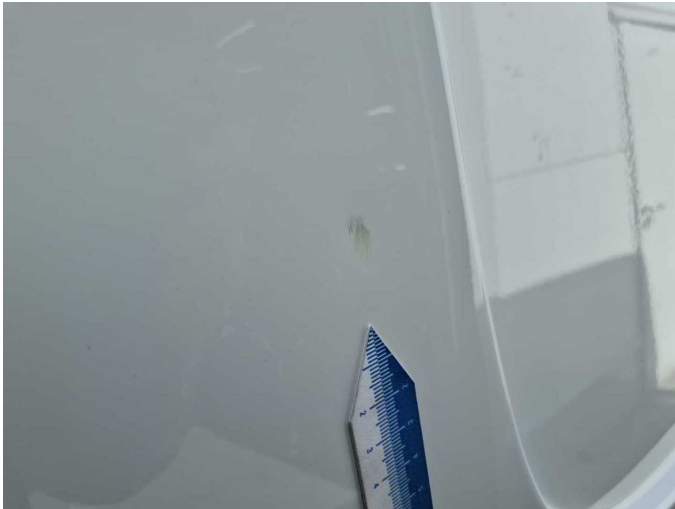
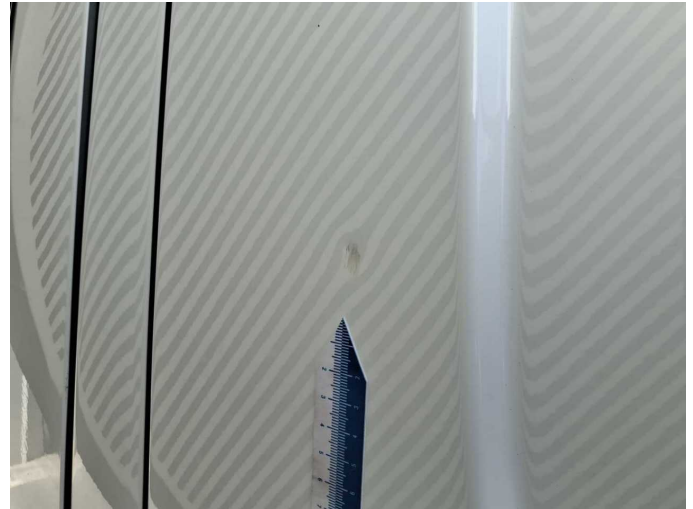
Damage 2: Side panel - rear left side: Side panel - Dent / paintcoat damage - Smart repair

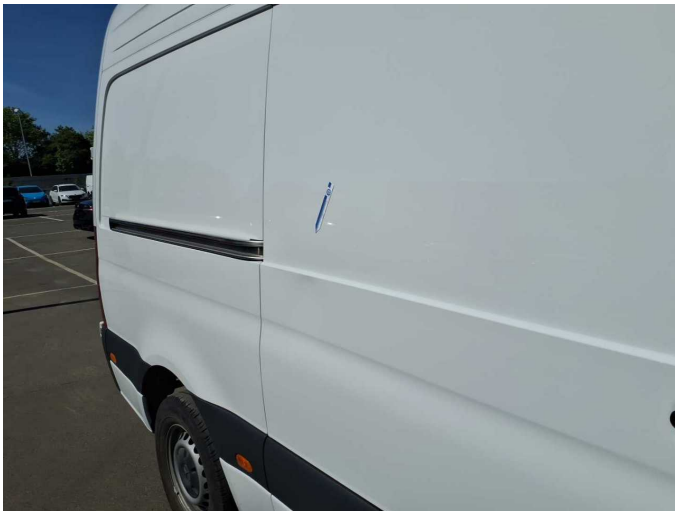
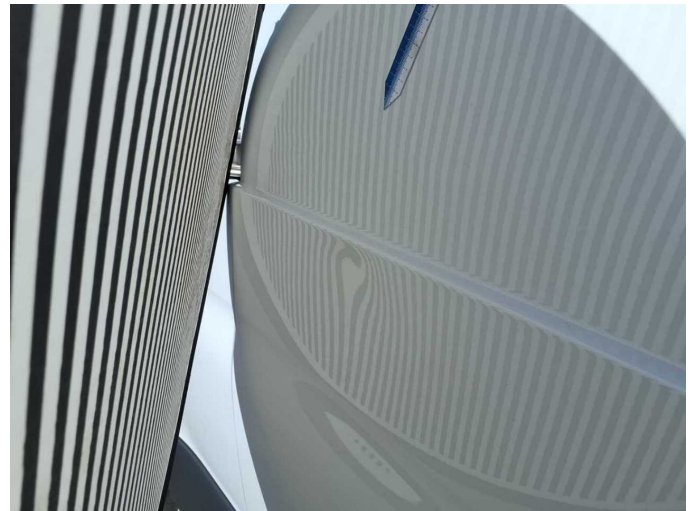
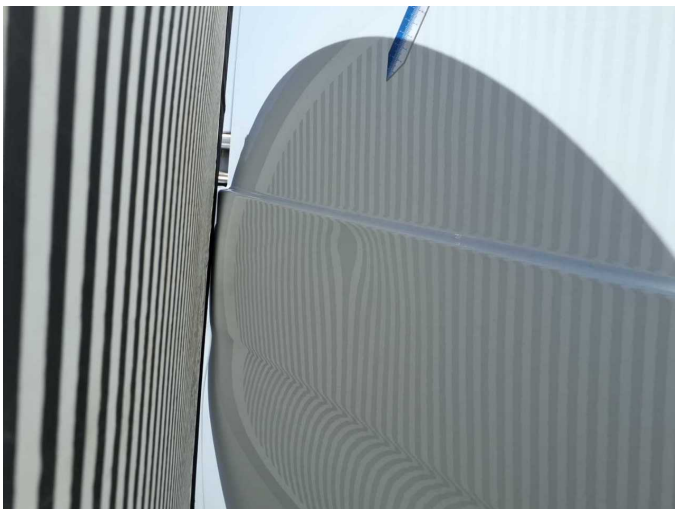
Damage 3: Sliding door, right: Sliding door - Deformed - Smart repair

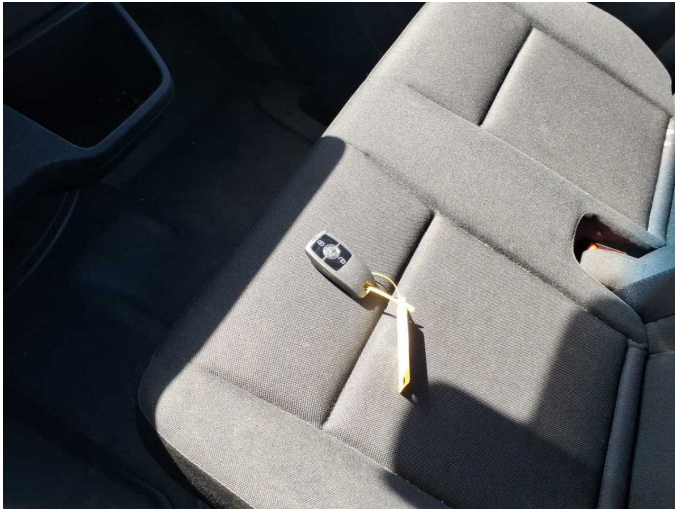
Missing part 2: Equipment: Vehicle key - Missing - Replace

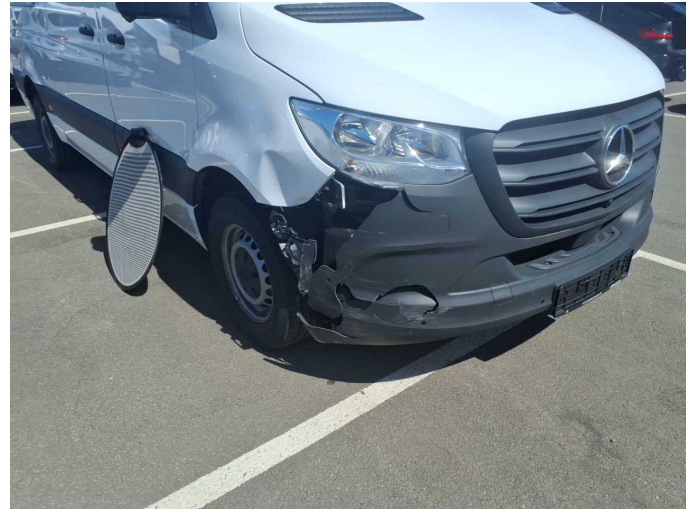
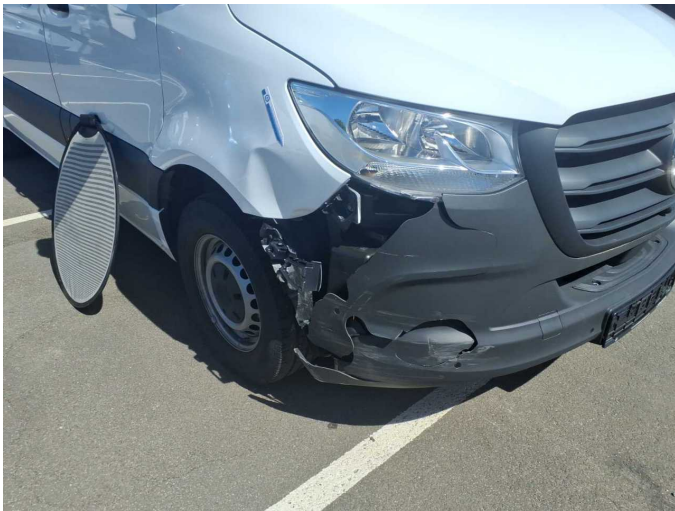
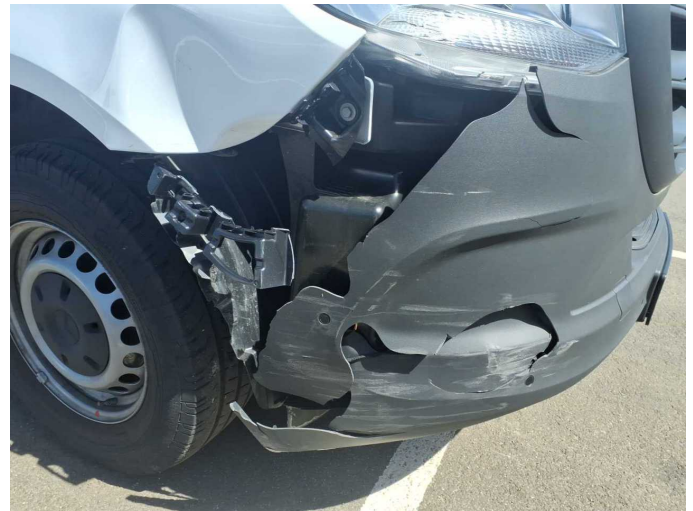
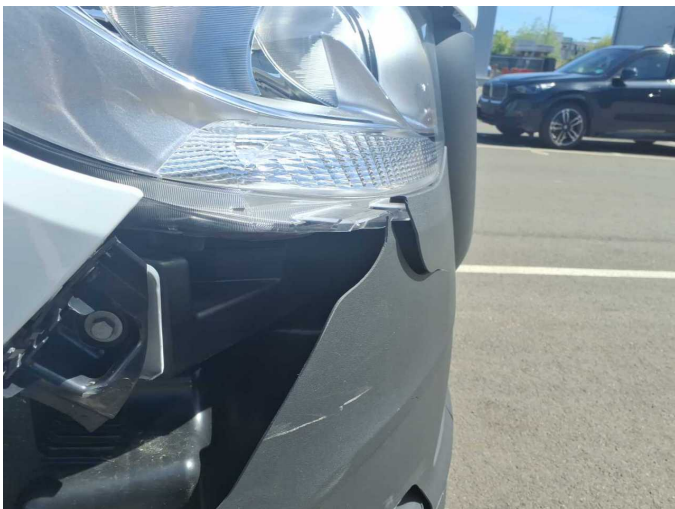
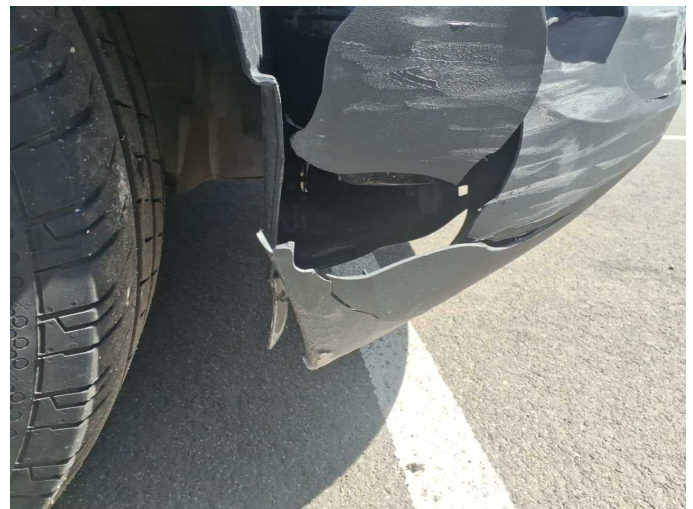
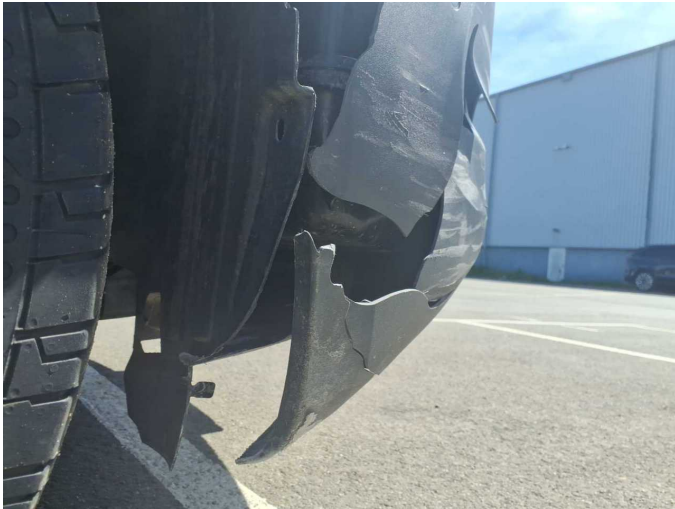
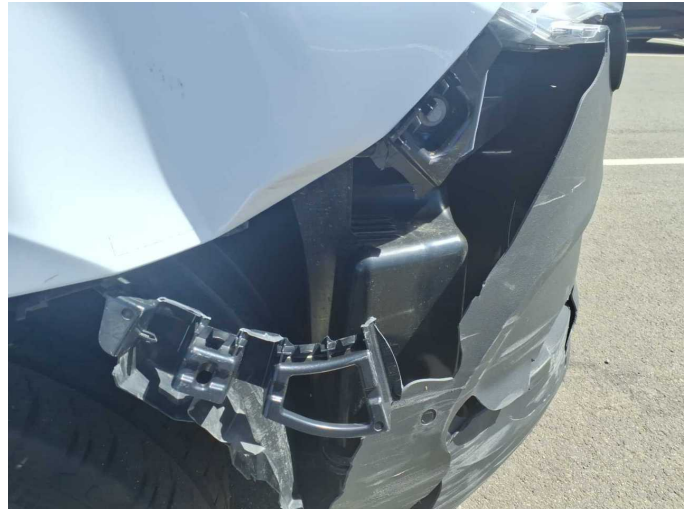
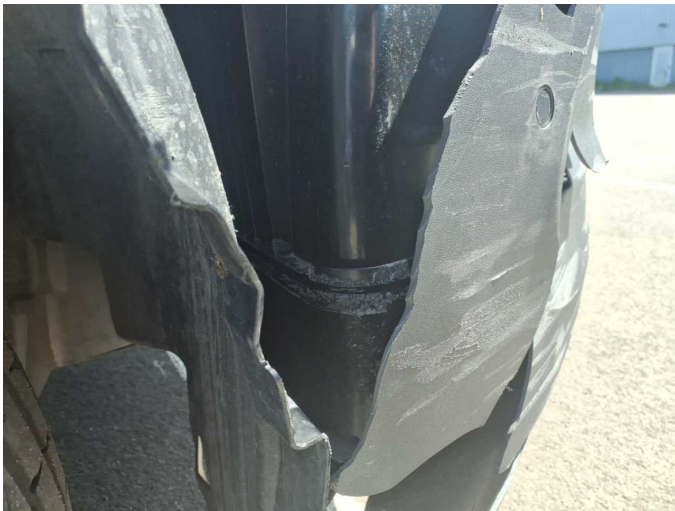
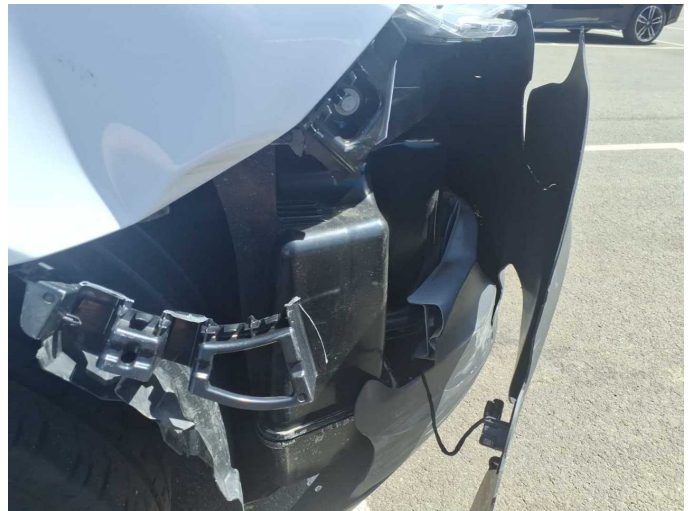
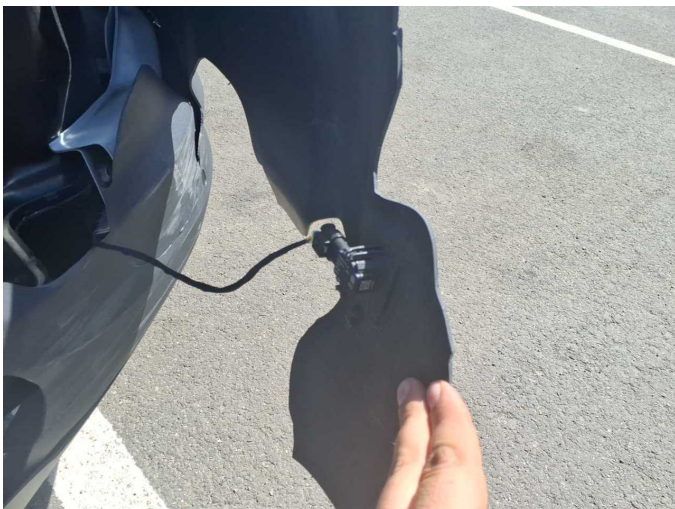
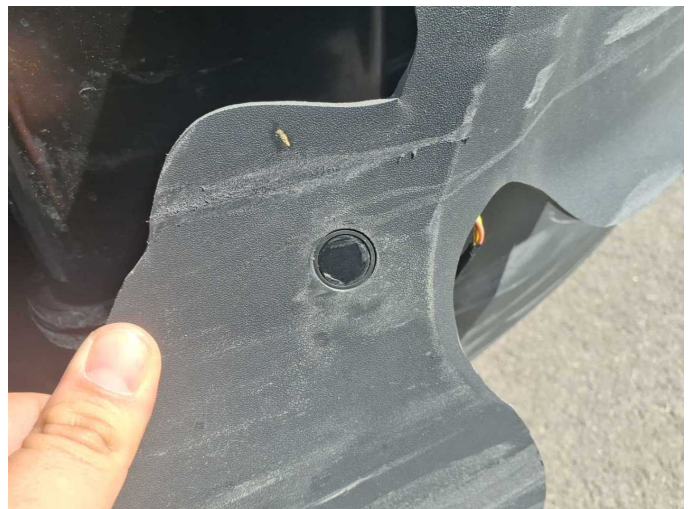
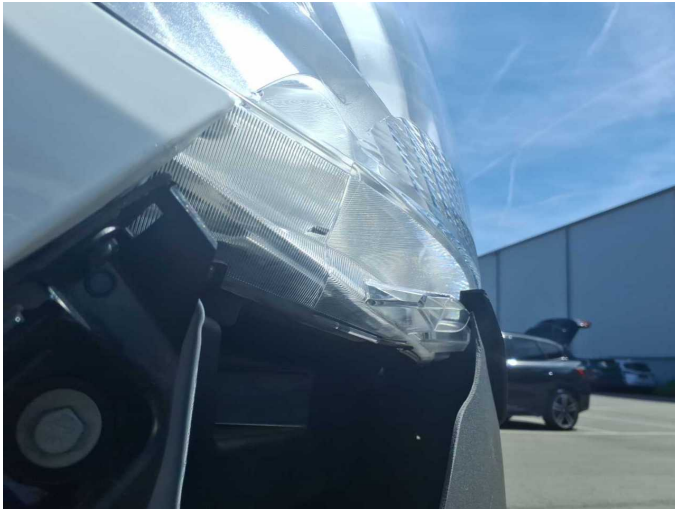
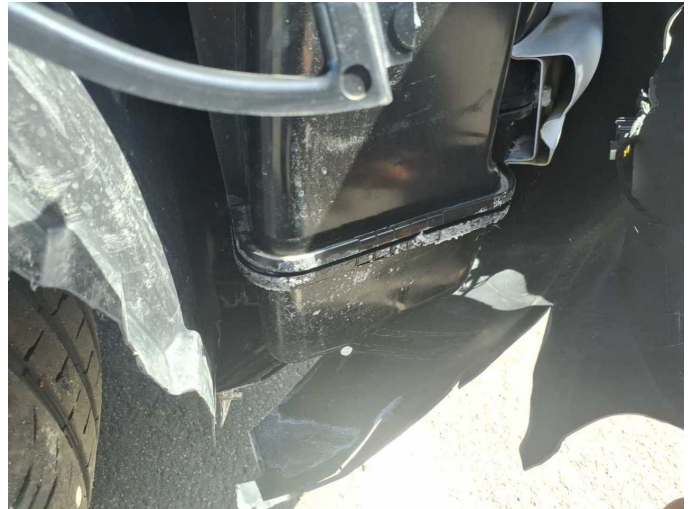
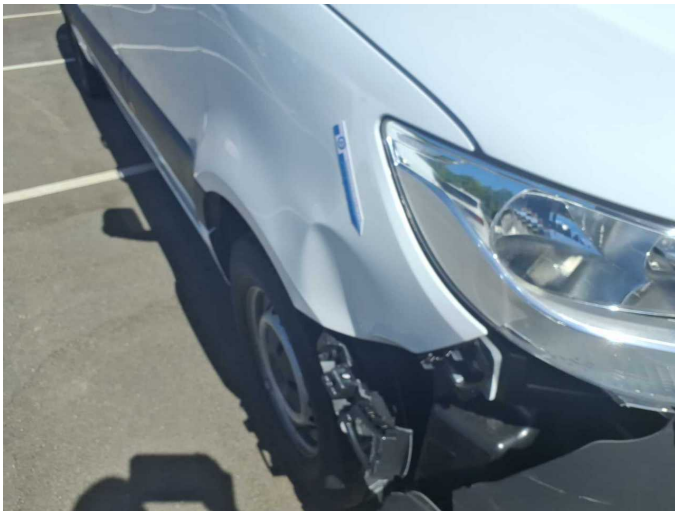
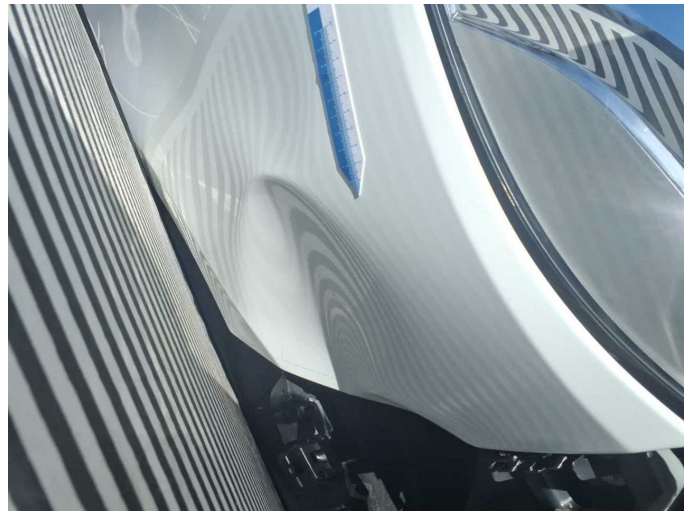
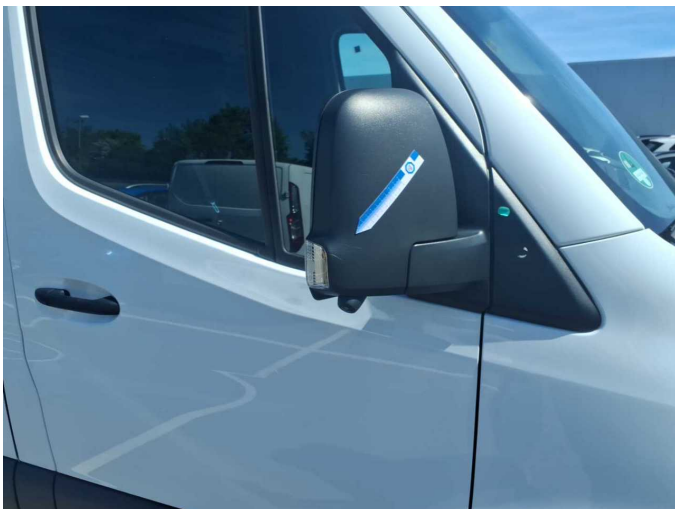
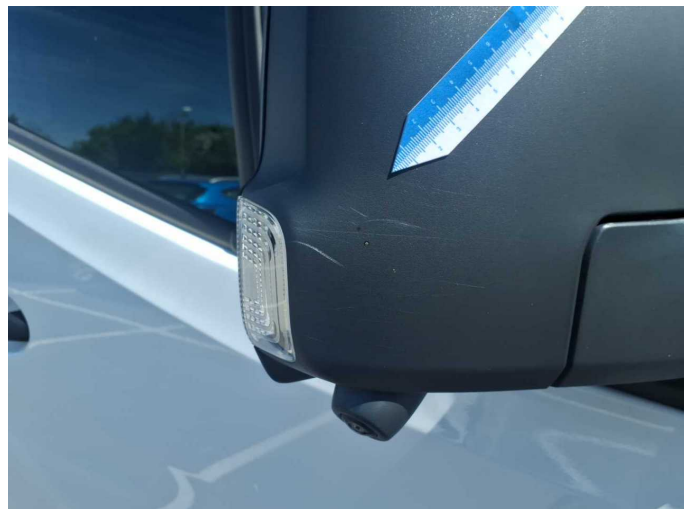
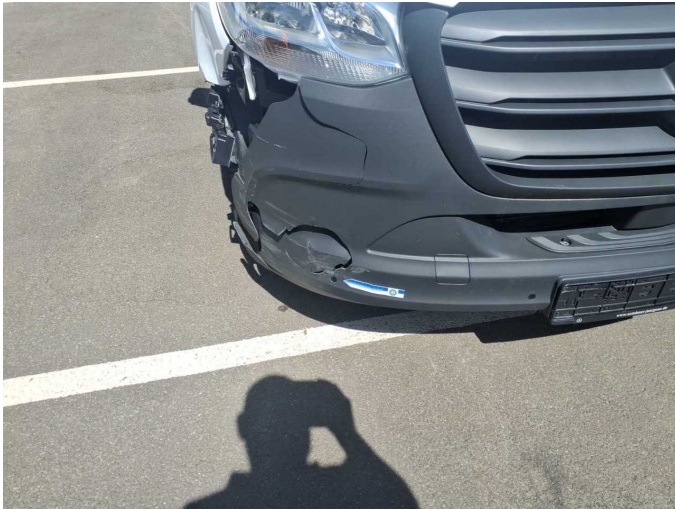
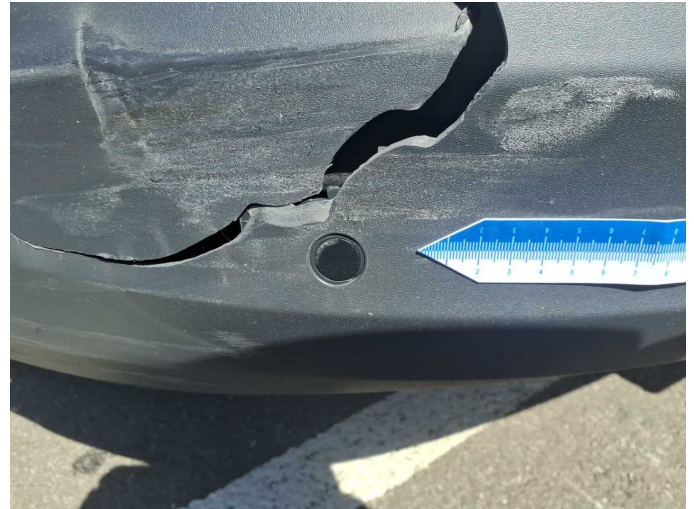
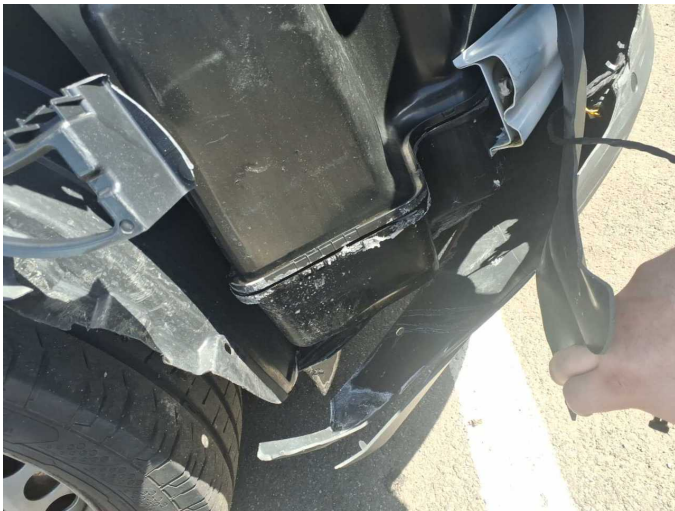
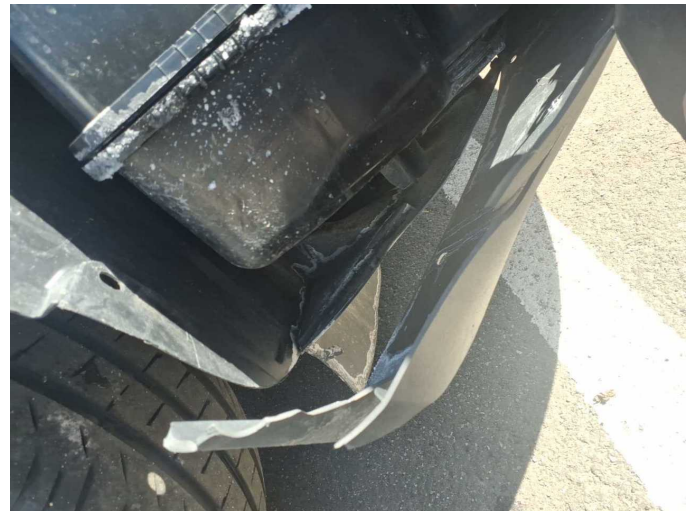
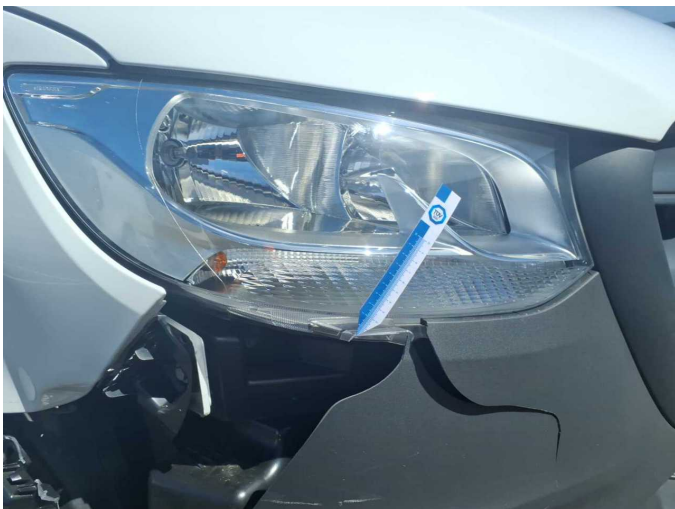
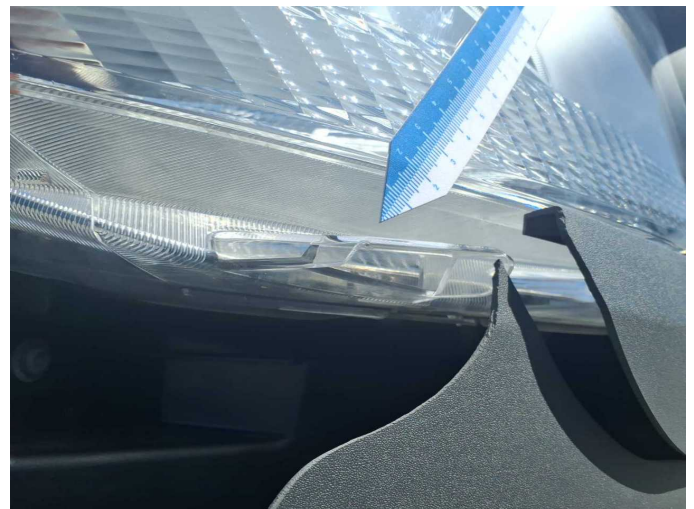
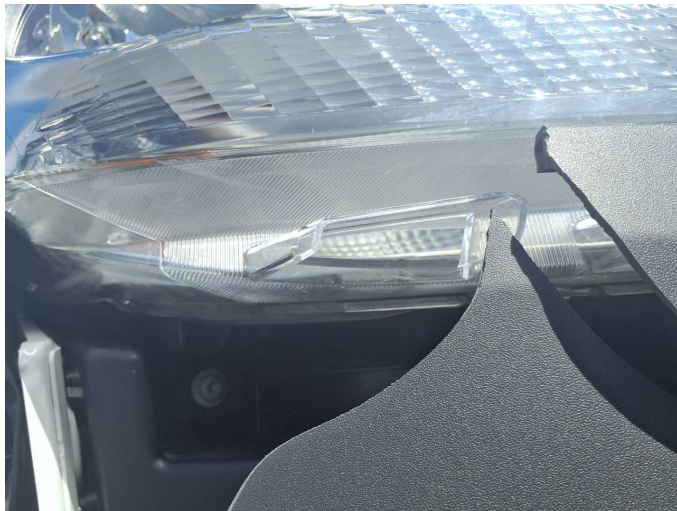
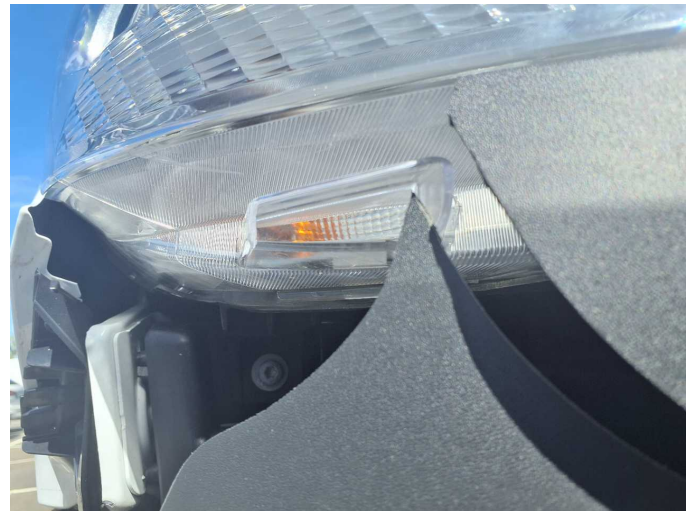
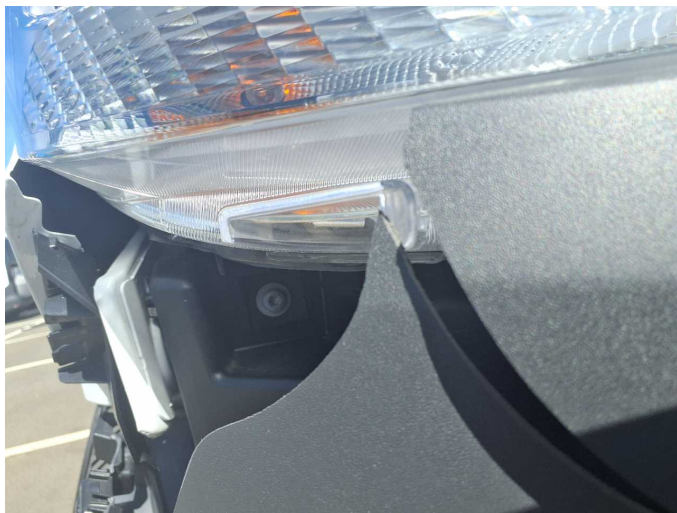
- 1 Front, Side right

Non-repaired previous damages were found at the vehicle. The necessary repair costs are listed in the expert report or if necessary, are listed in detail in a separately enclosed repair cost calculation.

Accident 1: Front, Side right
