Expertise

Protocol number: 46554359  
Order No. / Reference: 26547186  
Inspection date: 16 Jul 2026

Manufacturer: Skoda  
VIN: TMBJJ8NX2PY115555

Model: Octavia Combi 2.0 TDI DSG Style

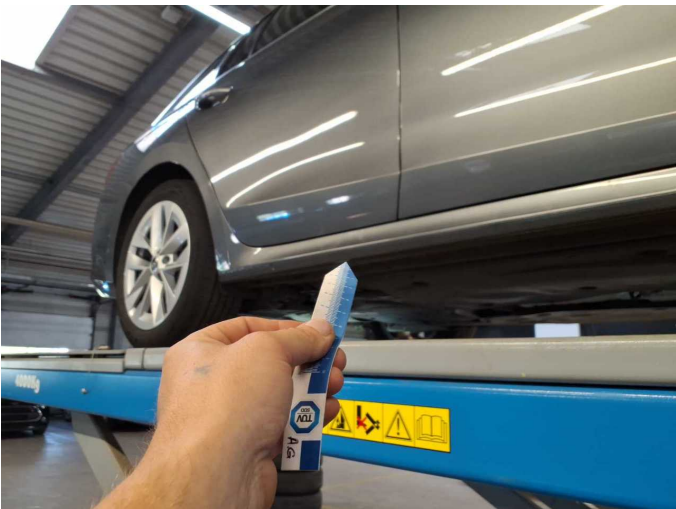
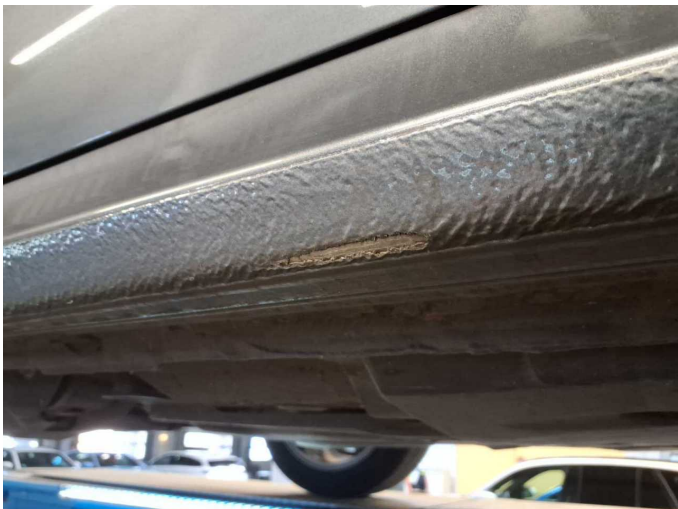
| No. | Component group | Description |
|---|---|---|
| 1 | Sill - right side | Sill - Paint defect - Smart repair |

Damage 1: Sill - right side: Sill - Paint defect - Smart repair

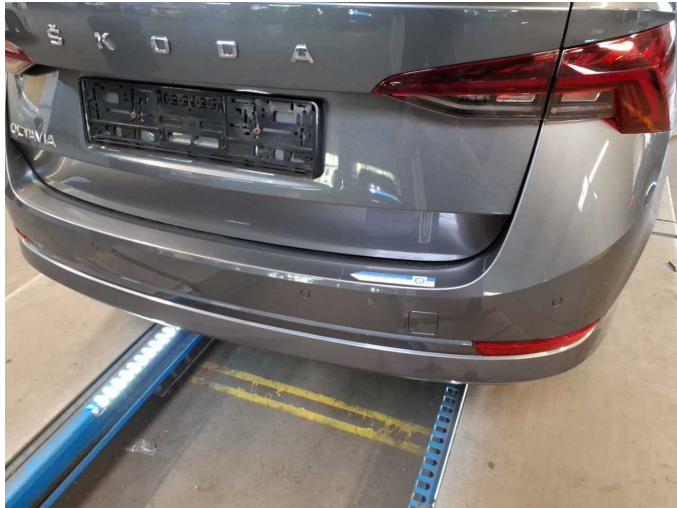
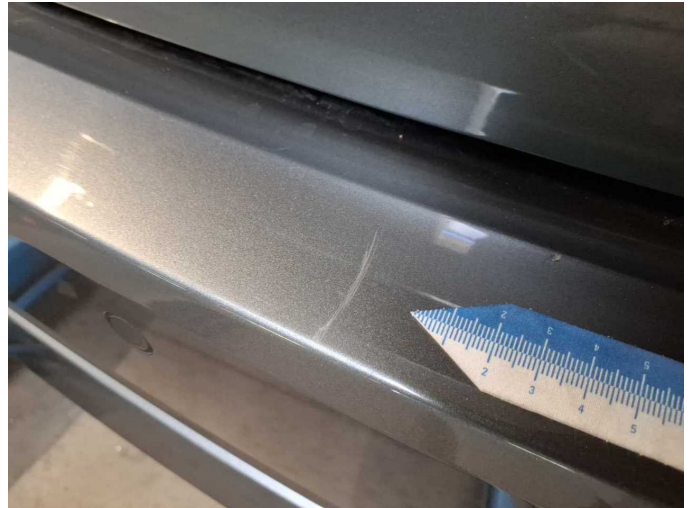
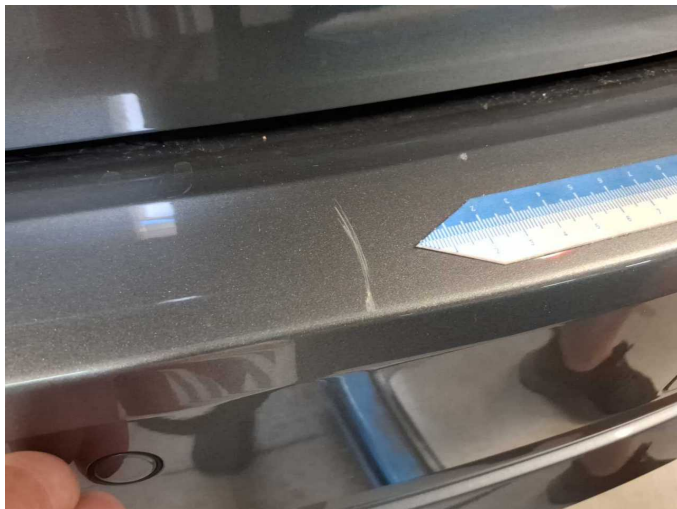
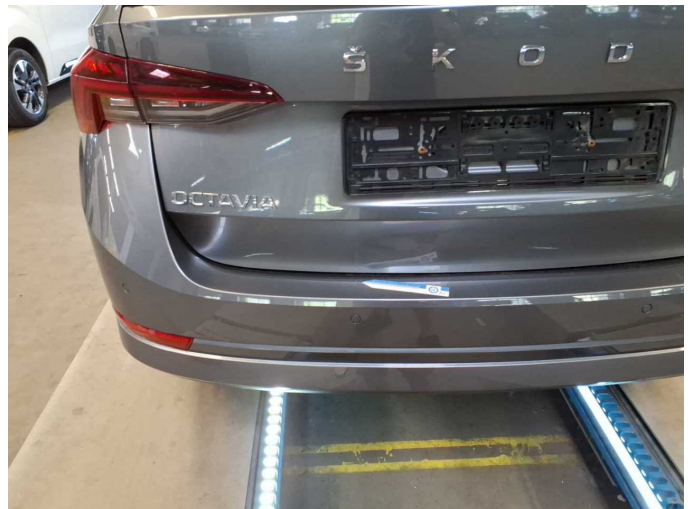
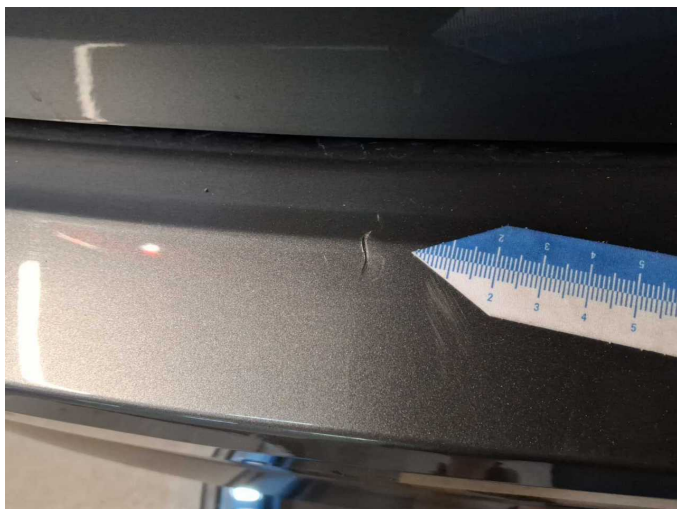
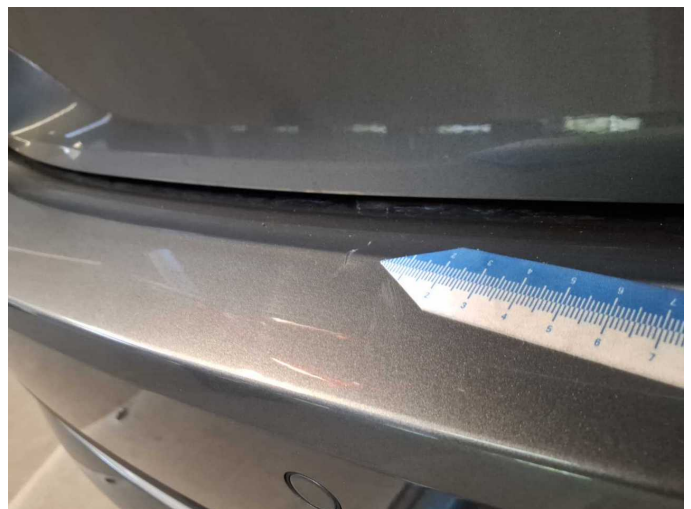
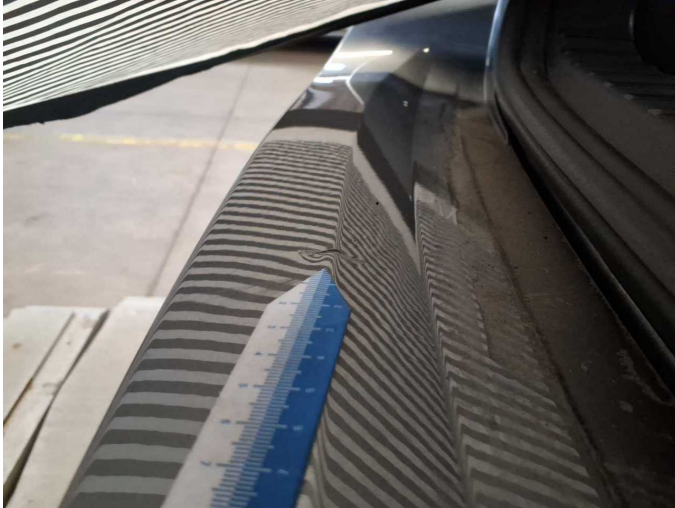
| No. | Component group | Description |
|---|---|---|
| 3 | Rear bumper | Rear bumper (Verformt) - Scratched - Repair and paint |

**Damage 3:** Rear bumper: Rear bumper (Verformt) - Scratched - Repair and paint

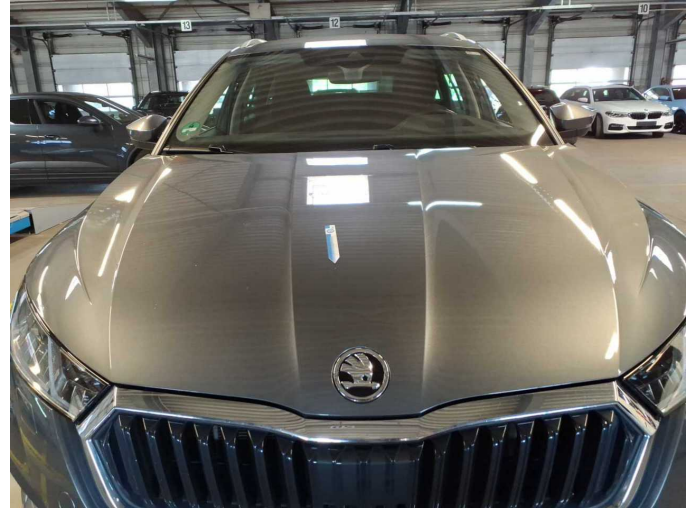
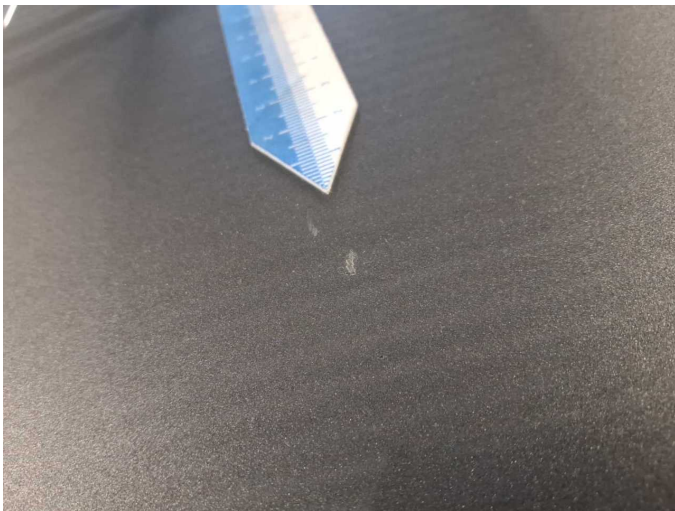
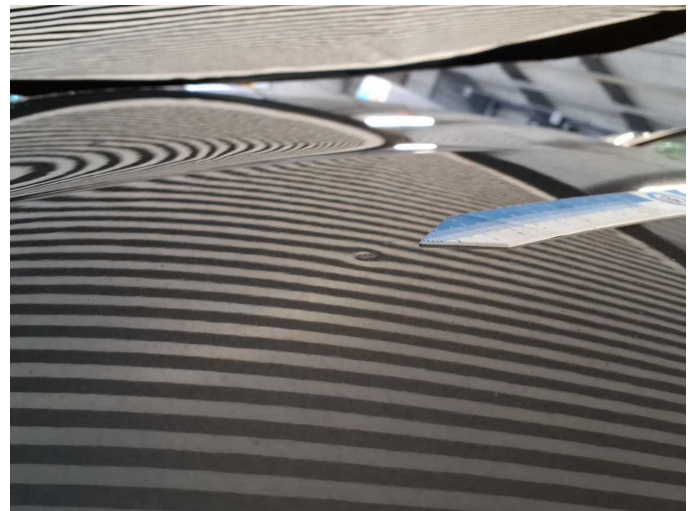
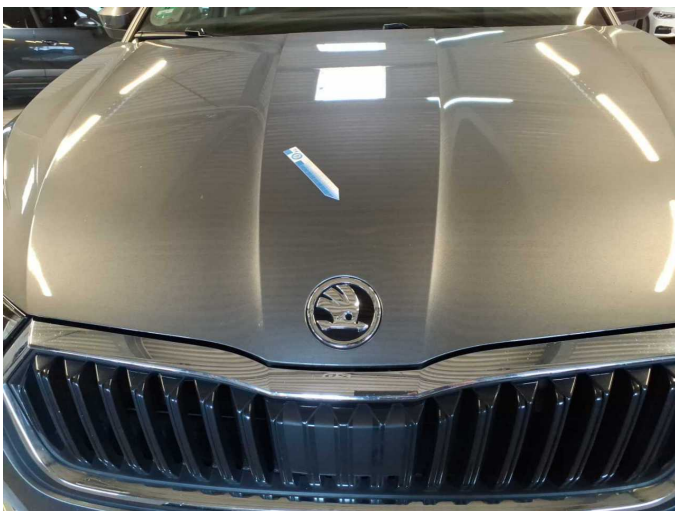
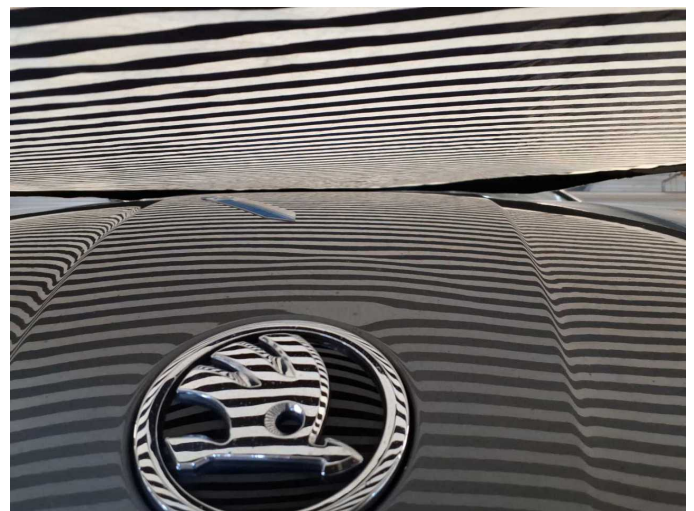
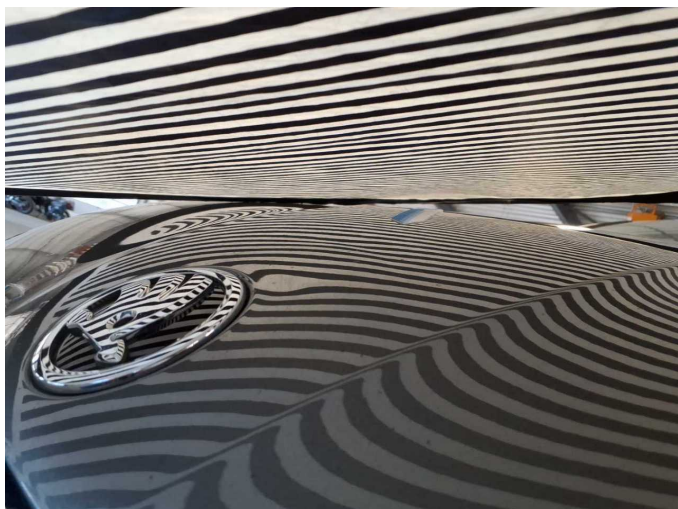
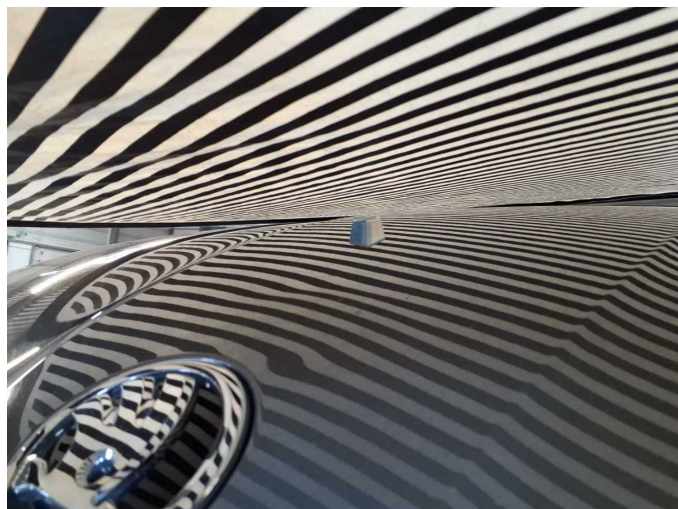
| No. | Component group | Description |
|---|---|---|
| 4 | Bonnet | Bonnet (Verformt) - Dent / paintcoat damage - Repair and paint |

**Damage 4:** Bonnet: Bonnet (Verformt) - Dent / paintcoat damage - Repair and paint

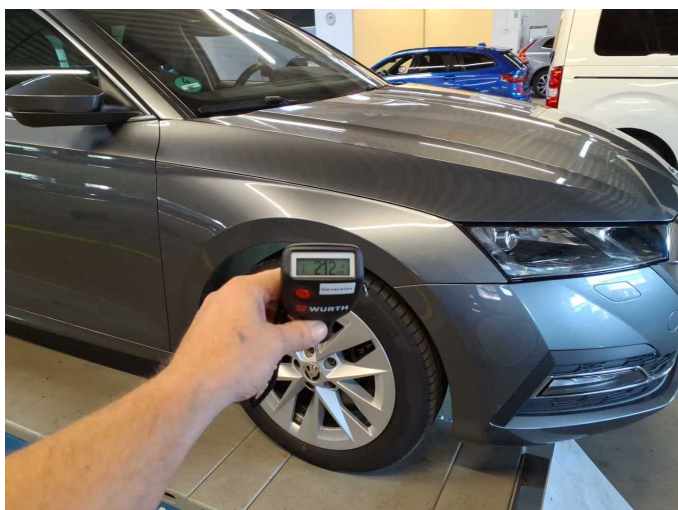
**Repainting 1:** Mudguard - right side

| No. | Repainting |
|---|---|
| 1 | Mudguard - right side, Professionally carried out, Invoice of repair done Non-existent |

| Mudguard - right side | 212 µm | Side panel - rear left side | 161 µm |

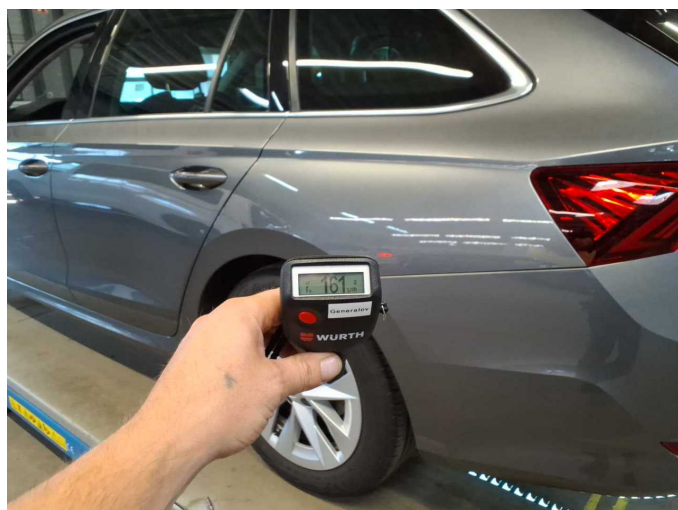
**Repainting 2:** Side panel - rear left side

| No. | Repainting |
|---|---|
| 2 | Side panel - rear left side, Professionally carried out, Invoice of repair done Non-existent |
