Expertise

Protocol number: 46065653  
Order No. / Reference: 26616983  
Inspection date: 22 Jun 2026

Manufacturer: Ford

Model: Focus Turnier 1.5 EcoBlue Start-Stopp-System Aut. TITANIUM

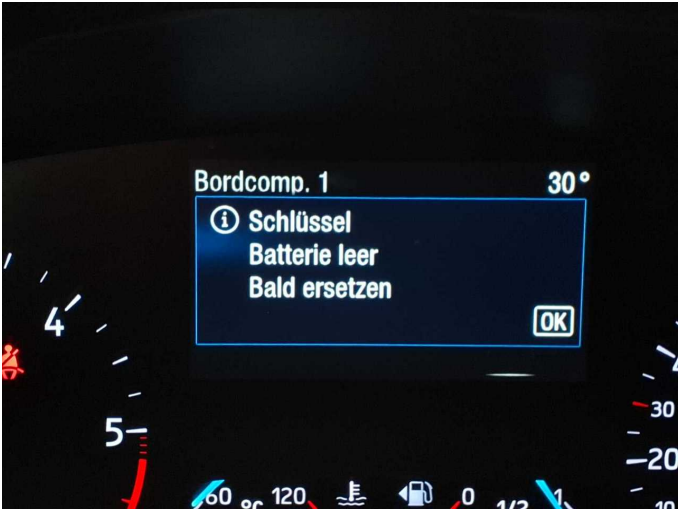
| No. | Component group | Description |
|---|---|---|
| 2 | Equipment | Vehicle key with remote control (Batterie) - Due - Replace |

Damage 2: Equipment: Vehicle key with remote control (Batterie) - Due - Replace

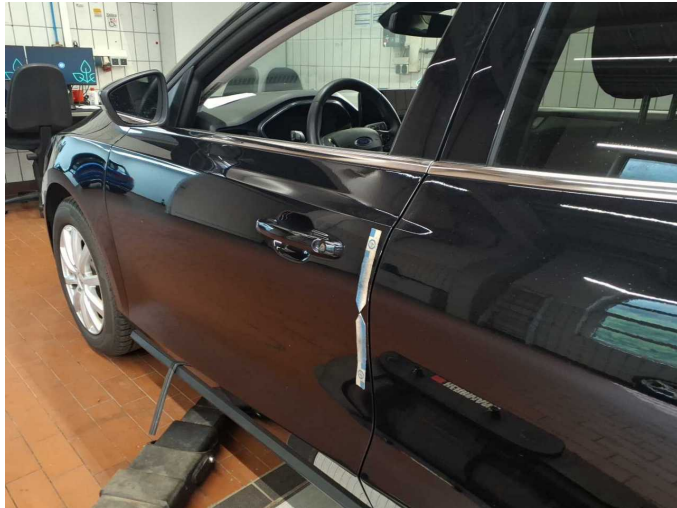
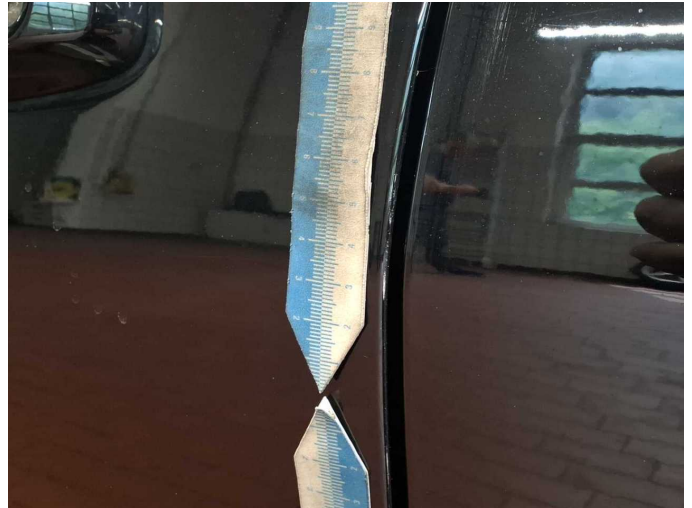
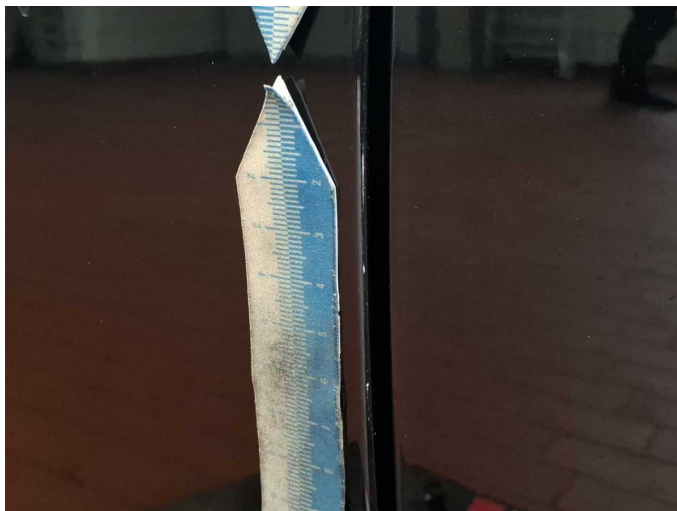
| No. | Component group | Description |
|---|---|---|
| 3 | Door - front left side | Door edge - Scratch(es) - Smart repair |

**Damage 3:** Door - front left side: Door edge - Scratch(es) - Smart repair

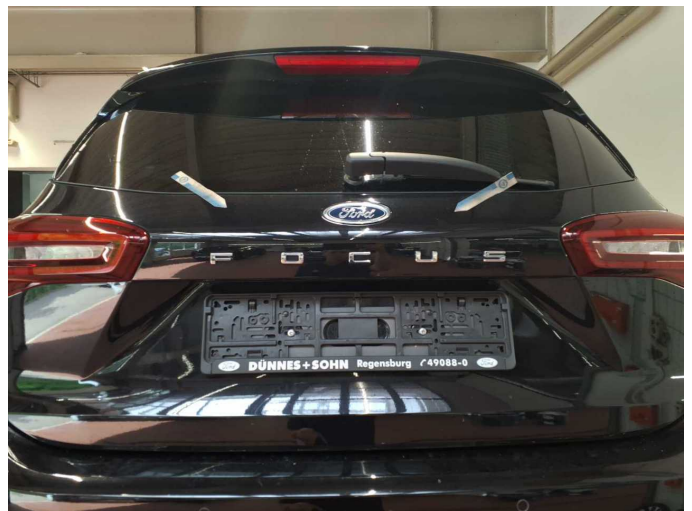
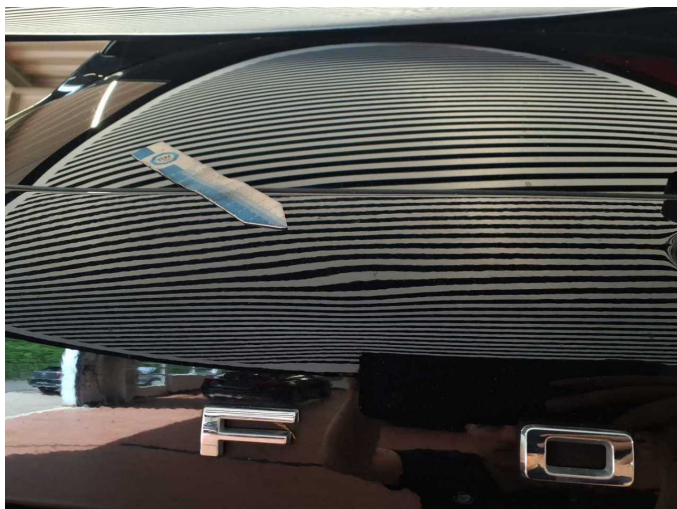
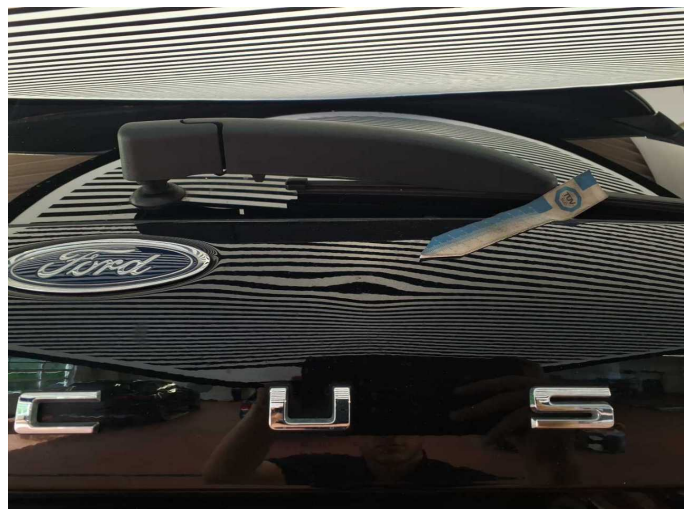
| No. | Component group | Description |
|---|---|---|
| 4 | Boot lid / rear door | Boot lid - dent(s) - Smart repair |

**Damage 4:** Boot lid / rear door: Boot lid - dent(s) - Smart repair

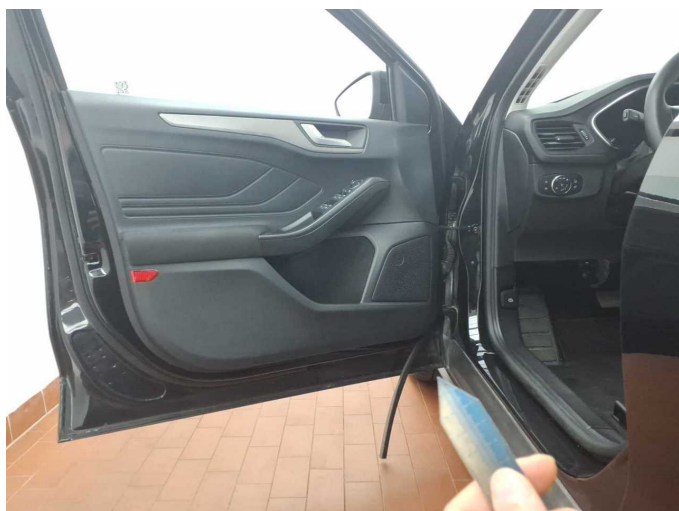
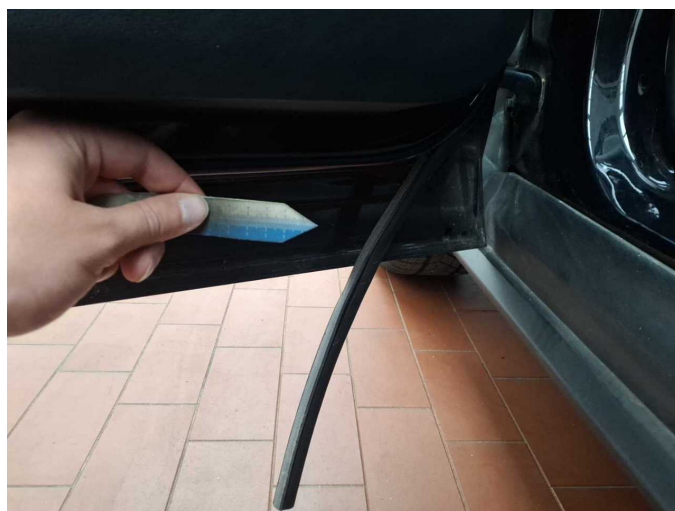
| No. | Component group | Description |
|---|---|---|
| 5 | Cab | Door rubber seal - left side (Tür vorne links) - Loose - Replace |

**Damage 5:** Cab: Door rubber seal - left side (Tür vorne links) - Loose - Replace

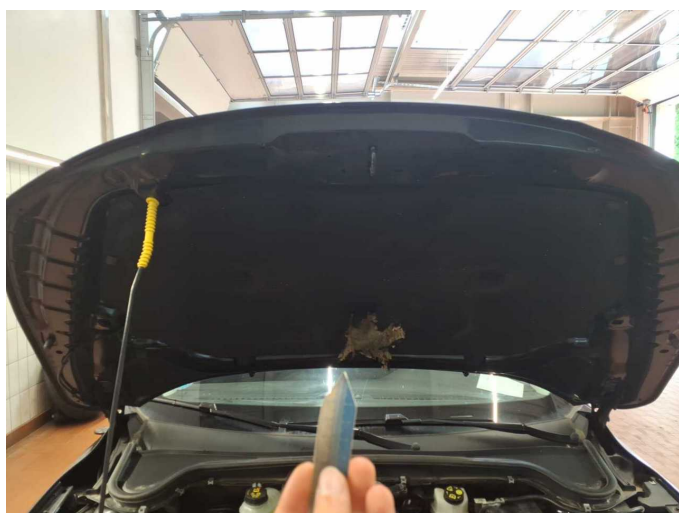
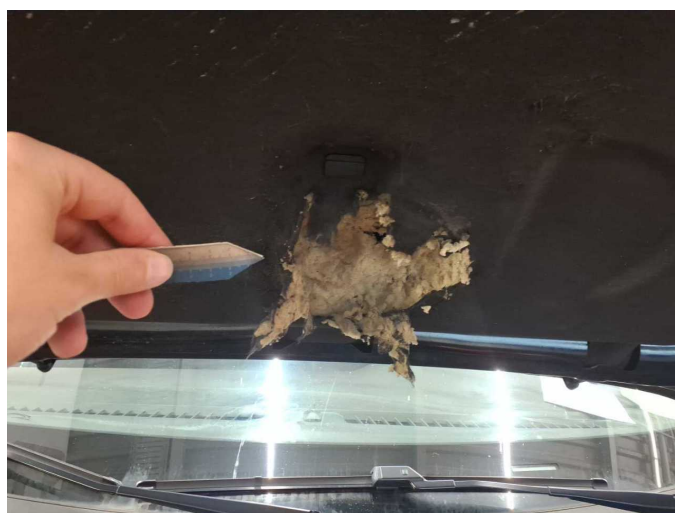
| No. | Component group | Description |
|---|---|---|
| 6 | Bonnet | Insulation lining - Damage caused by marten / rodent - Replace |

**Damage 6:** Bonnet: Insulation lining - Damage caused by marten / rodent - Replace

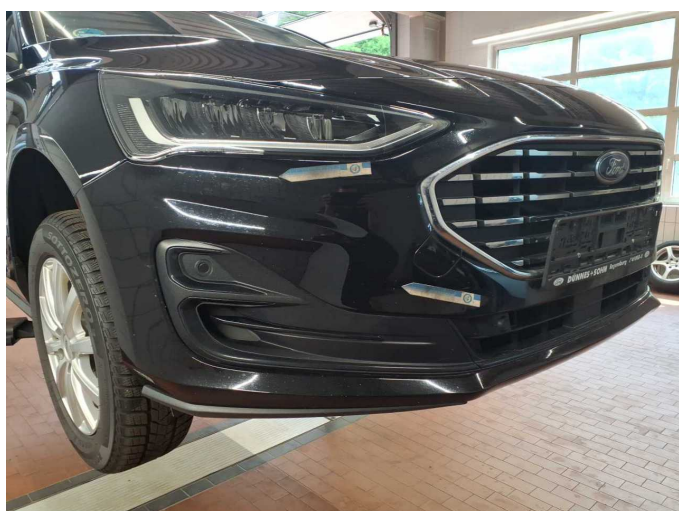
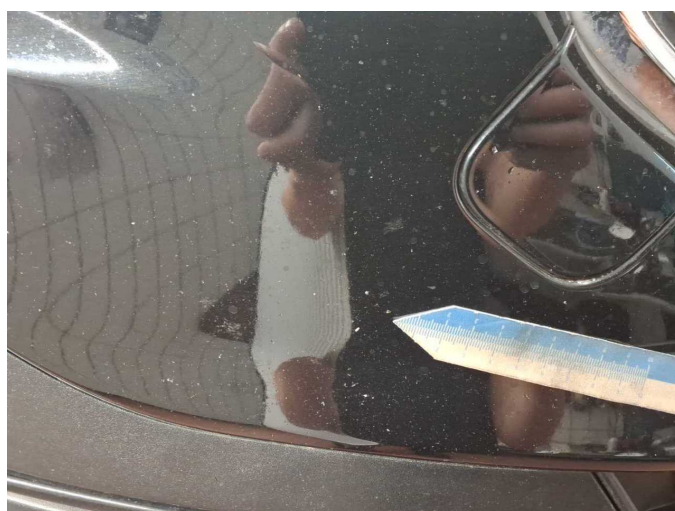
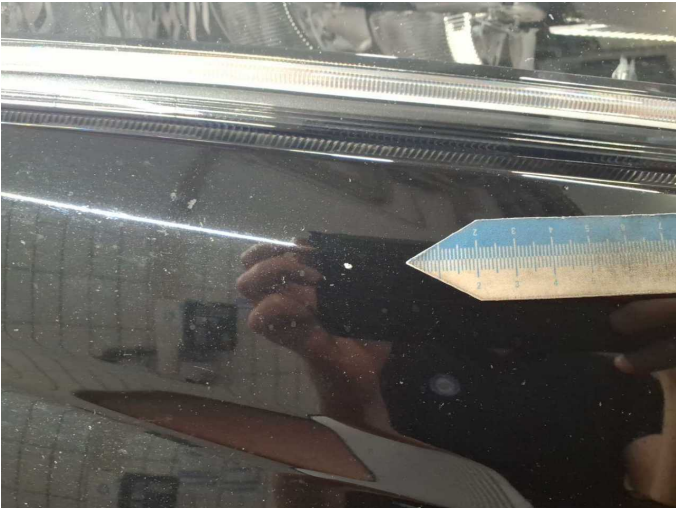
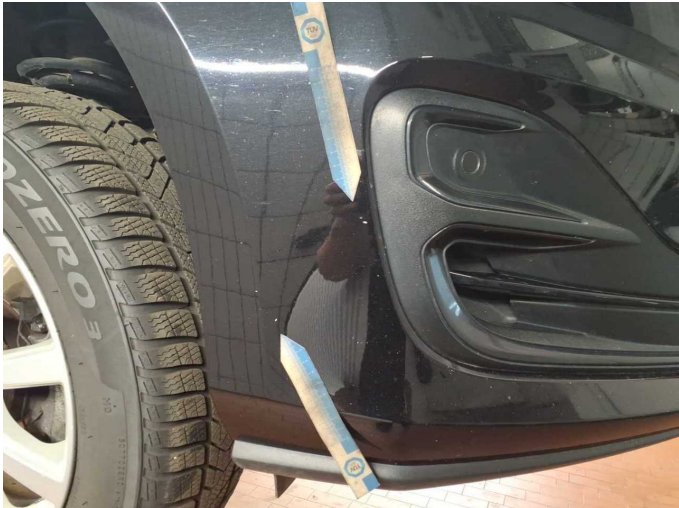
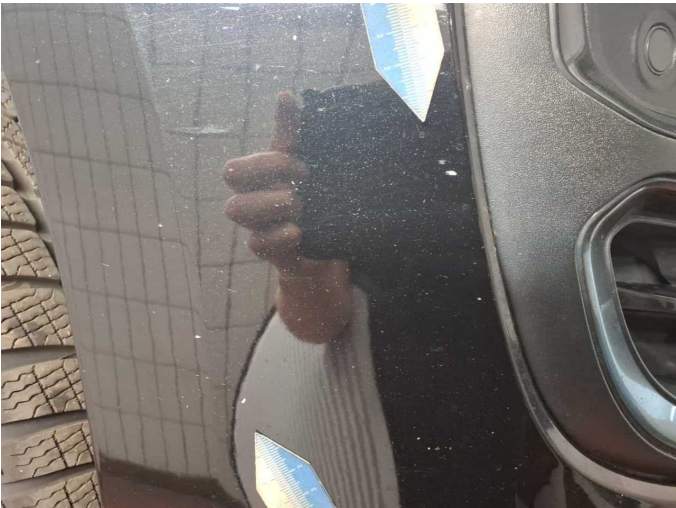
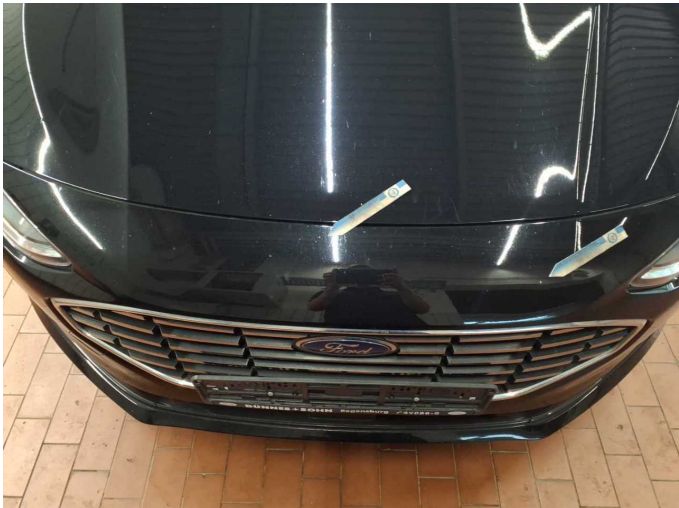
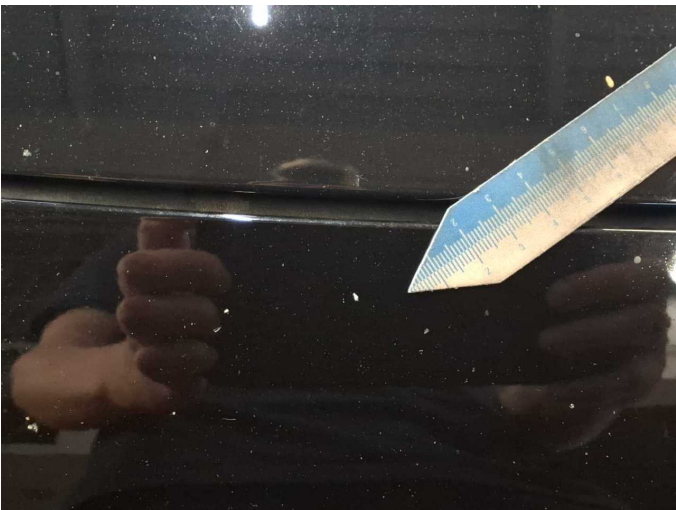
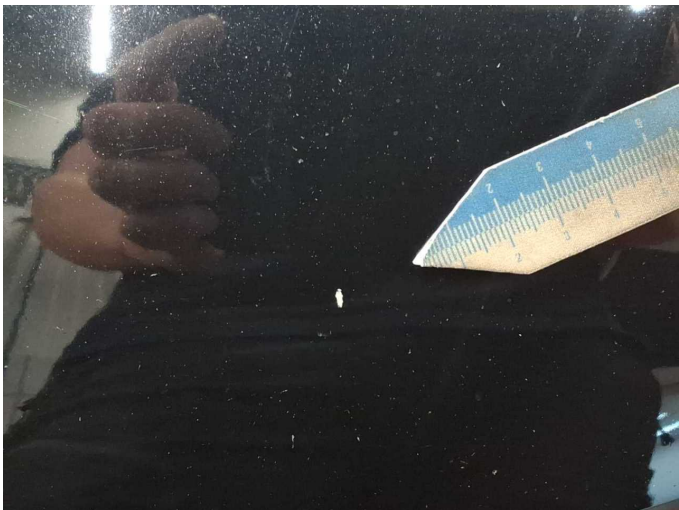
| No. | Component group | Description |
|---|---|---|
| 7 | Front bumper | Front bumper - Stone chips - Paint |

**Damage 7:** Front bumper: Front bumper - Stone chips - Paint

Damage 7: Front bumper: Front bumper - Stone chips - Paint

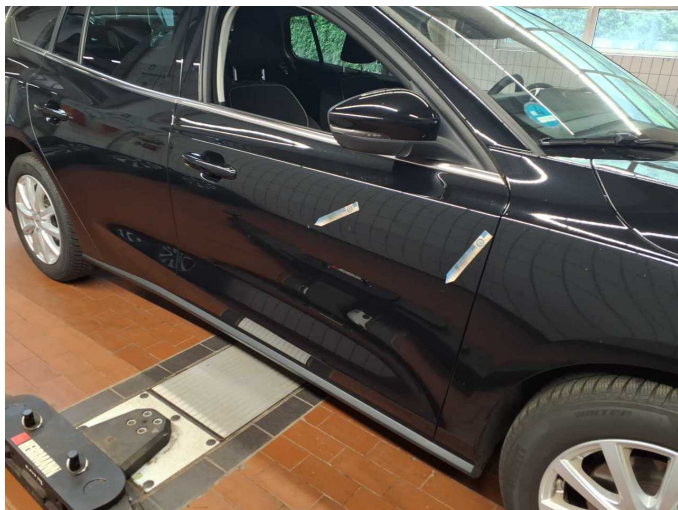
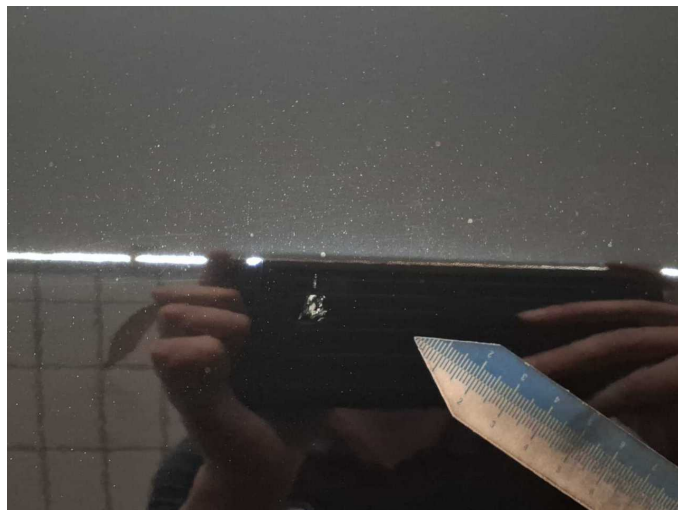
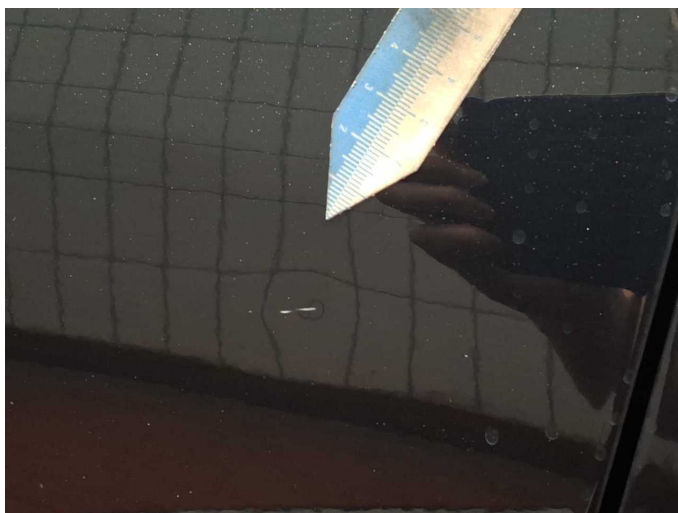
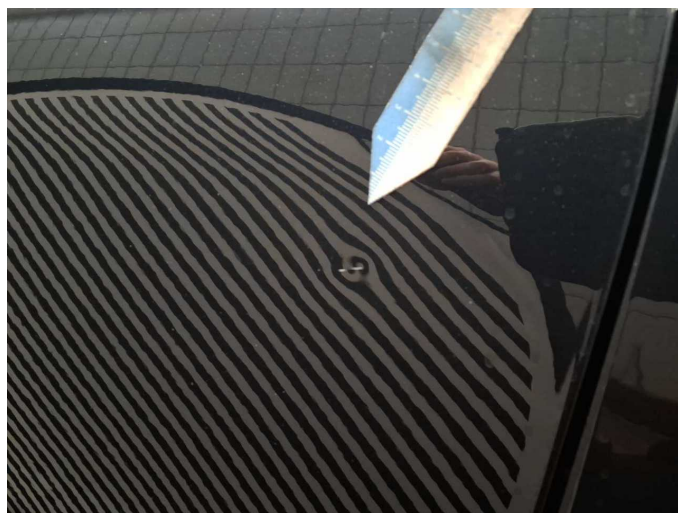
| No. | Component group | Description |
|---|---|---|
| 8 | Door - front right side | Door - Dent / paintcoat damage - Repair and paint |

**Damage 8:** Door - front right side: Door - Dent / paintcoat damage - Repair and paint

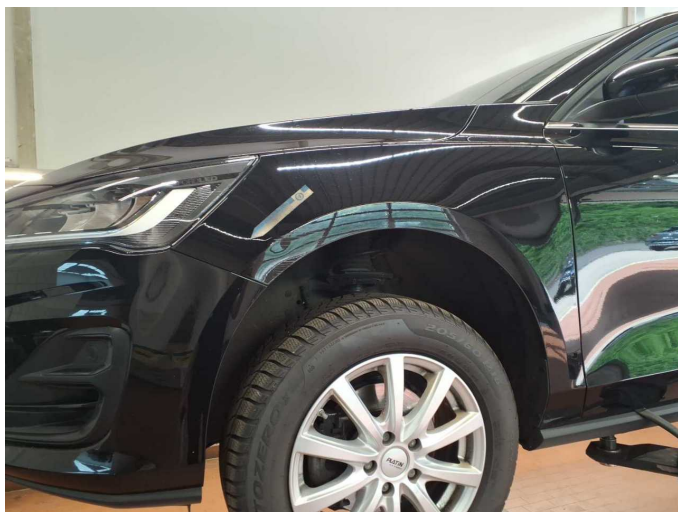
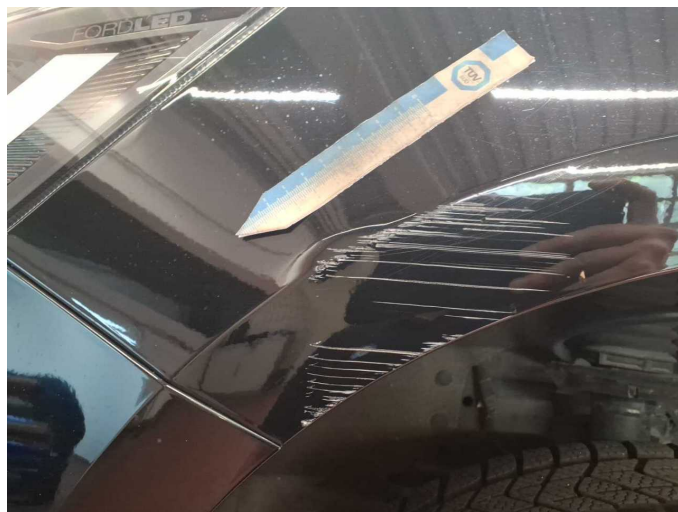
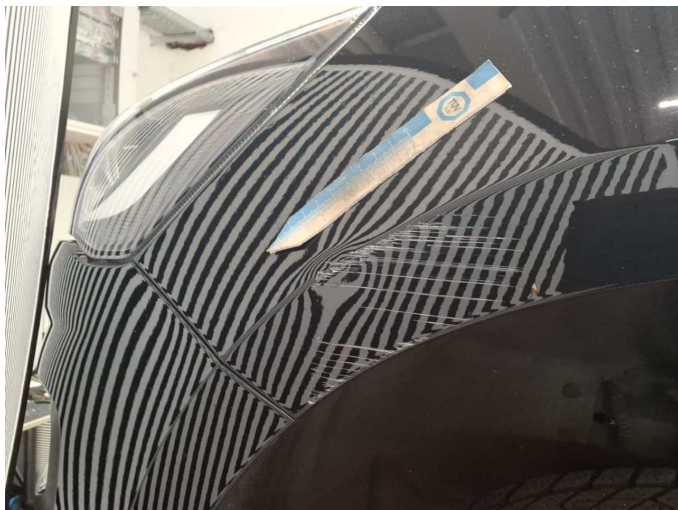
| No. | Component group | Description |
|---|---|---|
| 9 | Mudguard - left side | Mudguard - left side - Dent / paintcoat damage - Repair and paint |

**Damage 9:** Mudguard - left side: Mudguard - left side - Dent / paintcoat damage - Repair and paint

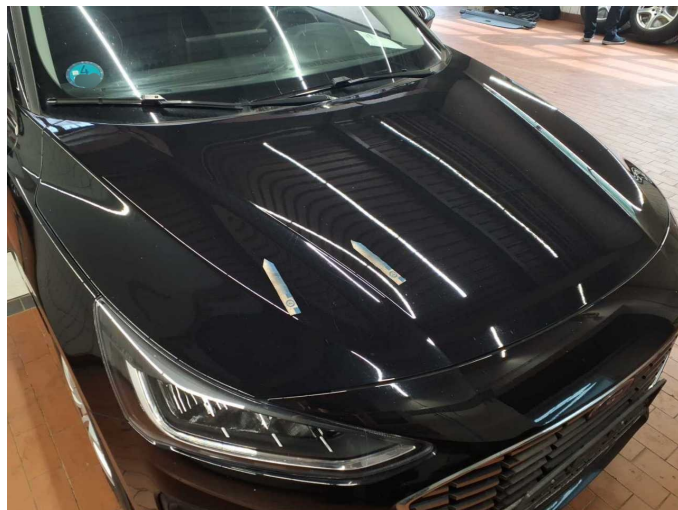
| No. | Component group | Description |
|---|---|---|
| 1 | Bonnet | Bonnet - Scratch(es) - No deduction |

**Wear and tear 1:** Bonnet: Bonnet - Scratch(es) - No deduction

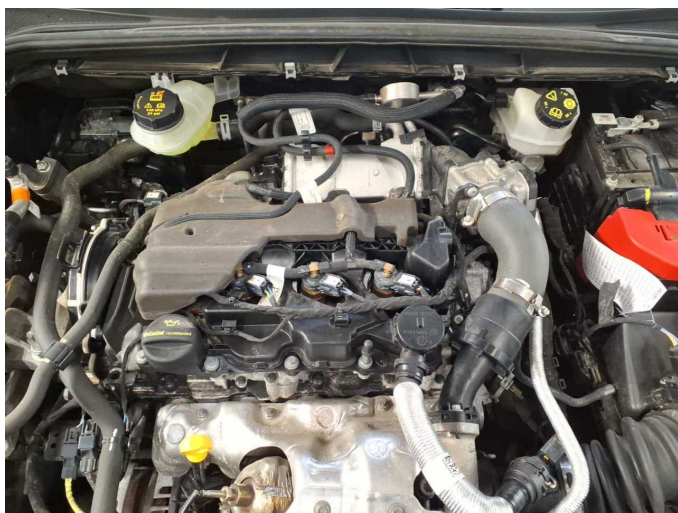
Engine - Engine cover

**Missing part 1:** Engine: Engine cover - Missing - Replace

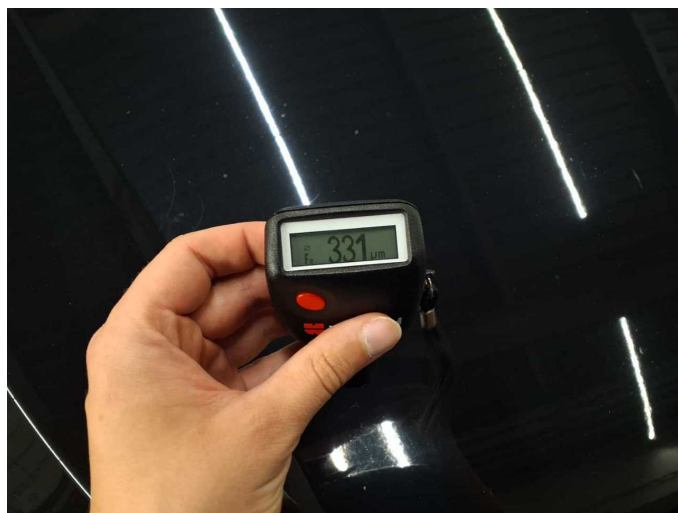
| 1 | Bonnet, Professionally carried out, Invoice of repair done Non-existent |

| Bonnet | 331 $\mu\text{m}$ |

Fahrzeug weist erhöhte Lackwerte auf.

**Repainting 1:** Bonnet
