Expertise

Protocol number: 46745500  
Order No. / Reference: 26734311  
Inspection date: 28 Jul 2026

Manufacturer: Peugeot

Model: Rifter BlueHDI 130 L1 Allure

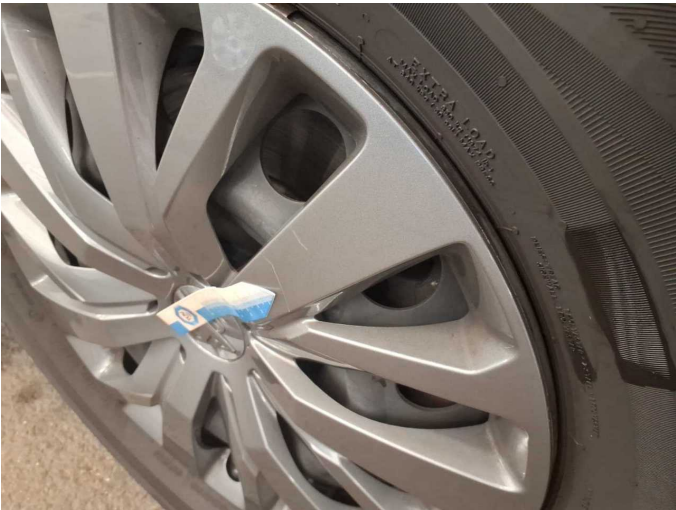
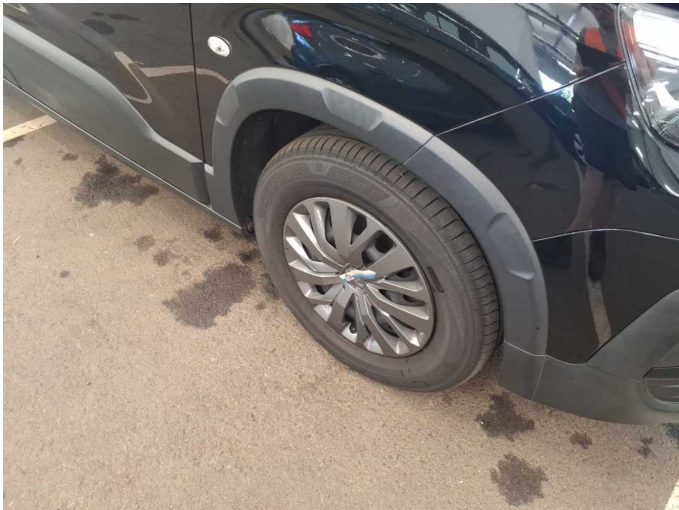
| No. | Component group | Description |
|---|---|---|
| 3 | Wheel / tyres | Wheel cover - front right side - Scratch(es) - Replace |

Damage 3: Wheel / tyres: Wheel cover - front right side - Scratch(es) - Replace

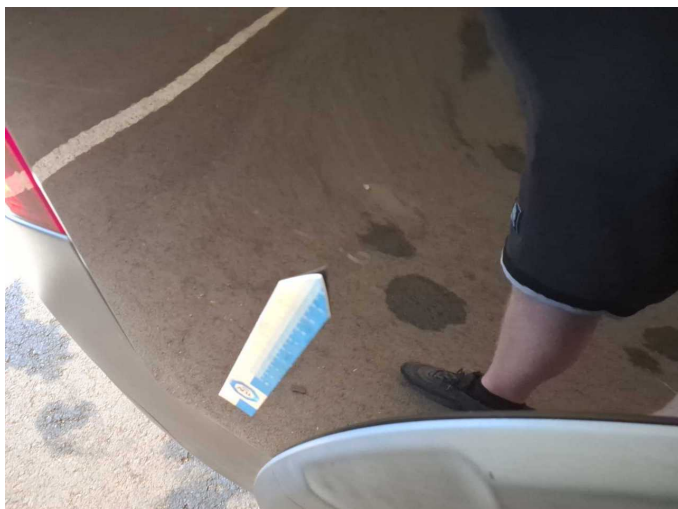
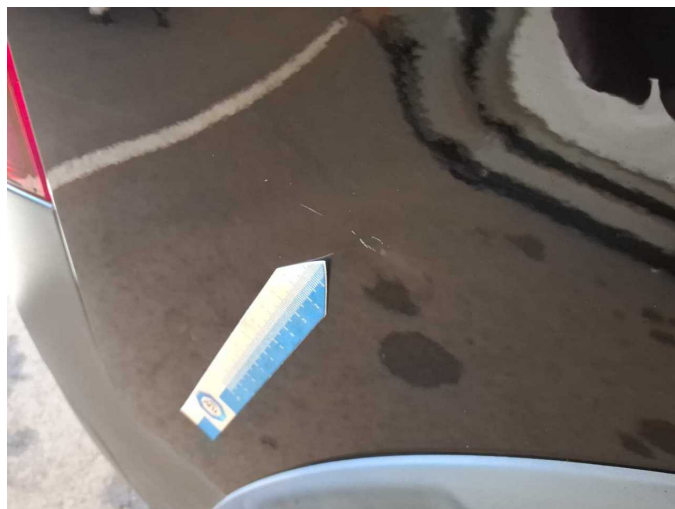
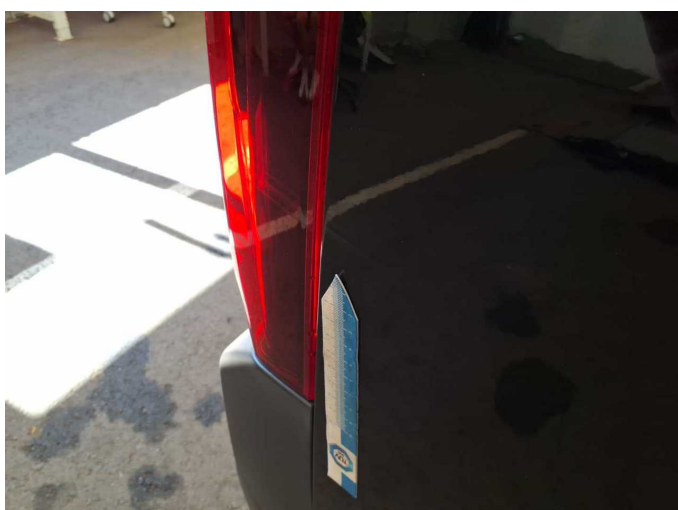
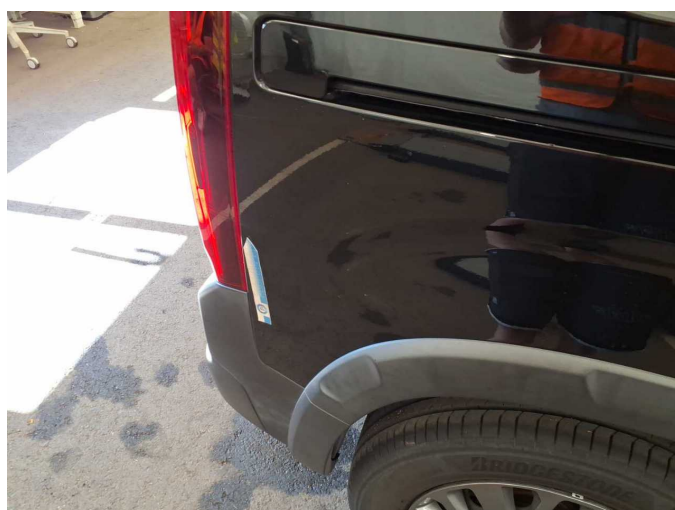
| No. | Component group | Description |
|---|---|---|
| 4 | Side panel - rear right side | Side panel - Scratch(es) - Paint |

**Damage 4:** Side panel - rear right side: Side panel - Scratch(es) - Paint

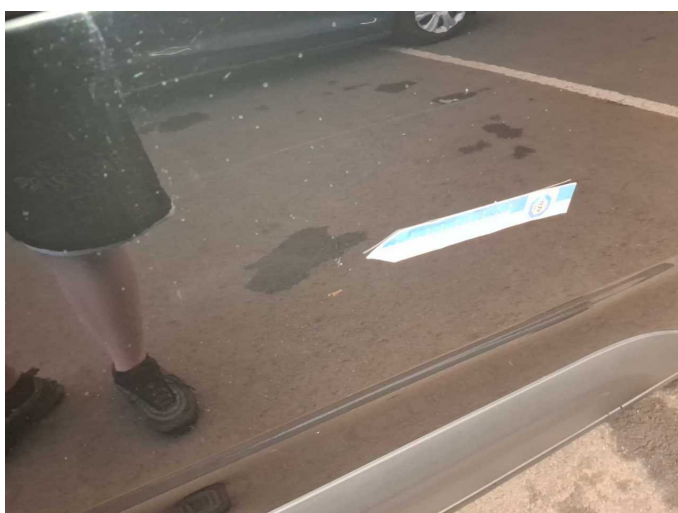
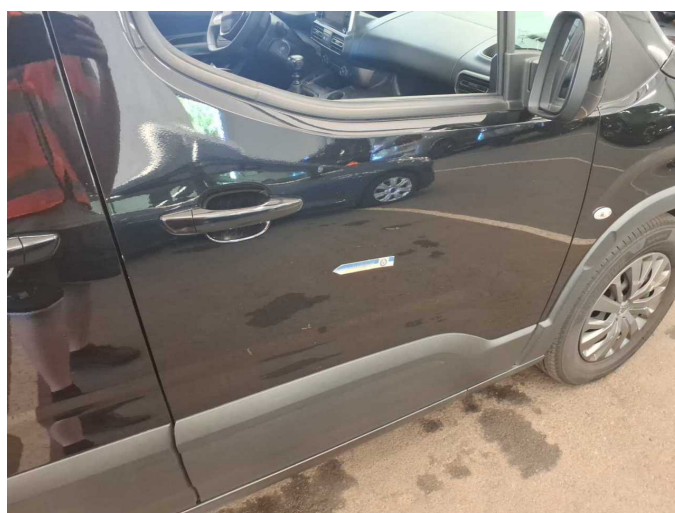
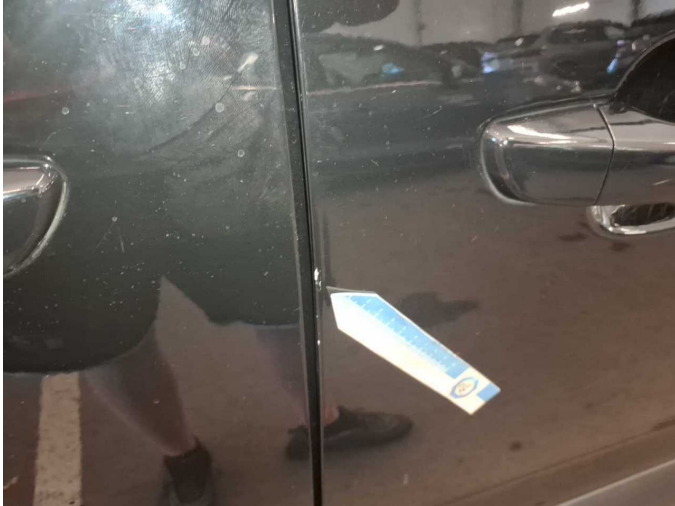
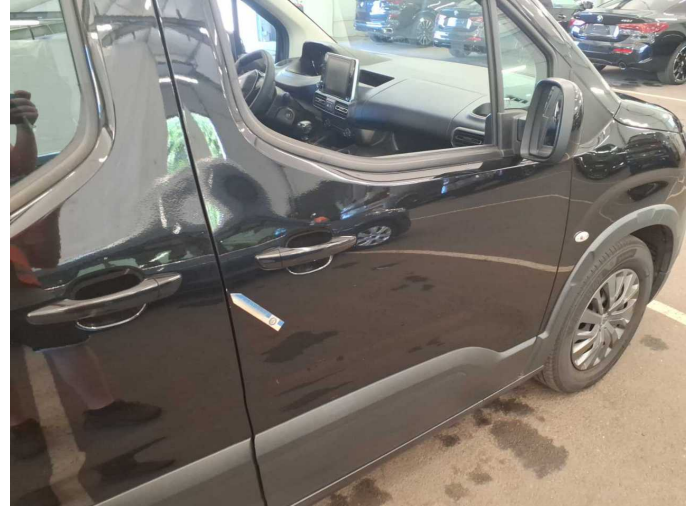
| No. | Component group | Description |
|---|---|---|
| 5 | Door - front right side | Door - Scratch(es) - Paint |

**Damage 5:** Door - front right side: Door - Scratch(es) - Paint

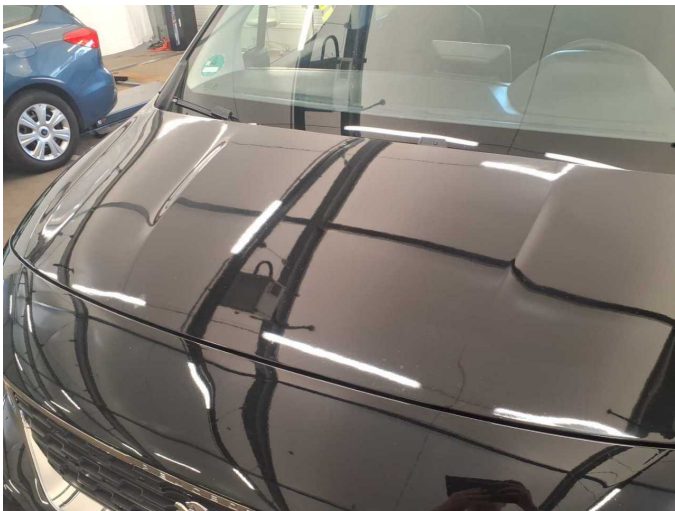
| No. | Component group | Description |
|---|---|---|
| 1 | Bonnet | Bonnet - Stone chips - No deduction |

**Wear and tear 1:** Bonnet: Bonnet - Stone chips - No deduction

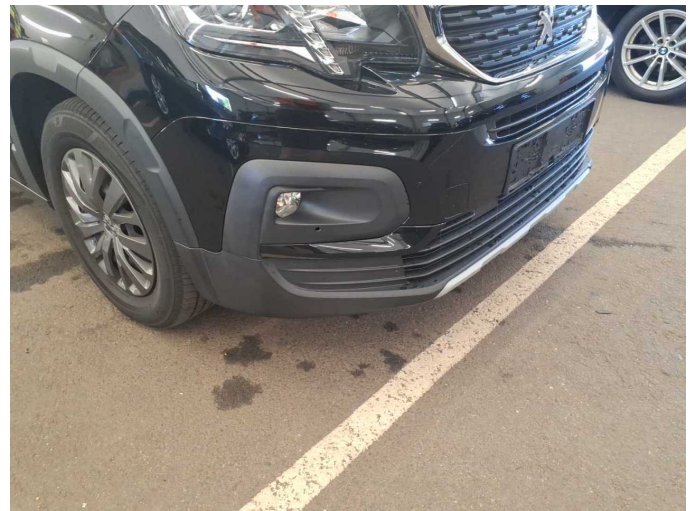
| No. | Component group | Description |
|---|---|---|
| 3 | Front bumper | Front bumper (unpainted) - Stone chips - No deduction |

**Wear and tear 3:** Front bumper: Front bumper (unpainted) - Stone chips - No deduction

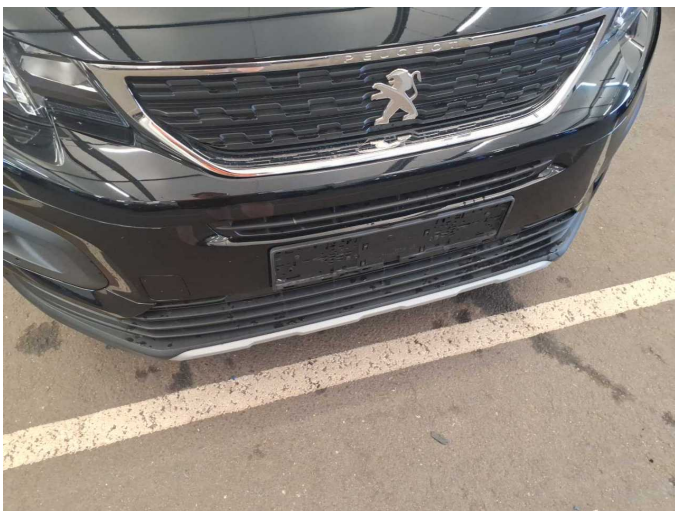
| No. | Component group | Description |
|---|---|---|
| 4 | Front bumper | Front bumper - Stone chips - No deduction |

**Wear and tear 4:** Front bumper: Front bumper - Stone chips - No deduction

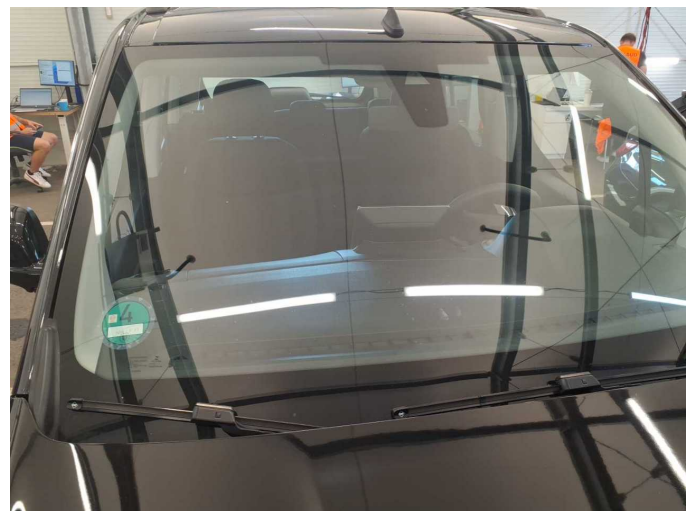
| No. | Component group | Description |
|---|---|---|
| 5 | Vehicle glazing | Windscreen - Stone chips - No deduction |

**Wear and tear 5:** Vehicle glazing: Windscreen - Stone chips - No deduction

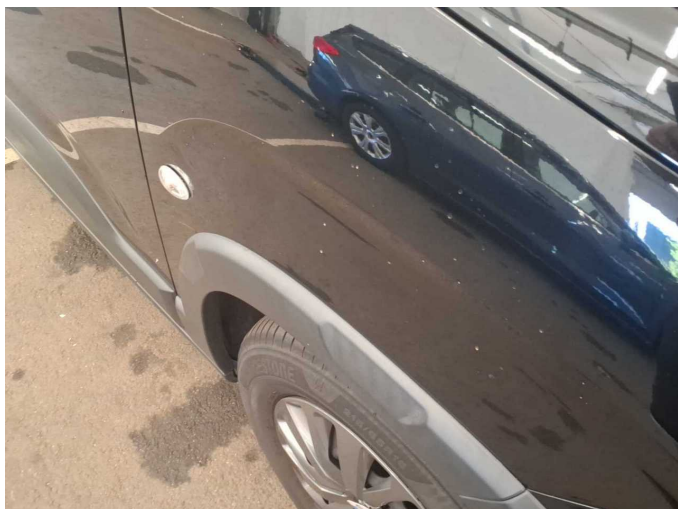
| No. | Component group | Description |
|---|---|---|
| 6 | Mudguard - right side | Mudguard - right side - Scratch(es) - No deduction |

**Wear and tear 6:** Mudguard - right side: Mudguard - right side - Scratch(es) - No deduction

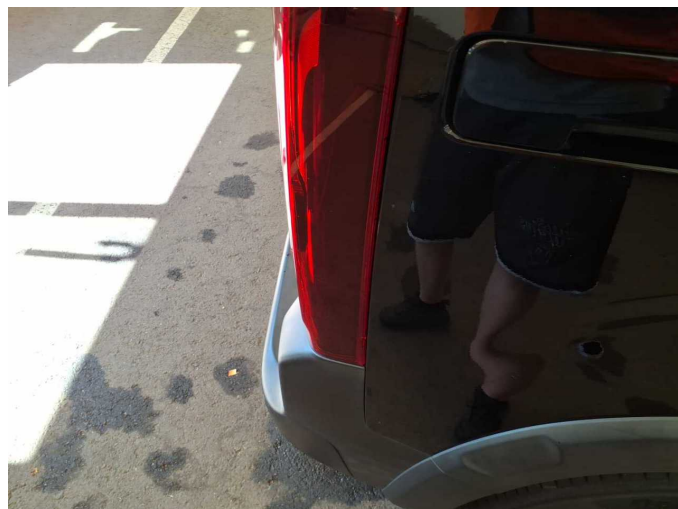
| No. | Component group | Description |
|---|---|---|
| 7 | Tail light | Tail lamp - right side - Scratch(es) - No deduction |

**Wear and tear 7:** Tail light: Tail lamp - right side - Scratch(es) - No deduction

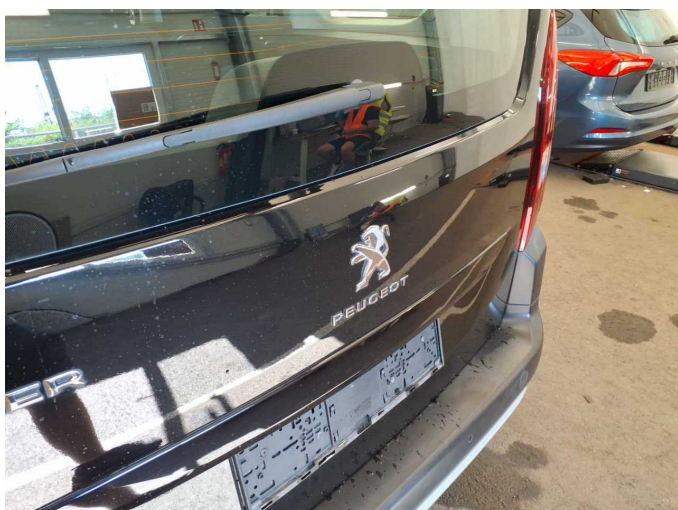
| No. | Component group | Description |
|---|---|---|
| 8 | Boot lid / rear door | Boot lid - Scratch(es) - No deduction |

**Wear and tear 8:** Boot lid / rear door: Boot lid - Scratch(es) - No deduction

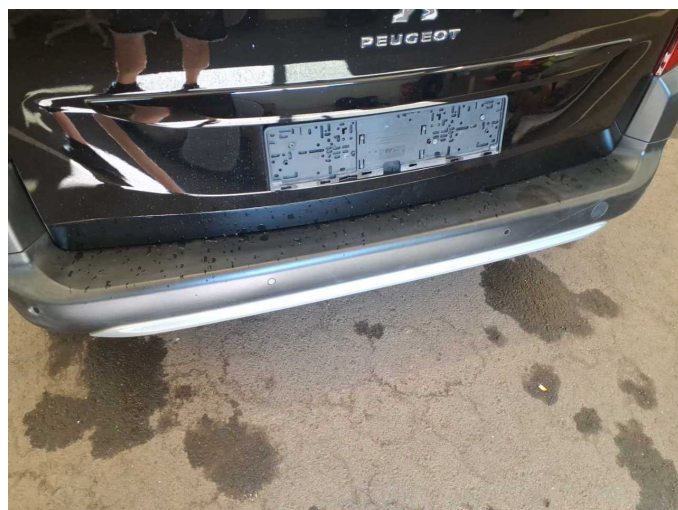
| No. | Component group | Description |
|---|---|---|
| 9 | Rear bumper | Rear bumper (unpainted) - Scratch(es) - No deduction |

**Wear and tear 9:** Rear bumper: Rear bumper (unpainted) - Scratch(es) - No deduction

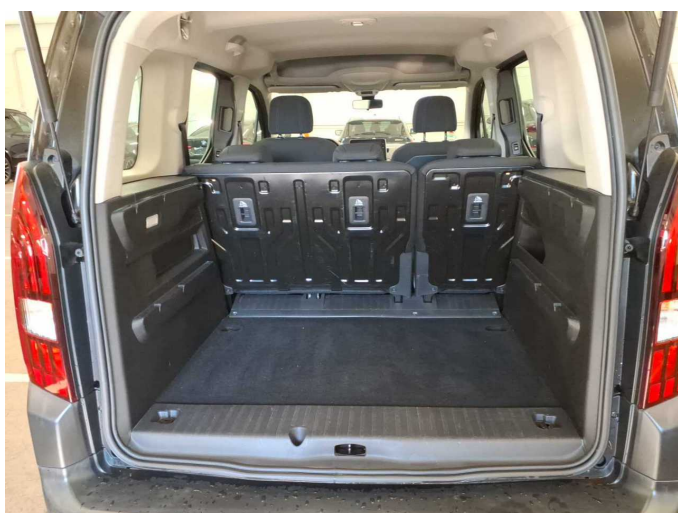
Interior - Rear shelf

**Missing part 1:** Interior: Rear shelf - Missing - Replace
