Expertise

Protocol number: 46229071
Order No. / Reference: 26588983
Inspection date: 30 Jun 2026

Model: MAN TGE 3.140 4X2F SB

VIN: WMA03VUY6P9021366

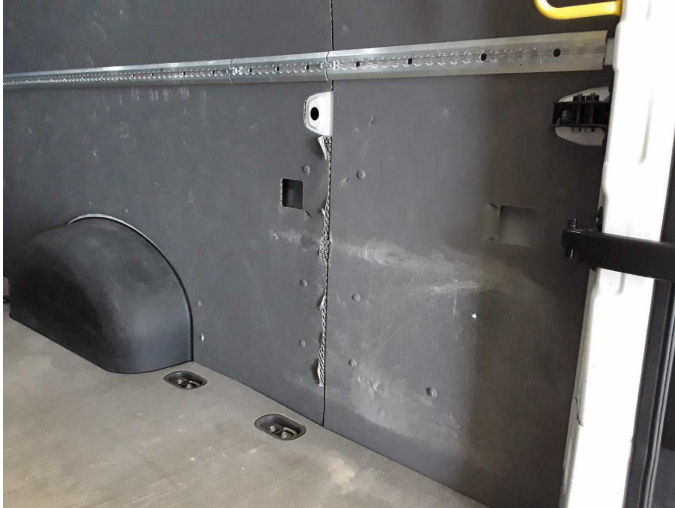
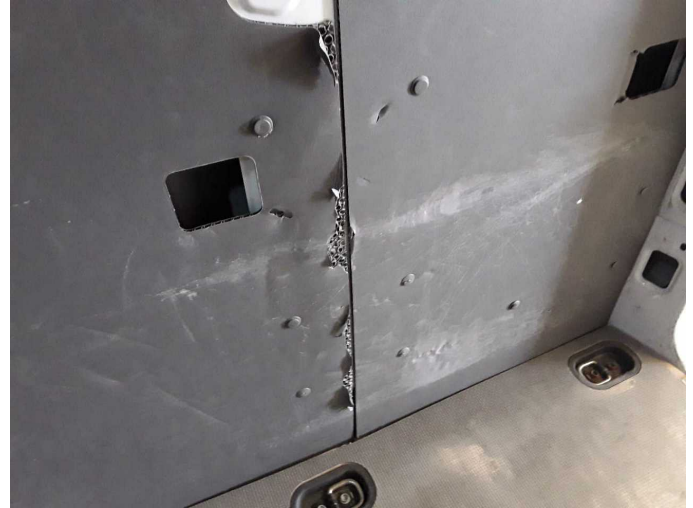
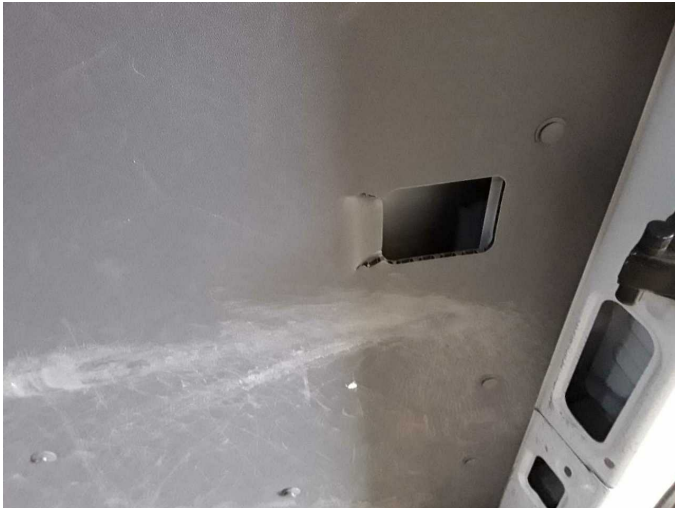
No.	Component group	Description
1	Interior	Interior (Laderaumverkleidungen) - Broken / torn - Replace

Damage 1: Interior: Interior (Laderaumverkleidungen) - Broken / torn - Replace

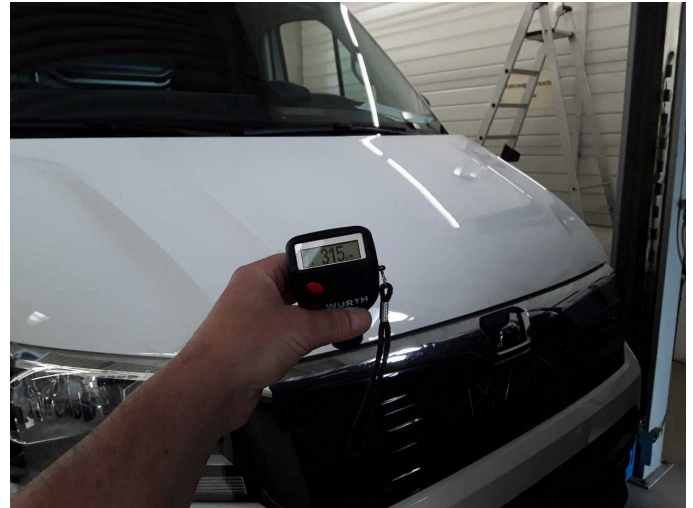
No.	Repainting
1	Bonnet, Professionally carried out

Bonnet	315 µm
--------	--------

Bonnet: 315 µm
