Expertise

Protocol number: 46516491  
Order No. / Reference: 26652071  
Inspection date: 1 Jul 2026

Manufacturer: Seat

Model: Cupra Leon Sportstourer 1.4 e-Hybrid (150 kW System)

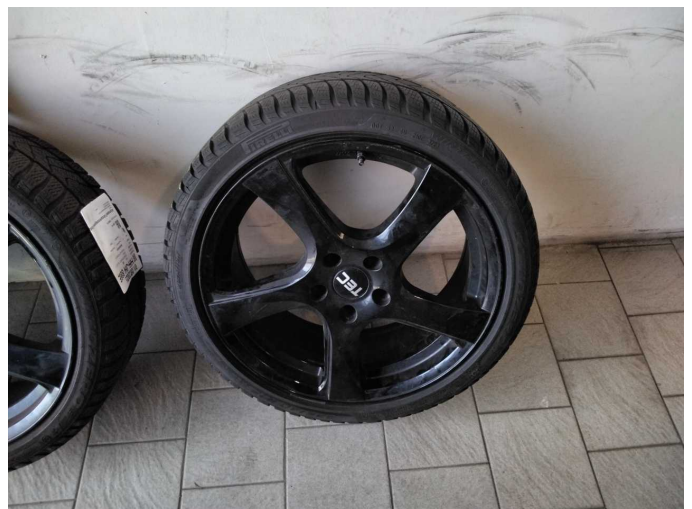
| No. | Component group | Description |
|---|---|---|
| 1 | 2nd wheel set | 1 tyre (Platt) - Perform diagnosis |

Damage 1: 2nd wheel set: 1 tyre (Platt) - Perform diagnosis

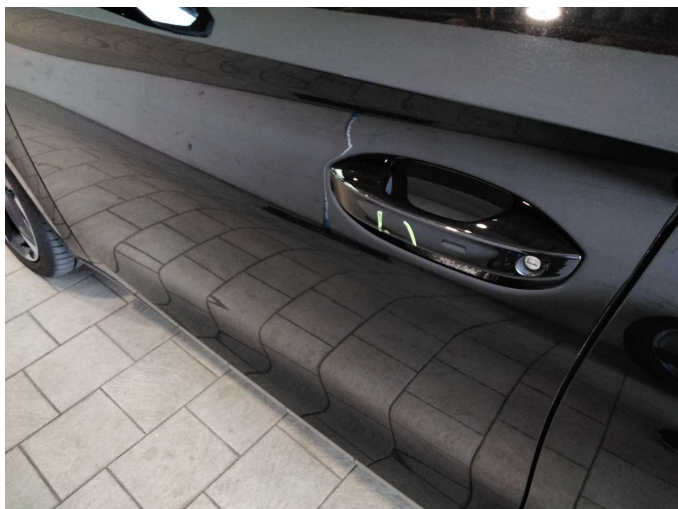
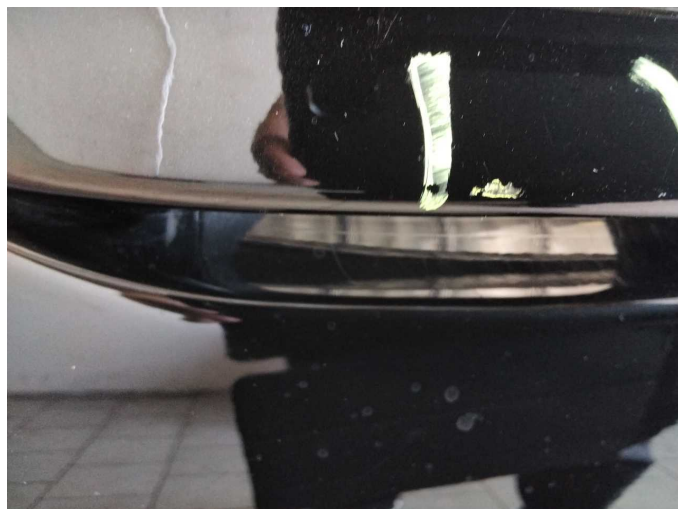
| No. | Component group | Description |
|---|---|---|
| 2 | Door - front left side | Door handle - outside - Scratch(es) - Smart repair |

**Damage 2:** Door - front left side: Door handle - outside - Scratch(es) - Smart repair

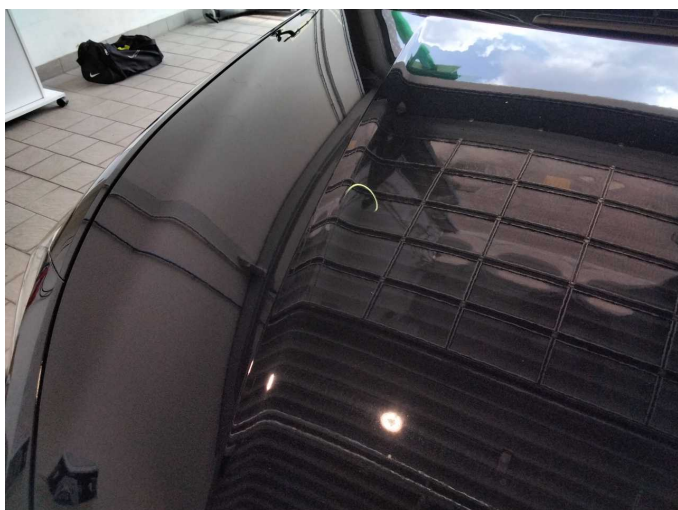
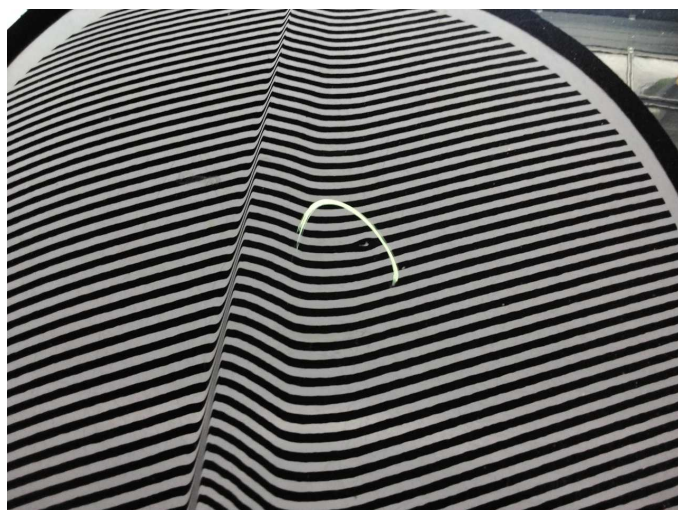
| No. | Component group | Description |
|---|---|---|
| 3 | Bonnet | Bonnet - dent(s) - Smooth repair work |

**Damage 3:** Bonnet: Bonnet - dent(s) - Smooth repair work

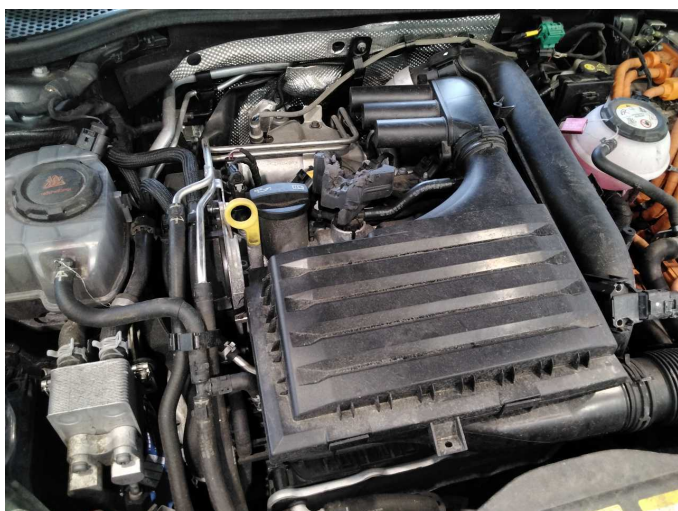
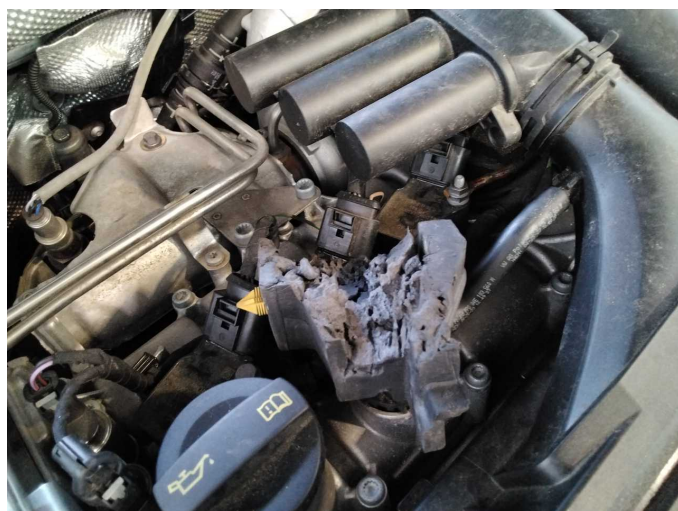
| No. | Component group | Description |
|---|---|---|
| 4 | Engine | Engine cover - Damage caused by marten / rodent - Replace |

**Damage 4:** Engine: Engine cover - Damage caused by marten / rodent - Replace

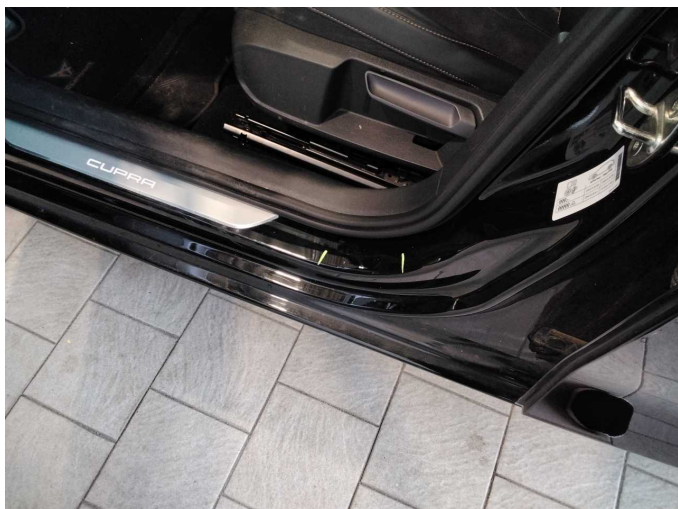
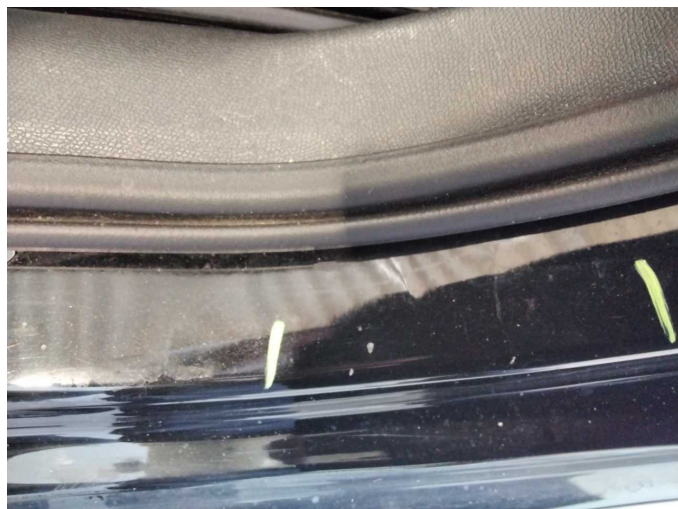
| No. | Component group | Description |
|---|---|---|
| 5 | Sill - left side | Sill - Scratch(es) - Smart repair |

**Damage 5:** Sill - left side: Sill - Scratch(es) - Smart repair

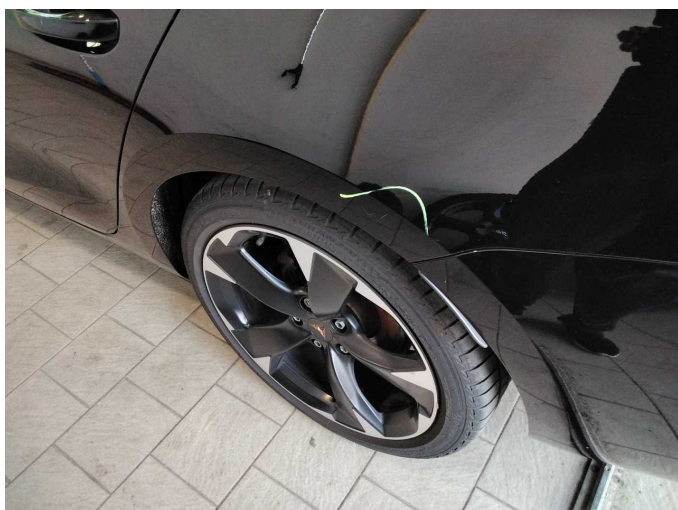
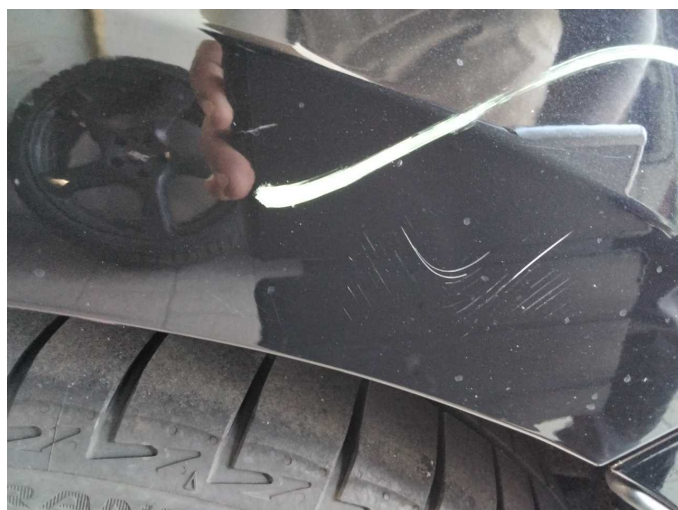
| No. | Component group | Description |
|---|---|---|
| 6 | Side panel - rear left side | Side panel - Scratch(es) - Smart repair |

**Damage 6:** Side panel - rear left side: Side panel - Scratch(es) - Smart repair

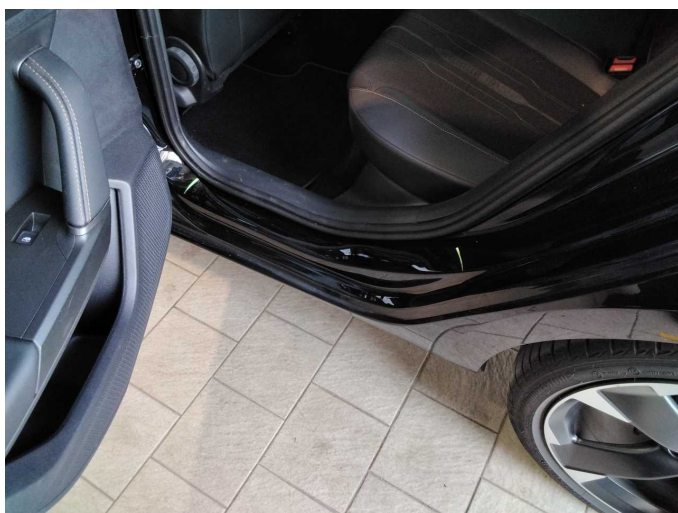
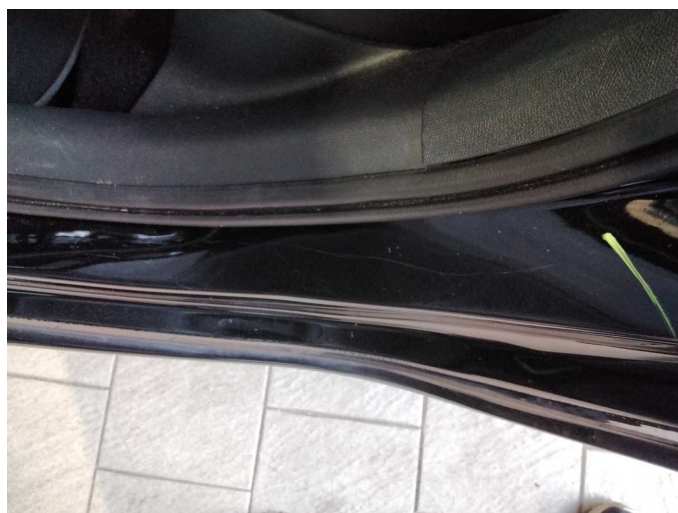
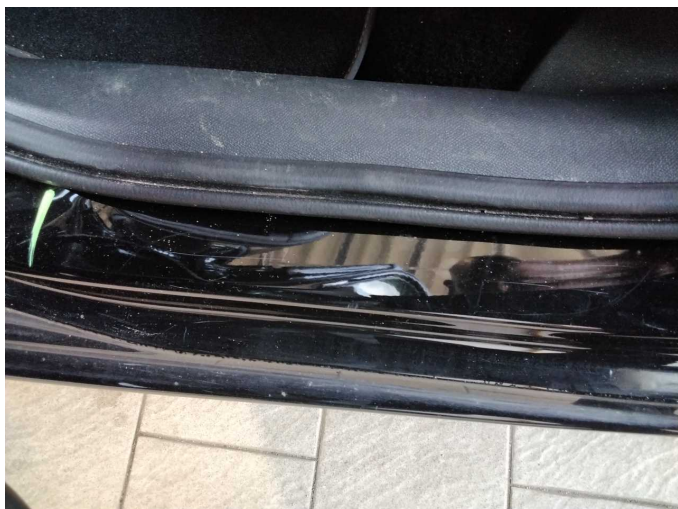
| No. | Component group | Description |
|---|---|---|
| 7 | Side panel - rear left side | Sill - Scratch(es) - Smart repair |

**Damage 7:** Side panel - rear left side: Sill - Scratch(es) - Smart repair

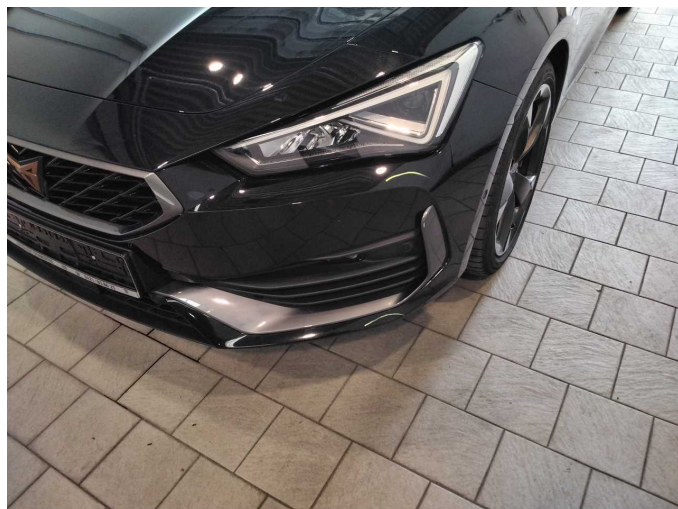
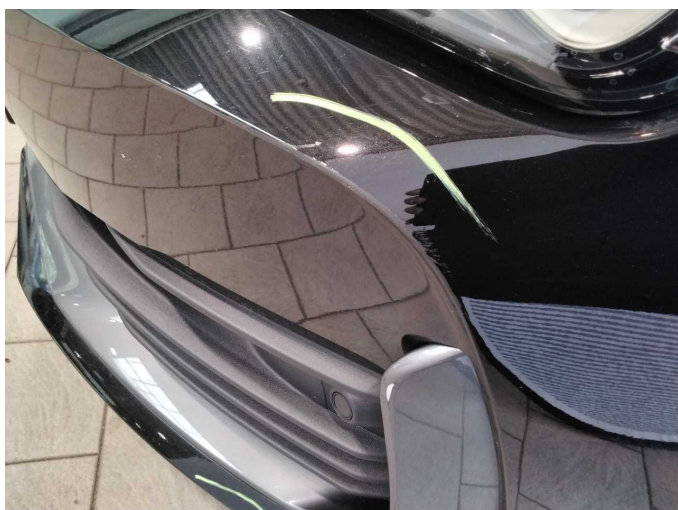
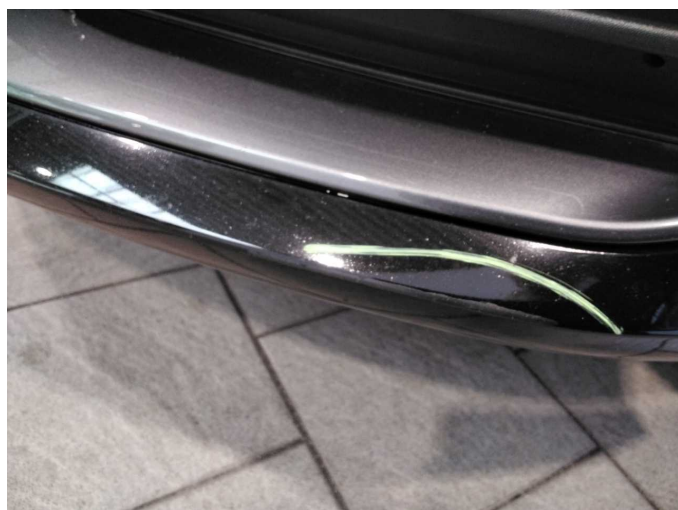
| No. | Component group | Description |
|---|---|---|
| 8 | Front bumper | Front bumper - Scratch(es) - Smart repair |

**Damage 8:** Front bumper: Front bumper - Scratch(es) - Smart repair

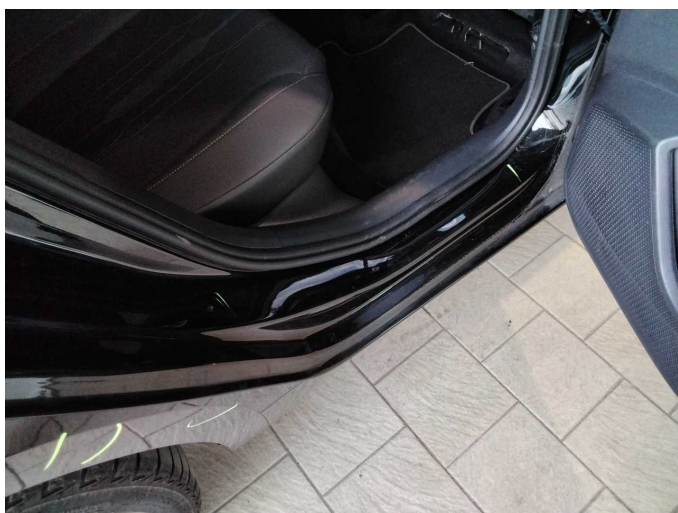
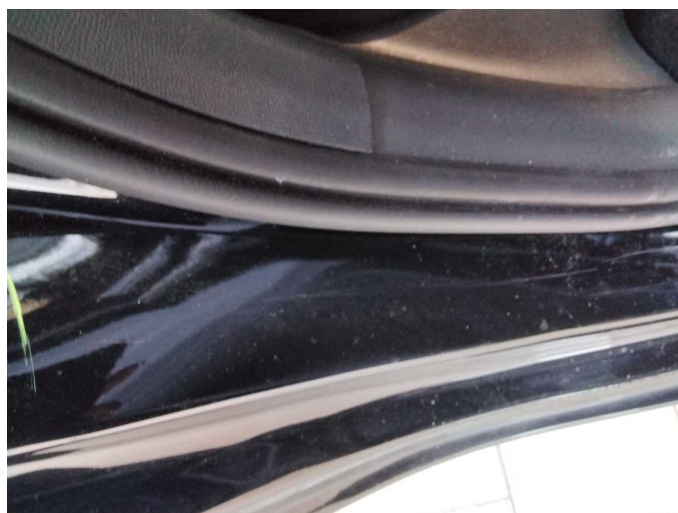
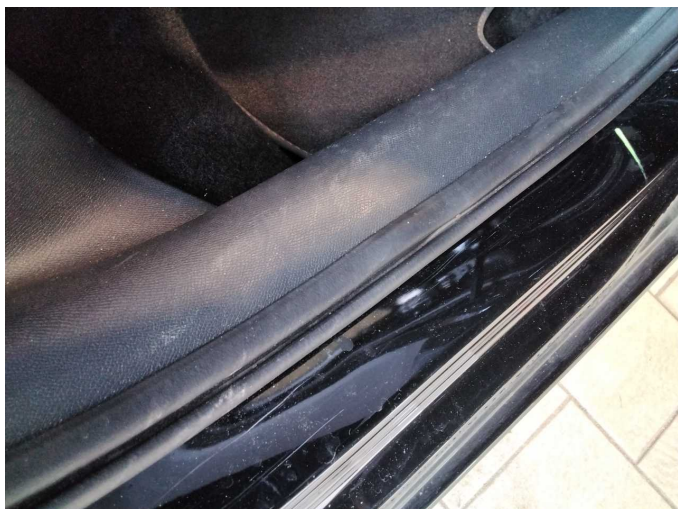
| No. | Component group | Description |
|---|---|---|
| 9 | Side panel - rear right side | Sill - Scratch(es) - Smart repair |

**Damage 9:** Side panel - rear right side: Sill - Scratch(es) - Smart repair

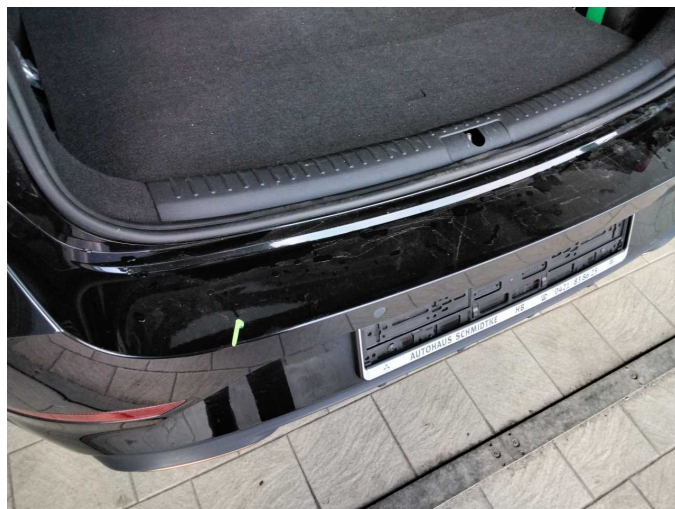
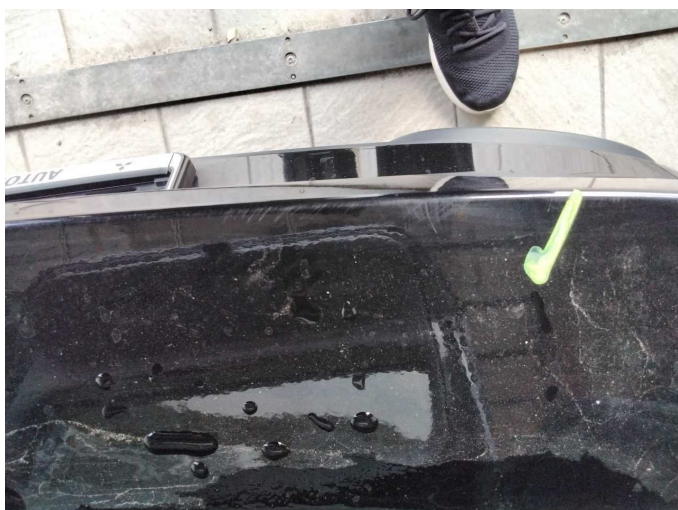
| No. | Component group | Description |
|---|---|---|
| 10 | Rear bumper | Rear bumper - Scratch(es) - Smart repair |

**Damage 10:** Rear bumper: Rear bumper - Scratch(es) - Smart repair

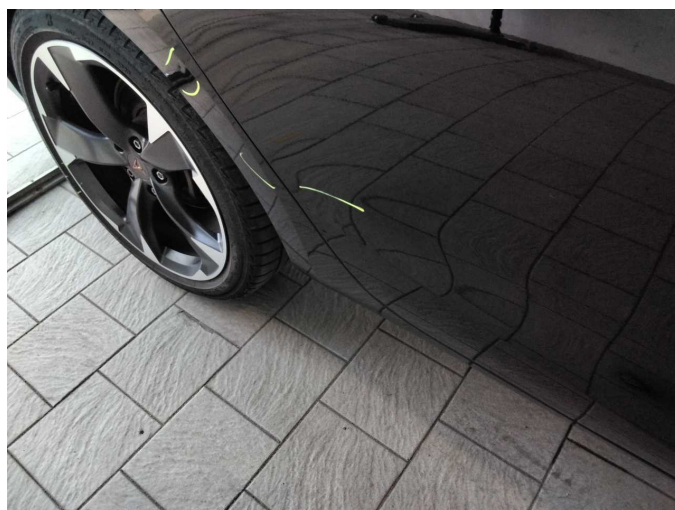
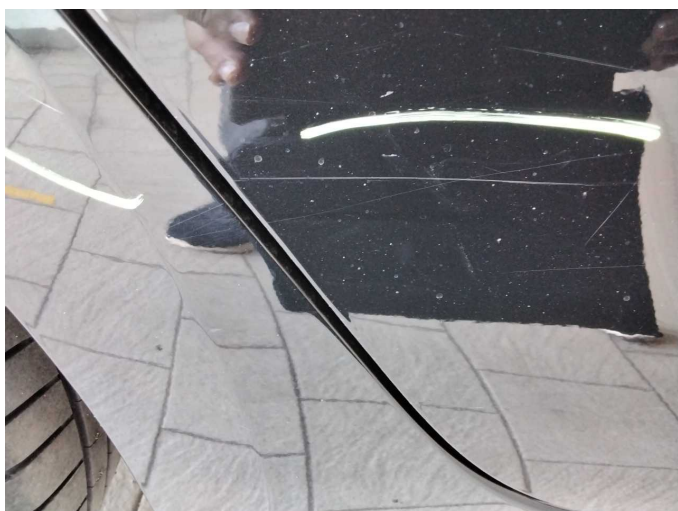
| No. | Component group | Description |
|---|---|---|
| 11 | Door - rear right side | Door - Scratch(es) - Smart repair |

**Damage 11:** Door - rear right side: Door - Scratch(es) - Smart repair

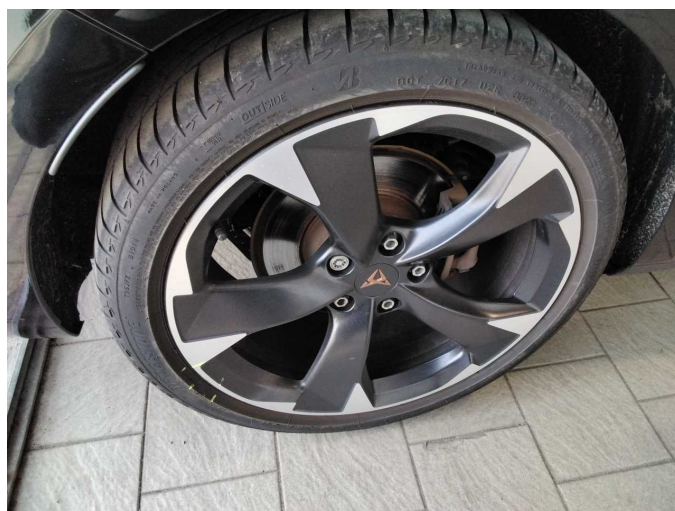
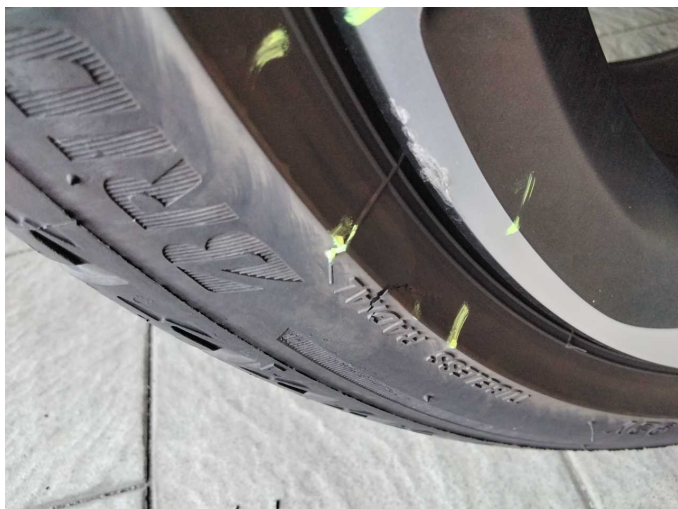
| No. | Component group | Description |
|---|---|---|
| 12 | Wheel / tyres | Tyre - rear right side (nicht fahrbereit) - Damaged - Replace |

**Damage 12:** Wheel / tyres: Tyre - rear right side (nicht fahrbereit) - Damaged - Replace

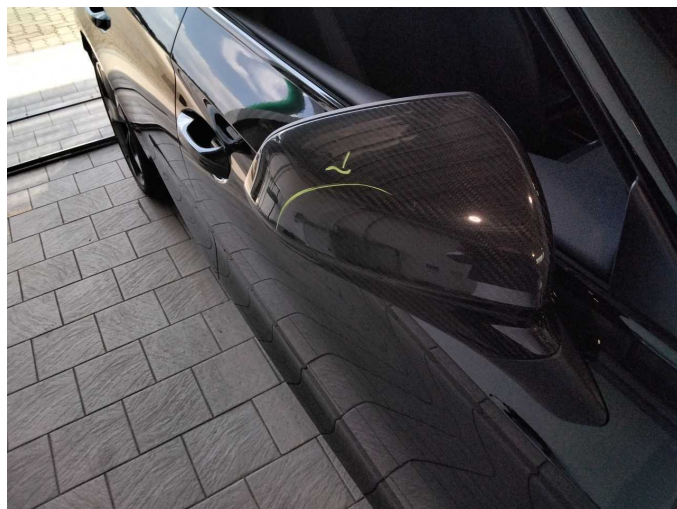
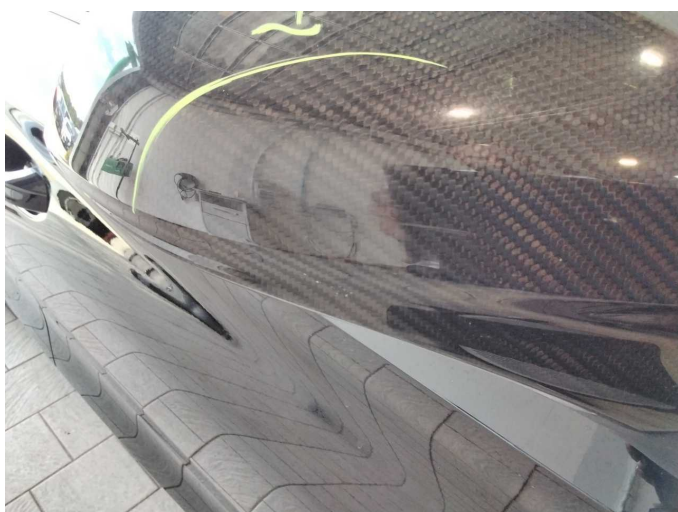
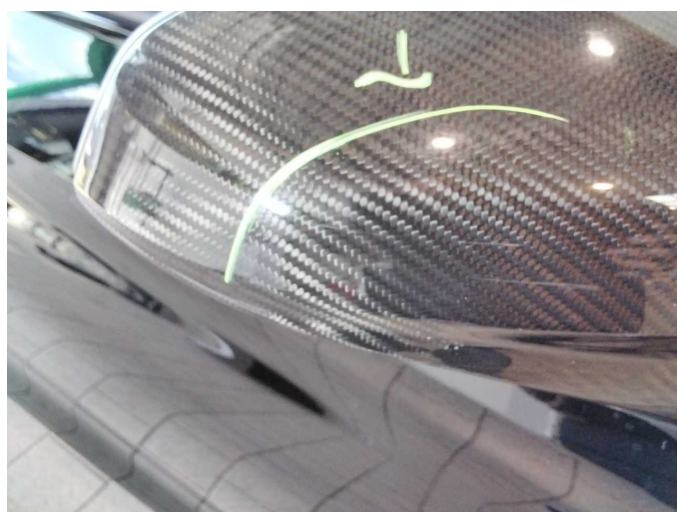
| No. | Component group | Description |
|---|---|---|
| 13 | Wing mirror - right side | Cap - Scratch(es) - Replace |

**Damage 13:** Wing mirror - right side: Cap - Scratch(es) - Replace

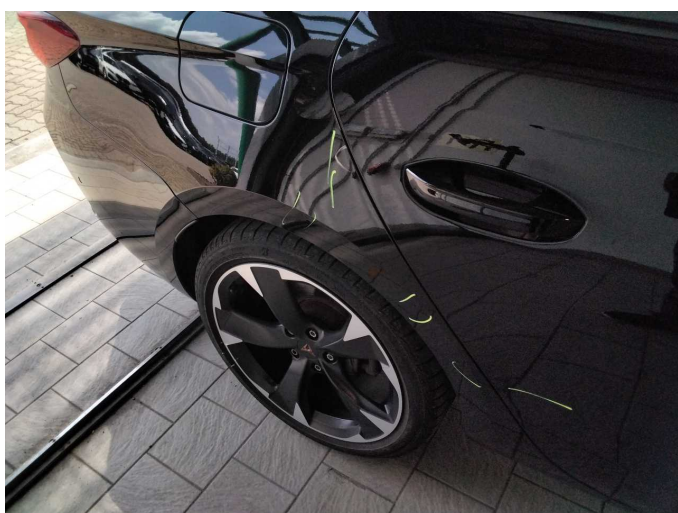
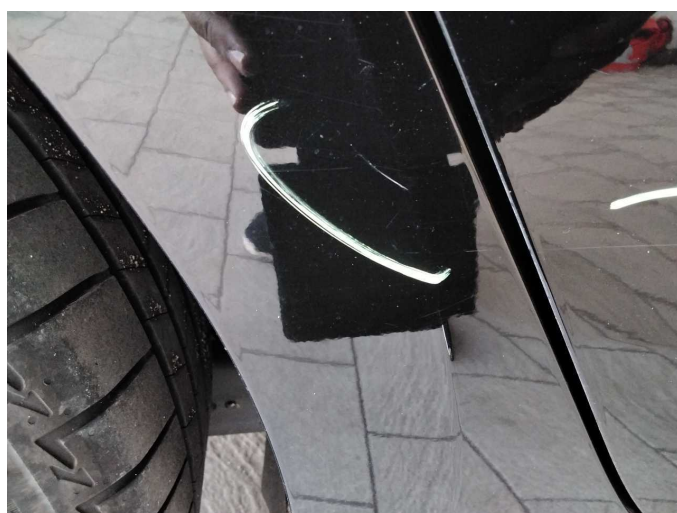
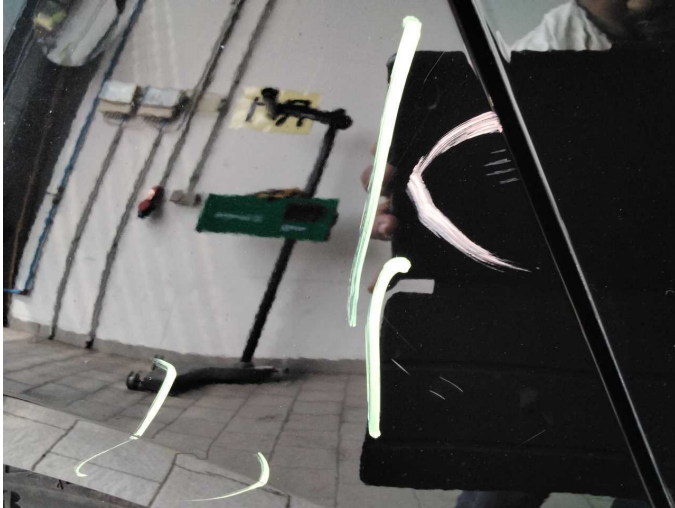
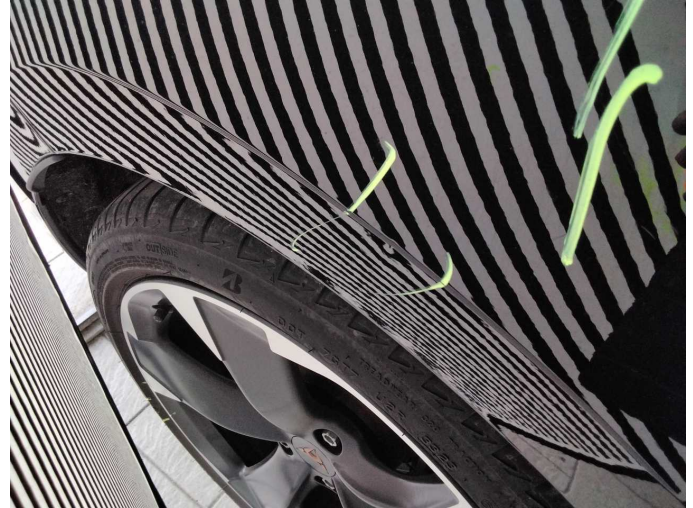
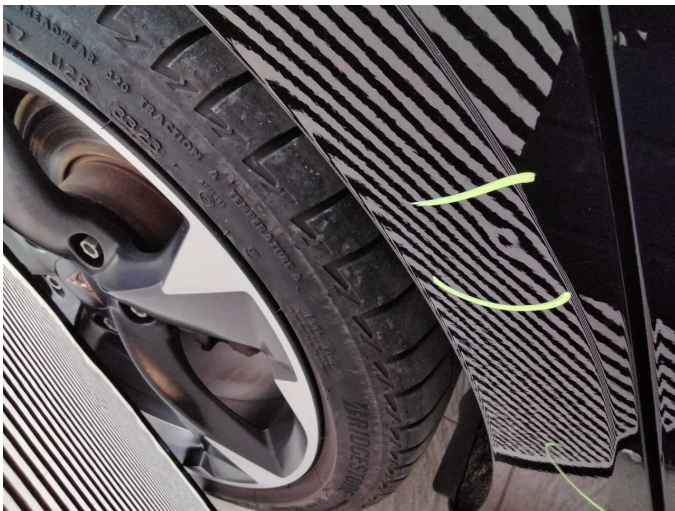
| No. | Component group | Description |
|---|---|---|
| 14 | Side panel - rear right side | Side panel - Dent / paintcoat damage - Repair and paint |

**Damage 14:** Side panel - rear right side: Side panel - Dent / paintcoat damage - Repair and paint

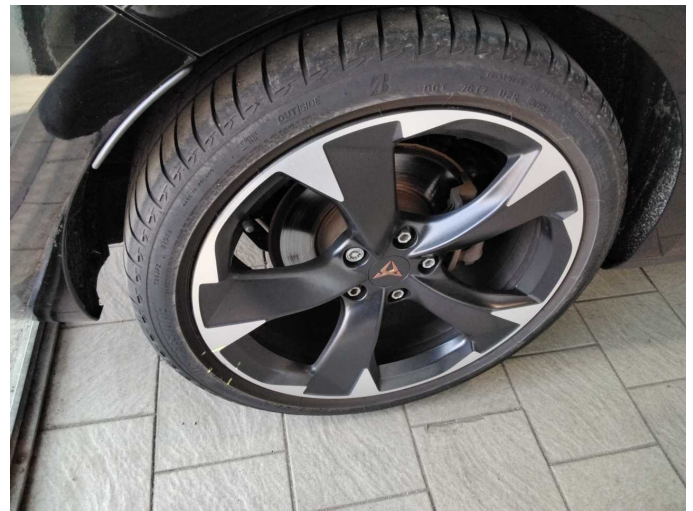
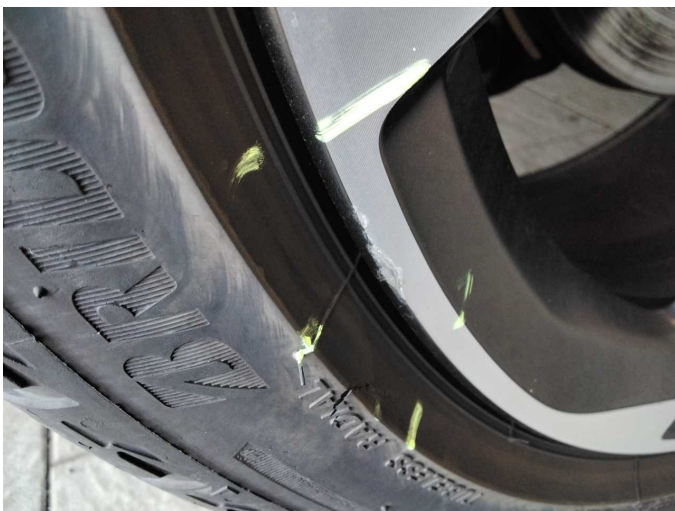
| No. | Component group | Description |
|---|---|---|
| 15 | Wheel / tyres | Alloy rim - rear right side - Scratched - Replace |

**Damage 15:** Wheel / tyres: Alloy rim - rear right side - Scratched - Replace

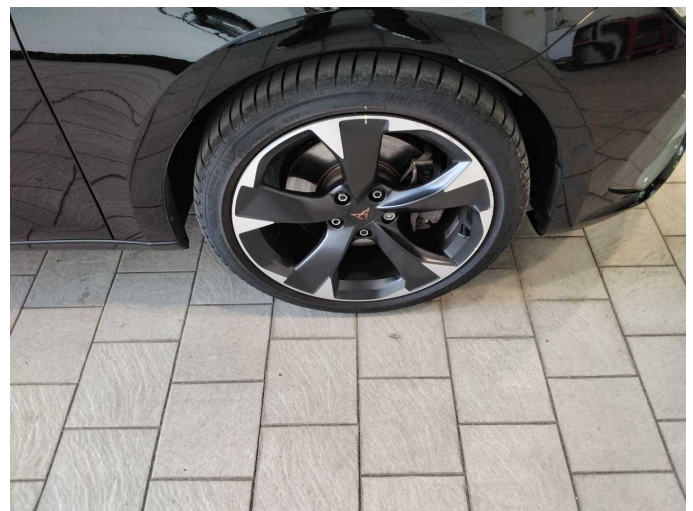
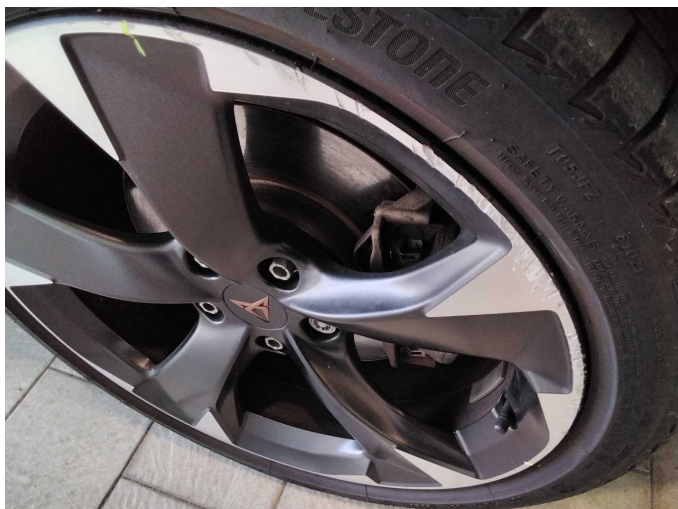
| No. | Component group | Description |
|---|---|---|
| 16 | Wheel / tyres | Alloy rim - front right side - Scratch(es) - Replace |

**Damage 16:** Wheel / tyres: Alloy rim - front right side - Scratch(es) - Replace

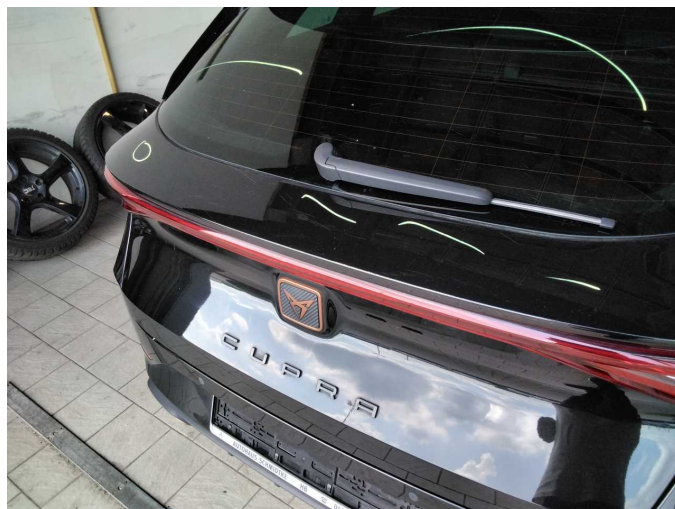
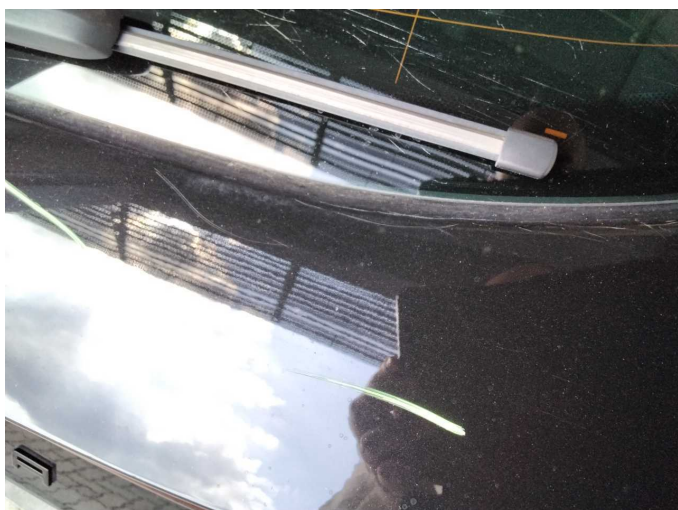
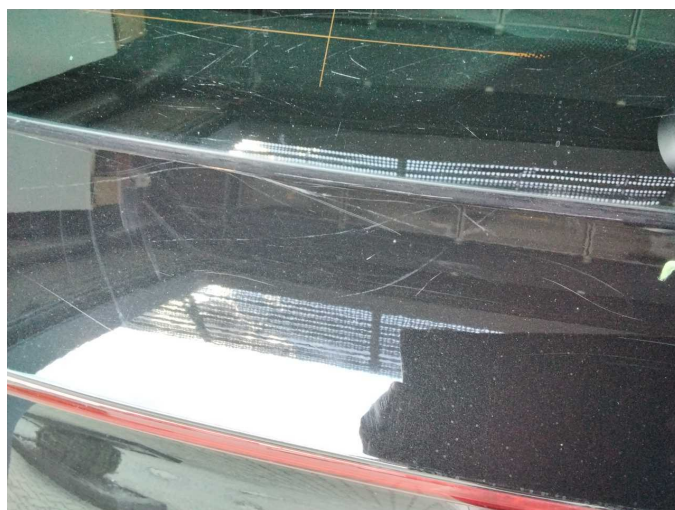
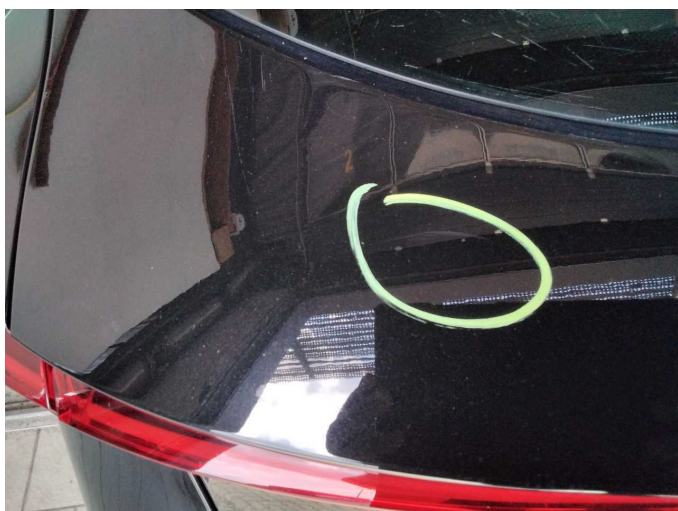
| No. | Component group | Description |
|---|---|---|
| 17 | Boot lid / rear door | Boot lid - Scratch(es) - Paint |

**Damage 17:** Boot lid / rear door: Boot lid - Scratch(es) - Paint

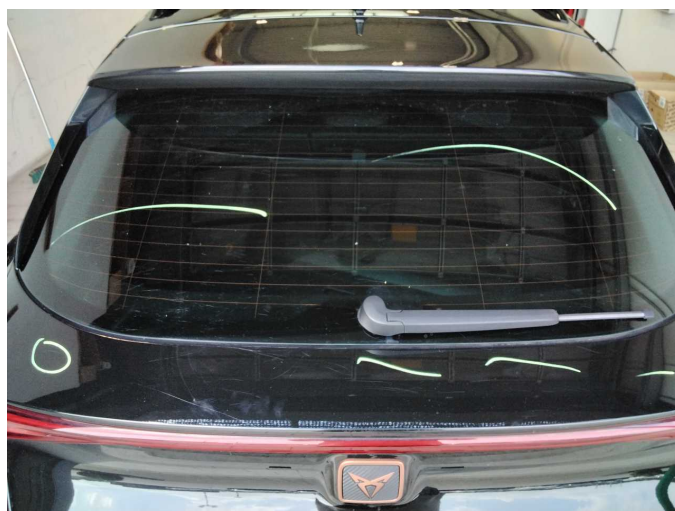
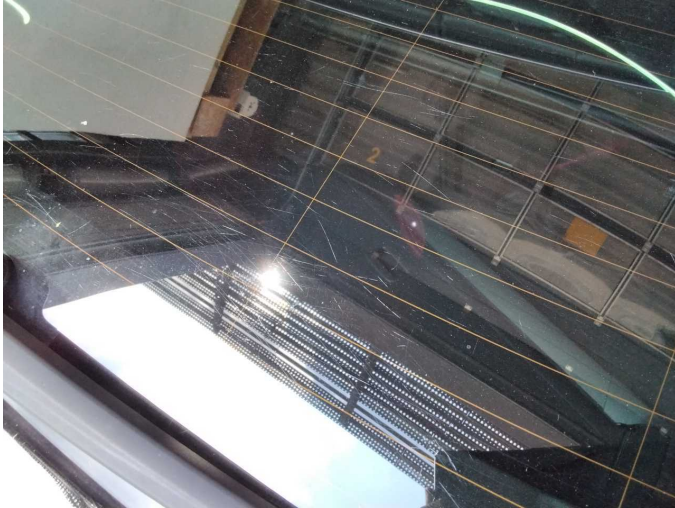
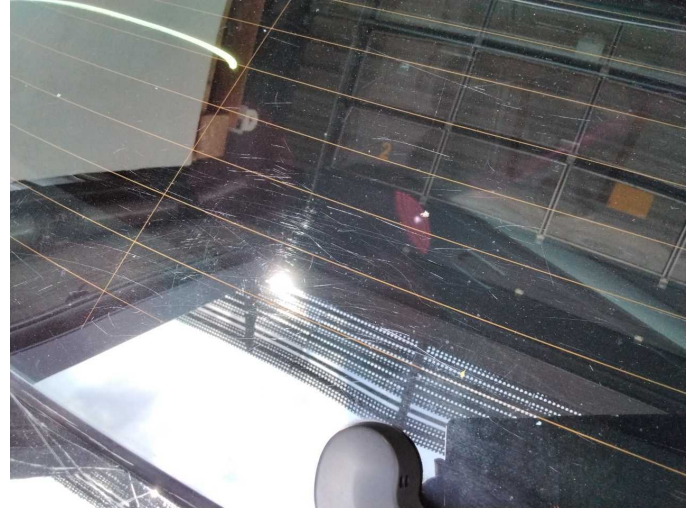
| No. | Component group | Description |
|---|---|---|
| 18 | Vehicle glazing | Rear window - Scratch(es) - Replace |

**Damage 18:** Vehicle glazing: Rear window - Scratch(es) - Replace

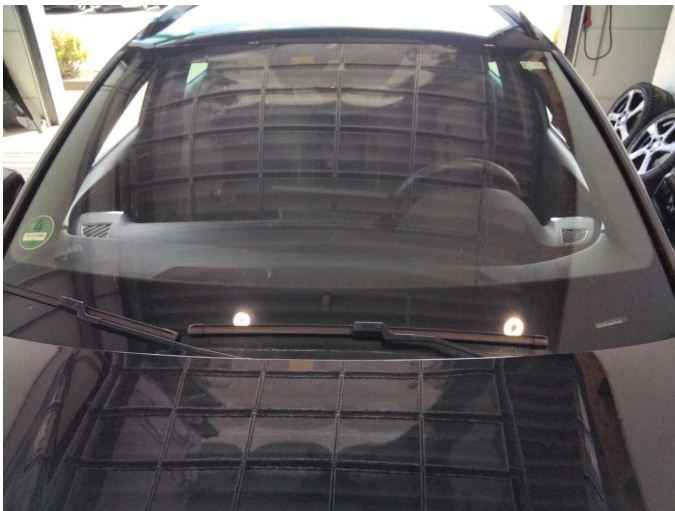
| No. | Component group | Description |
|---|---|---|
| 1 | Vehicle glazing | Windscreen - Stone chips - No deduction |

**Wear and tear 1:** Vehicle glazing: Windscreen - Stone chips - No deduction
