Expertise

Protocol number: 46632568  
Order No. / Reference: 26662974  
Inspection date: 1 Jul 2026

Manufacturer: Volkswagen

Model: Caddy Cargo 2.0 TDI BMT

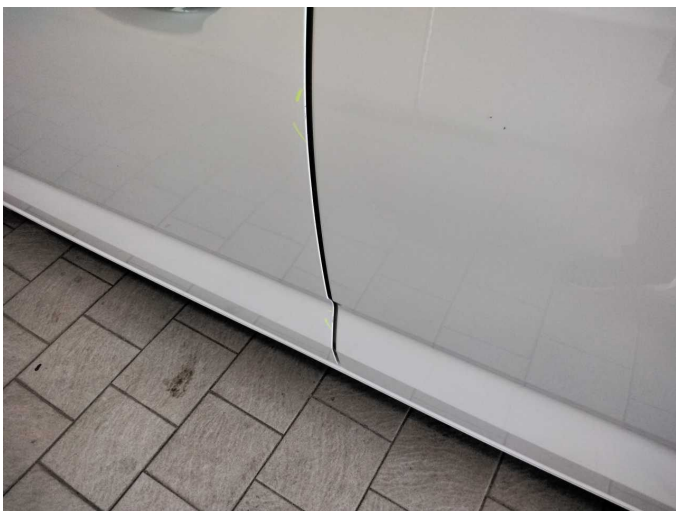
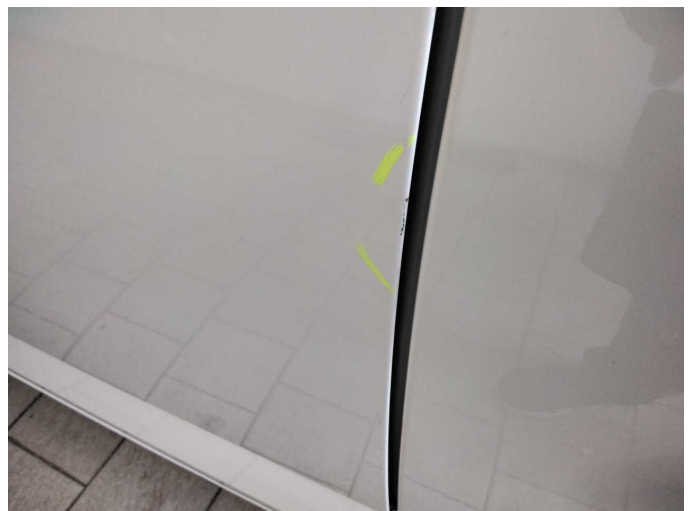
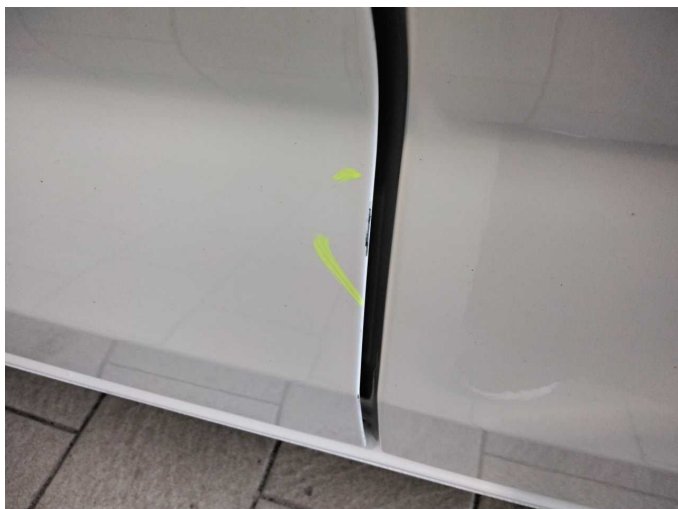
| No. | Component group | Description |
|---|---|---|
| 1 | Door - front left side | Door edge - Scratch(es) - Smart repair |

Damage 1: Door - front left side: Door edge - Scratch(es) - Smart repair

**Damage 1:** Door - front left side: Door edge - Scratch(es) - Smart repair

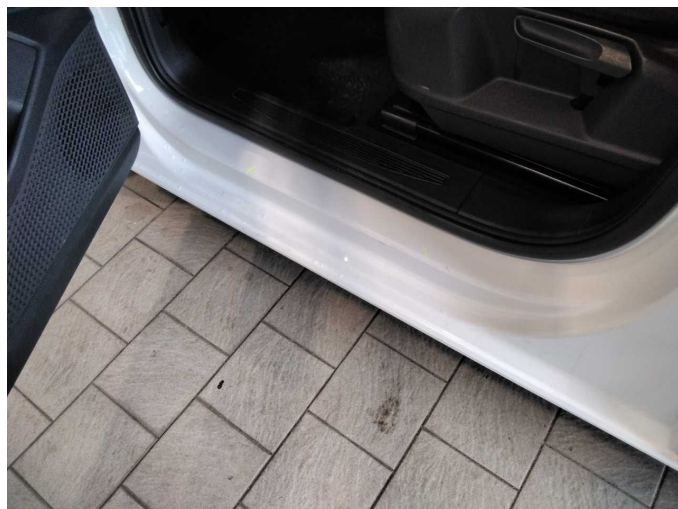
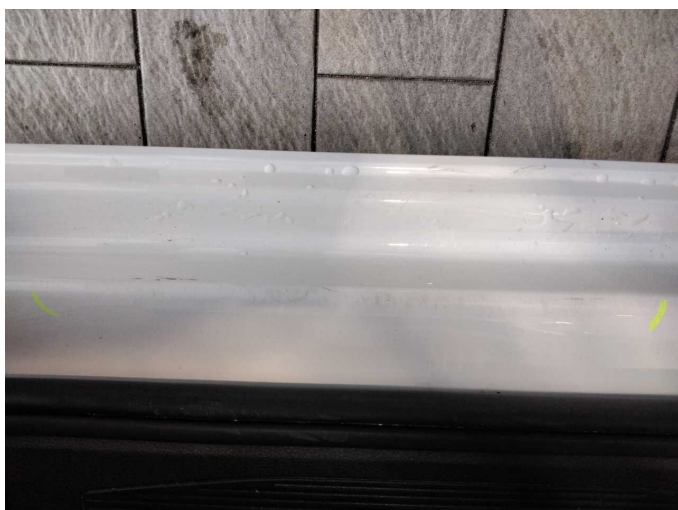
| No. | Component group | Description |
|---|---|---|
| 2 | Sill - left side | Sill - Scratch(es) - Smart repair |

**Damage 2:** Sill - left side: Sill - Scratch(es) - Smart repair

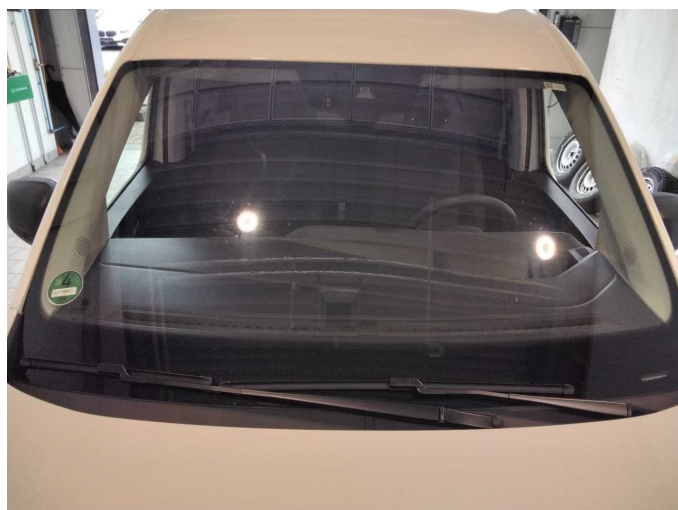
| No. | Component group | Description |
|---|---|---|
| 1 | Vehicle glazing | Windscreen - Stone chips - No deduction |

**Wear and tear 1:** Vehicle glazing: Windscreen - Stone chips - No deduction

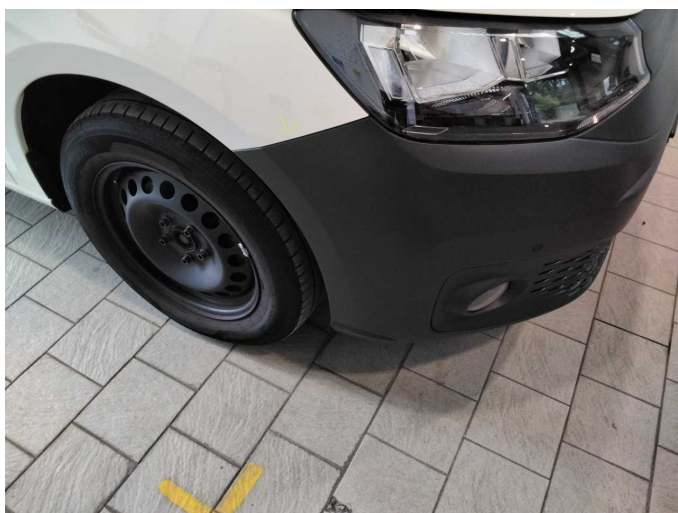
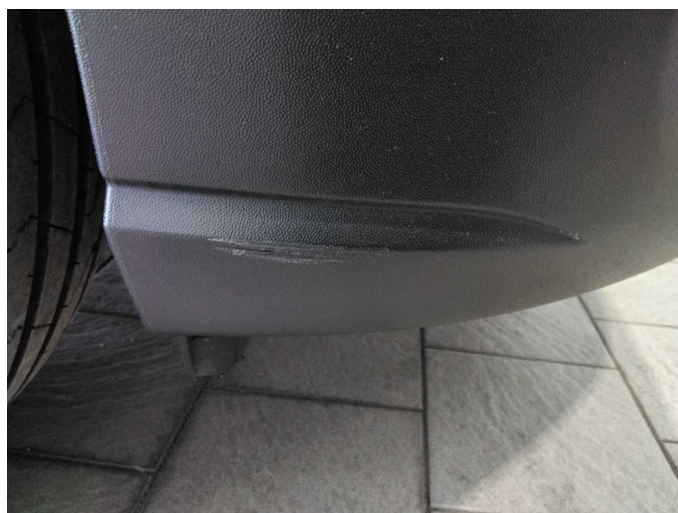
| No. | Component group | Description |
|---|---|---|
| 3 | Front bumper | Front bumper - Scratch(es) - No deduction |

**Wear and tear 3:** Front bumper: Front bumper - Scratch(es) - No deduction

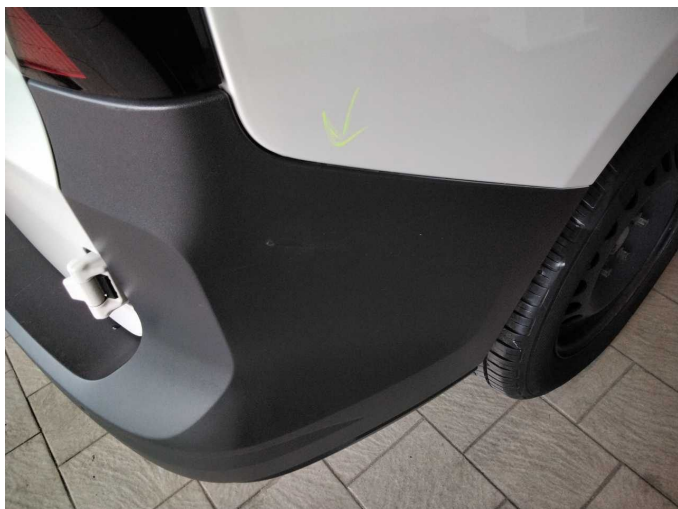
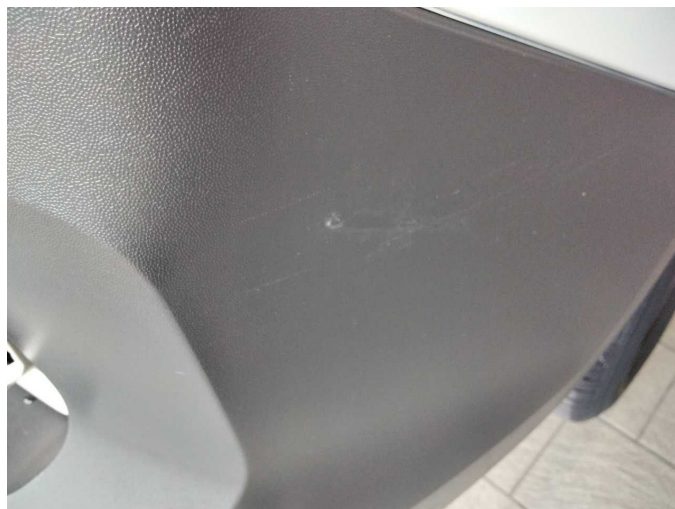
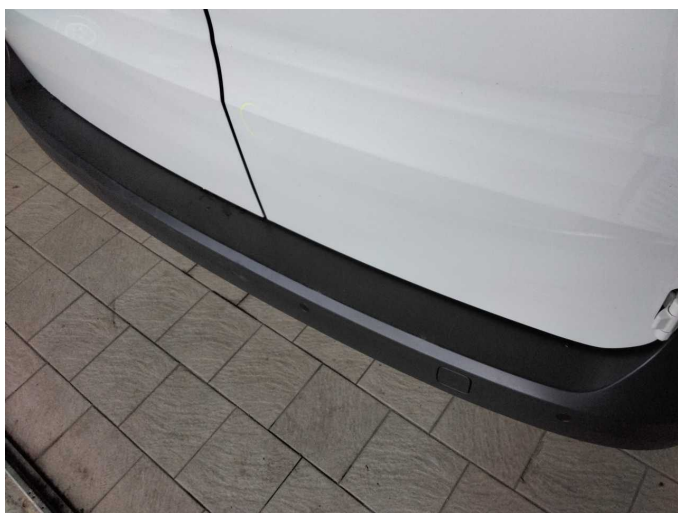
| No. | Component group | Description |
|---|---|---|
| 4 | Rear bumper | Rear bumper - Scratch(es) - No deduction |

**Wear and tear 4:** Rear bumper: Rear bumper - Scratch(es) - No deduction

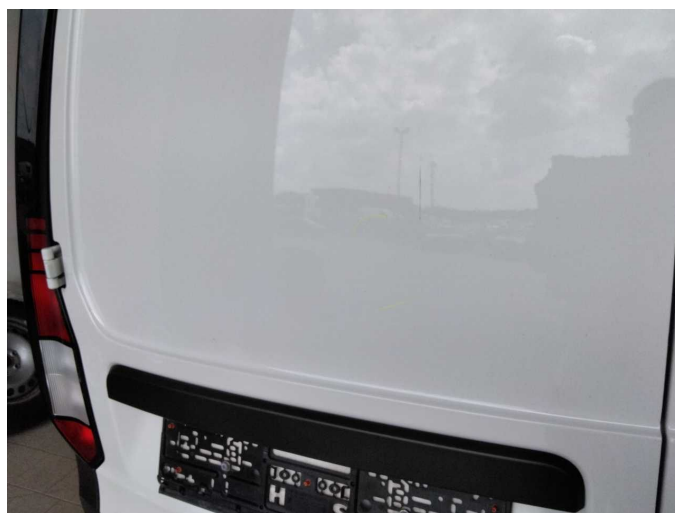
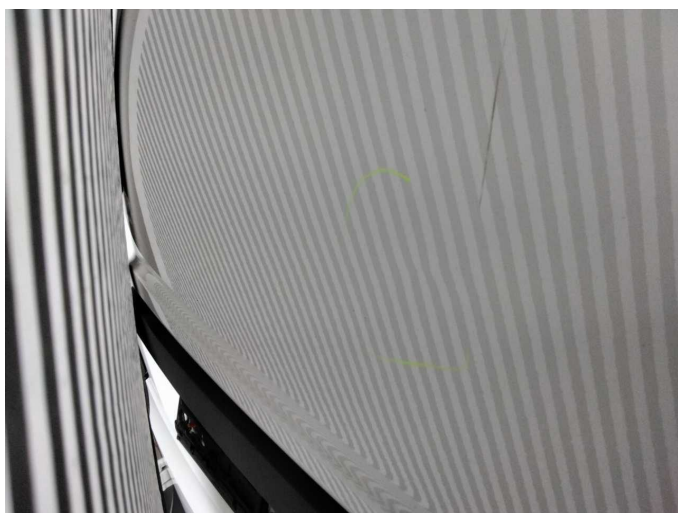
| No. | Component group | Description |
|---|---|---|
| 5 | Boot lid / rear door | Rear door - left side - dent(s) - No deduction |

**Wear and tear 5:** Boot lid / rear door: Rear door - left side - dent(s) - No deduction

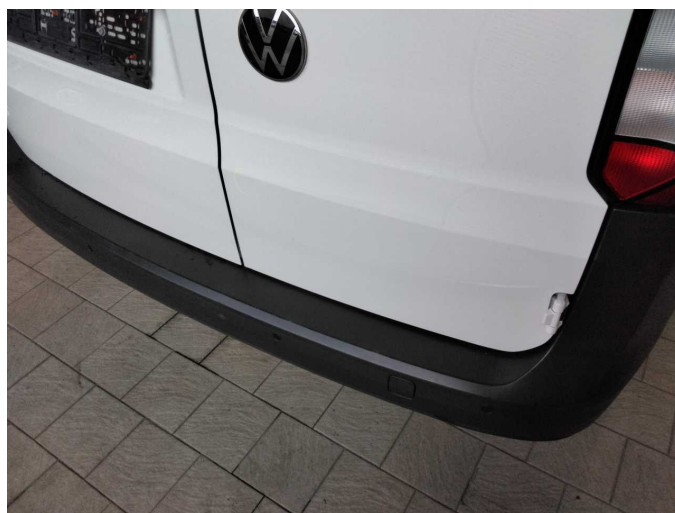
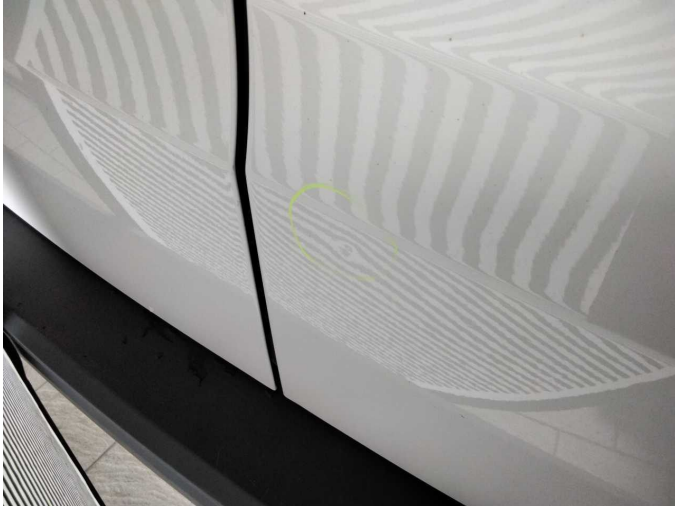
| No. | Component group | Description |
|---|---|---|
| 6 | Boot lid / rear door | Rear door - right side - dent(s) - No deduction |

**Wear and tear 6:** Boot lid / rear door: Rear door - right side - dent(s) - No deduction

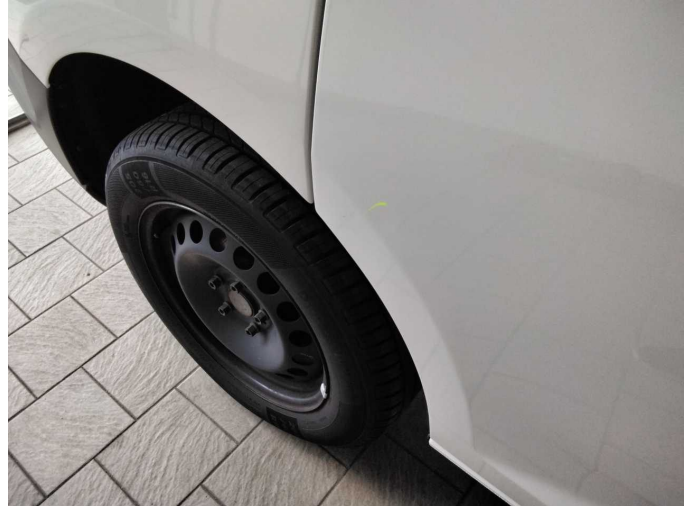
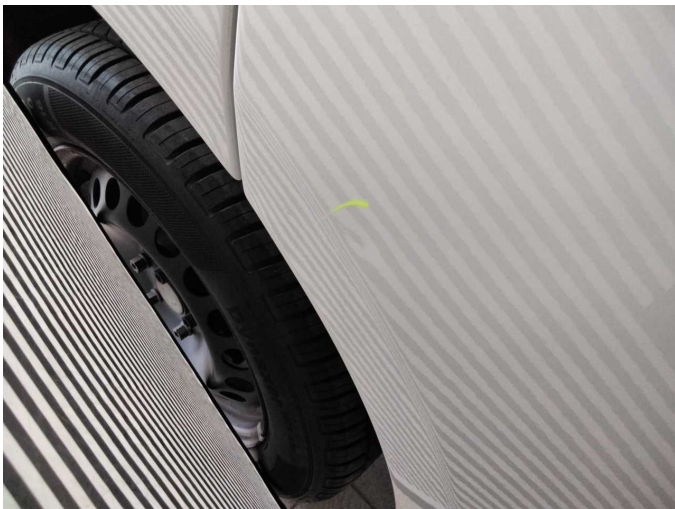
| No. | Component group | Description |
|---|---|---|
| 7 | Sliding door, right | Sliding door - dent(s) - No deduction |

**Wear and tear 7:** Sliding door, right: Sliding door - dent(s) - No deduction

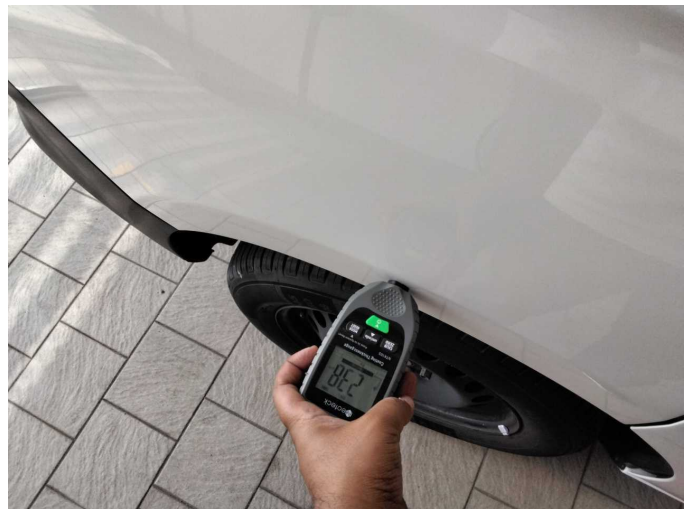
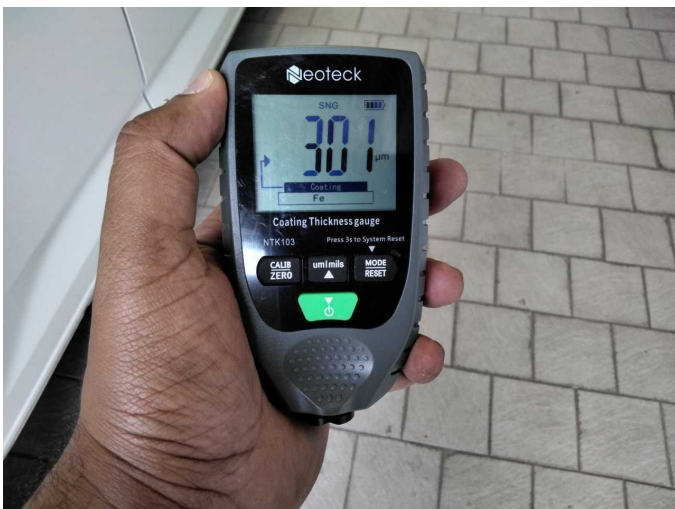
**Side panel - rear right side:** 301 µm

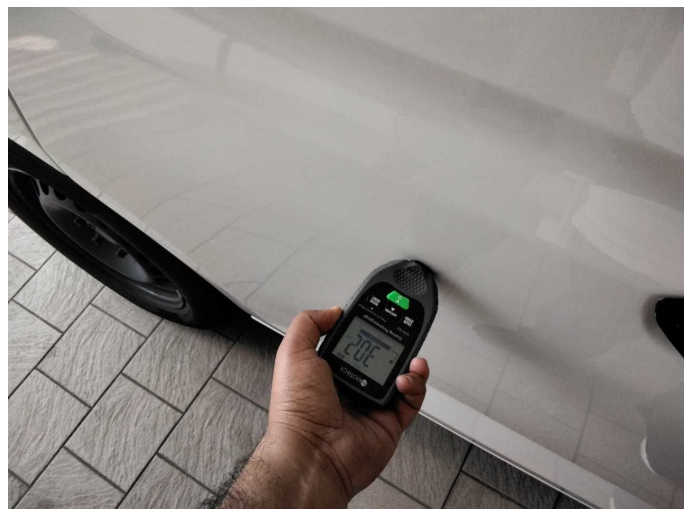
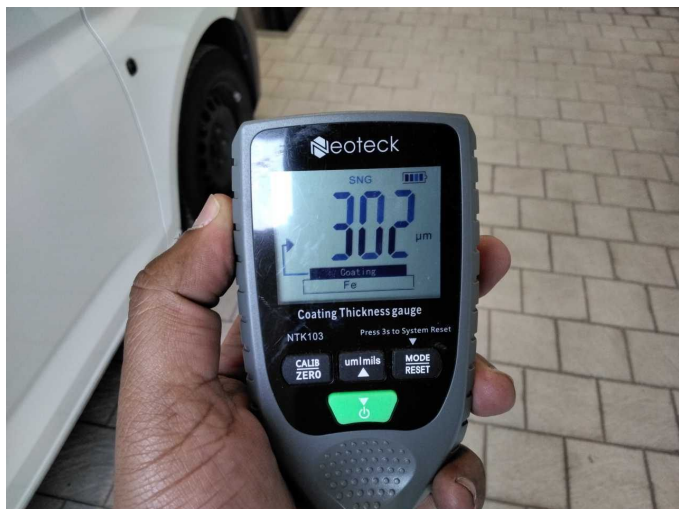
**Door - rear right side:** 302 µm

Door - rear right side: 302 µm
