Expertise

Protocol number: 46203060
Order No. / Reference: 26495131
Inspection date: 29 Jun 2026

Model: Tarraco 2.0 TDI 4Drive DSG SCR FR

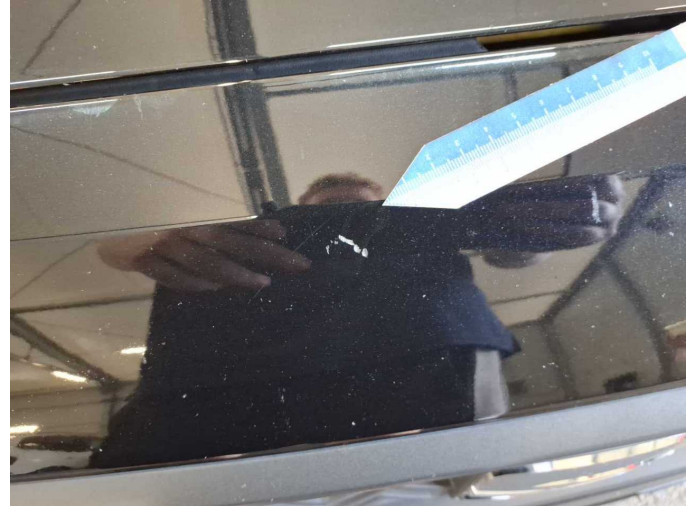
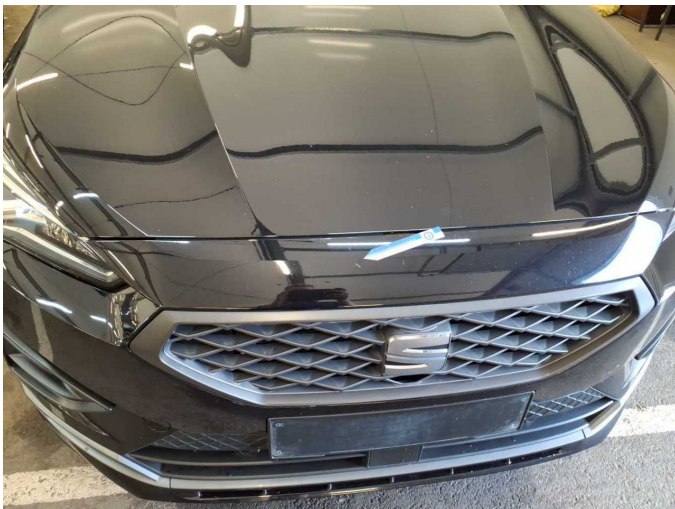
Damage 1: Front bumper: Front bumper - Scratch(es) - Smart repair

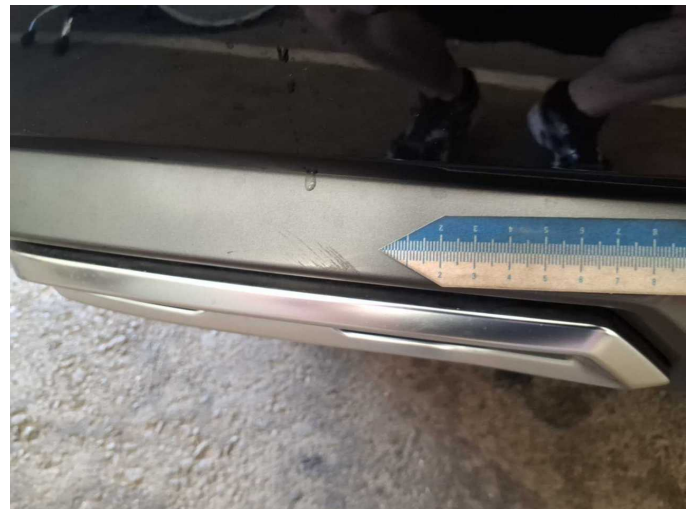
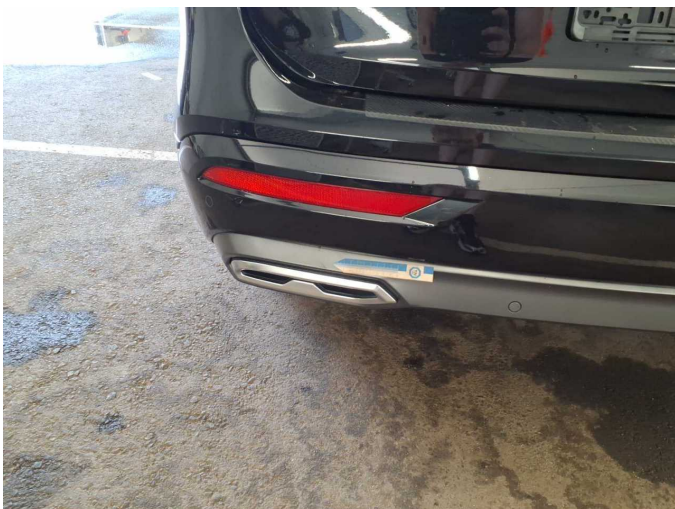
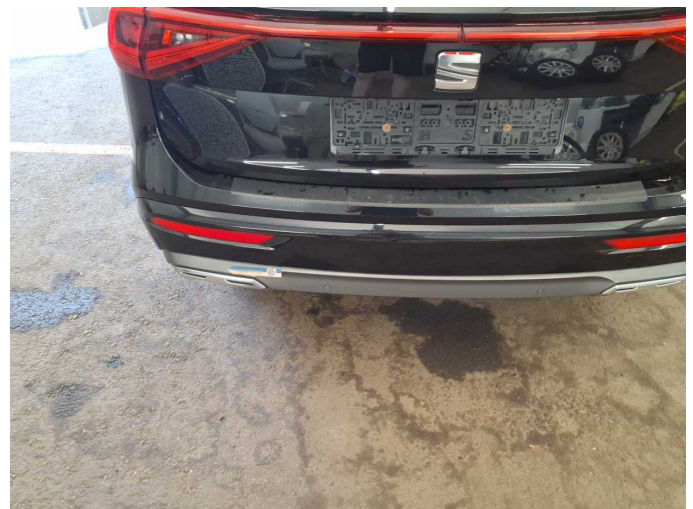
Damage 2: Rear bumper: Spoiler - Scratch(es) - Replace

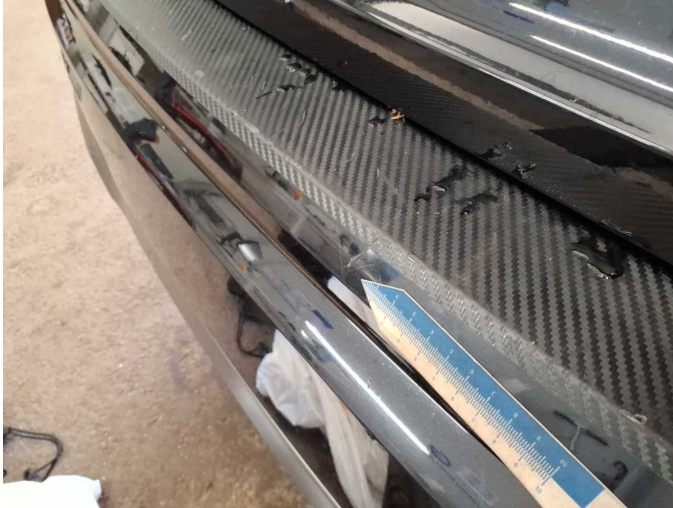
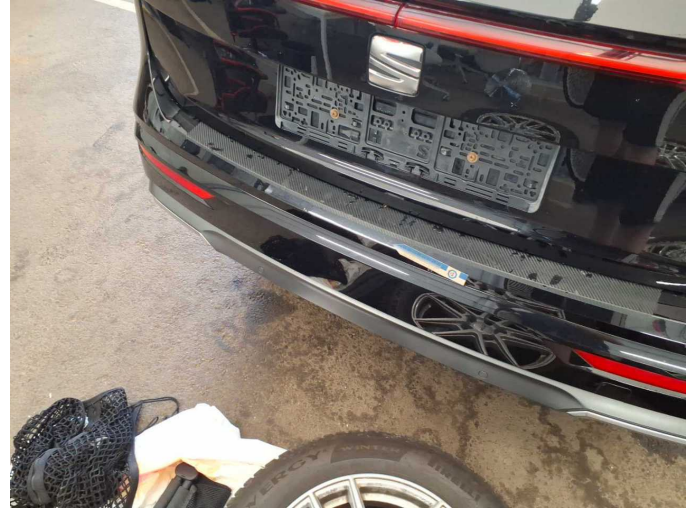
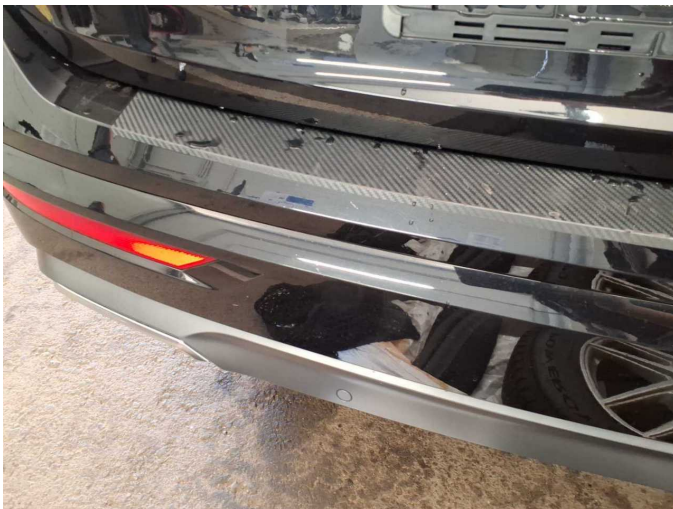
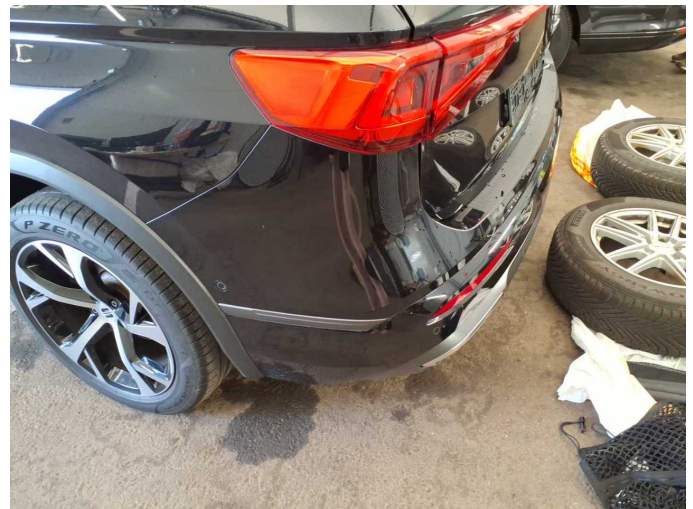
Damage 3: Rear bumper: Rear bumper - Scratch(es) - Paint

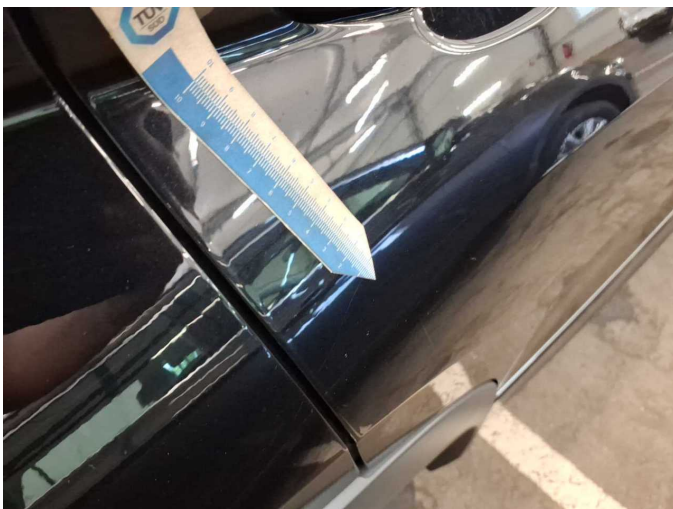
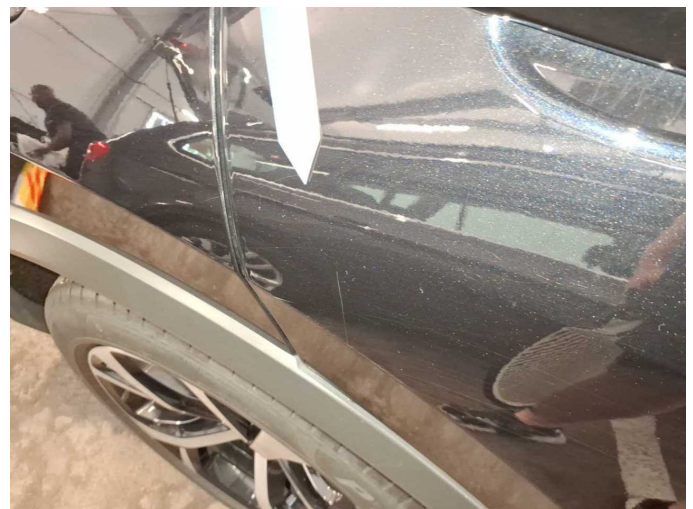
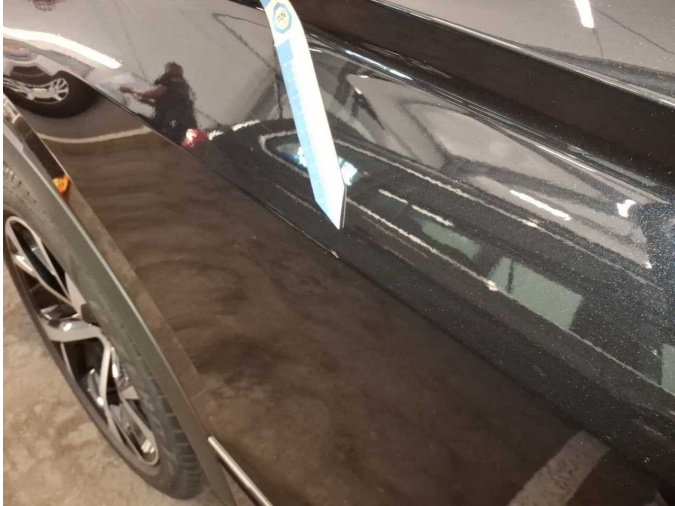
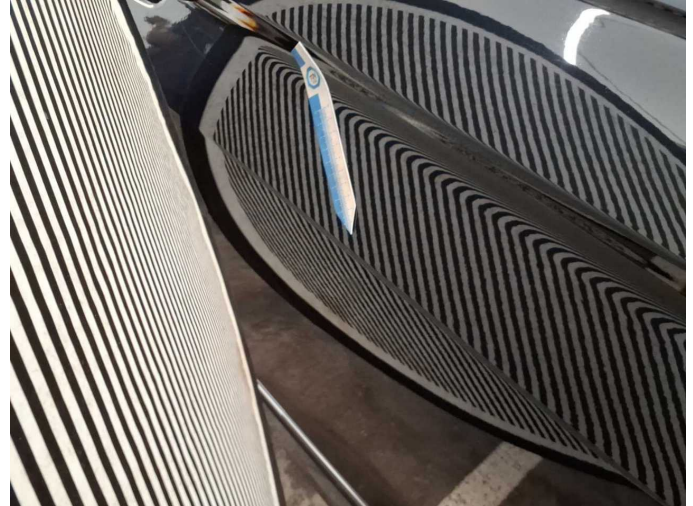
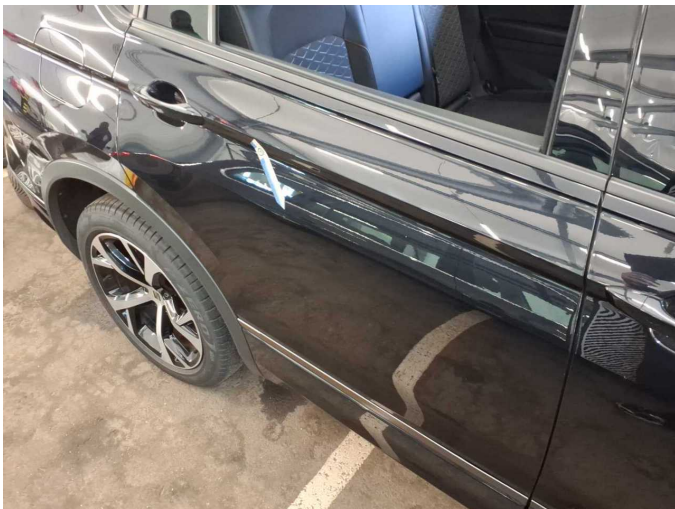
Damage 4: Door - rear right side: Door - Dent / paintcoat damage - Repair and paint

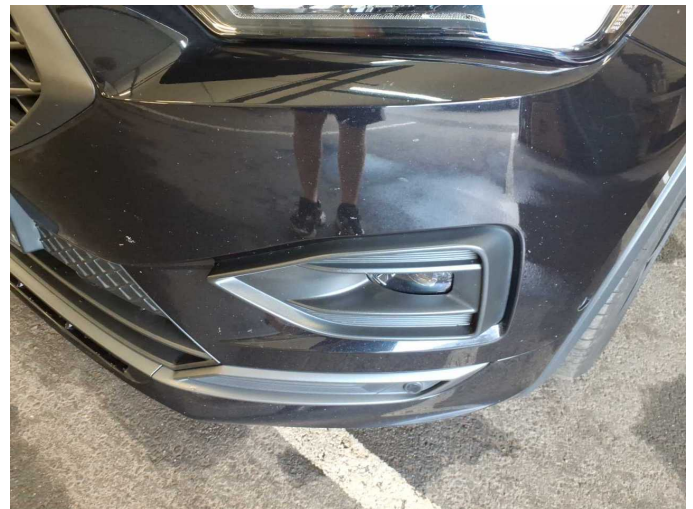
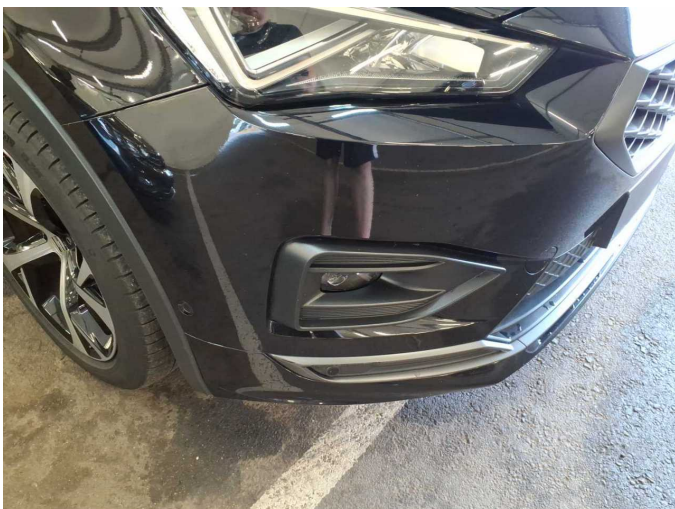
Wear and tear 1: Front bumper: Front bumper - Stone chips - No deduction

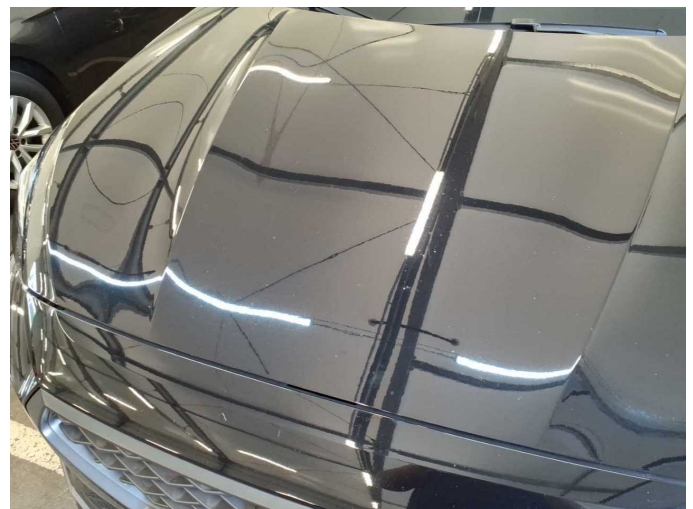
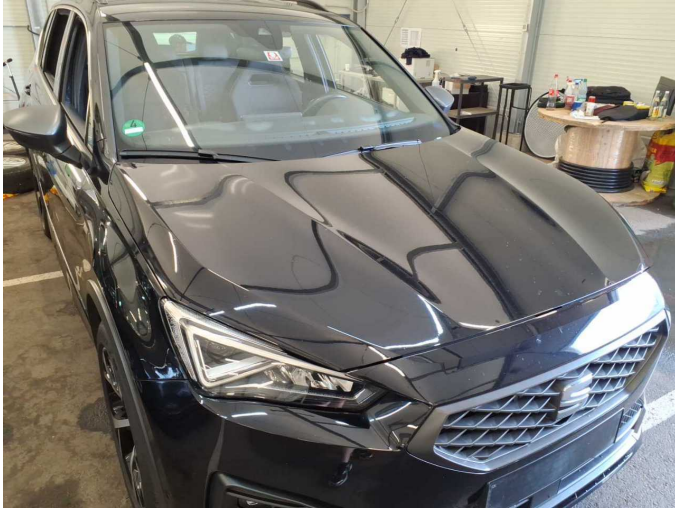
Wear and tear 2: Bonnet: Bonnet - Stone chips - No deduction
