Expertise

Protocol number: 46068120
Order No. / Reference: 26520730
Inspection date: 22 Jun 2026

Manufacturer: Seat

Model: Born 150kW/58kWh

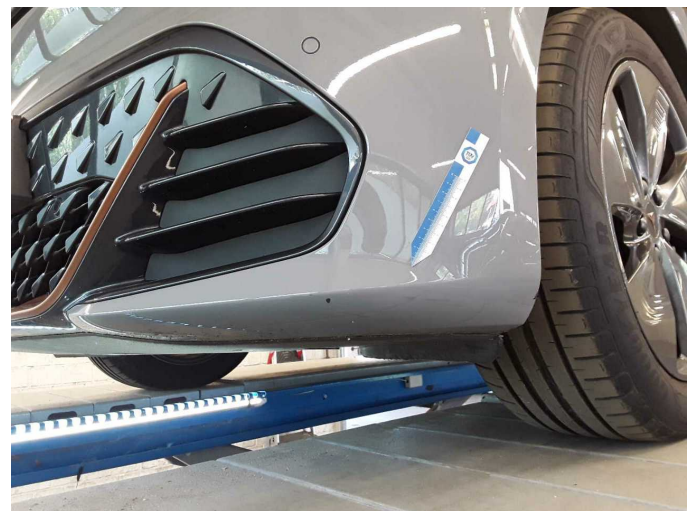
No.	Component group	Description
1	Front bumper	Front bumper - Scratch(es) - Smart repair
2	Wheel / tyres	Alloy rim - front left side - Scratched - Loss in value

Damage 1: Front bumper: Front bumper - Scratch(es) - Smart repair

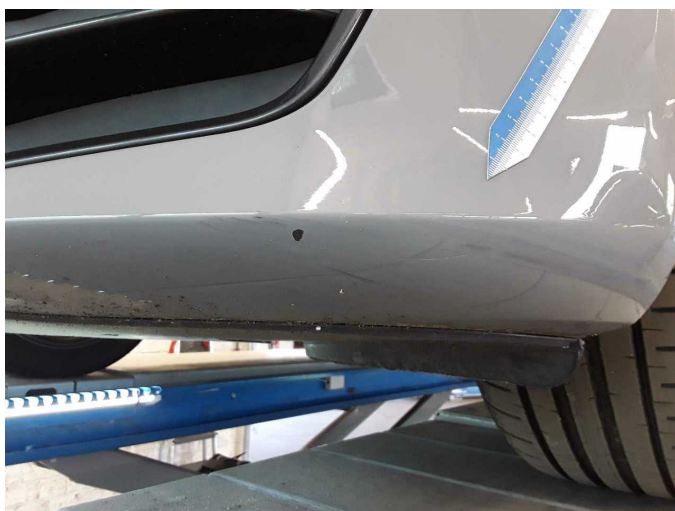
Damage 1: Front bumper: Front bumper - Scratch(es) - Smart repair

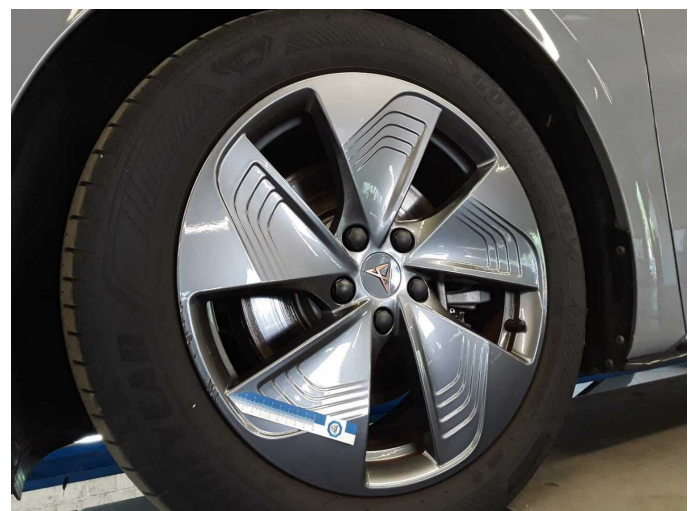
Damage 2: Wheel / tyres: Alloy rim - front left side - Scratched - Loss in value

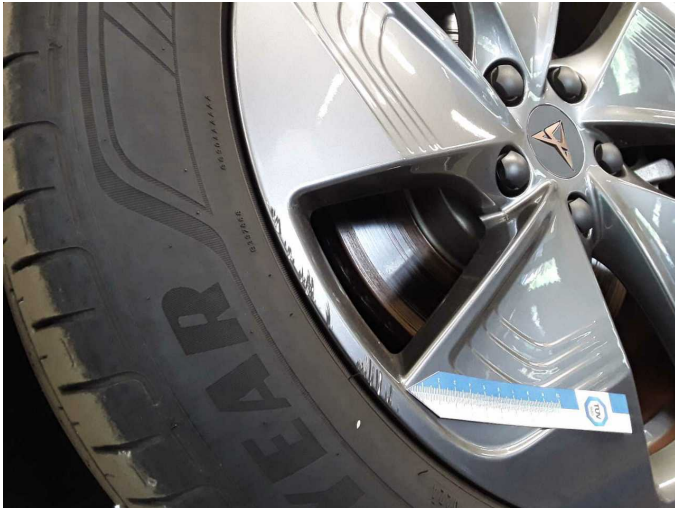
Damage 2: Wheel / tyres: Alloy rim - front left side - Scratched - Loss in value

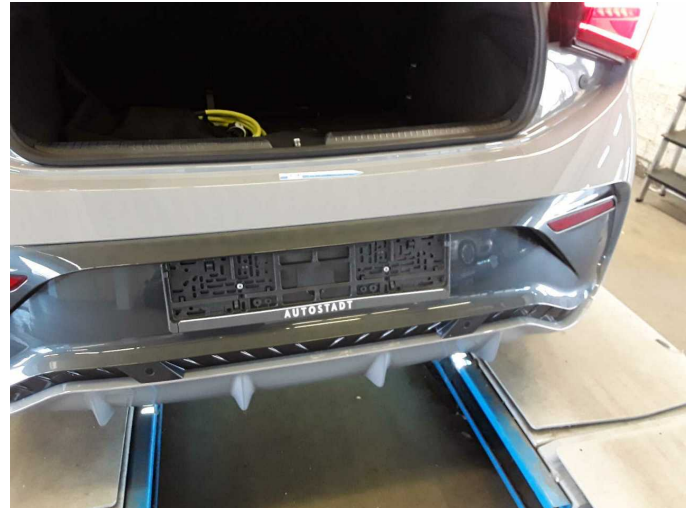
No.	Component group	Description
1	Rear bumper	Rear bumper - Scratch(es) - No deduction
2	Bonnet	Bonnet - Stone chips - No deduction
3	Vehicle glazing	Windscreen - Stone chips - No deduction

Wear and tear 1: Rear bumper: Rear bumper - Scratch(es) - No deduction

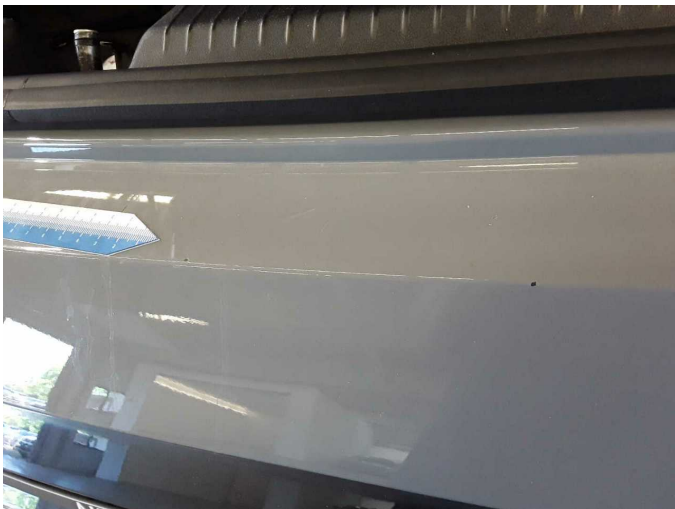
Wear and tear 1: Rear bumper: Rear bumper - Scratch(es) - No deduction

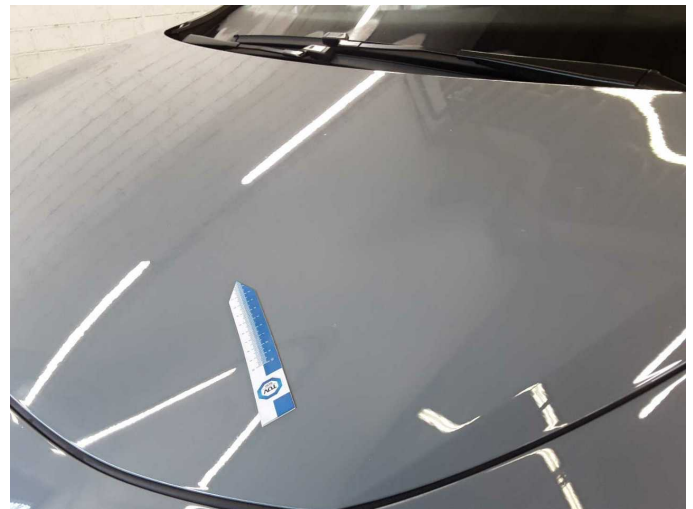
Wear and tear 2: Bonnet: Bonnet - Stone chips - No deduction

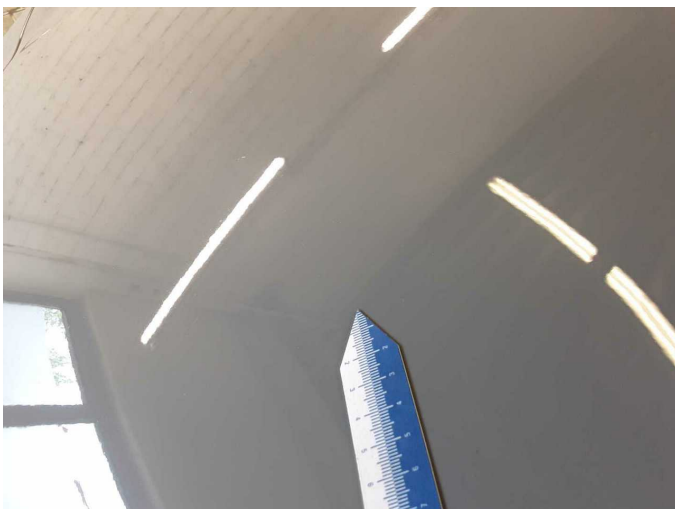
Wear and tear 2: Bonnet: Bonnet - Stone chips - No deduction

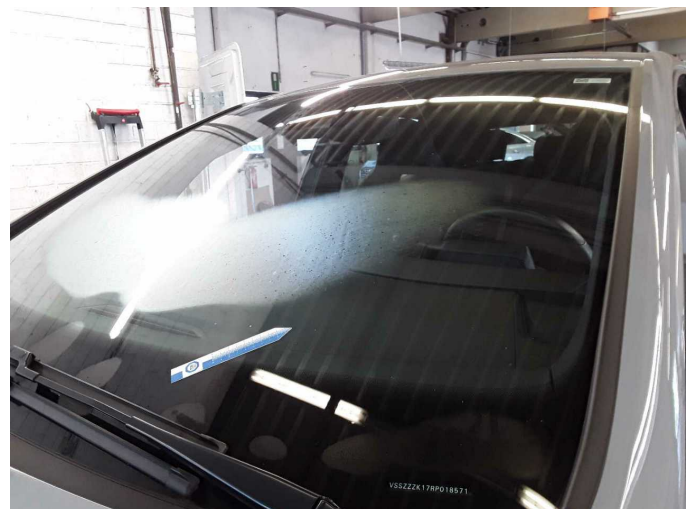
Wear and tear 3: Vehicle glazing: Windscreen - Stone chips - No deduction

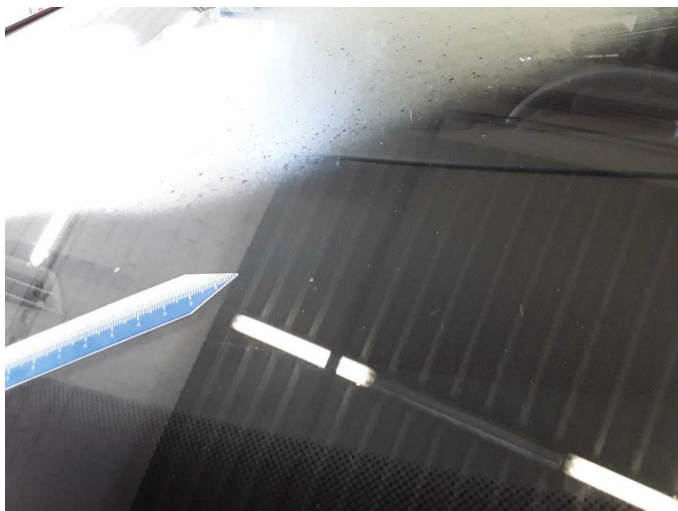
Wear and tear 3: Vehicle glazing: Windscreen - Stone chips - No deduction

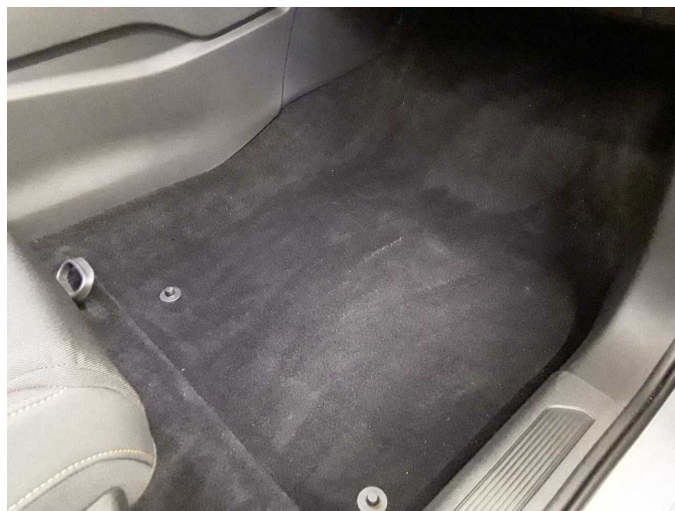
Trim / covers - Floor mats

Missing part 1: Trim / covers: Floor mats - Missing - Replace

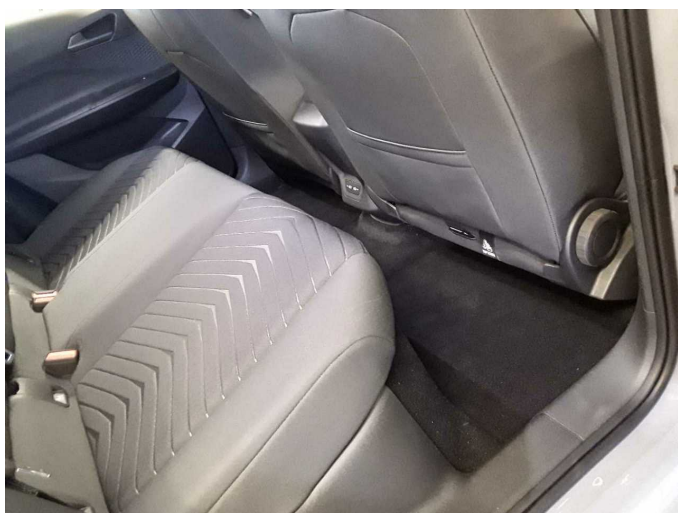
Missing part 1: Trim / covers: Floor mats - Missing - Replace
