## Expertise

Protocol number: 46220965  
Order No. / Reference: 26622725  
Inspection date: 29 Jun 2026

Manufacturer: CUPRA

Model: Leon Sportstourer 1.4 e-Hybrid (150 kW System)

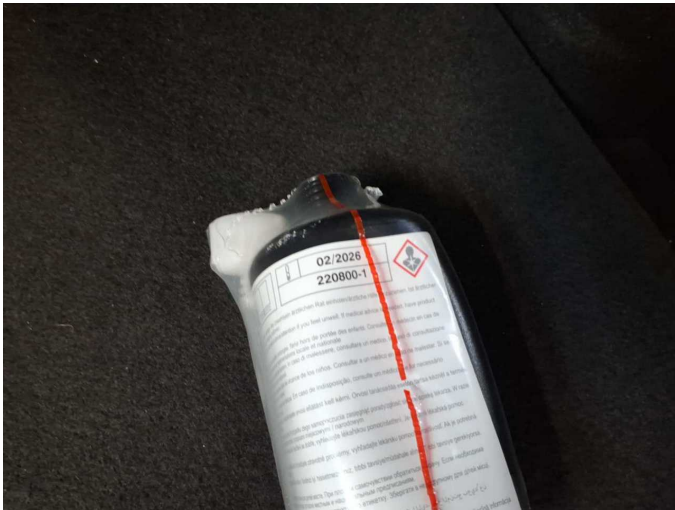
Damage 1: Equipment: Tirefit filler - Due - Replace

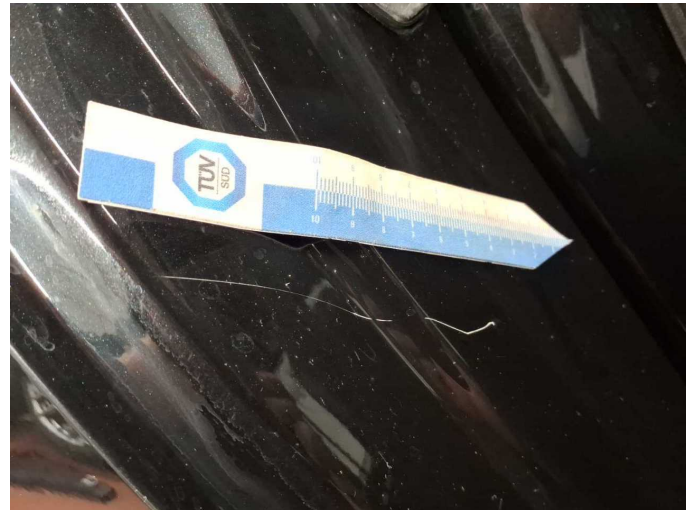
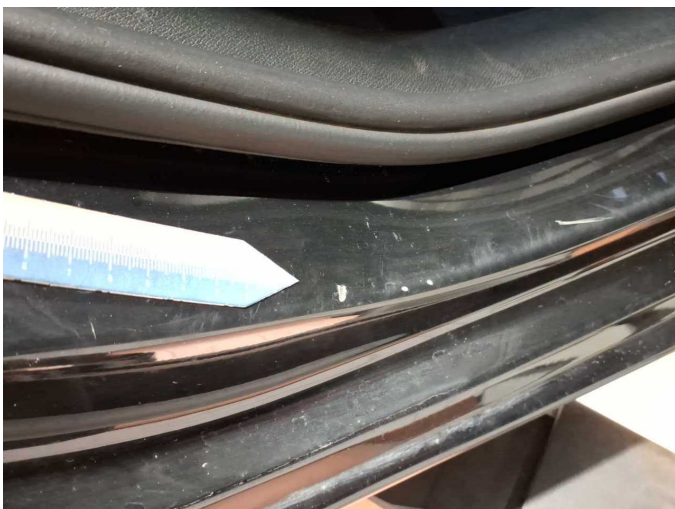
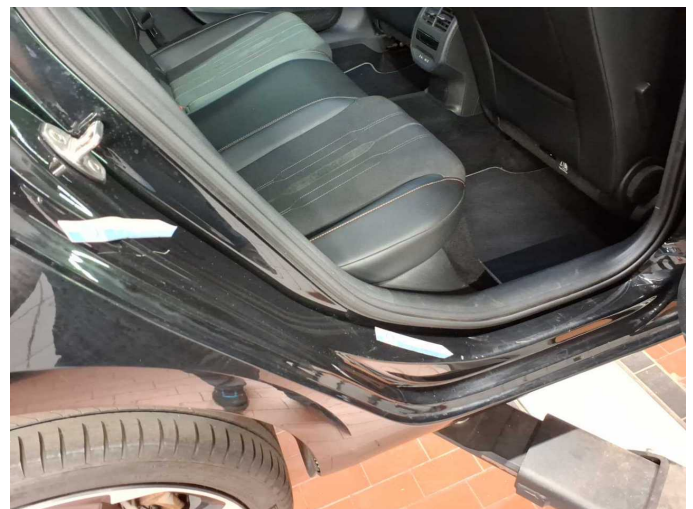
Damage 2: Side panel - rear right side: Sill - Scratch(es) - Smart repair

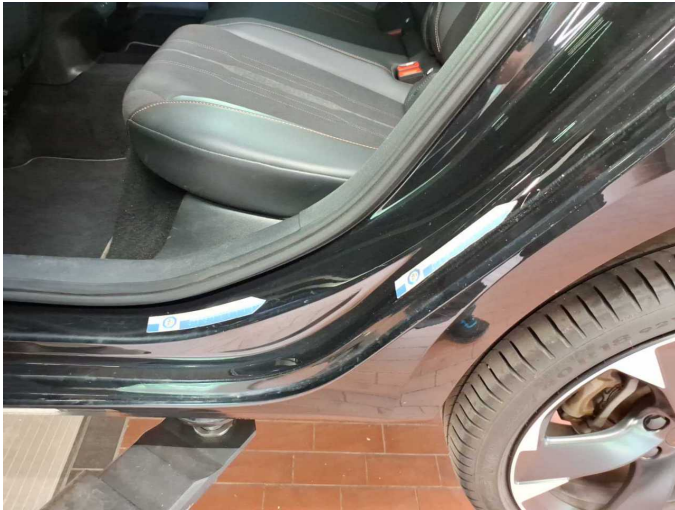
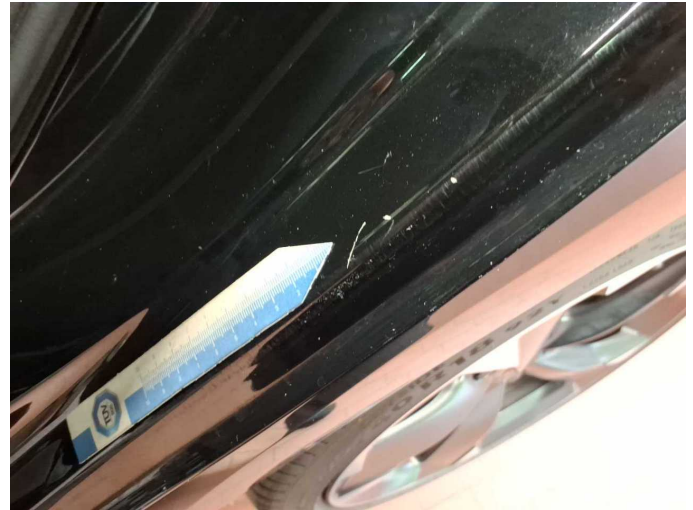
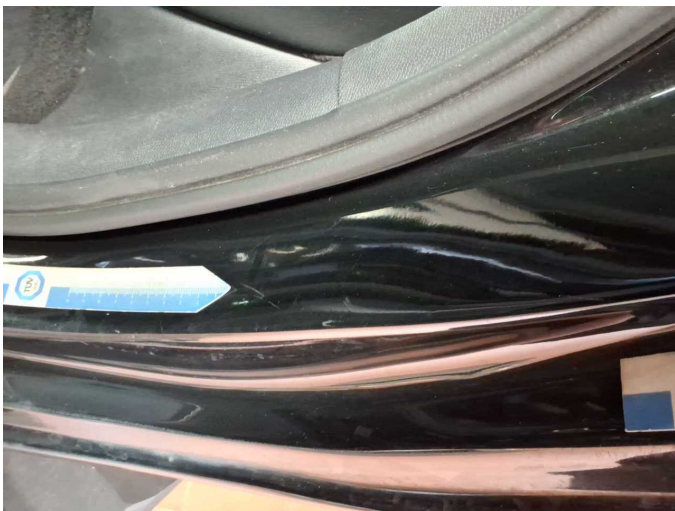
**Damage 3:** Side panel - rear left side: Sill - Scratch(es) - Smart repair

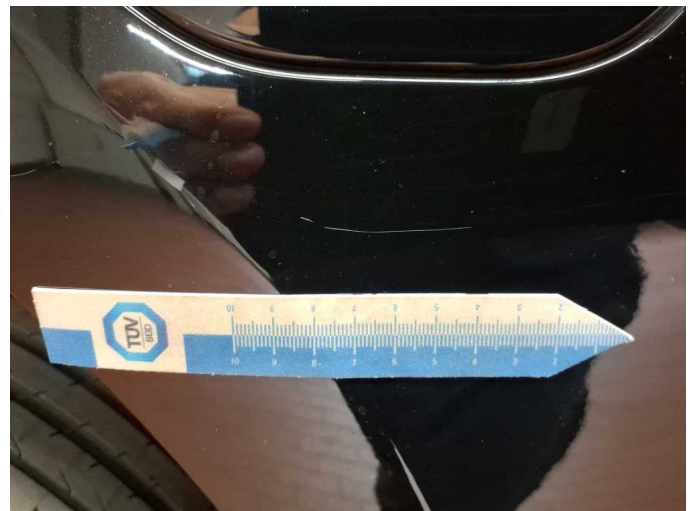
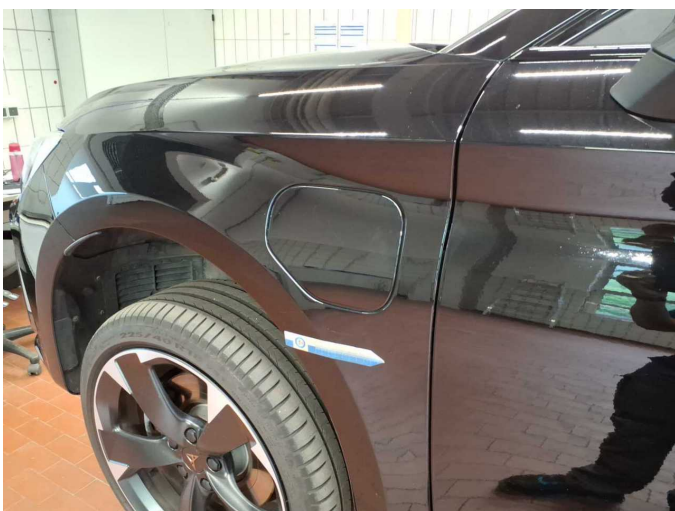
**Damage 4:** Mudguard - left side: Mudguard - left side - Scratch(es) - Smart repair

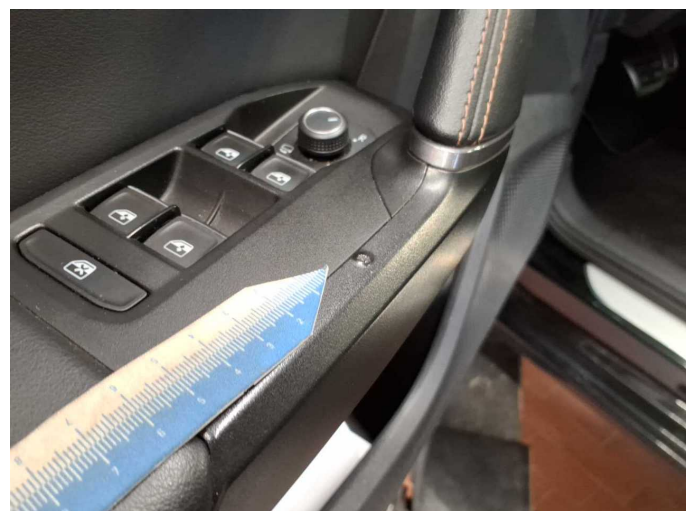
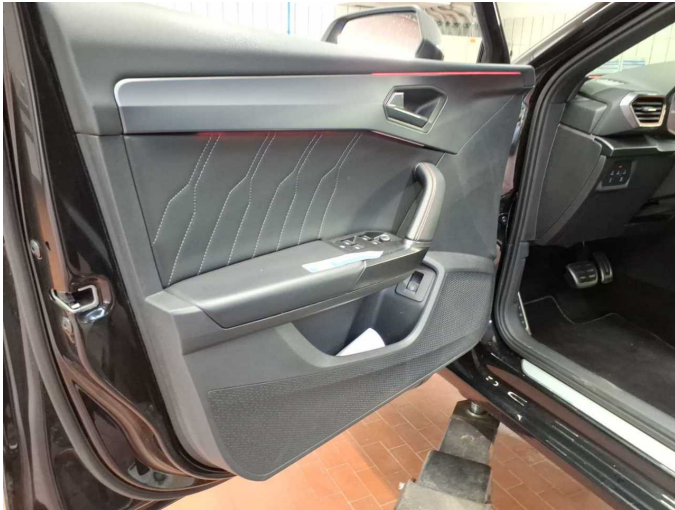
**Damage 5:** Trim / covers: Door trim - front left side (Blende) - Scratch(es) - Replace

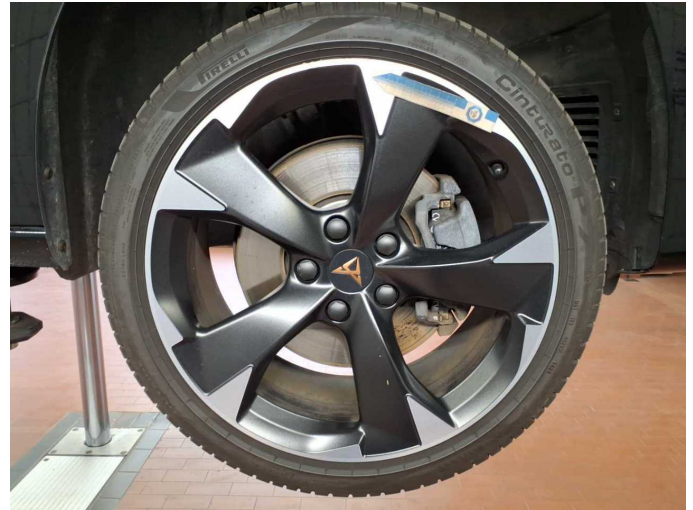
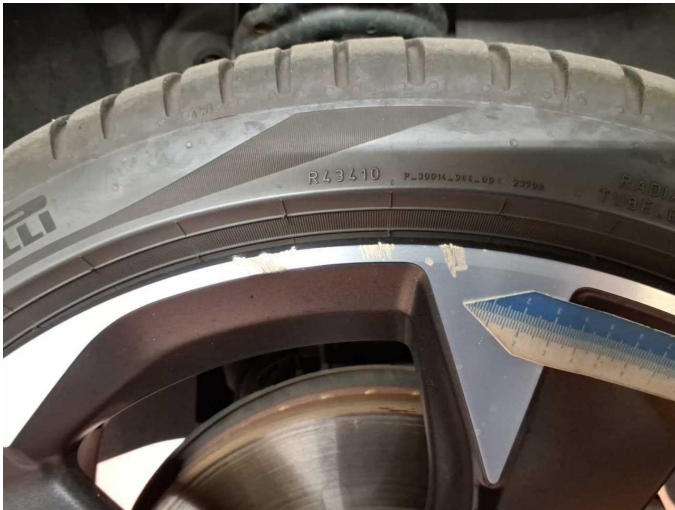
**Damage 6:** Wheel / tyres: Alloy rim - front right side - Scratch(es) - Loss in value

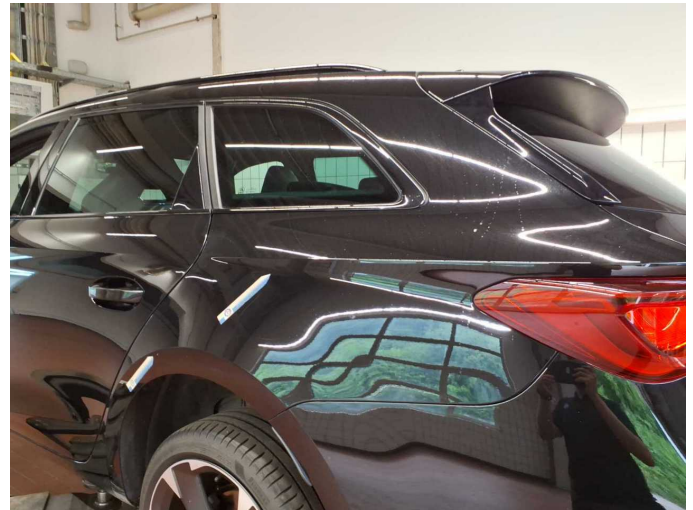
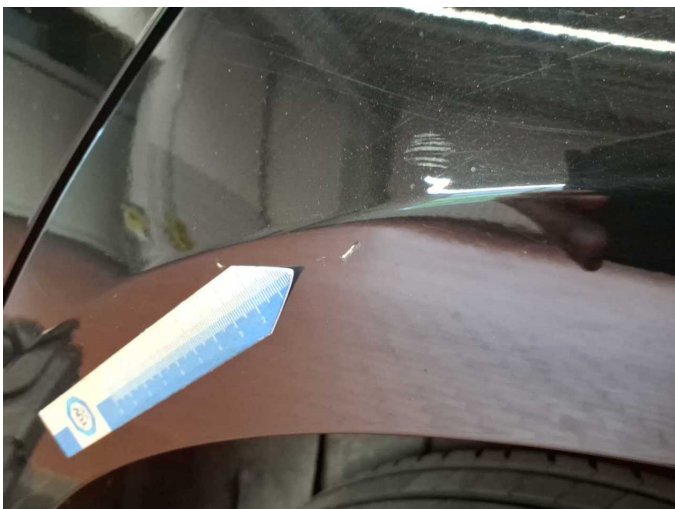
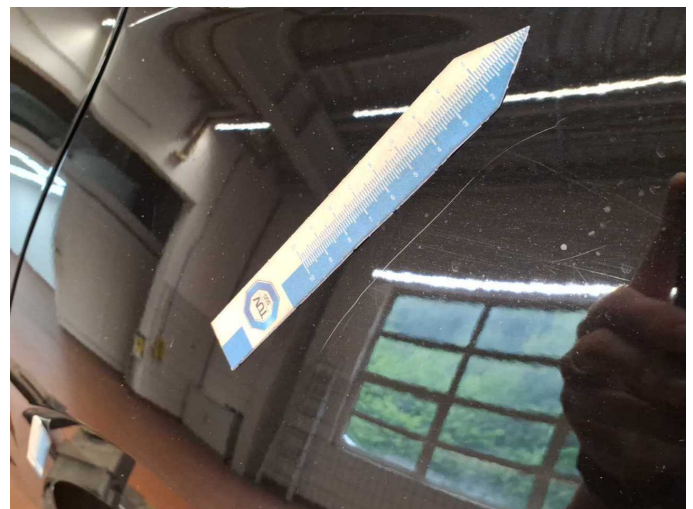
**Damage 7:** Side panel - rear left side: Side panel - Scratch(es) - Paint

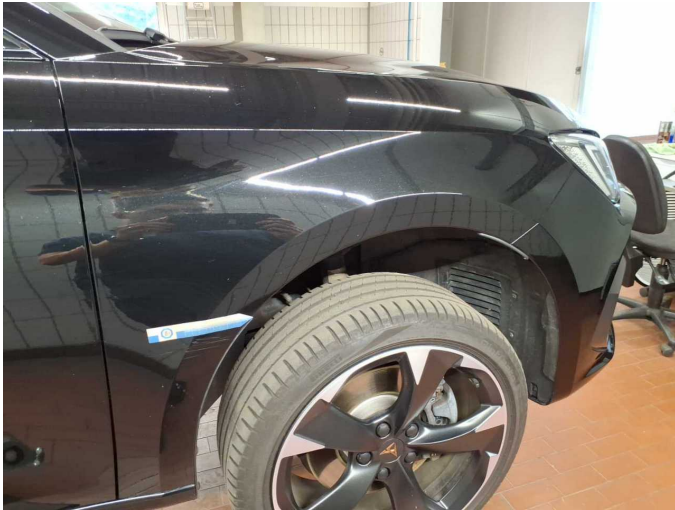
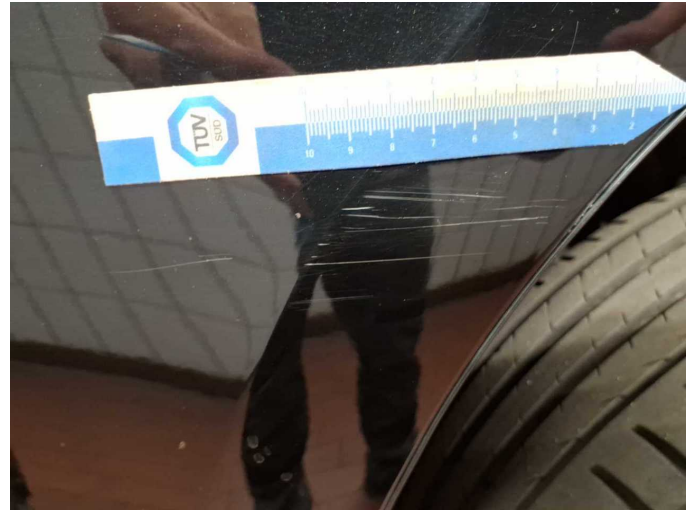
**Damage 8:** Mudguard - right side: Mudguard - right side - Scratch(es) - Paint

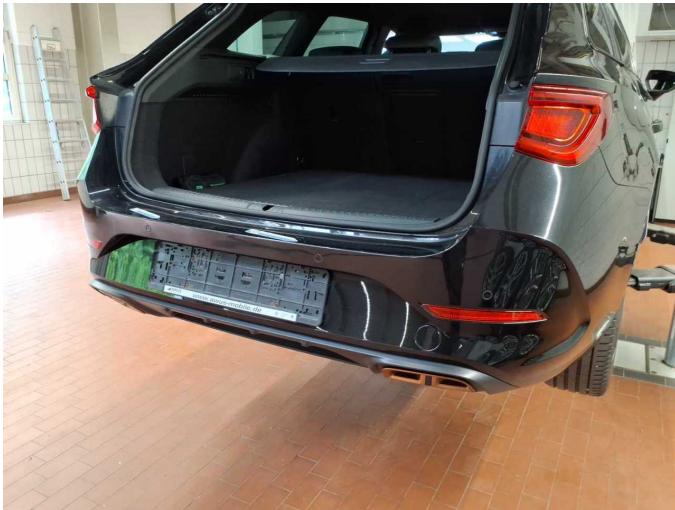
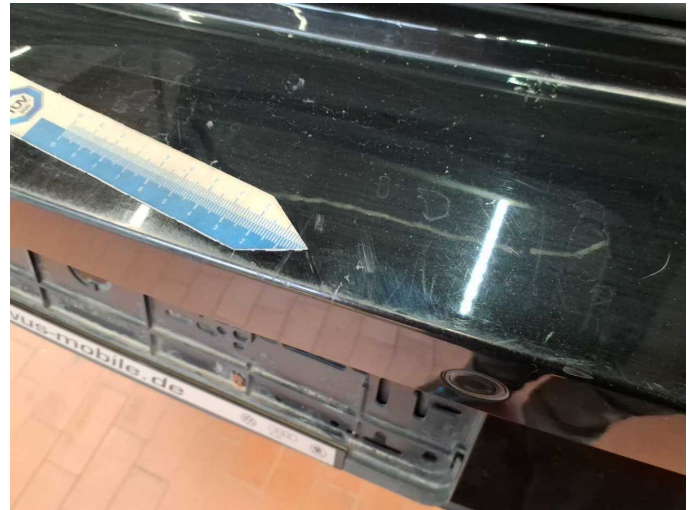
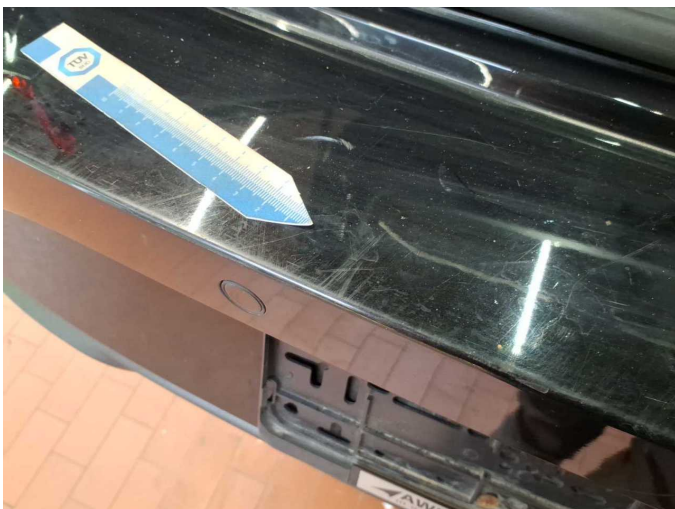
**Damage 9:** Rear bumper: Rear bumper - Scratch(es) - Paint

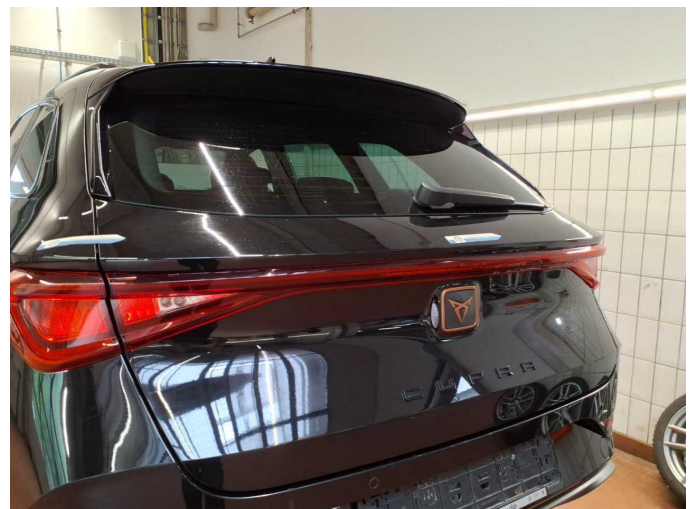
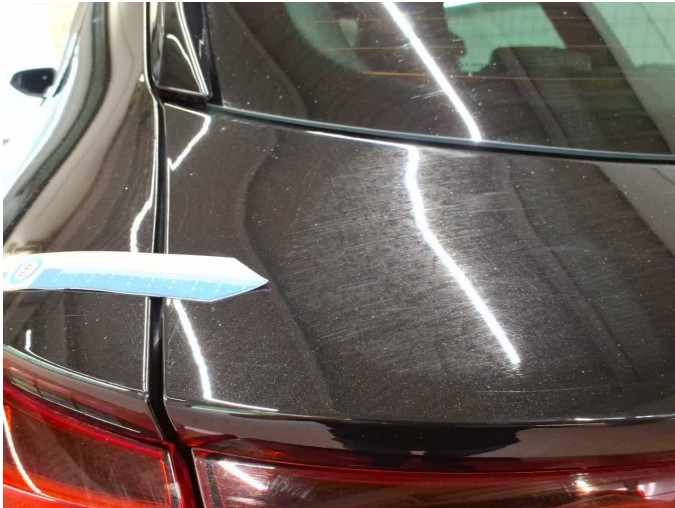
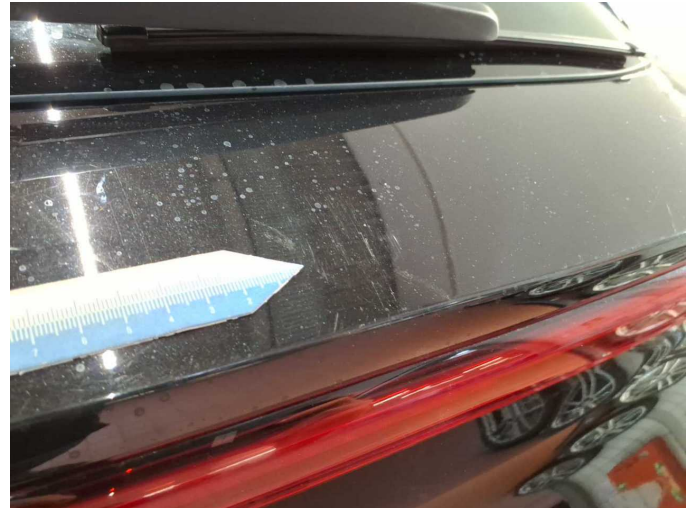
**Damage 10:** Boot lid / rear door: Boot lid - Scratch(es) - Paint

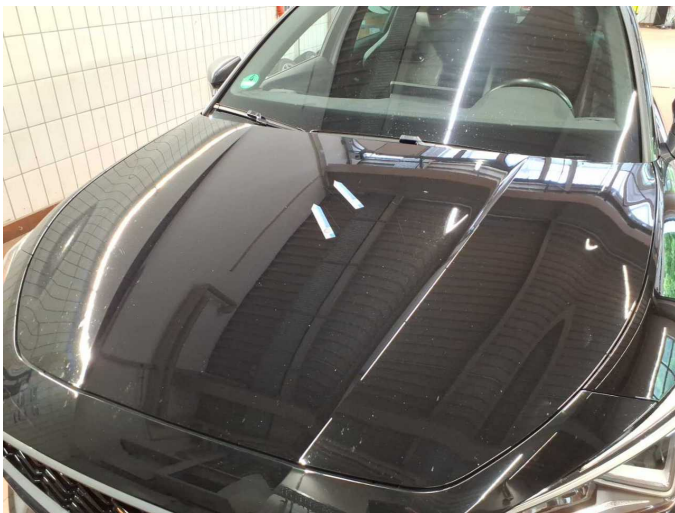
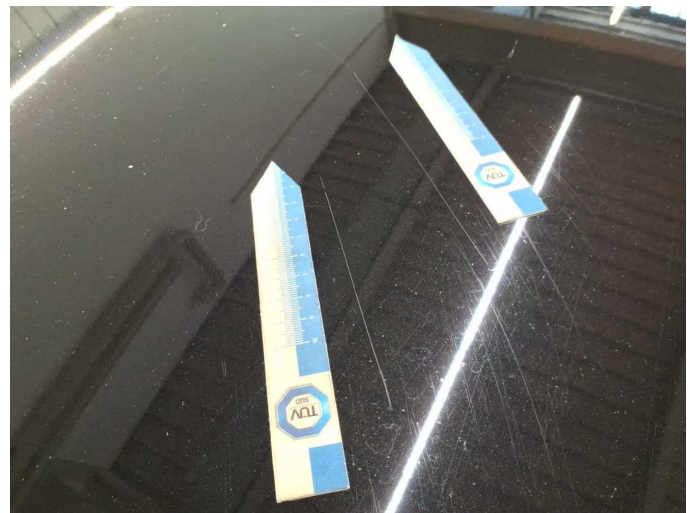
**Damage 11:** Bonnet: Bonnet - Stone chips - Paint

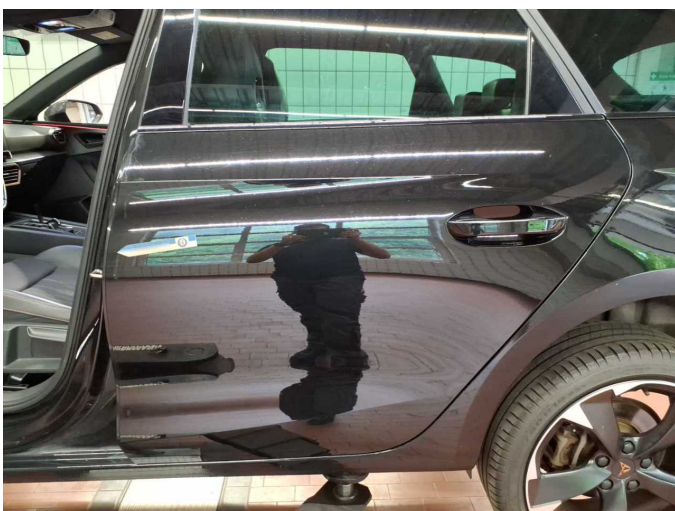
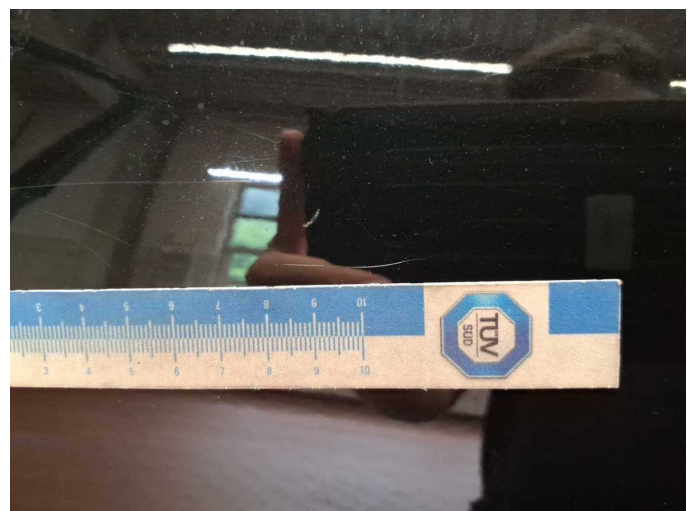
**Wear and tear 1:** Door - rear left side: Door - Scratch(es) - No deduction

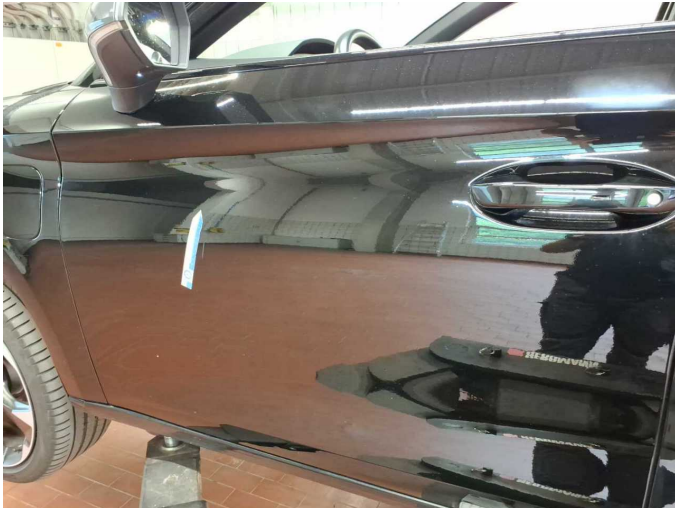
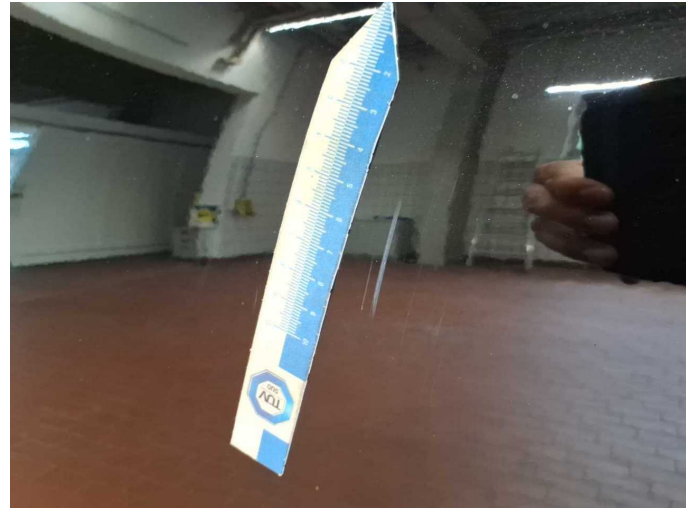
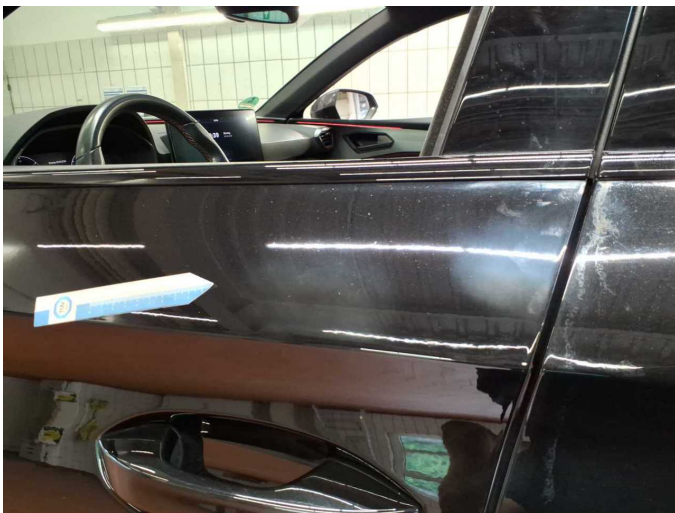
**Wear and tear 2:** Door - front left side: Door - Scratch(es) - No deduction

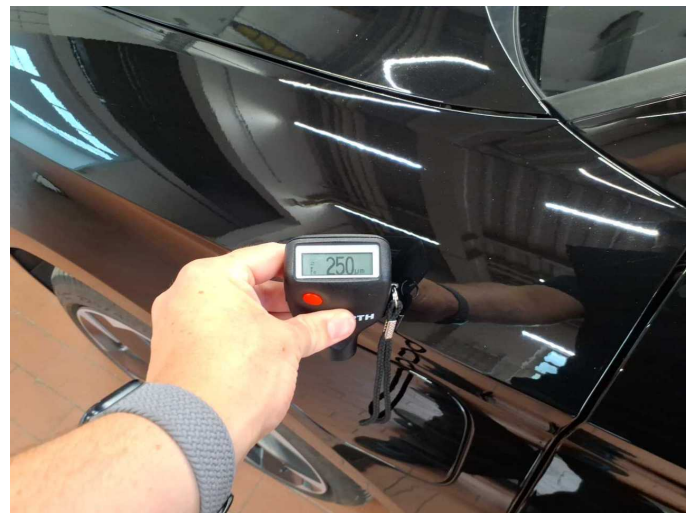
Mudguard - left side	250 µm	Door - front left side	270 µm
----------------------	--------	------------------------	--------

**Repainting 1:** Mudguard - left side

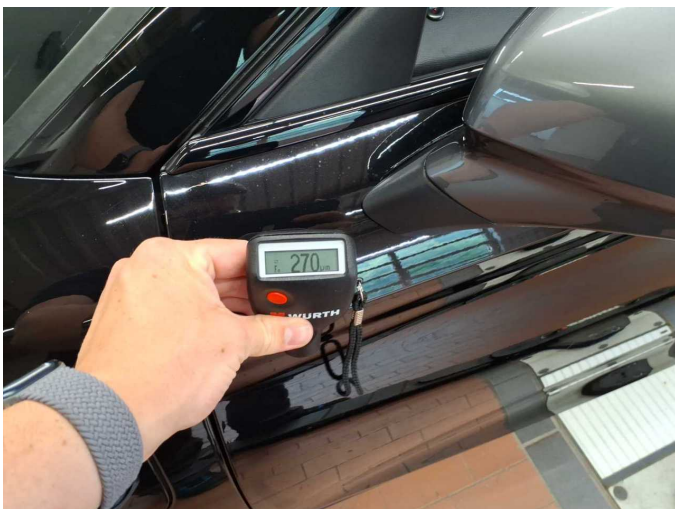
**Repainting 2:** Door - front left side
