Expertise

Protocol number: 46360171
Order No. / Reference: 26490095
Inspection date: 6 Jul 2026

Manufacturer: Ford

Model: Kuga 2.5 Duratec FHEV TITANIUM

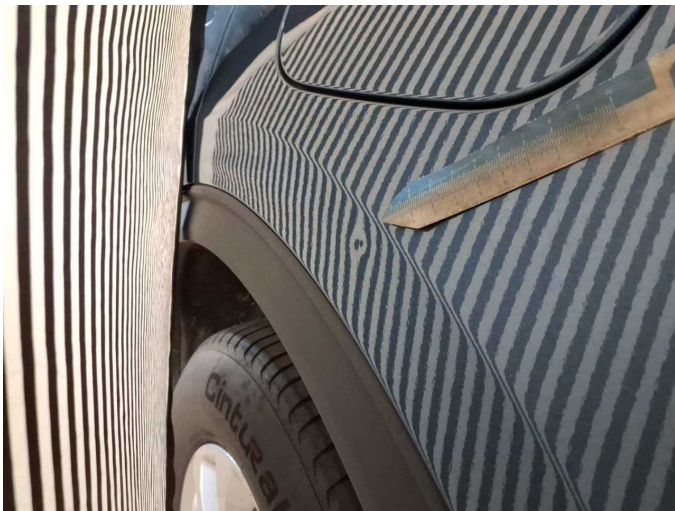
Damage 1: Side panel - rear left side: Side panel - dent(s) - Smooth repair work

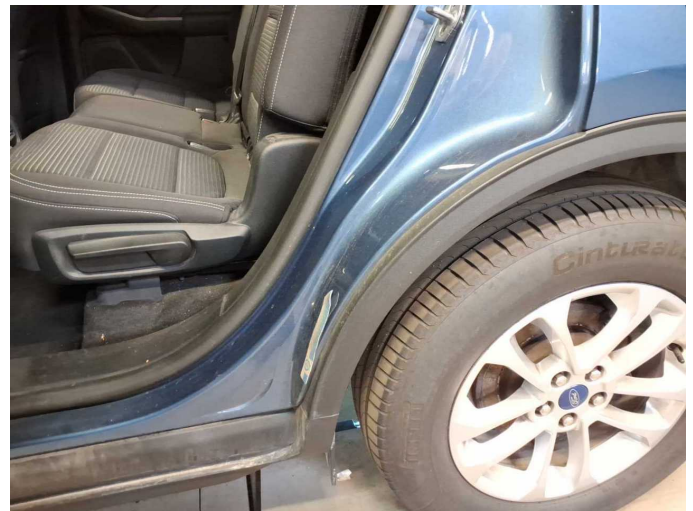
Damage 1: Side panel - rear left side: Side panel - dent(s) - Smooth repair work

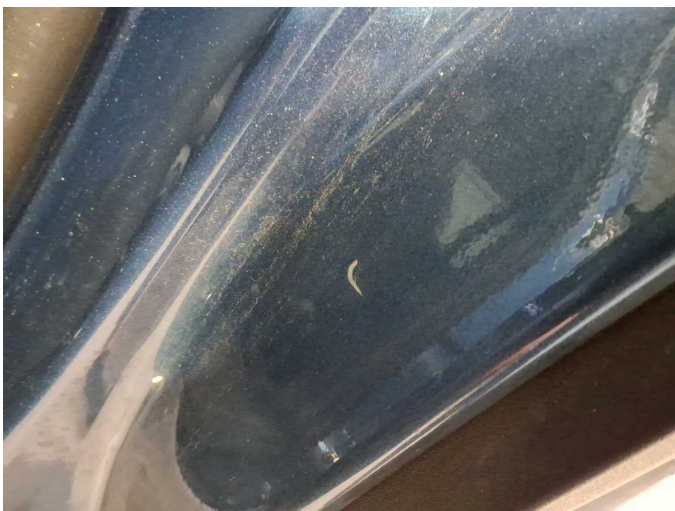
Damage 2: Side panel - rear left side: Sill - Dent / paintcoat damage - Smart repair

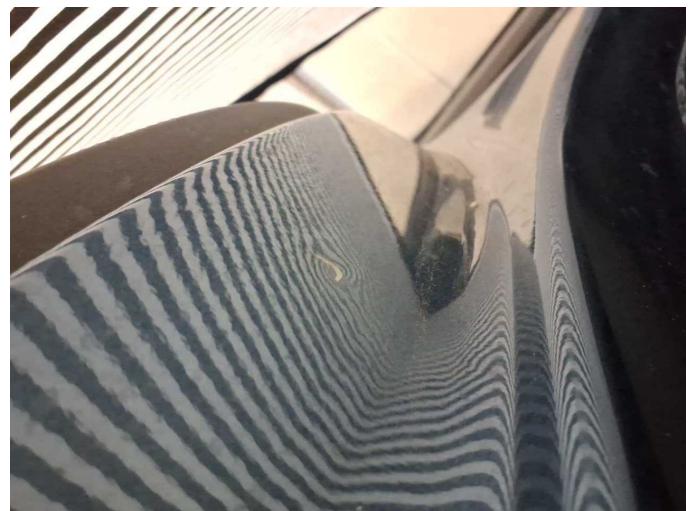
Damage 2: Side panel - rear left side: Sill - Dent / paintcoat damage - Smart repair

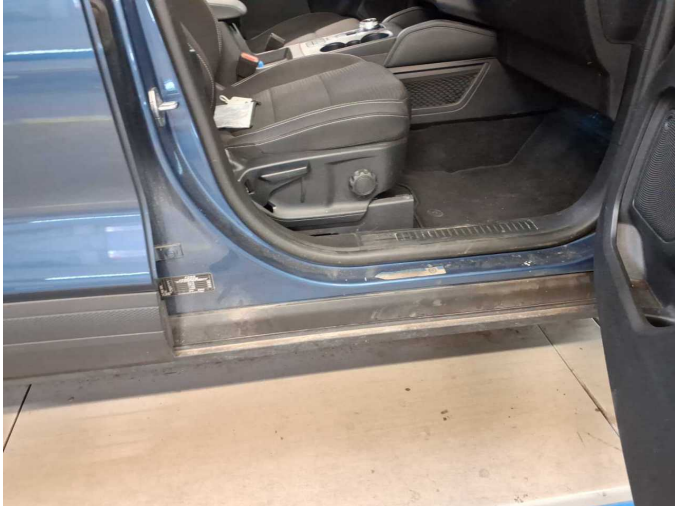
Damage 2: Side panel - rear left side: Sill - Dent / paintcoat damage - Smart repair

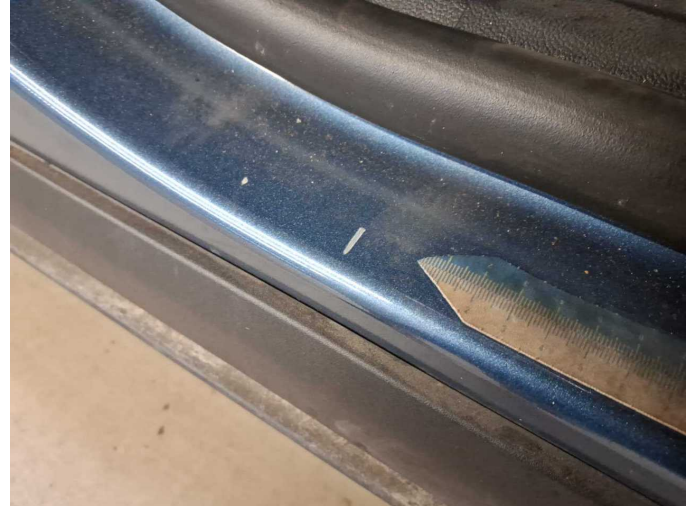
Damage 3: Sill - right side: Sill - Dent / paintcoat damage - Smart repair

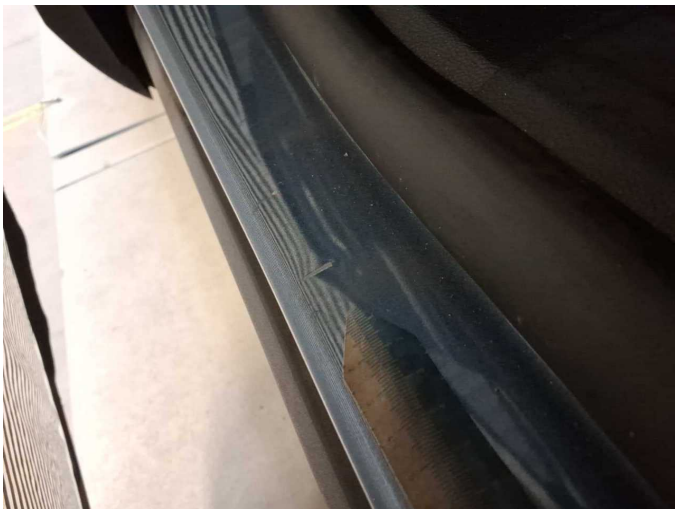
Damage 3: Sill - right side: Sill - Dent / paintcoat damage - Smart repair

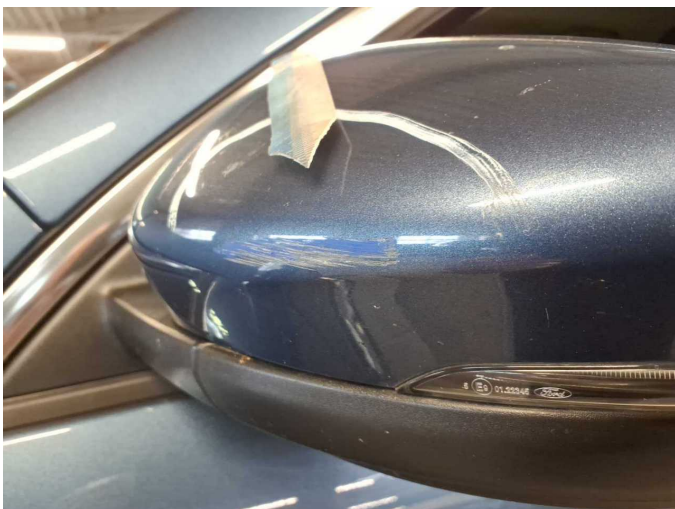
Damage 4: Wing mirror - left side: Cap - Scratch(es) - Paint

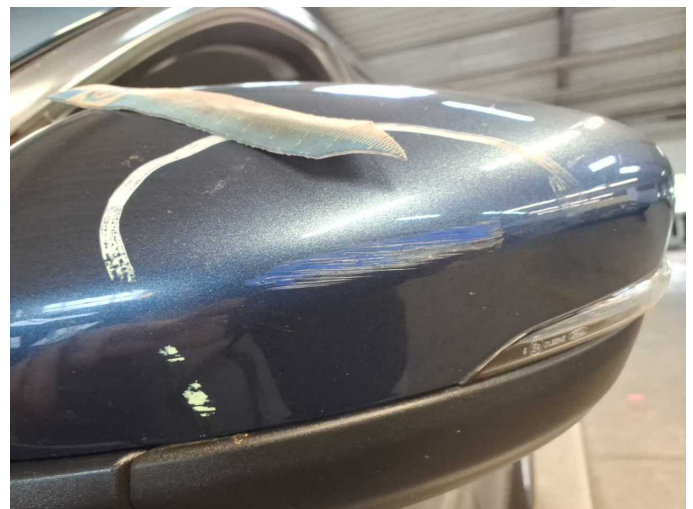
Damage 4: Wing mirror - left side: Cap - Scratch(es) - Paint

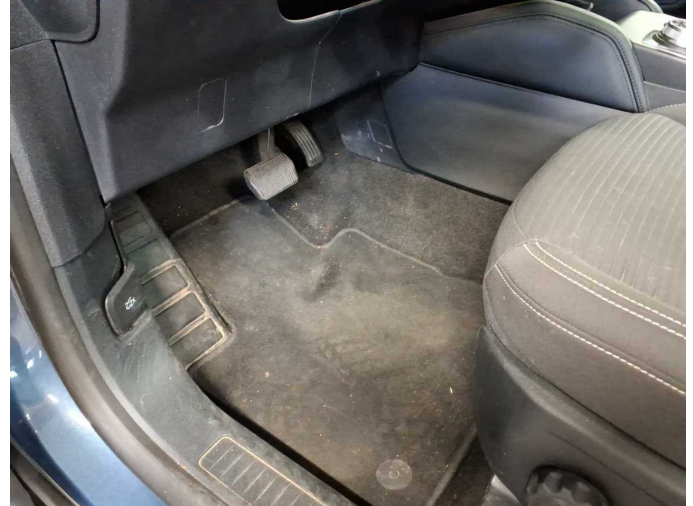
Damage 5: Interior: Interior - Soiled - Clean

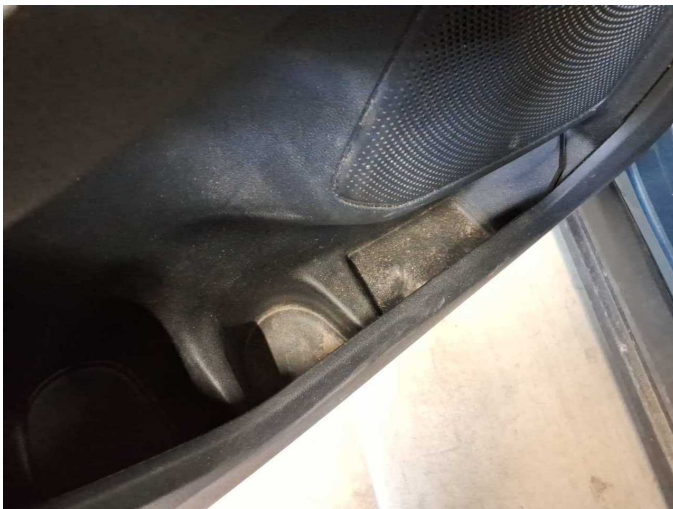
Damage 5: Interior: Interior - Soiled - Clean

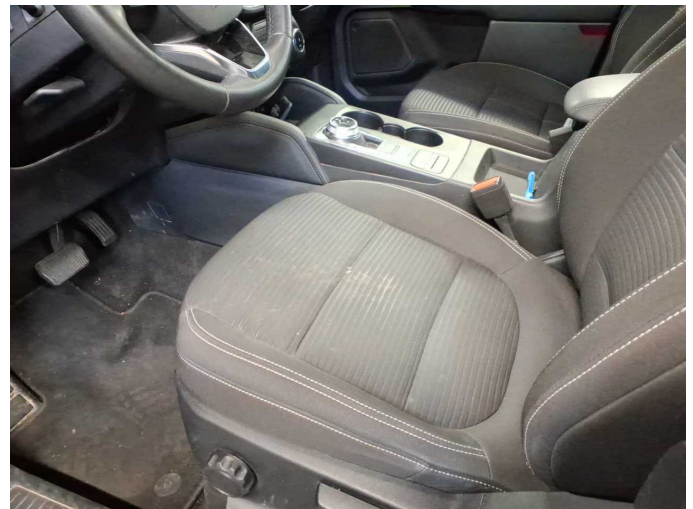
Damage 5: Interior: Interior - Soiled - Clean

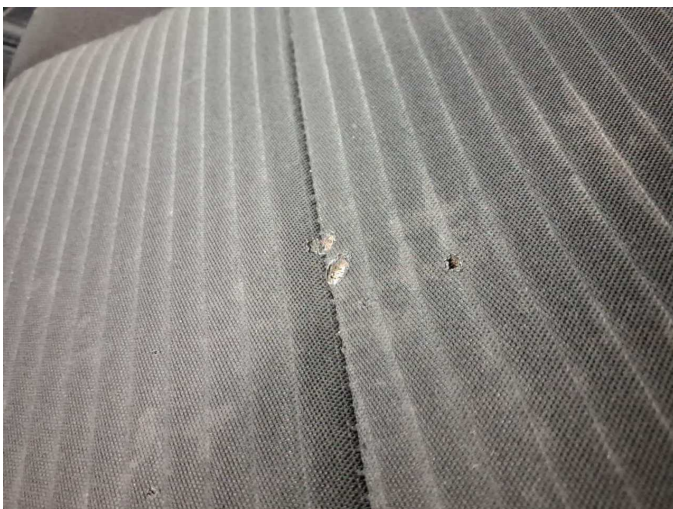
Damage 6: Seat - front: Seat cover - left side - Burn hole (cigarettes) - Replace

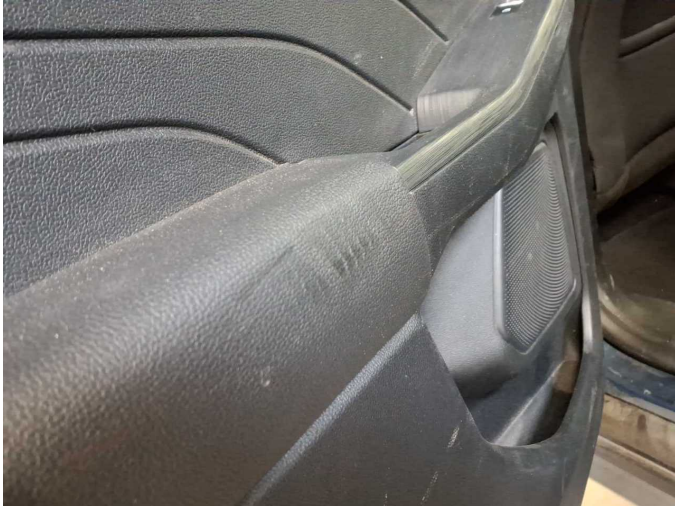
Damage 7: Trim / covers: Door trim - rear left side - Deformed - Replace

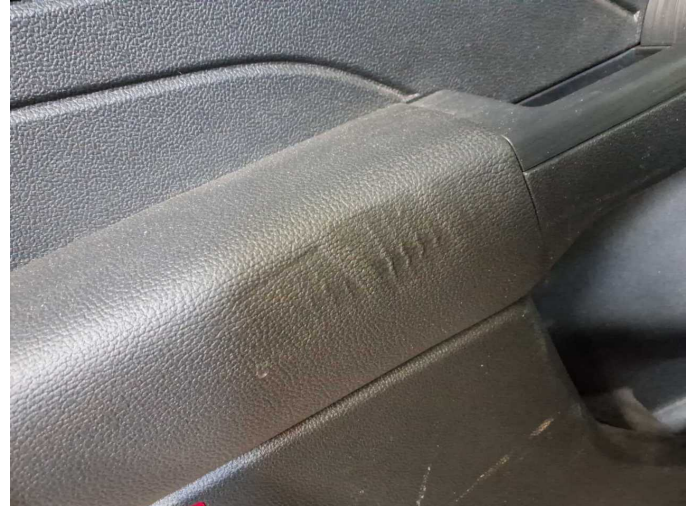
Damage 7: Trim / covers: Door trim - rear left side - Deformed - Replace

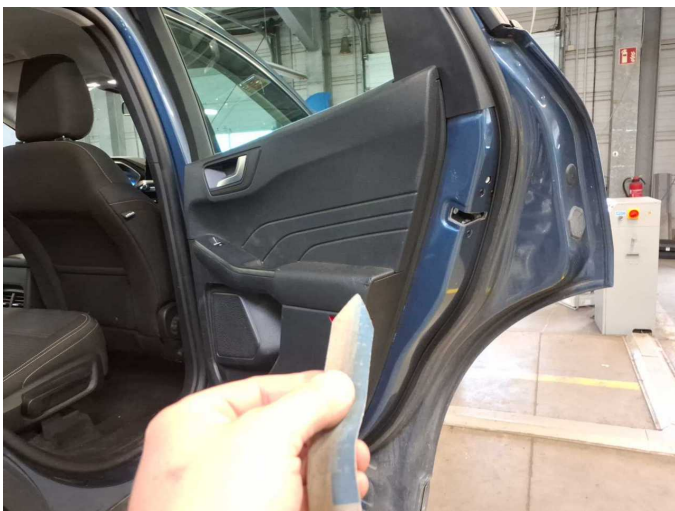
Damage 7: Trim / covers: Door trim - rear left side - Deformed - Replace

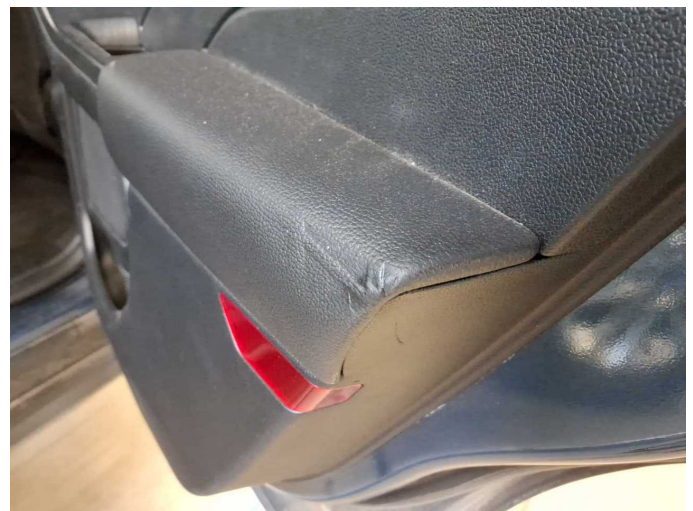
Damage 8: Trim / covers: Door trim - rear right side - Deformed - Replace

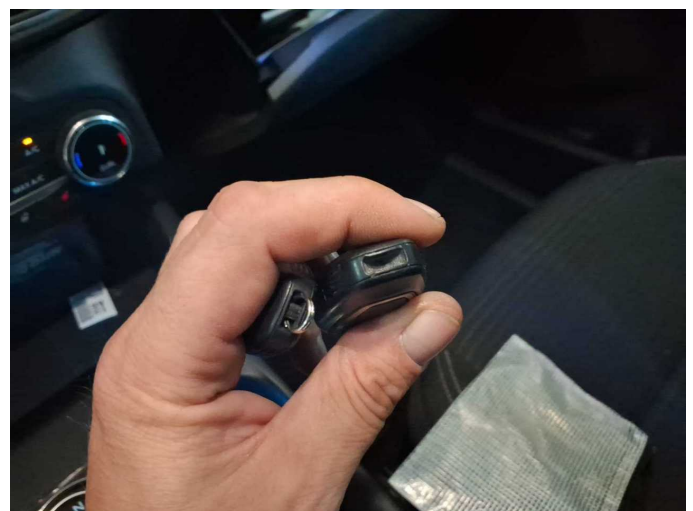
Damage 9: Equipment: Vehicle key with remote control - Damaged - Replace

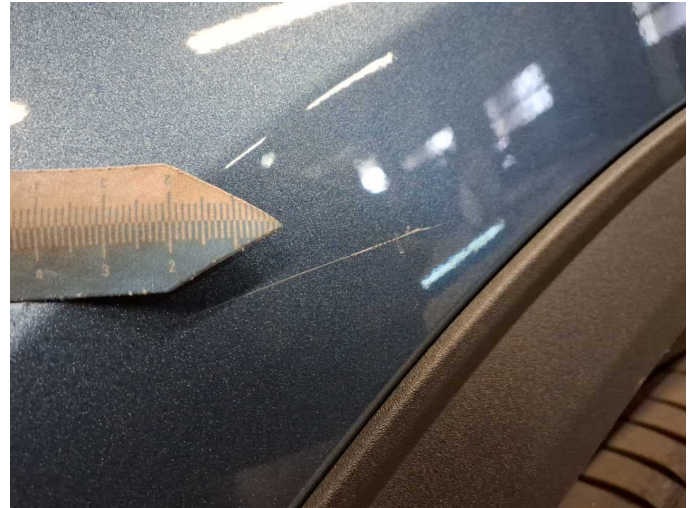
Damage 10: Side panel - rear right side: Side panel - Scratch(es) - Paint

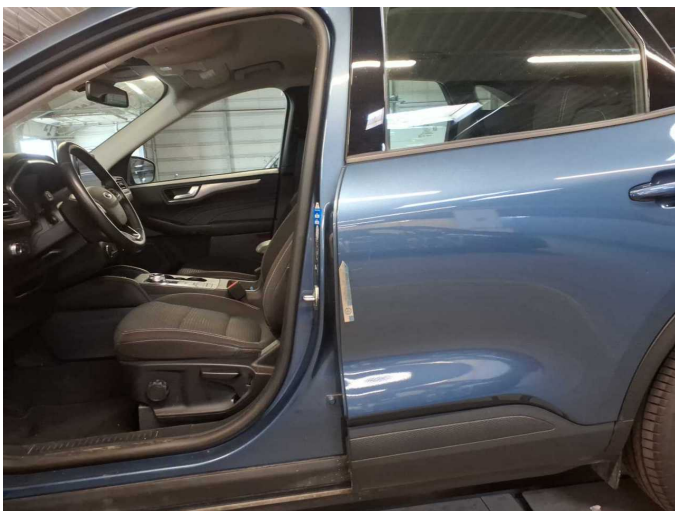
Damage 10: Side panel - rear right side: Side panel - Scratch(es) - Paint

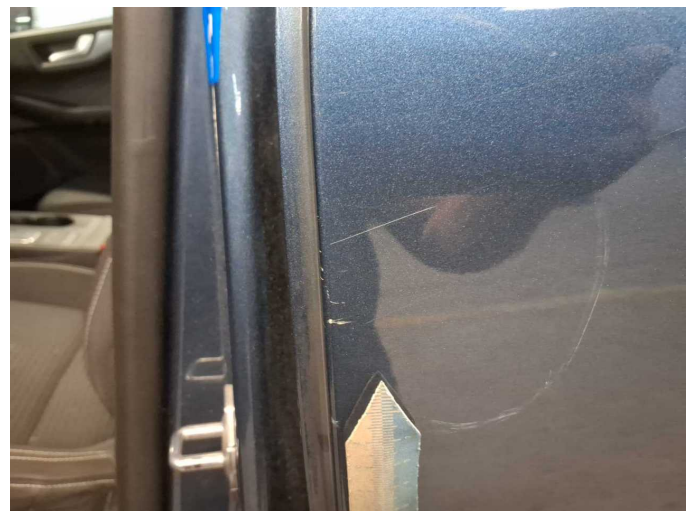
Damage 11: Door - rear left side: Door - Scratch(es) - Paint

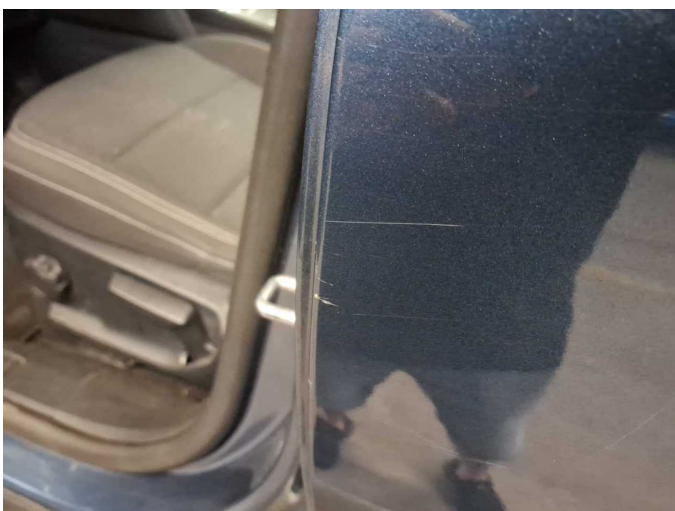
Damage 11: Door - rear left side: Door - Scratch(es) - Paint

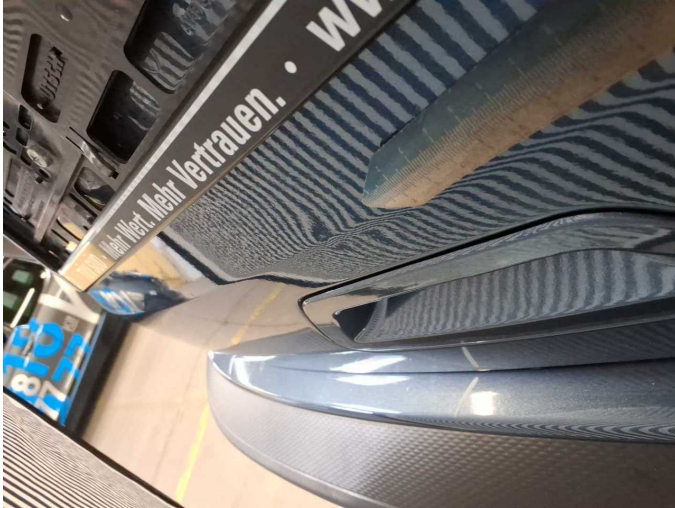
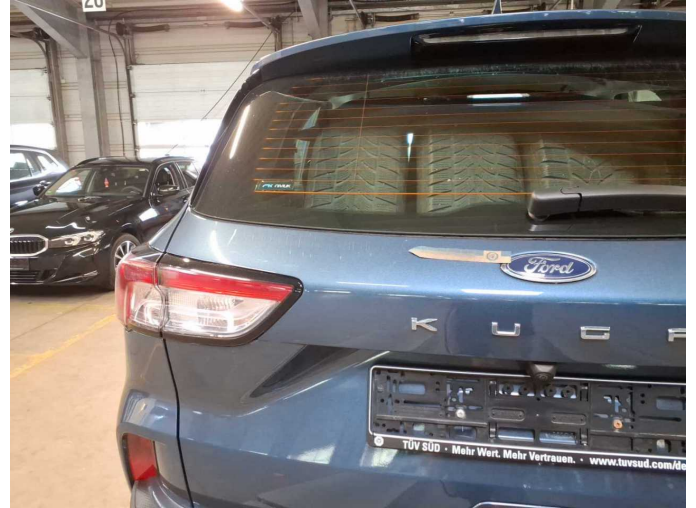
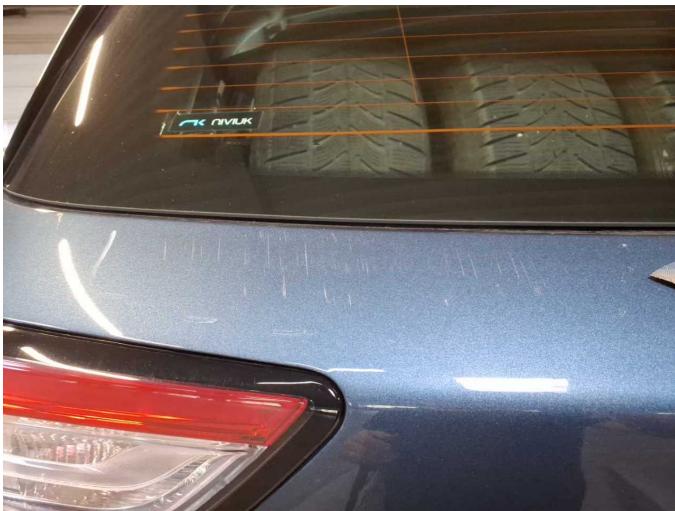
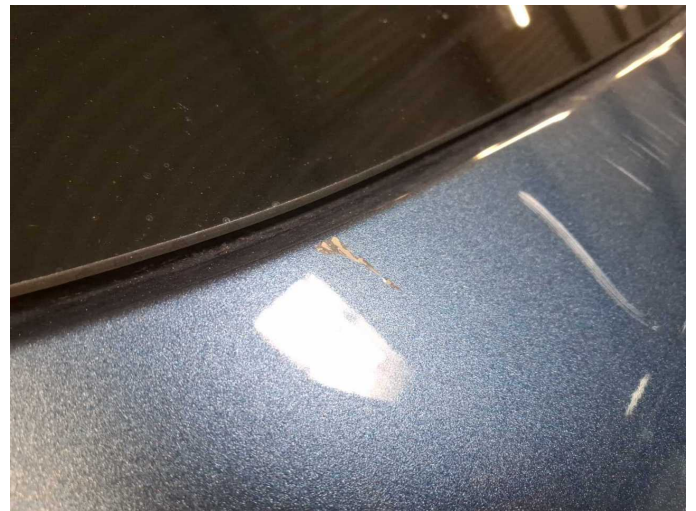
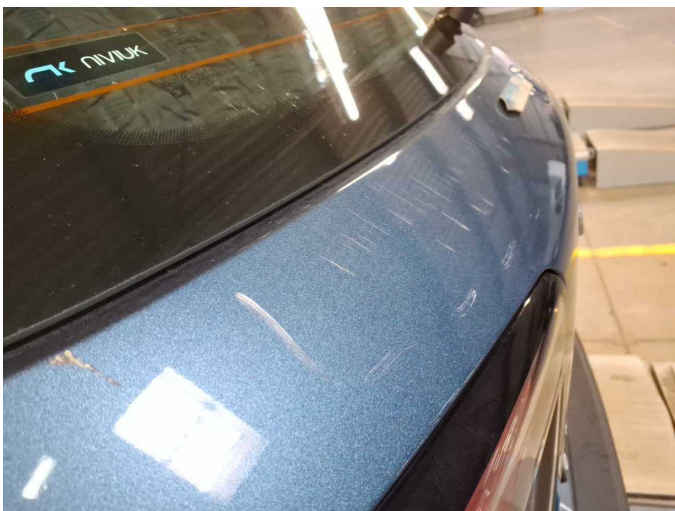
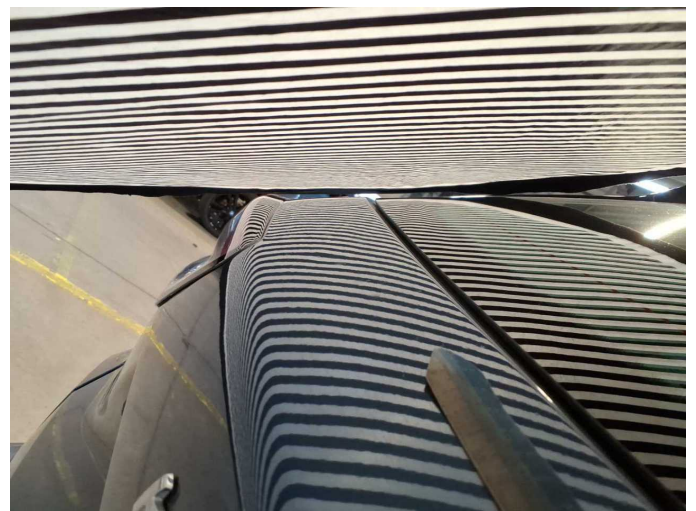
Damage 12: Boot lid / rear door: Boot lid - Dent / paintcoat damage - Repair and paint

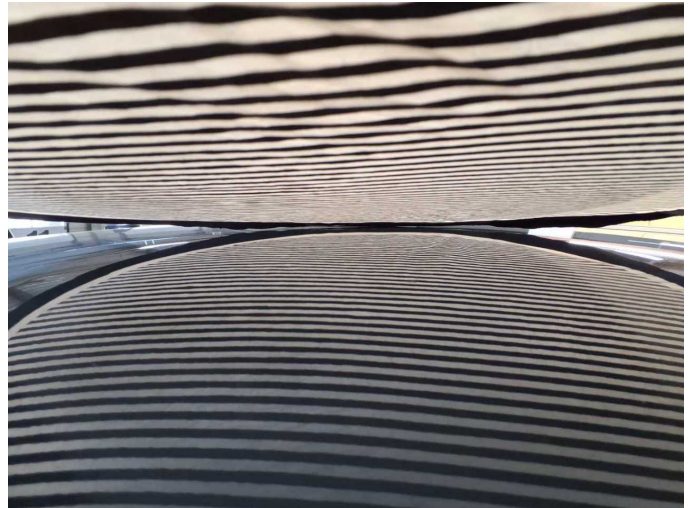
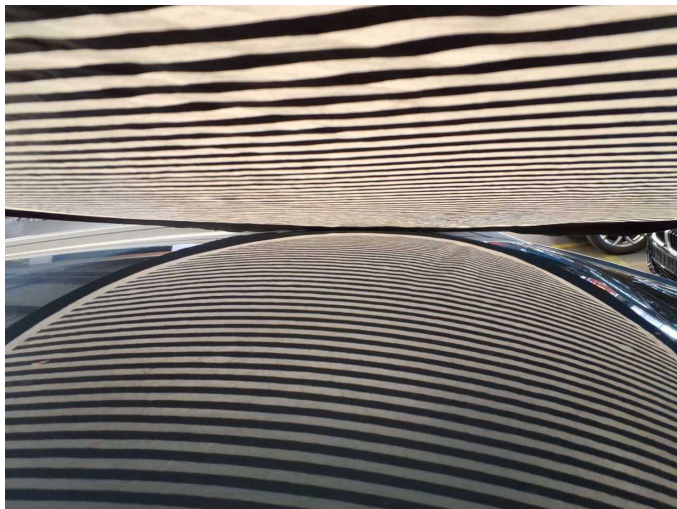
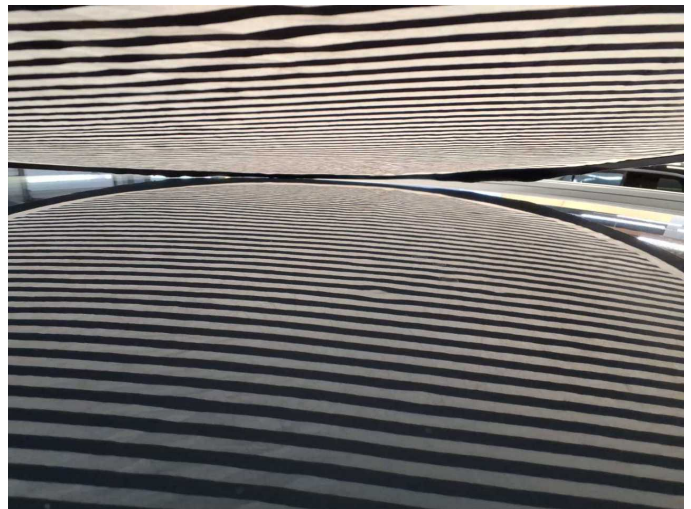
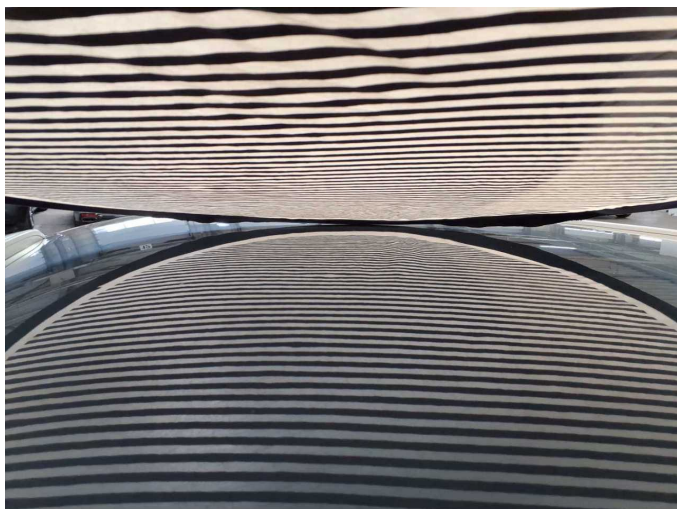
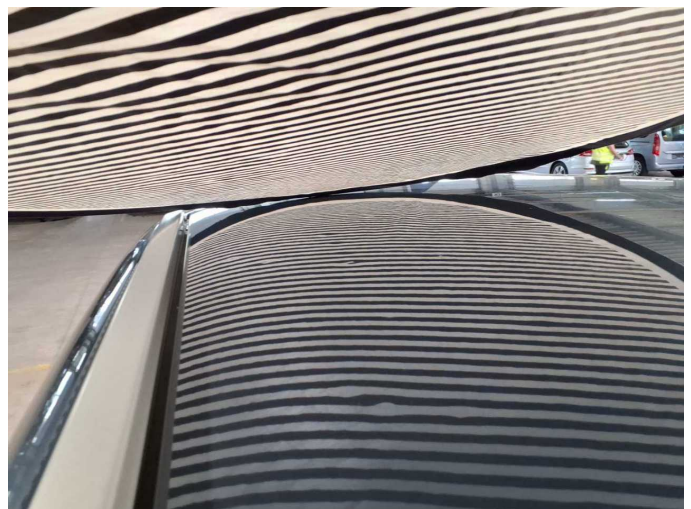
Damage 13: Roof: Roof - Damage by hail - Smooth repair work

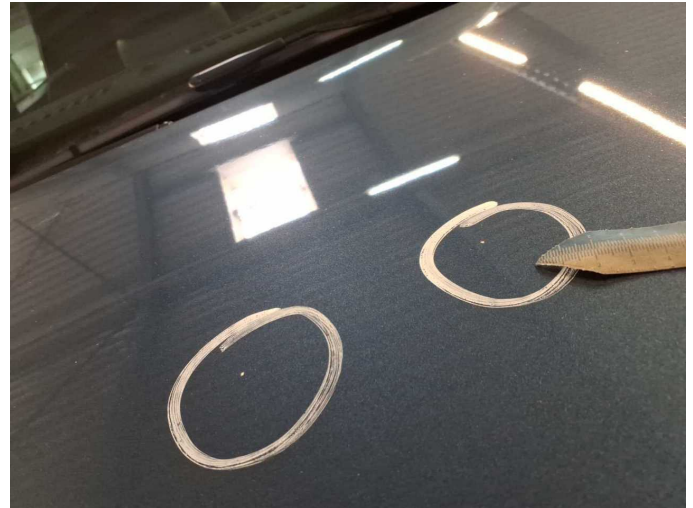
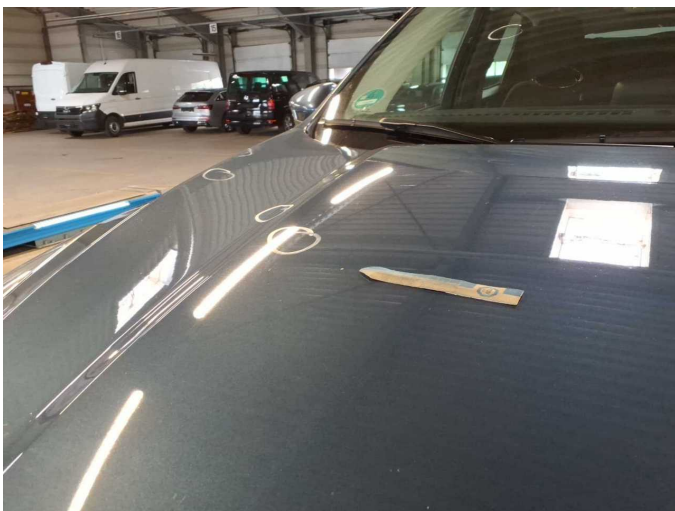
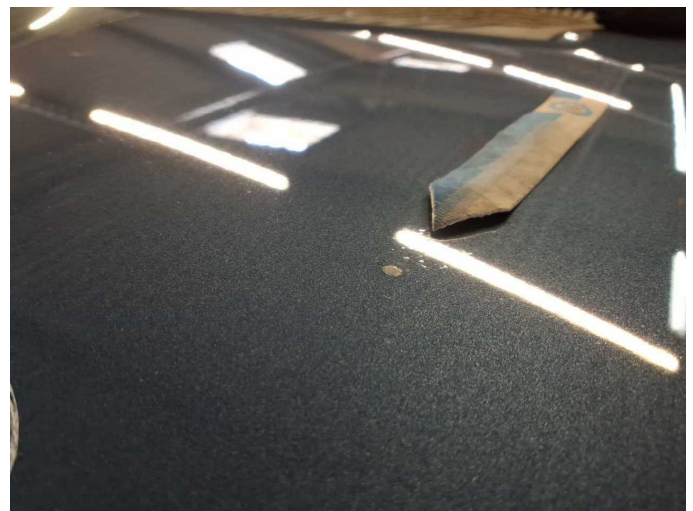
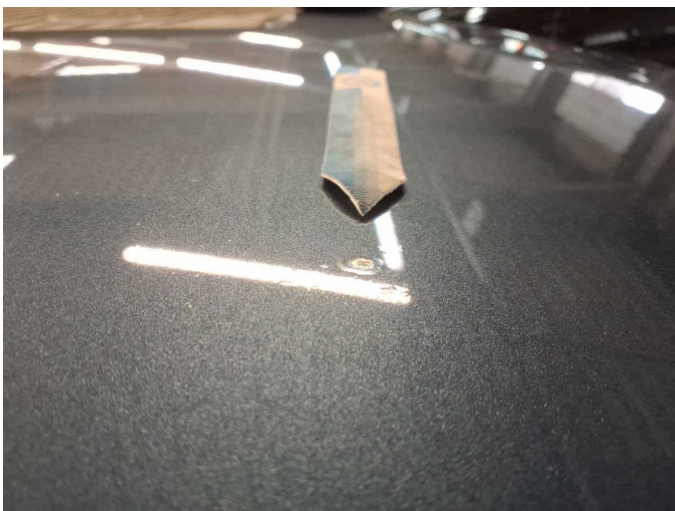
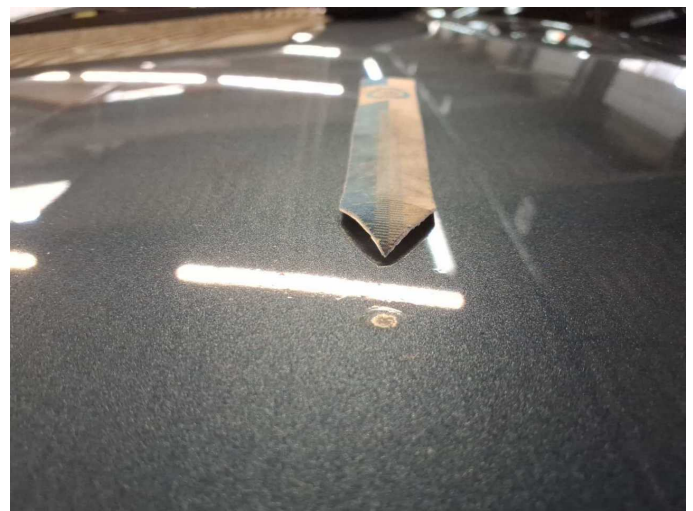
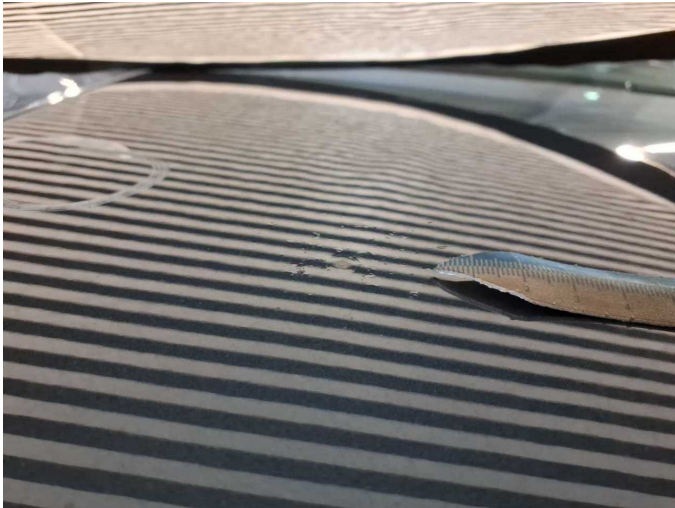
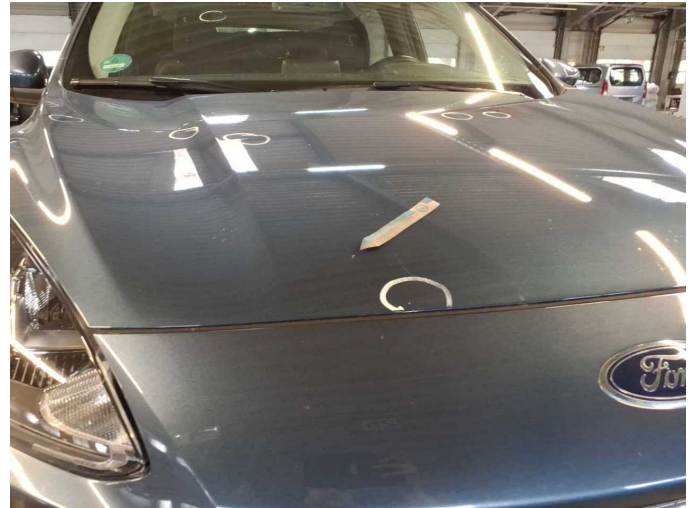
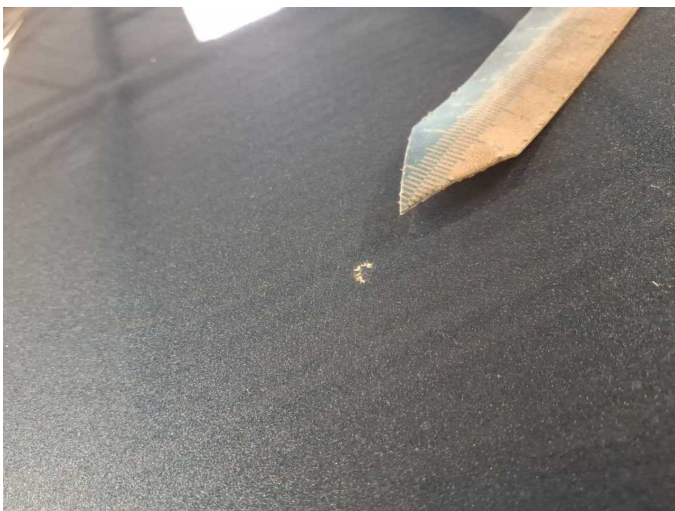
Damage 14: Bonnet: Bonnet (Steinschlag) - Corrosion - Paint

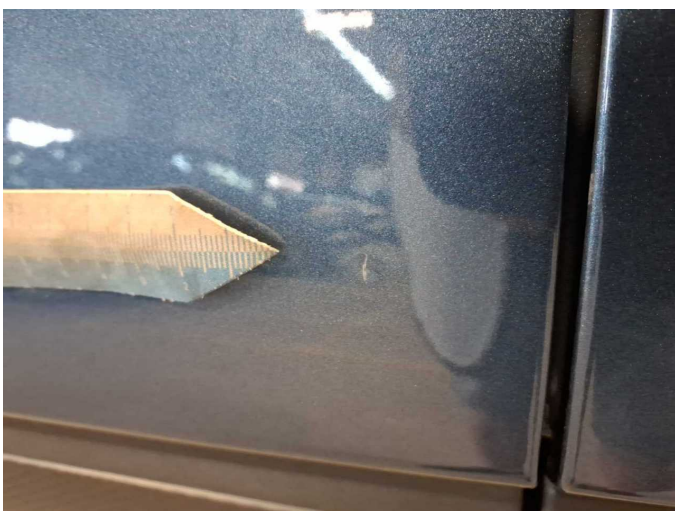
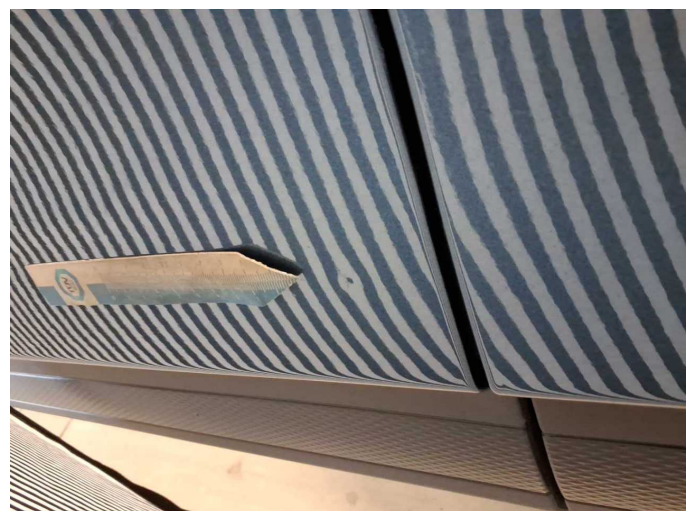
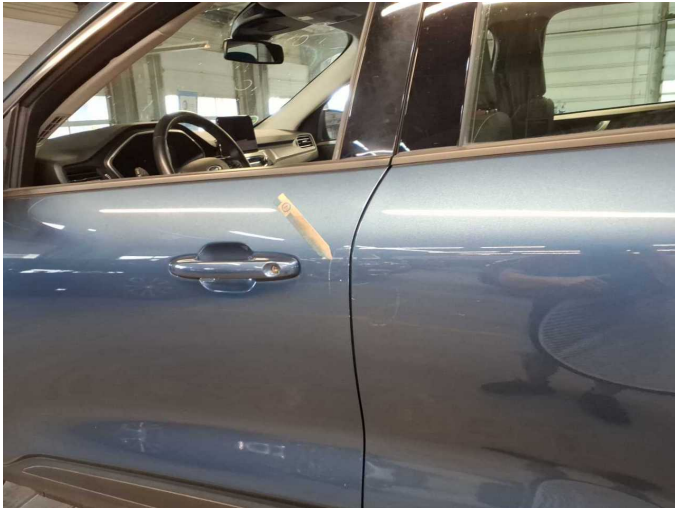
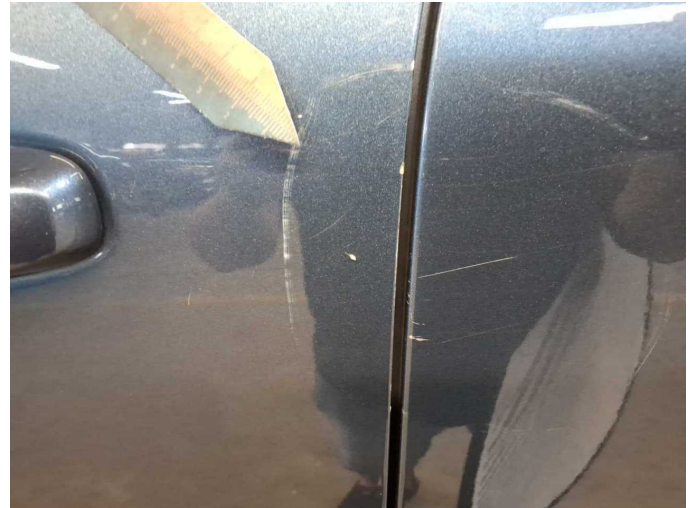
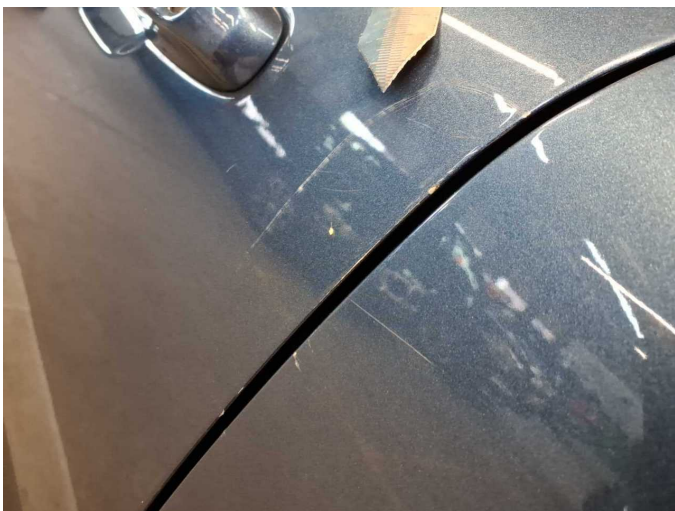
Damage 15: Door - front left side: Door - Dent / paintcoat damage - Repair and paint

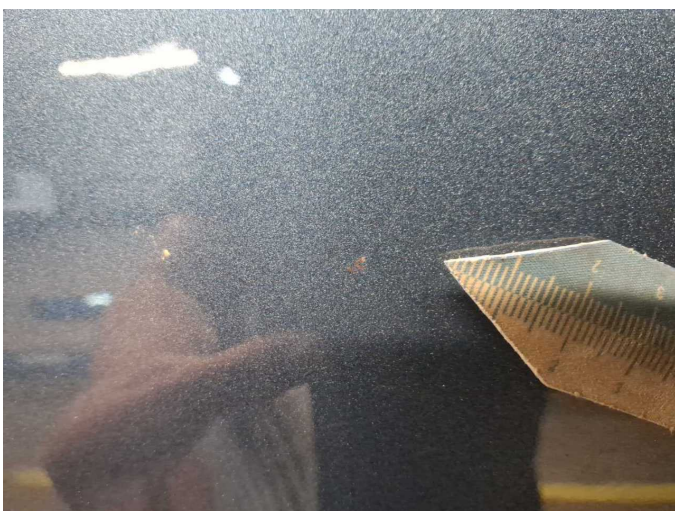
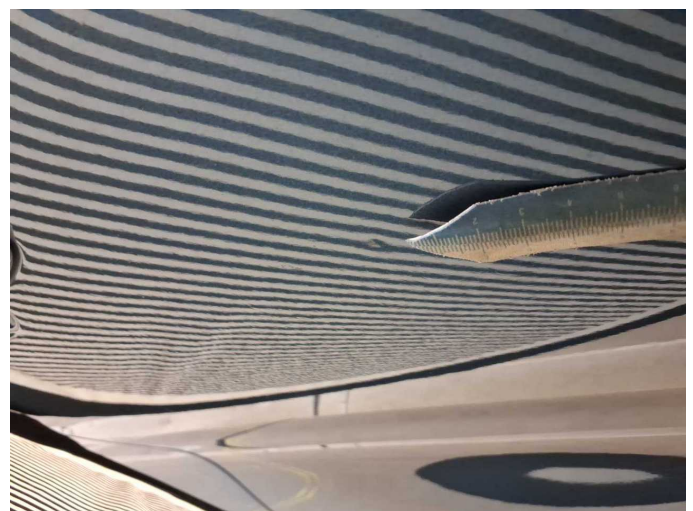
Damage 16: Door - front right side: Door - Dent / paintcoat damage - Repair and paint

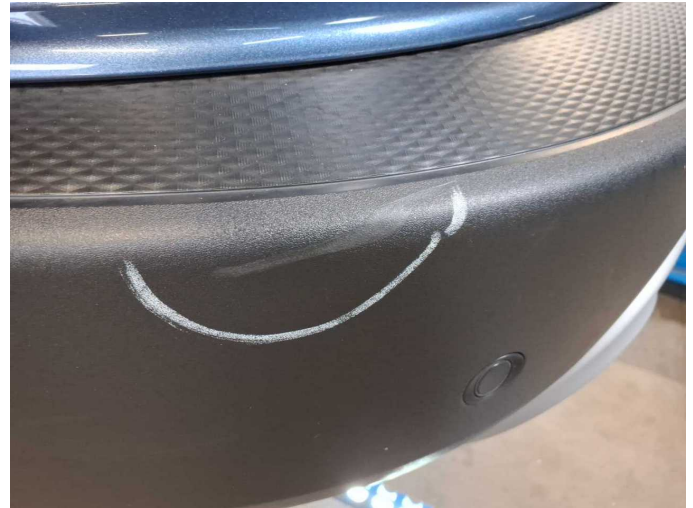
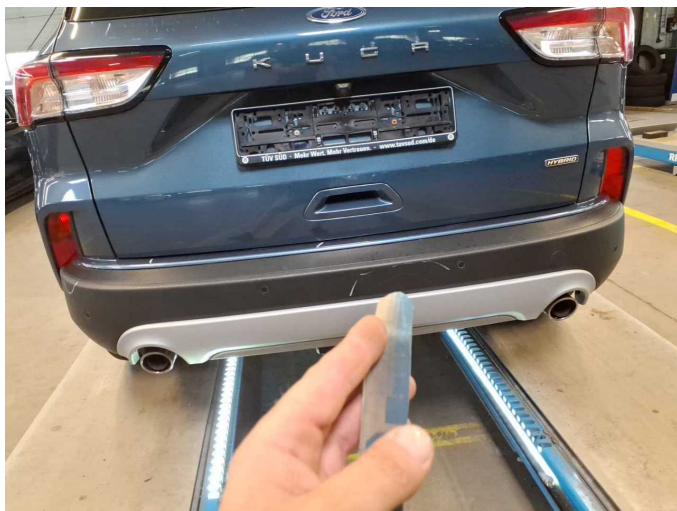
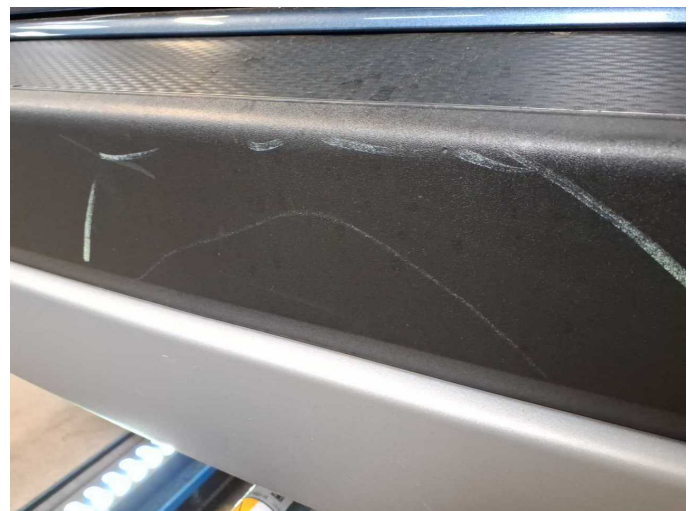
Wear and tear 2: Rear bumper: Rear bumper (unpainted) - Scratch(es) - No deduction
