Expertise

Protocol number: 45522310
Order No. / Reference: 26212431
Inspection date: 11 May 2026

Model: V60 T6 AWD Recharge Geartronic Inscription Expression

VIN: YV1ZWBFDVDM1444185

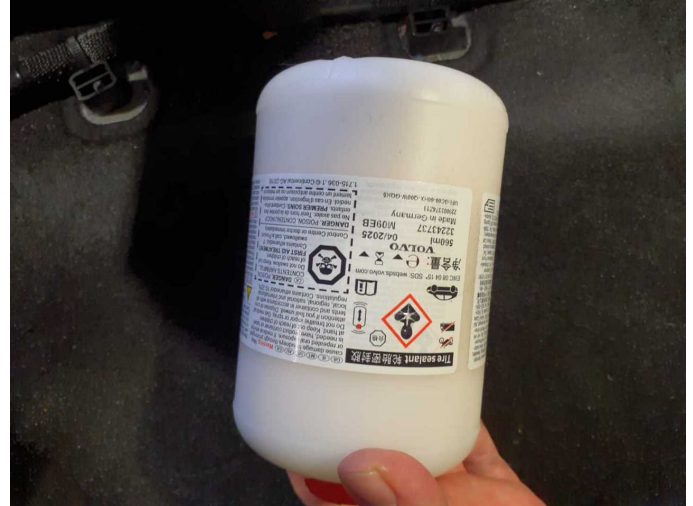
Damage 1: Equipment: Tirefit filler - Expired - Replace

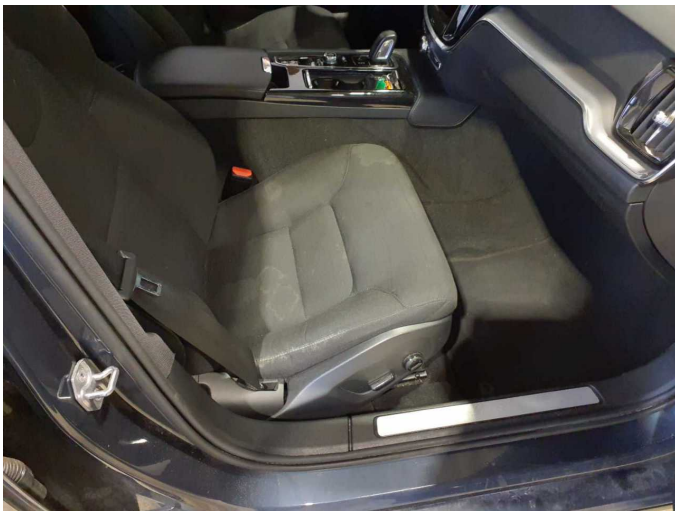
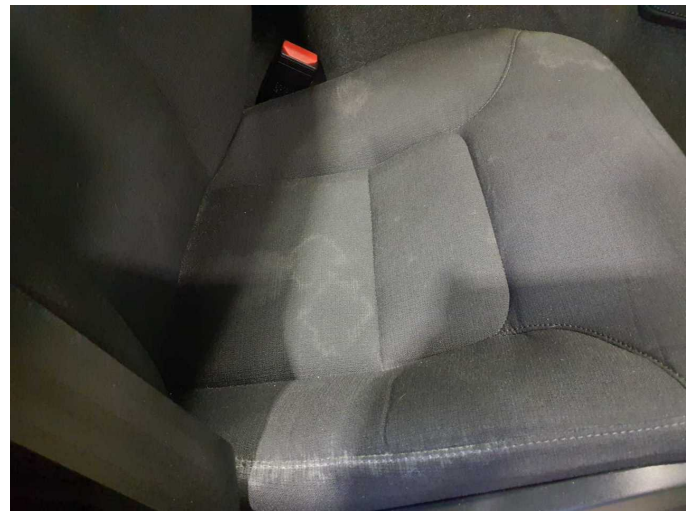
Damage 2: Seat - front: Seat cover - right side - Soiled - Clean

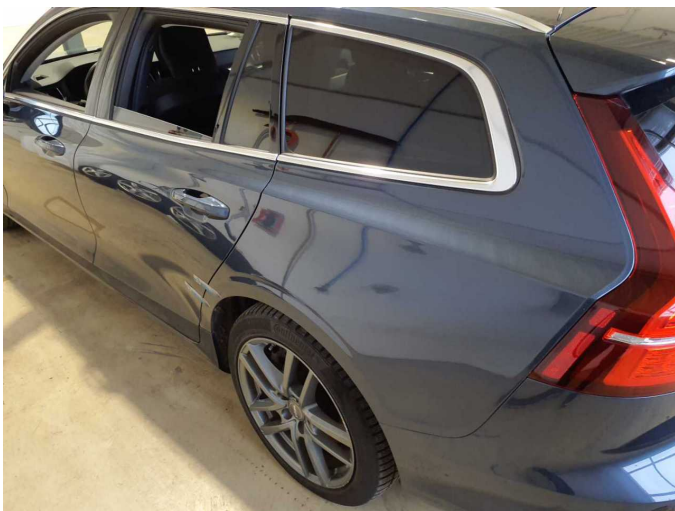
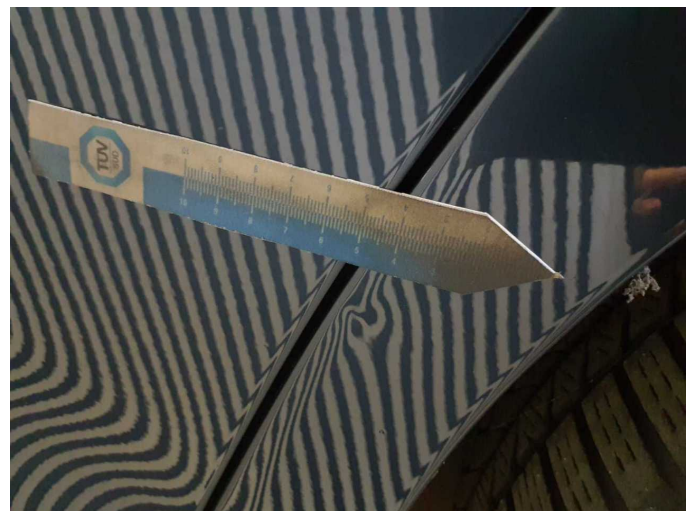
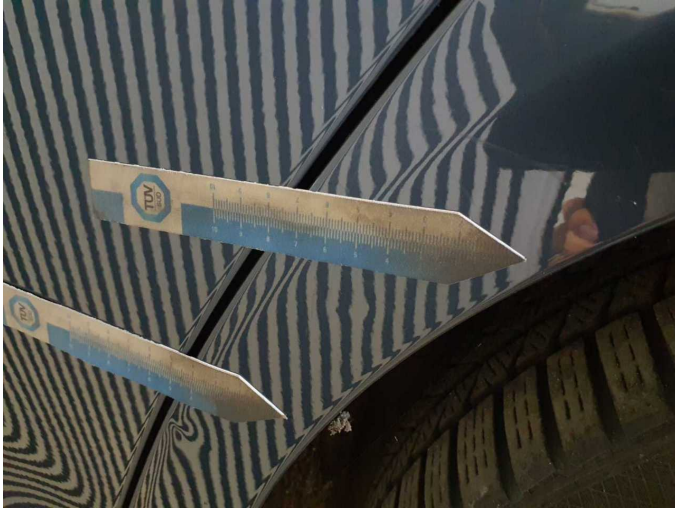
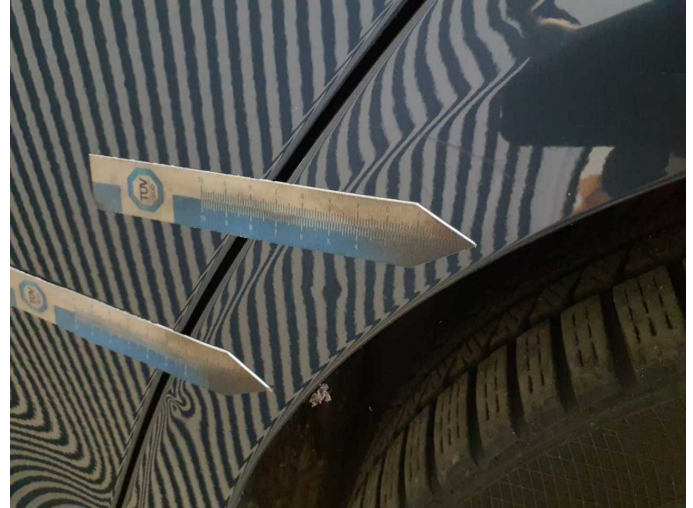
Damage 4: Side panel - rear left side: Side panel - dent(s) - Smart repair

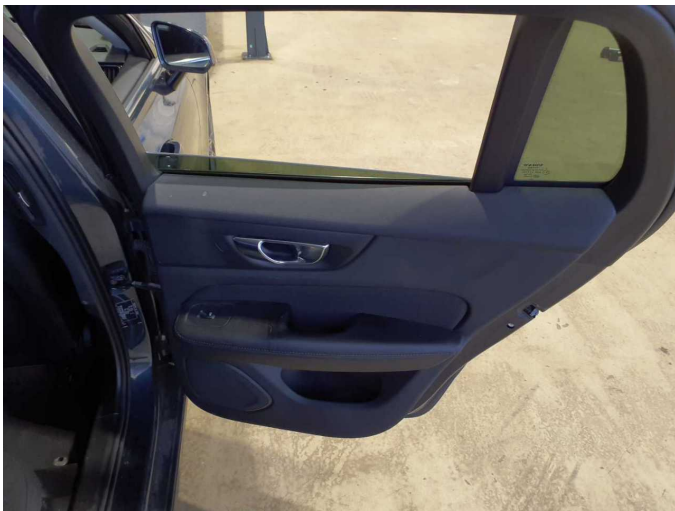
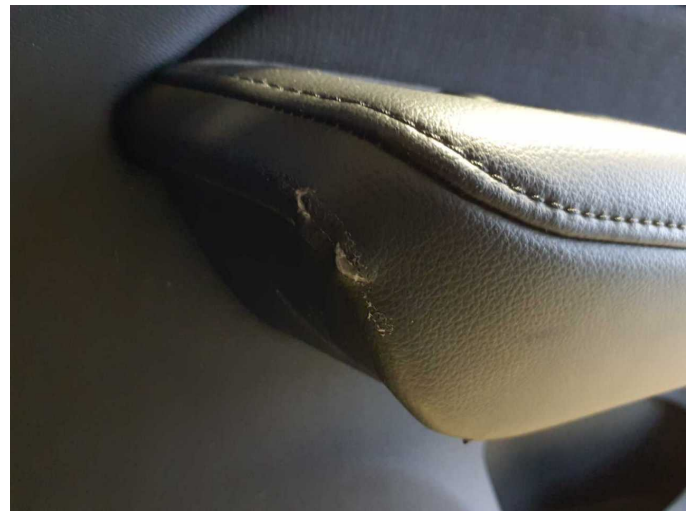
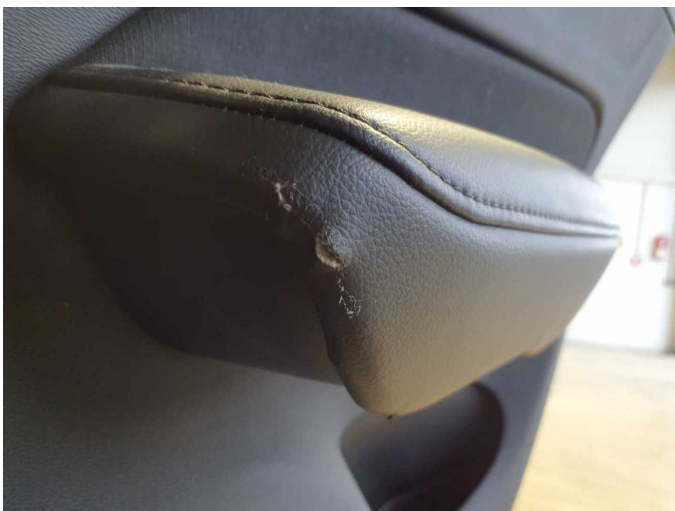
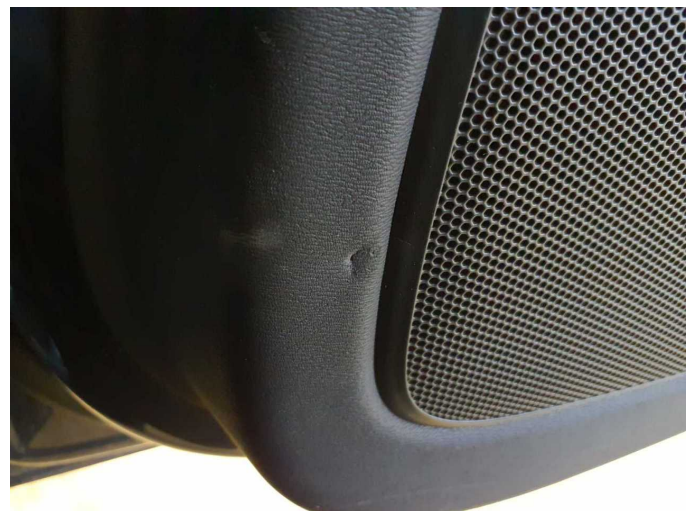
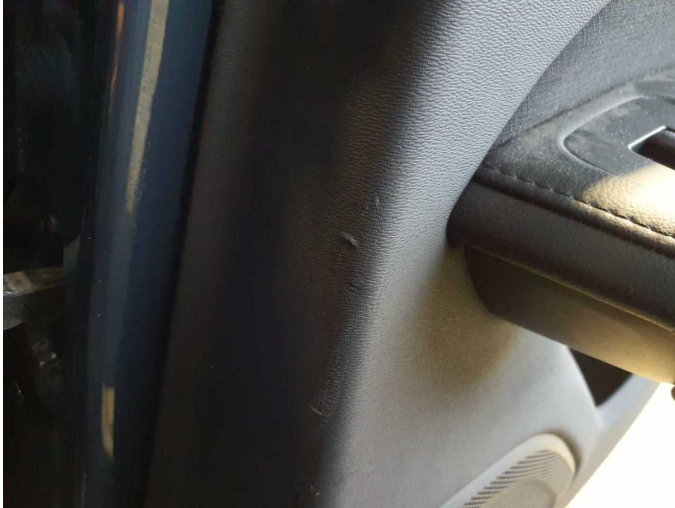
Damage 5: Trim / covers: Door trim - rear right side - Broken / torn - Loss in value

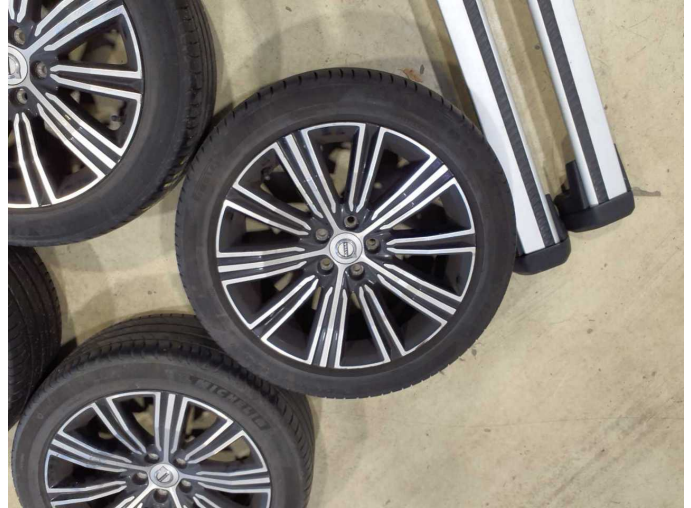
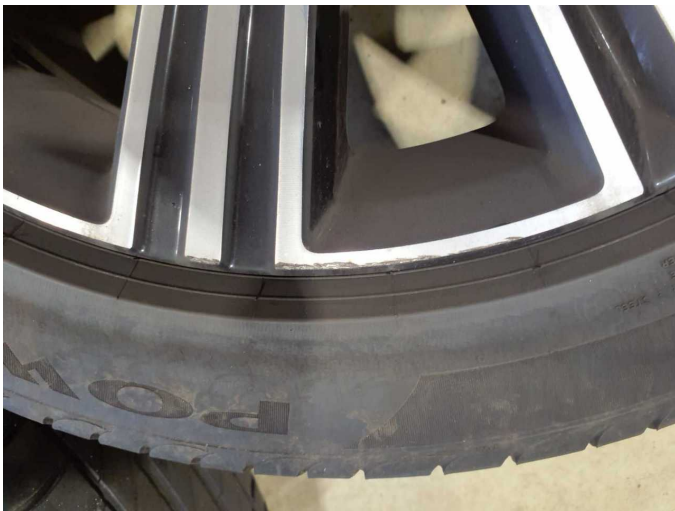
Damage 6: 2nd wheel set: 1 alloy rim - Scratch(es) - Loss in value

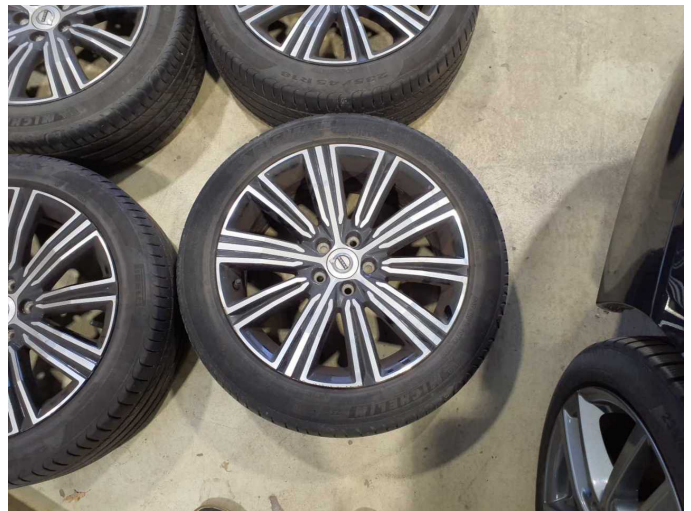
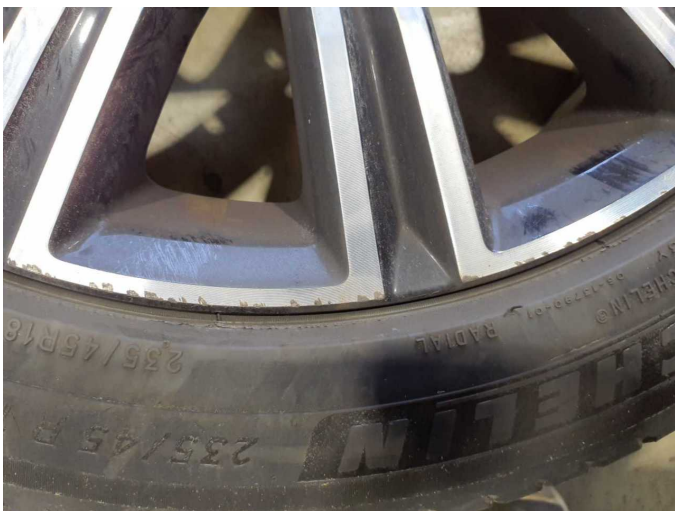
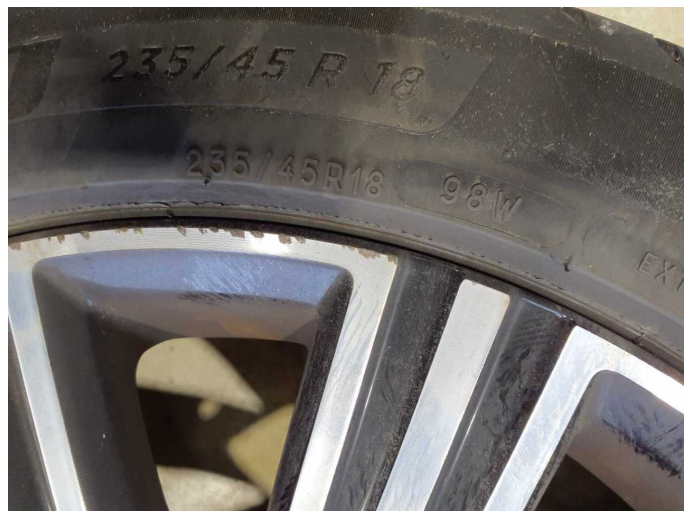
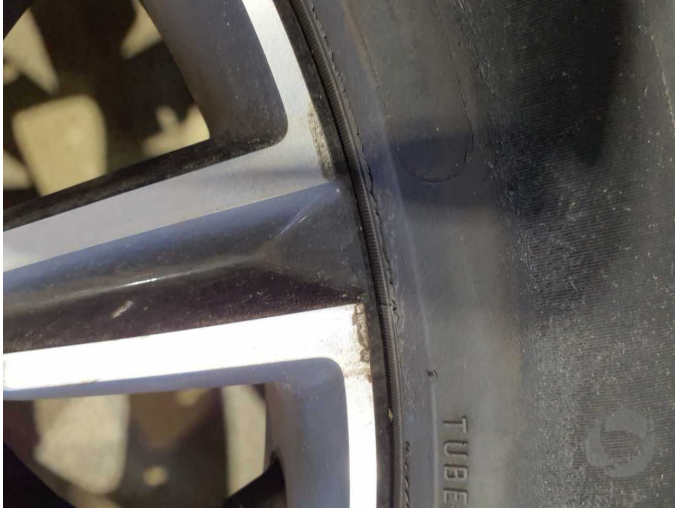
Damage 7: 2nd wheel set: 1 alloy rim - Scratch(es) - Loss in value

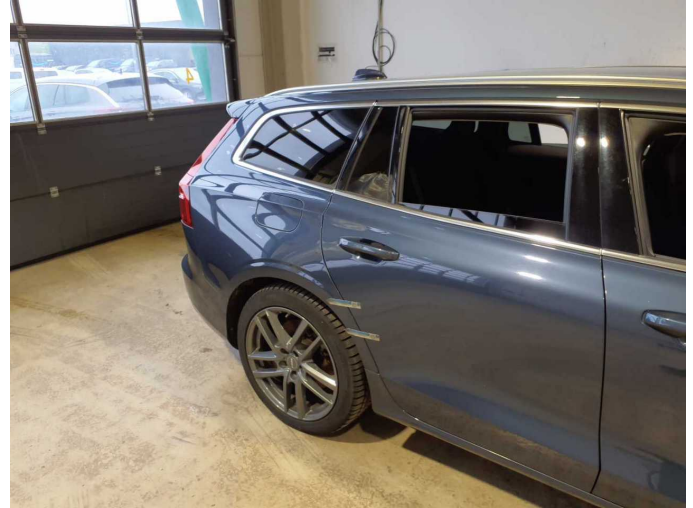
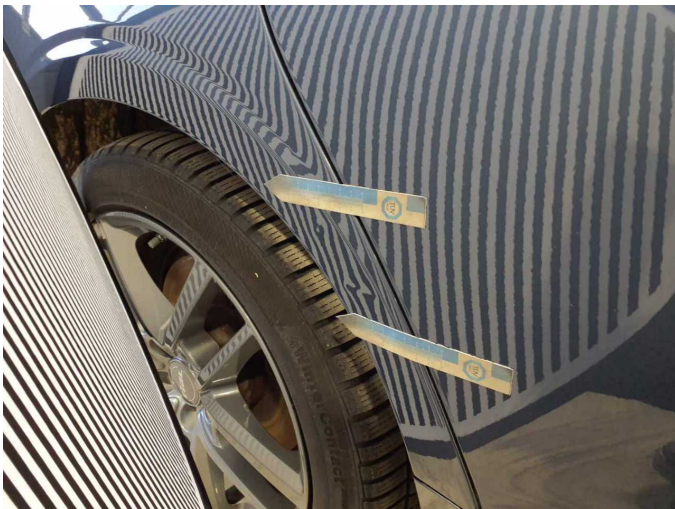
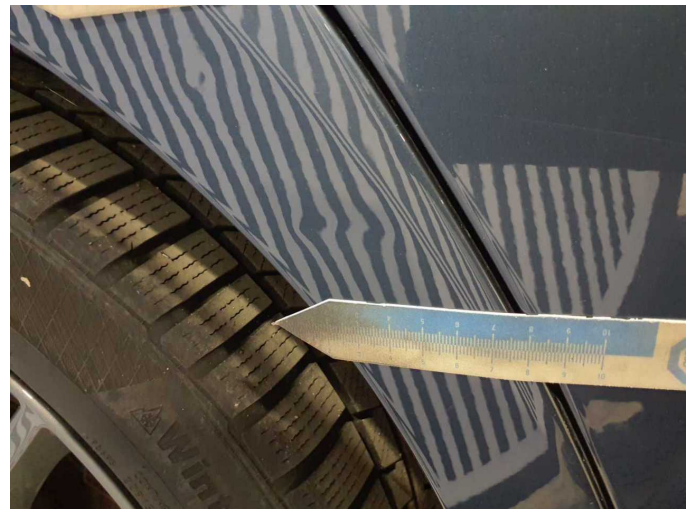
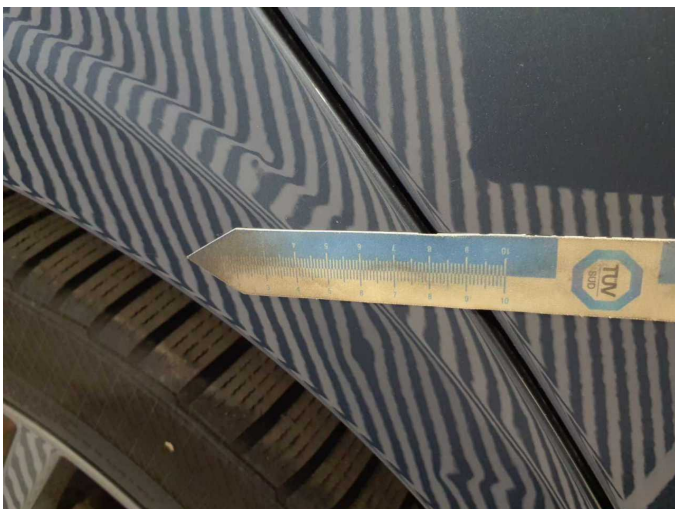
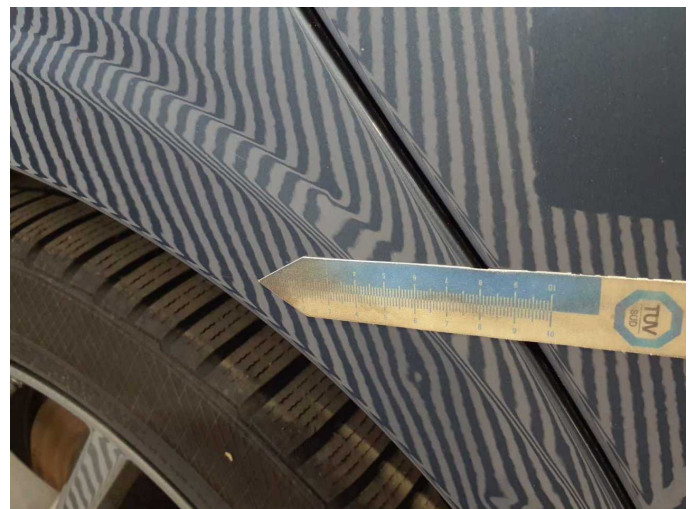
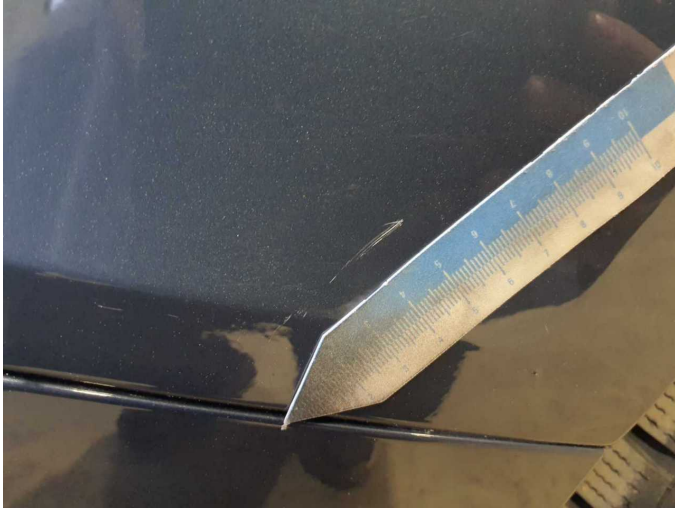
Damage 8: Side panel - rear right side: Side panel - Deformed - Paint

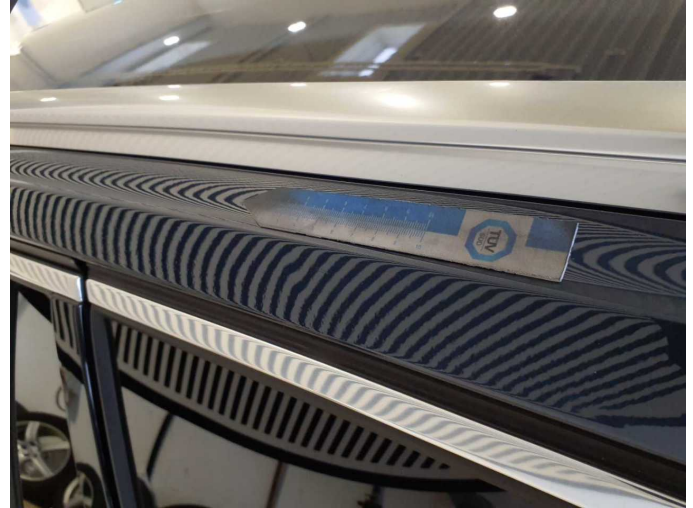
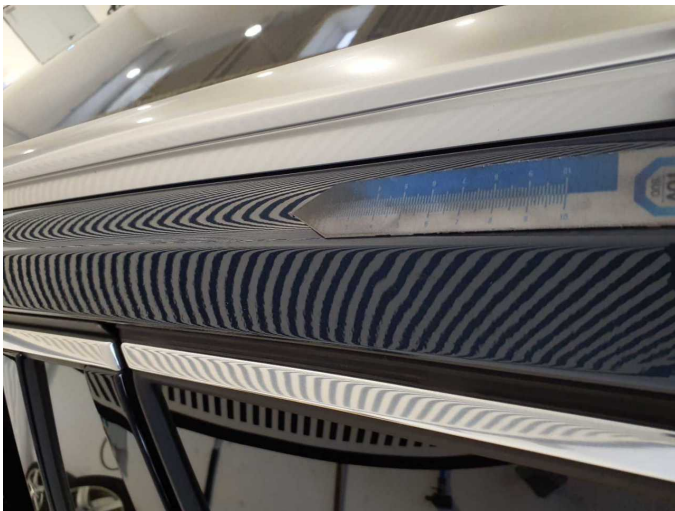
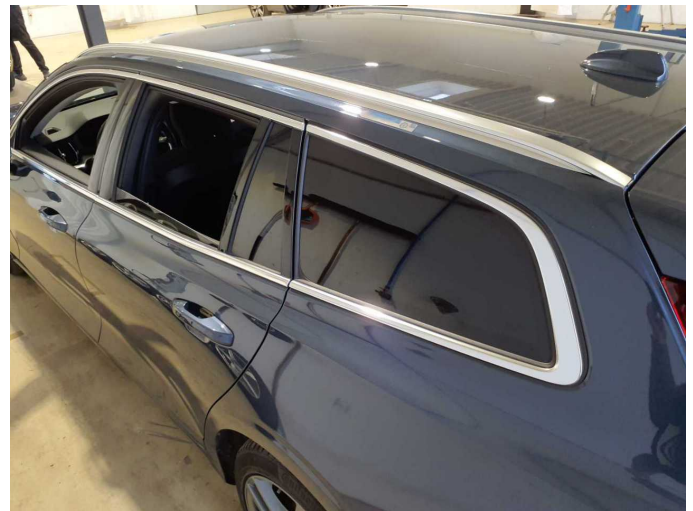
Wear and tear 7: Roof: Roof rail - left side - dent(s) - No deduction

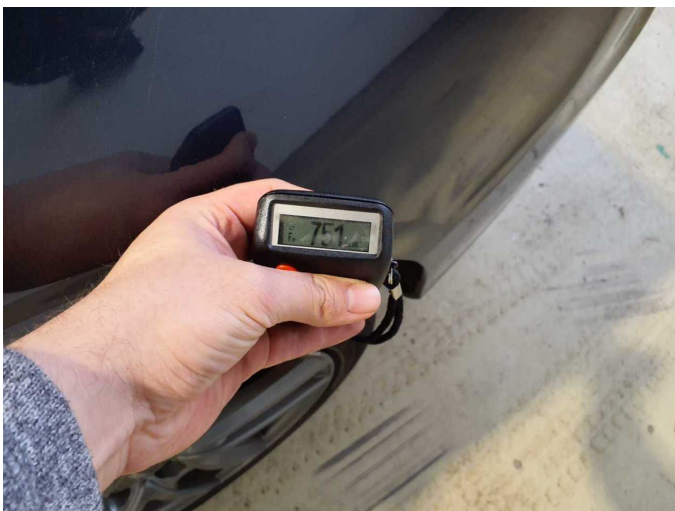
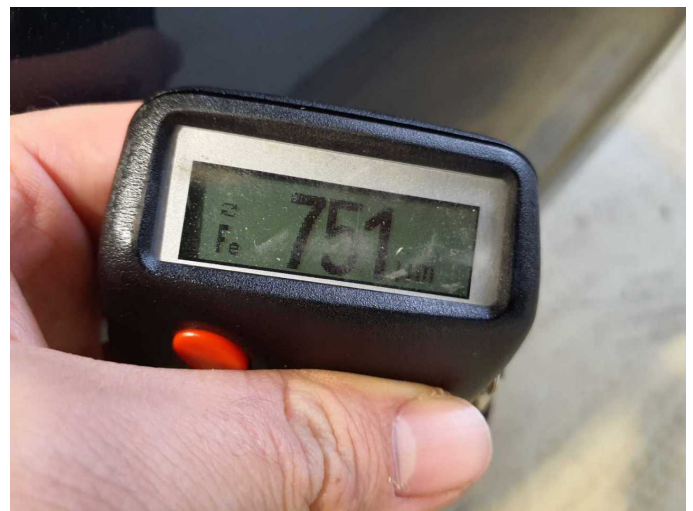
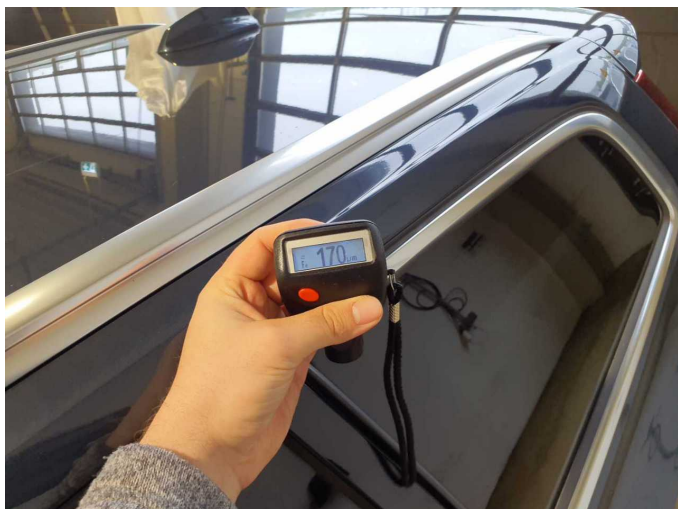
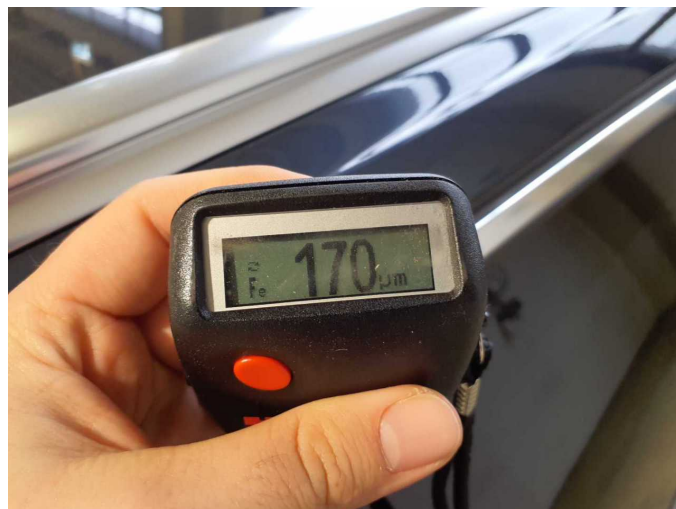
1 Roof rail - left side, Side panel - rear left side, Professionally carried out, Invoice of repair done Non-existent

Roof rail - left side	170 µm	Side panel - rear left side	751 µm
-----------------------	--------	-----------------------------	--------

Repainting 1: Roof rail - left side, Side panel - rear left side
