Expertise

Protocol number: 46023491
Order No. / Reference: 26461114
Inspection date: 18 Jun 2026

Manufacturer: Ford

Model: Transit Connect 220 L1 S&S Trend

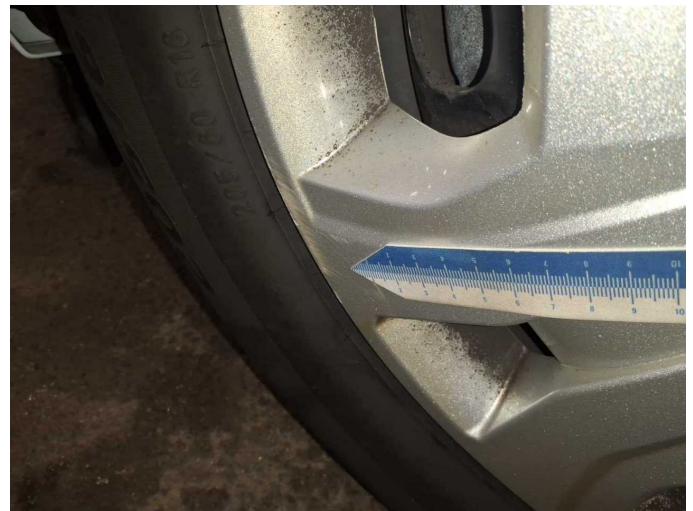
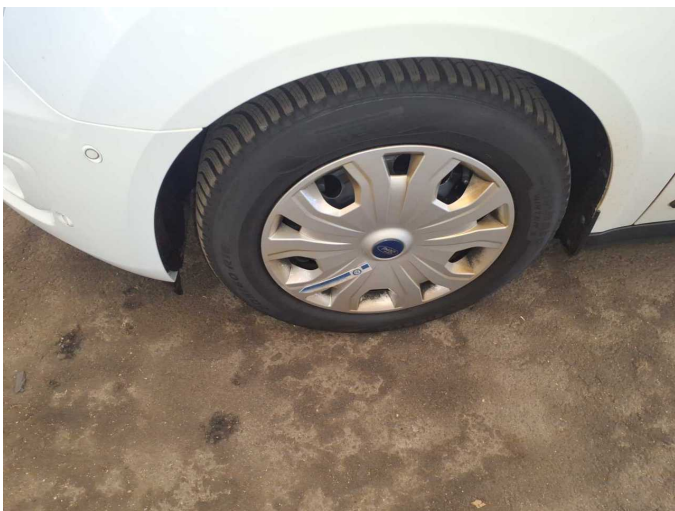
Damage 2: Wheel / tyres: Wheel cover - front left side - Scratch(es) - Replace

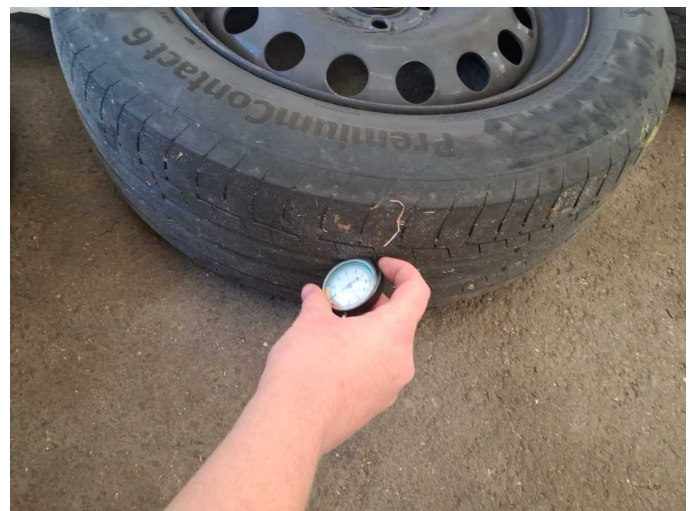
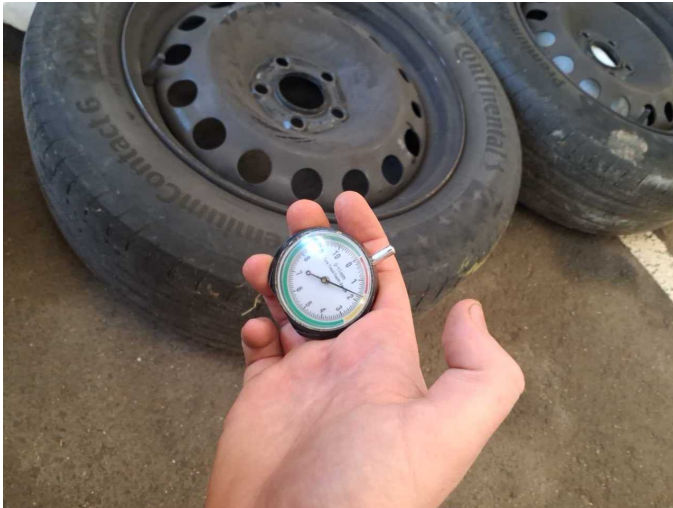
Damage 3: 2nd wheel set: 1 tyre - Does not meet the leasing specifications - Replace

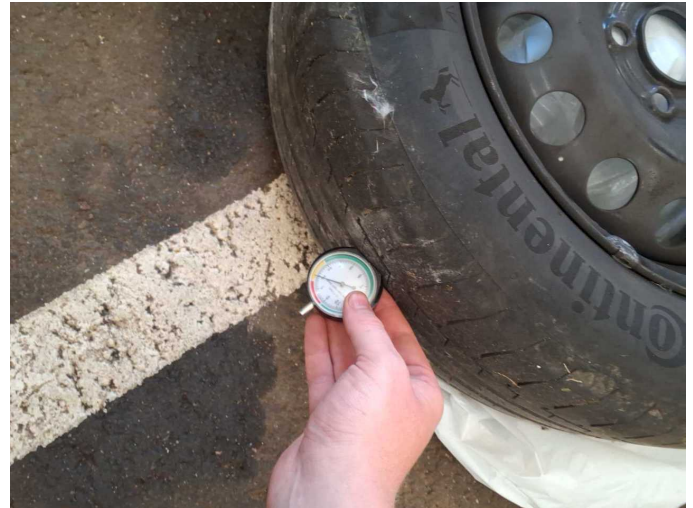
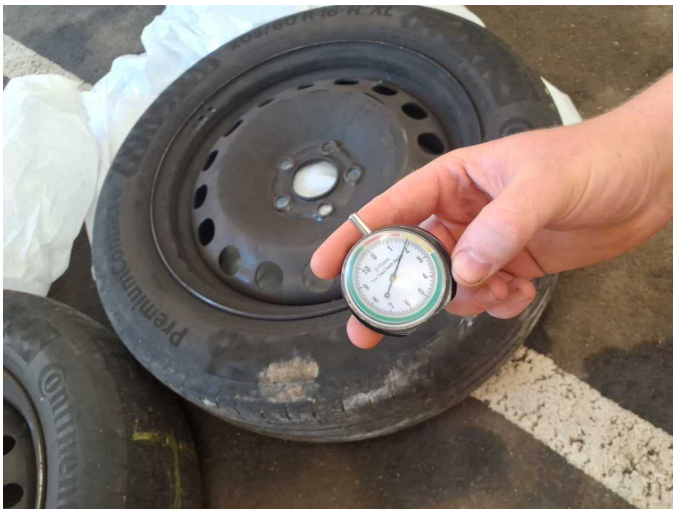
Damage 4: 2nd wheel set: 1 tyre - Does not meet the leasing specifications - Replace

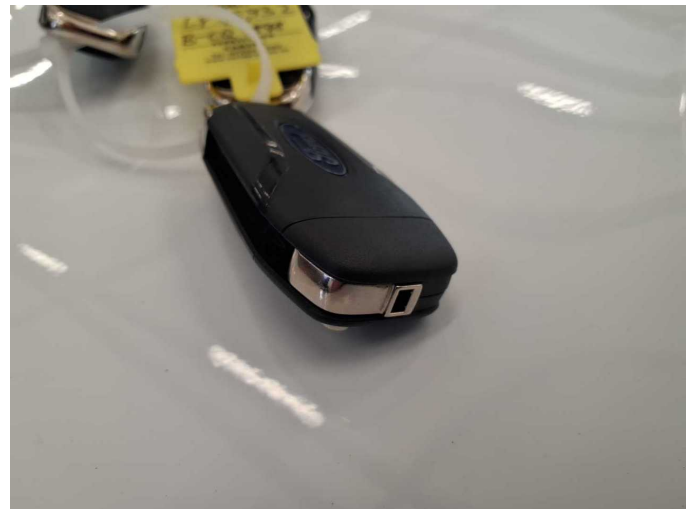
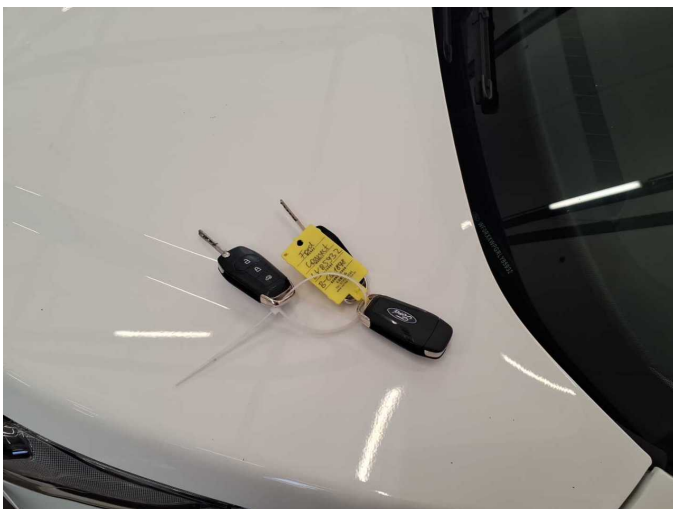
Damage 5: Equipment: Vehicle key - Damaged - Replace

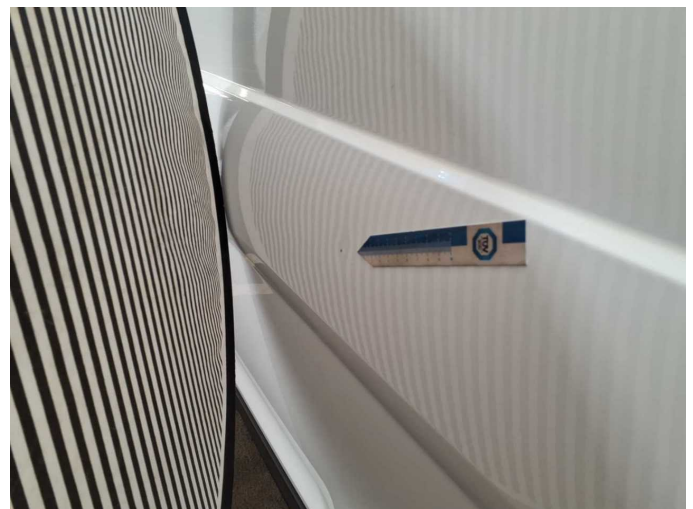
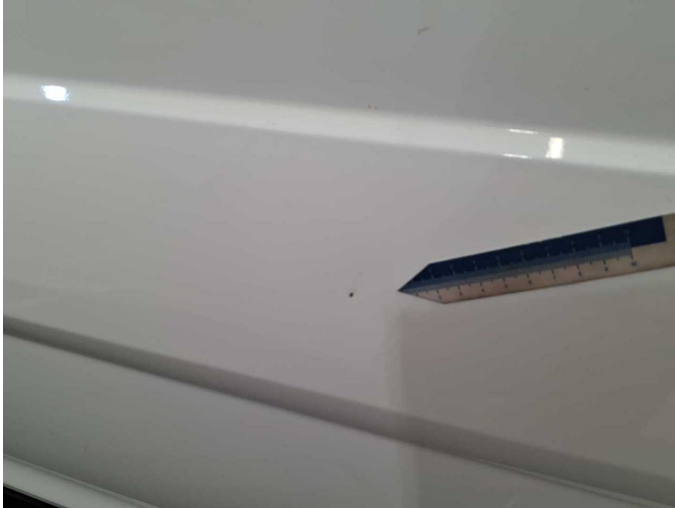
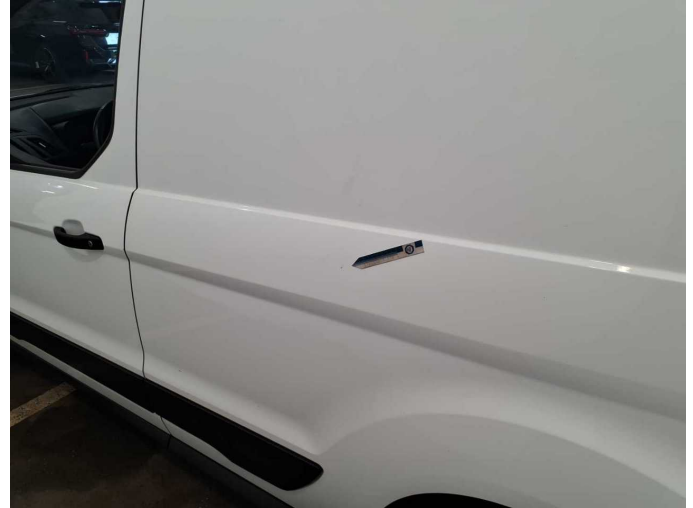
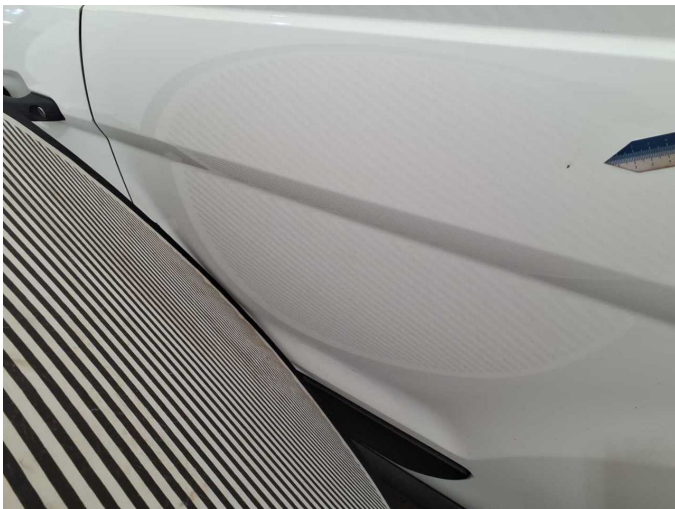
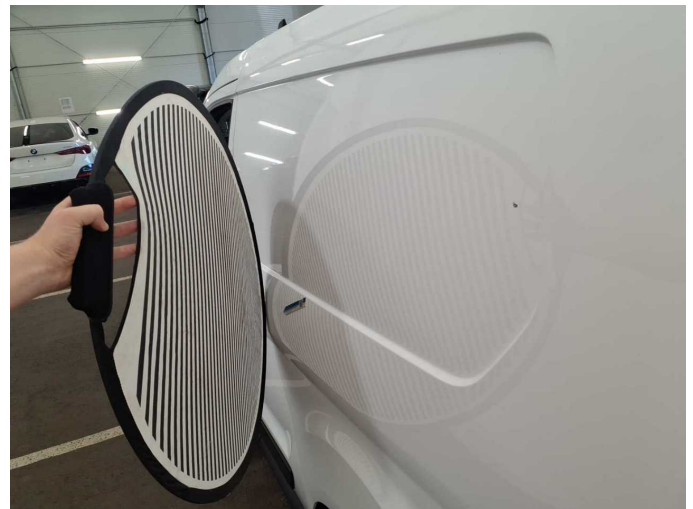
Damage 6: Side panel - rear left side: Side panel - Dent / paintcoat damage - Repair and paint

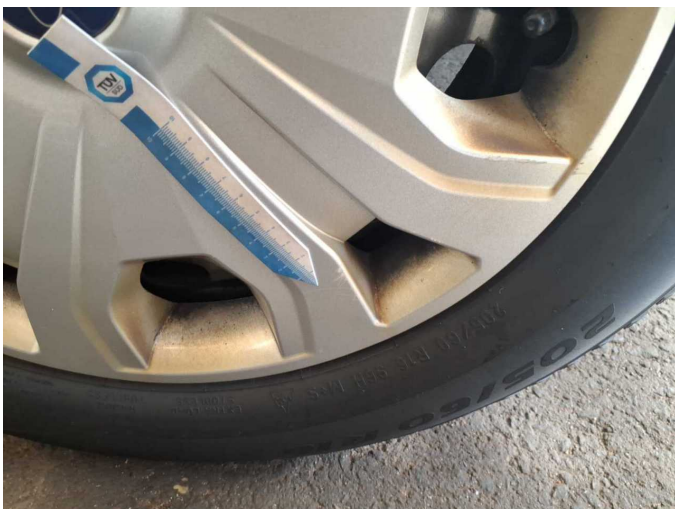
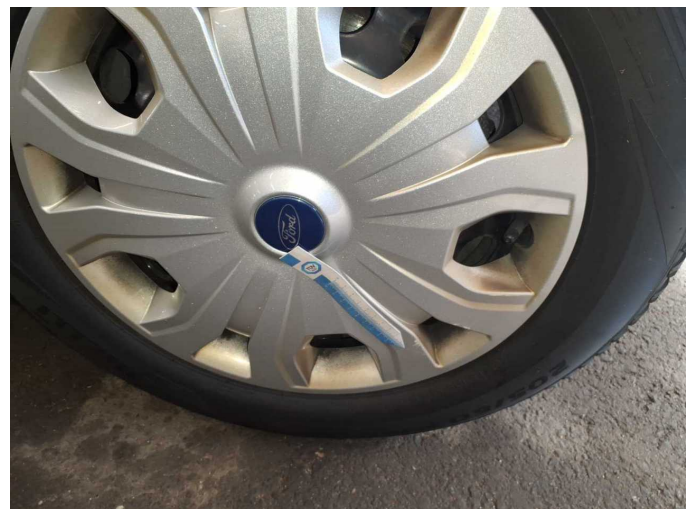
Wear and tear 7: Wheel / tyres: Wheel cover - rear left side - Scratch(es)
- No deduction
