Expertise

Protocol number: 46860446  
Order No. / Reference: 26816255  
Inspection date: 3 Aug 2026

| Manufacturer: Opel | Model: Astra Sports Tourer 1.5 D Automatik Business Elegance |
| VIN: VXXKFCYHZTP1075881 | |

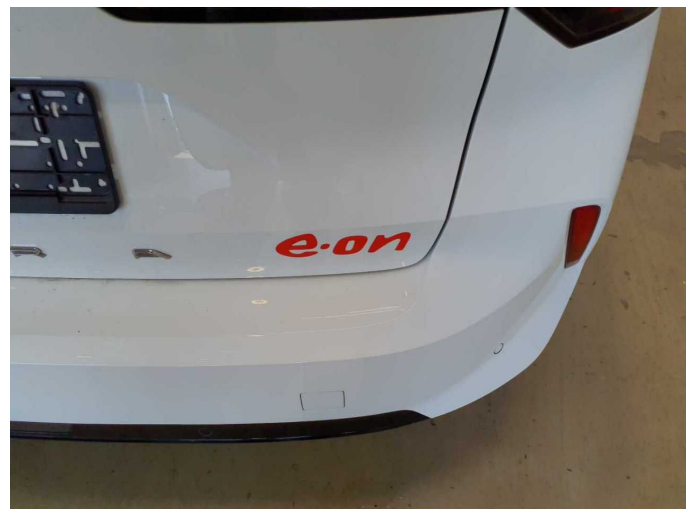
| No. | Component group | Description |
|---|---|---|
| 1 | Boot lid / rear door | Boot lid - Glued / labelled - De-glue / neutralise |

**Damage 1:** Boot lid / rear door: Boot lid - Glued / labelled - De-glue / neutralise

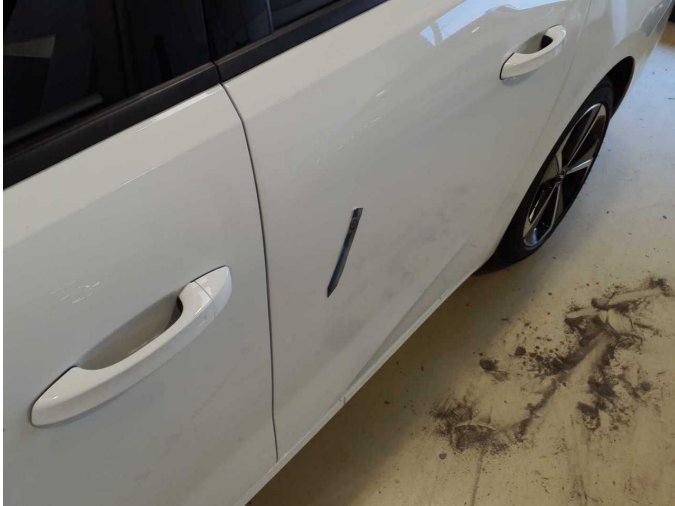
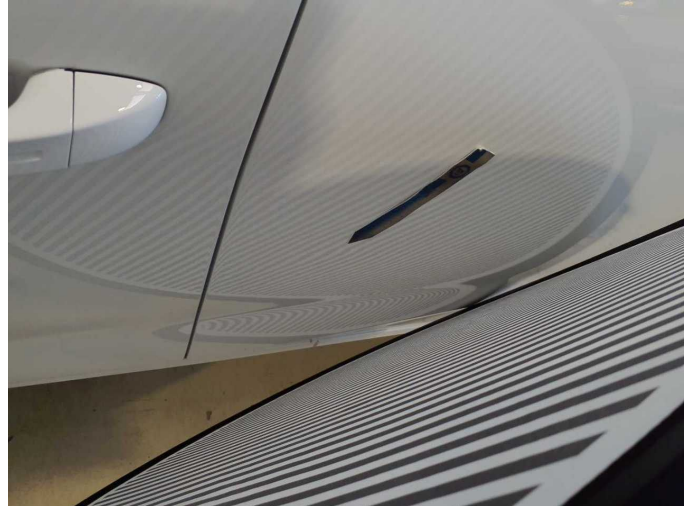
| No. | Component group | Description |
|---|---|---|
| 2 | Door - rear left side | Door - dent(s) - Smooth repair work |

**Damage 2:** Door - rear left side: Door - dent(s) - Smooth repair work

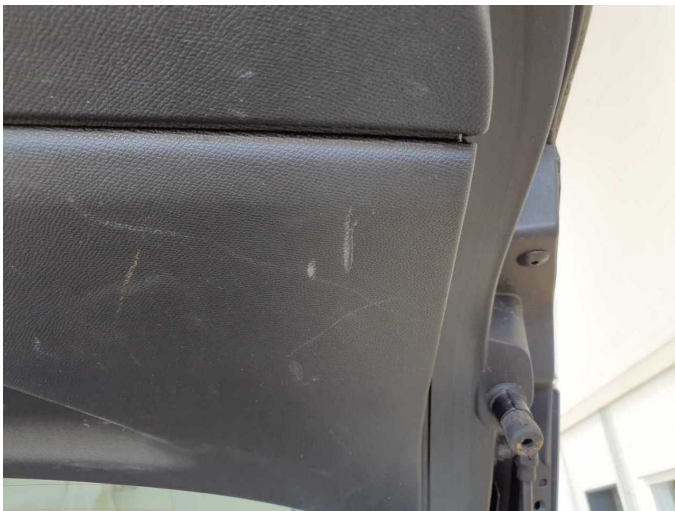
| No. | Component group | Description |
|---|---|---|
| 3 | Trim / covers | Boot lid - interior trim - Scratch(es) - Loss in value |

**Damage 3:** Trim / covers: Boot lid - interior trim - Scratch(es) - Loss in value

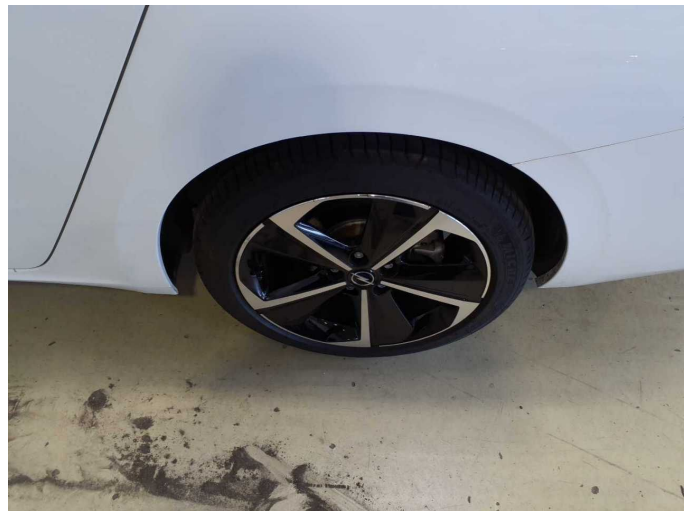
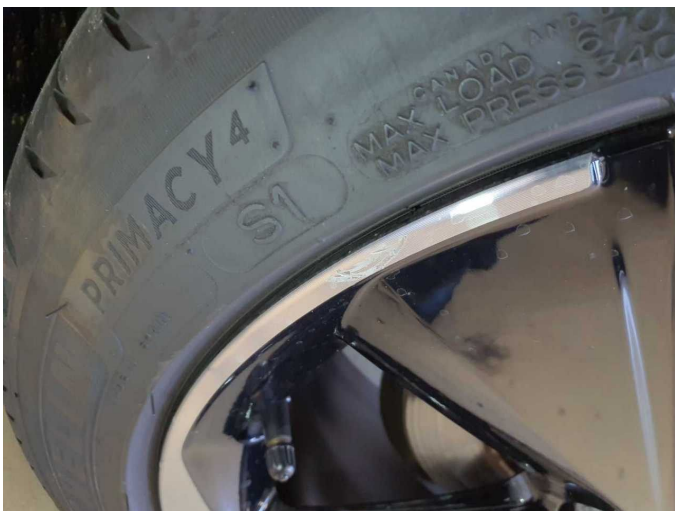
| No. | Component group | Description |
|---|---|---|
| 4 | Wheel / tyres | Alloy rim - rear left side - Scratch(es) - Loss in value |

**Damage 4:** Wheel / tyres: Alloy rim - rear left side - Scratch(es) - Loss in value

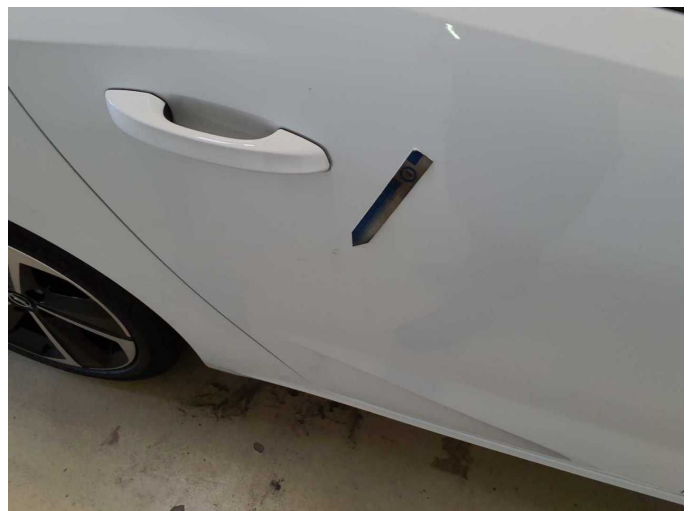
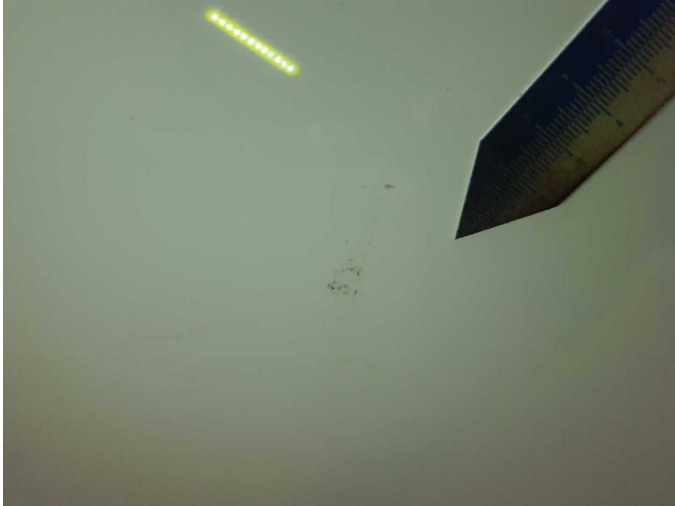
| No. | Component group | Description |
|---|---|---|
| 5 | Door - rear right side | Door - Scratch(es) - Smart repair |

**Damage 5:** Door - rear right side: Door - Scratch(es) - Smart repair

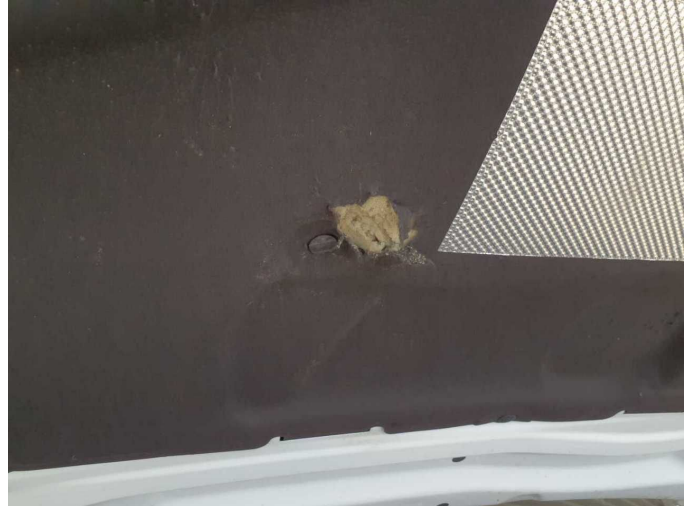
| No. | Component group | Description |
|---|---|---|
| 6 | Bonnet | Insulation lining - Damage caused by marten / rodent - Replace |

**Damage 6:** Bonnet: Insulation lining - Damage caused by marten / rodent - Replace

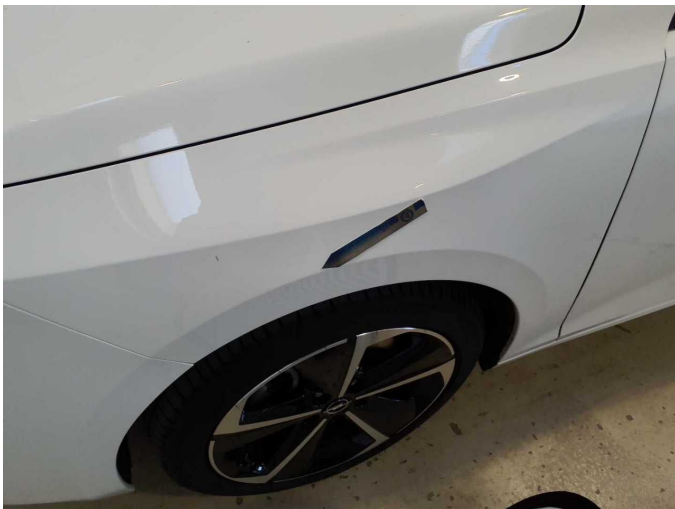
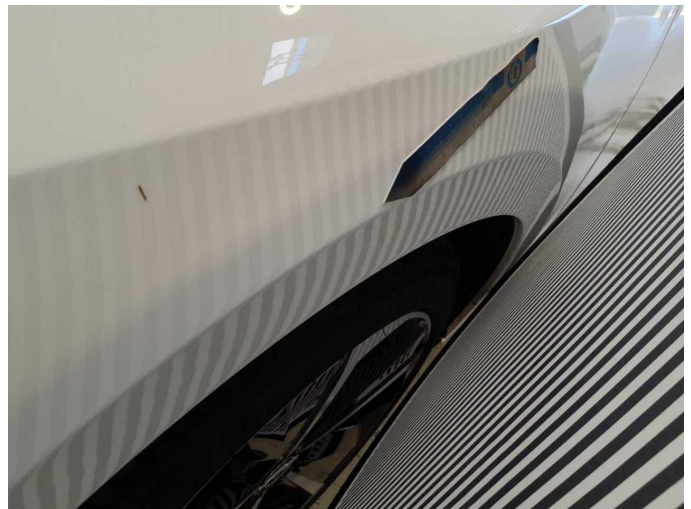
| No. | Component group | Description |
|---|---|---|
| 8 | Mudguard - left side | Mudguard - left side (Einschluss) - Paint defect - Paint |

**Damage 8:** Mudguard - left side: Mudguard - left side (Einschluss) - Paint defect - Paint

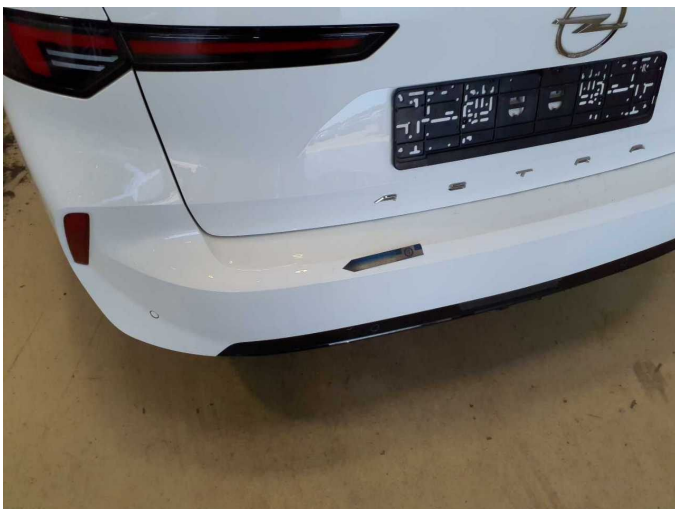
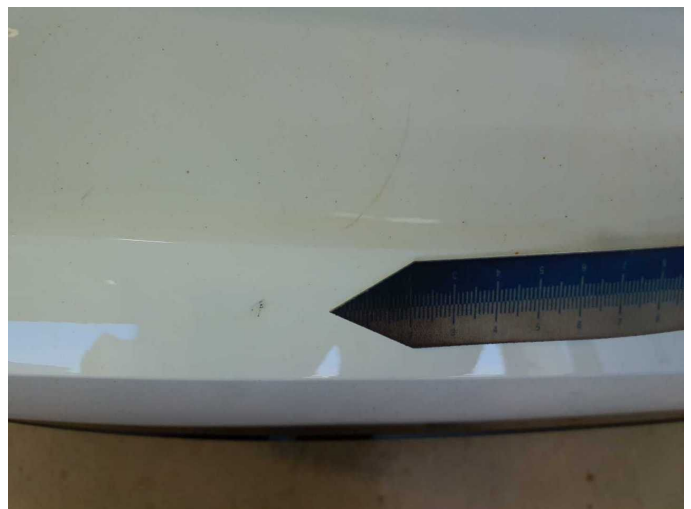
| No. | Component group | Description |
|---|---|---|
| 9 | Rear bumper | Rear bumper - Scratch(es) - Paint |

**Damage 9:** Rear bumper: Rear bumper - Scratch(es) - Paint

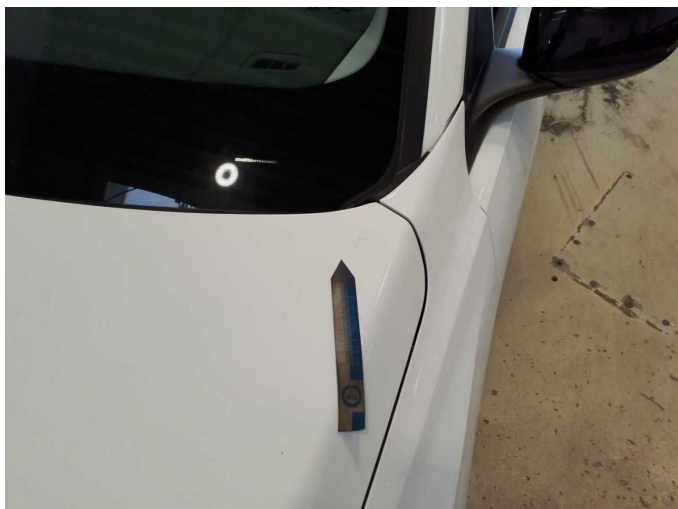
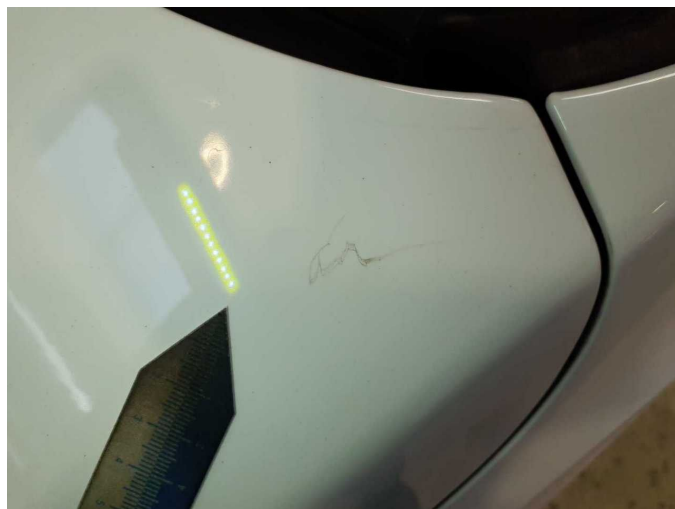
| No. | Component group | Description |
|---|---|---|
| 10 | Bonnet | Bonnet - Scratch(es) - Paint |

**Damage 10:** Bonnet: Bonnet - Scratch(es) - Paint

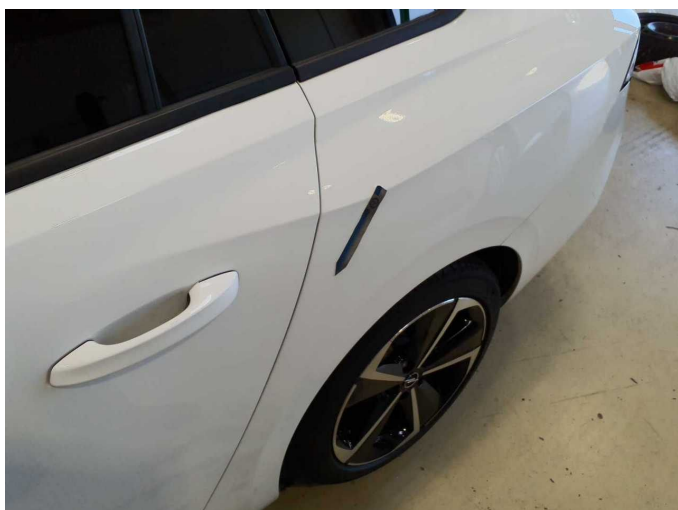
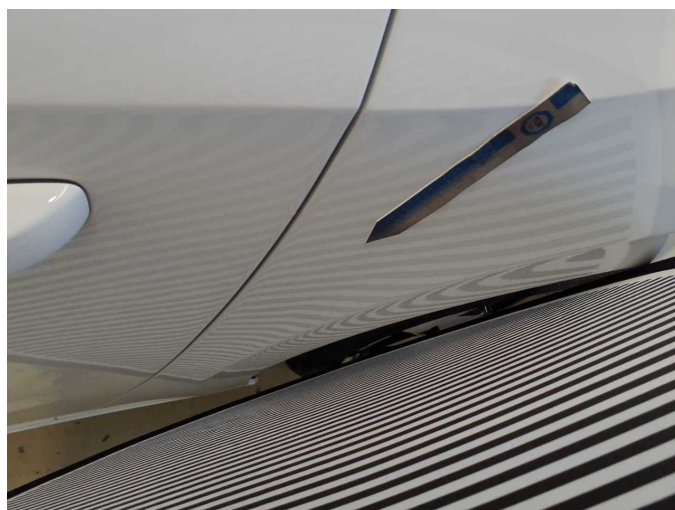
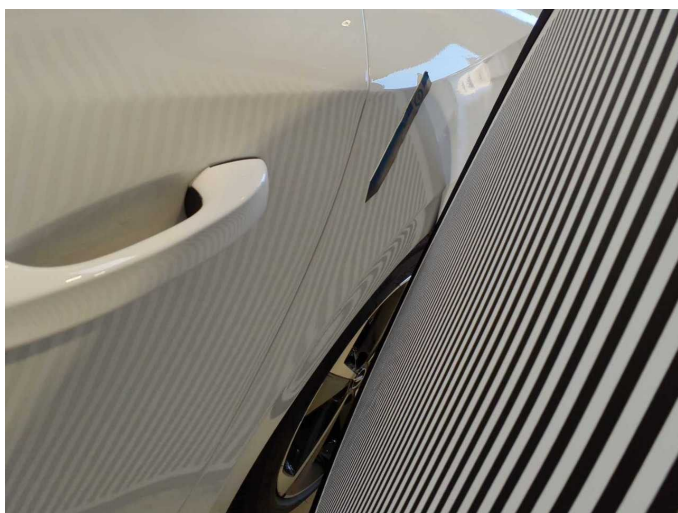
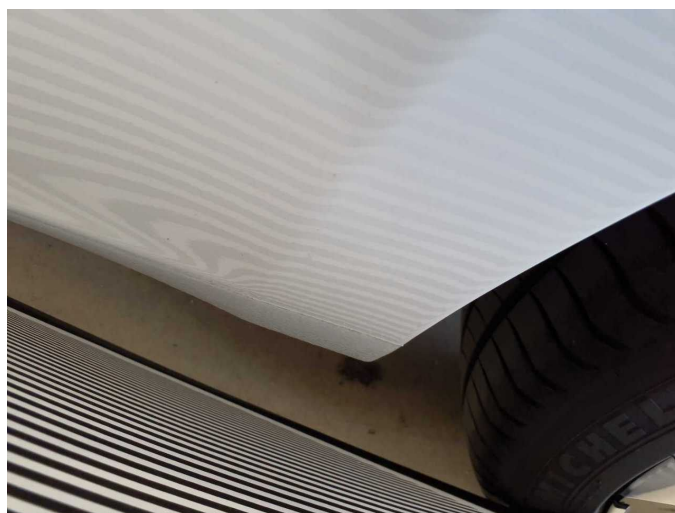
| No. | Component group | Description |
|---|---|---|
| 11 | Side panel - rear left side | Side panel (Wellig und einschlüsse) - Unprofessionally repaired - Repair and paint |

**Damage 11:** Side panel - rear left side: Side panel (Wellig und einschüsse) - Unprofessionally repaired - Repair and paint

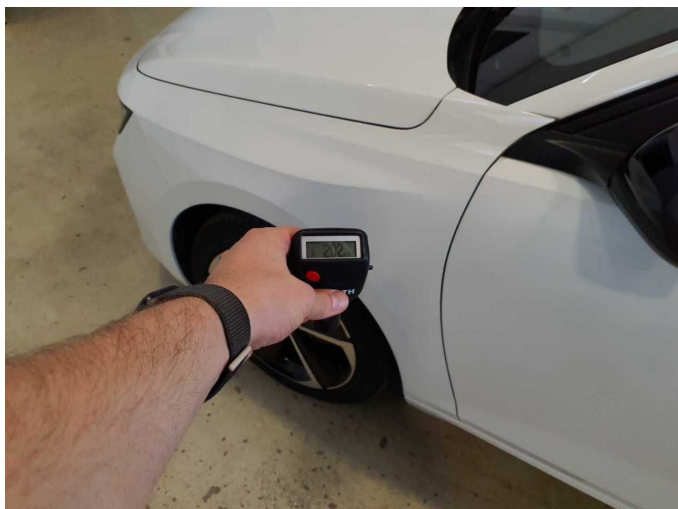
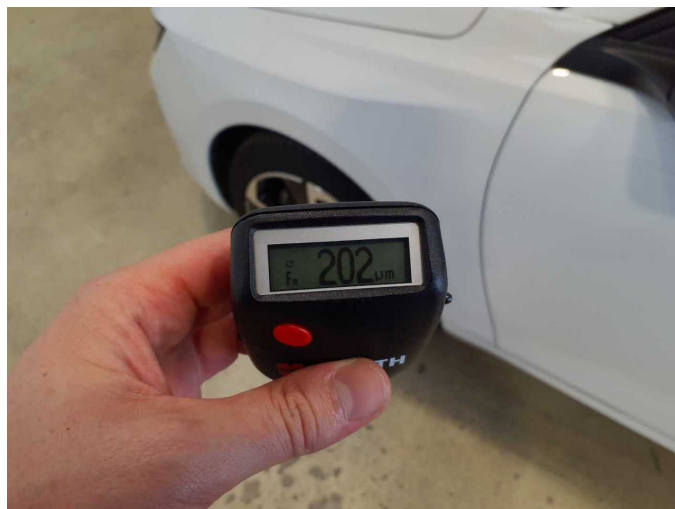
| Mudguard - left side | 202 µm | Side panel - rear left side | 560 µm |

**Repainting 1:** Mudguard - left side

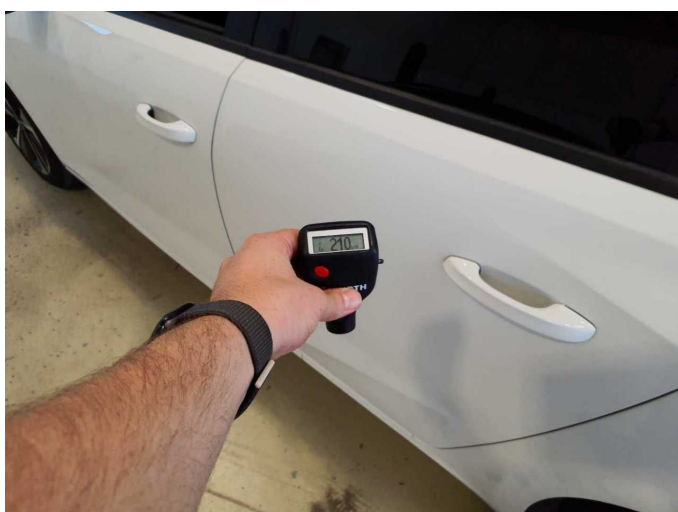
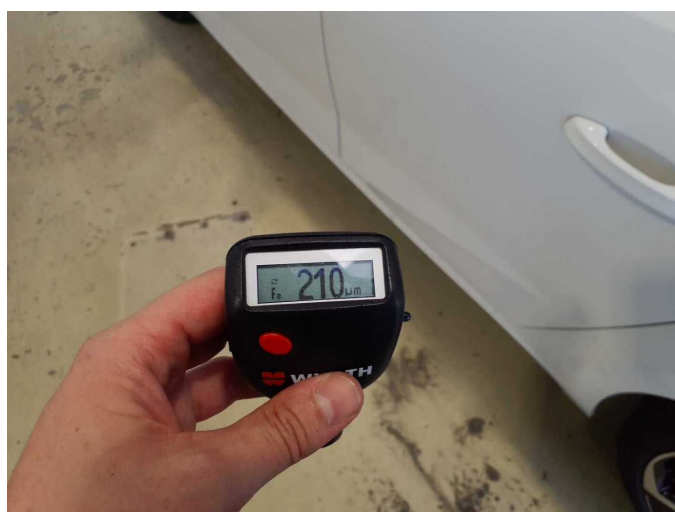
| Door - rear left side | 210 µm | Door - front left side | 178 µm |

**Repainting 2:** Door - rear left side

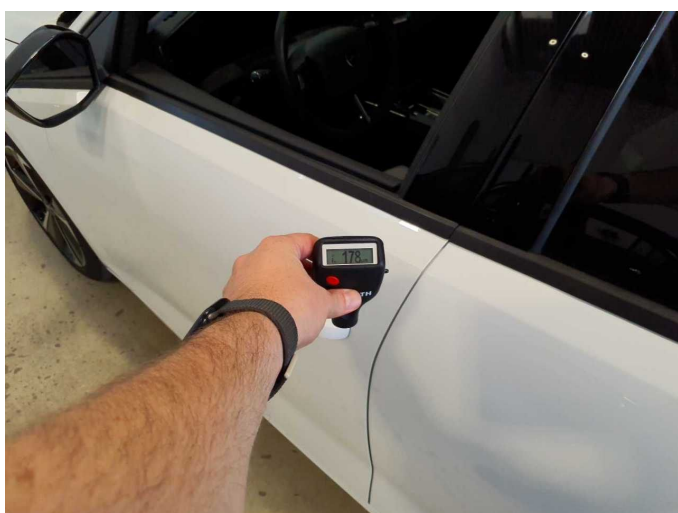
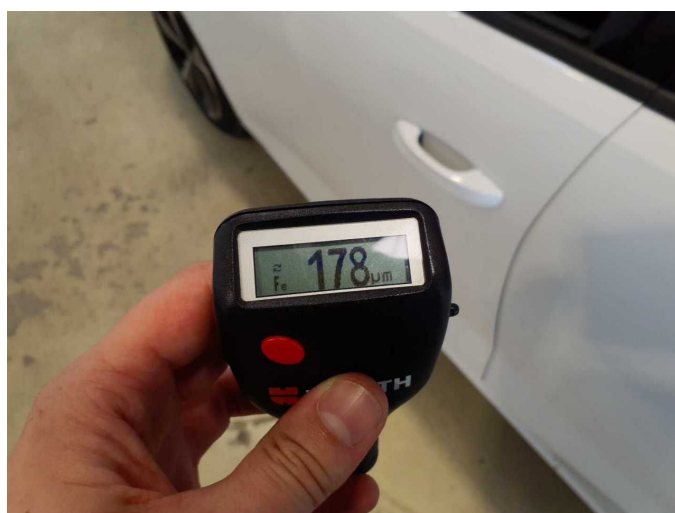
**Repainting 3:** Door - front left side

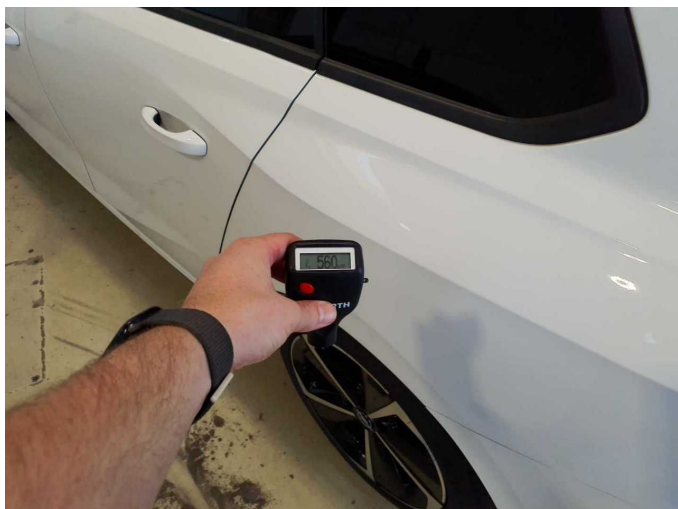
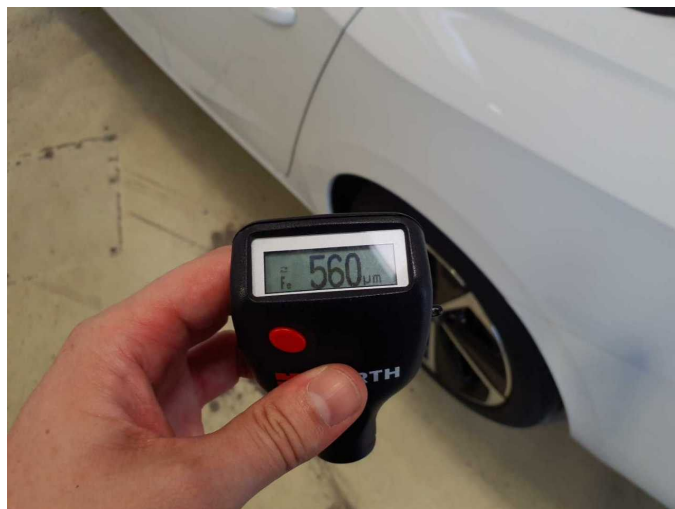
- 1 Mudguard - left side, Professionally carried out, Invoice of repair done Non-existent
- 2 Door - rear left side, Professionally carried out, Invoice of repair done Non-existent
- 3 Door - front left side, Professionally carried out, Invoice of repair done Non-existent
- 4 Side panel - rear left side, Unprofessionally carried out, Invoice of repair done Non-existent

**Repainting 4:** Side panel - rear left side
