Expertise

Protocol number: 46749207  
Order No. / Reference: 26740797  
Inspection date: 28 Jul 2026

| Manufacturer: Opel | Model: Insignia Sports Tourer 2.0 Diesel Aut. Elegance |

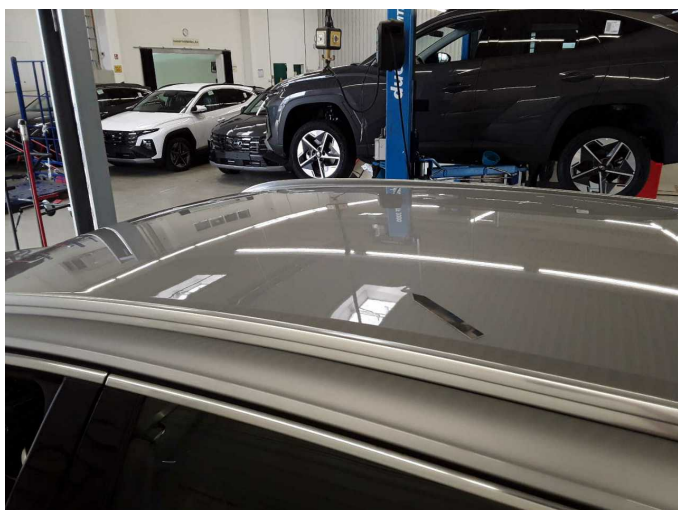
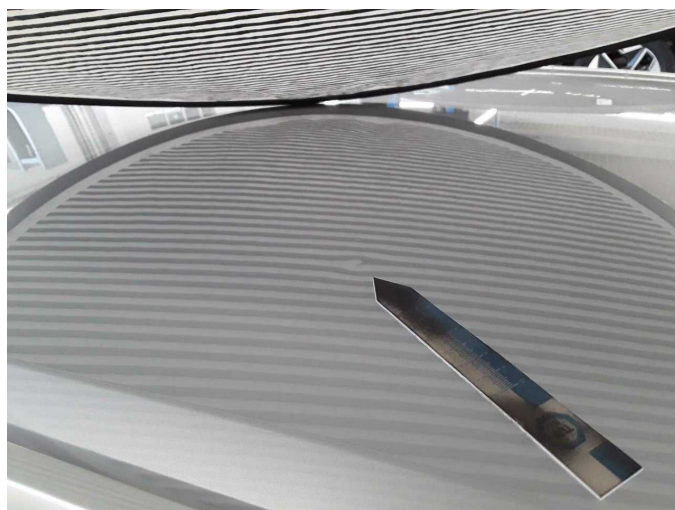
| No. | Component group | Description |
|---|---|---|
| 1 | Roof | Roof - dent(s) - Smart repair |

**Damage 1:** Roof: Roof - dent(s) - Smart repair

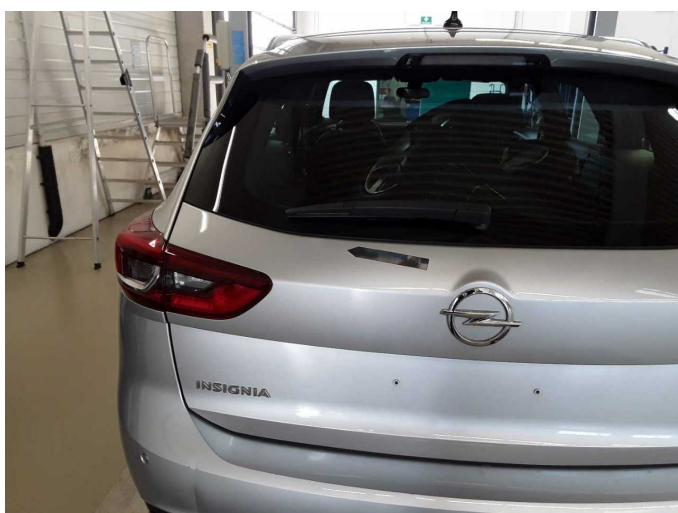
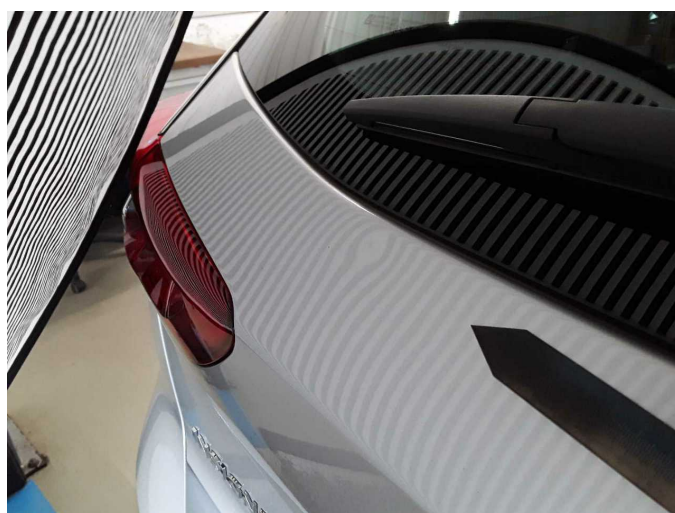
| No. | Component group | Description |
|---|---|---|
| 2 | Boot lid / rear door | Boot lid glazed - dent(s) - Smart repair |

**Damage 2:** Boot lid / rear door: Boot lid glazed - dent(s) - Smart repair

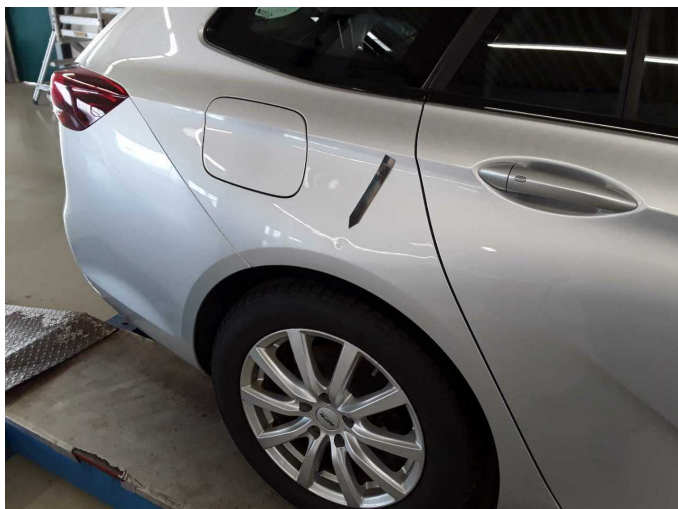
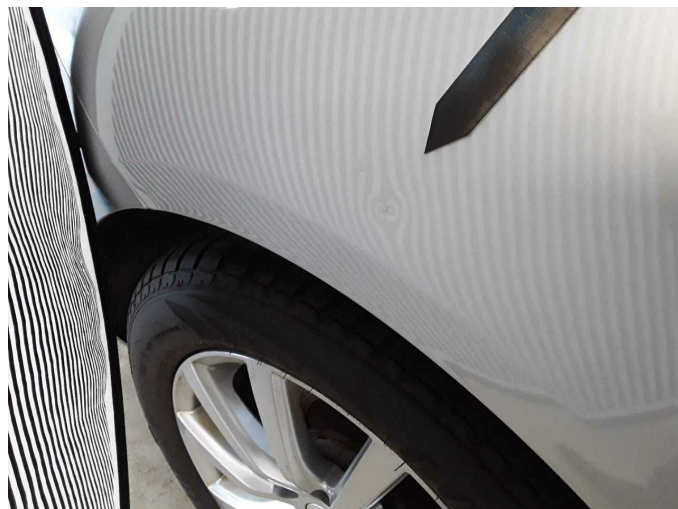
| No. | Component group | Description |
|---|---|---|
| 3 | Side panel - rear right side | Side panel - Dent / paintcoat damage - Smart repair |

**Damage 3:** Side panel - rear right side: Side panel - Dent / paintcoat damage - Smart repair

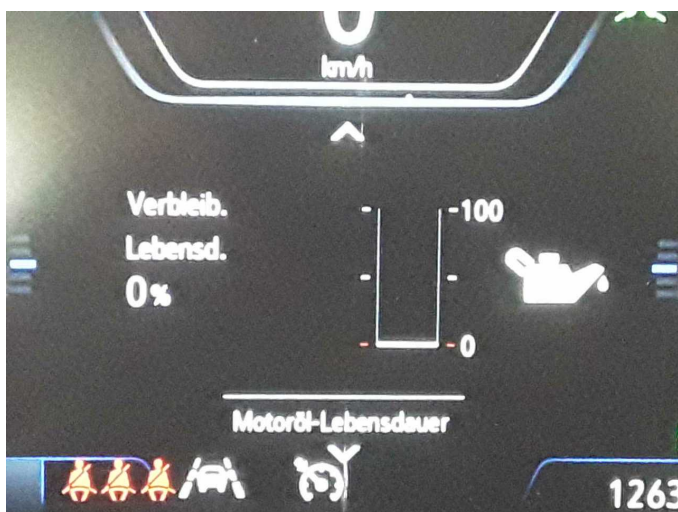
| No. | Component group | Description |
|---|---|---|
| 4 | Misc. | Inspection / maintenance - Due - Perform |

**Damage 4:** Misc.: Inspection / maintenance - Due - Perform

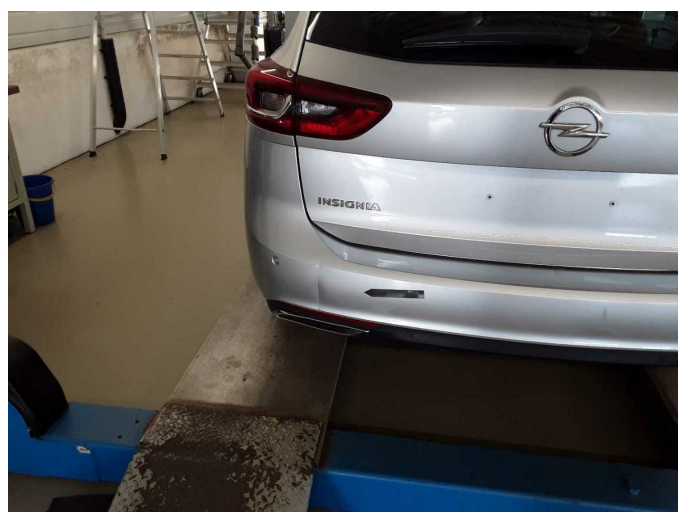
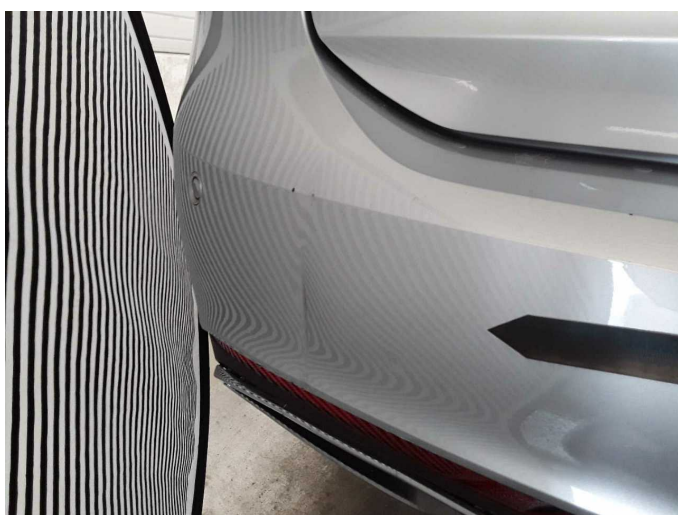
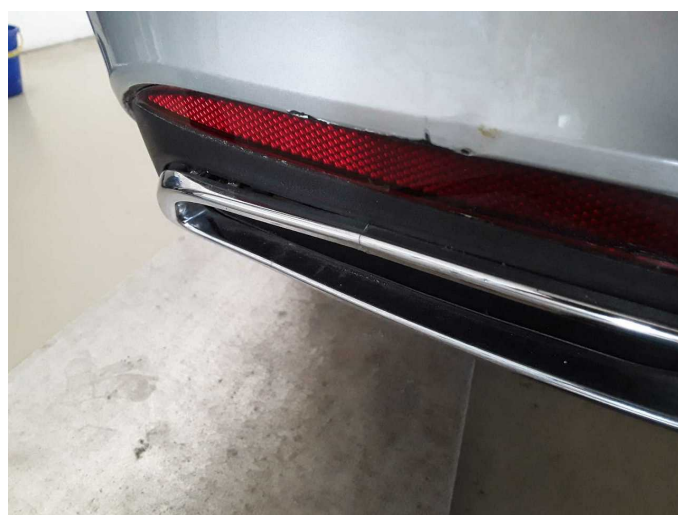
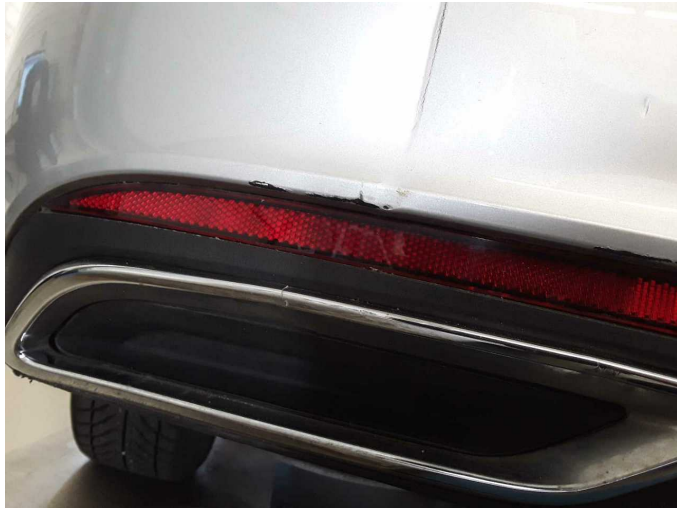
| No. | Component group | Description |
|---|---|---|
| 5 | Rear bumper | Rear bumper - Deformed - repair according to calculation |

**Damage 5:** Rear bumper: Rear bumper - Deformed - repair according to calculation

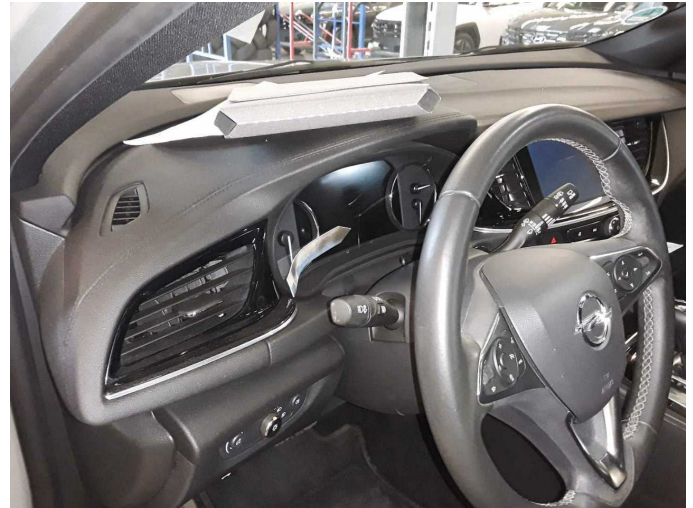
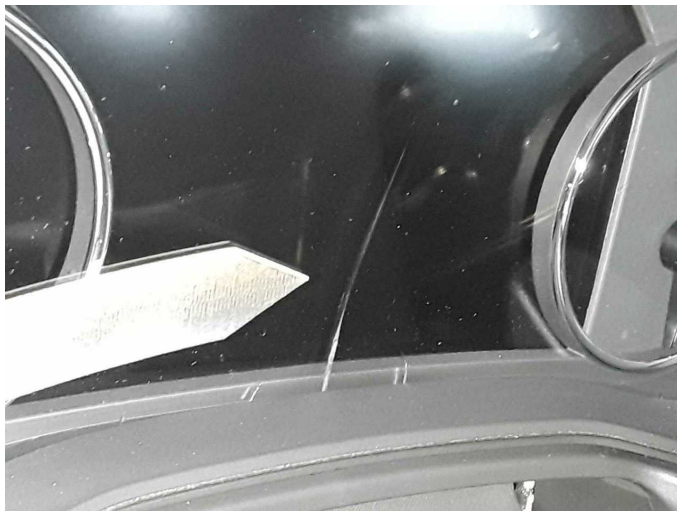
| No. | Component group | Description |
|---|---|---|
| 6 | Instrument panel | Instrument cluster - Broken / torn - Replace |

**Damage 6:** Instrument panel: Instrument cluster - Broken / torn - Replace
