Protocol number: 45904864
Order No. / Reference: 26406075
Inspection date: 9 Jun 2026

Manufacturer: Volkswagen

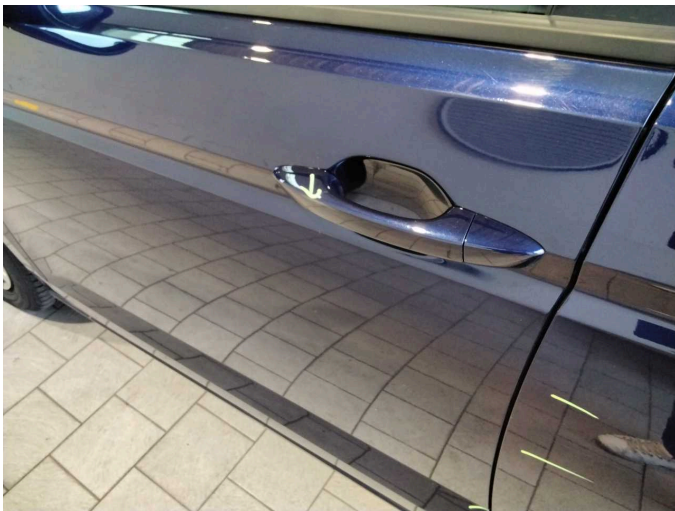
Damage 1: Door - front left side: Door handle - outside - Scratch(es) - Smart repair

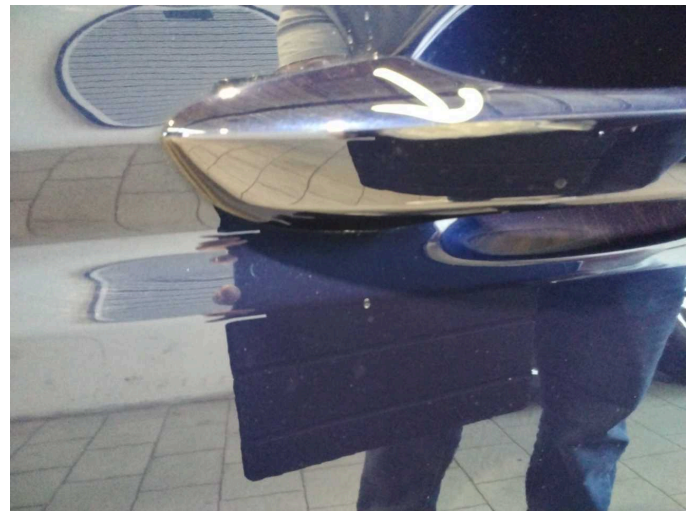
Damage 1: Door - front left side: Door handle - outside - Scratch(es) - Smart repair

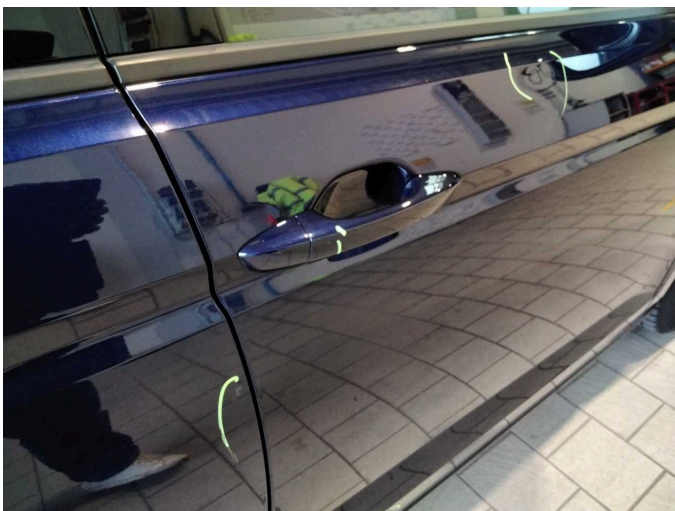
Damage 2: Door - front right side: Door handle - outside - Scratch(es) - Smart repair

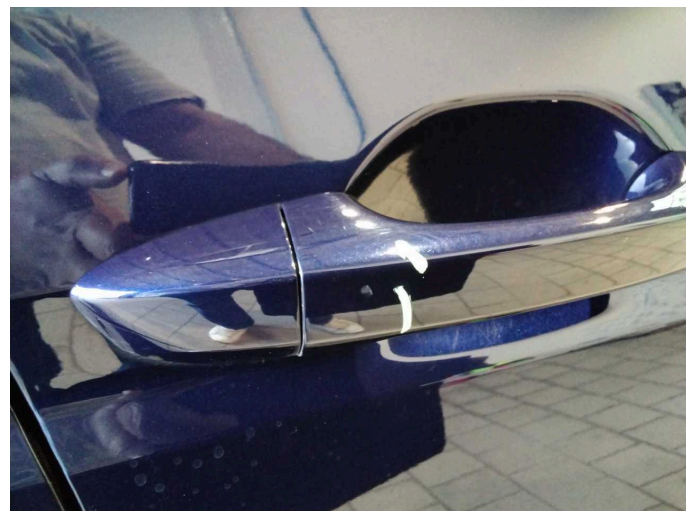
Damage 2: Door - front right side: Door handle - outside - Scratch(es) - Smart repair

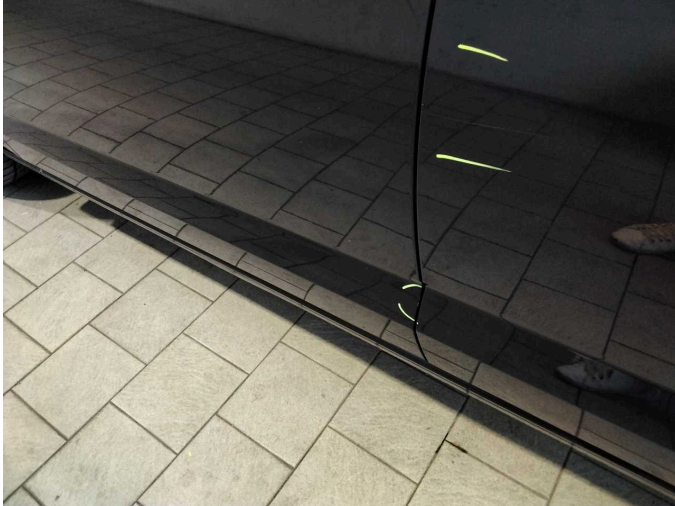
Damage 3: Door - front left side: Door edge - Scratch(es) - Smart repair

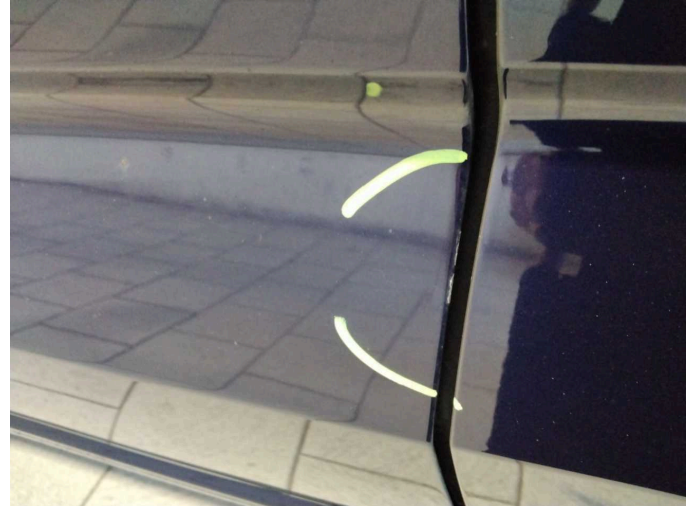
Damage 3: Door - front left side: Door edge - Scratch(es) - Smart repair

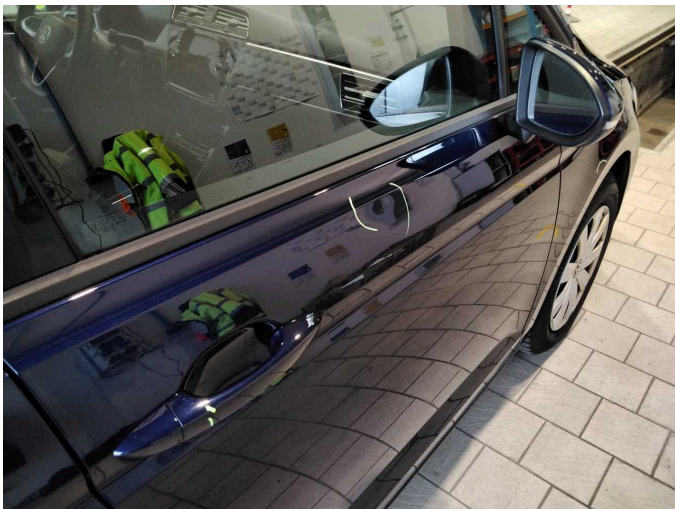
Damage 4: Door - front right side: Door - dent(s) - Smooth repair work

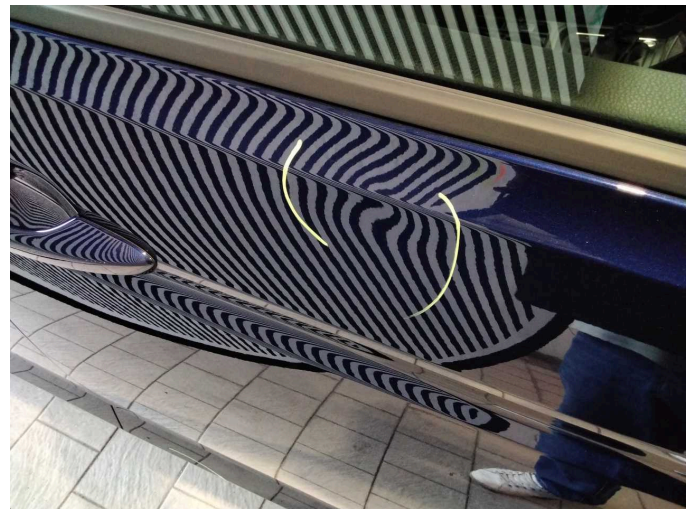
Damage 4: Door - front right side: Door - dent(s) - Smooth repair work

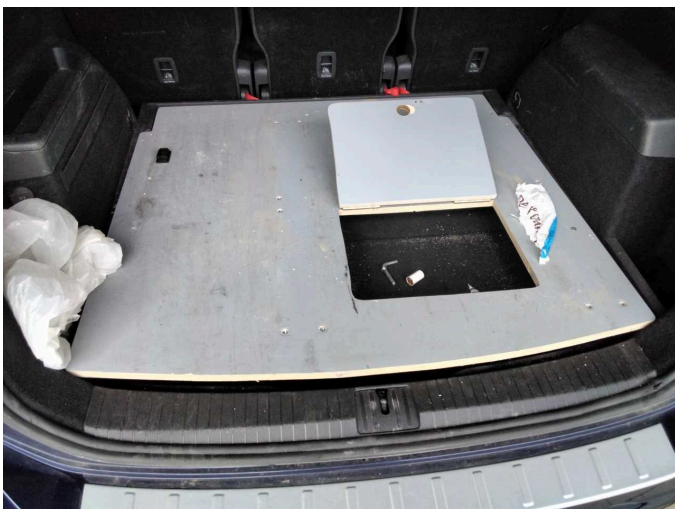
Damage 5: Rear of vehicle: Boot floor (Holzplatte angeschraubt) - Remove

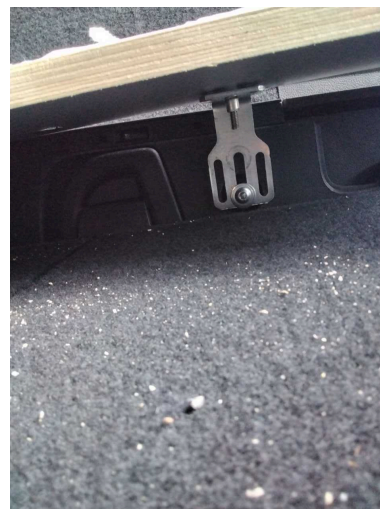
Damage 5: Rear of vehicle: Boot floor (Holzplatte angeschraubt) - Remove

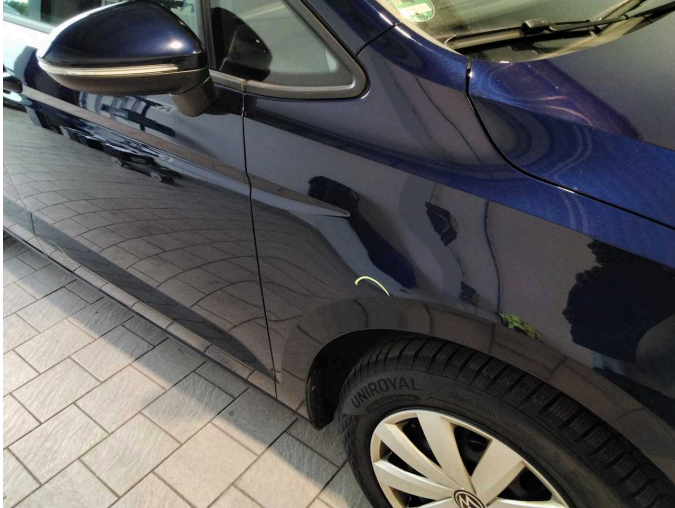
Damage 6: Mudguard - right side: Mudguard - right side - Scratch(es) - Smart repair

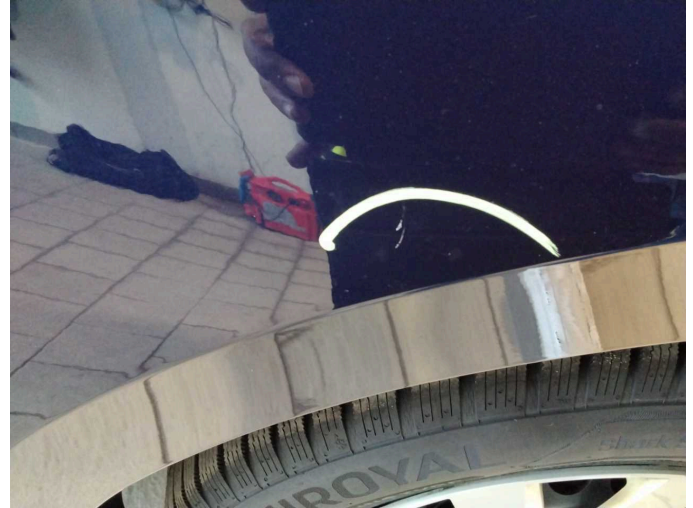
Damage 6: Mudguard - right side: Mudguard - right side - Scratch(es) - Smart repair

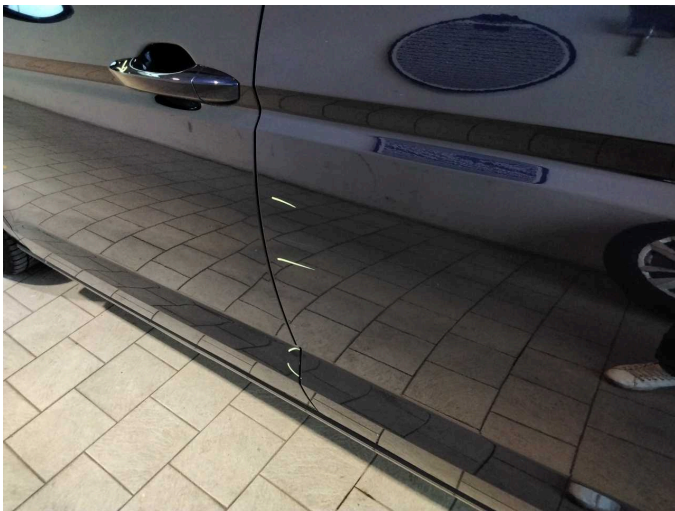
Damage 7: Door - rear left side: Door - Scratch(es) - Smart repair

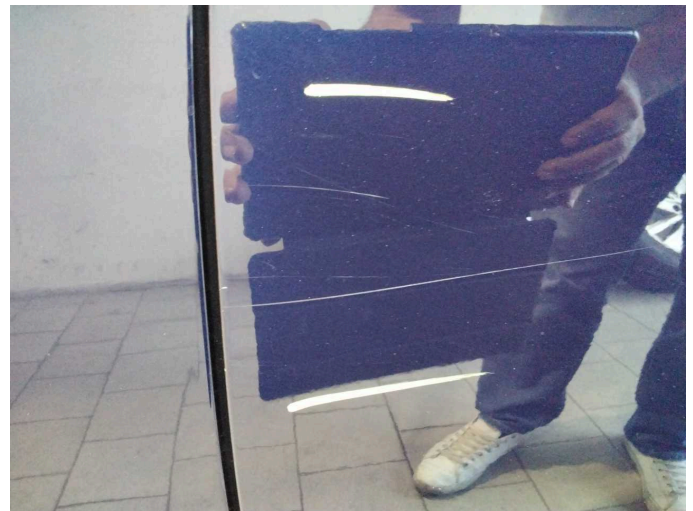
Damage 7: Door - rear left side: Door - Scratch(es) - Smart repair

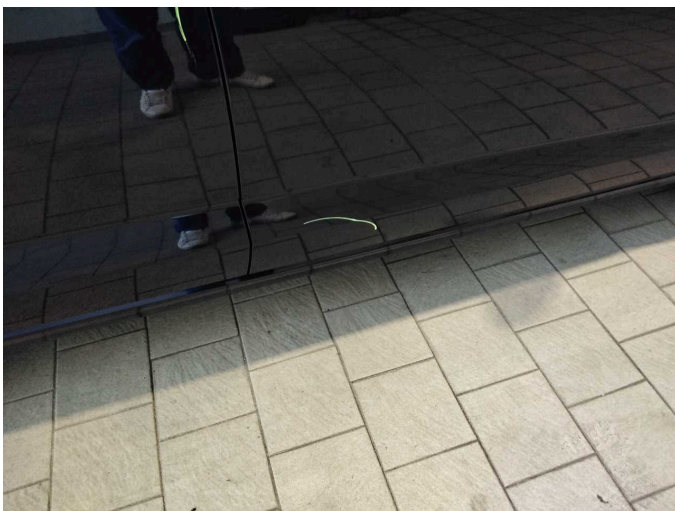
Damage 8: Door - front right side: Door - Scratch(es) - Smart repair

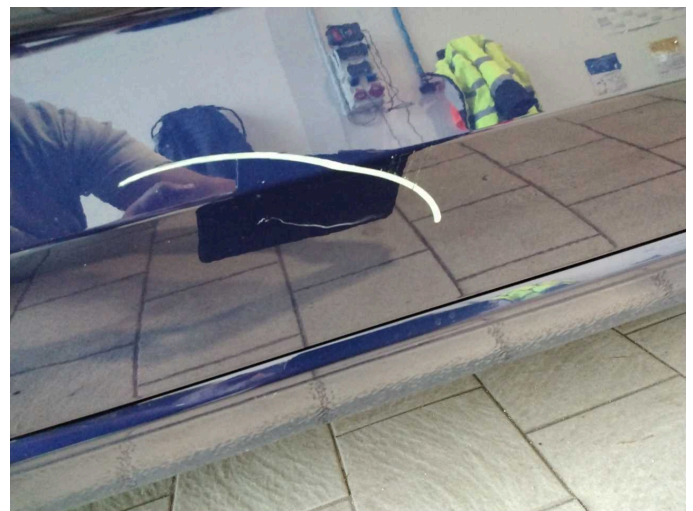
Damage 8: Door - front right side: Door - Scratch(es) - Smart repair

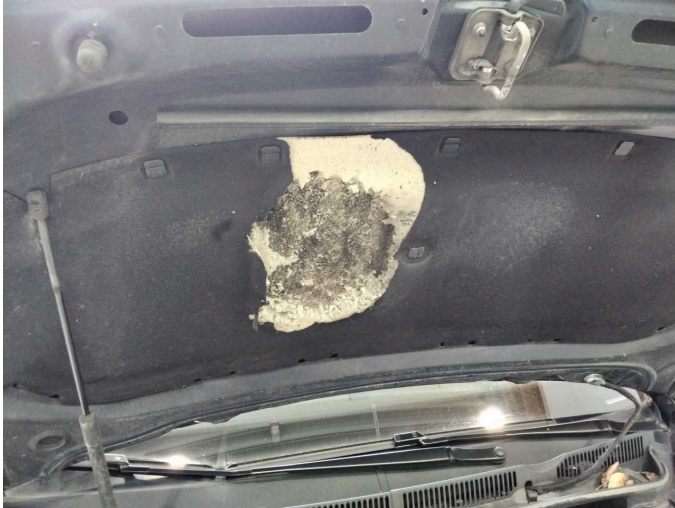
Damage 9: Bonnet: Insulation lining - Damage caused by marten / rodent - Replace

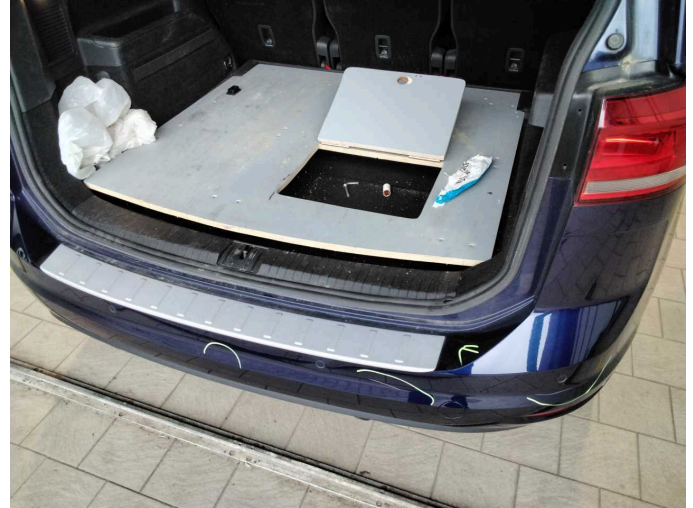
Damage 10: Boot lid / rear door: Seal - Broken / torn - Replace

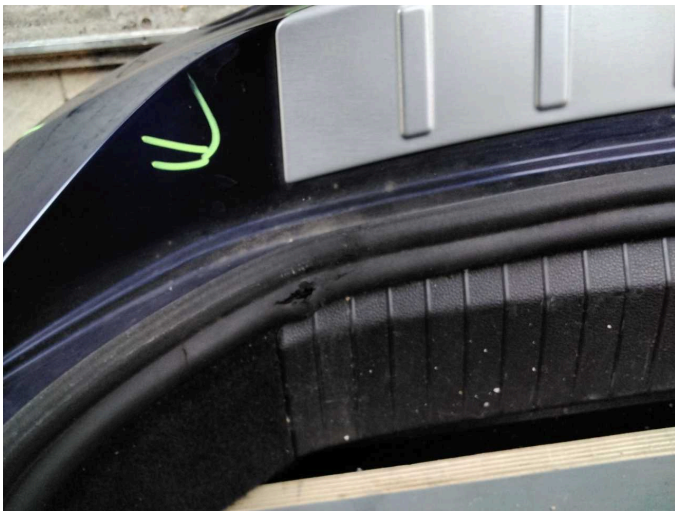
Damage 10: Boot lid / rear door: Seal - Broken / torn - Replace

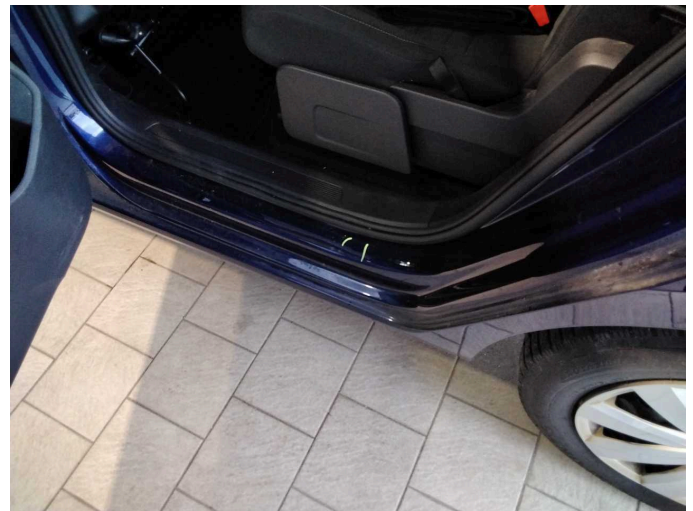
Damage 11: Side panel - rear left side: Sill - Dent / paintcoat damage - Smart repair

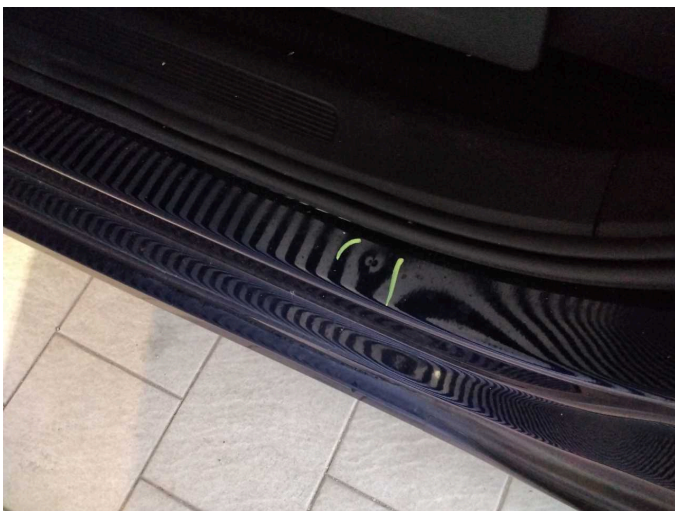
Damage 11: Side panel - rear left side: Sill - Dent / paintcoat damage - Smart repair

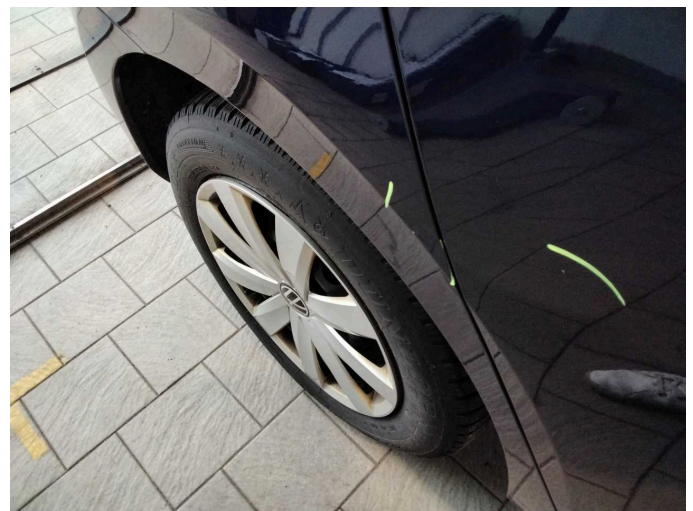
Damage 12: Side panel - rear right side: Side panel - Dent / paintcoat damage - Smart repair

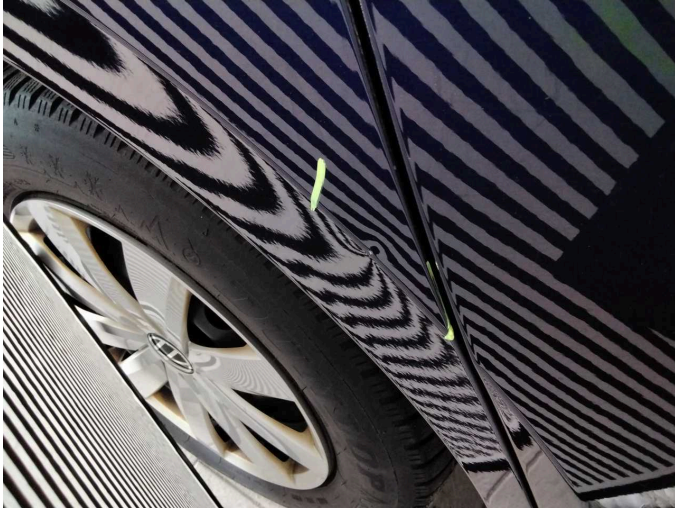
Damage 12: Side panel - rear right side: Side panel - Dent / paintcoat damage - Smart repair

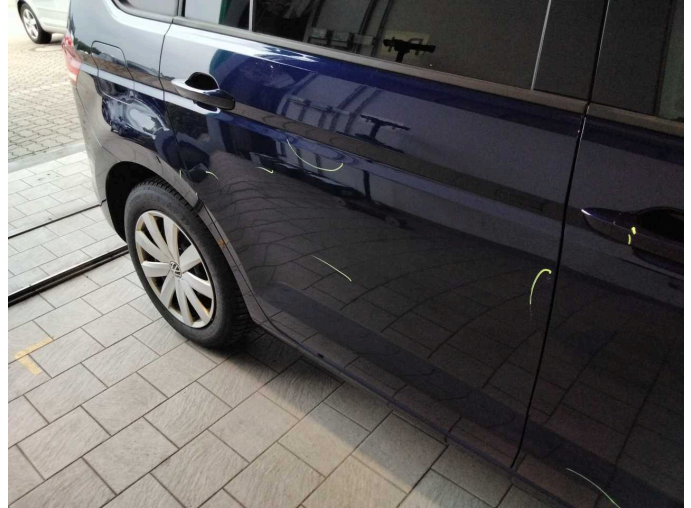
Damage 13: Door - rear right side: Door - Scratch(es) - Paint

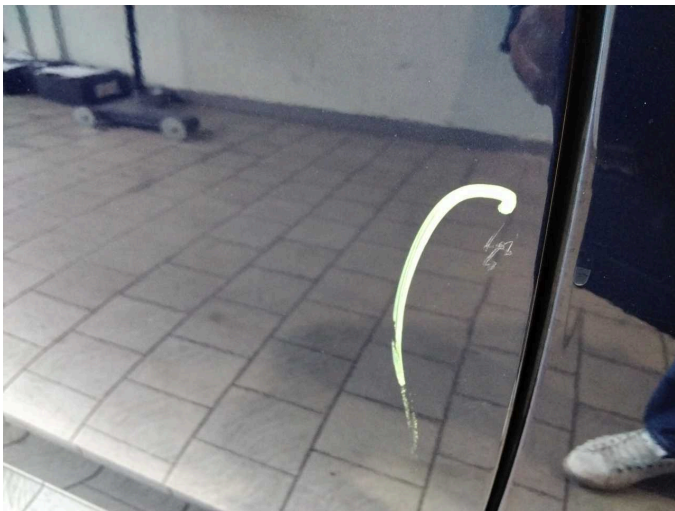
Damage 13: Door - rear right side: Door - Scratch(es) - Paint

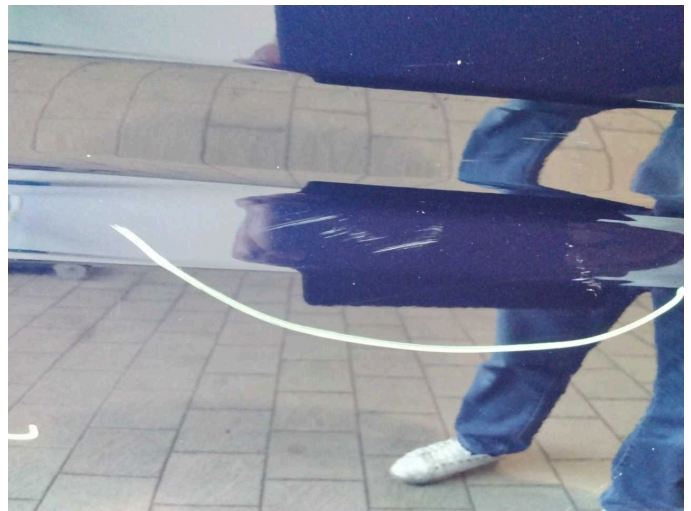
Damage 13: Door - rear right side: Door - Scratch(es) - Paint

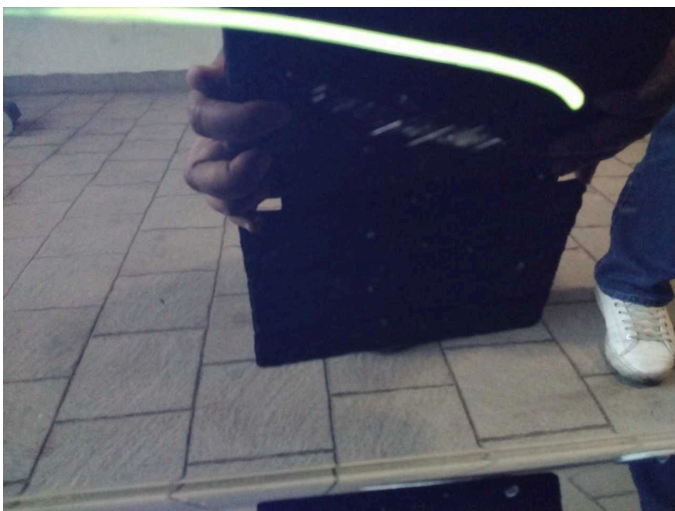
Damage 13: Door - rear right side: Door - Scratch(es) - Paint

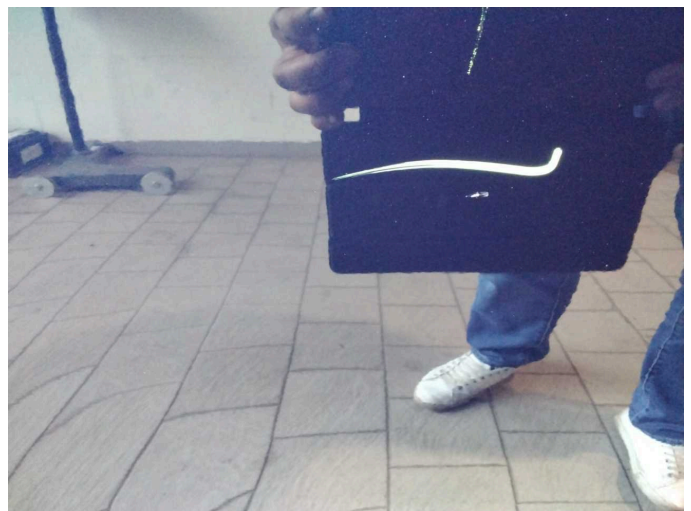
Damage 13: Door - rear right side: Door - Scratch(es) - Paint

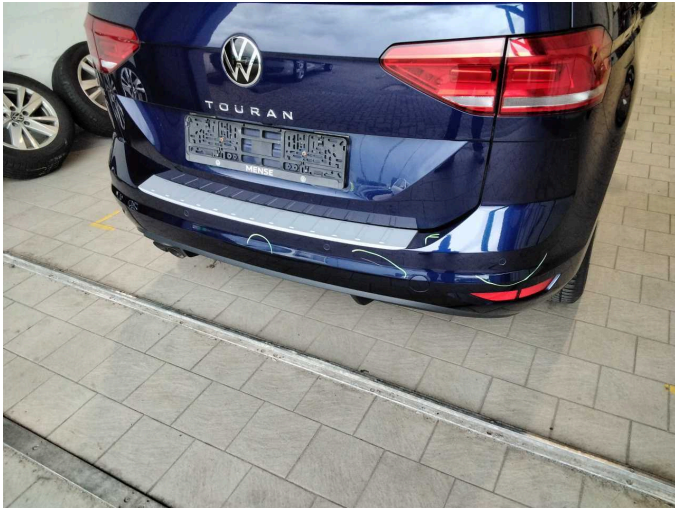
Damage 14: Rear bumper: Rear bumper - Scratch(es) - Paint

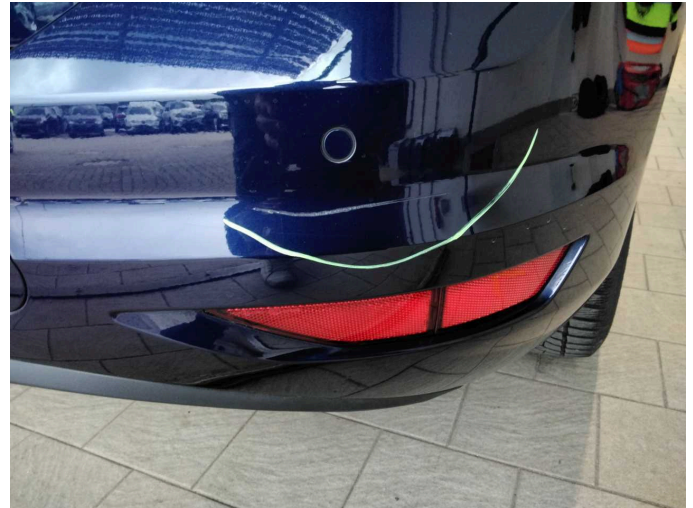
Damage 14: Rear bumper: Rear bumper - Scratch(es) - Paint

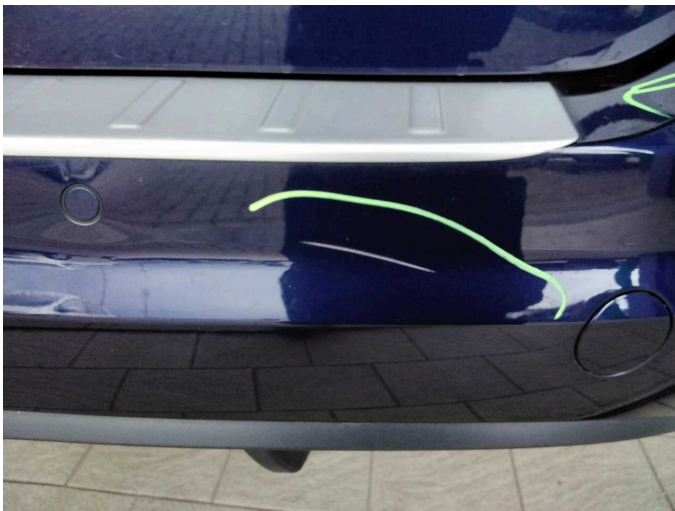
Damage 14: Rear bumper: Rear bumper - Scratch(es) - Paint

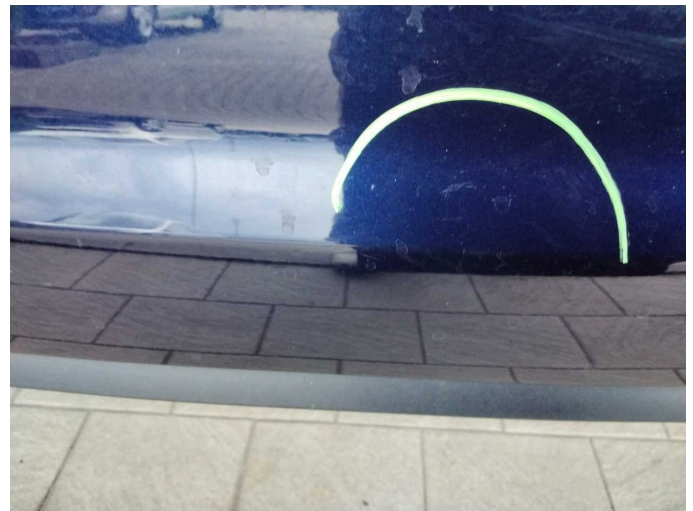
Damage 14: Rear bumper: Rear bumper - Scratch(es) - Paint

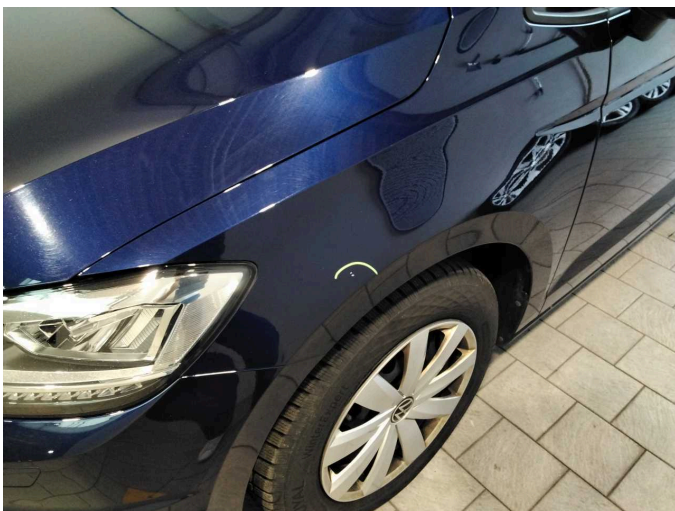
Damage 15: Mudguard - left side: Mudguard - left side - Scratch(es) - Paint

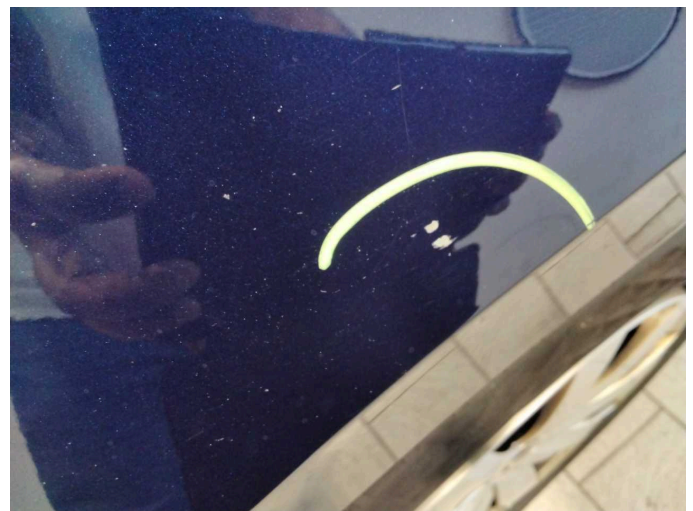
Damage 15: Mudguard - left side: Mudguard - left side - Scratch(es) - Paint

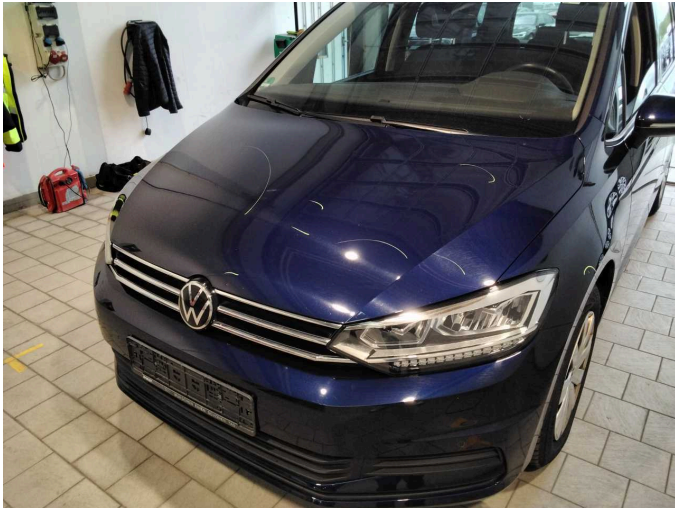
Damage 16: Bonnet: Bonnet - Dent / paintcoat damage - Repair and paint

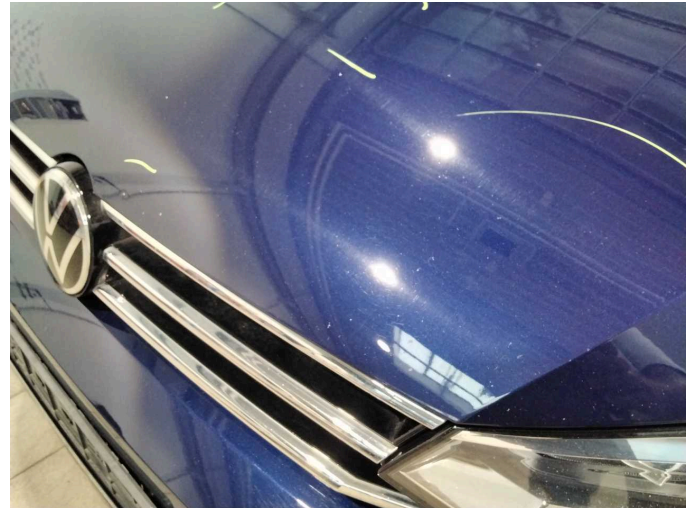
Damage 16: Bonnet: Bonnet - Dent / paintcoat damage - Repair and paint

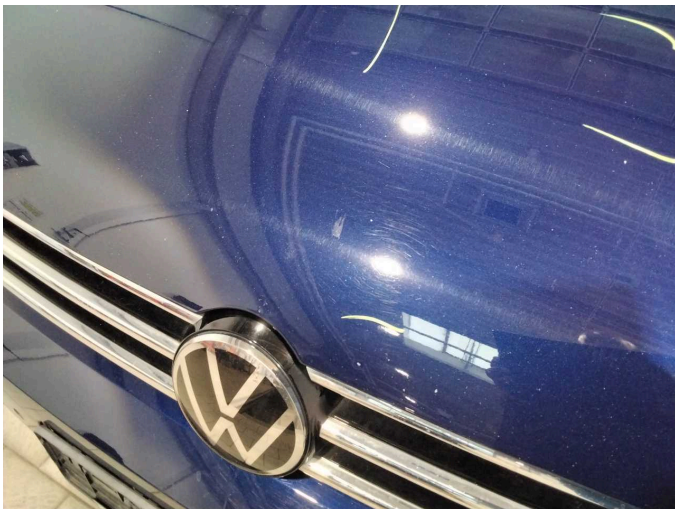
Damage 16: Bonnet: Bonnet - Dent / paintcoat damage - Repair and paint

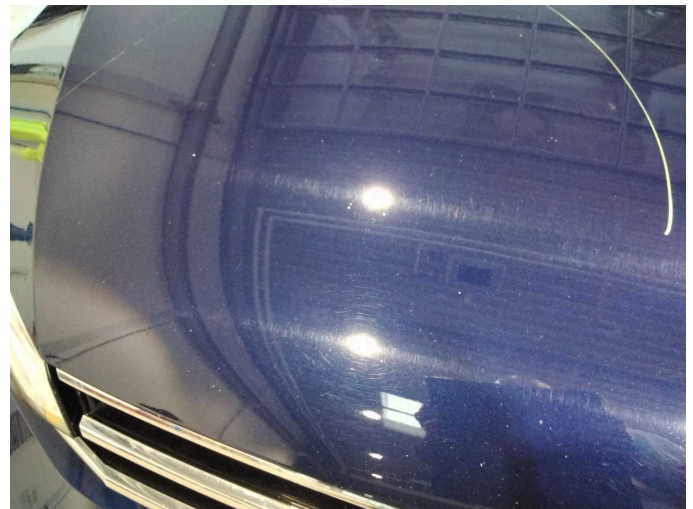
Damage 16: Bonnet: Bonnet - Dent / paintcoat damage - Repair and paint

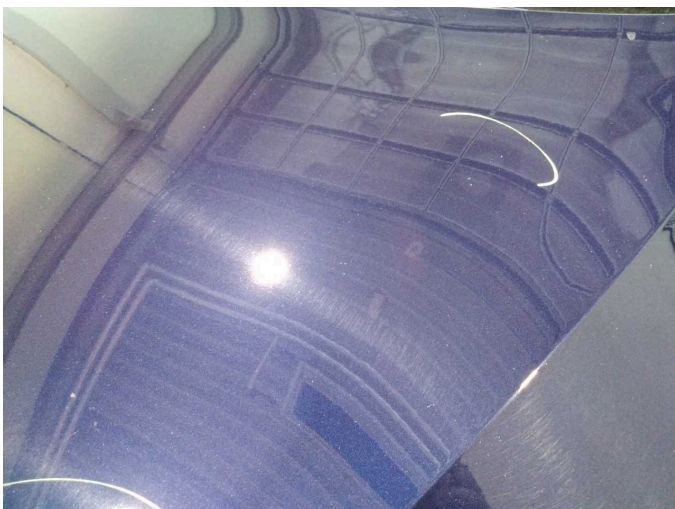
Damage 16: Bonnet: Bonnet - Dent / paintcoat damage - Repair and paint

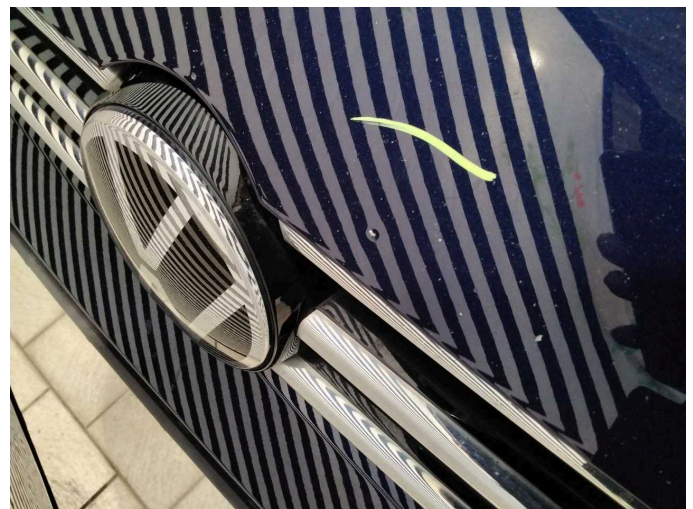
Damage 16: Bonnet: Bonnet - Dent / paintcoat damage - Repair and paint

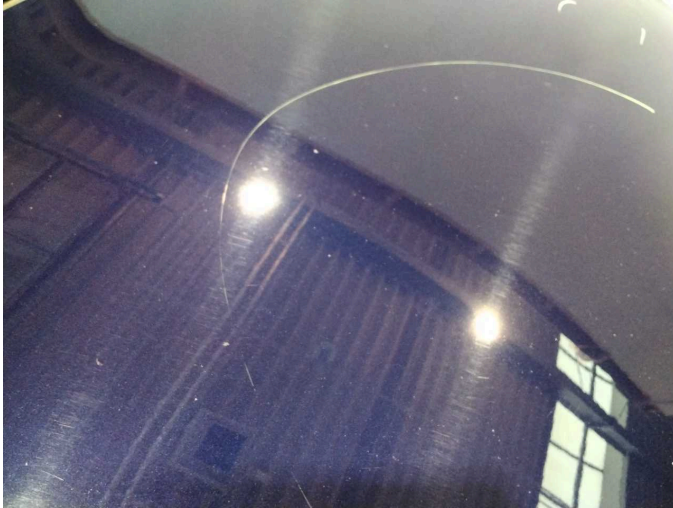
Damage 16: Bonnet: Bonnet - Dent / paintcoat damage - Repair and paint

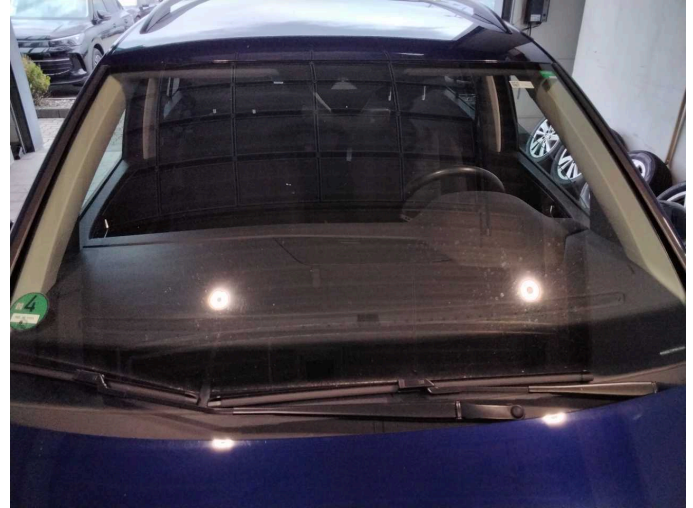
Wear and tear 1: Vehicle glazing: Windscreen - Stone chips - No deduction

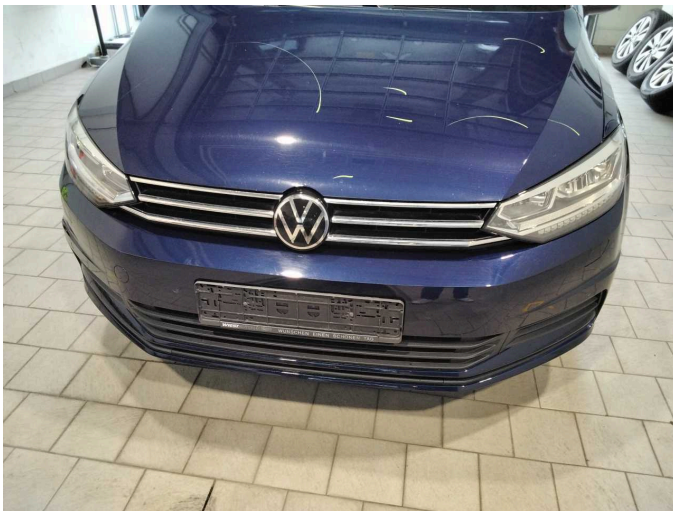
Wear and tear 2: Front bumper: Front bumper - Stone chips - No deduction

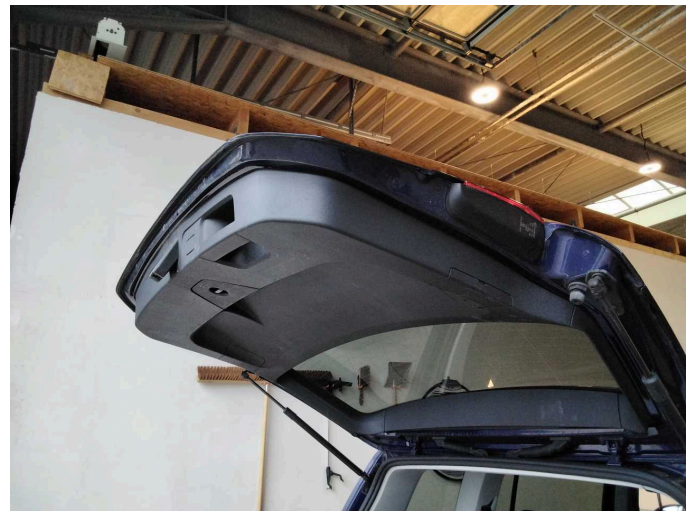
Wear and tear 3: Trim / covers: Boot lining - Scratch(es) - No deduction

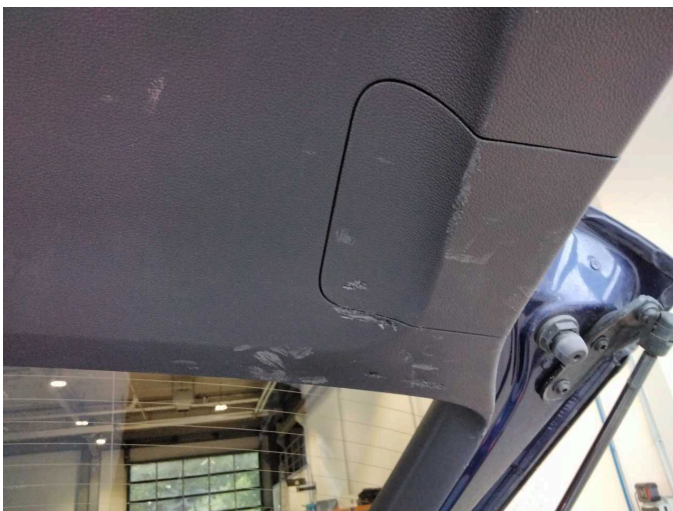
Wear and tear 3: Trim / covers: Boot lining - Scratch(es) - No deduction

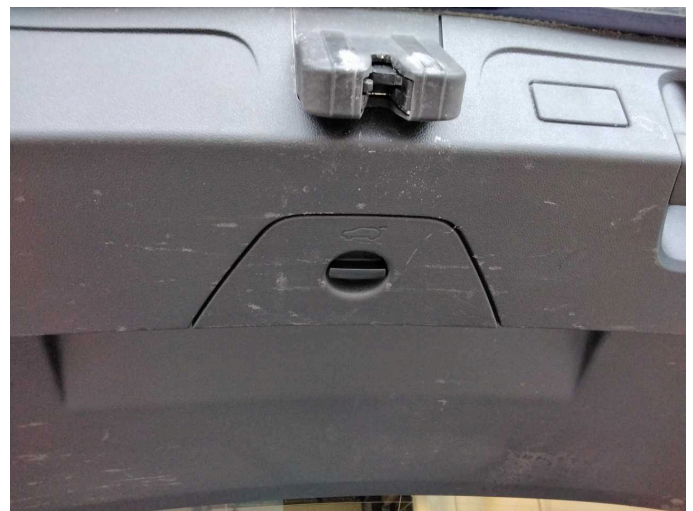
Wear and tear 3: Trim / covers: Boot lining - Scratch(es) - No deduction

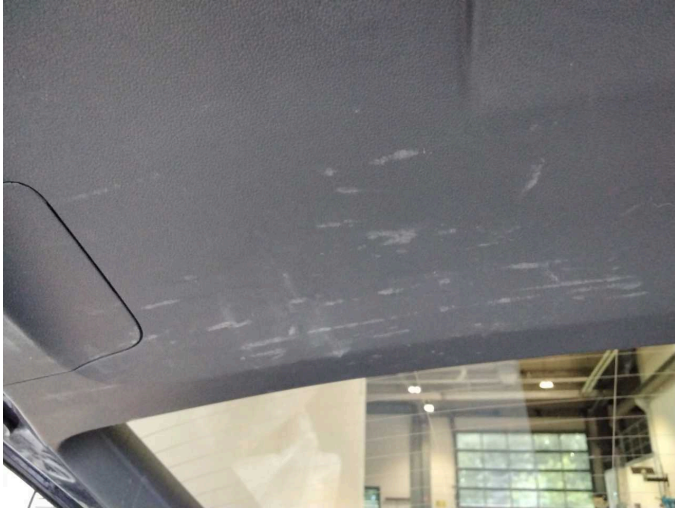
Wear and tear 3: Trim / covers: Boot lining - Scratch(es) - No deduction
