## Expertise

Protocol number: 45791110  
Order No. / Reference: 26153129  
Inspection date: 2 Jun 2026

Manufacturer: Mercedes-Benz

Model: 317 CDI Sprinter Standard HA PRO

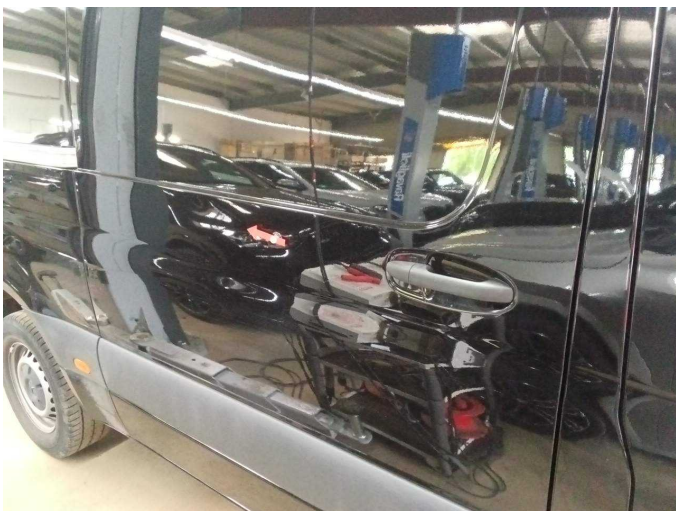
No.	Component group	Description
1	Misc.	Main inspection - No evidence - No deduction
2	Misc.	Inspection / maintenance - No evidence - No deduction
3	Sliding door, right	Sliding door - dent(s) - Smooth repair work
4	Side panel - rear left side	Side panel - dent(s) - Smooth repair work
5	Door - front right side	Door - Defective - Smooth repair work
6	Side panel - rear right side	Side panel - dent(s) - Smooth repair work
7	Roof	Roof rail - left side - Scratch(es) - Smart repair
8	Sliding door, right	Door seal - Broken / torn - Replace
9	Side panel - rear left side	Interior trim - Broken / torn - Replace
10	Side panel - rear right side	Interior trim - Broken / torn - Replace
11	Bonnet	Bonnet - Scratch(es) - Paint

Damage 3: Sliding door, right: Sliding door - dent(s) - Smooth repair work

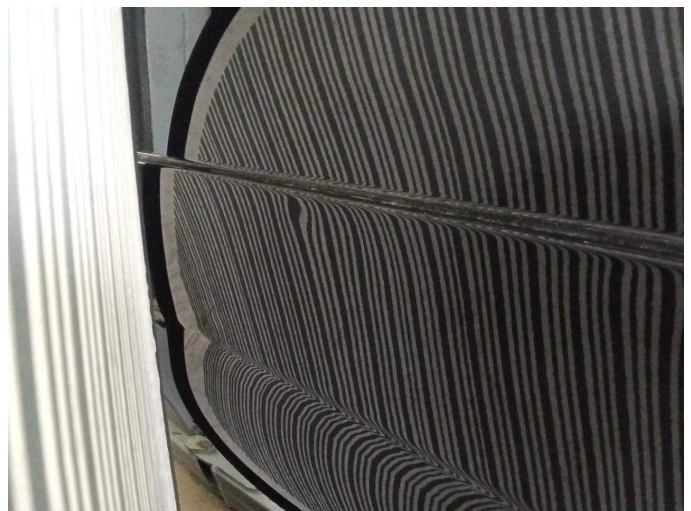
Damage 3: Sliding door, right: Sliding door - dent(s) - Smooth repair work

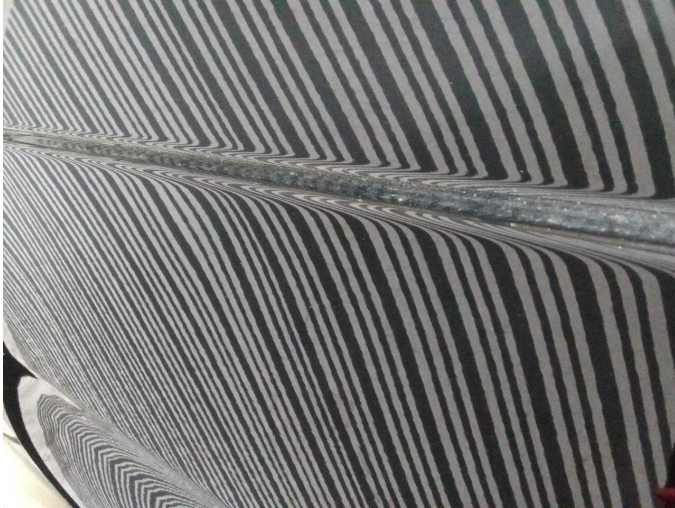
**Damage 3:** Sliding door, right: Sliding door - dent(s) - Smooth repair work

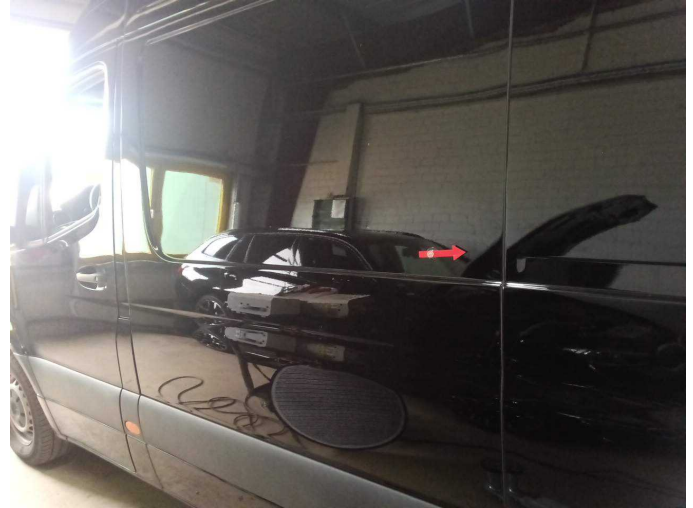
**Damage 4:** Side panel - rear left side: Side panel - dent(s) - Smooth repair work

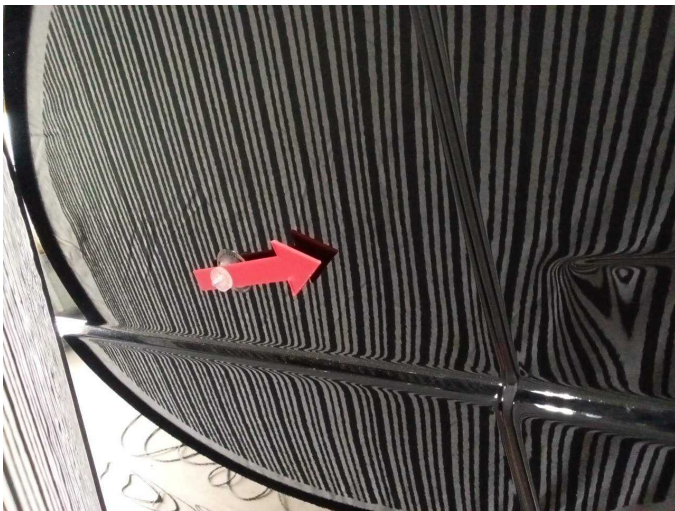
**Damage 4:** Side panel - rear left side: Side panel - dent(s) - Smooth repair work

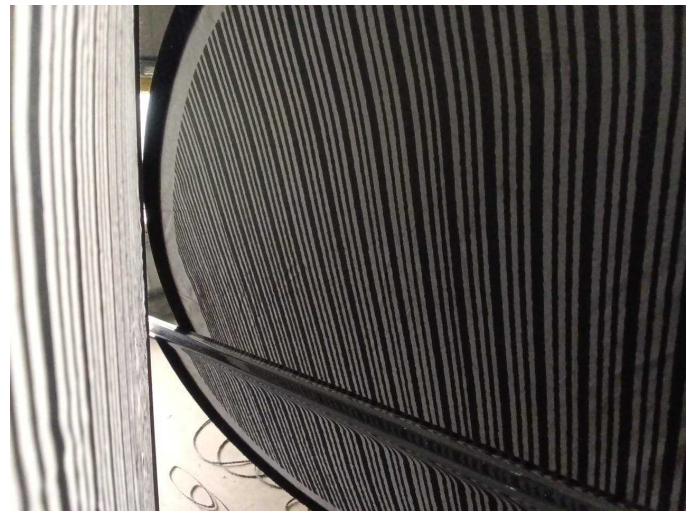
**Damage 4:** Side panel - rear left side: Side panel - dent(s) - Smooth repair work

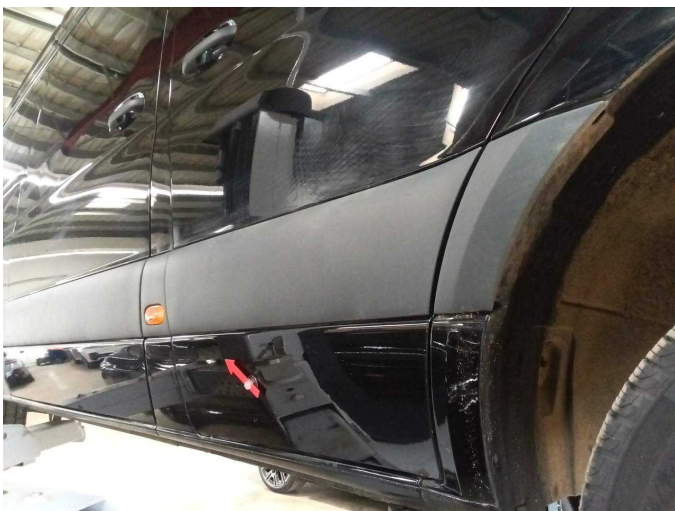
**Damage 5:** Door - front right side: Door - Defective - Smooth repair work

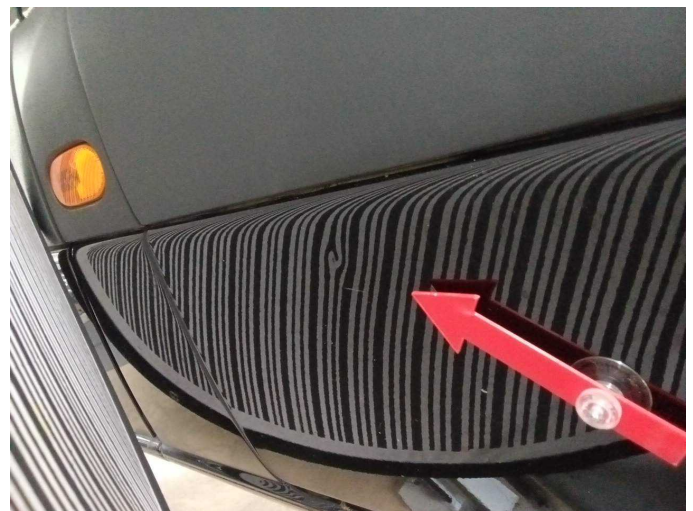
**Damage 5:** Door - front right side: Door - Defective - Smooth repair work

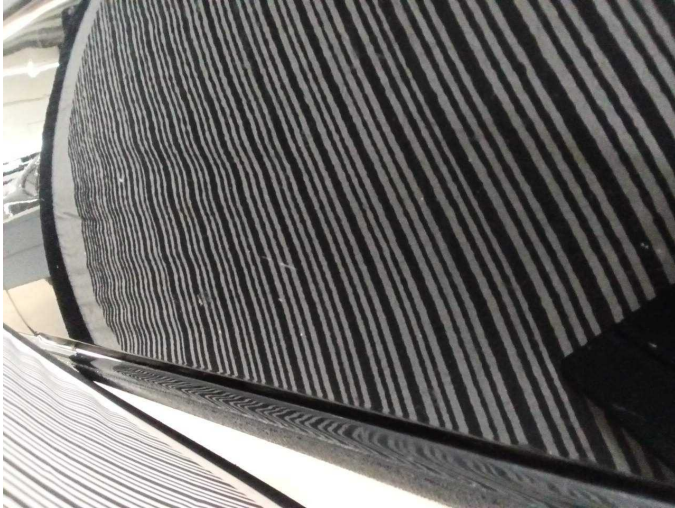
**Damage 5:** Door - front right side: Door - Defective - Smooth repair work

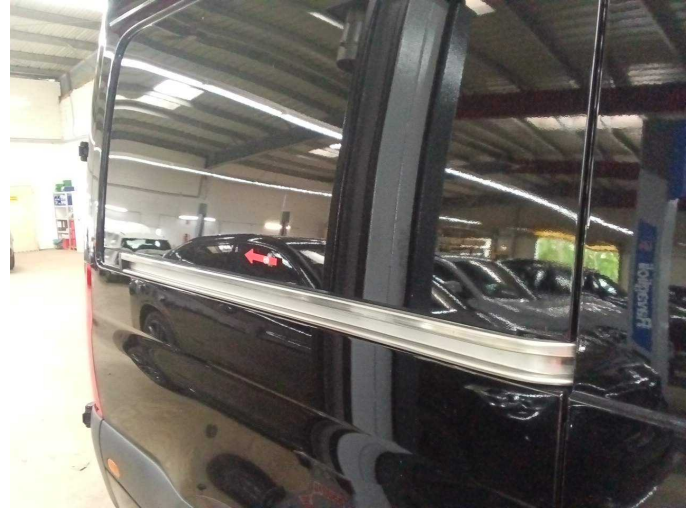
**Damage 6:** Side panel - rear right side: Side panel - dent(s) - Smooth repair work

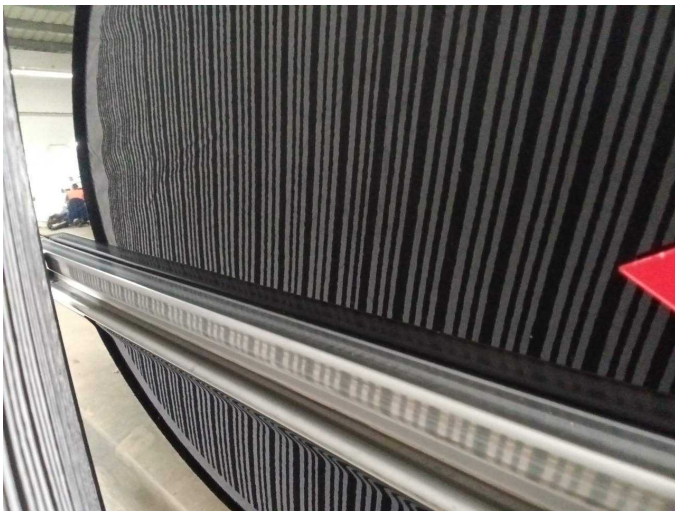
**Damage 6:** Side panel - rear right side: Side panel - dent(s) - Smooth repair work

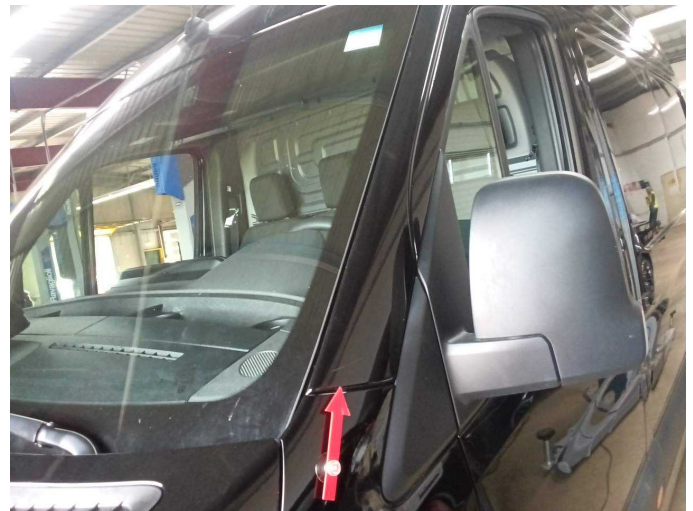
**Damage 7:** Roof: Roof rail - left side - Scratch(es) - Smart repair

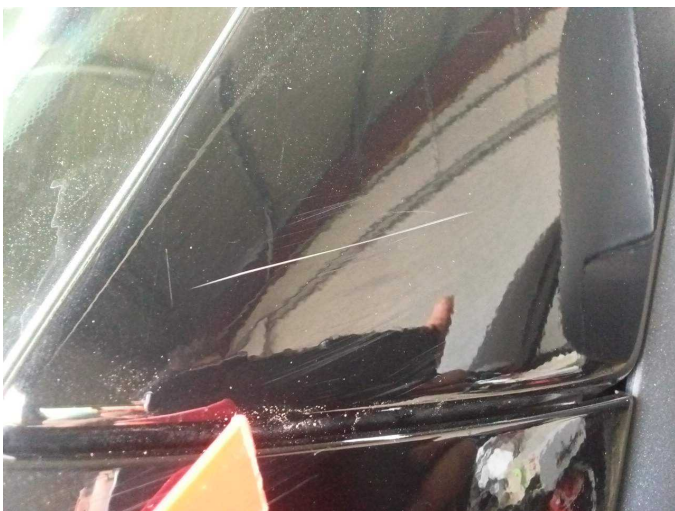
**Damage 7:** Roof: Roof rail - left side - Scratch(es) - Smart repair

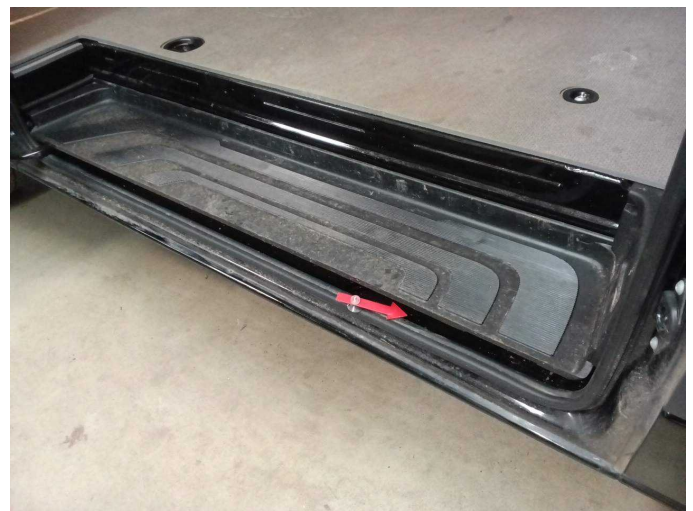
**Damage 8:** Sliding door, right: Door seal - Broken / torn - Replace

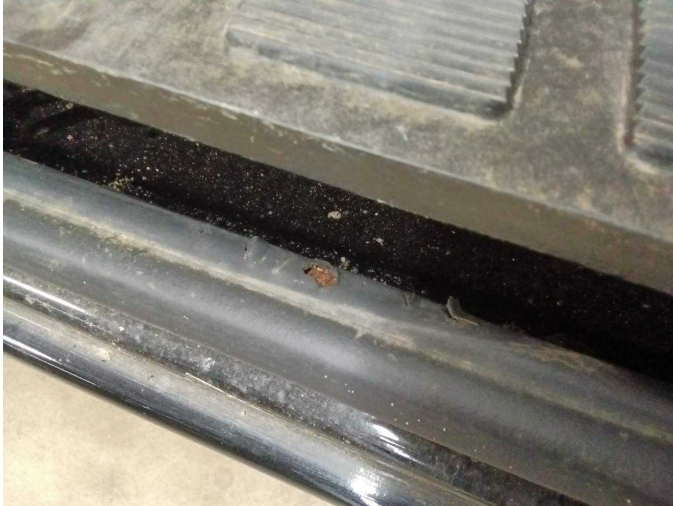
**Damage 8:** Sliding door, right: Door seal - Broken / torn - Replace

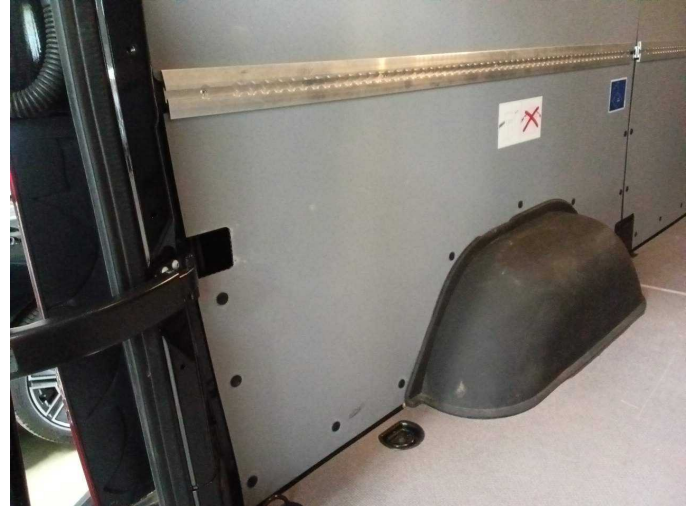
**Damage 9:** Side panel - rear left side: Interior trim - Broken / torn - Replace

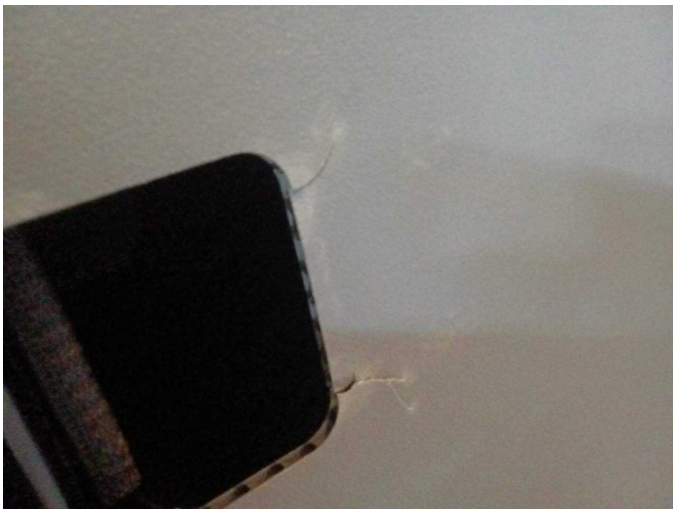
**Damage 9:** Side panel - rear left side: Interior trim - Broken / torn - Replace

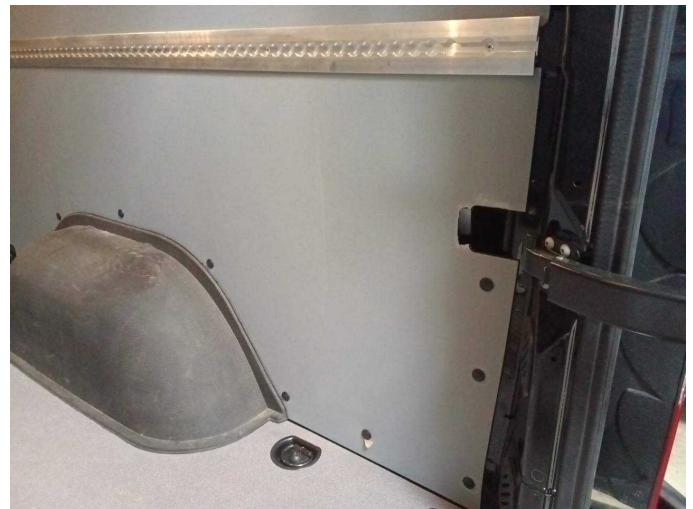
**Damage 10:** Side panel - rear right side: Interior trim - Broken / torn - Replace

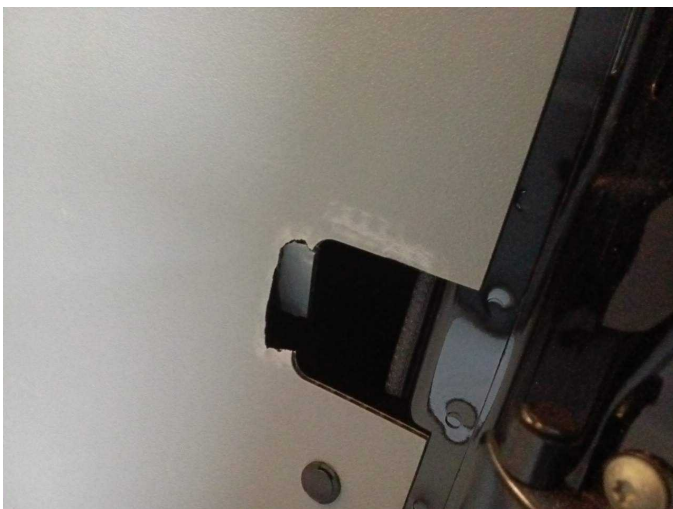
**Damage 10:** Side panel - rear right side: Interior trim - Broken / torn - Replace

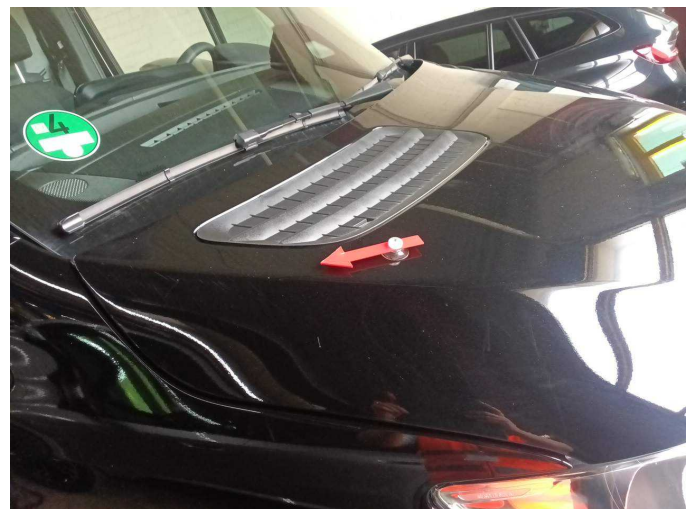
**Damage 11:** Bonnet: Bonnet - Scratch(es) - Paint

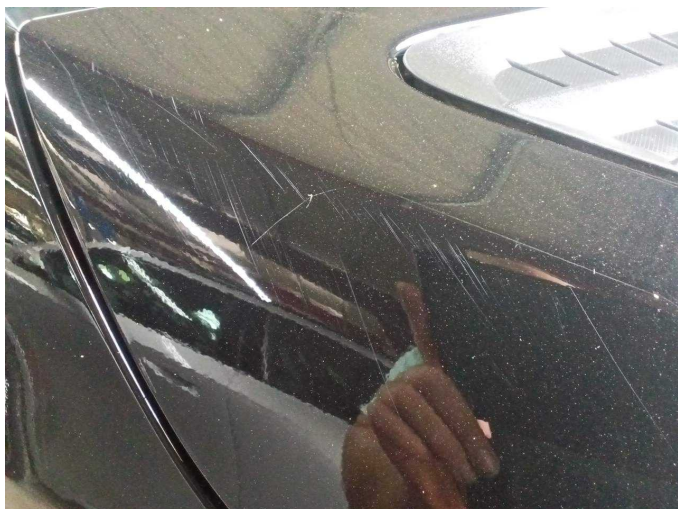
**Damage 11:** Bonnet: Bonnet - Scratch(es) - Paint

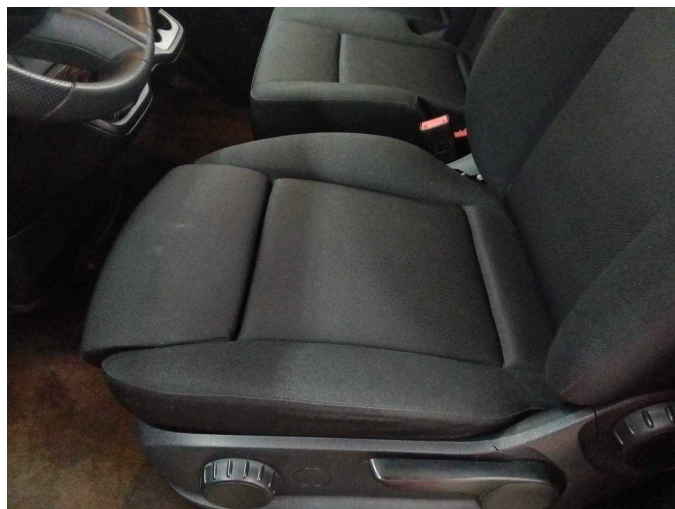
No.	Component group	Description
1	Vehicle glazing	Windscreen - Stone chips - No deduction
2	Wing mirror - left side	Mirror housing - Scratch(es) - No deduction
3	Interior	Separation net - Scratch(es) - No deduction
4	Rear of vehicle	Boot floor - Scratch(es) - No deduction
5	Seat - front	Seat cover - left side - No deduction

**Wear and tear 5:** Seat - front: Seat cover - left side - No deduction

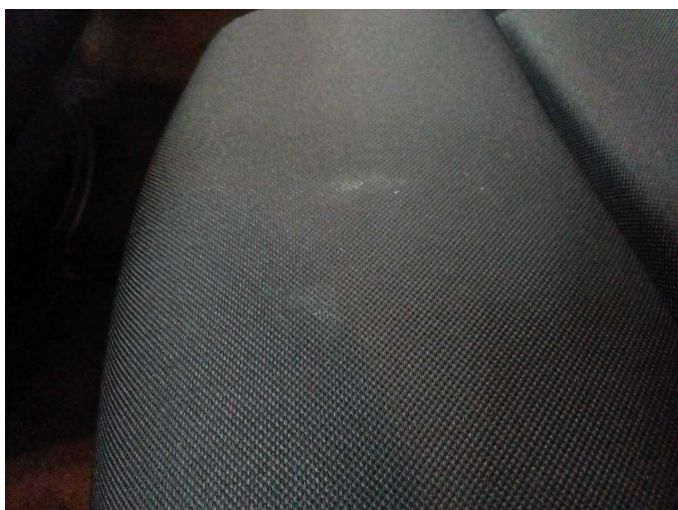
**Wear and tear 5:** Seat - front: Seat cover - left side - No deduction
