Expertise

Protocol number: 46738620  
Order No. / Reference: 26703236  
Inspection date: 27 Jul 2026

Manufacturer: Peugeot

Model: 308 SW BlueHDi 130 EAT8 Allure

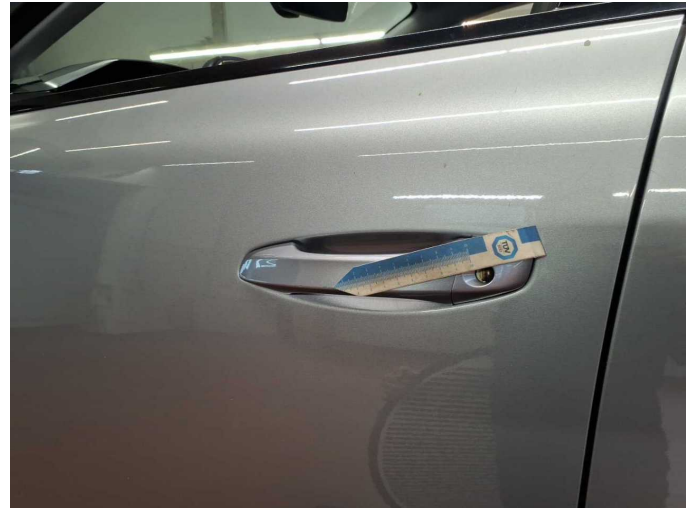
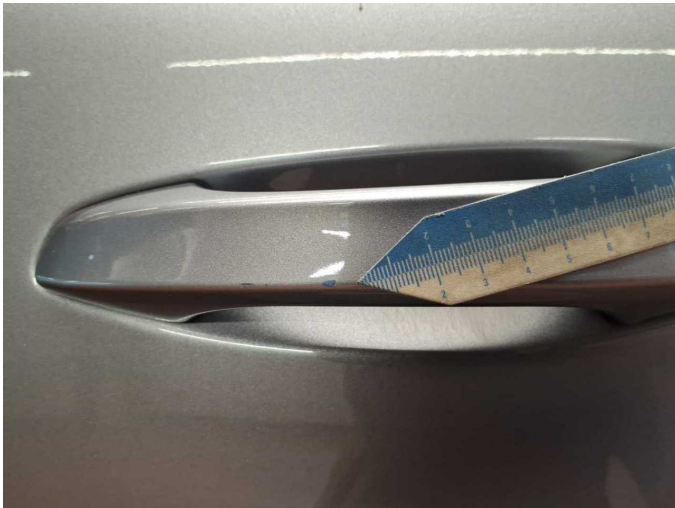
| No. | Component group | Description |
|---|---|---|
| 1 | Door - front left side | Door handle - outside - Scratch(es) - Smart repair |

**Damage 1:** Door - front left side: Door handle - outside - Scratch(es) - Smart repair

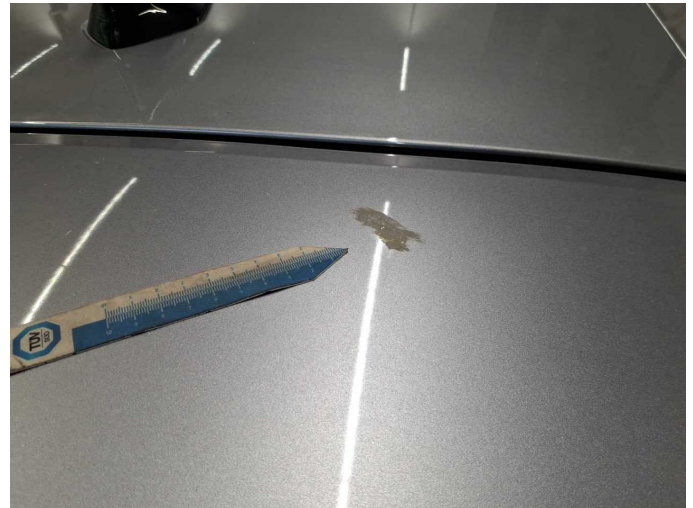
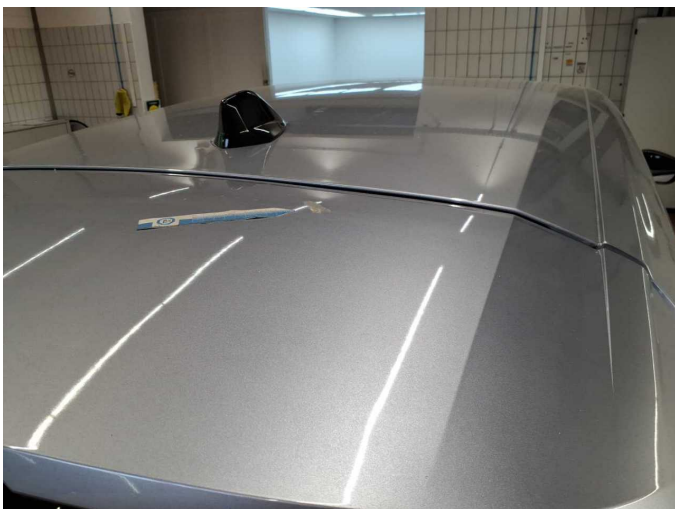
| No. | Component group | Description |
|---|---|---|
| 2 | Boot lid / rear door | Rear spoiler - Soiled - Clean |

**Damage 2:** Boot lid / rear door: Rear spoiler - Soiled - Clean

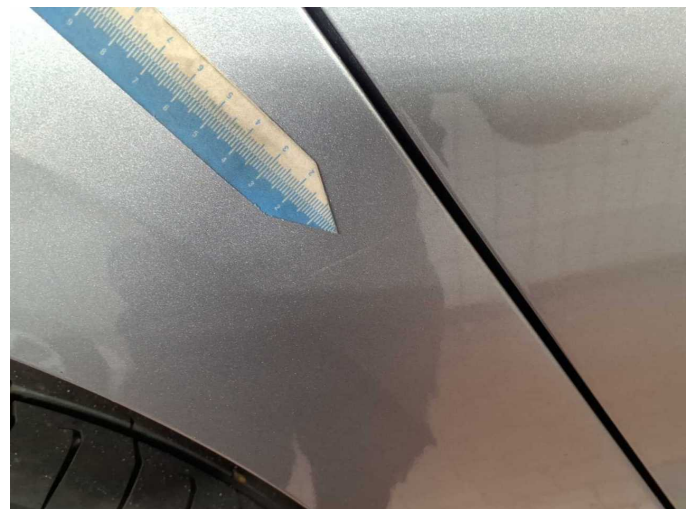
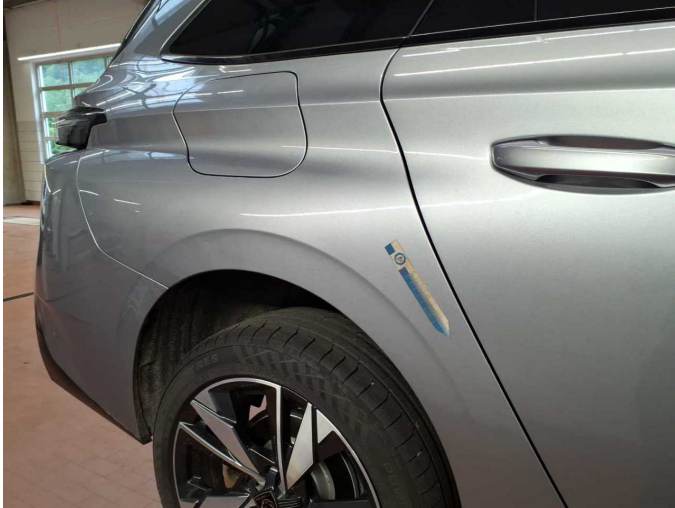
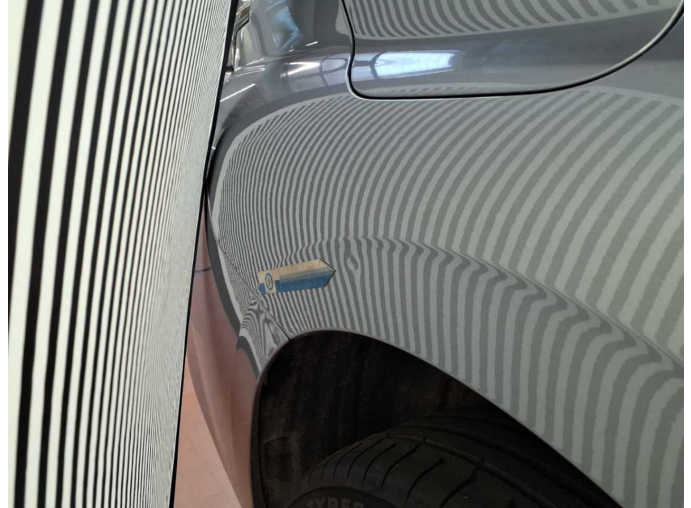
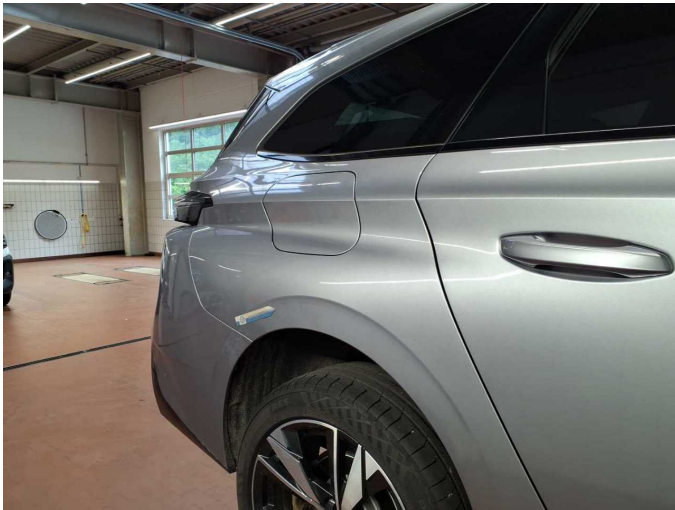
| No. | Component group | Description |
|---|---|---|
| 3 | Side panel - rear right side | Side panel - dent(s) - Smooth repair work |

**Damage 3:** Side panel - rear right side: Side panel - dent(s) - Smooth repair work

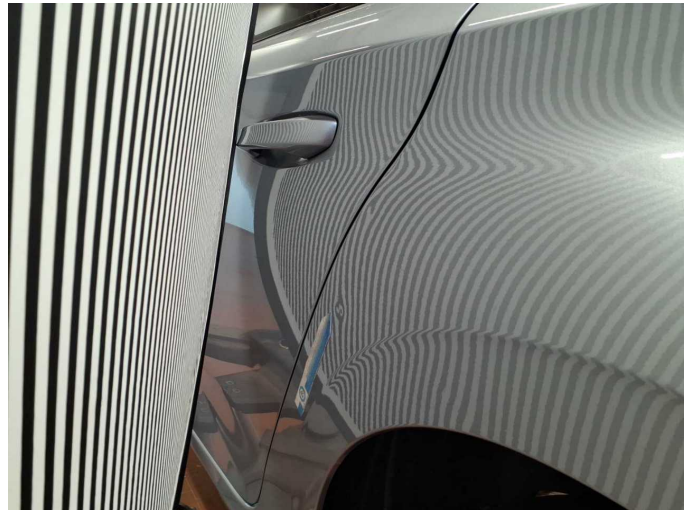
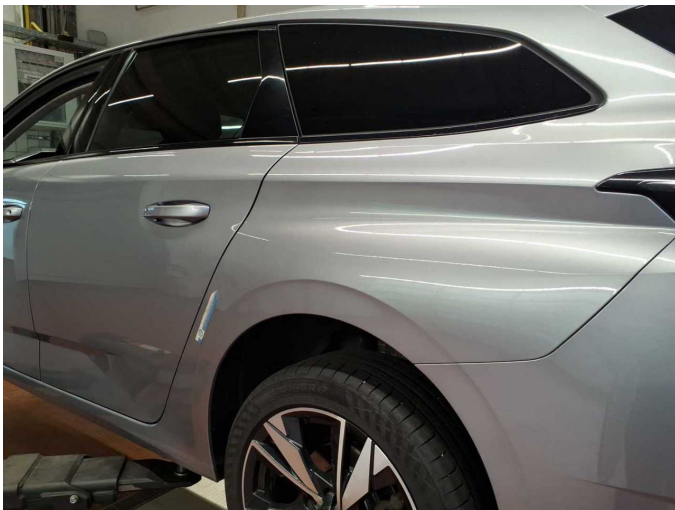
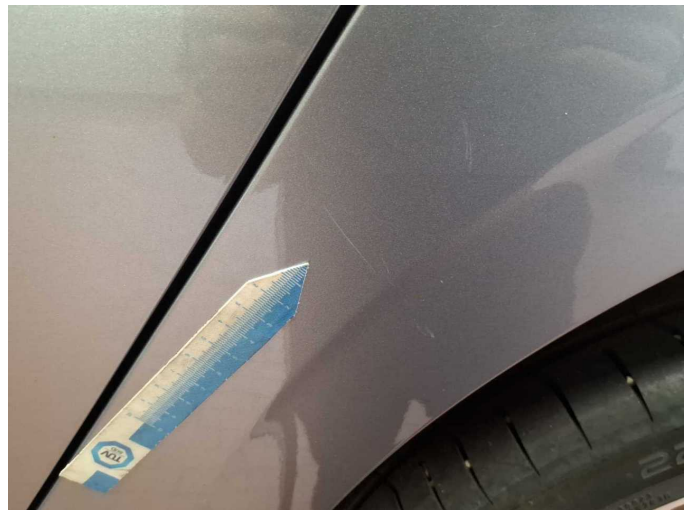
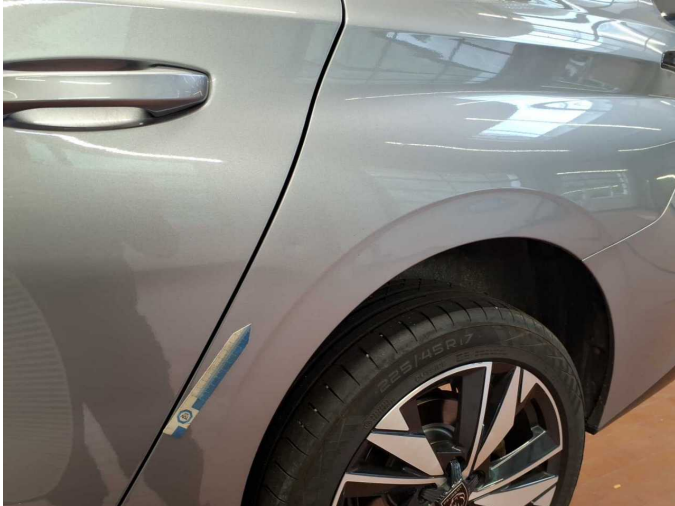
| No. | Component group | Description |
|---|---|---|
| 4 | Side panel - rear left side | Side panel - Dent / paintcoat damage - Smart repair |

**Damage 4:** Side panel - rear left side: Side panel - Dent / paintcoat damage - Smart repair

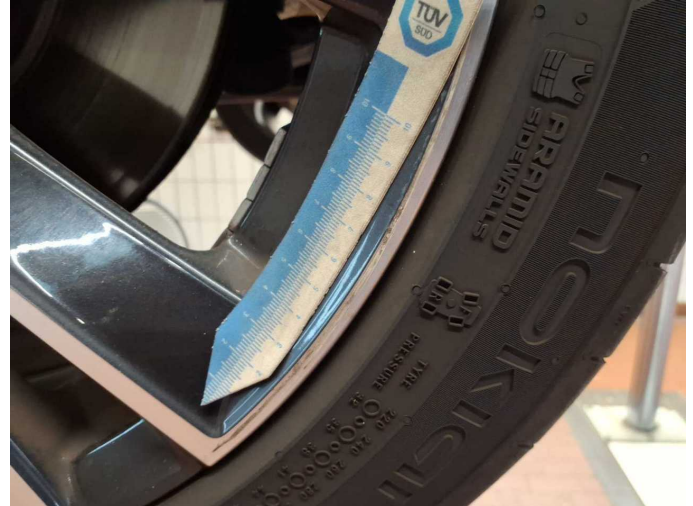
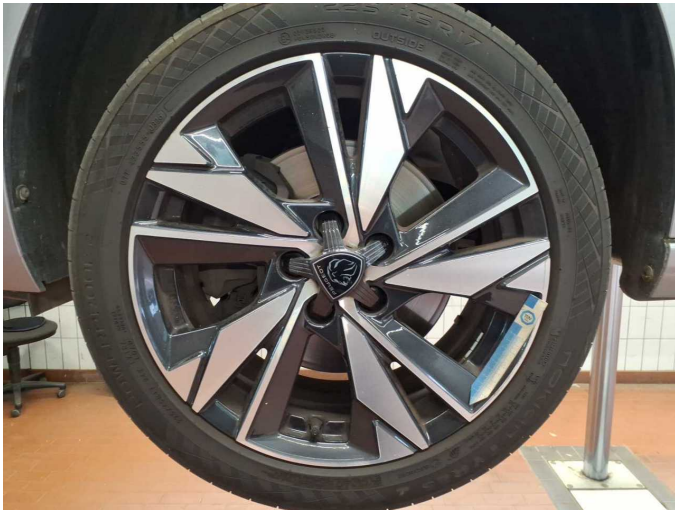
| No. | Component group | Description |
|---|---|---|
| 5 | Wheel / tyres | Alloy rim - front left side - Scratched - Loss in value |

**Damage 5:** Wheel / tyres: Alloy rim - front left side - Scratched - Loss in value

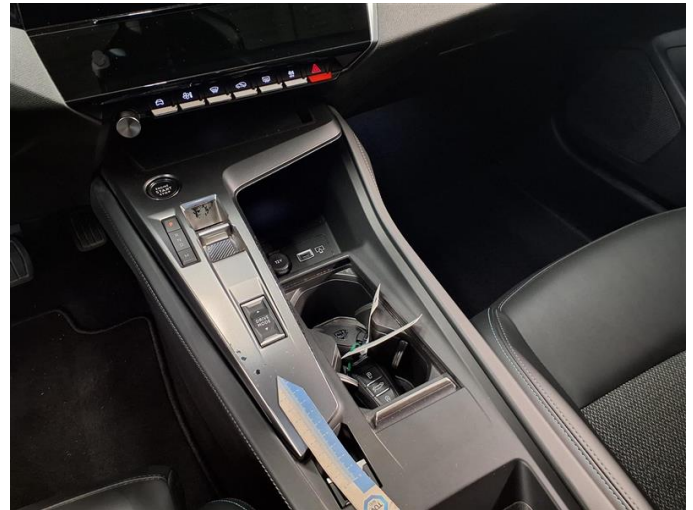
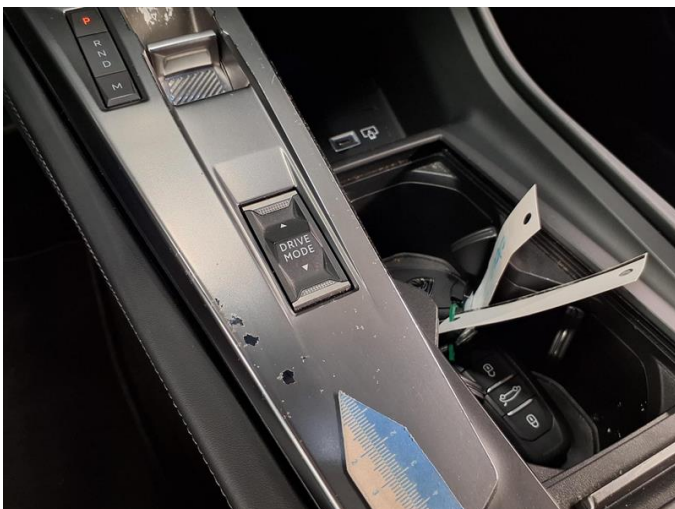
| No. | Component group | Description |
|---|---|---|
| 6 | Instrument panel | Centre console - front - Porous / cracked - Replace |

**Damage 6:** Instrument panel: Centre console - front - Porous / cracked - Replace

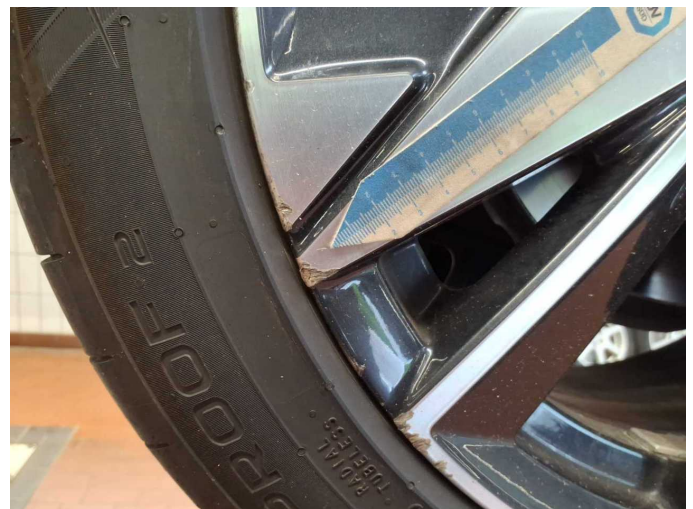
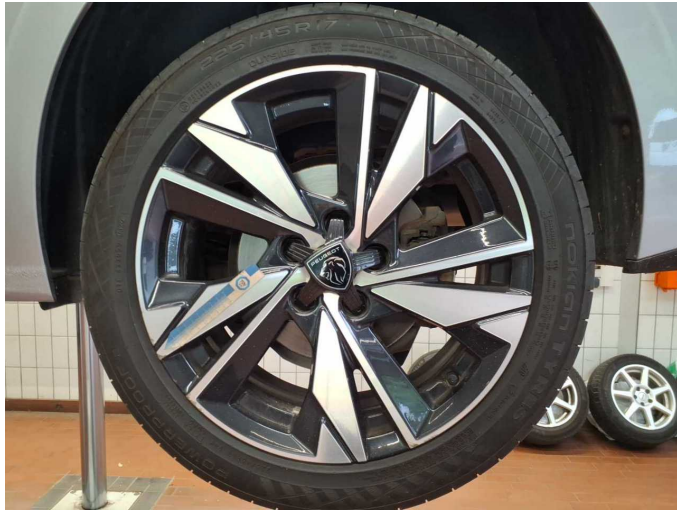
| No. | Component group | Description |
|---|---|---|
| 7 | Wheel / tyres | Alloy rim - rear left side - Scratched - Replace |

**Damage 7:** Wheel / tyres: Alloy rim - rear left side - Scratched - Replace

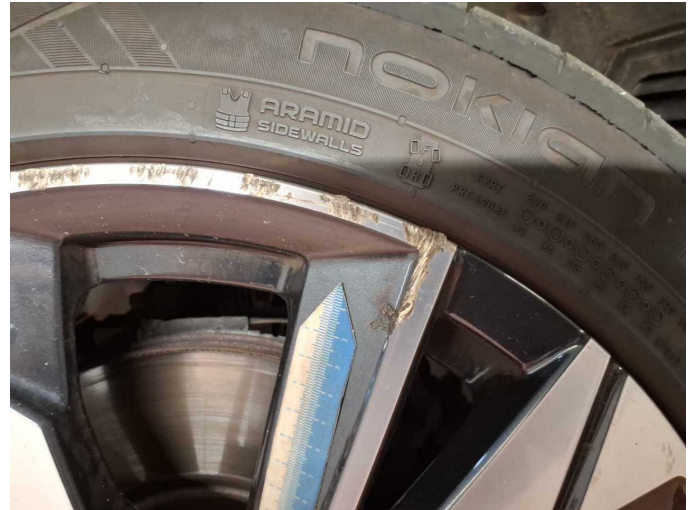
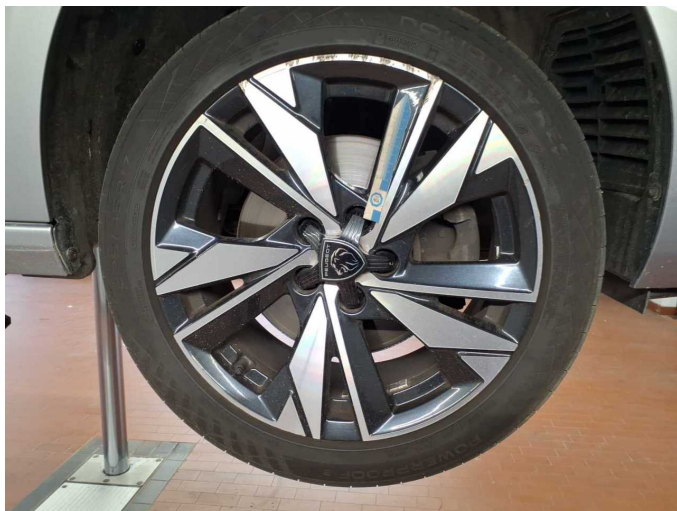
| No. | Component group | Description |
|---|---|---|
| 8 | Wheel / tyres | Alloy rim - front right side - Scratched - Replace |

**Damage 8:** Wheel / tyres: Alloy rim - front right side - Scratched - Replace

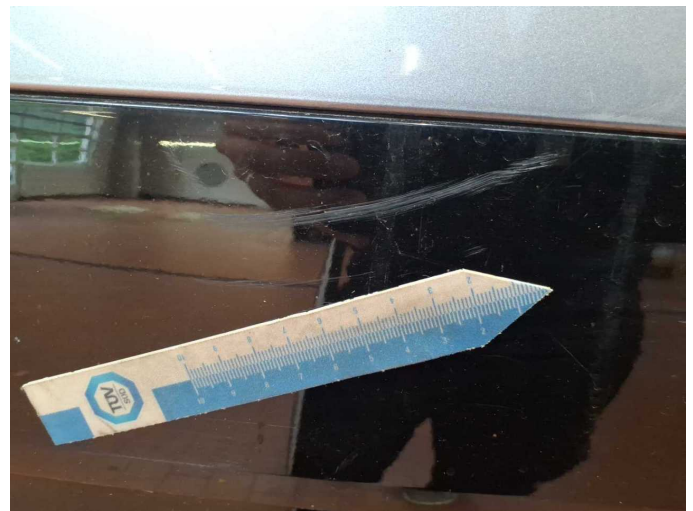
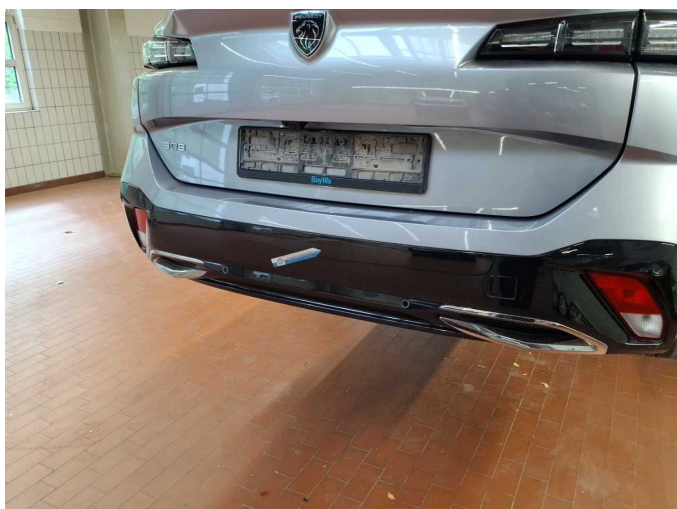
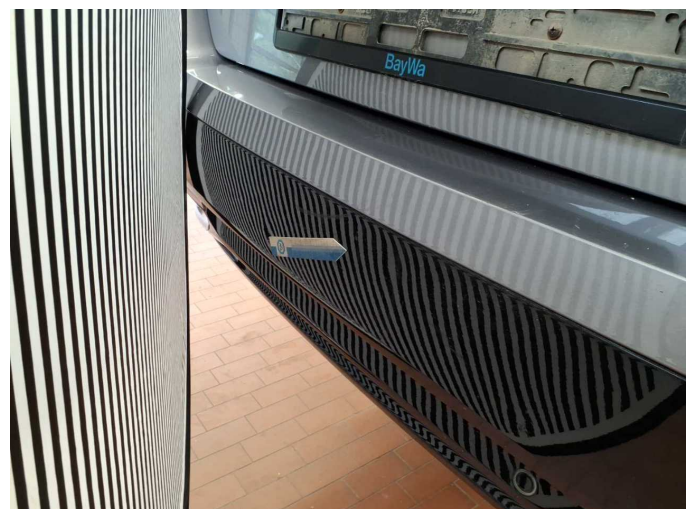
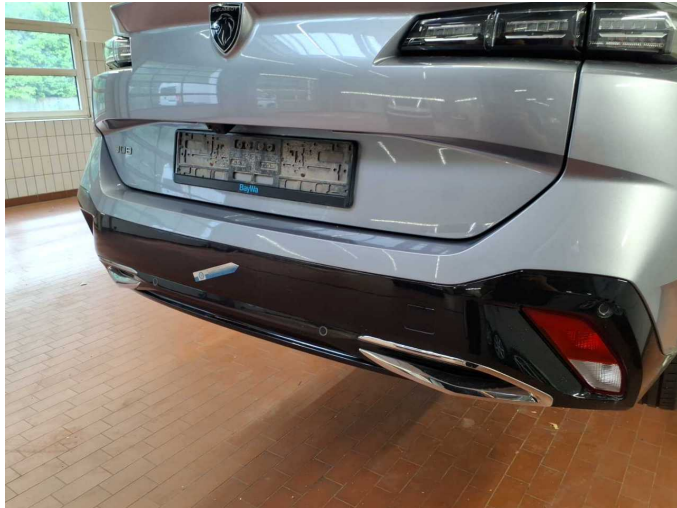
| No. | Component group | Description |
|---|---|---|
| 9 | Rear bumper | Spoiler - Dent / paintcoat damage - Replace |

**Damage 9:** Rear bumper: Spoiler - Dent / paintcoat damage - Replace

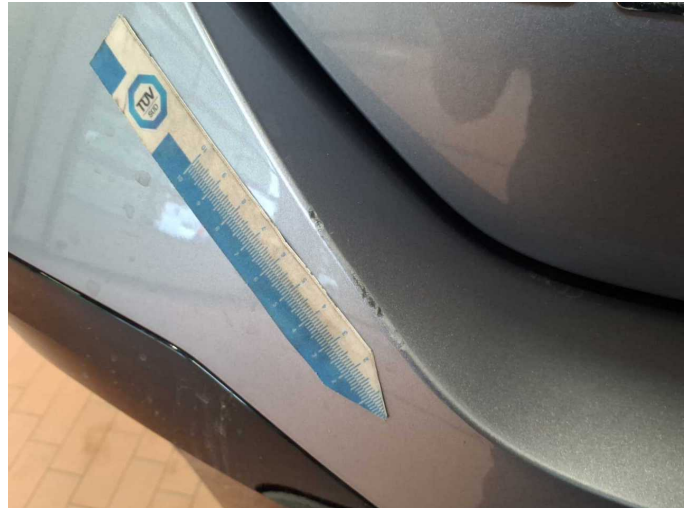
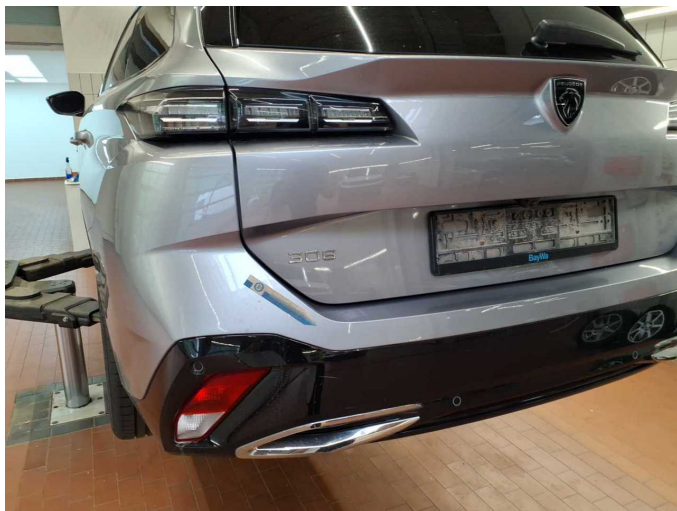
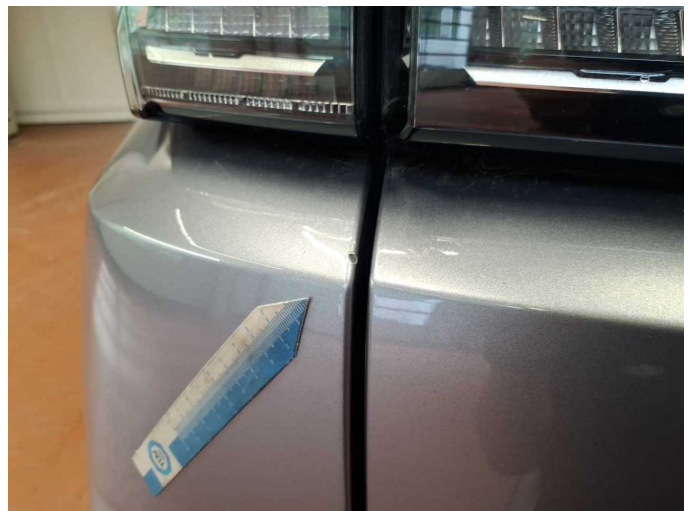
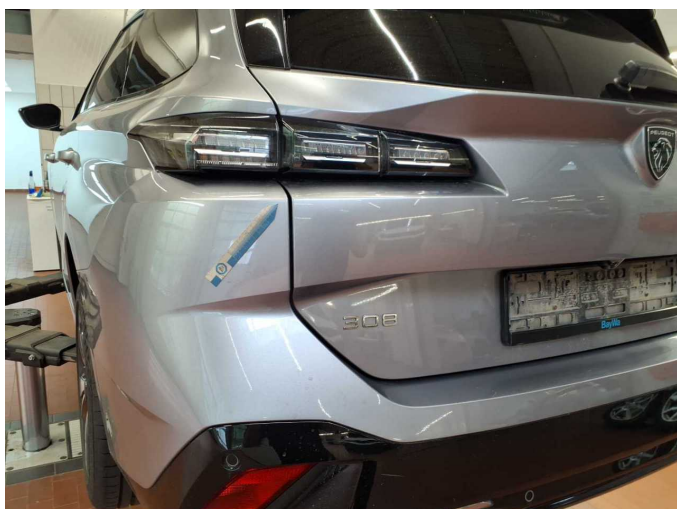
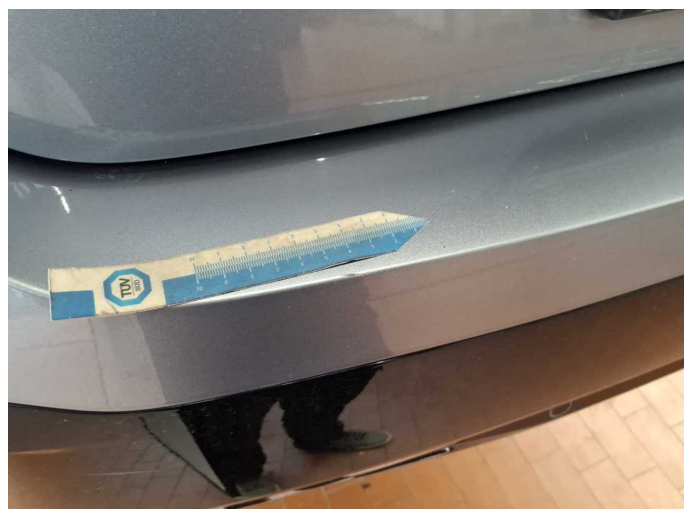
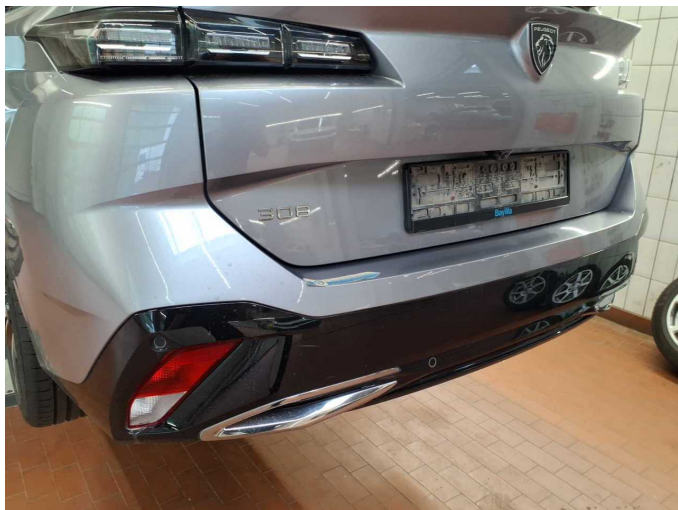
| No. | Component group | Description |
|---|---|---|
| 10 | Rear bumper | Rear bumper - Scratch(es) - Paint |

**Damage 10:** Rear bumper: Rear bumper - Scratch(es) - Paint

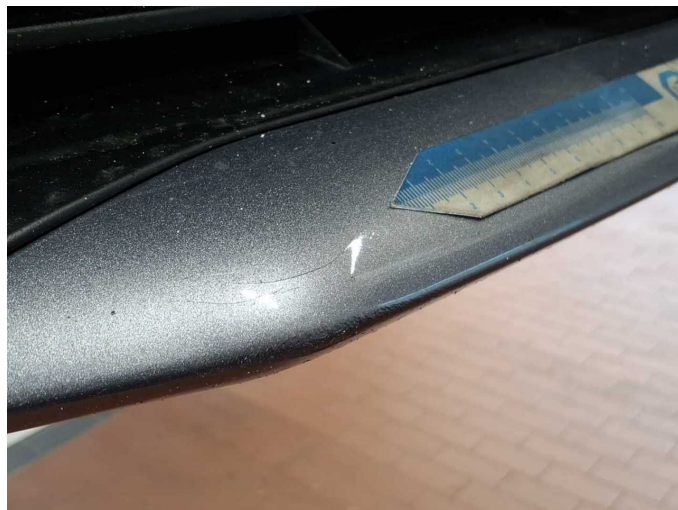
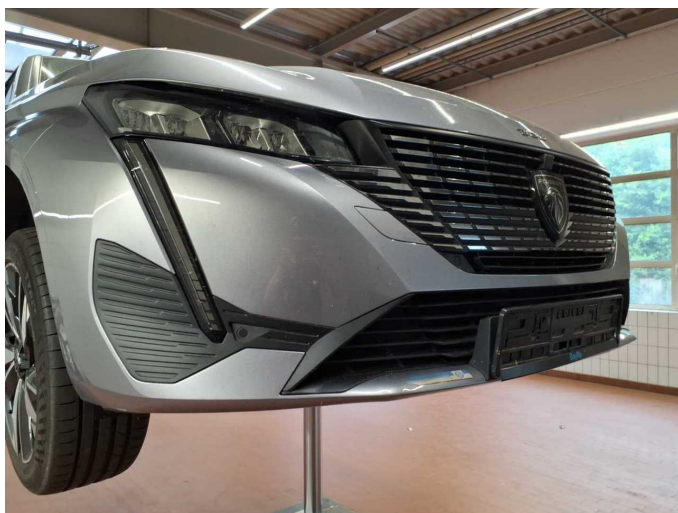
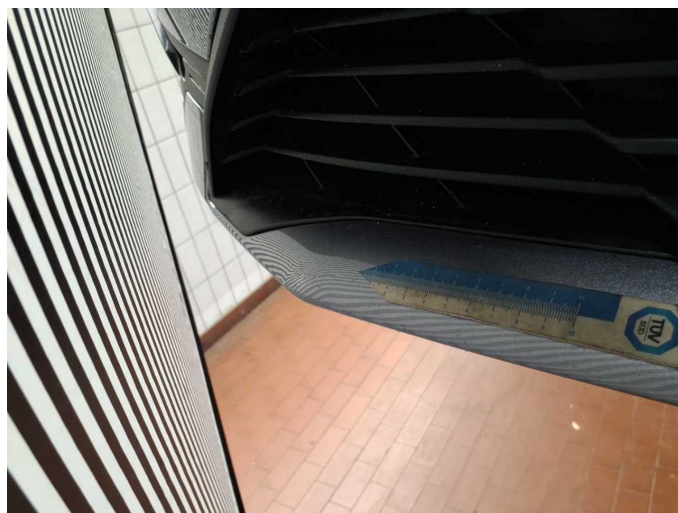
| No. | Component group | Description |
|---|---|---|
| 11 | Front bumper | Front bumper - Dent / paintcoat damage - Paint |

**Damage 11:** Front bumper: Front bumper - Dent / paintcoat damage - Paint
