Expertise

Protocol number: 46896692  
Order No. / Reference: 26733391  
Inspection date: 5 Aug 2026

Manufacturer: Volkswagen

Model: Touran 1.5 TSI ACT OPF DSG Comfortline

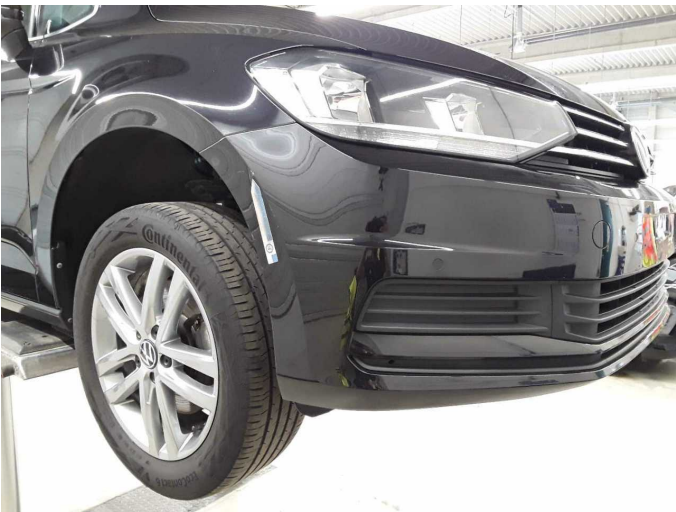
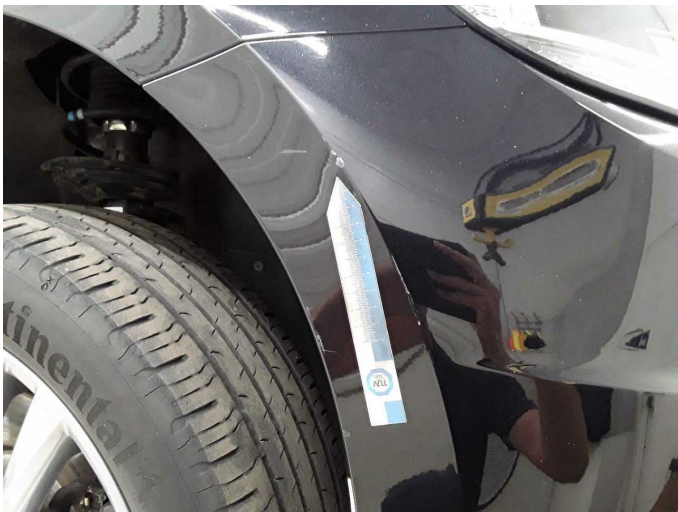
| No. | Component group | Description |
|---|---|---|
| 1 | Front bumper | Front bumper - Scratched - Smart repair |

Damage 1: Front bumper: Front bumper - Scratched - Smart repair

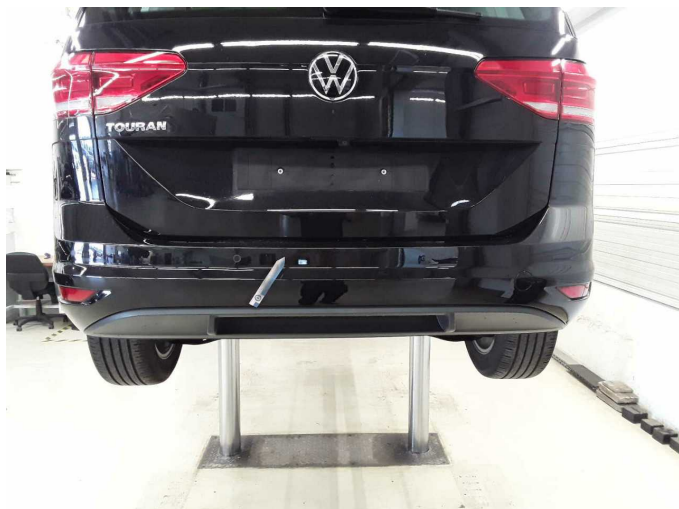
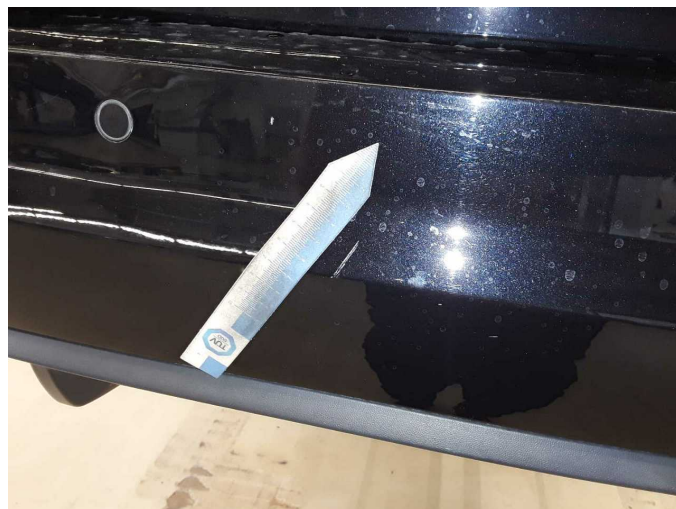
| No. | Component group | Description |
|---|---|---|
| 2 | Rear bumper | Rear bumper - Scratch(es) - Smart repair |

**Damage 2:** Rear bumper: Rear bumper - Scratch(es) - Smart repair

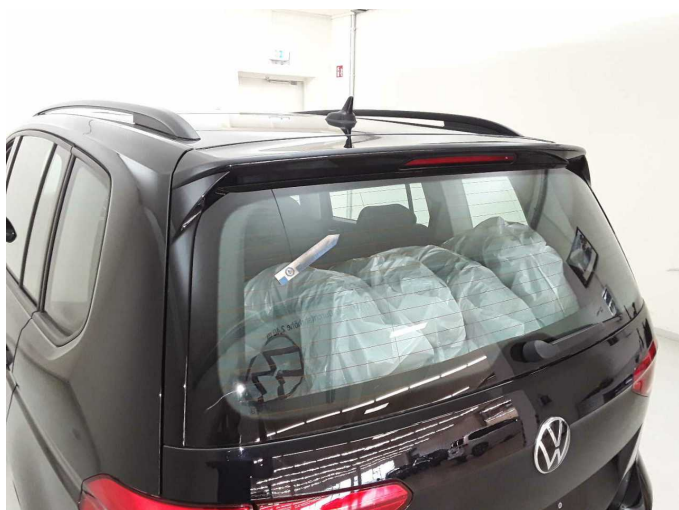
| No. | Component group | Description |
|---|---|---|
| 1 | Vehicle glazing | Rear window - Scratch(es) - No deduction |

**Wear and tear 1:** Vehicle glazing: Rear window - Scratch(es) - No deduction

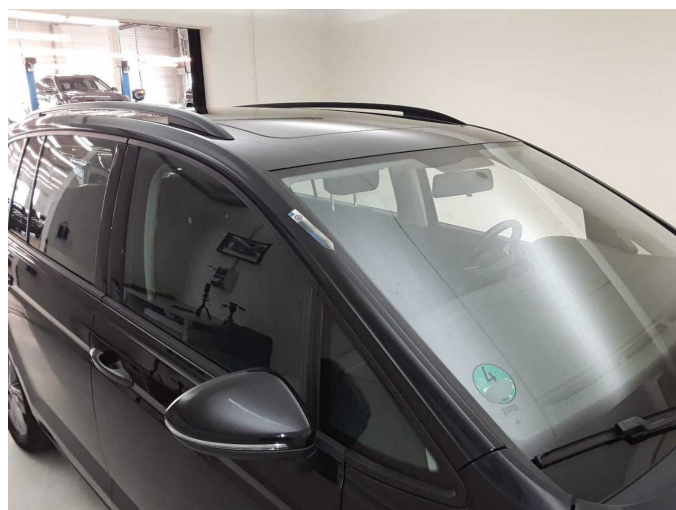
| No. | Component group | Description |
|---|---|---|
| 2 | Roof | Roof rail - right side - Stone chips - No deduction |

**Wear and tear 2:** Roof: Roof rail - right side - Stone chips - No deduction

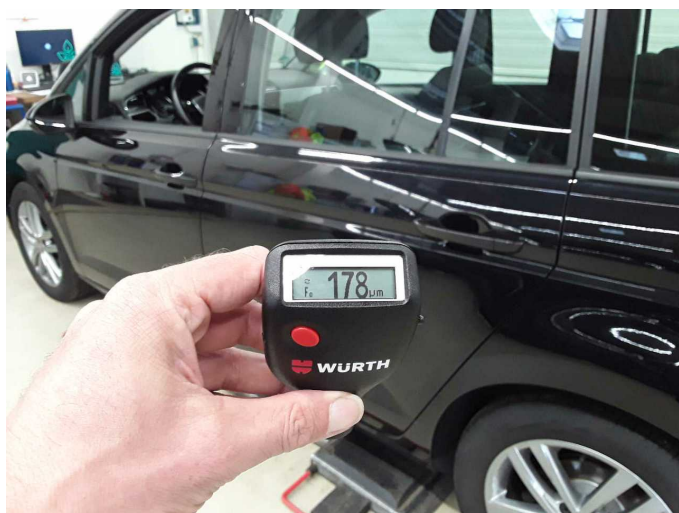
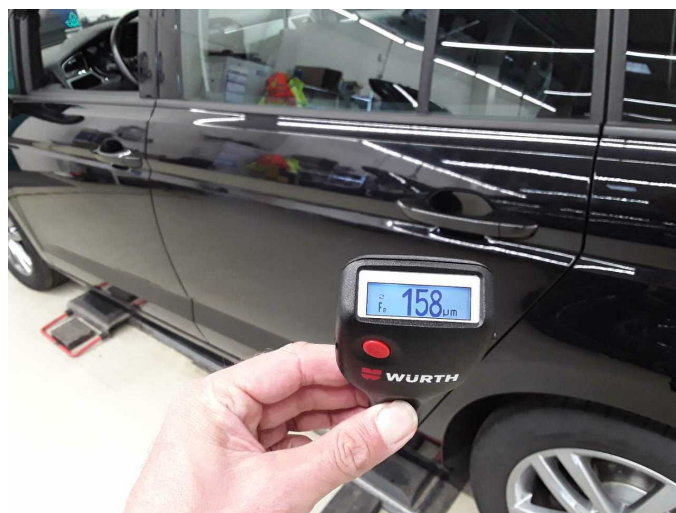
**Door - rear left side:** 178 µm

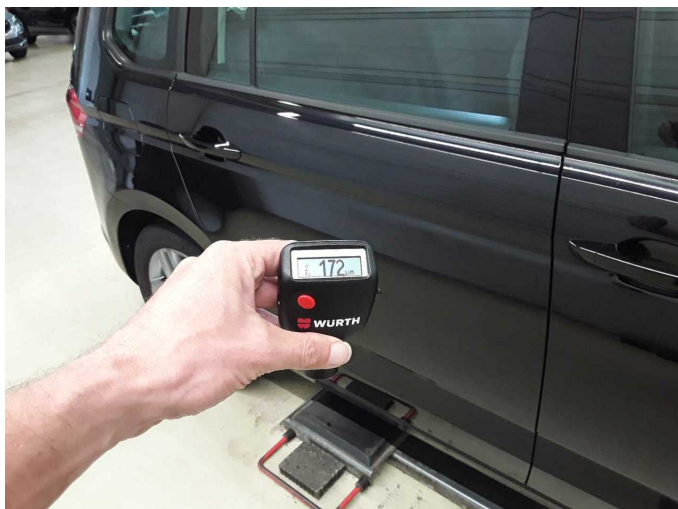
**Door - rear right side: 172 µm**
