Expertise

Protocol number: 46567592  
Order No. / Reference: 26622326  
Inspection date: 17 Jul 2026

Manufacturer: Ford

Model: S-Max 2.0 EcoBlue Aut. TITANIUM

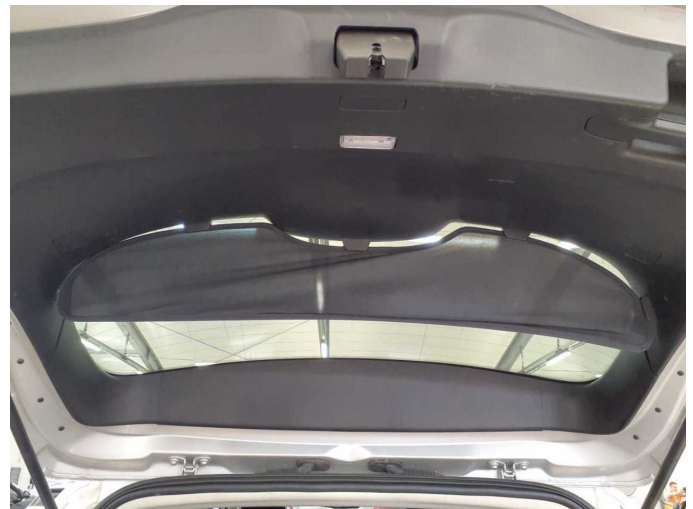
| No. | Component group | Description |
|---|---|---|
| 1 | Interior | Roller blind rear window (Halterung) - Missing - Replace |

**Damage 1:** Interior: Roller blind rear window (Halterung) - Missing - Replace

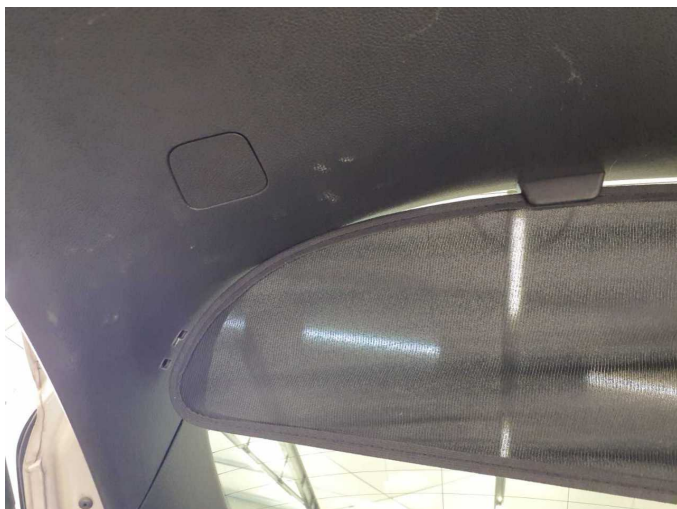
**Damage 1:** Interior: Roller blind rear window (Halterung) - Missing - Replace

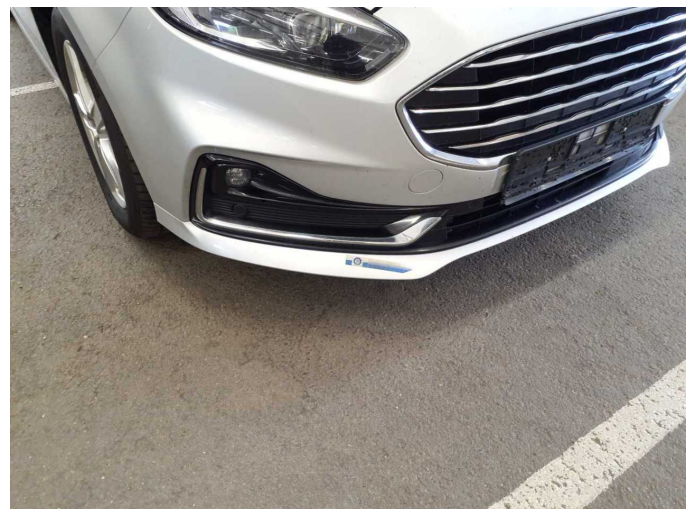
| No. | Component group | Description |
|---|---|---|
| 2 | Front bumper | Spoiler - Scratch(es) - Paint |

**Damage 2:** Front bumper: Spoiler - Scratch(es) - Paint

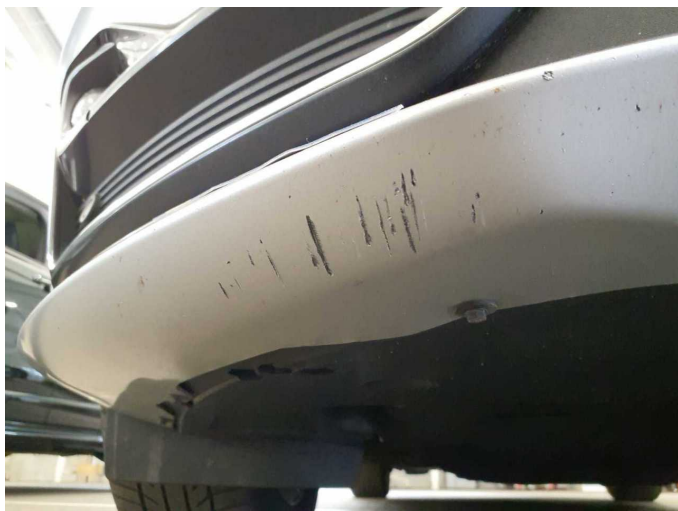
**Damage 2:** Front bumper: Spoiler - Scratch(es) - Paint

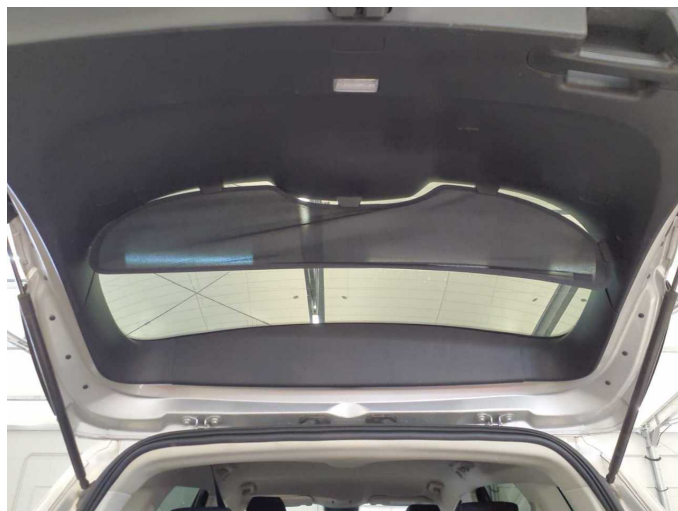
| No. | Component group | Description |
|---|---|---|
| 1 | Trim / covers | Boot lid - interior trim - Scratch(es) - No deduction |

**Wear and tear 1:** Trim / covers: Boot lid - interior trim - Scratch(es) - No deduction

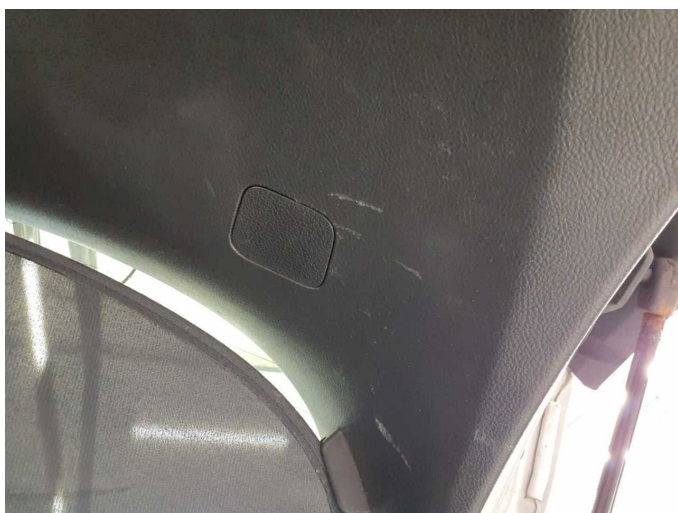
**Wear and tear 1:** Trim / covers: Boot lid - interior trim - Scratch(es) - No deduction

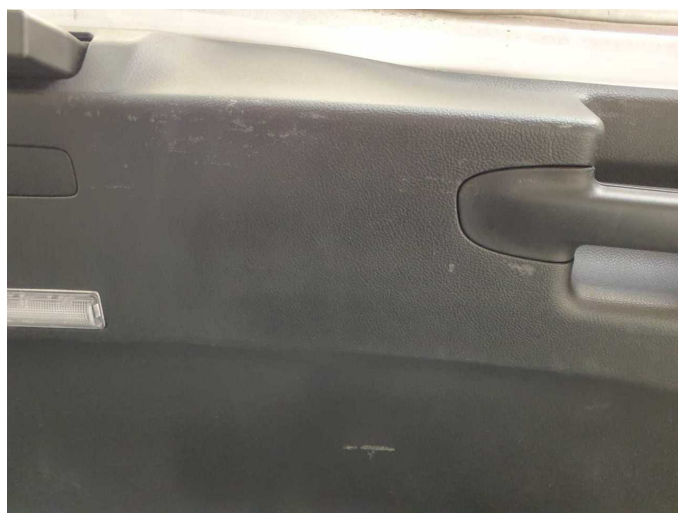
**Wear and tear 1:** Trim / covers: Boot lid - interior trim - Scratch(es) - No deduction

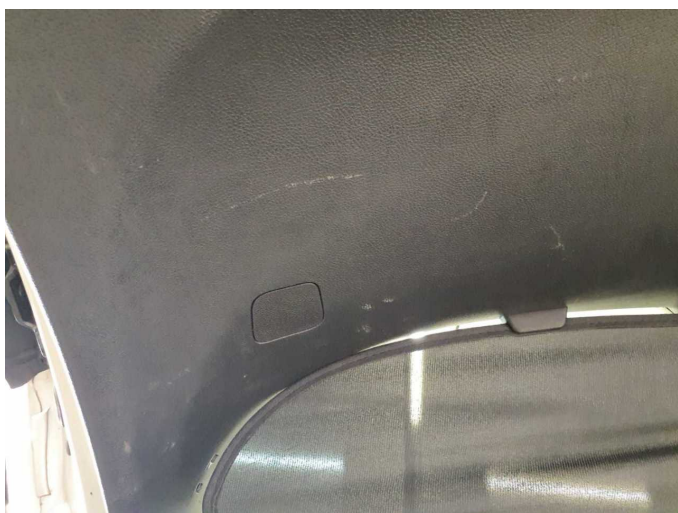
**Wear and tear 1:** Trim / covers: Boot lid - interior trim - Scratch(es) - No deduction

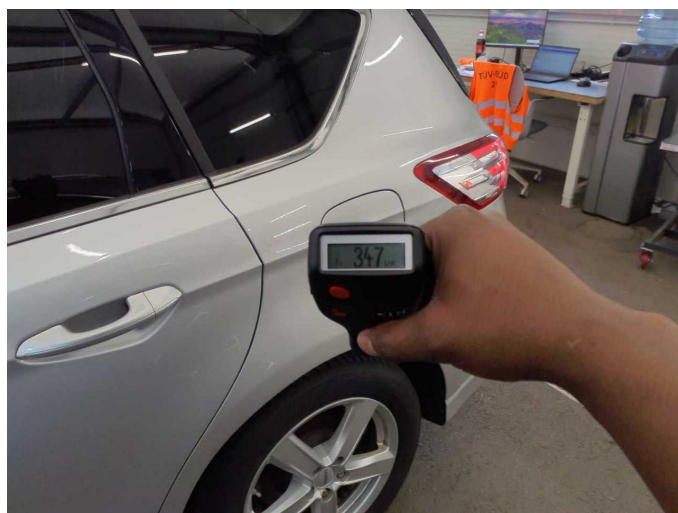
| No. | Repainting |
|---|---|
| 1 | Side panel - rear left side, Professionally carried out, Invoice of repair done Non-existent |

| Side panel - rear left side | 347 µm | Door - front left side | 255 µm |

**Repainting 1:** Side panel - rear left side

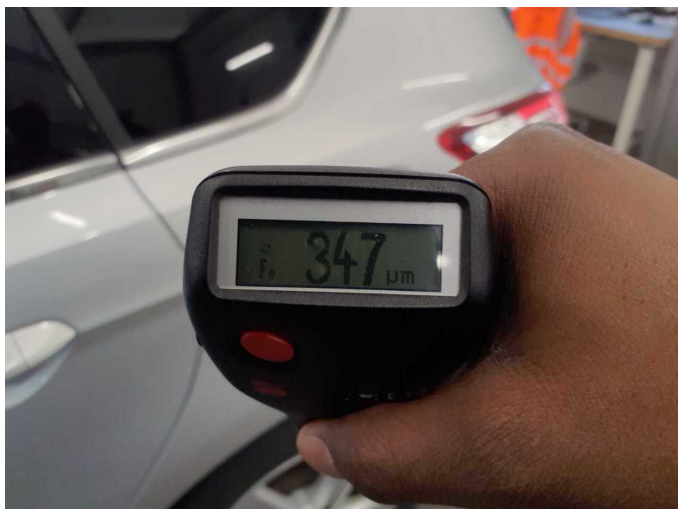
**Repainting 1:** Side panel - rear left side

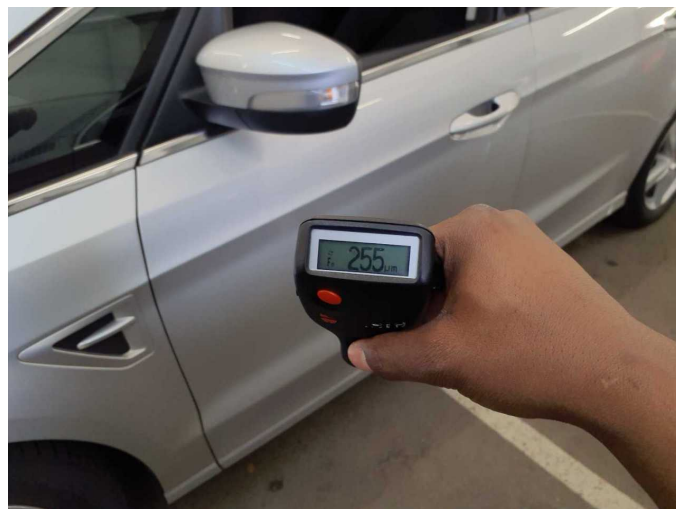
| No. | Repainting |
|---|---|
| 2 | Door - front left side, Professionally carried out, Invoice of repair done Non-existent |

**Repainting 2:** Door - front left side

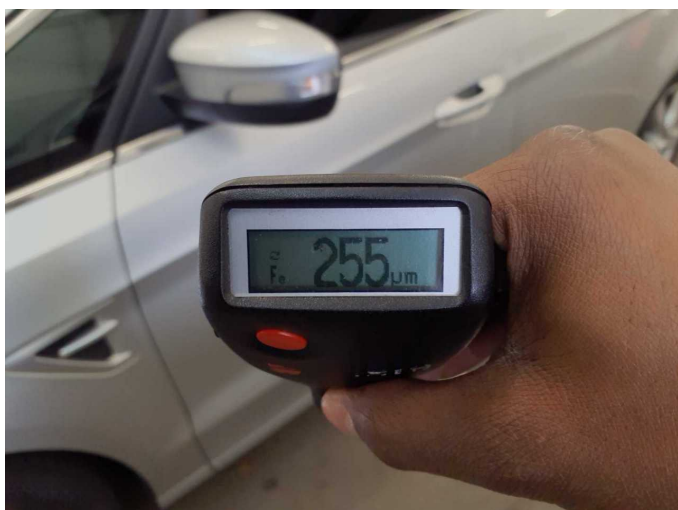
**Repainting 2:** Door - front left side
