Expertise

Protocol number: 46043424
Order No. / Reference: 26063419
Inspection date: 16 Jun 2026

Manufacturer: Mercedes-Benz

Model: Vito 116 CDI Tourer Extralang Aut. PRO

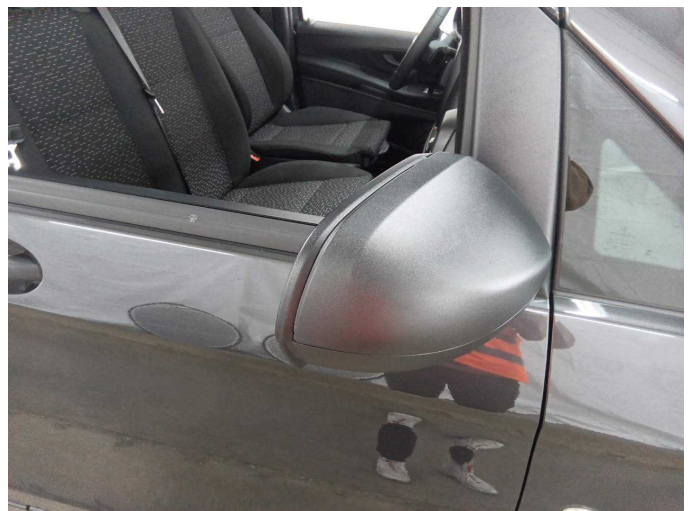
Damage 3: Wing mirror - right side: Cap - Malposition - Un- / install

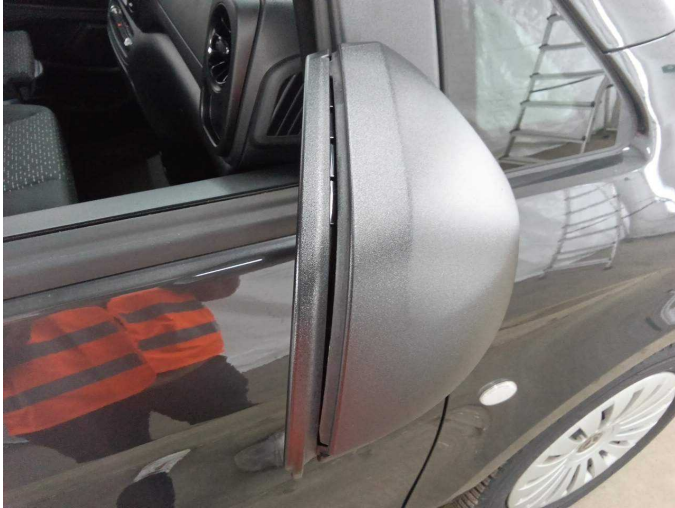
Damage 3: Wing mirror - right side: Cap - Malposition - Un- / install

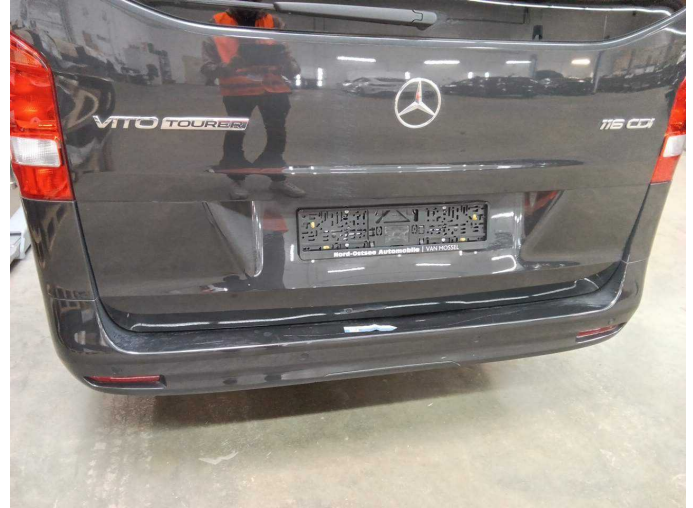
Damage 4: Rear bumper: Rear bumper - Scratch(es) - Smart repair

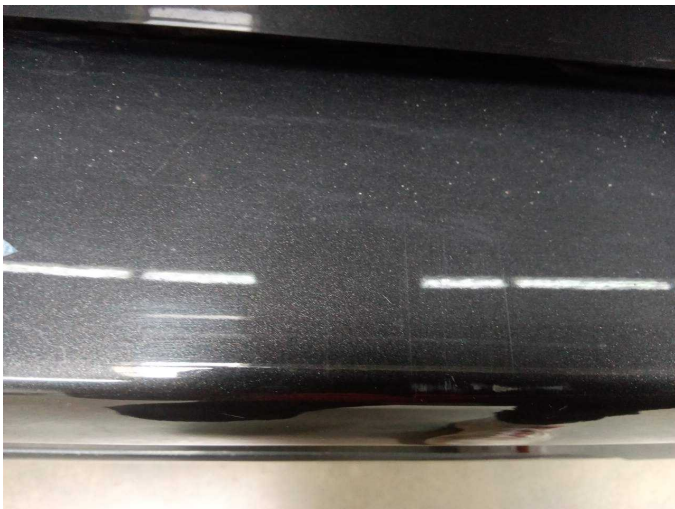
Damage 4: Rear bumper: Rear bumper - Scratch(es) - Smart repair

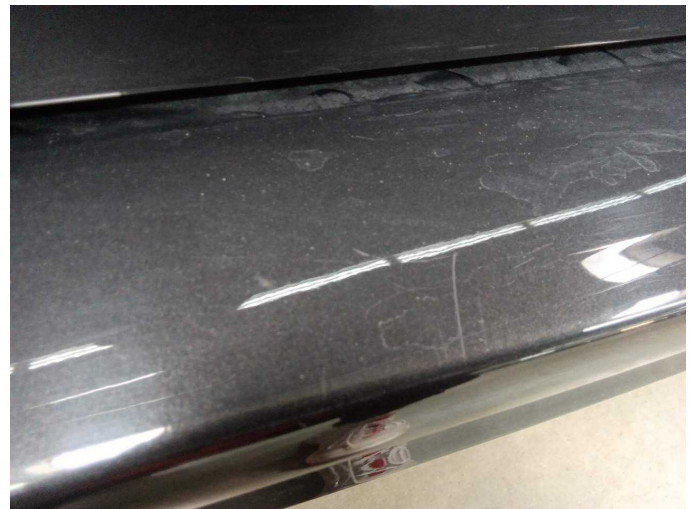
Damage 4: Rear bumper: Rear bumper - Scratch(es) - Smart repair

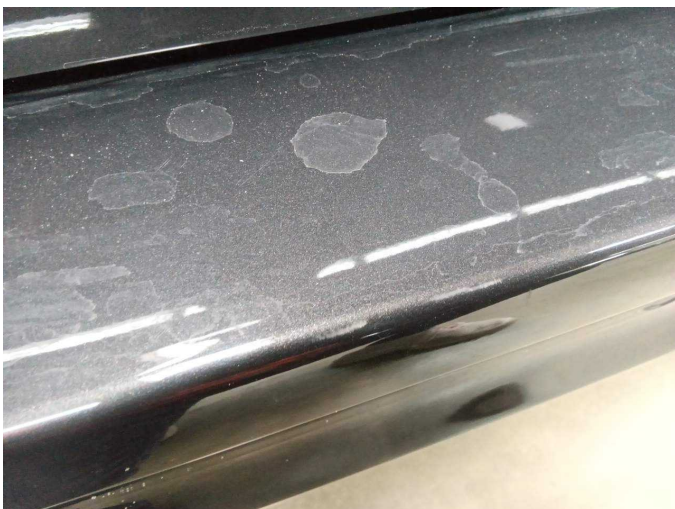
Damage 4: Rear bumper: Rear bumper - Scratch(es) - Smart repair

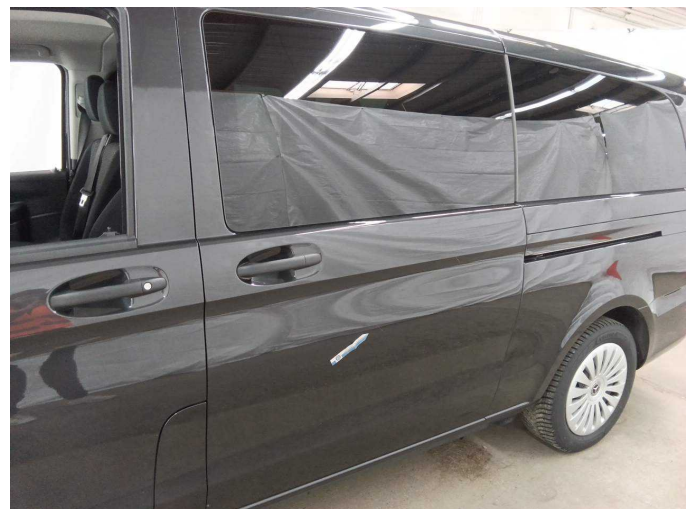
Damage 5: Sliding door - left side: Sliding door - Scratch(es) - Paint

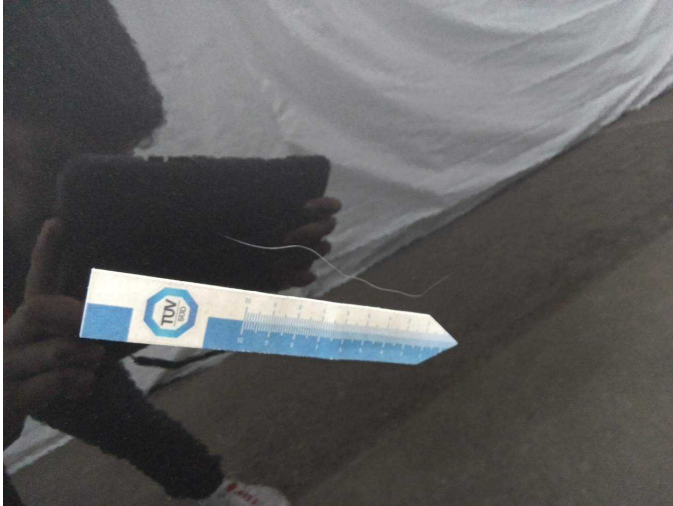
Damage 5: Sliding door - left side: Sliding door - Scratch(es) - Paint

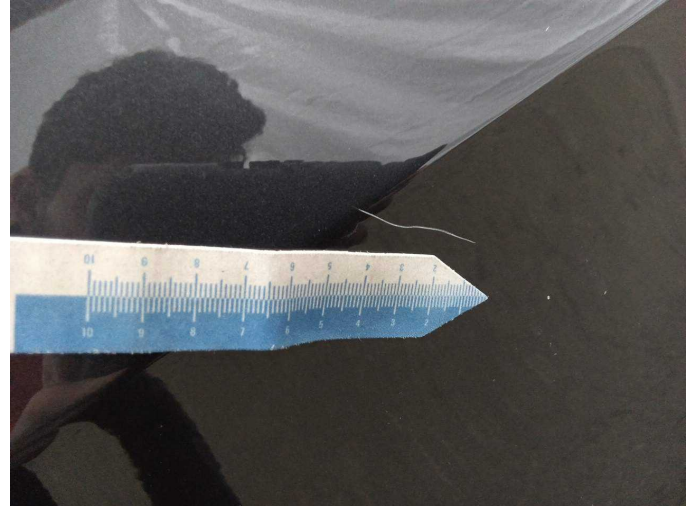
Damage 5: Sliding door - left side: Sliding door - Scratch(es) - Paint

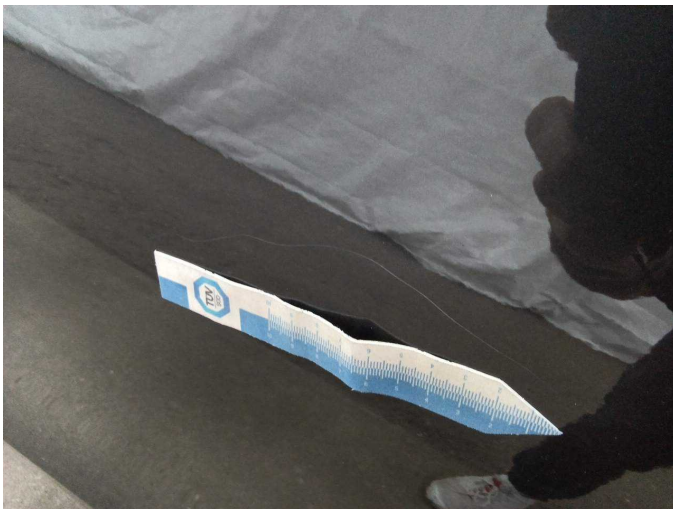
Damage 5: Sliding door - left side: Sliding door - Scratch(es) - Paint

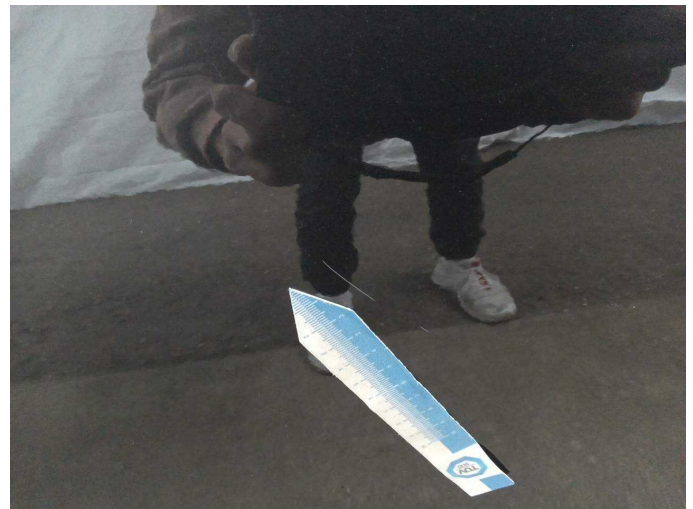
Damage 5: Sliding door - left side: Sliding door - Scratch(es) - Paint

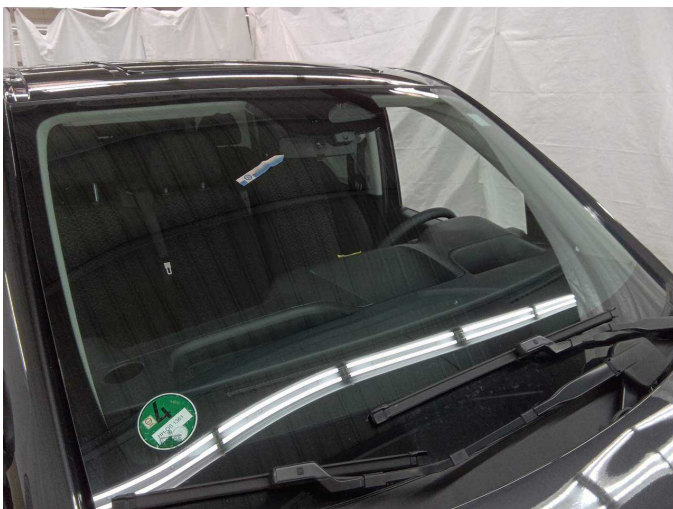
Damage 6: Vehicle glazing: Windscreen - Stone chips - repair according to calculation

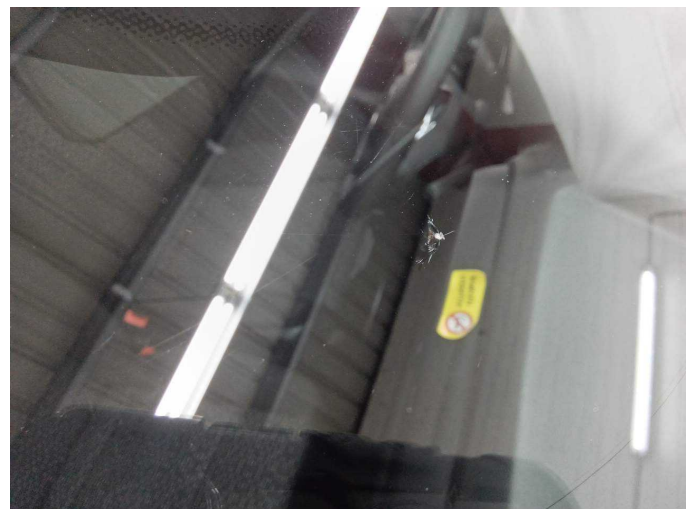
Damage 6: Vehicle glazing: Windscreen - Stone chips - repair according to calculation

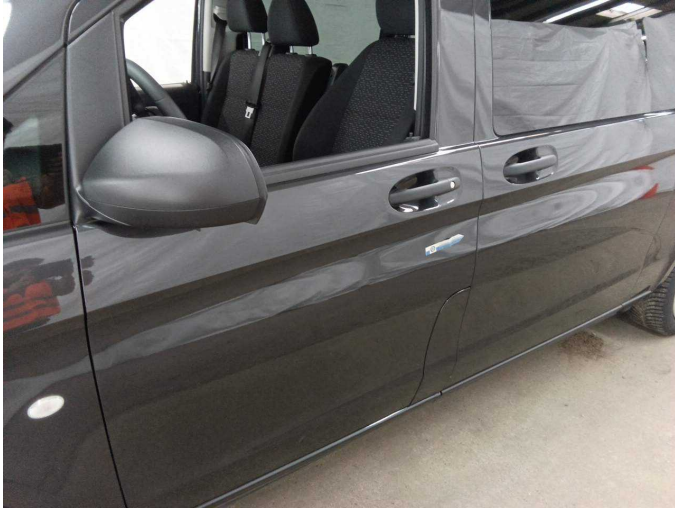
Wear and tear 3: Door - front left side: Door edge - Scratch(es) - Cover / polish

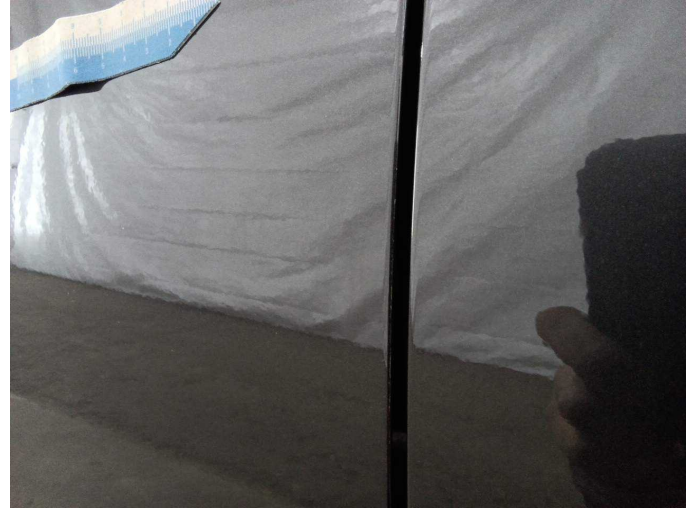
Wear and tear 3: Door - front left side: Door edge - Scratch(es) - Cover / polish

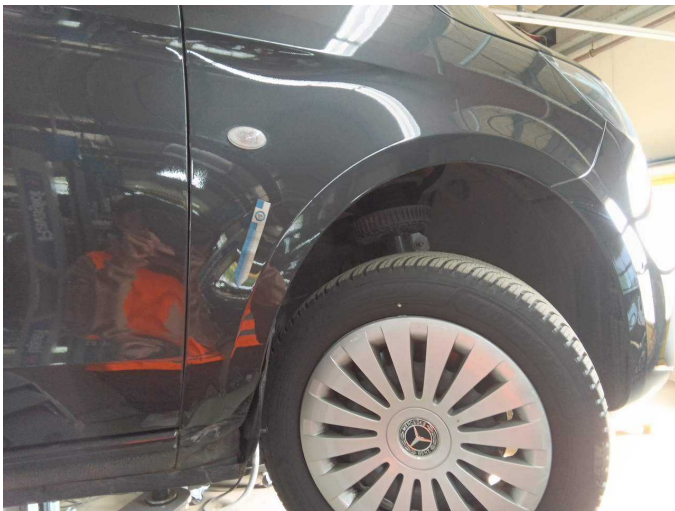
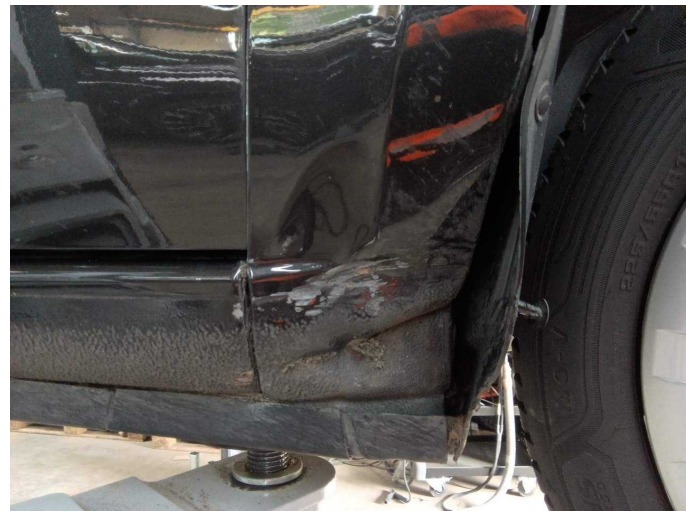
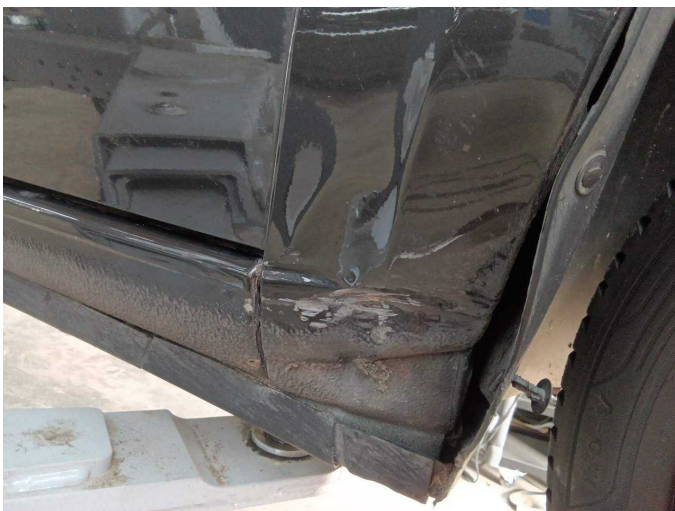
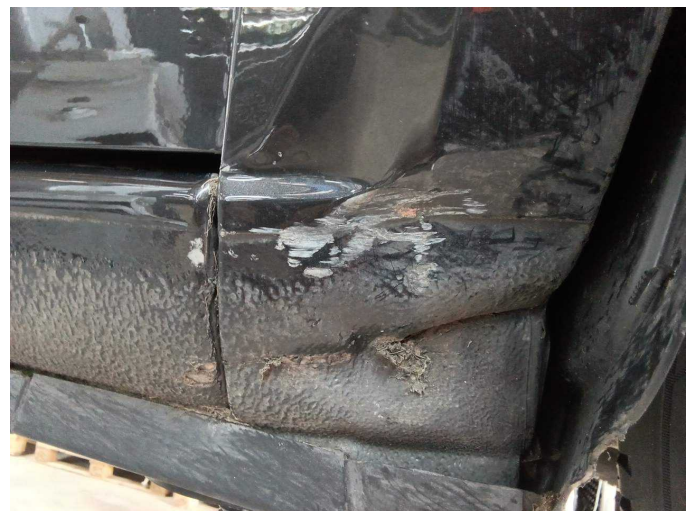
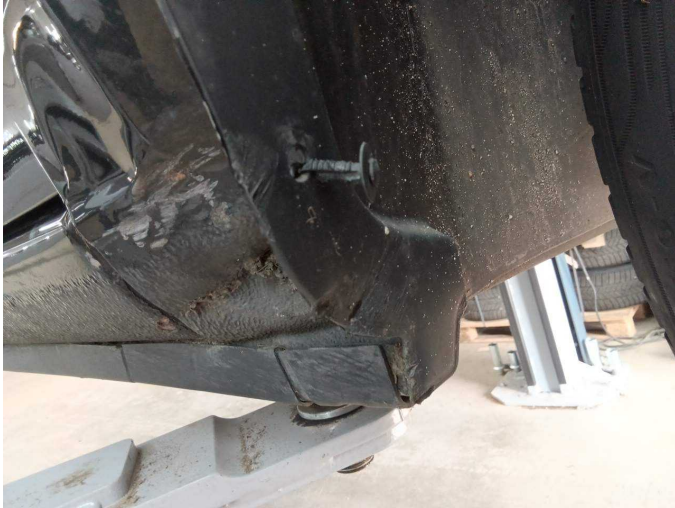
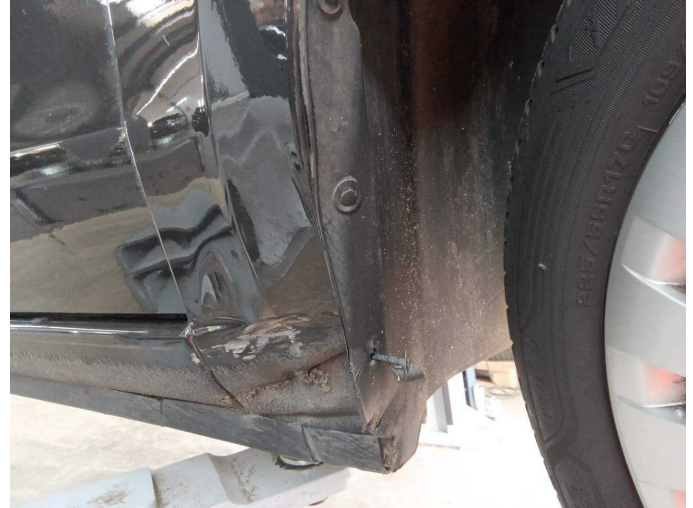
Non-repaired previous damages were found at the vehicle. The necessary repair costs are listed in the expert report or if necessary, are listed in detail in a separately enclosed repair cost calculation.

Accident 1: Side right
