Expertise

Protocol number: 46557814  
Order No. / Reference: 26547723  
Inspection date: 16 Jul 2026

Manufacturer: Peugeot

Model: 5008 BlueHDi 130 EAT8 Allure Pack

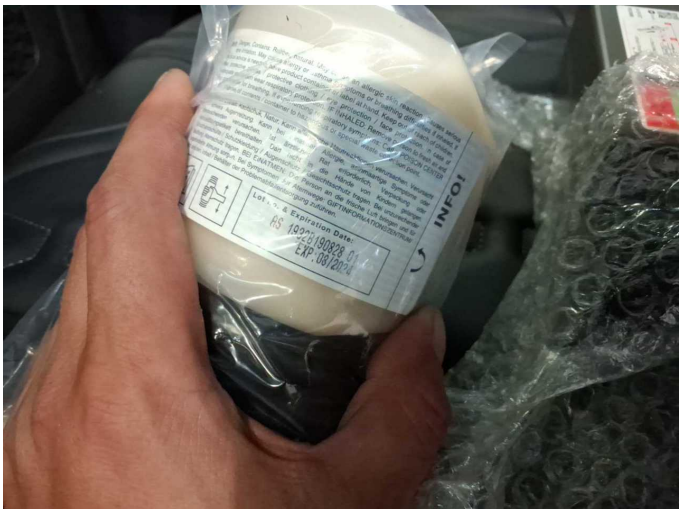
| No. | Component group | Description |
|---|---|---|
| 1 | Equipment | Tirefit filler - Expired - Replace |

Damage 1: Equipment: Tirefit filler - Expired - Replace

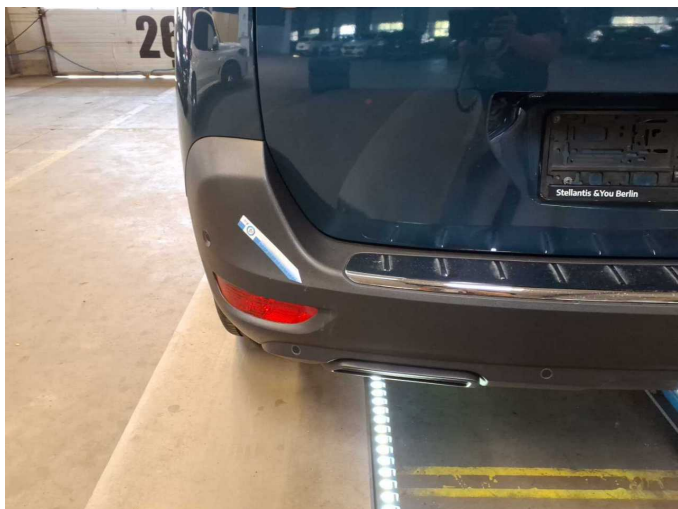
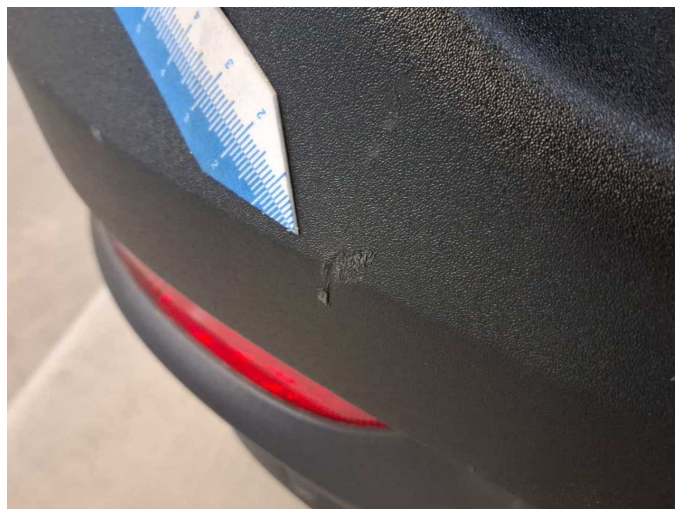
| No. | Component group | Description |
|---|---|---|
| 2 | Rear bumper | Rear bumper (unpainted) - Scratch(es) - Smart repair |

**Damage 2:** Rear bumper: Rear bumper (unpainted) - Scratch(es) - Smart repair

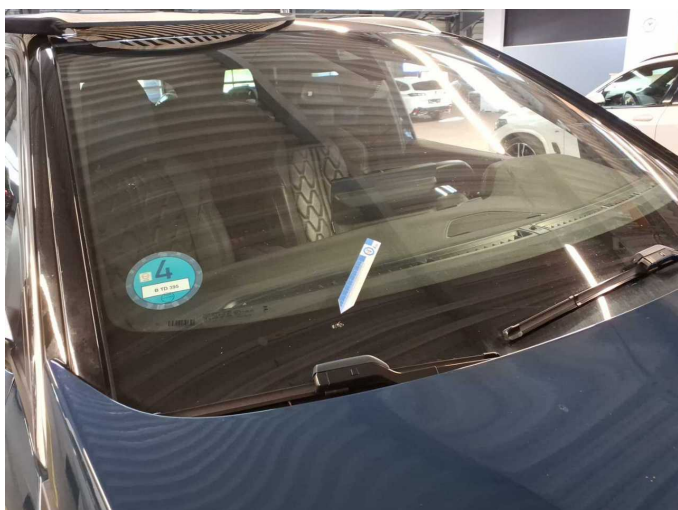
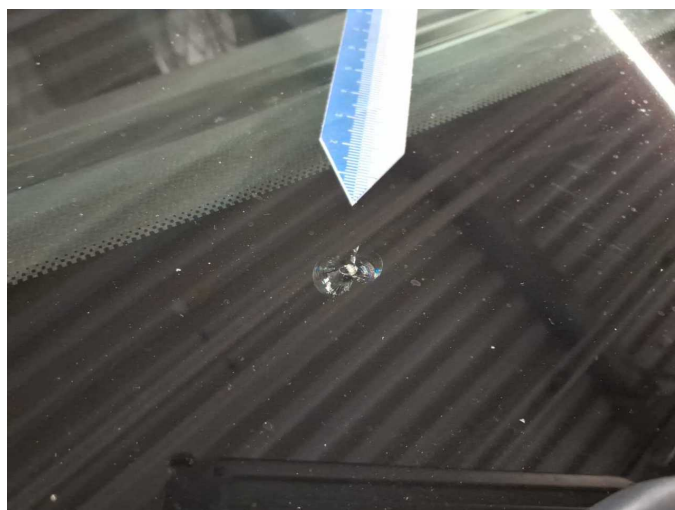
| No. | Component group | Description |
|---|---|---|
| 3 | Vehicle glazing | Windscreen - Stone chips - Replace |

**Damage 3:** Vehicle glazing: Windscreen - Stone chips - Replace

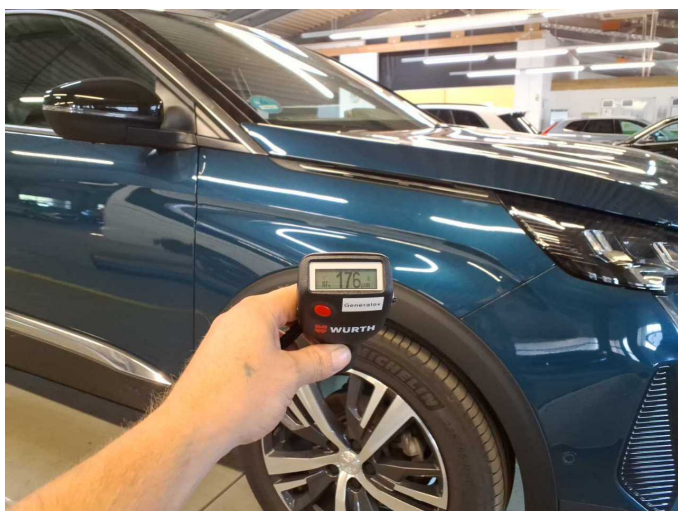
| No. | Repainting |
|---|---|
| 1 | Mudguard - right side, Professionally carried out, Invoice of repair done Non-existent |

| Mudguard - right side | 176 µm | Side panel - rear right side | 394 µm |

**Repainting 1:** Mudguard - right side

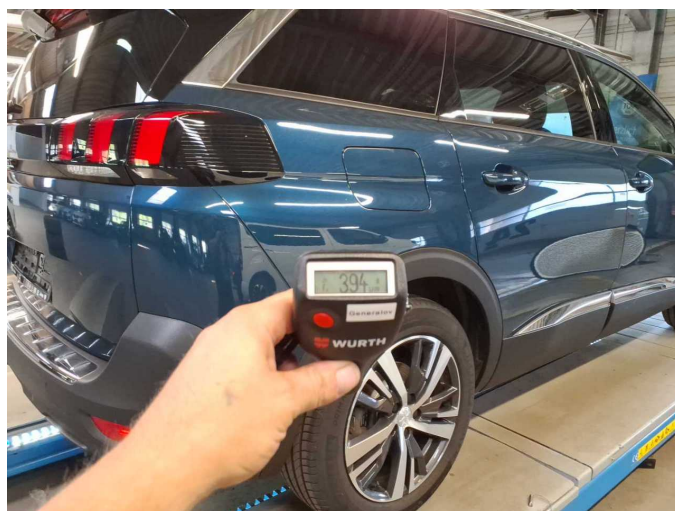
| No. | Repainting |
|---|---|
| 2 | Side panel - rear right side, Professionally carried out, Invoice of repair done Non-existent |

**Repainting 2:** Side panel - rear right side

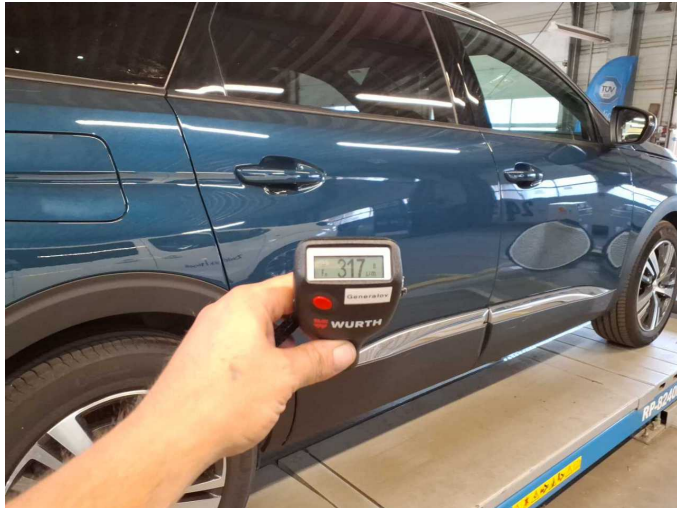
| No. | Repainting |
|---|---|
| 3 | Door - rear right side, Professionally carried out, Invoice of repair done Non-existent |

| Door - rear right side | 317 µm | Door - front right side | 298 µm |

**Repainting 3:** Door - rear right side

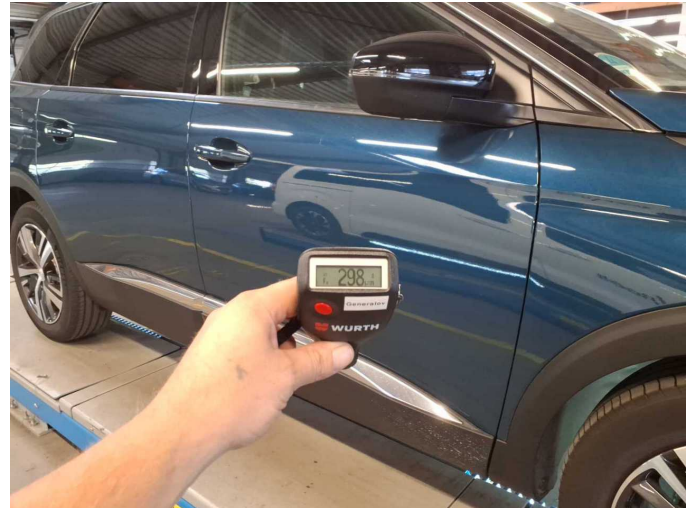
| No. | Repainting |
|---|---|
| 4 | Door - front right side, Professionally carried out, Invoice of repair done Non-existent |

**Repainting 4:** Door - front right side
