Expertise

Protocol number: 45555222
Order No. / Reference: 26316813
Inspection date: 8 May 2026

Model: Astra 1.5 D Start/Stop Sports Tourer Automatik Edition

VIN: W0VBD8EV2N8031989

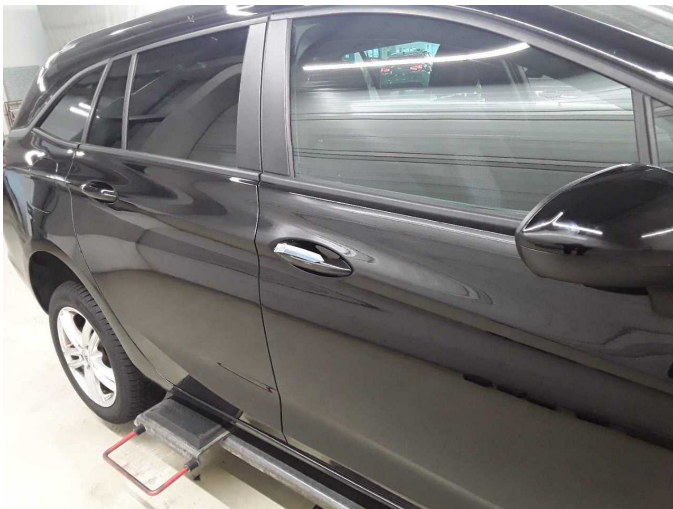
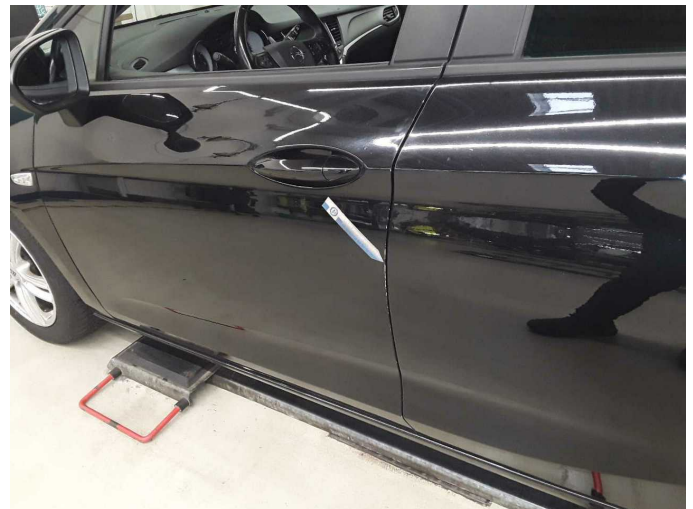
Damage 2: Door - front right side: Door handle - outside - Scratched - Smart repair

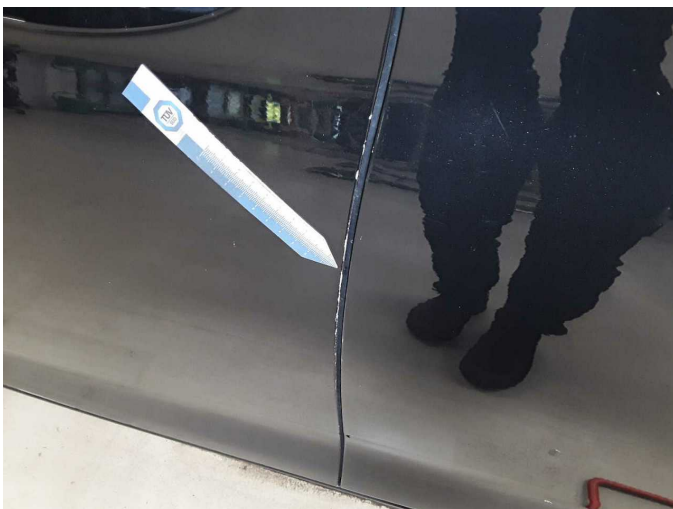
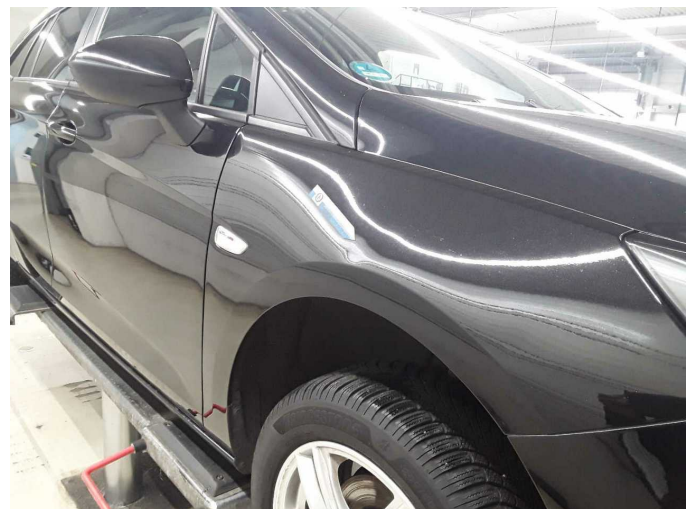
Damage 3: Door - front left side: Door - Scratch(es) - Smart repair

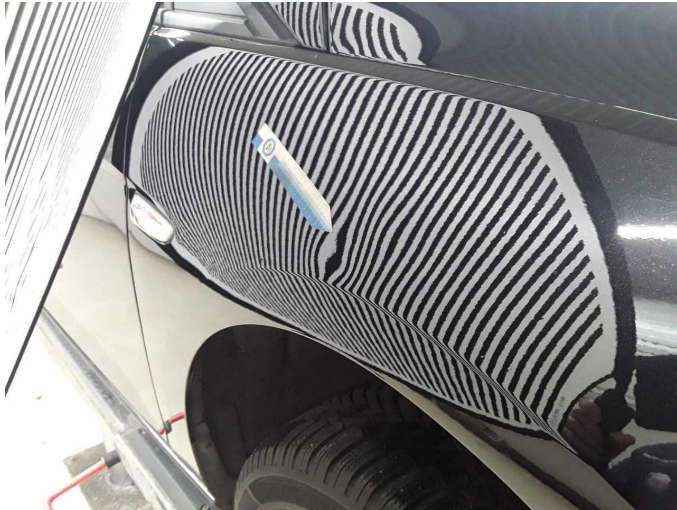
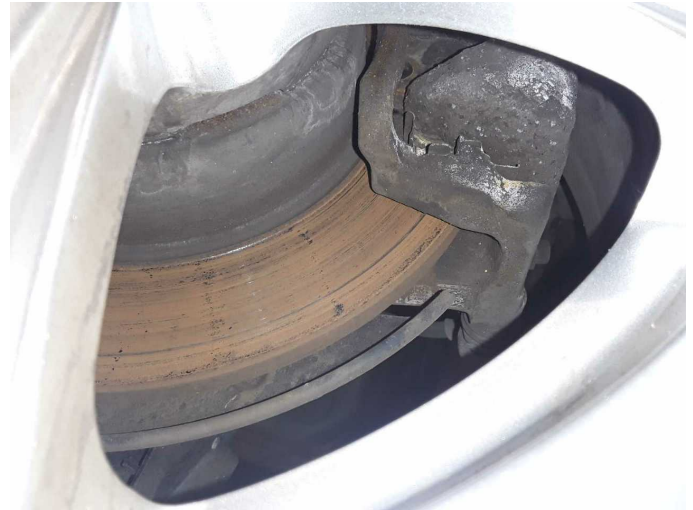
Damage 4: Mudguard - right side: Mudguard - right side - dent(s) - Smooth repair work

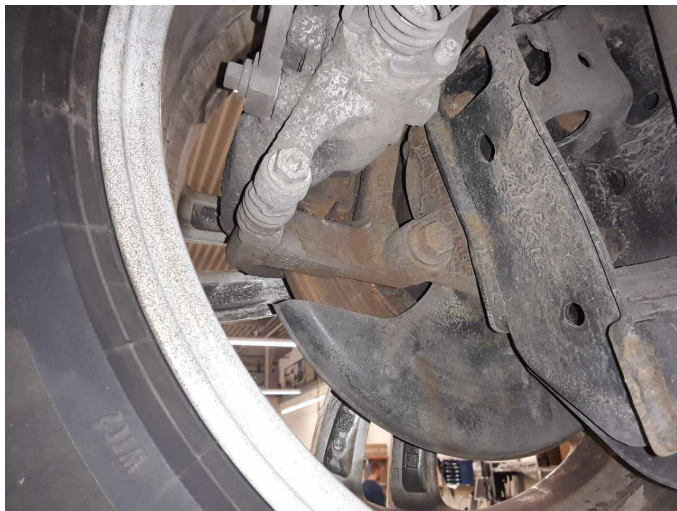
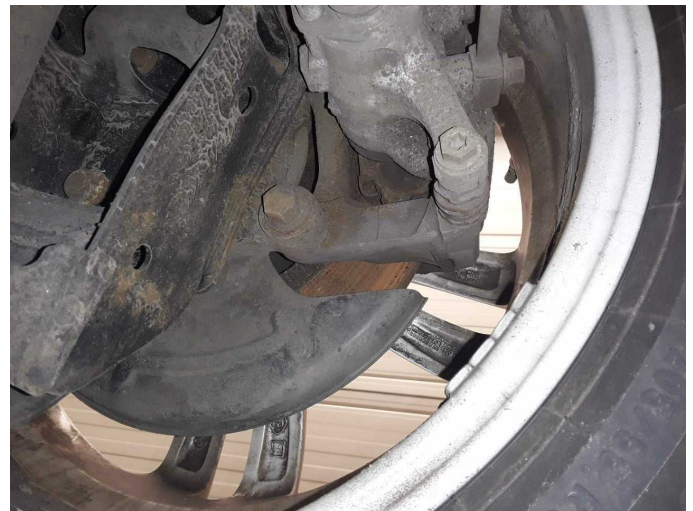
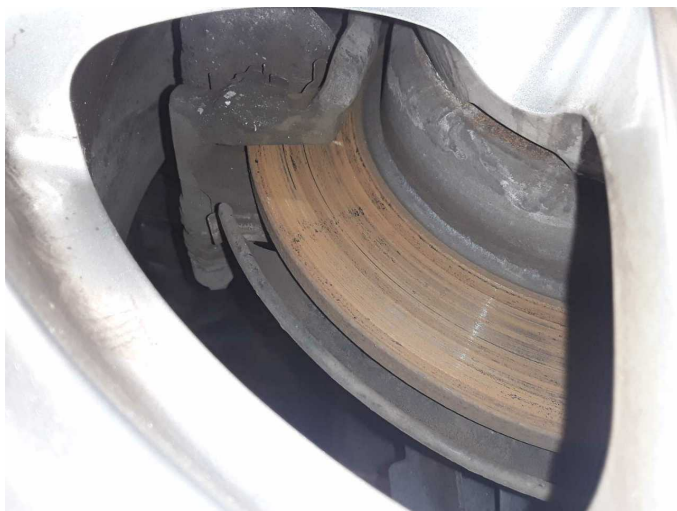
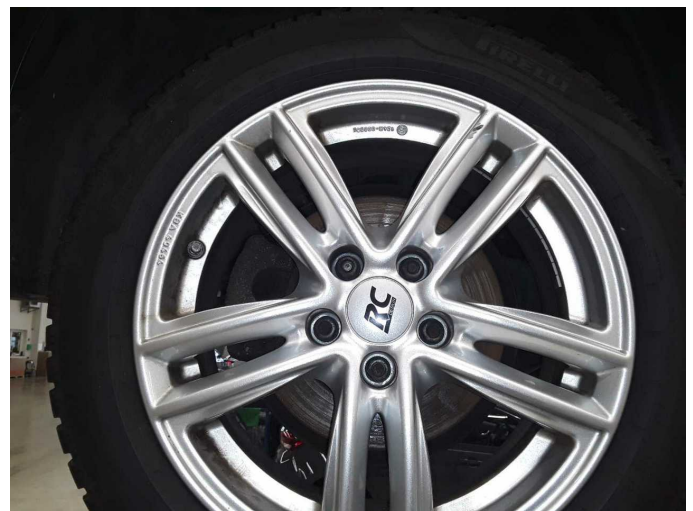
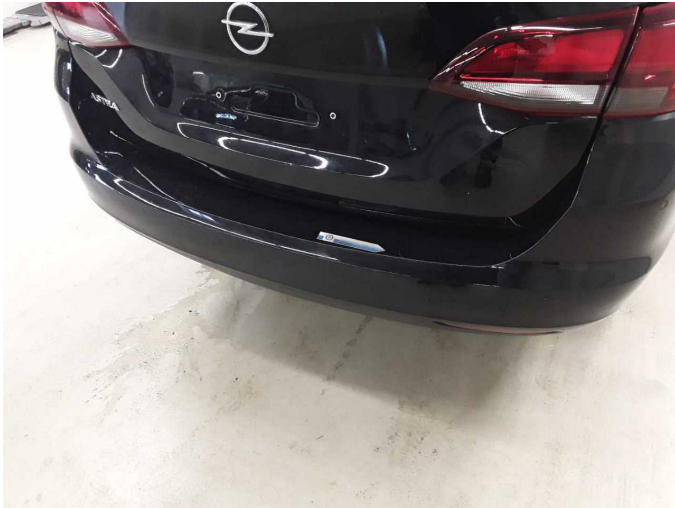
Damage 5: Braking system: Brake discs and pads - rear (Freibremsten) - Corrosion - Perform

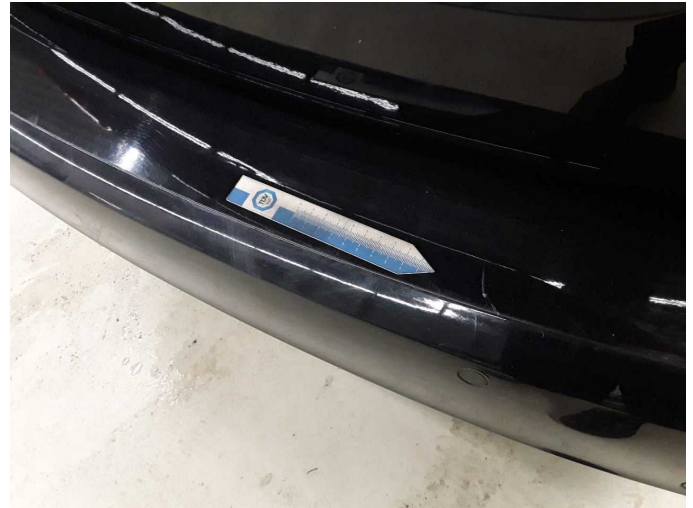
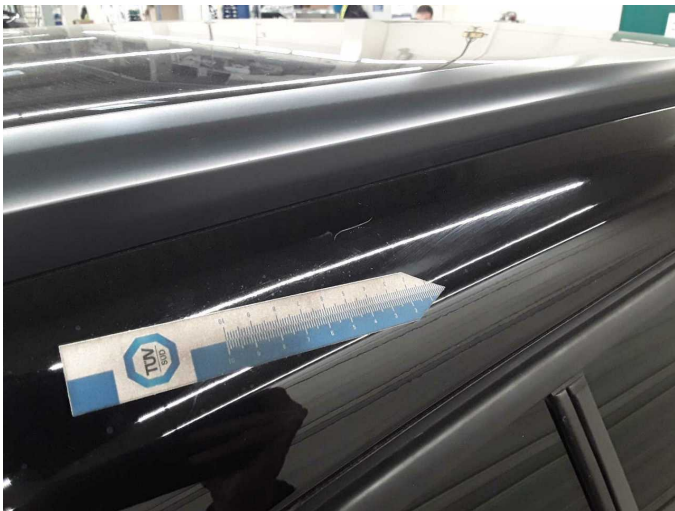
Damage 6: Rear bumper: Rear bumper - Scratch(es) - Smart repair

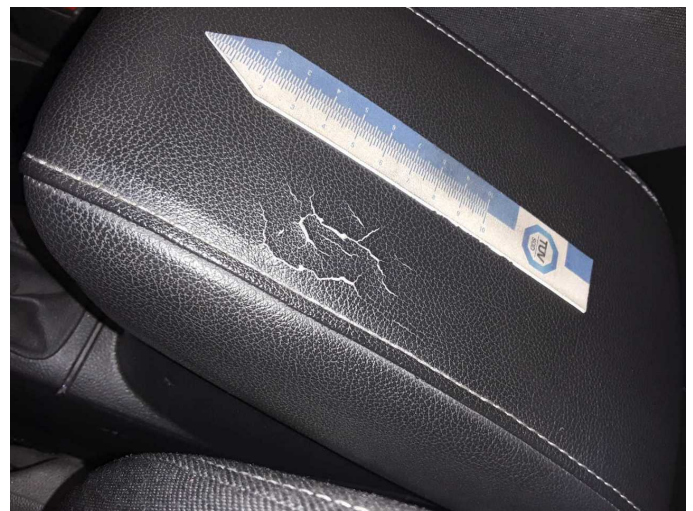
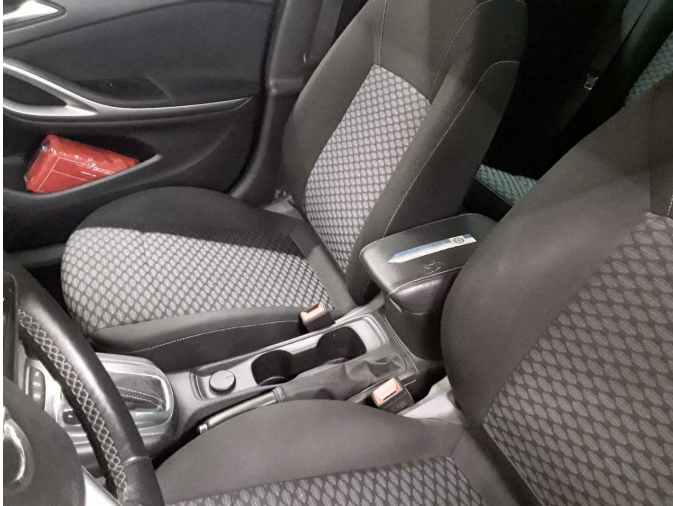
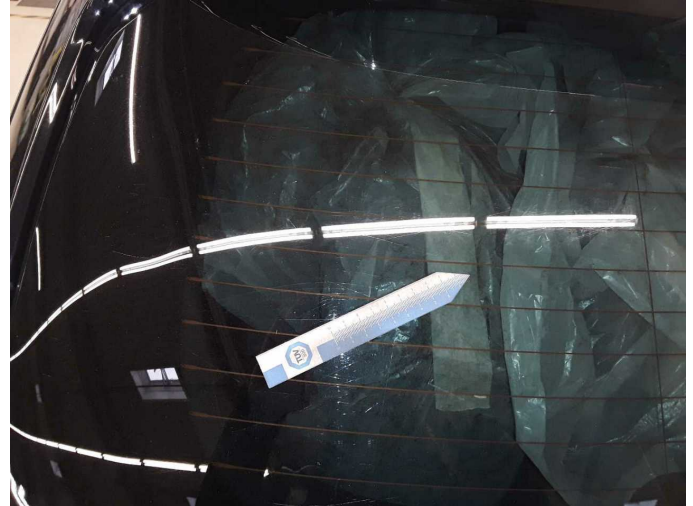
Damage 8: Instrument panel: Centre console - front (Kunstleder) - Broken / torn - Replace

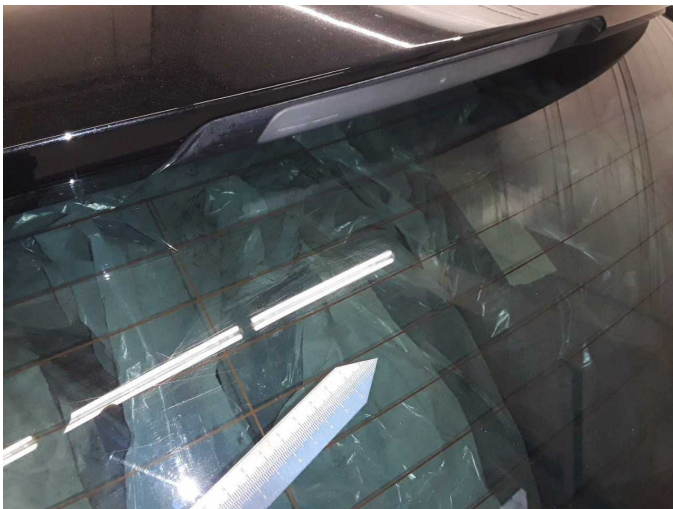
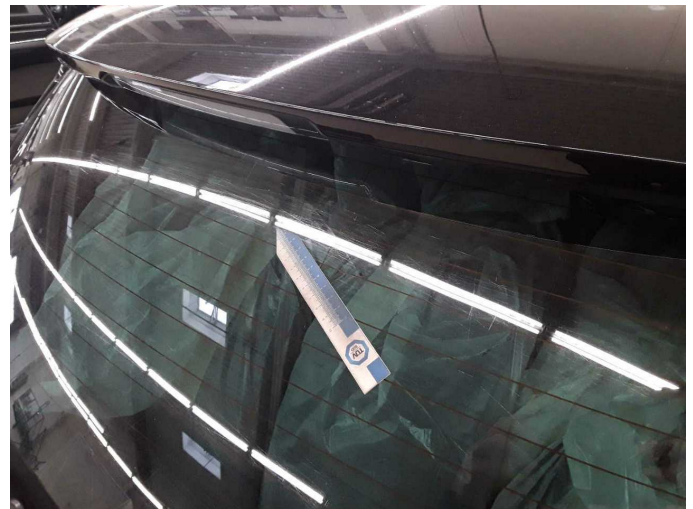
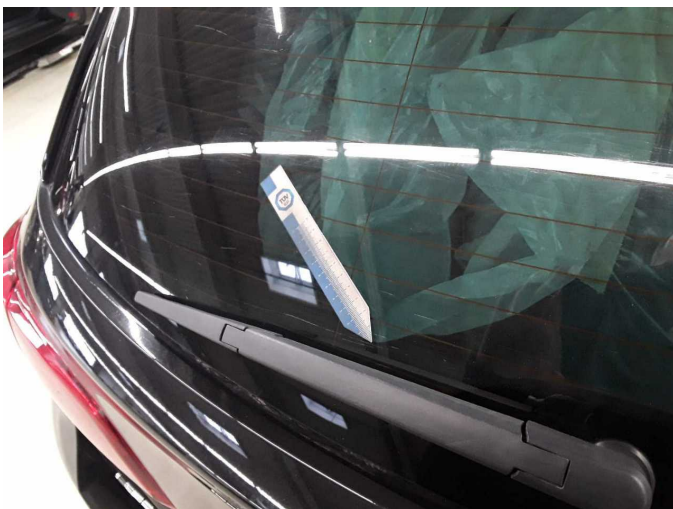
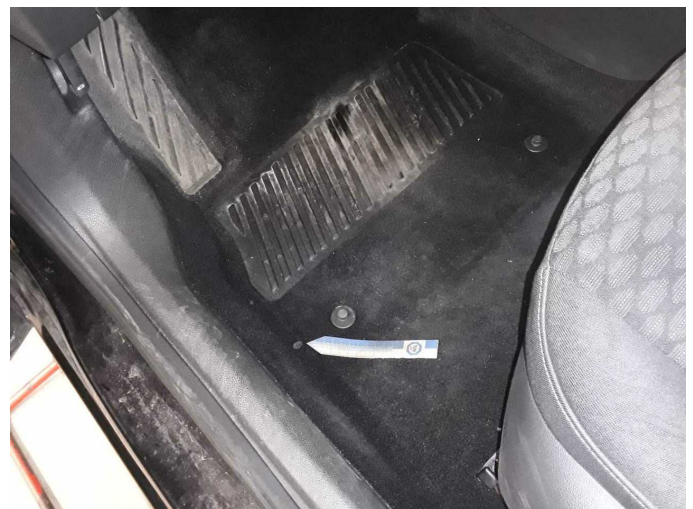
Damage 9: Vehicle glazing: Rear window - Scratch(es) - Loss in value

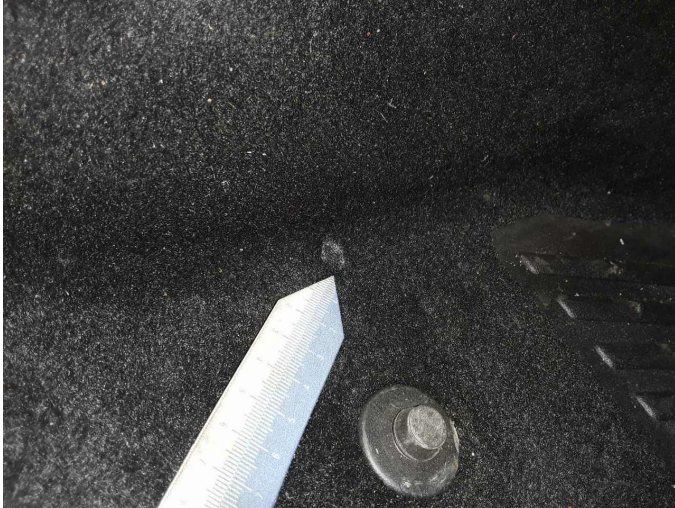
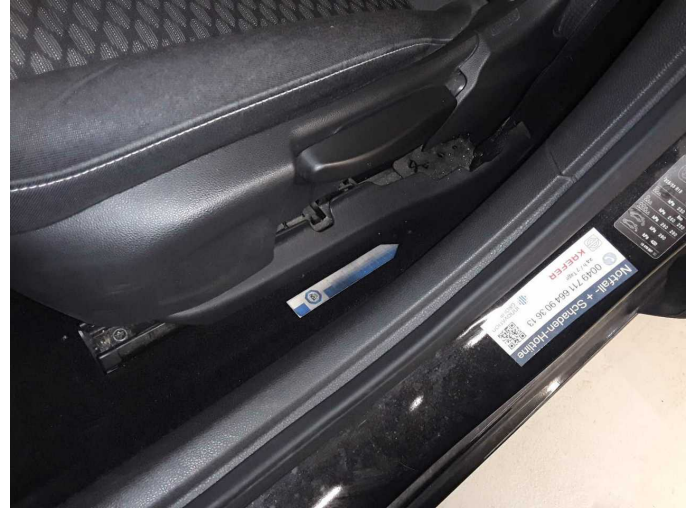
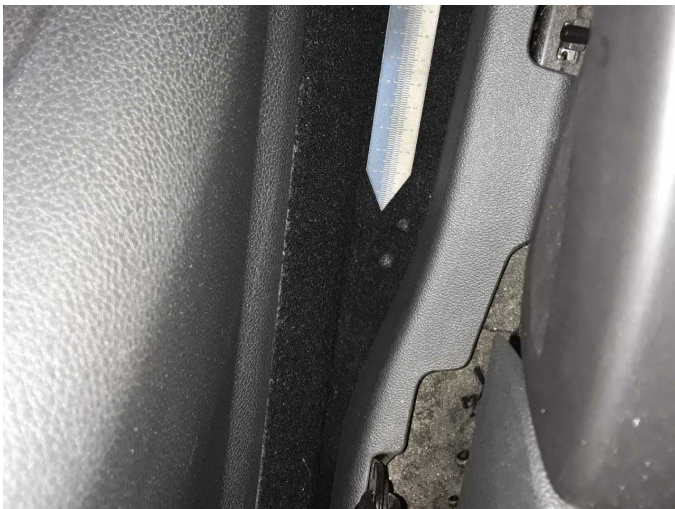
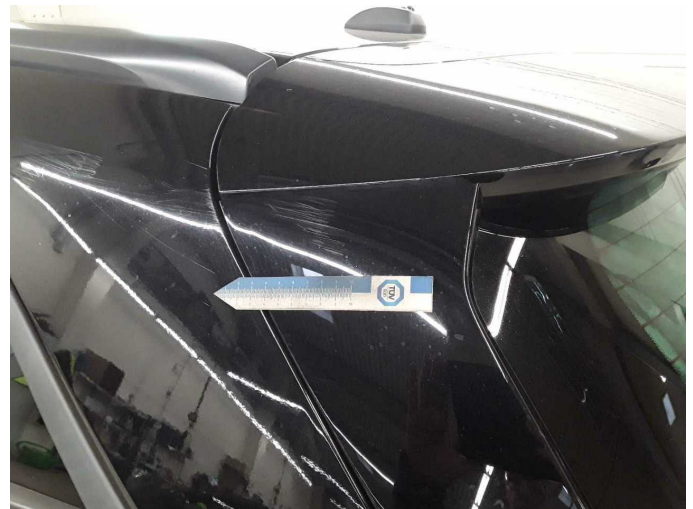
Damage 10: Trim / covers: Carpet - front left side - Burn hole (cigarettes) - Smart repair

Damage 10: Trim / covers: Carpet - front left side - Burn hole (cigarettes)
- Smart repair

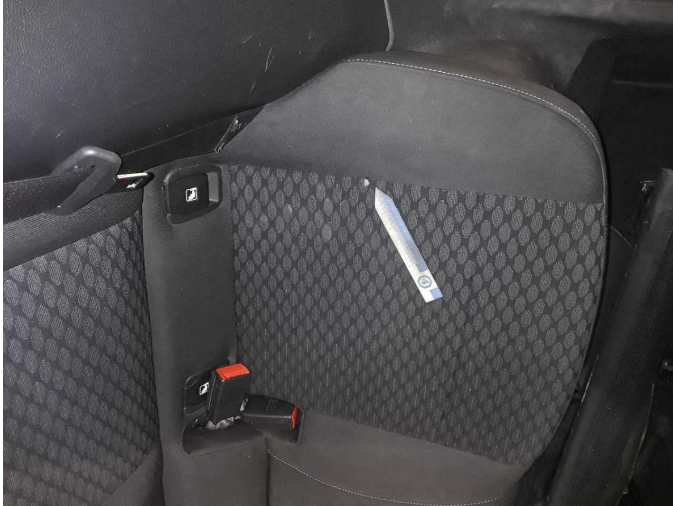
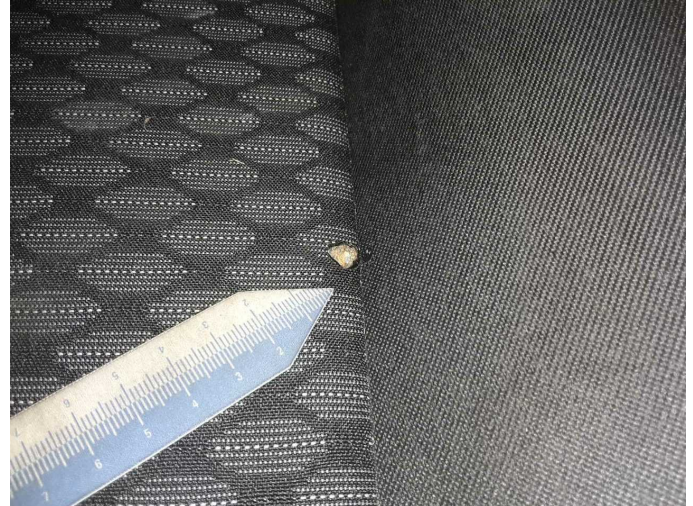
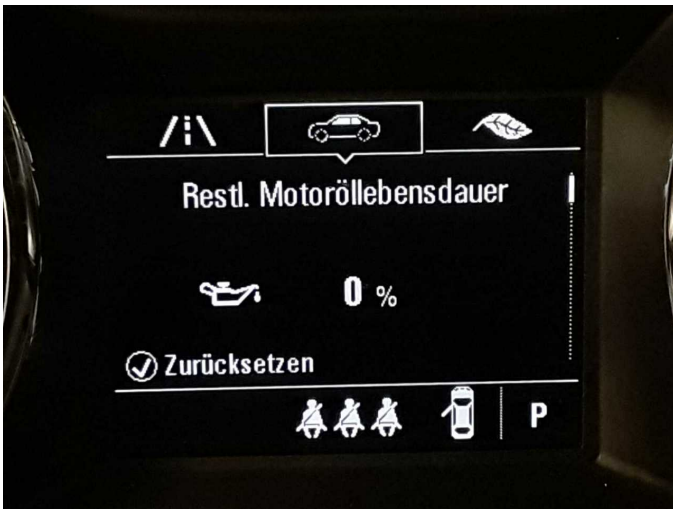
Damage 12: Seat - rear: Back seat - Burn hole (cigarettes) - Replace

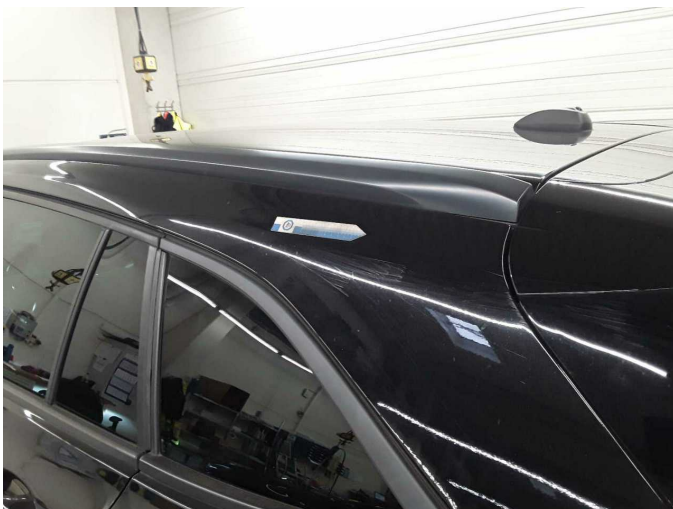
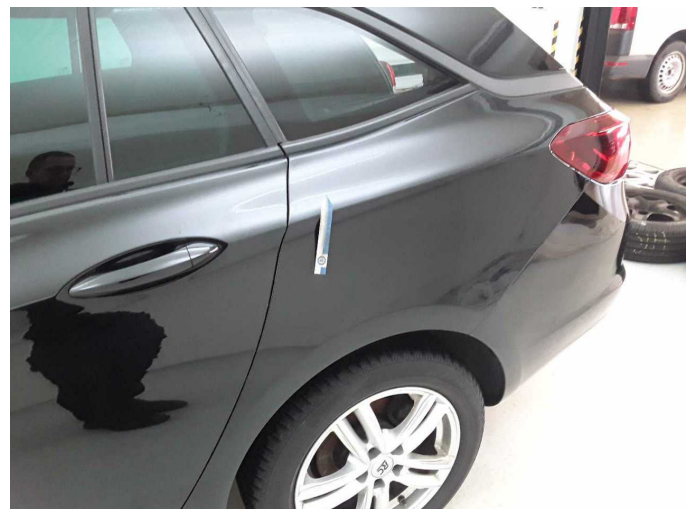
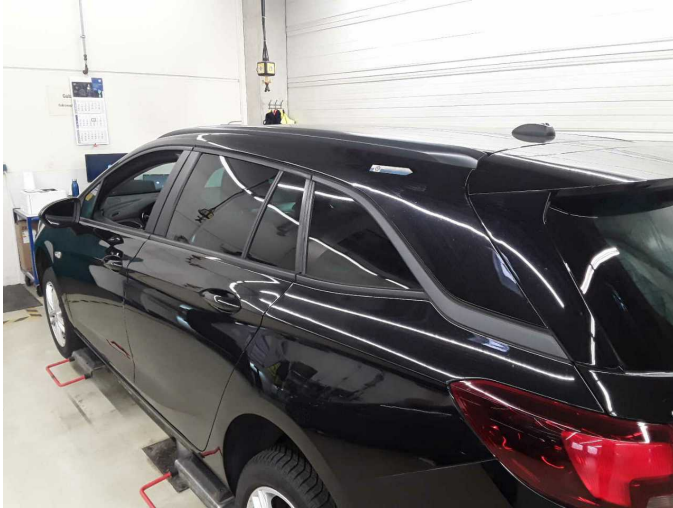
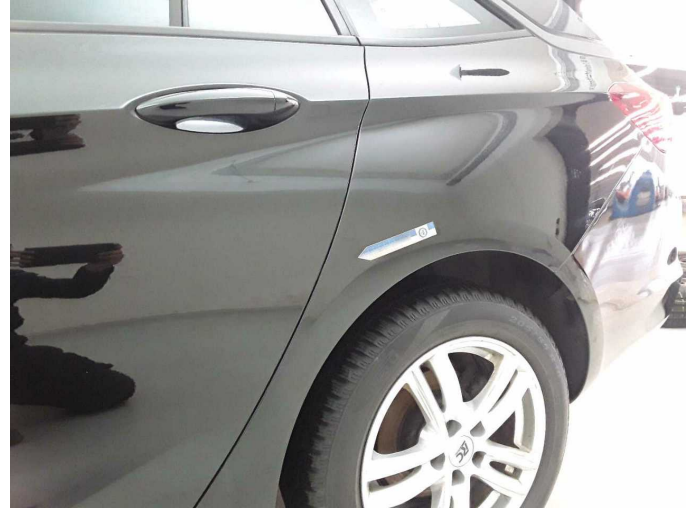
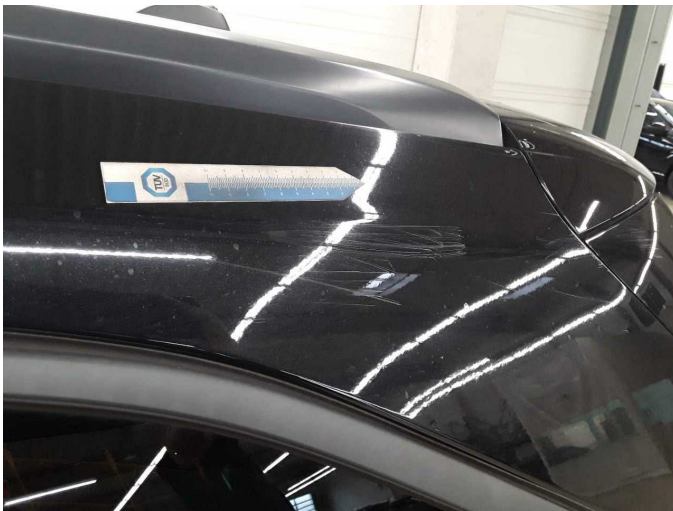
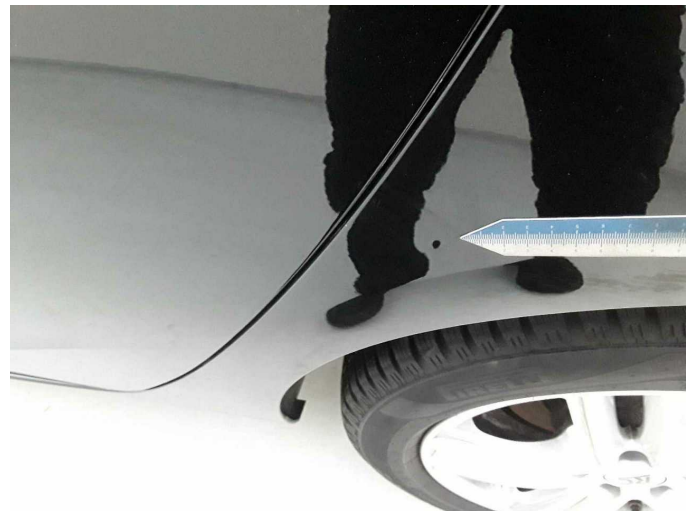
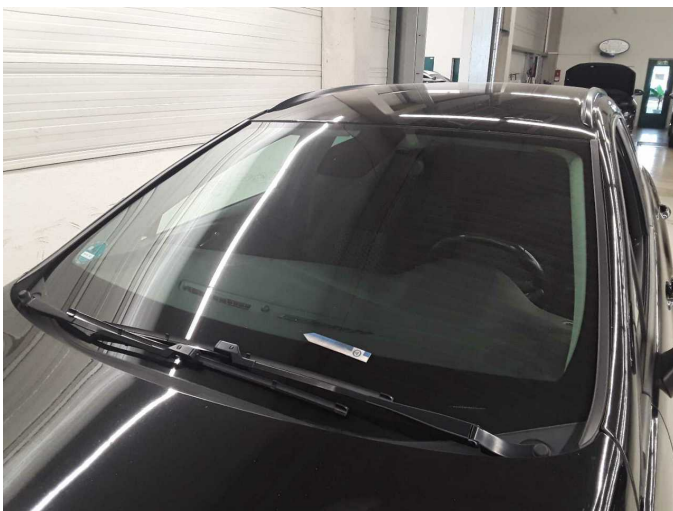
Damage 14: Side panel - rear left side: Side panel - Dent / paintcoat damage - Paint

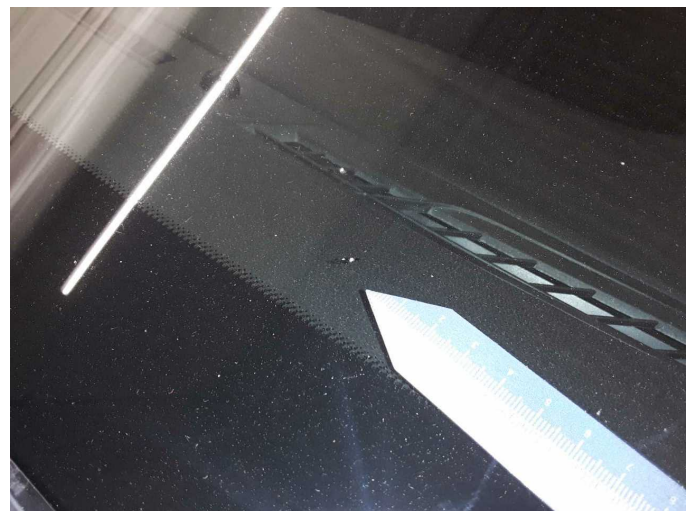
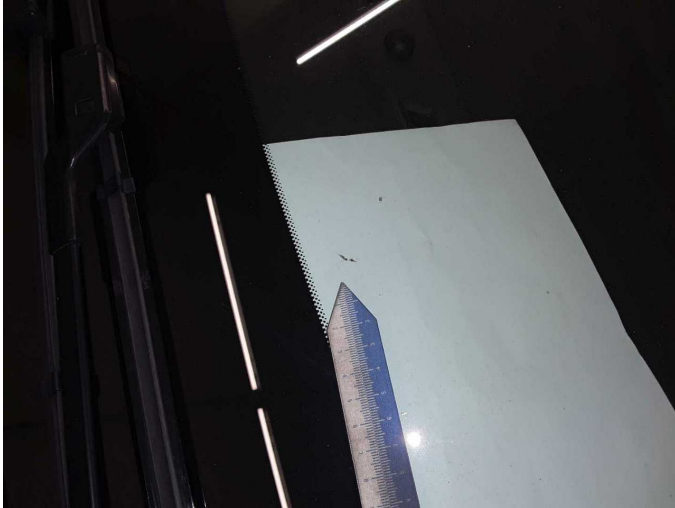
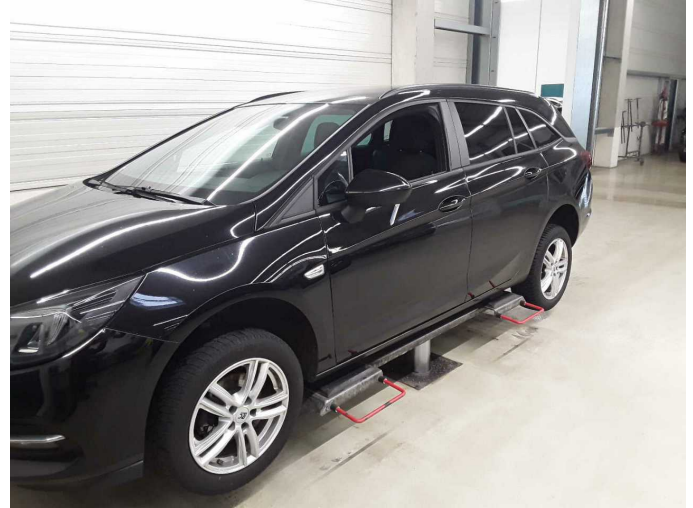
Damage 15: Vehicle glazing: Windscreen - Stone chips - Replace

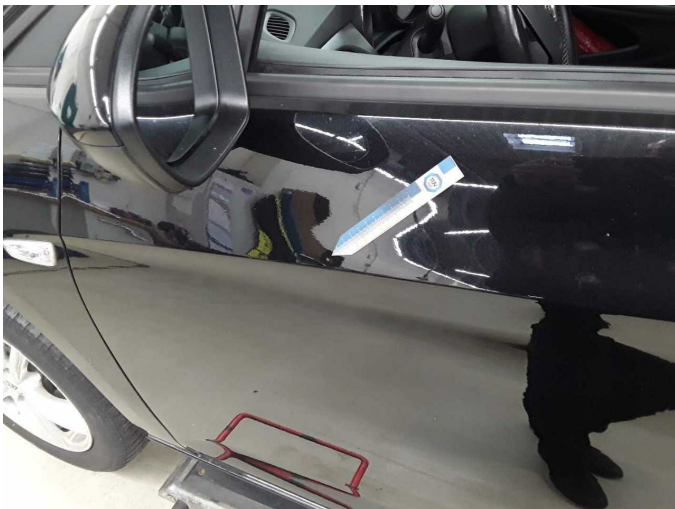
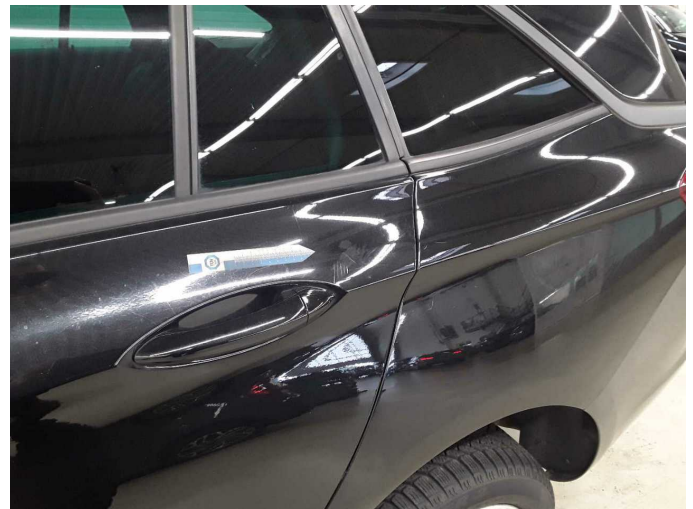
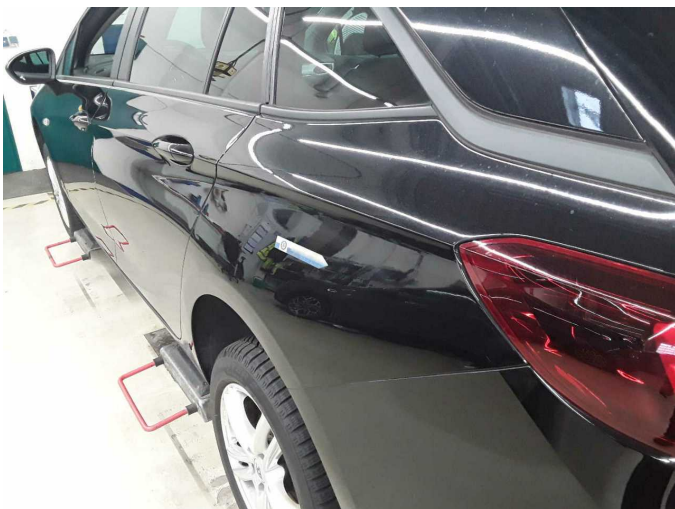
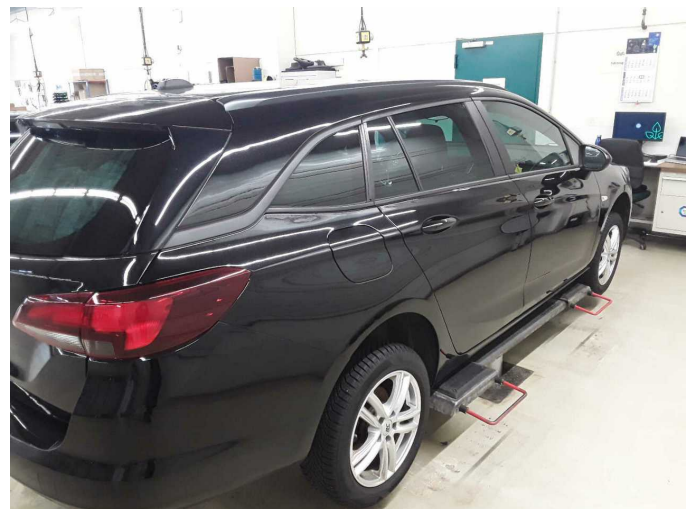
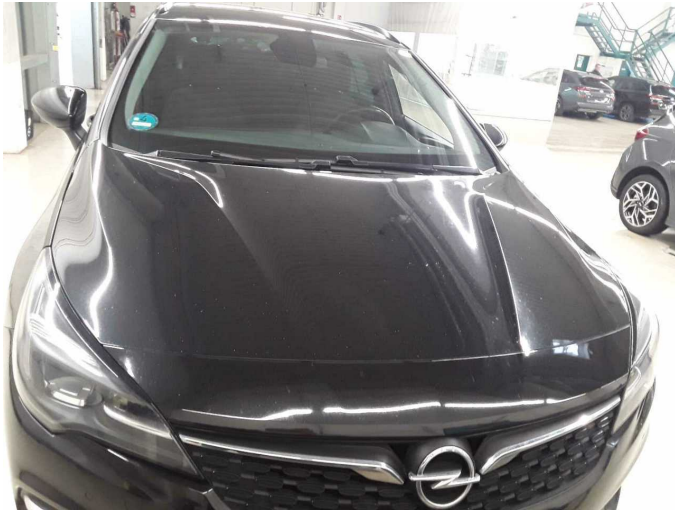
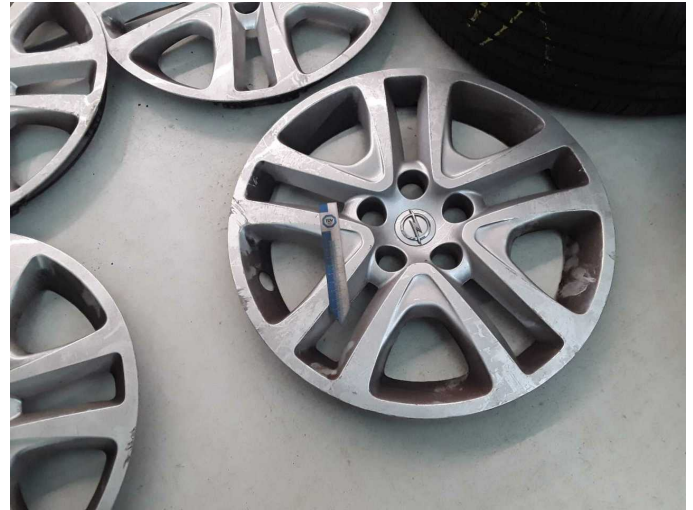
Wear and tear 1: Body: Body (Dellen und) - Scratch(es) - No deduction

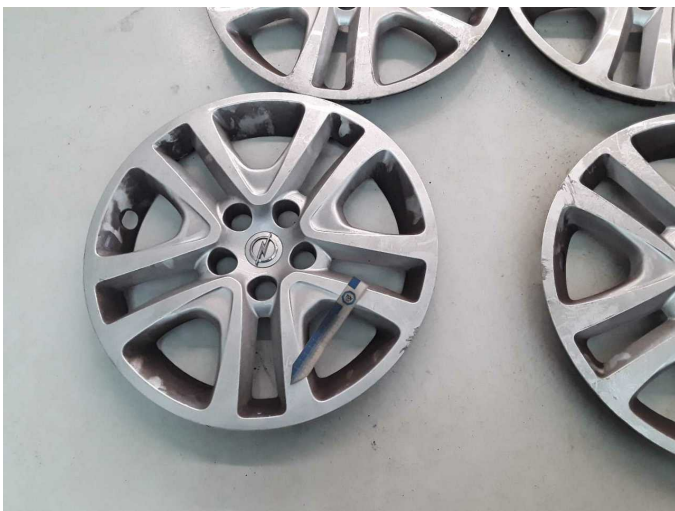
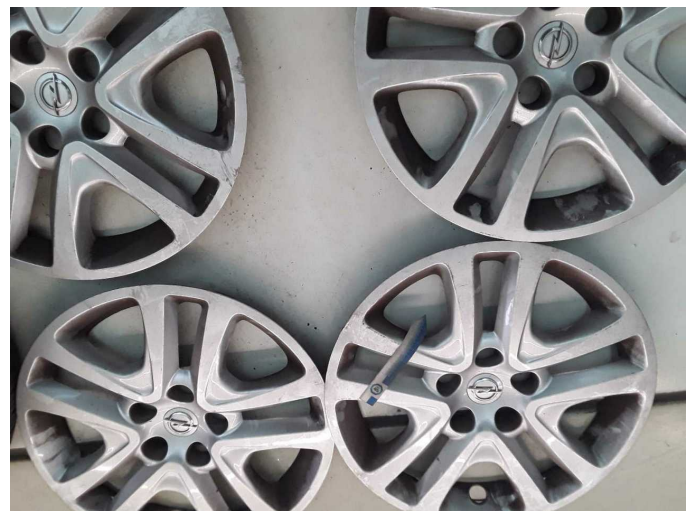
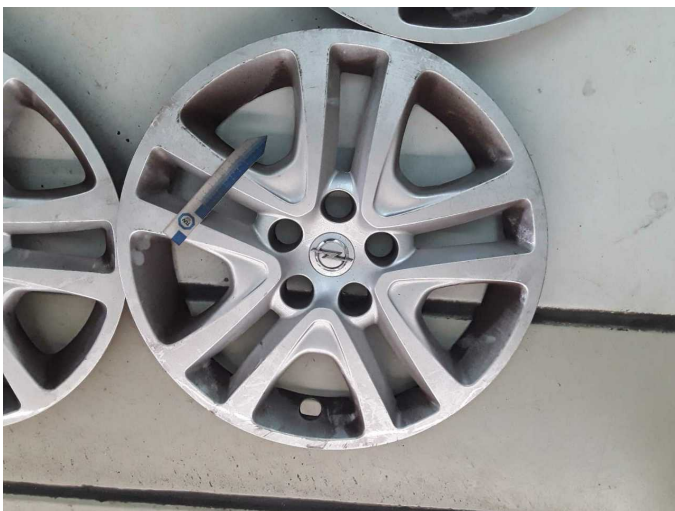
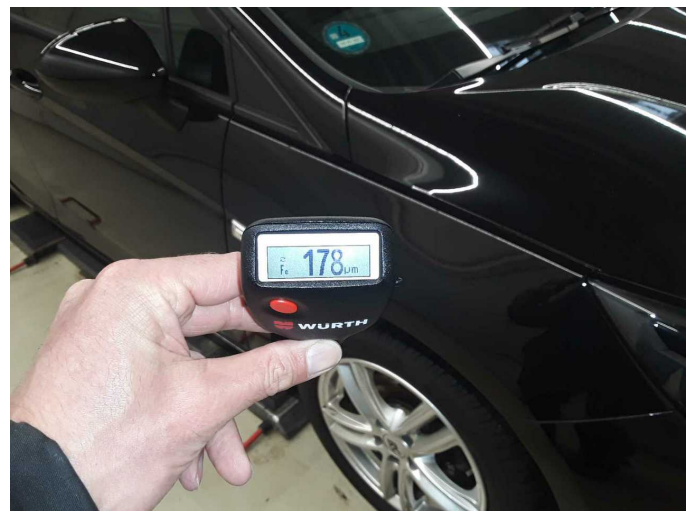
Wear and tear 2: 2nd wheel set: 3 wheel covers - Scratched - No deduction

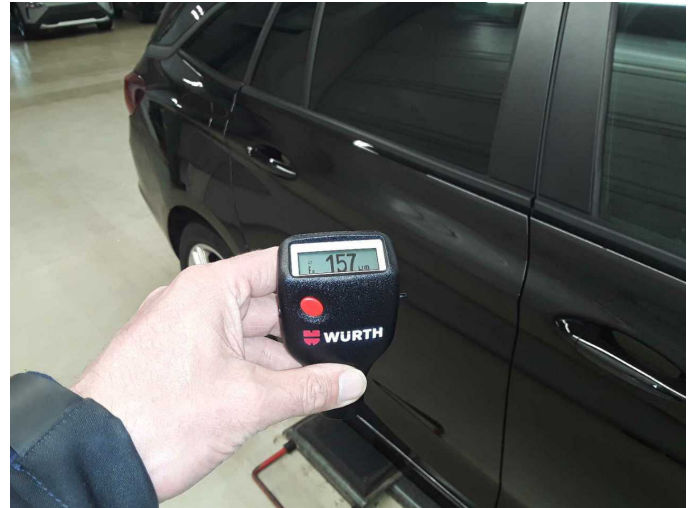
Mudguard - right side	178 µm	Side panel - rear right side	765 µm
Door - rear right side	157 µm	Door - front right side	147 µm

Repainting 1: Mudguard - right side, Side panel - rear right side, Door - rear right side, Door - front right side
