Expertise

Protocol number: 46062156
Order No. / Reference: 26546649
Inspection date: 22 Jun 2026

Manufacturer: MAN

Model: TGE 3.140 4X2F SB

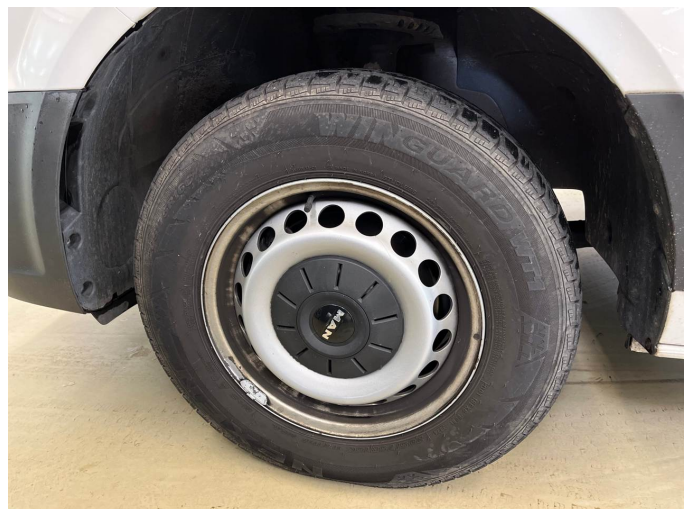
Figure 12: Mounted tyres

Mounted tyres				
#	Tyre size	Type of tyre	Manufacturer	Tread depth
1)	205/75 R16 113R	Winter tyres on Steel rim with wheel cover	Nexen	6mm / 6mm
2)	205/75 R16 113R	All-season tyres on Steel rim with wheel cover	Continental	6mm / 6mm

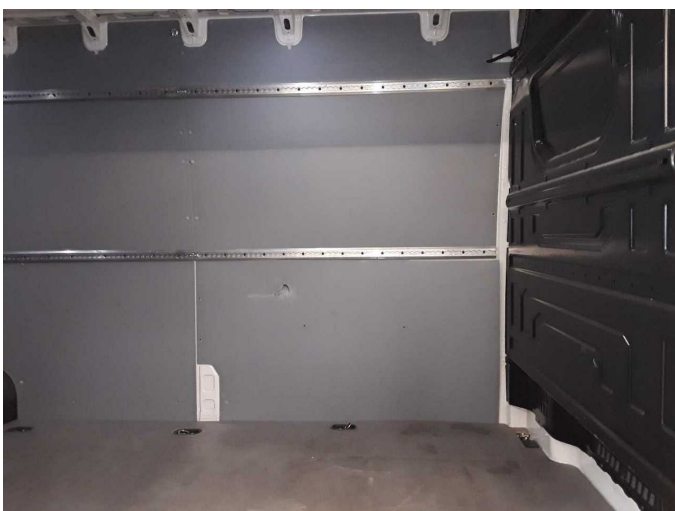
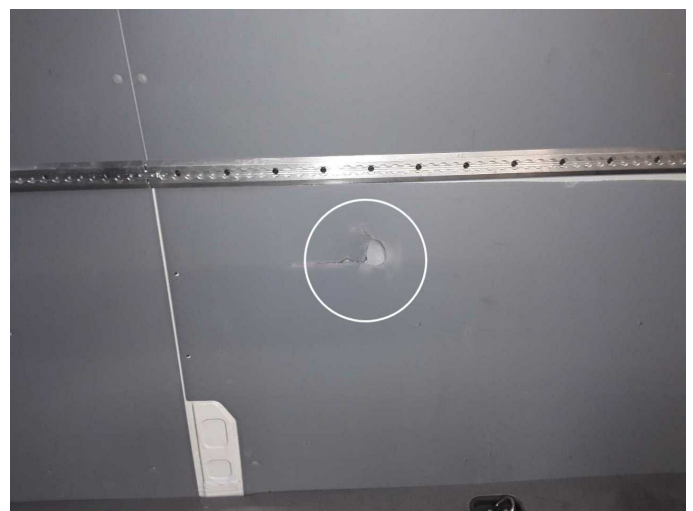
Damage 1: Side panel - rear left side: Interior trim - Broken / torn - Replace

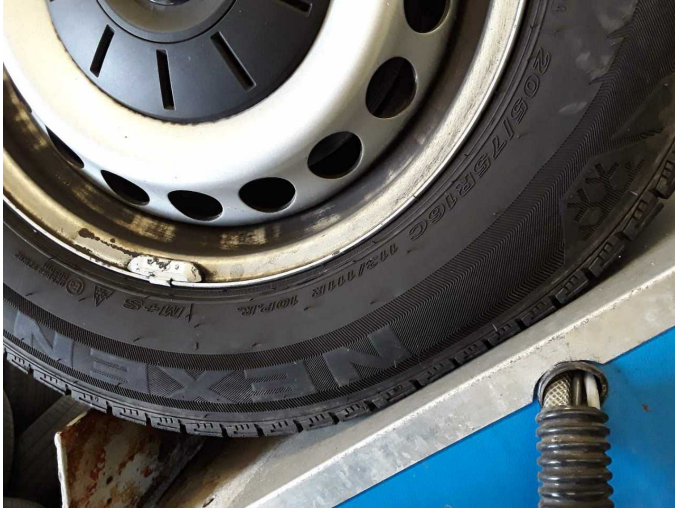
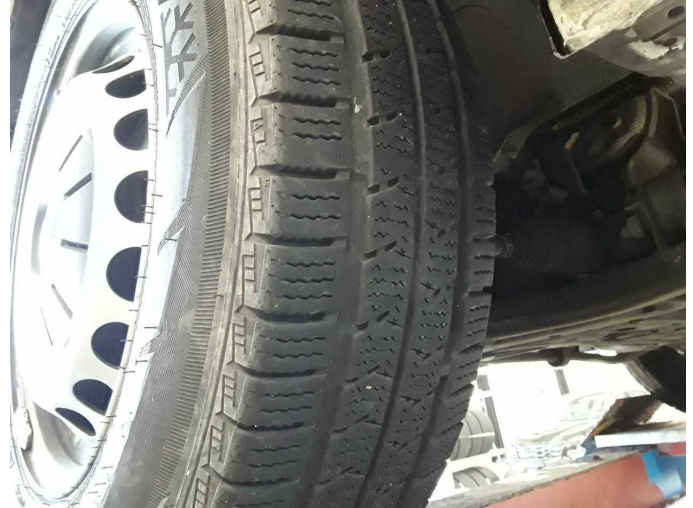
Damage 2: Wheel / tyres: Tyre - front (Winterreifen statt Ganzjahresreifen montiert, Mischbereifung) - Differs from the original configuration - Replace

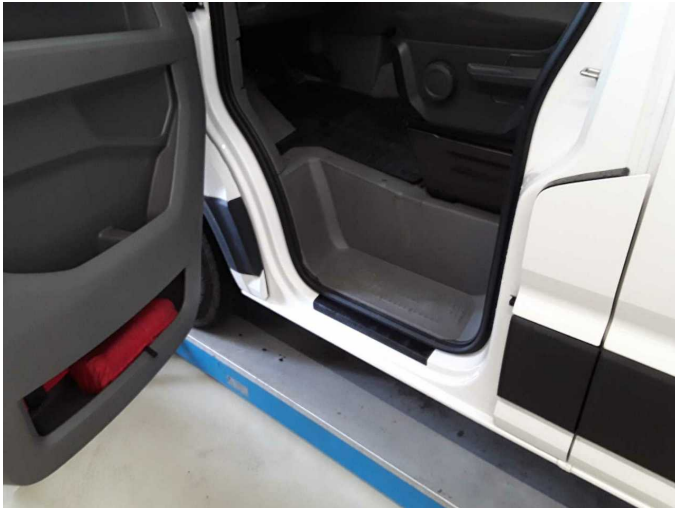
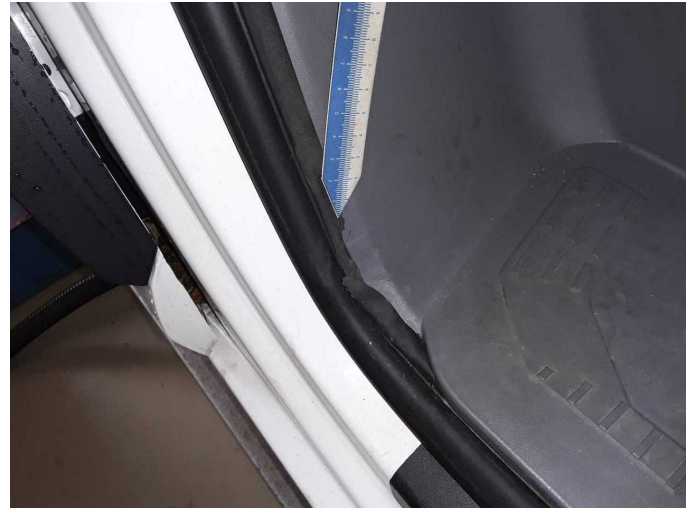
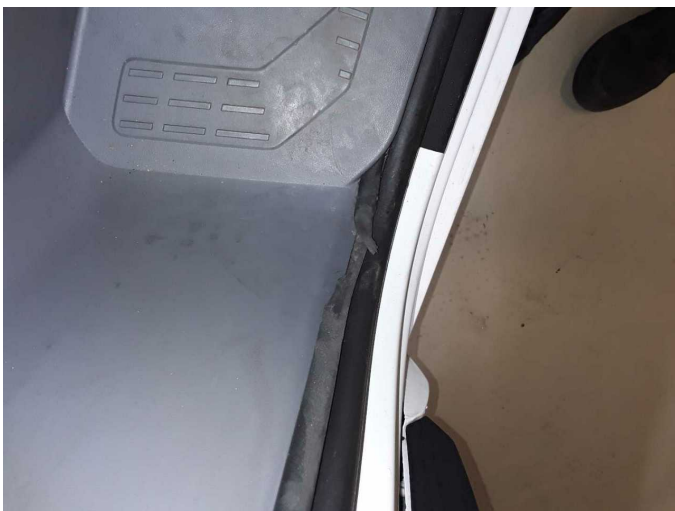
Damage 3: Door - front left side: Door seal - Broken / torn - Replace

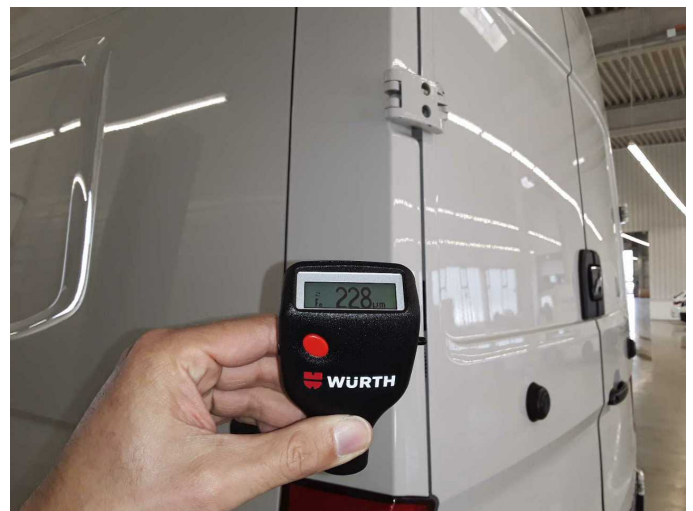
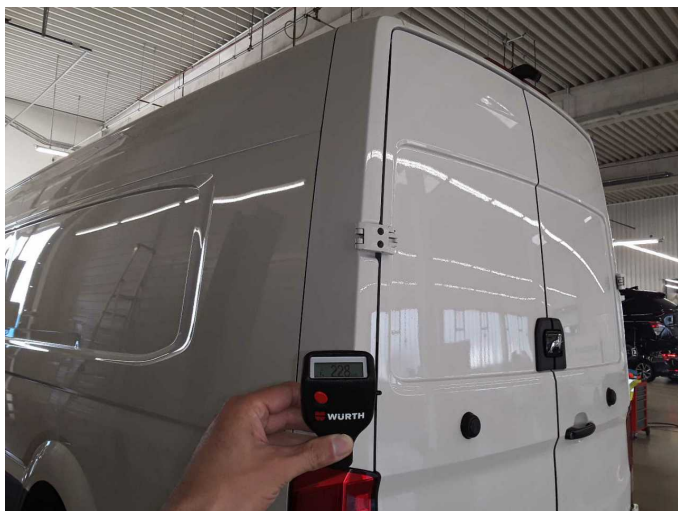
- 1 Side panel - rear left side, Door - front right side, Professionally carried out

Side panel - rear left side: 228 µm

Side panel - rear left side: 228 μm

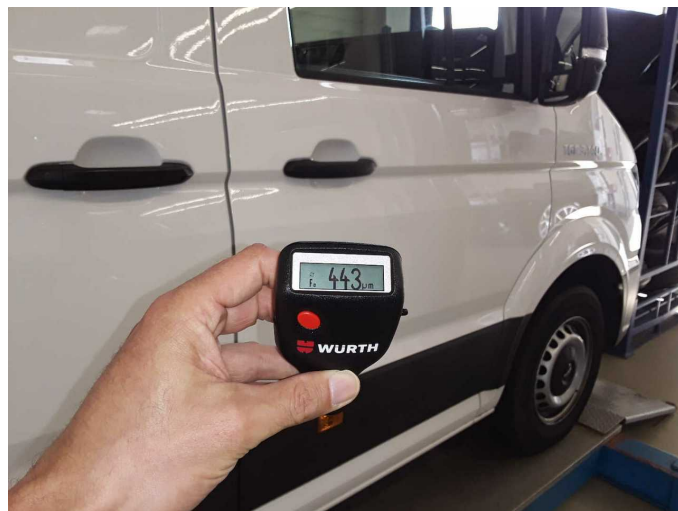
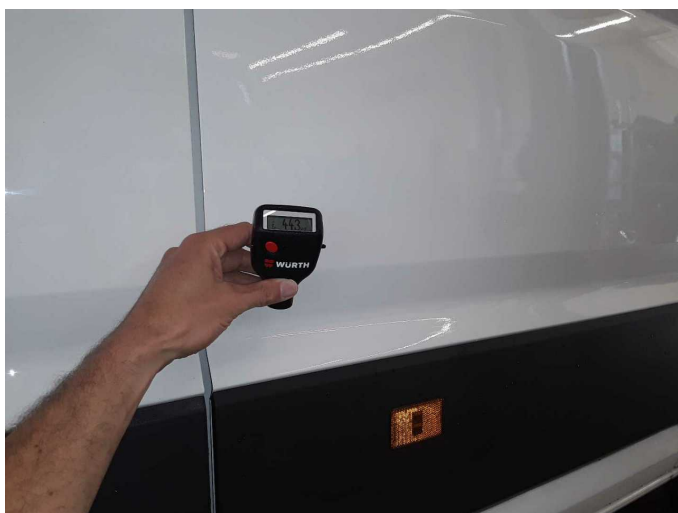
Door - front right side: 443 μm
