Expertise

Protocol number: 46047313
Order No. / Reference: 26488495
Inspection date: 17 Jun 2026

Model: Transit Custom 280 L1H1 LKW VA Trend

VIN: WF0YXXTTGYNT01459

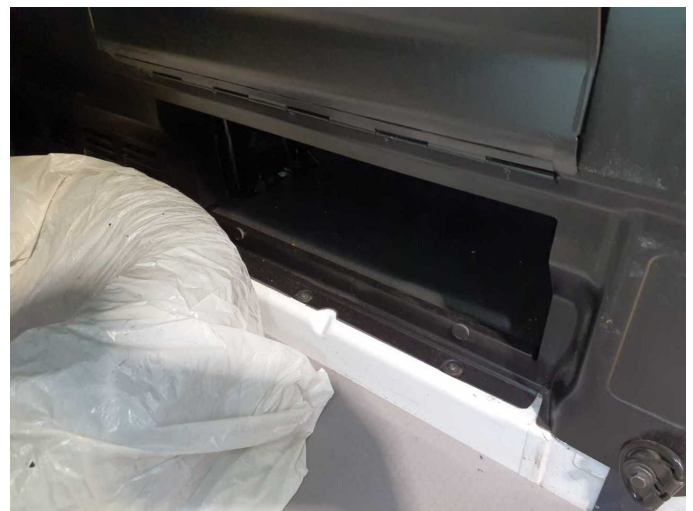
Damage 1: Trim / covers: Trim / covers - Missing - Replace

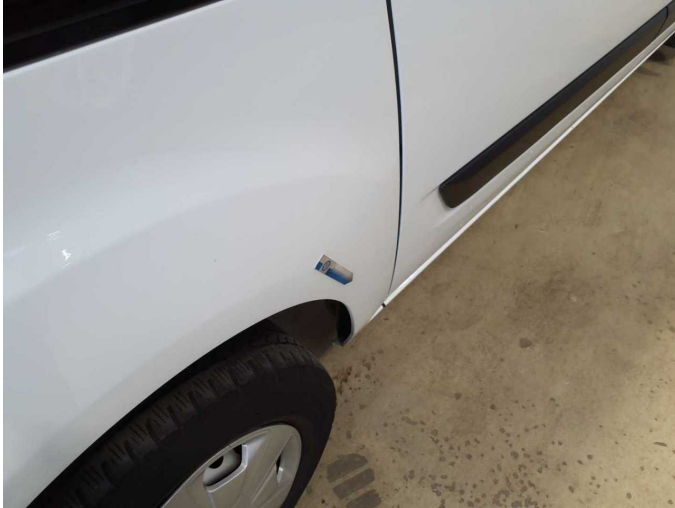
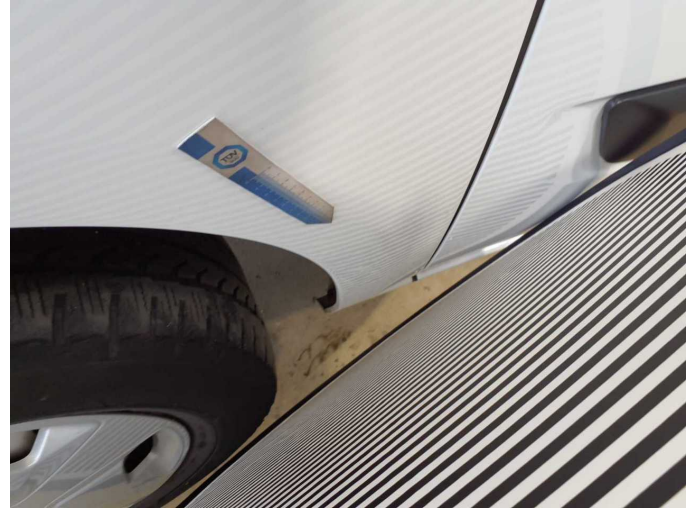
Damage 2: Side panel - rear right side: Side panel - dent(s) - Smooth repair work

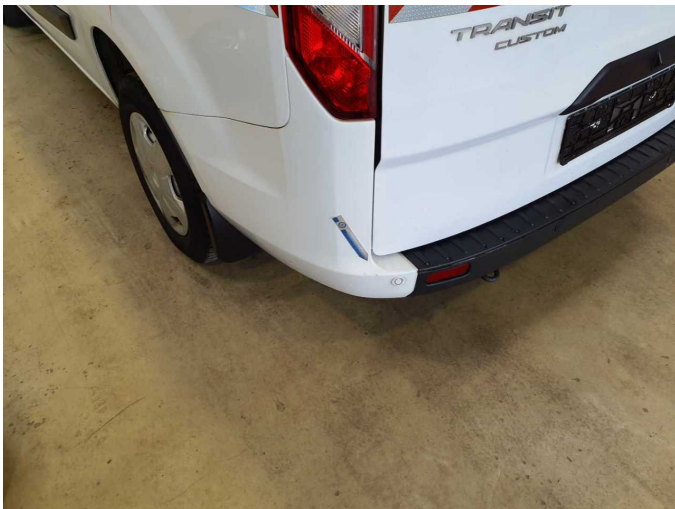
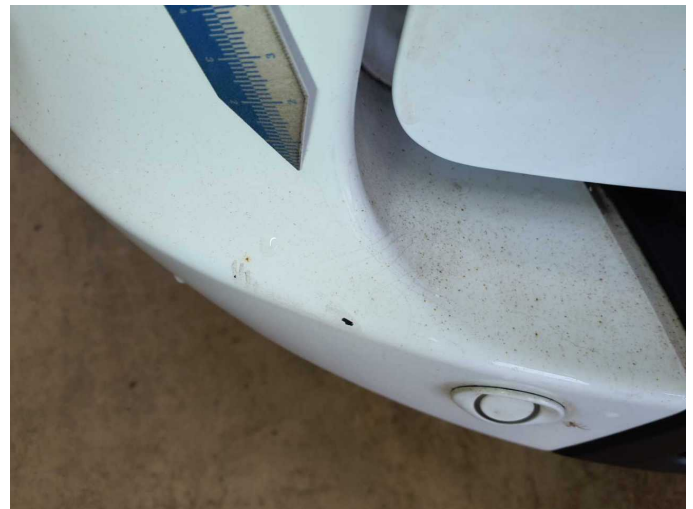
Damage 3: Rear bumper: Rear bumper - Scratch(es) - Smart repair

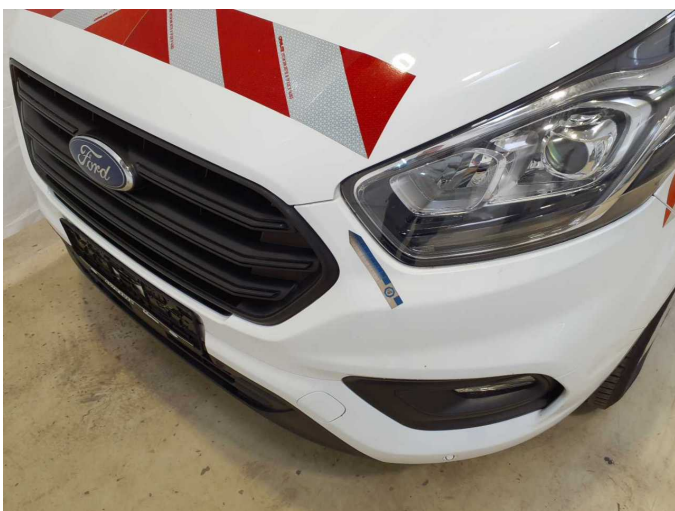
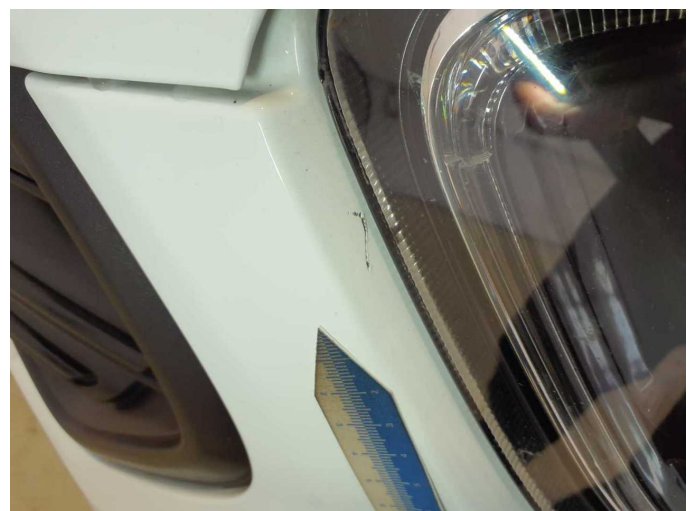
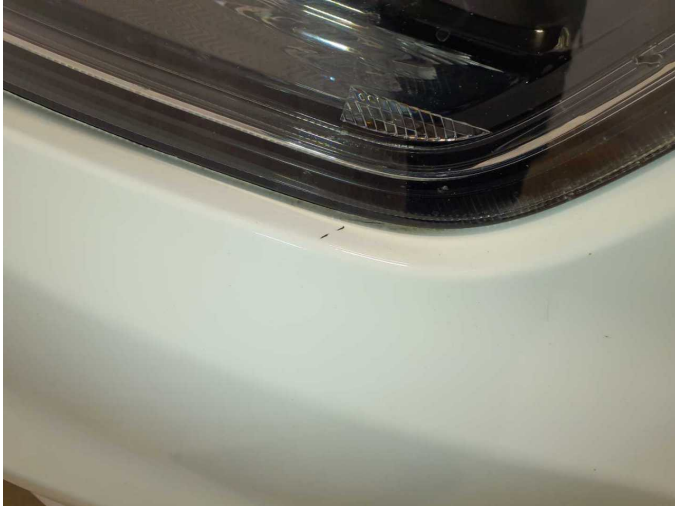
Damage 4: Front bumper: Front bumper - Scratch(es) - Smart repair

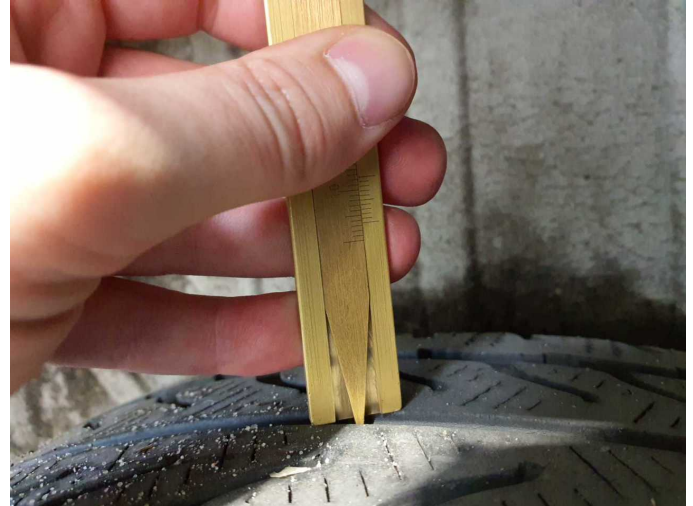
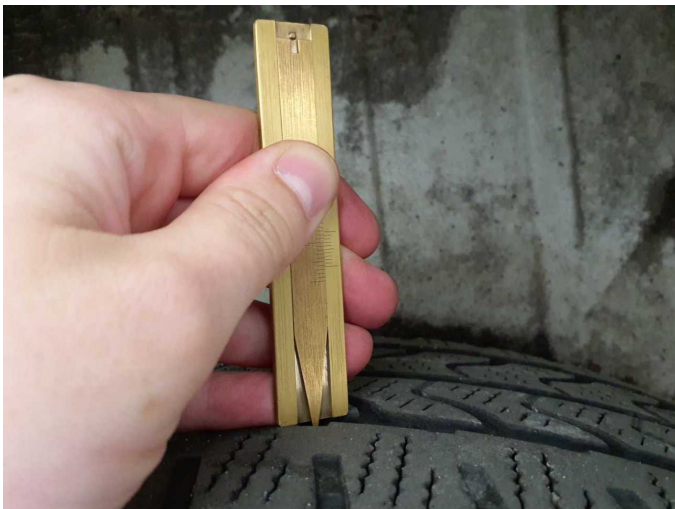
Damage 5: Wheel / tyres: Tyre - right (Winterreifen Profiltiefe <4mm) - Does not meet the leasing specifications - Replace

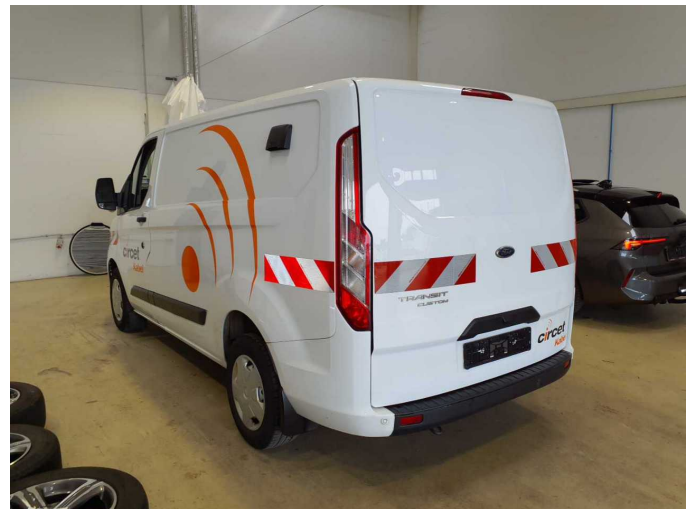
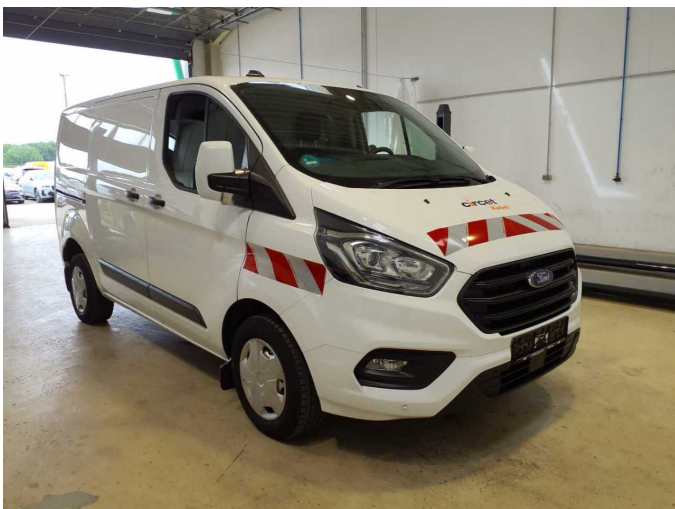
Damage 6: Body: Body - Glued / labelled - De-glug / neutralise

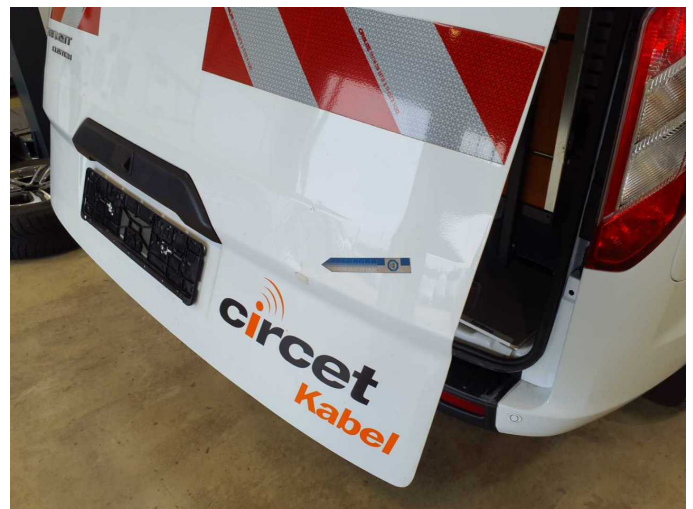
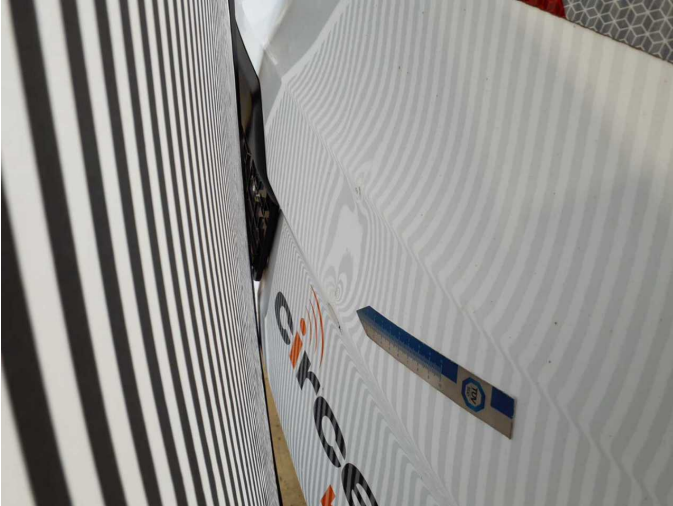
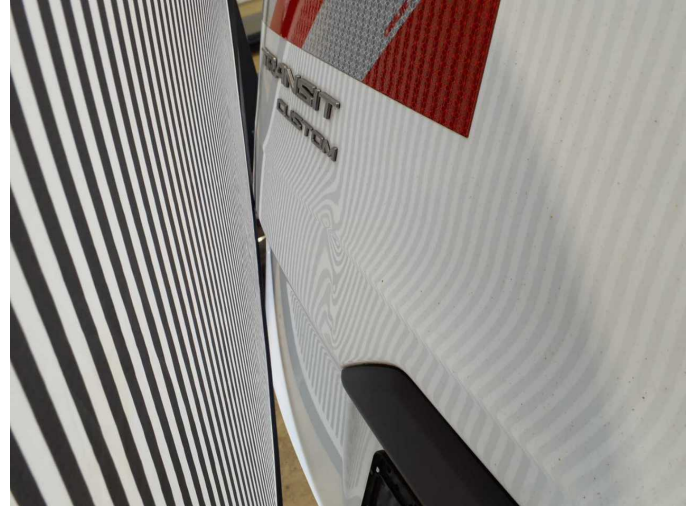
Damage 7: Boot lid / rear door: Boot lid - Dent / paintcoat damage - Paint

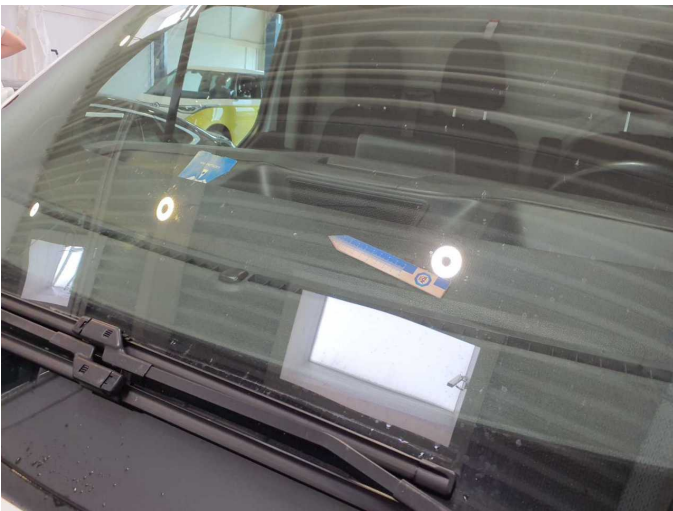
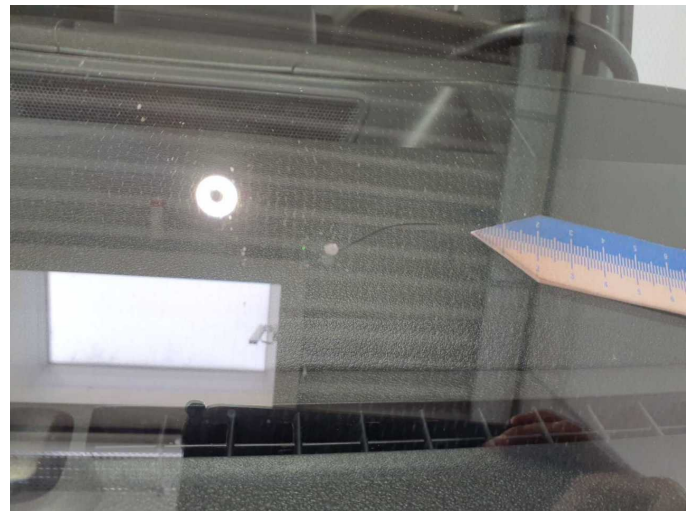
Damage 8: Vehicle glazing: Windscreen - Broken / torn - Replace

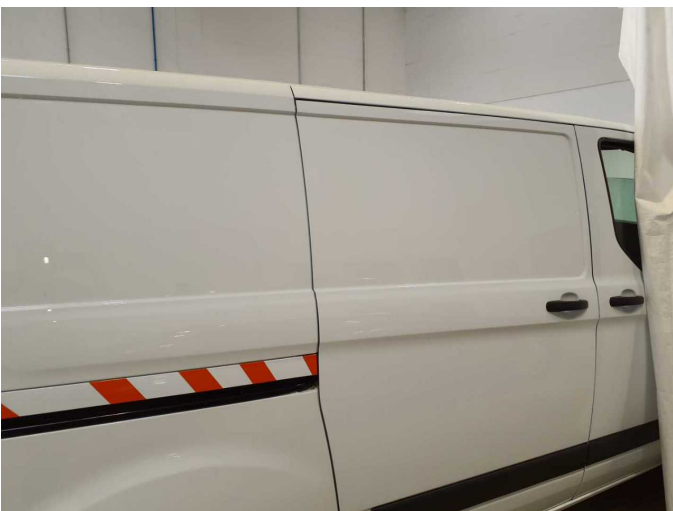
Wear and tear 3: Sliding door, right: Sliding door (Farb unterschied und seitenwand) - No deduction

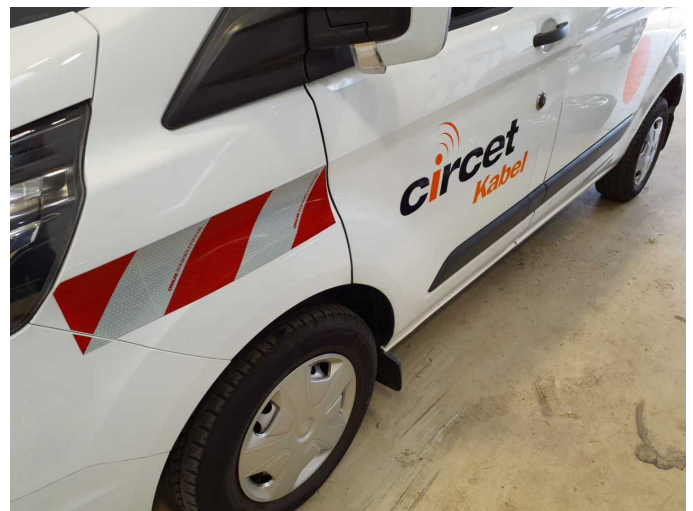
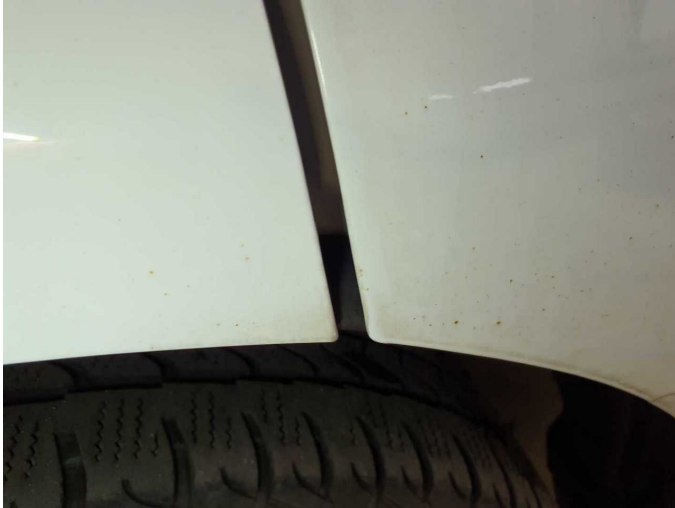
Wear and tear 4: Body: Body - Stone chips - No deduction

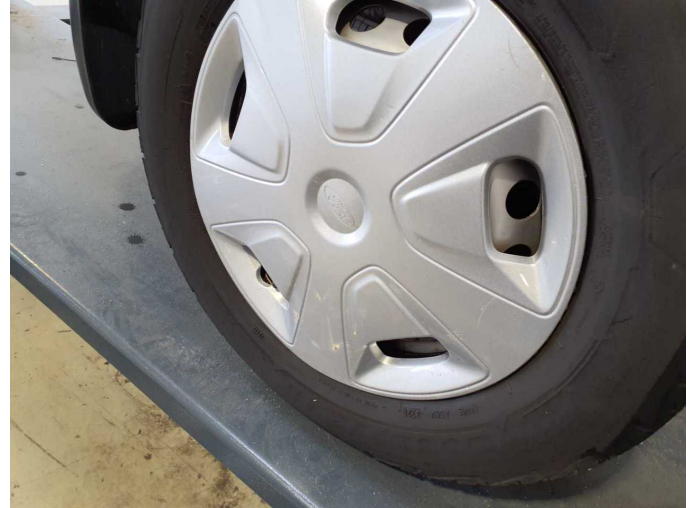
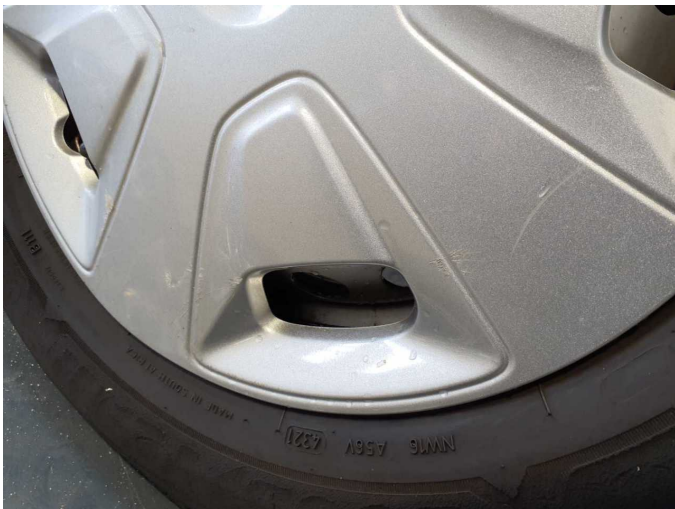
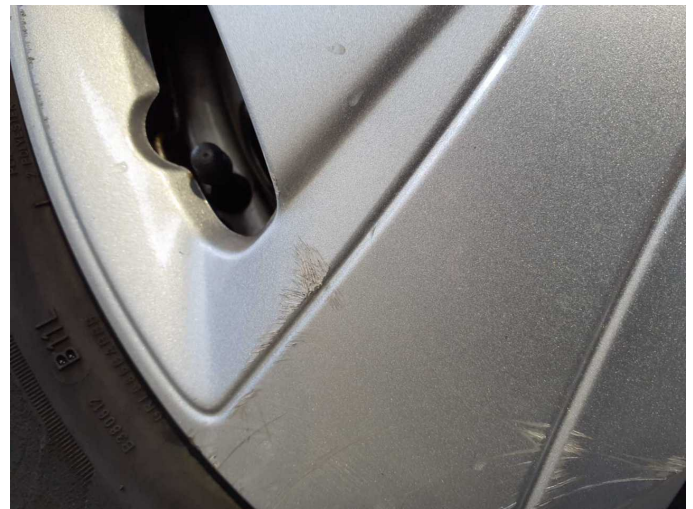
Wear and tear 5: Wheel / tyres: Wheel cover - rear right side - Scratch(es) - No deduction

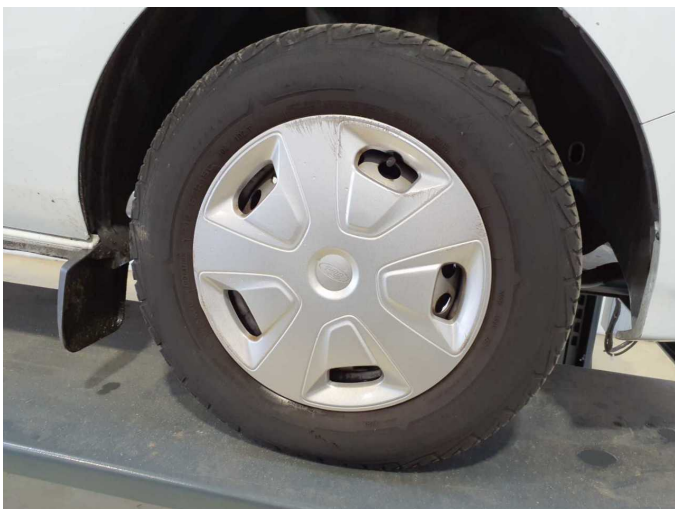
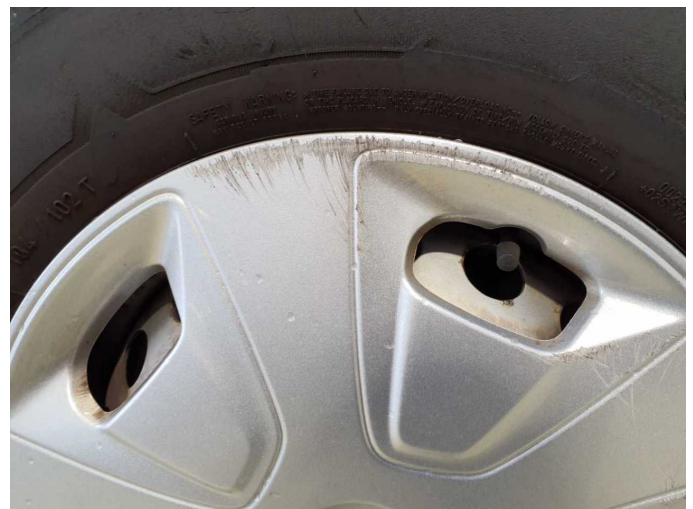
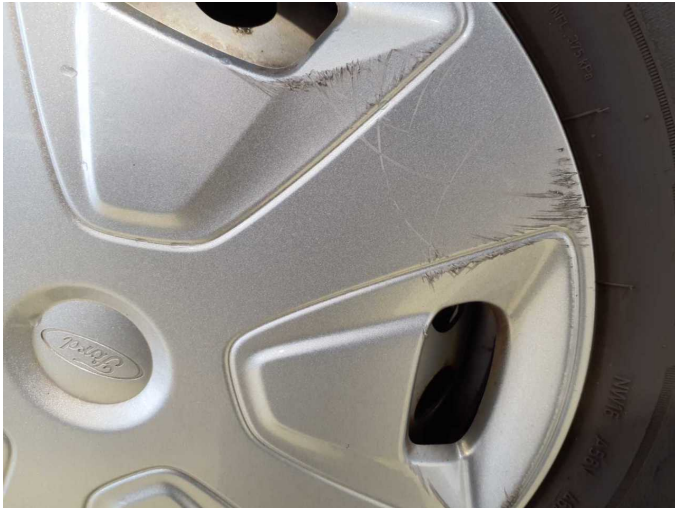
Wear and tear 6: Wheel / tyres: Wheel cover - front right side - Scratch(es) - No deduction

Wear and tear 6: Wheel / tyres: Wheel cover - front right side -
Scratch(es) - No deduction

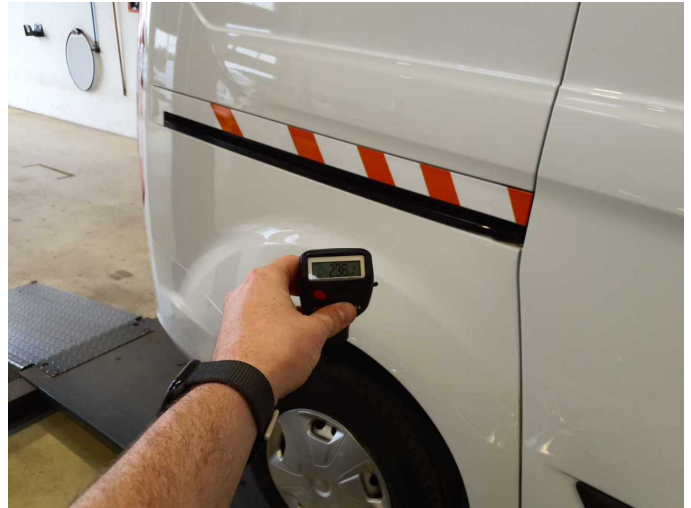
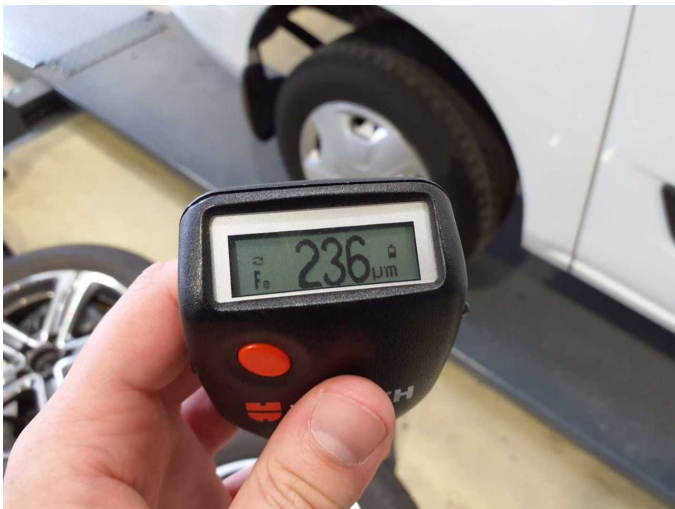
Side panel - rear right side	236 µm	Door - rear right side	171 µm
------------------------------	--------	------------------------	--------

Repainting 1: Side panel - rear right side

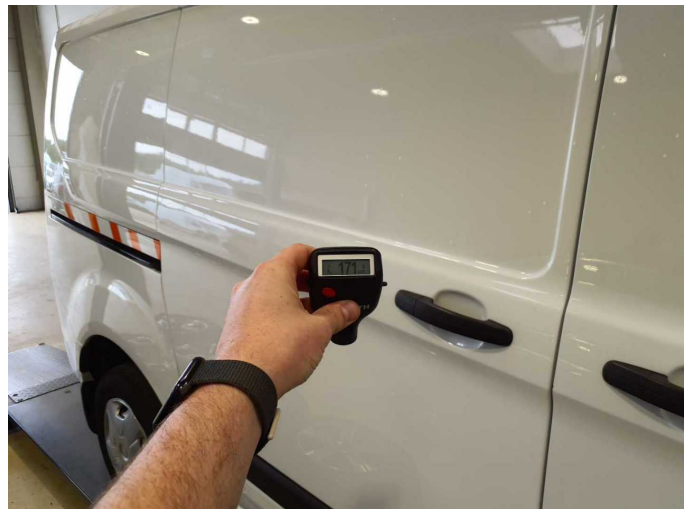
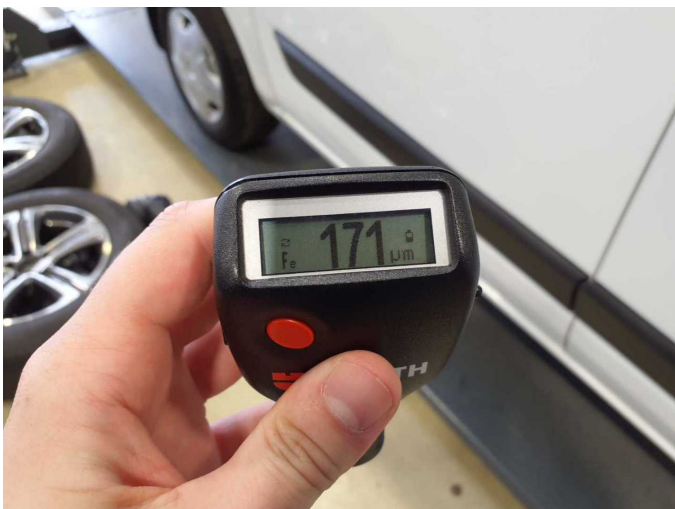
Repainting 2: Door - rear right side
