# Assessment

- Vehicle Inspection Report -

Number: 10171312  
From: 05.03.2026

<b>Vehicle category:</b>	Passenger Car
<b>Vehicle type:</b>	EstateCar
<b>Make:</b>	Volkswagen
<b>Model:</b>	Passat
<b>Manufacturers and type code:</b>	0603 / BQS
<b>Date of first registration:</b>	08.07.2022
<b>Mileage:</b>	144,619 km
<b>Proof of mileage:</b>	ReadOff
<b>Exterior colour:</b>	Aquamarinblau Metallic
<b>Roof colour:</b>	Aquamarinblau Metallic
<b>Propulsion:</b>	Front
<b>Fuel:</b>	Diesel
<b>Engine size (cc):</b>	2,000 ccm
<b>Performance:</b>	110 kW (150 PS)
<b>Length:</b>	
<b>Height:</b>	
<b>Width:</b>	
<b>Permitted total weight:</b>	
<b>Wheelbase:</b>	
<b>Number of powered axles:</b>	2
<b>Cylinders:</b>	4
<b>Euronorm:</b>	Euro 6
<b>Number of doors:</b>	4
<b>Number of seats:</b>	5
<b>Gearbox:</b>	Automatic 7-speed
<b>Upholstery type:</b>	Lining fabrics
<b>Interior colour:</b>	Titanschwarz/Titanschwarz/Titanschwarz
<b>Number of keys:</b>	2

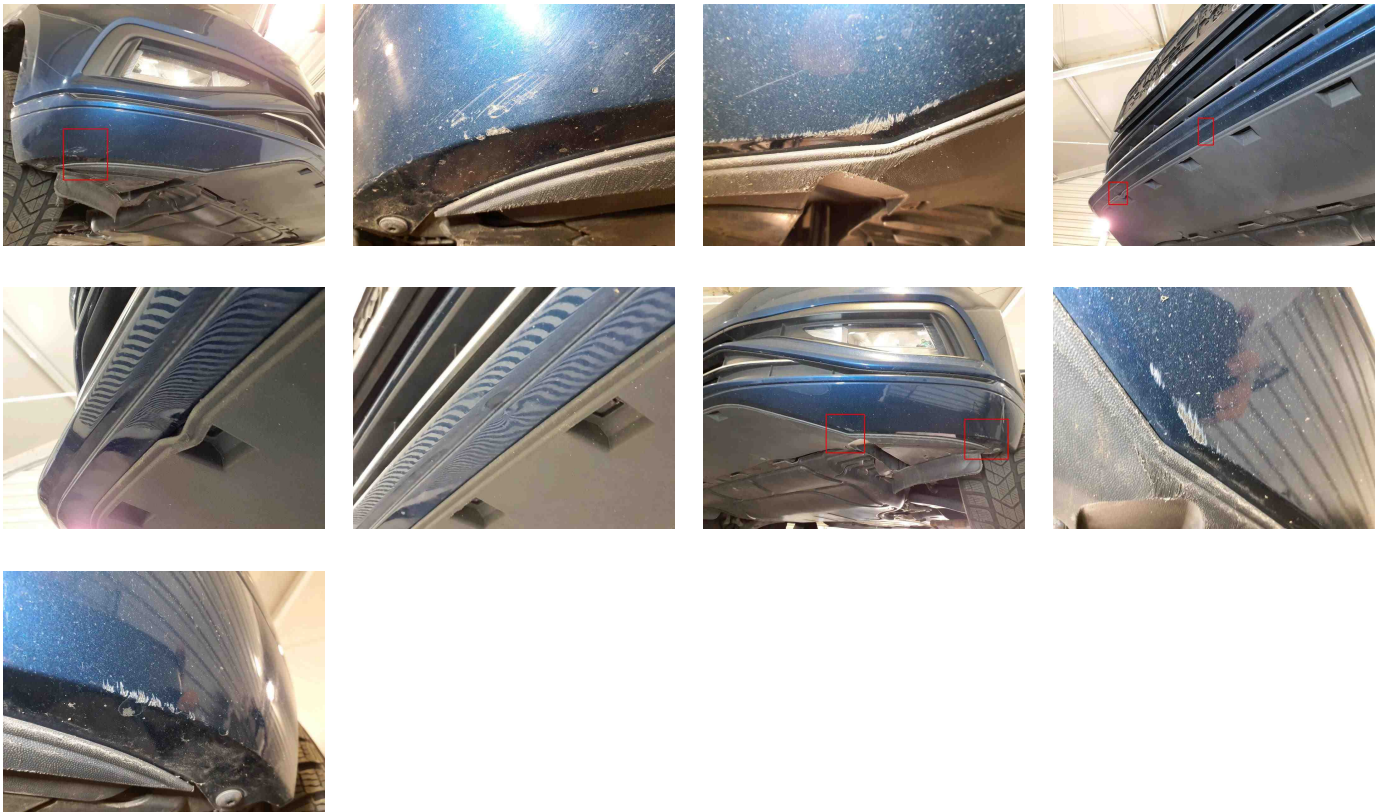
## 5 - Bumper spoiler F - Dent(s) and scratch(es) - Repair and paint (complete)

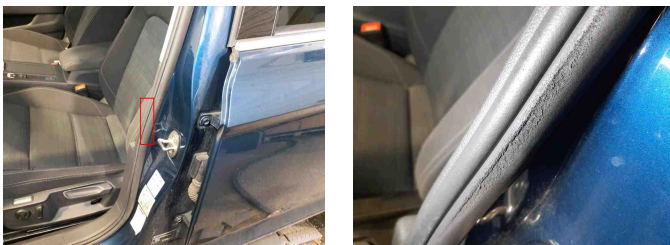
## 6 - Door seal FL - Teared - Replace

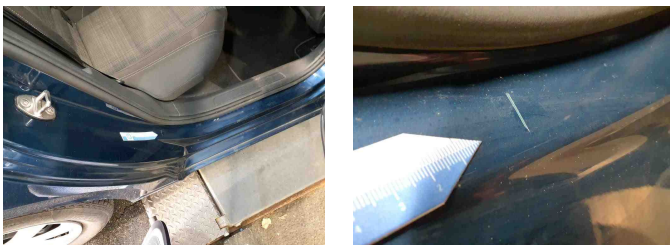
## 7 - Inner door sill RR - Scratch(es) - Smart repair

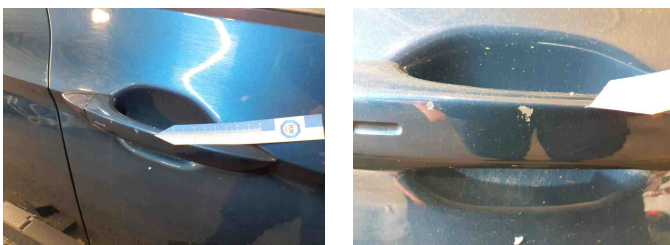
## 8 - Outer door handle FR - Scratch(es) - Paint
