Expertise

Protocol number: 46607899  
Order No. / Reference: 26688208  
Inspection date: 20 Jul 2026

Manufacturer: Ford

Model: Grand Tourneo Connect 2.0 EcoBlue TITANIUM

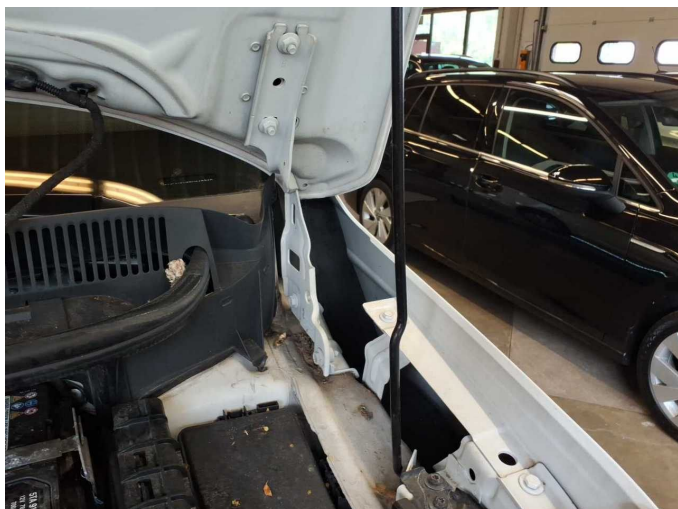
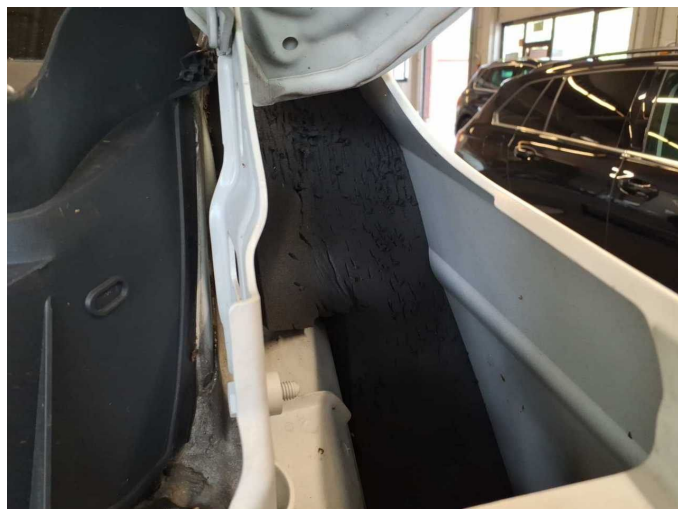
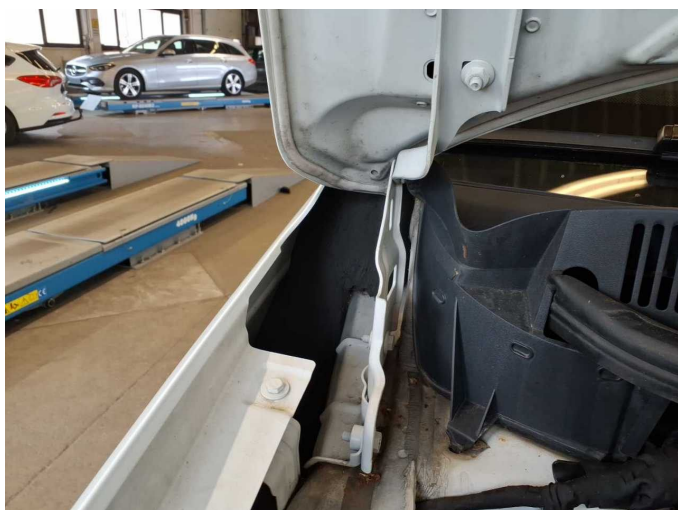
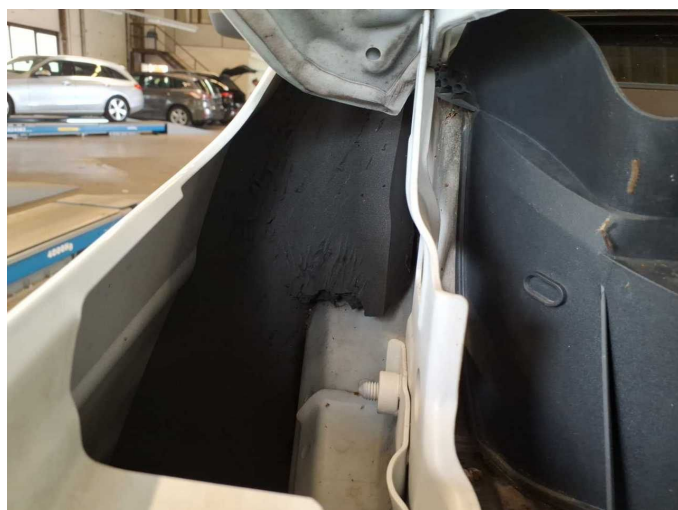
| No. | Component group | Description |
|---|---|---|
| 1 | Trim / covers | Trim / covers (Dämmung Kotflügel) - Damage caused by marten / rodent - Replace |

**Damage 1:** Trim / covers: Trim / covers (Dämmung Kotflügel) - Damage caused by marten / rodent - Replace

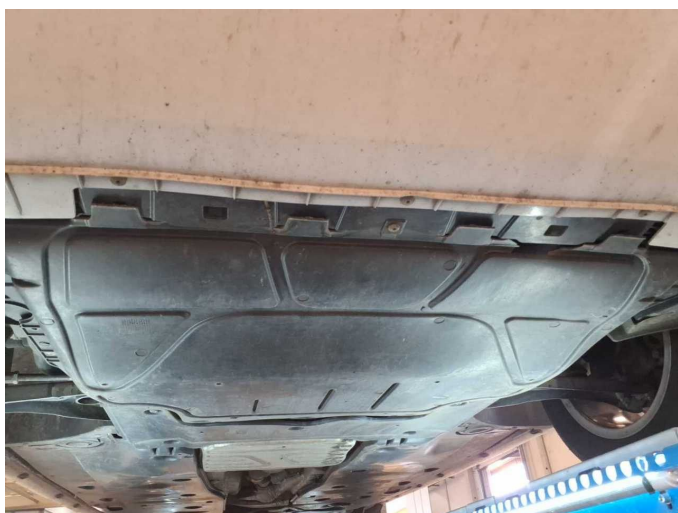
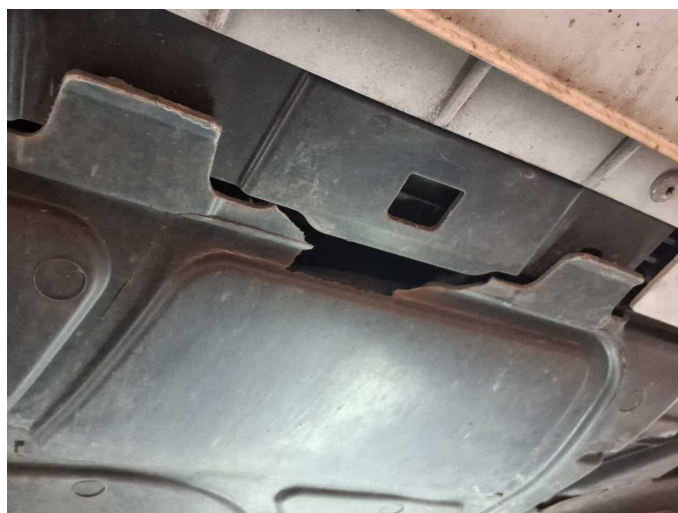
| No. | Component group | Description |
|---|---|---|
| 2 | Engine | Engine cowling - lower - Broken / torn - Replace |

**Damage 2:** Engine: Engine cowling - lower - Broken / torn - Replace

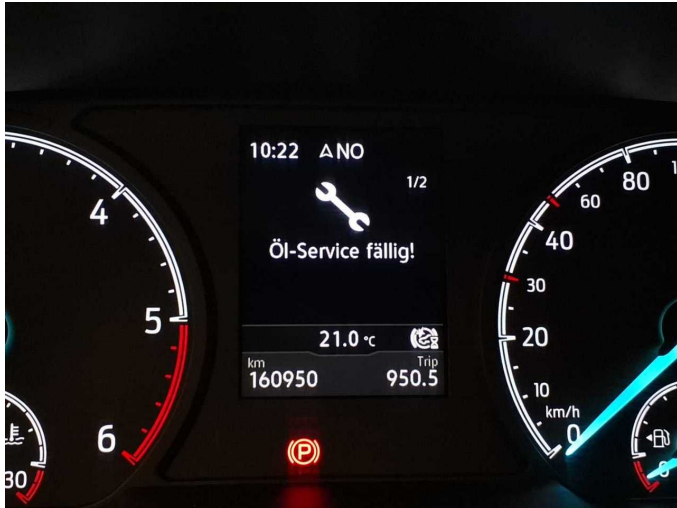
| No. | Component group | Description |
|---|---|---|
| 3 | Misc. | Inspection / maintenance - Due - Perform |

**Damage 3:** Misc.: Inspection / maintenance - Due - Perform

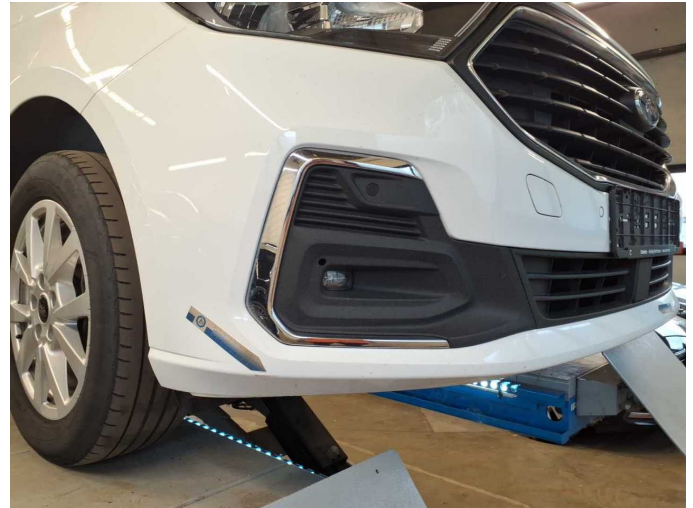
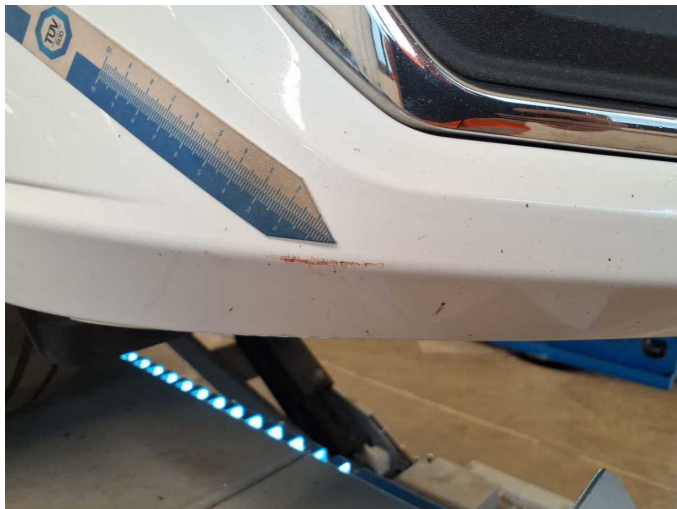
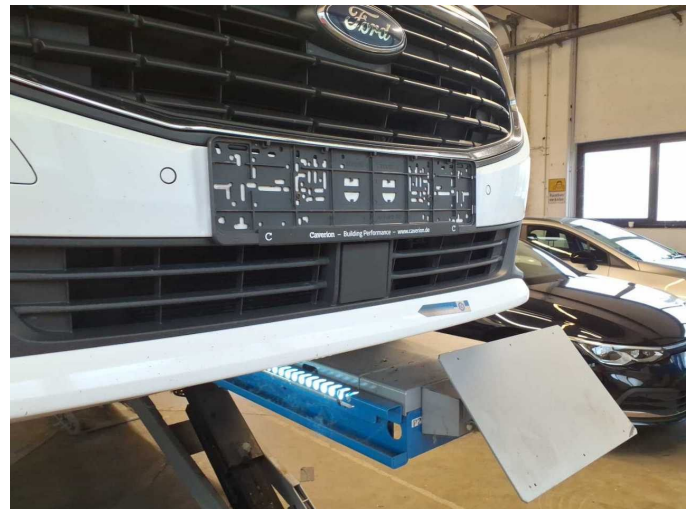
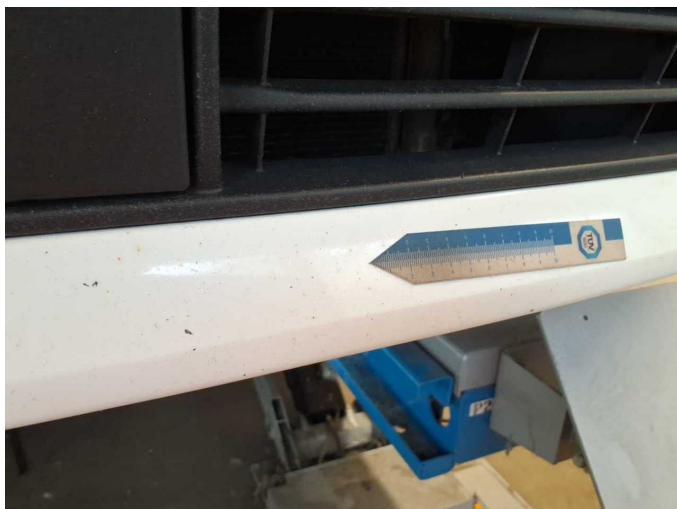
| No. | Component group | Description |
|---|---|---|
| 4 | Front bumper | Front bumper (+ Steinschläge) - Scratch(es) - Paint |

**Damage 4:** Front bumper: Front bumper (+ Steinschläge) - Scratch(es) - Paint

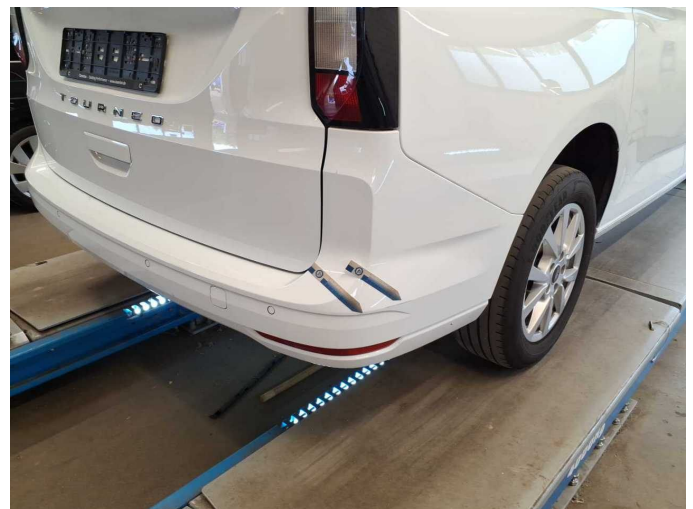
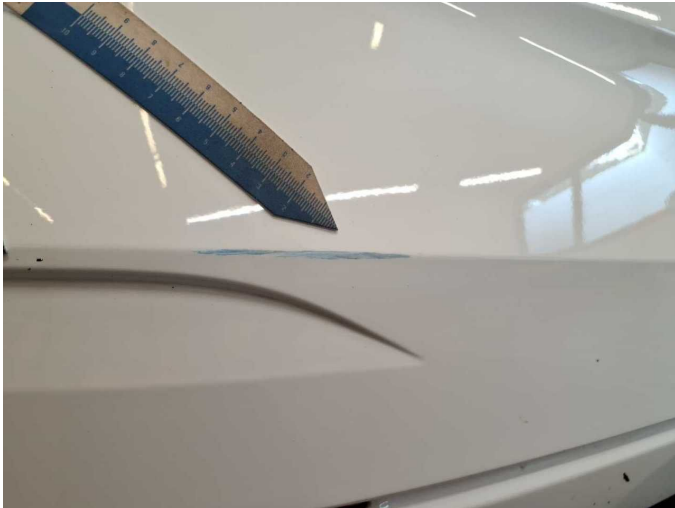
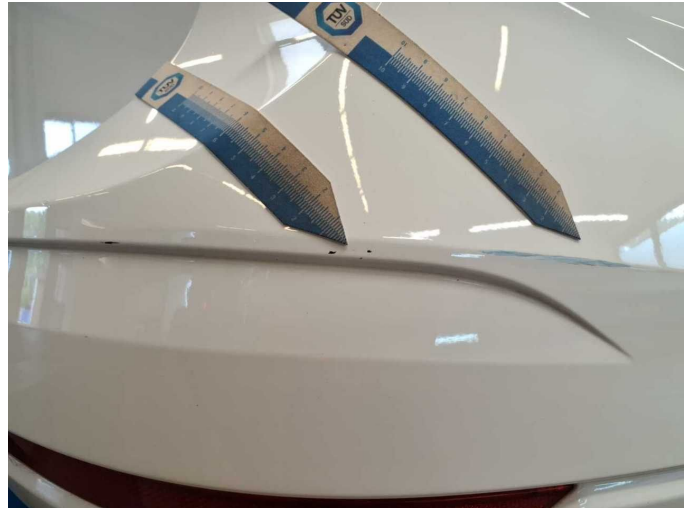
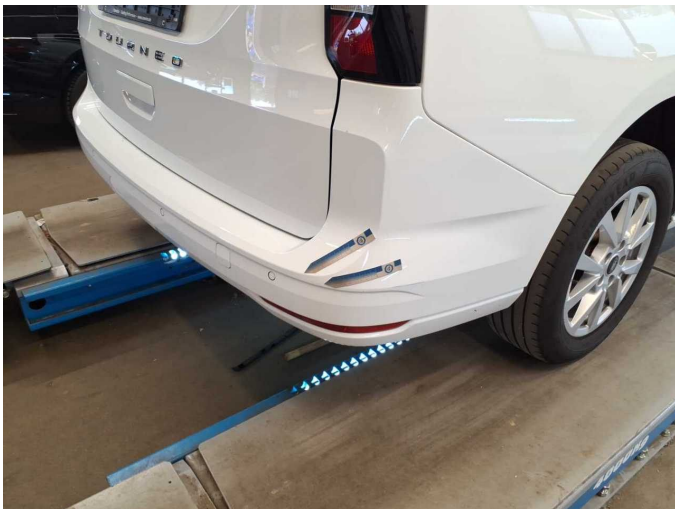
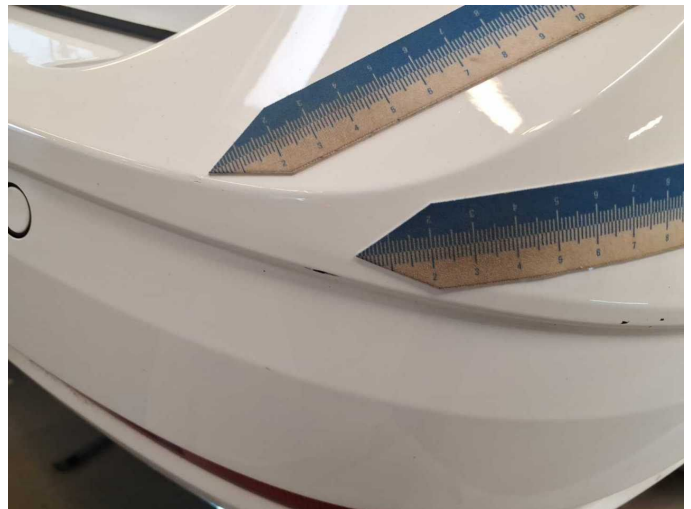
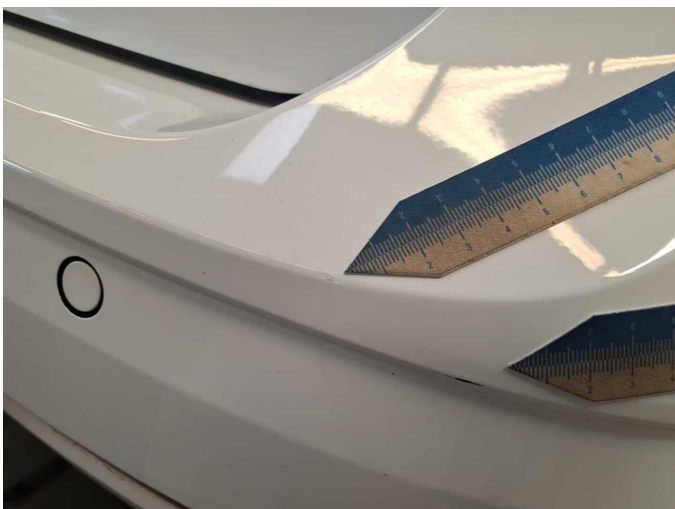
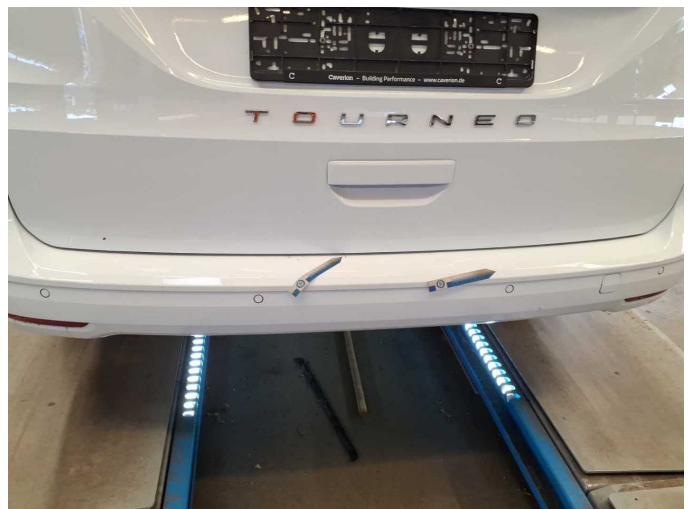
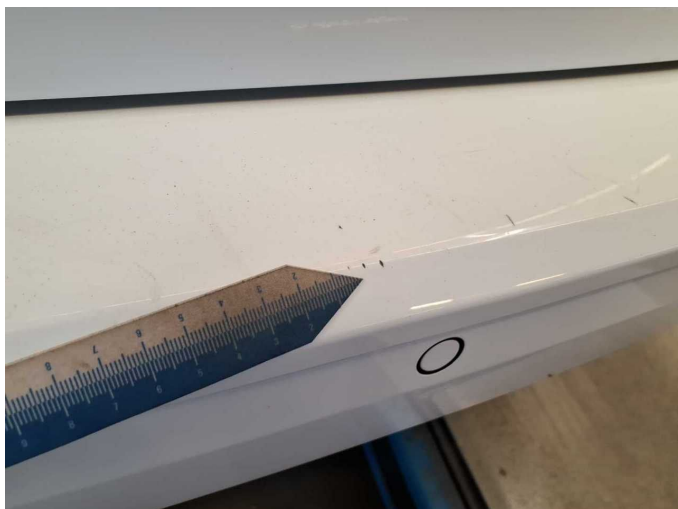
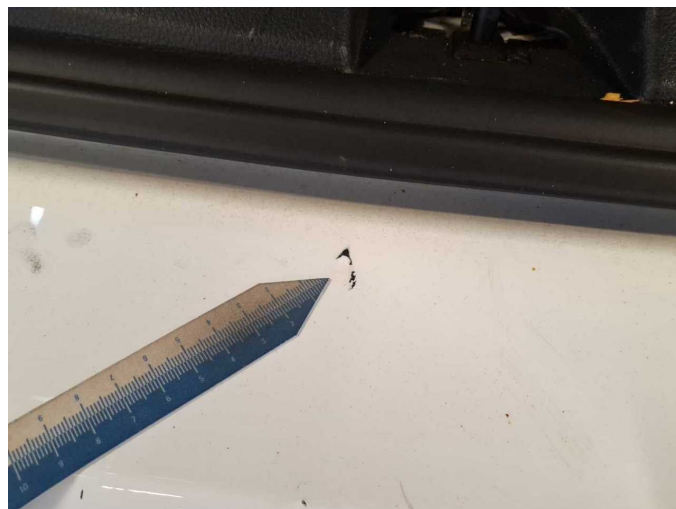
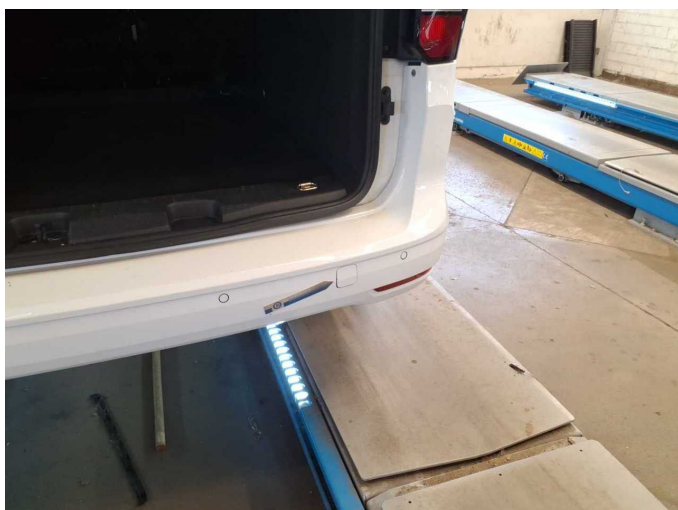
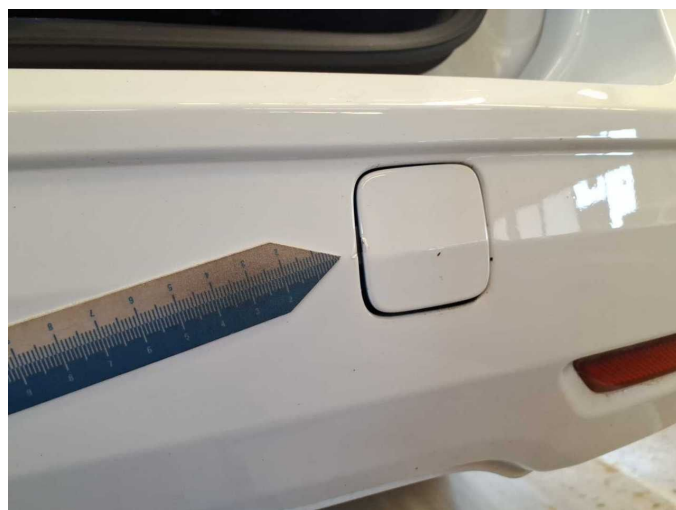
| No. | Component group | Description |
|---|---|---|
| 5 | Rear bumper | Rear bumper (+ Abdeckkappe) - Scratch(es) - Paint |

**Damage 5:** Rear bumper: Rear bumper (+ Abdeckkappe) - Scratch(es) - Paint

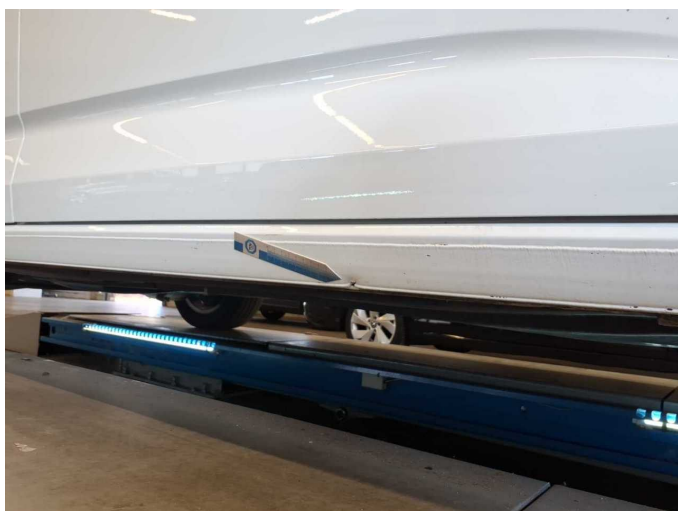
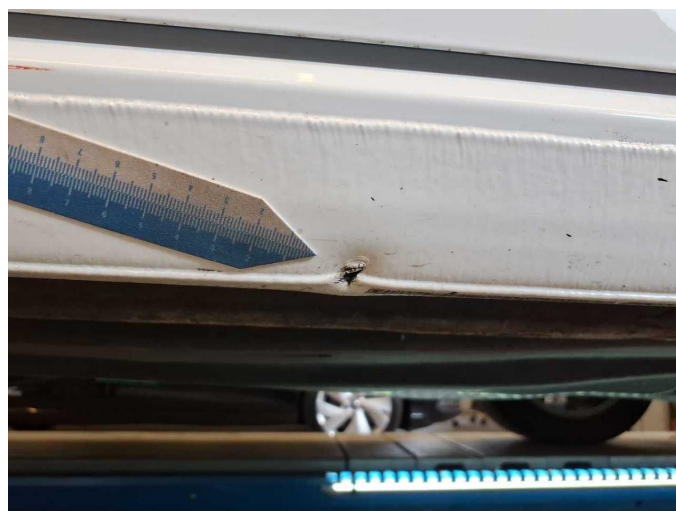
| No. | Component group | Description |
|---|---|---|
| 6 | Sill - right side | Sill - Deformed - Repair and paint |

**Damage 6:** Sill - right side: Sill - Deformed - Repair and paint

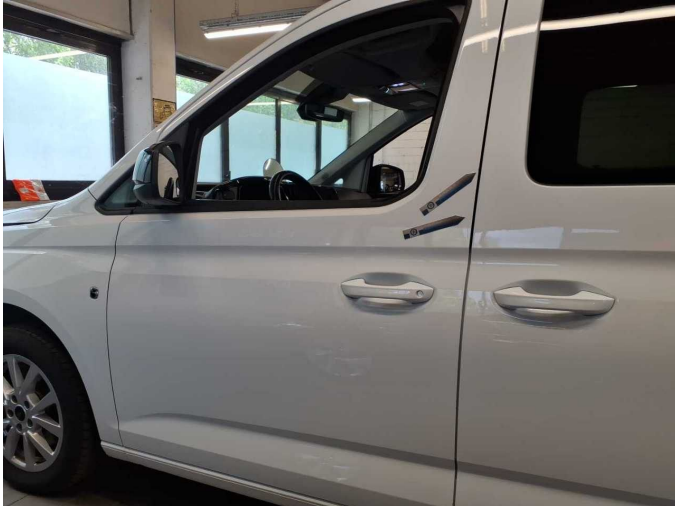
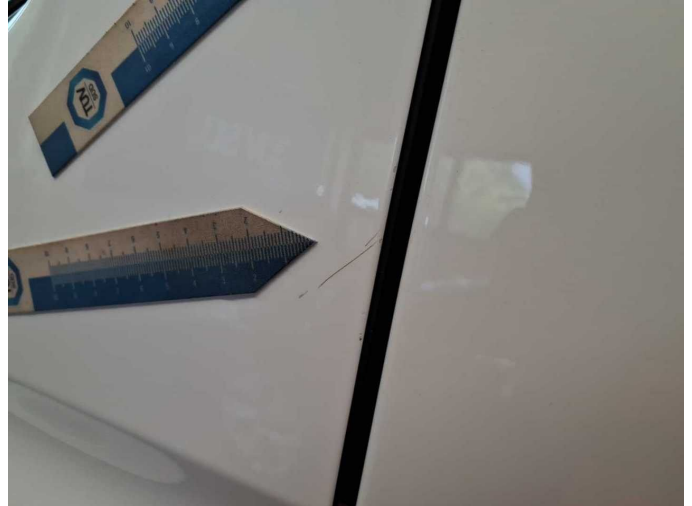
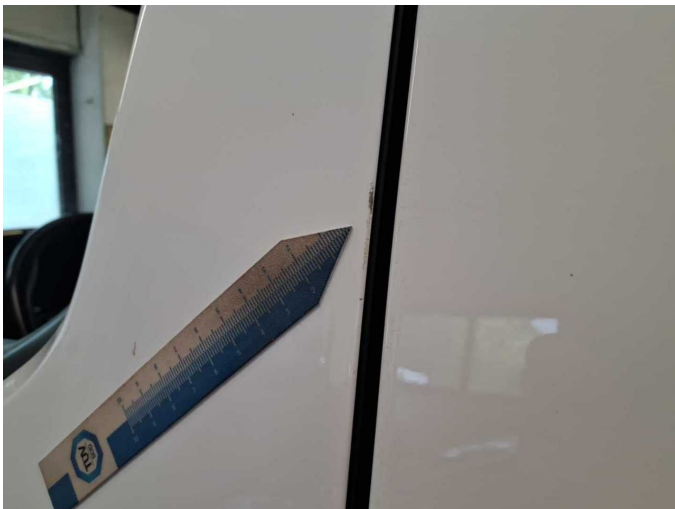
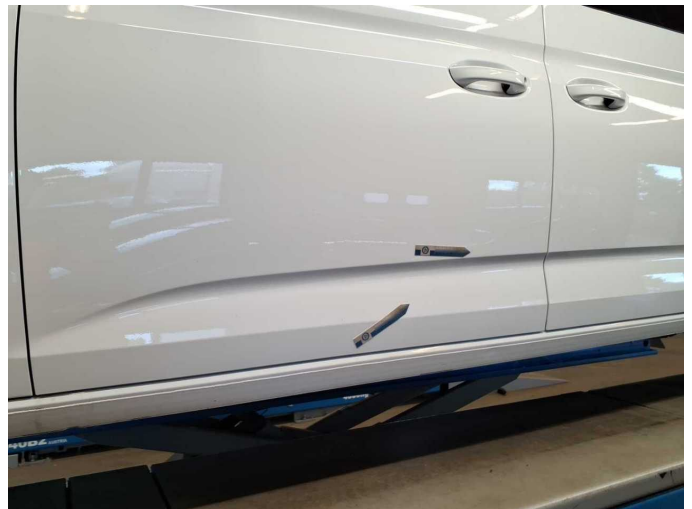
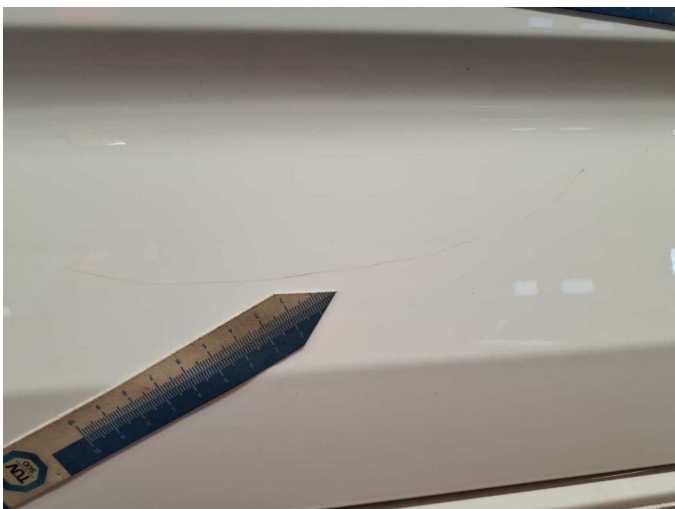
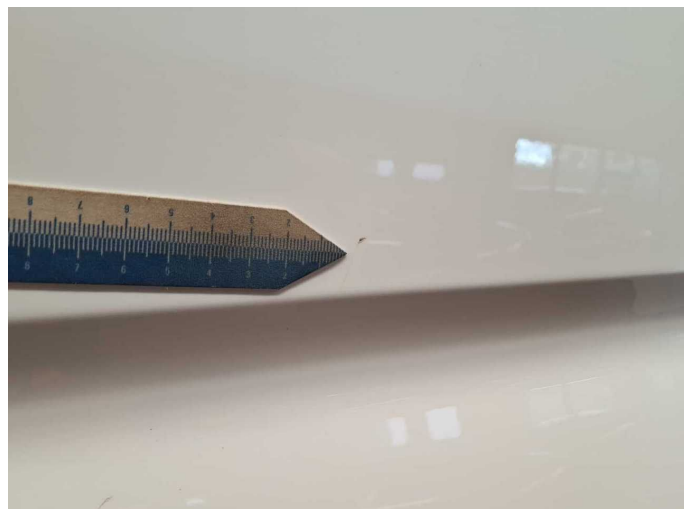
| No. | Component group | Description |
|---|---|---|
| 7 | Door - front left side | Door - Scratch(es) - Paint |

**Damage 7:** Door - front left side: Door - Scratch(es) - Paint

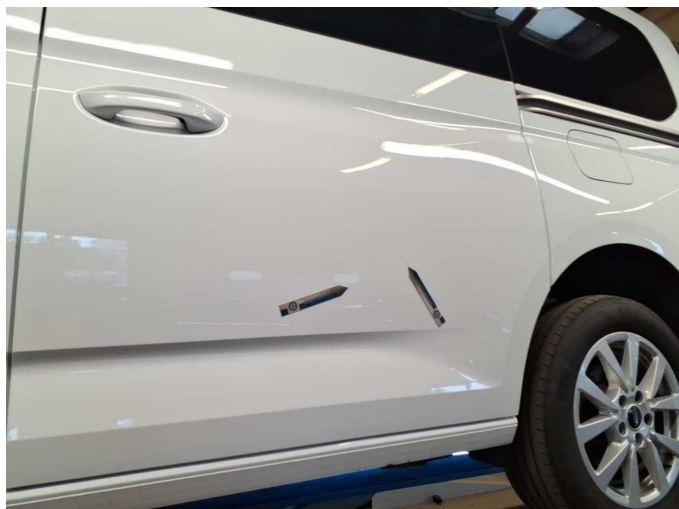
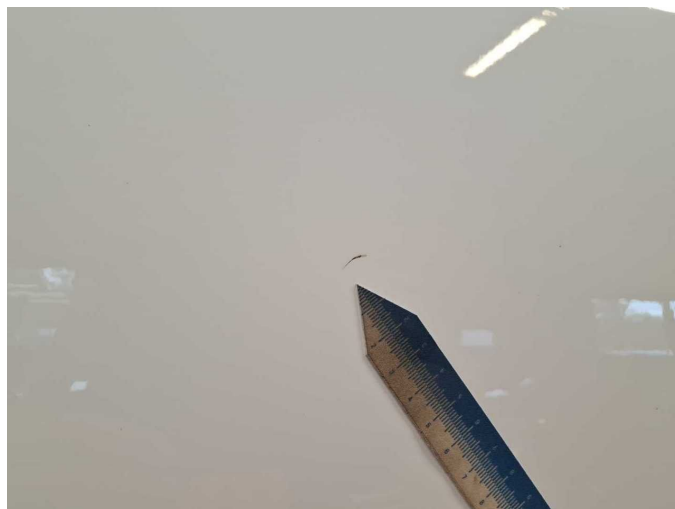
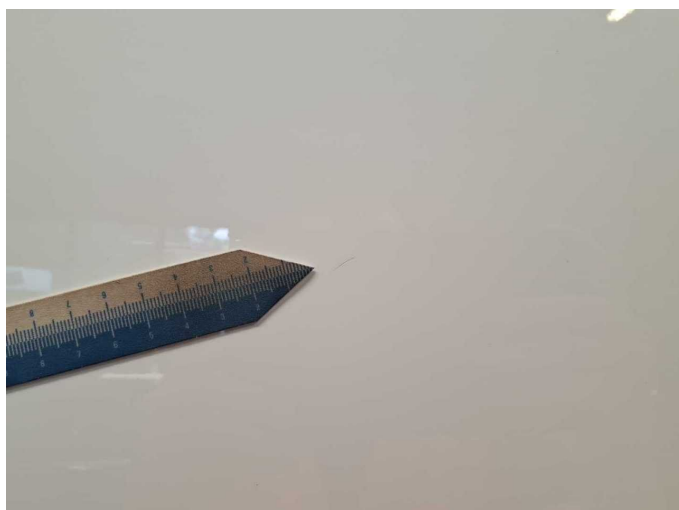
| No. | Component group | Description |
|---|---|---|
| 8 | Sliding door - left side | Sliding door with glass panel - Scratch(es) - Paint |

**Damage 8:** Sliding door - left side: Sliding door with glass panel - Scratch(es) - Paint

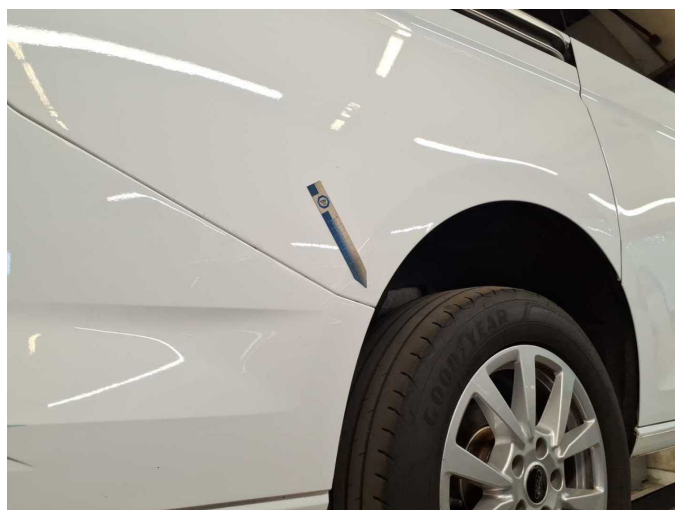
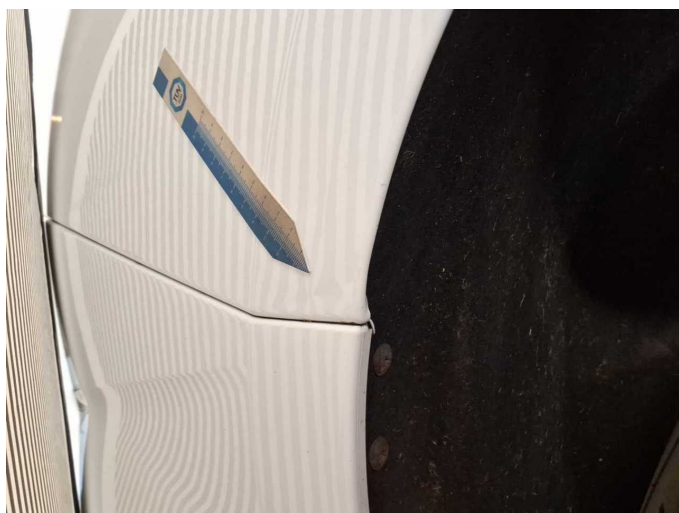
| No. | Component group | Description |
|---|---|---|
| 4 | Side panel - rear right side | Side panel - dent(s) - No deduction |

**Wear and tear 4:** Side panel - rear right side: Side panel - dent(s) - No deduction

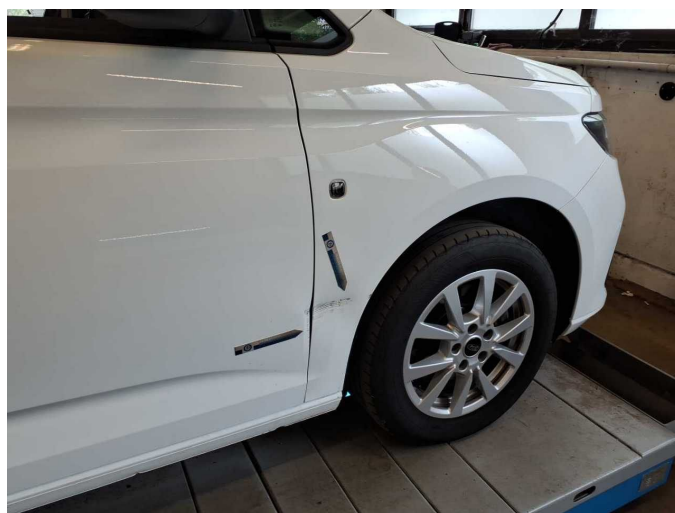
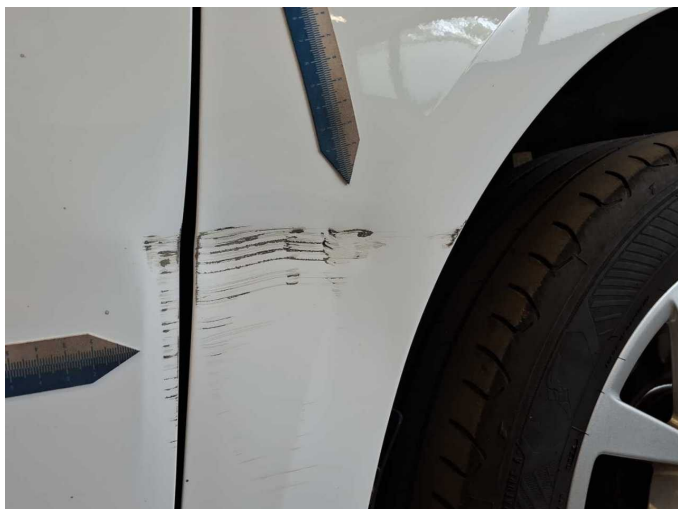
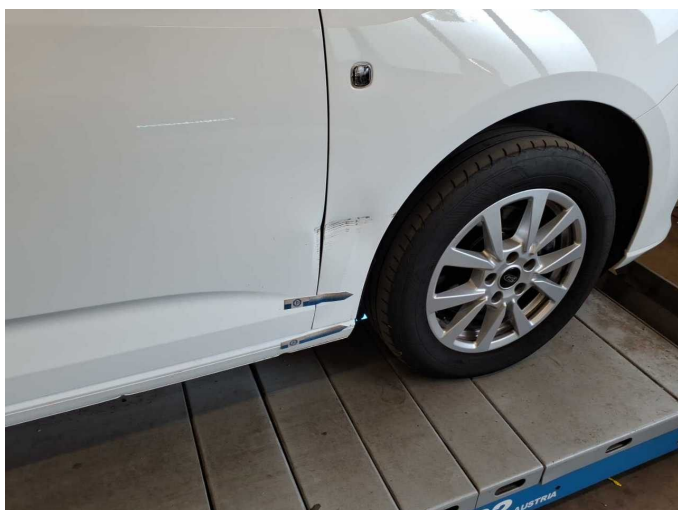
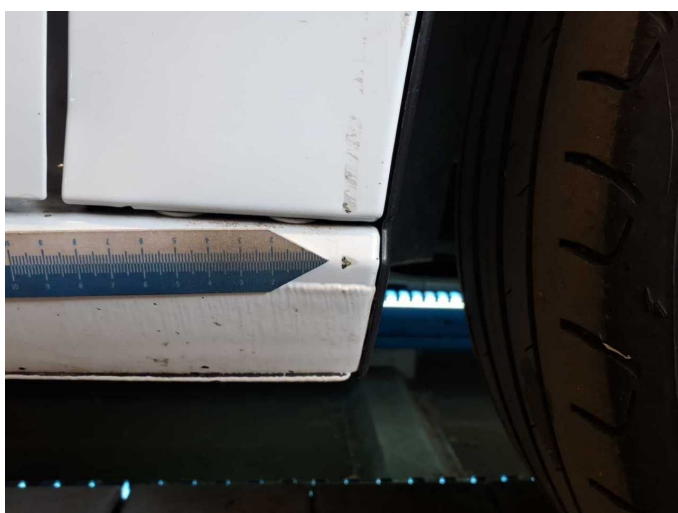
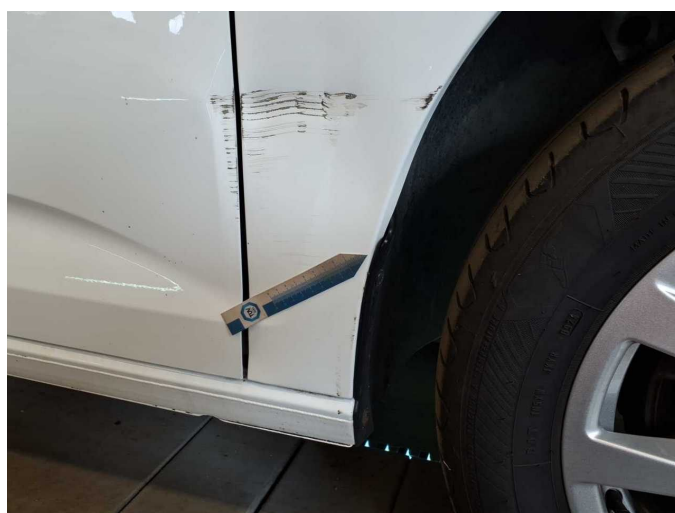
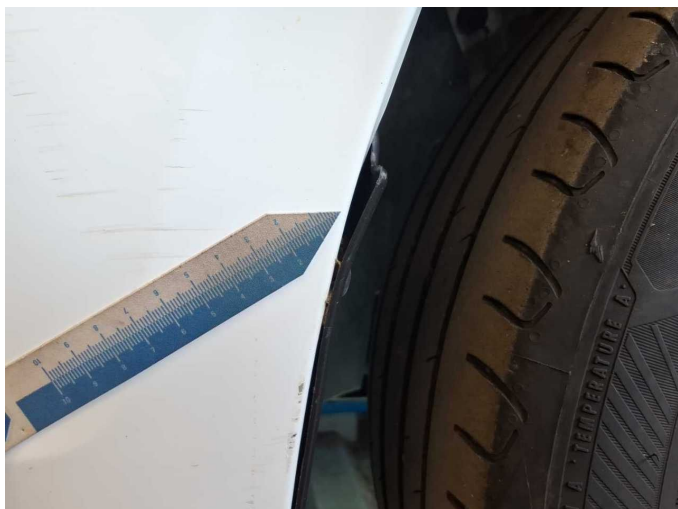
- 1 Side right

Non-repaired previous damages were found at the vehicle. The necessary repair costs are listed in the expert report or if necessary, are listed in detail in a separately enclosed repair cost calculation.

**Accident 1:** Side right

**Accident 1: Side right**
