## Expertise

Protocol number: 46006998  
Order No. / Reference: 26152451  
Inspection date: 17 Jun 2026

Model: 317 CDI Sprinter Standard HA 9G-TRONIC PRO

VIN: W1V3KBFZXP861599

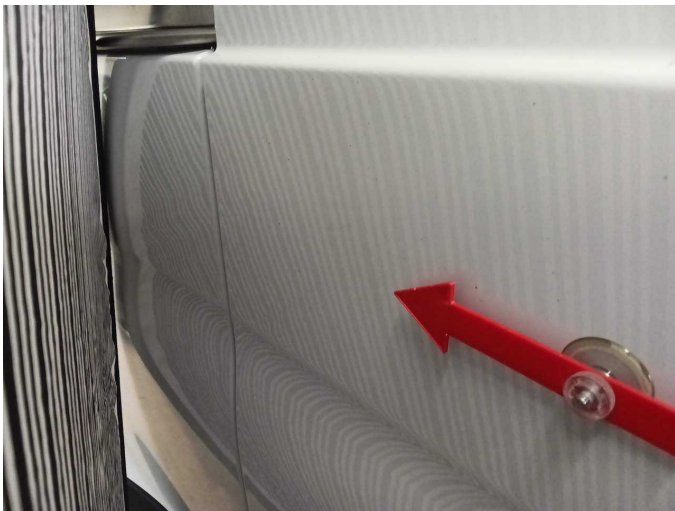
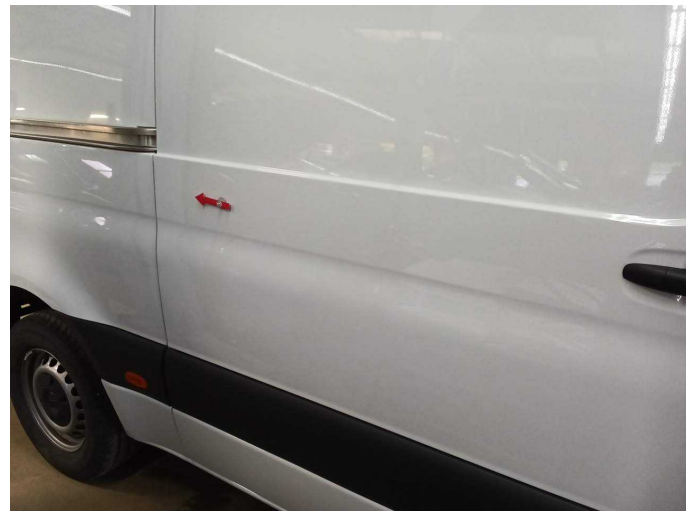
No.	Component group	Description
1	Sliding door, right	Sliding door - dent(s) - Smooth repair work

Damage 1: Sliding door, right: Sliding door - dent(s) - Smooth repair work
