Expertise

Protocol number: 46801774  
Order No. / Reference: 26775488  
Inspection date: 29 Jul 2026

Manufacturer: Skoda  
VIN: TMBLN9NSXN8510006

Model: Kodiahq 2.0 TDI 4x4 DSG Style

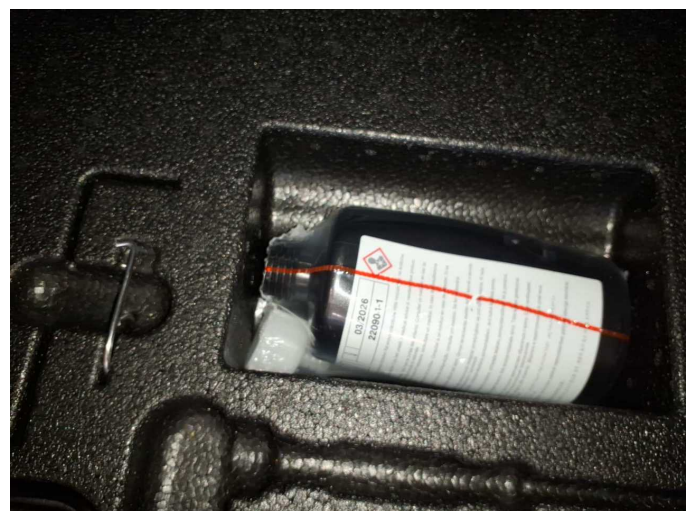
| No. | Component group | Description |
|---|---|---|
| 1 | Equipment | Tirefit filler - Expired - Replace |

Damage 1: Equipment: Tirefit filler - Expired - Replace

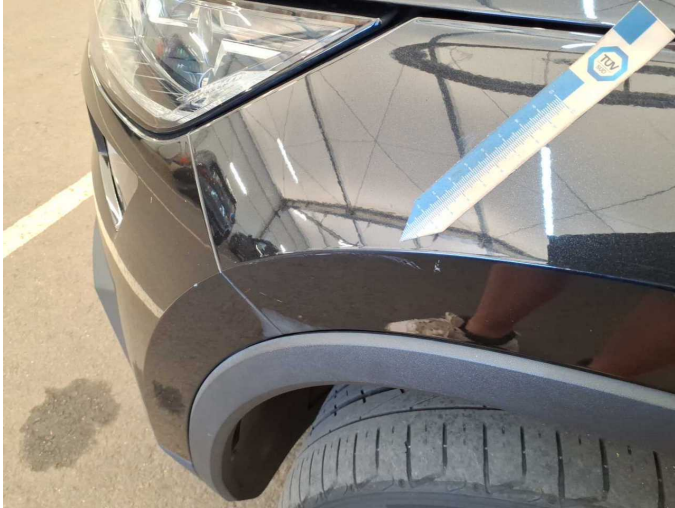
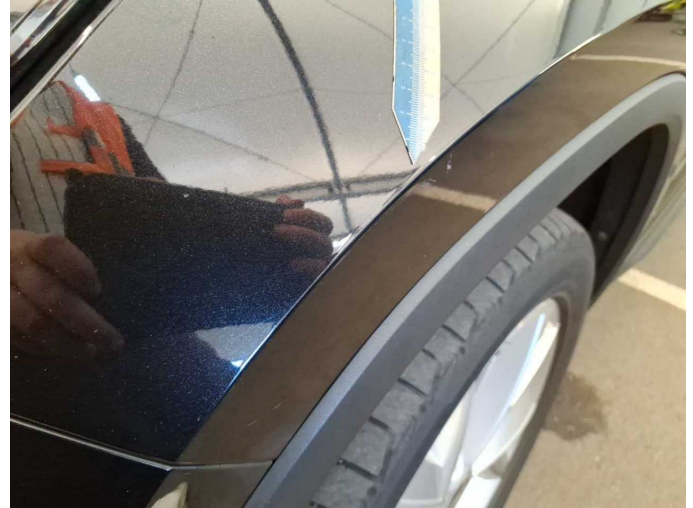
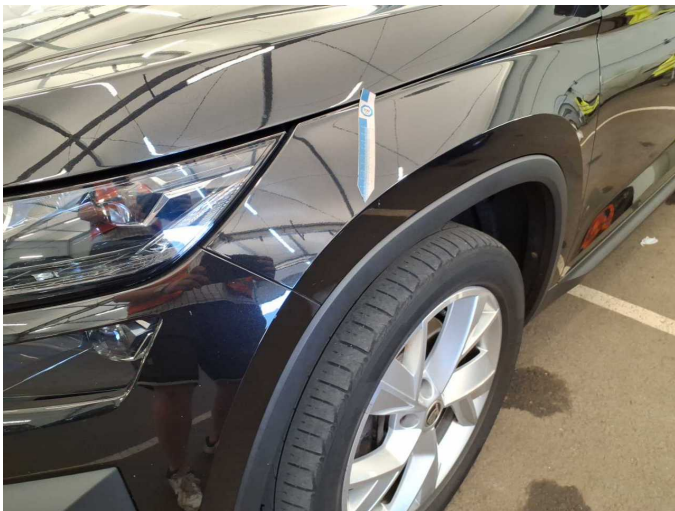
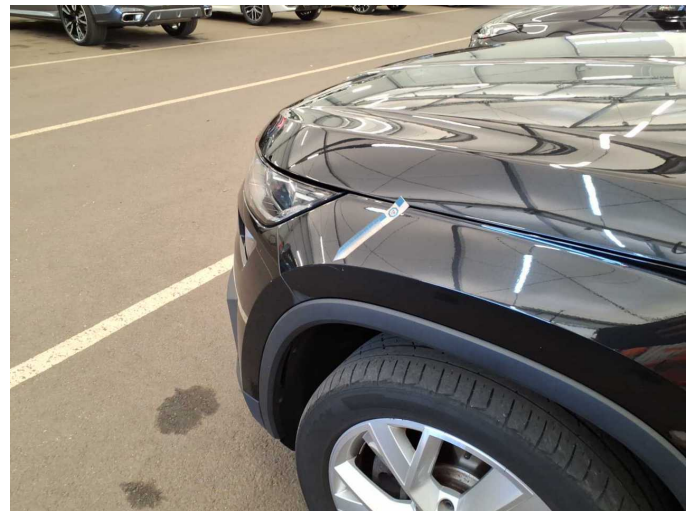
| No. | Component group | Description |
|---|---|---|
| 2 | Mudguard - left side | Mudguard - left side - Scratch(es) - Smart repair |

**Damage 2:** Mudguard - left side: Mudguard - left side - Scratch(es) - Smart repair

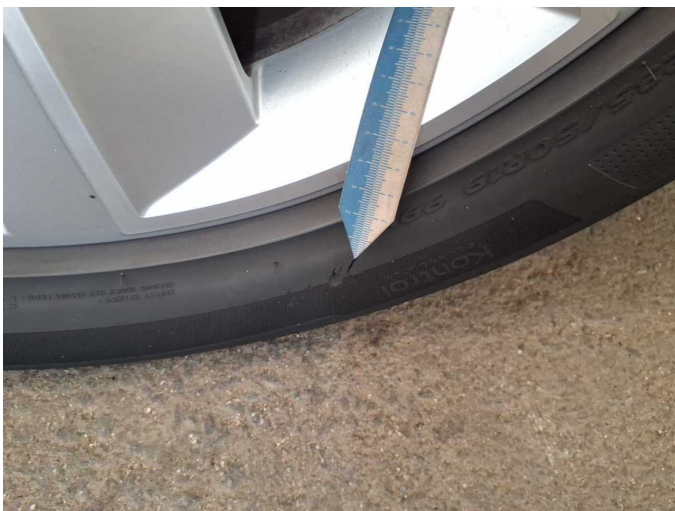
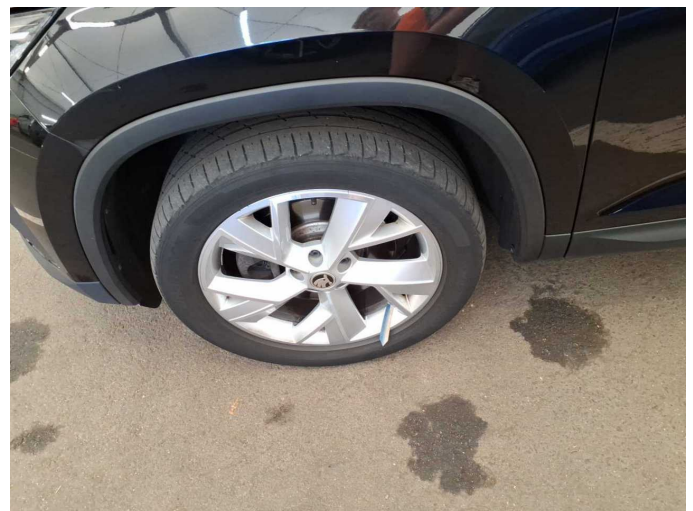
| No. | Component group | Description |
|---|---|---|
| 3 | Wheel / tyres | Tyre - front left side - Broken / torn - Replace |

**Damage 3:** Wheel / tyres: Tyre - front left side - Broken / torn - Replace

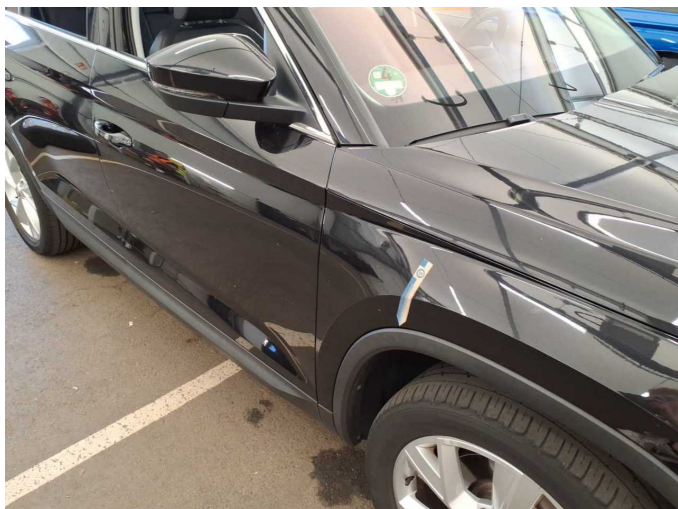
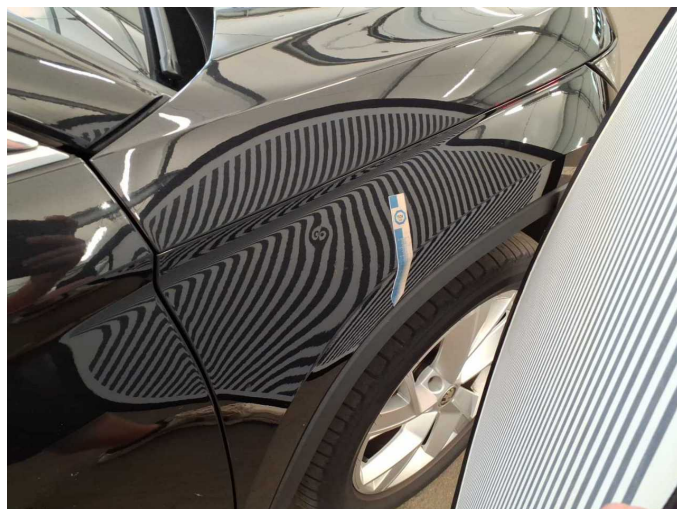
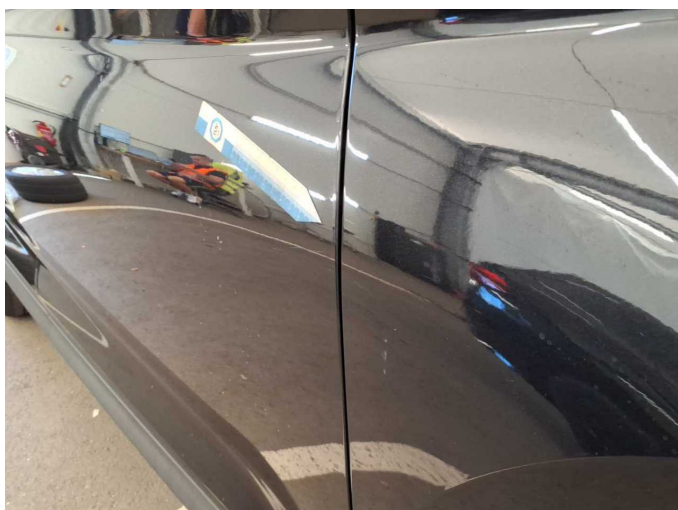
| No. | Component group | Description |
|---|---|---|
| 4 | Mudguard - right side | Mudguard - right side - Dent / paintcoat damage - Repair and paint |

**Damage 4:** Mudguard - right side: Mudguard - right side - Dent / paintcoat damage - Repair and paint

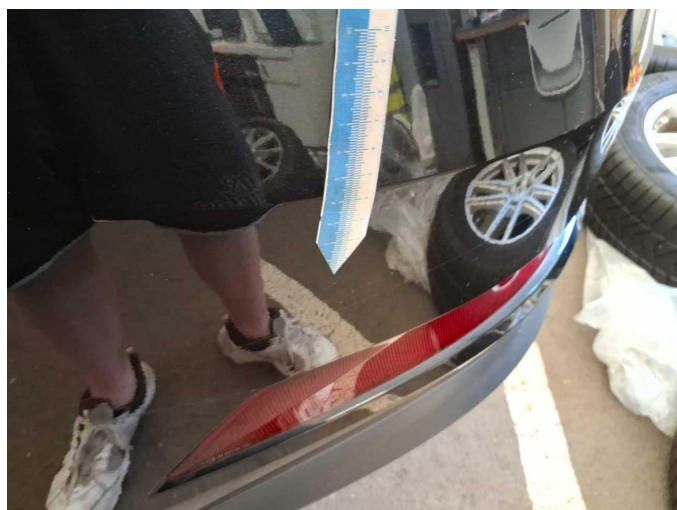
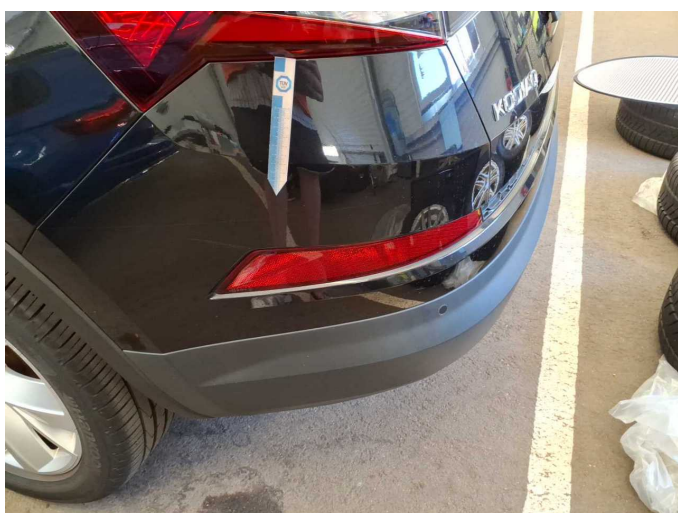
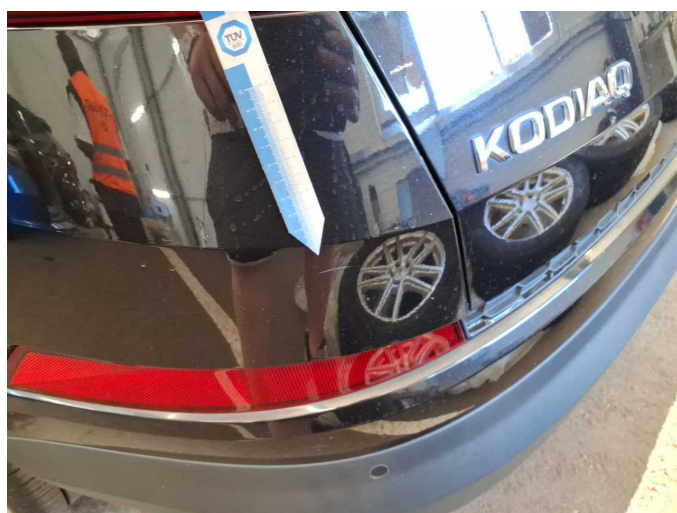
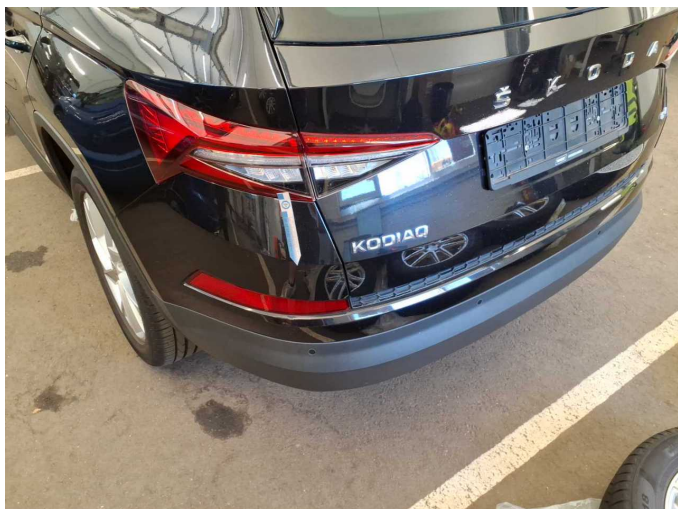
| No. | Component group | Description |
|---|---|---|
| 5 | Rear bumper | Rear bumper - Scratch(es) - Paint |

**Damage 5:** Rear bumper: Rear bumper - Scratch(es) - Paint

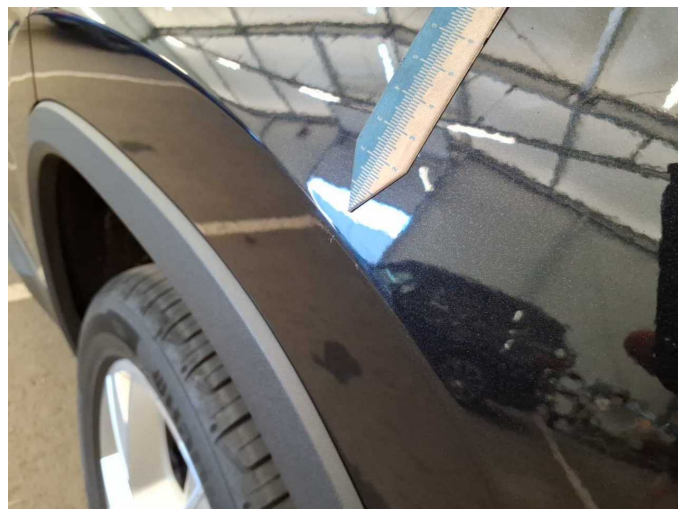
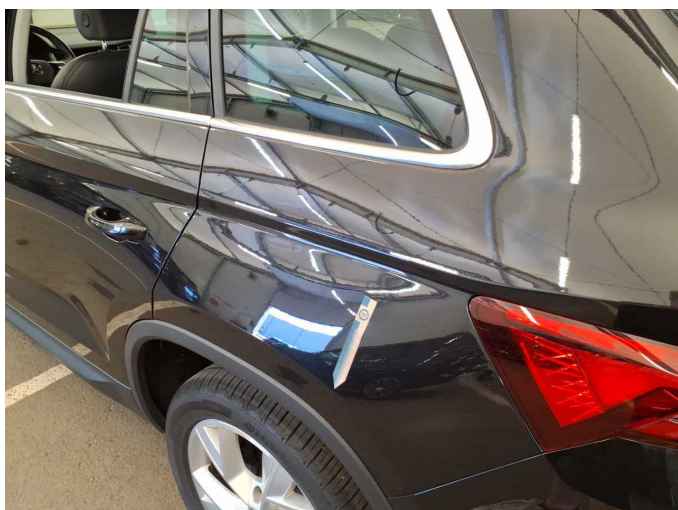
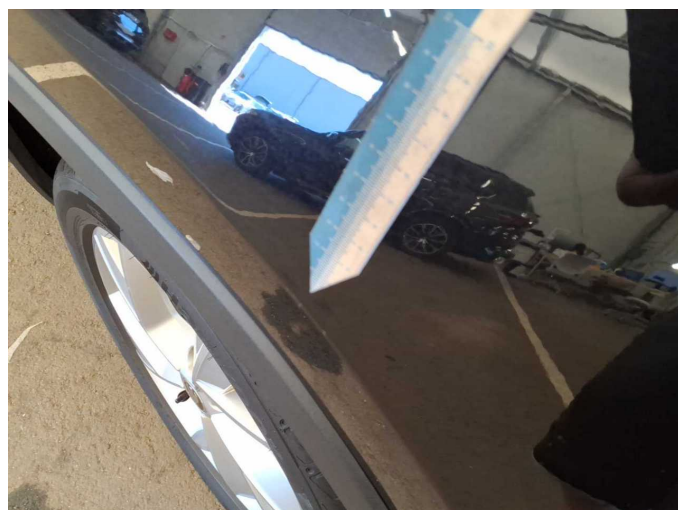
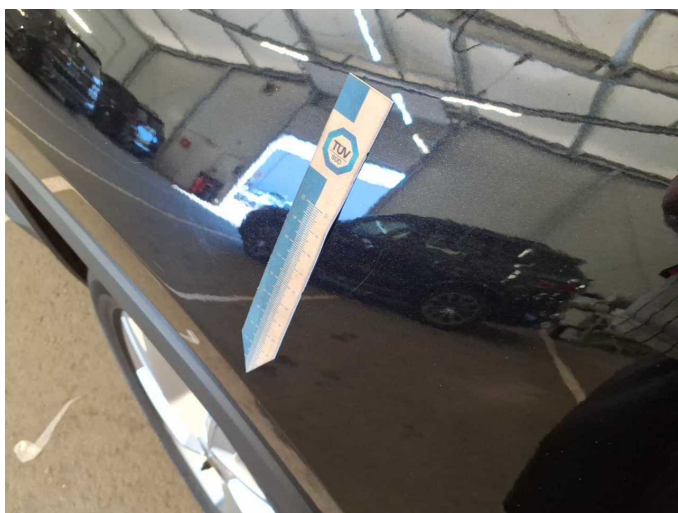
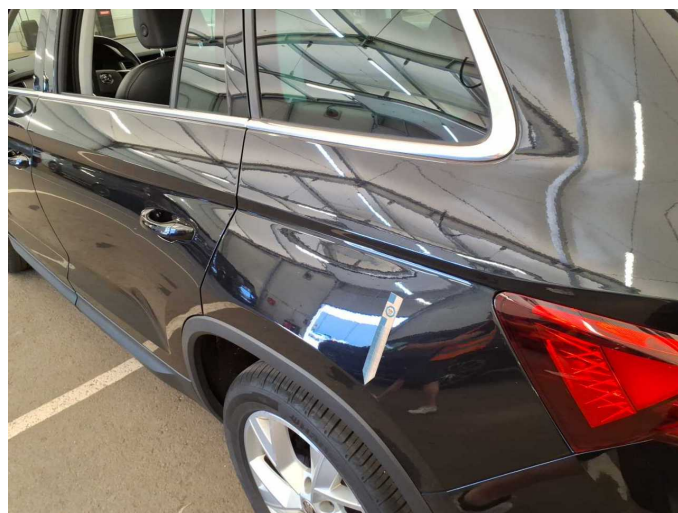
| No. | Component group | Description |
|---|---|---|
| 6 | Side panel - rear left side | Side panel - Scratch(es) - Paint |

**Damage 6:** Side panel - rear left side: Side panel - Scratch(es) - Paint

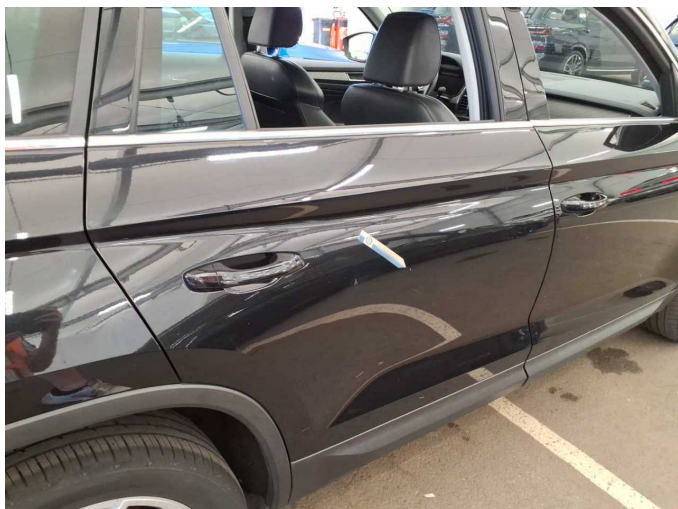
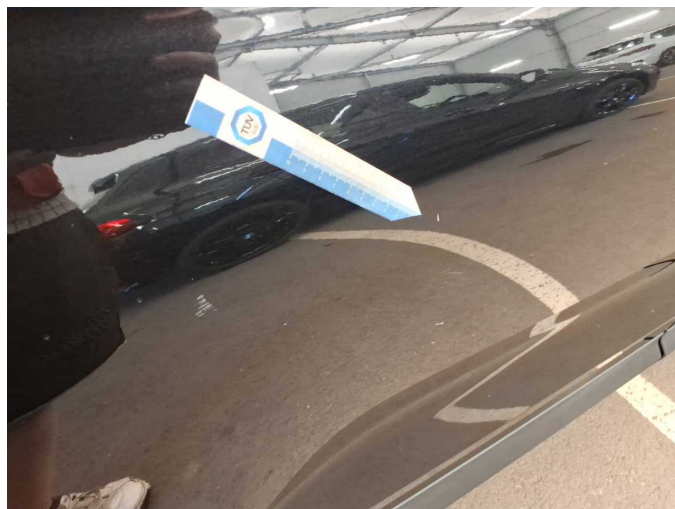
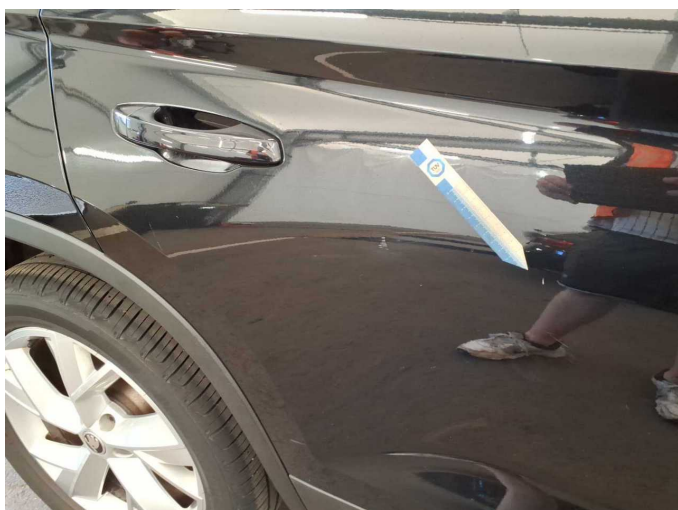
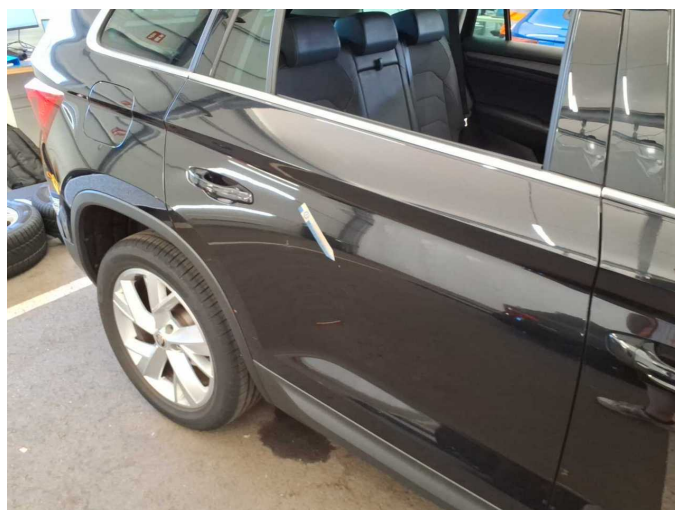
| No. | Component group | Description |
|---|---|---|
| 7 | Door - rear right side | Door - Scratch(es) - Paint |

**Damage 7:** Door - rear right side: Door - Scratch(es) - Paint

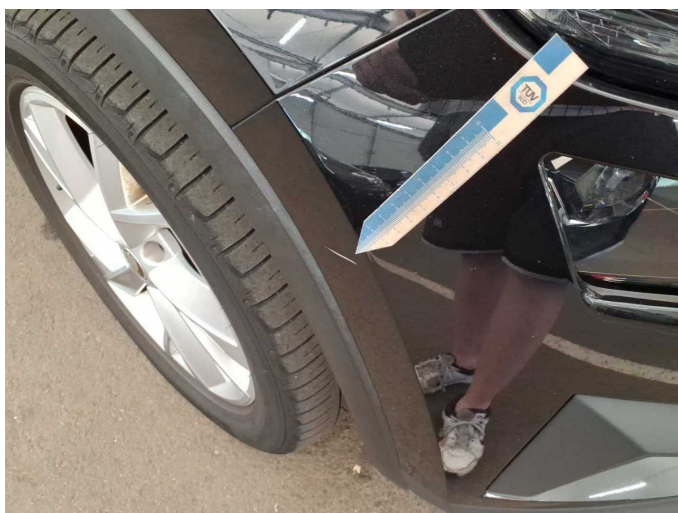
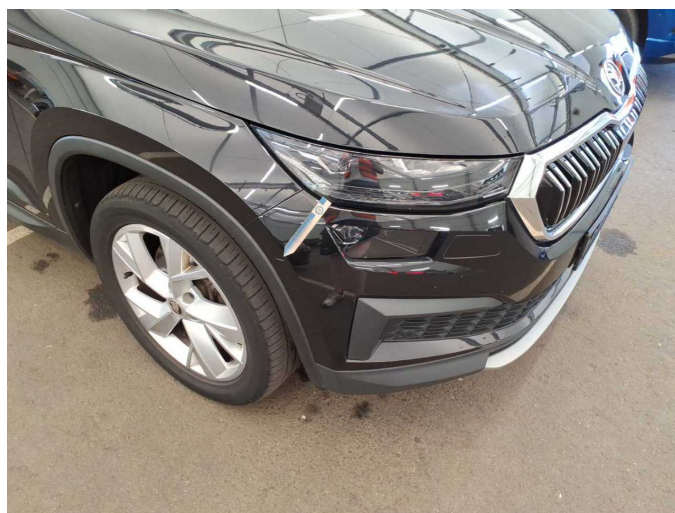
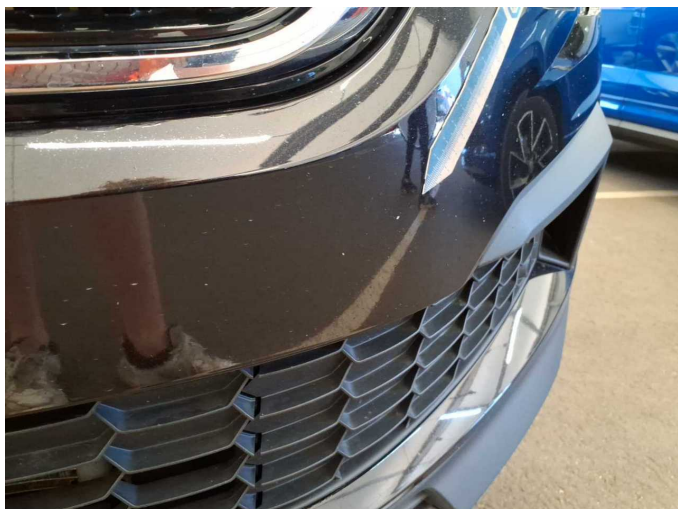
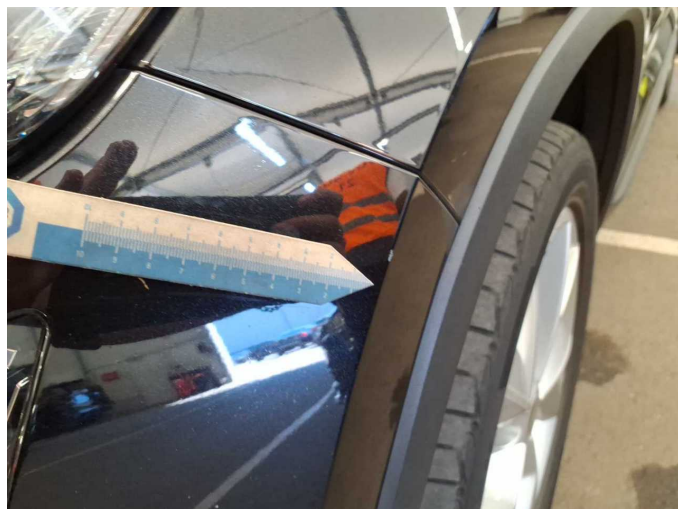
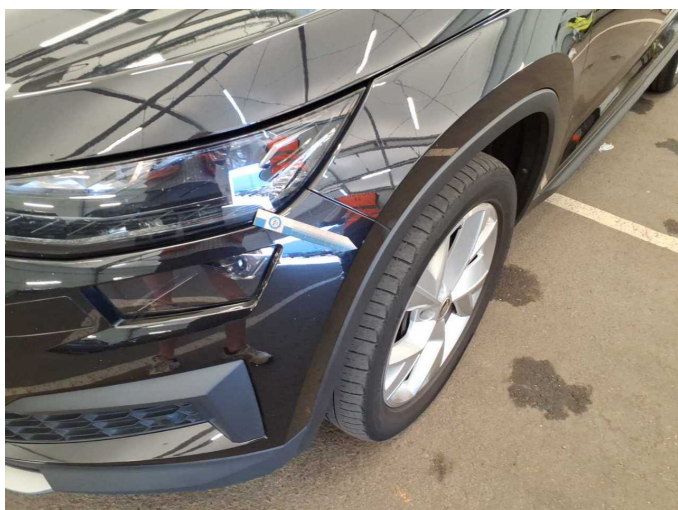
| No. | Component group | Description |
|---|---|---|
| 8 | Front bumper | Front bumper - Scratched - Paint |

**Damage 8:** Front bumper: Front bumper - Scratched - Paint

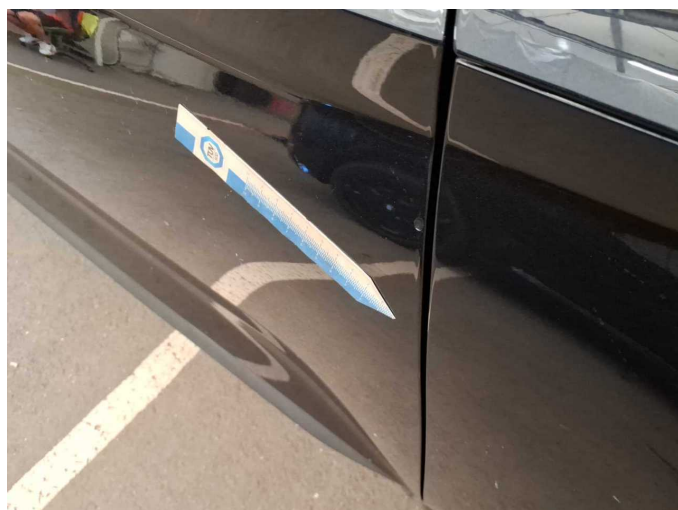
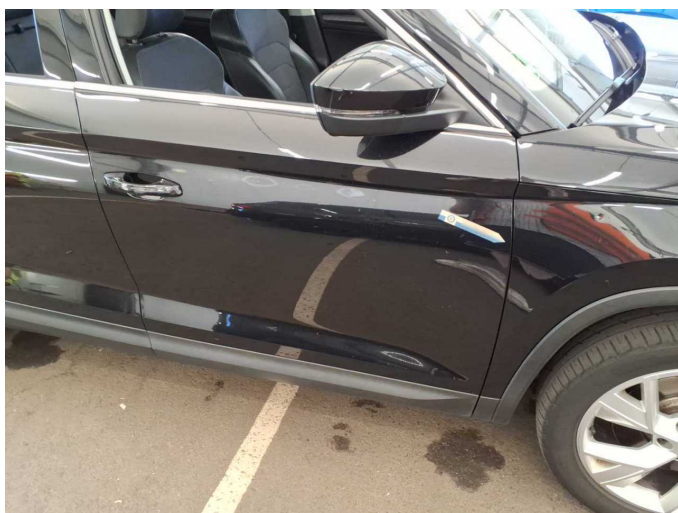
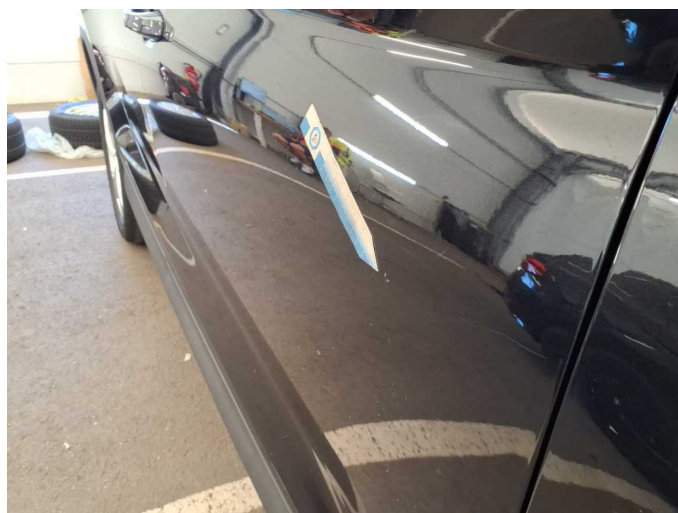
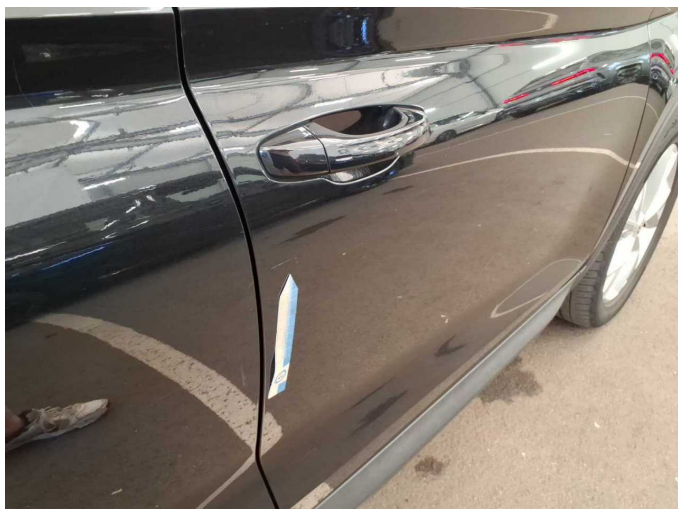
| No. | Component group | Description |
|---|---|---|
| 9 | Door - front right side | Door - Scratch(es) - Paint |

**Damage 9:** Door - front right side: Door - Scratch(es) - Paint

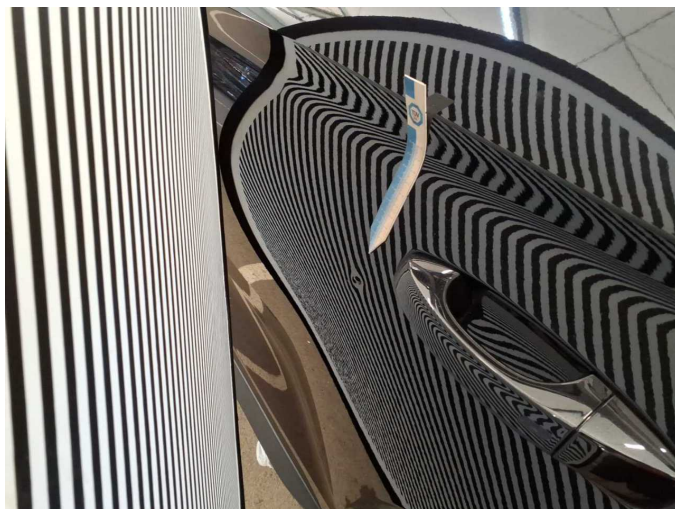
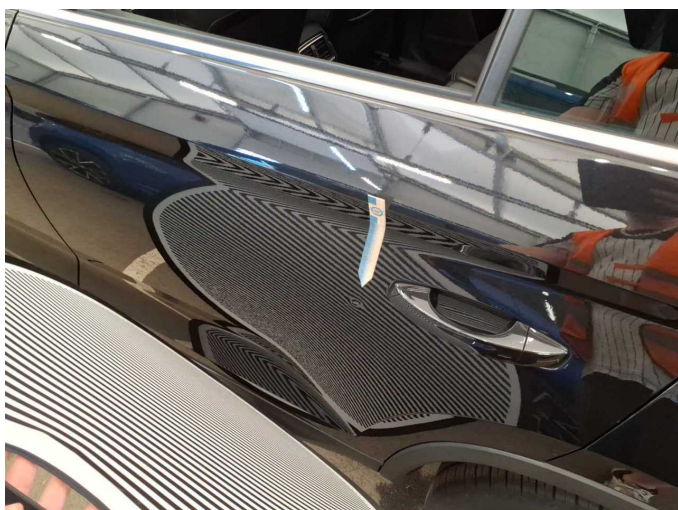
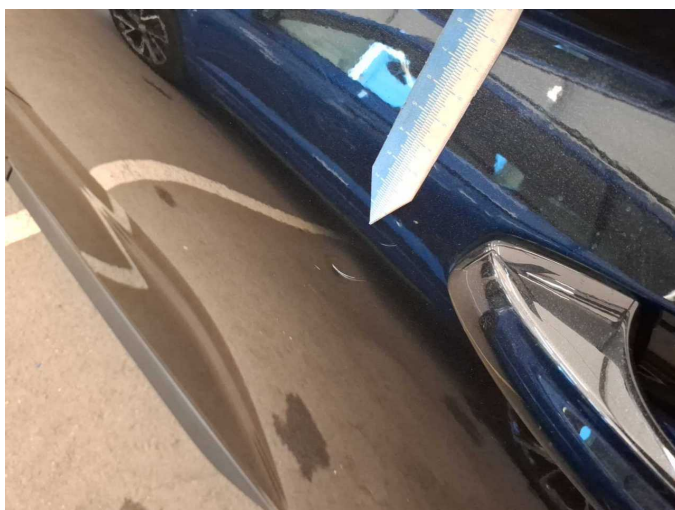
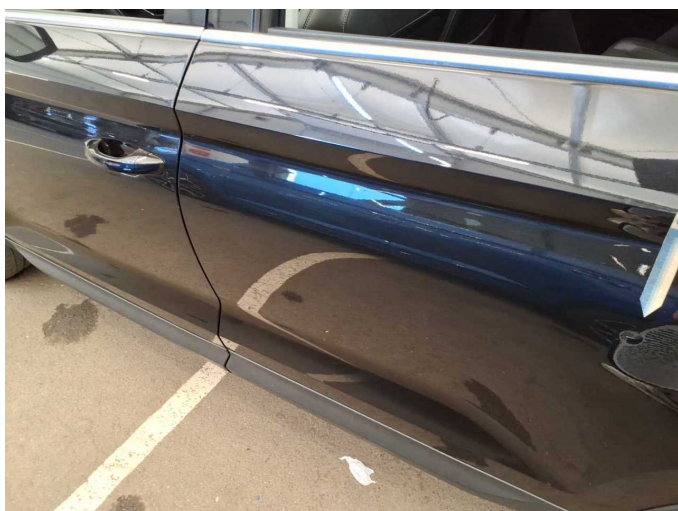
| No. | Component group | Description |
|---|---|---|
| 10 | Door - rear left side | Door - Dent / paintcoat damage - Repair and paint |

**Damage 10:** Door - rear left side: Door - Dent / paintcoat damage - Repair and paint

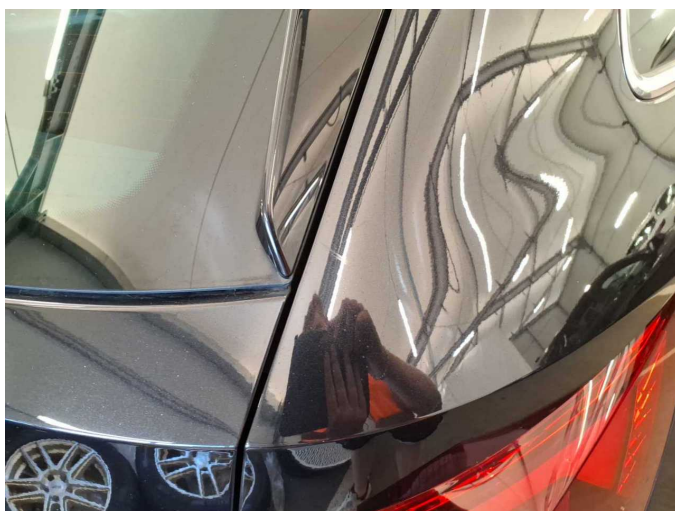
| No. | Component group | Description |
|---|---|---|
| 3 | Side panel - rear right side | Side panel - Scratch(es) - No deduction |

**Wear and tear 3:** Side panel - rear right side: Side panel - Scratch(es) - No deduction

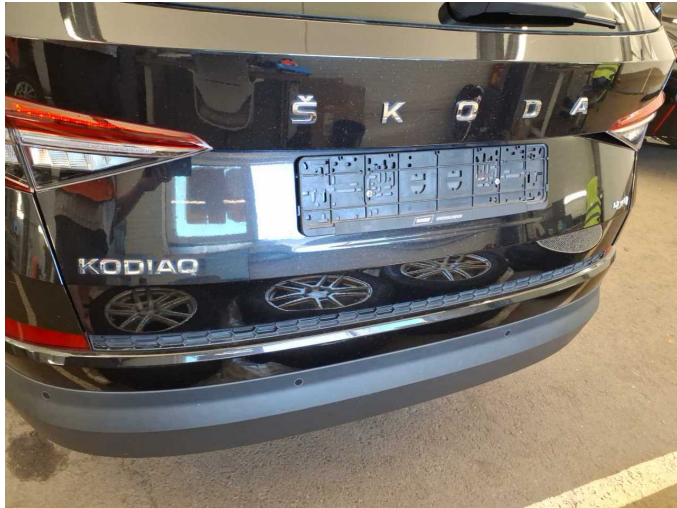
| No. | Component group | Description |
|---|---|---|
| 4 | Boot lid / rear door | Boot lid - Scratch(es) - No deduction |

**Wear and tear 4:** Boot lid / rear door: Boot lid - Scratch(es) - No deduction

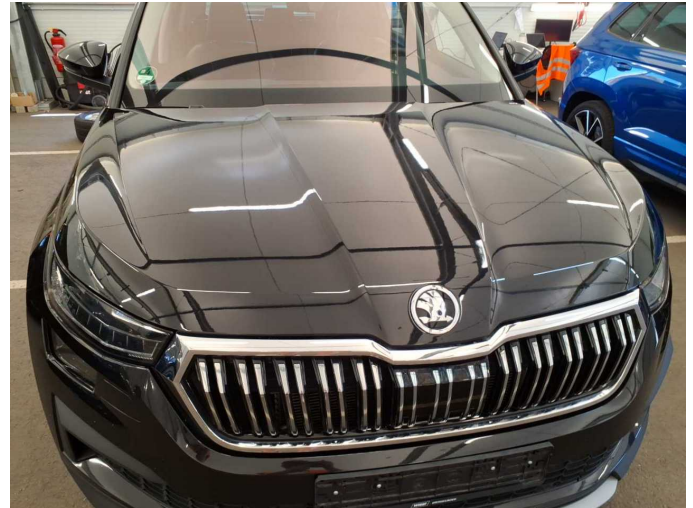
| No. | Component group | Description |
|---|---|---|
| 5 | Bonnet | Bonnet - Stone chips - No deduction |

**Wear and tear 5:** Bonnet: Bonnet - Stone chips - No deduction

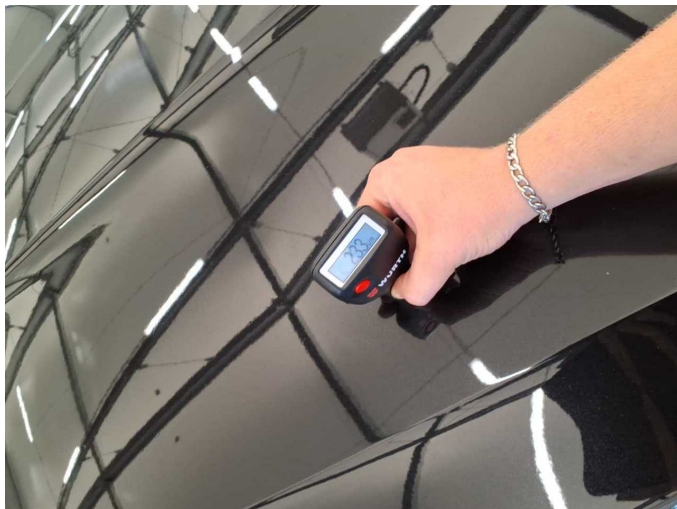
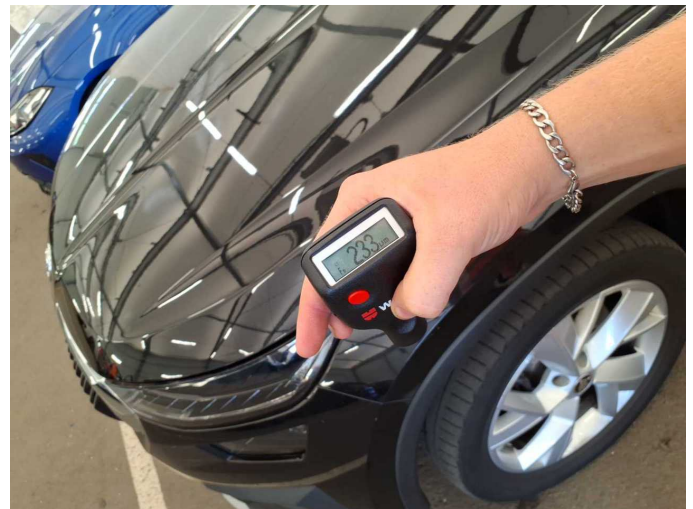
| Bonnet | 233 µm | Side panel - rear left side | 257 µm |

**Repainting 1:** Bonnet

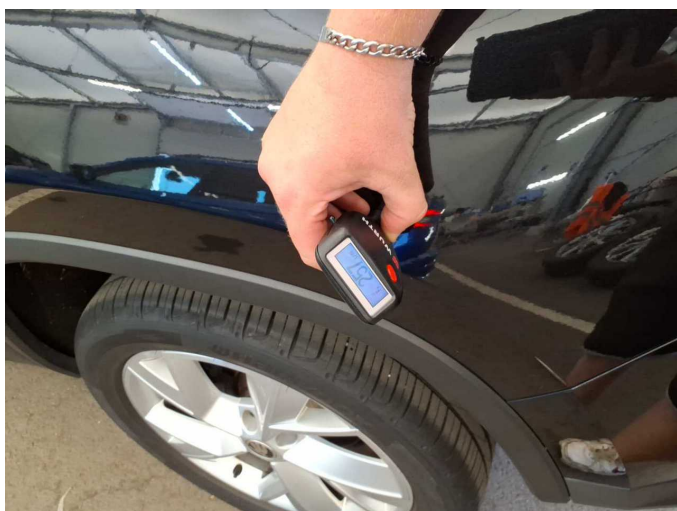
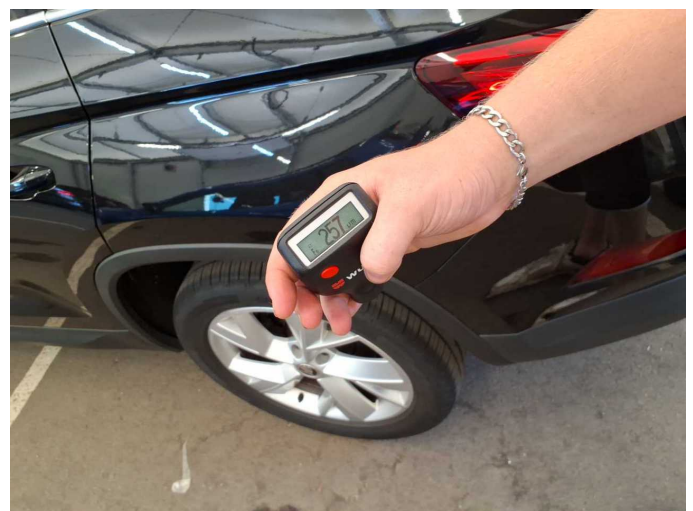
**Repainting 2:** Side panel - rear left side

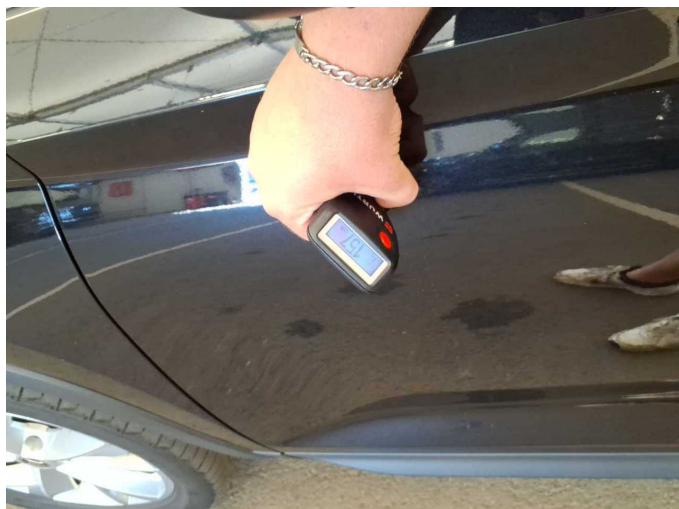
| Door - front left side | 157 µm | | |

**Repainting 3:** Door - front left side
