Expertise

Protocol number: 45666883
Order No. / Reference: 25932999
Inspection date: 21 May 2026

Model: Vito 116 CDI Extralang HA Aut. PRO

VIN: W1VVLCEZ1T4562453

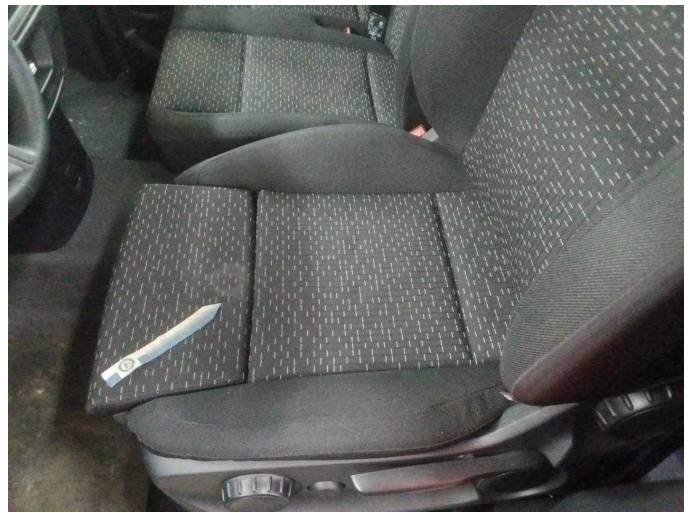
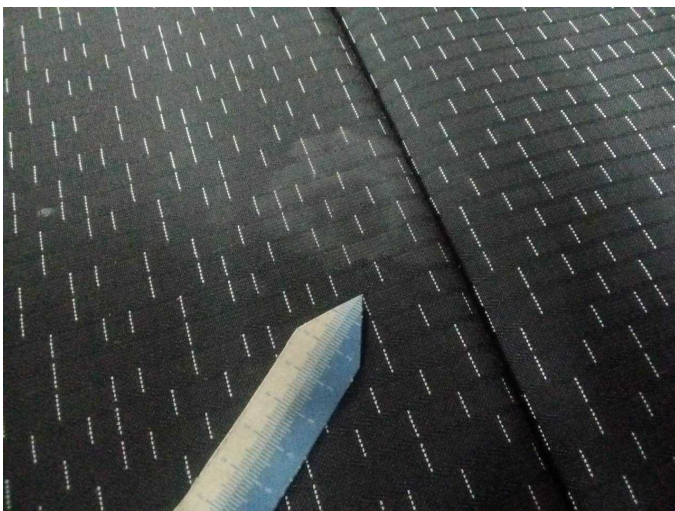
Damage 1: Seat - front: Seat cover - left side - Soiled - Clean

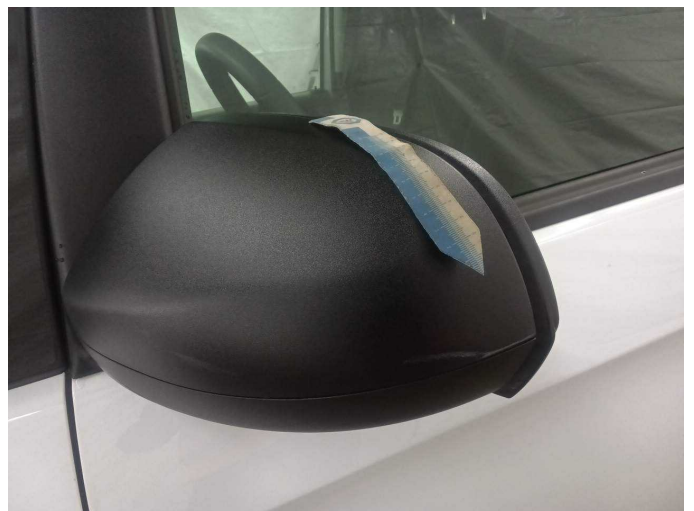
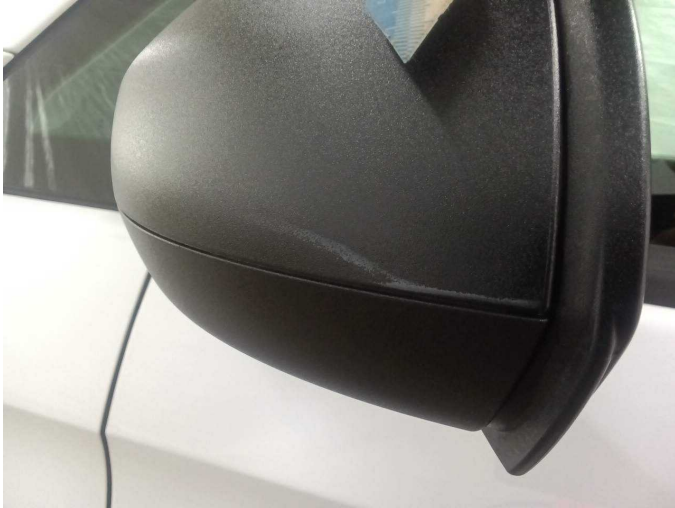
Damage 2: Wing mirror - left side: Mirror housing - Scratch(es) - Replace
