Expertise

Protocol number: 46631492  
Order No. / Reference: 26662986  
Inspection date: 1 Jul 2026

Manufacturer: Mazda

Model: CX-60 AWD PHEV Aut. HOMURA

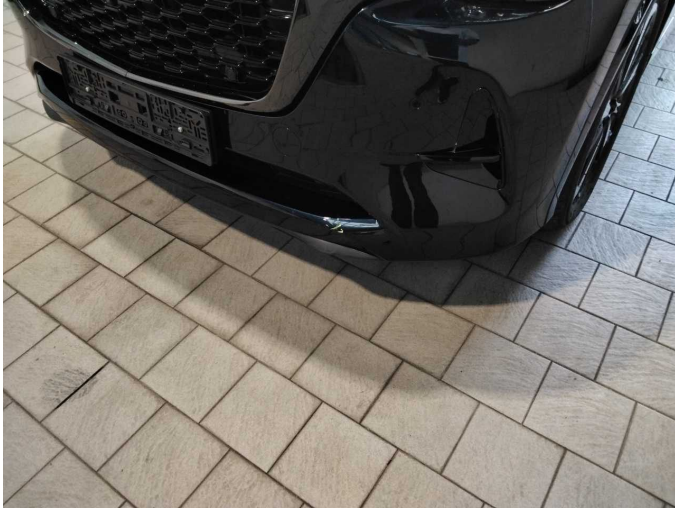
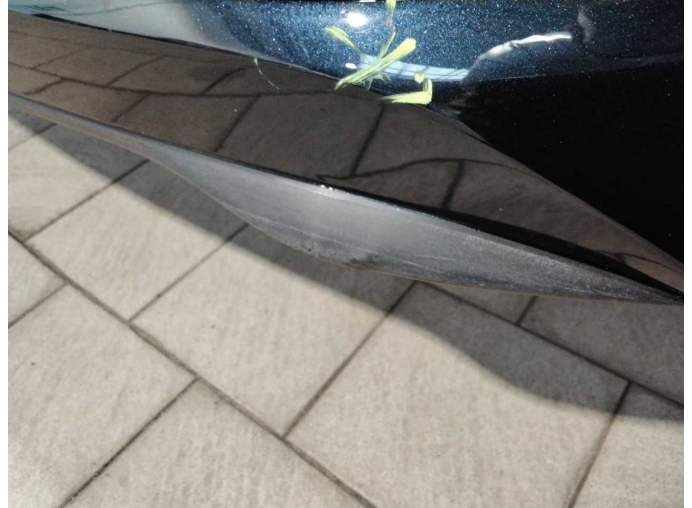
| No. | Component group | Description |
|---|---|---|
| 1 | Front bumper | Spoiler - Deformed - Loss in value |

**Damage 1:** Front bumper: Spoiler - Deformed - Loss in value

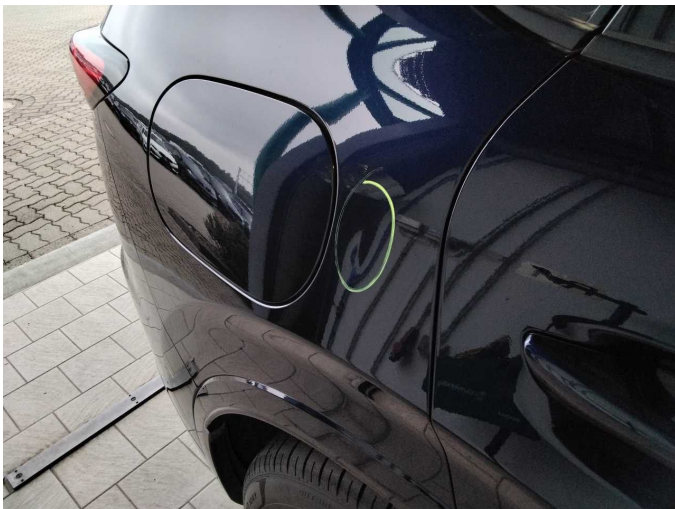
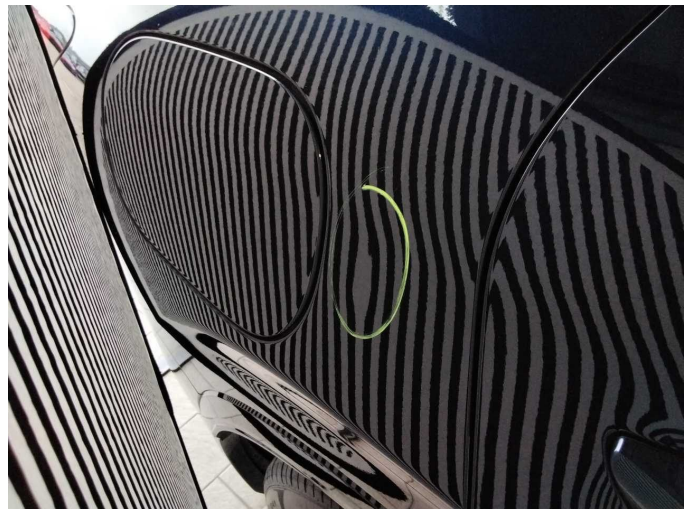
| No. | Component group | Description |
|---|---|---|
| 2 | Side panel - rear right side | Side panel - dent(s) - Smooth repair work |

**Damage 2:** Side panel - rear right side: Side panel - dent(s) - Smooth repair work

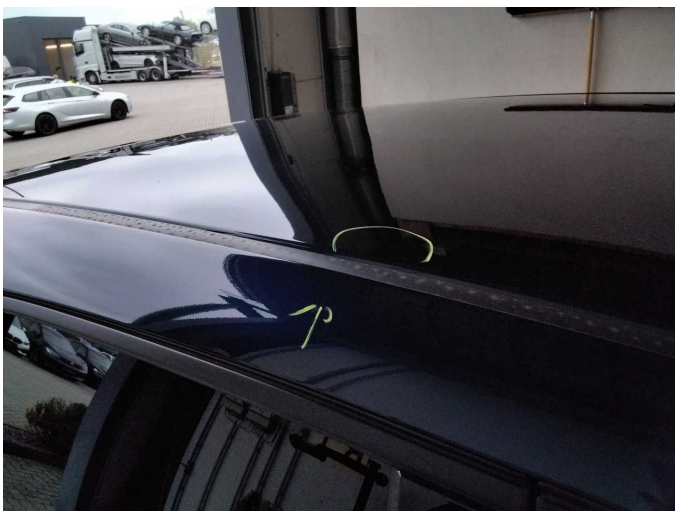
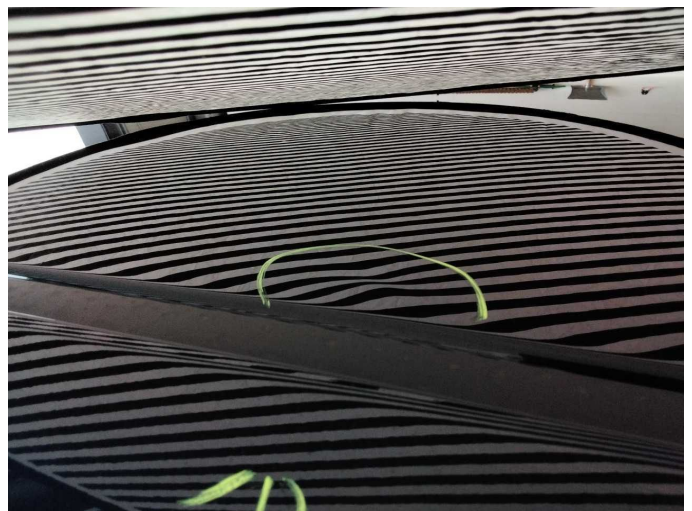
| No. | Component group | Description |
|---|---|---|
| 3 | Roof | Roof - dent(s) - Smooth repair work |

**Damage 3:** Roof: Roof - dent(s) - Smooth repair work

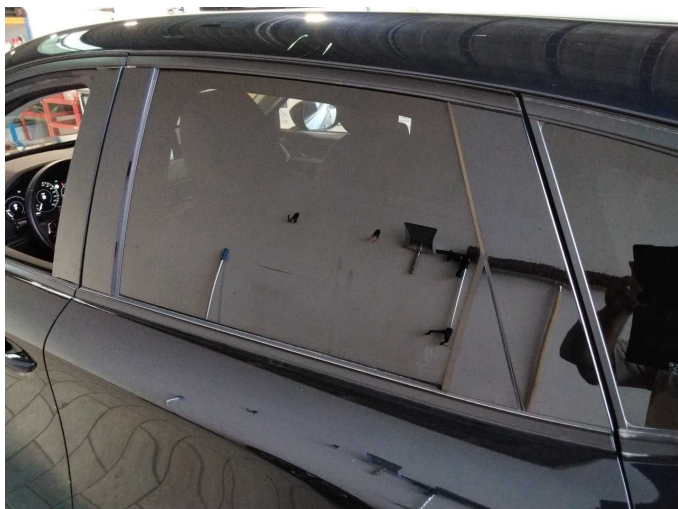
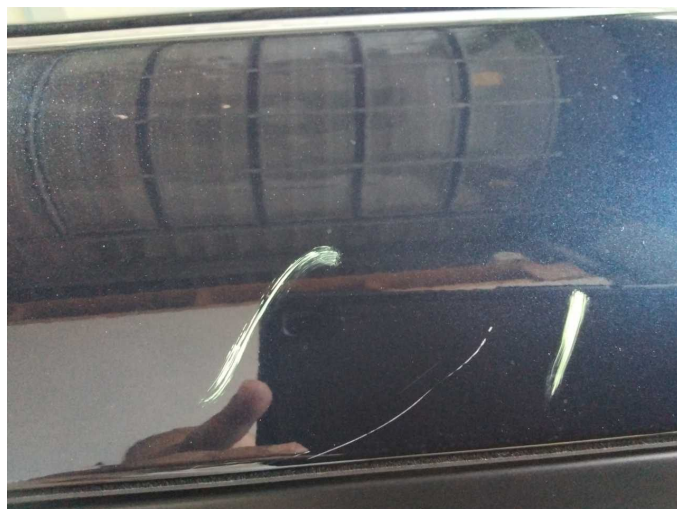
| No. | Component group | Description |
|---|---|---|
| 4 | Roof | Roof rail - left side - Scratch(es) - Smart repair |

**Damage 4:** Roof: Roof rail - left side - Scratch(es) - Smart repair

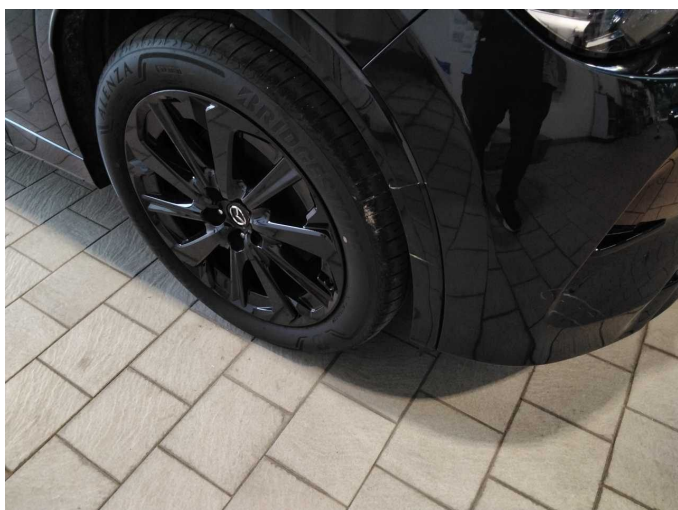
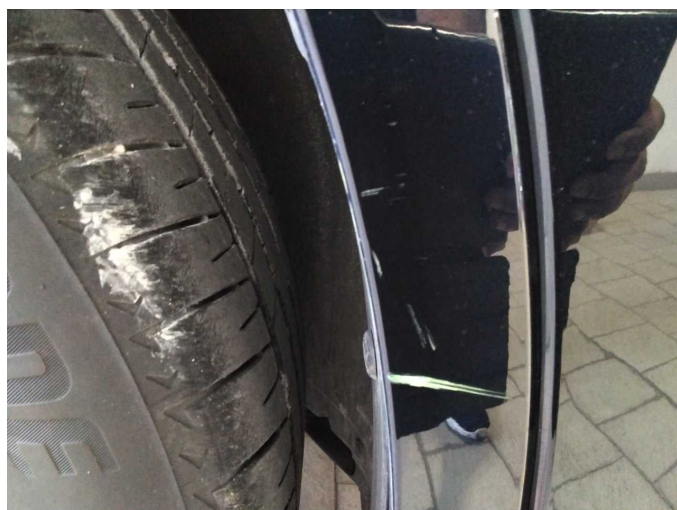
| No. | Component group | Description |
|---|---|---|
| 5 | Mudguard - right side | Wheel well extension - Scratch(es) - Smart repair |

**Damage 5:** Mudguard - right side: Wheel well extension - Scratch(es) - Smart repair

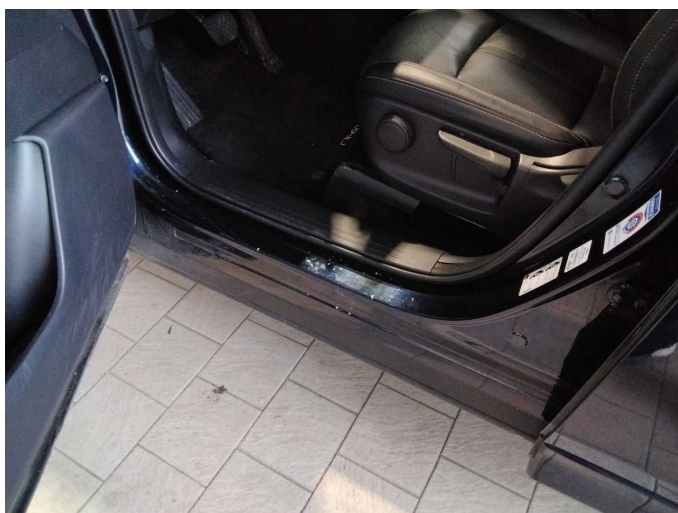
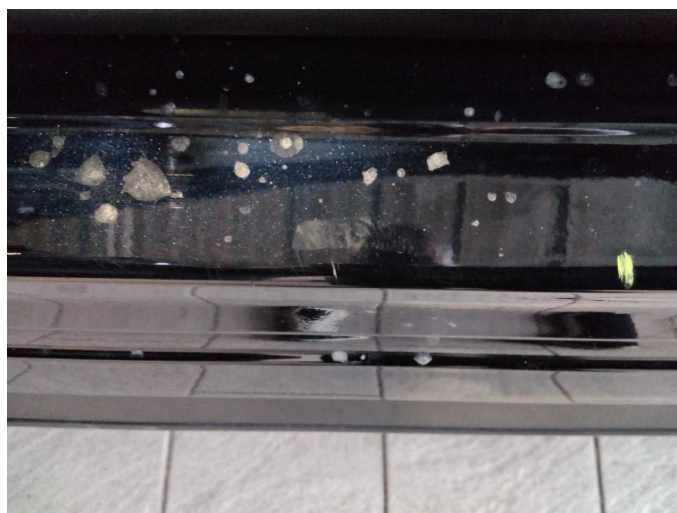
| No. | Component group | Description |
|---|---|---|
| 6 | Sill - left side | Sill - Scratch(es) - Smart repair |

**Damage 6:** Sill - left side: Sill - Scratch(es) - Smart repair

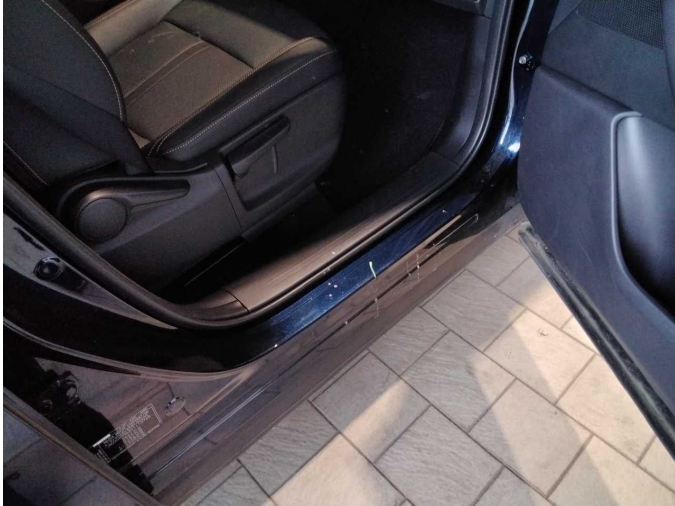
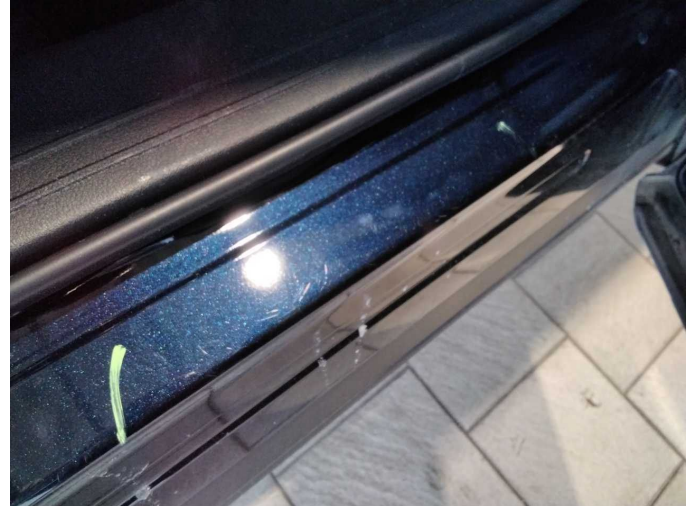
| No. | Component group | Description |
|---|---|---|
| 7 | Sill - right side | Sill - Scratch(es) - Smart repair |

**Damage 7:** Sill - right side: Sill - Scratch(es) - Smart repair

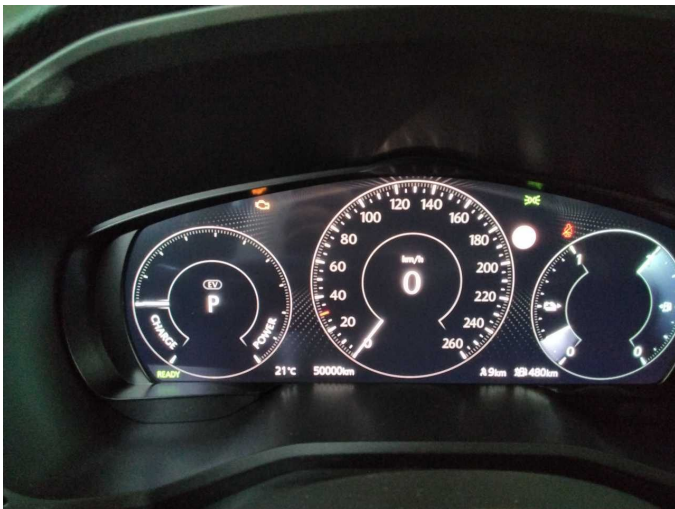
| Engine function test | An engine test run was performed, problem has been detected<br>This is due to the following reason.:<br>Motorkontrolle aktiv |

| No. | Component group | Description |
|---|---|---|
| 8 | Instrument panel | Indicator light (Motorkontrollleuchte ist aktiv) - on - Perform diagnosis |

**Damage 8:** Instrument panel: Indicator light (Motorkontrollleuchte ist aktiv) - on - Perform diagnosis

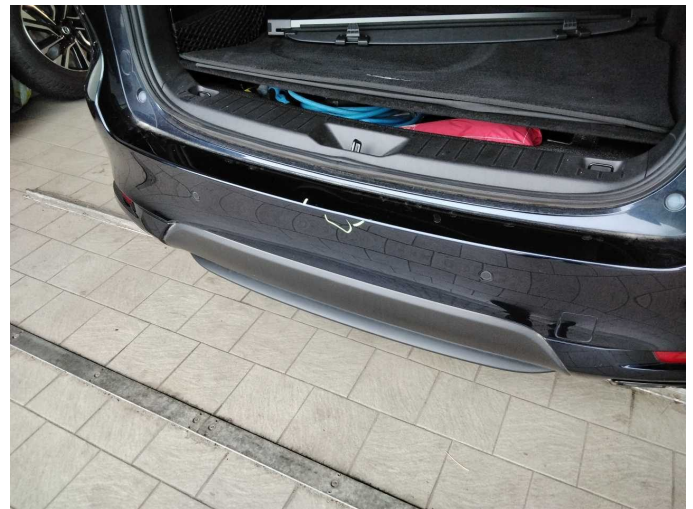
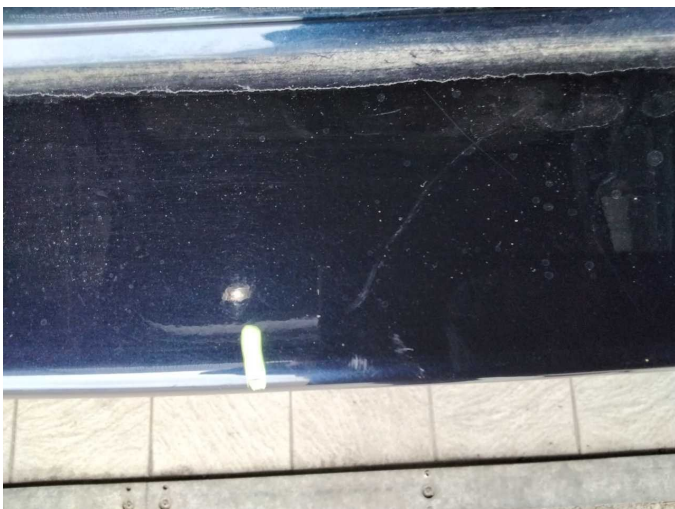
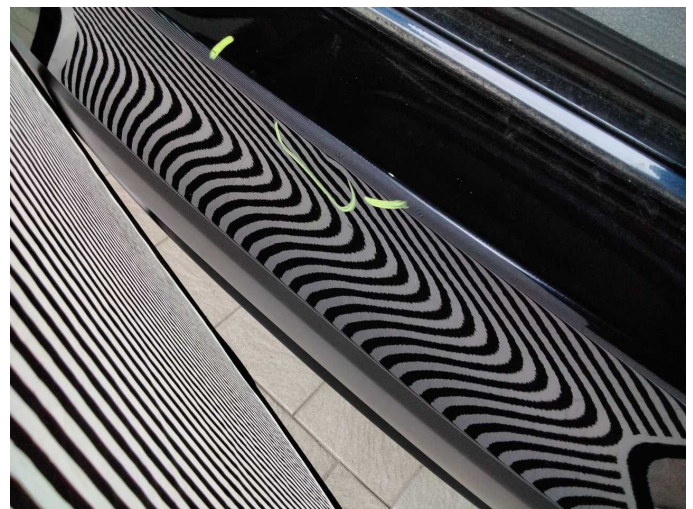
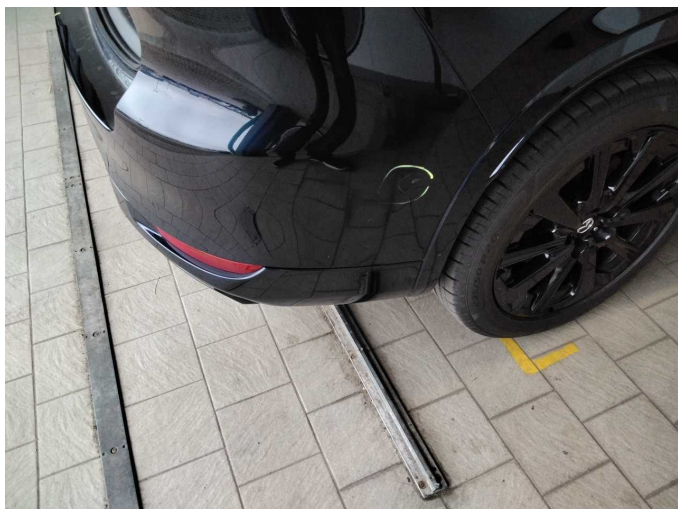
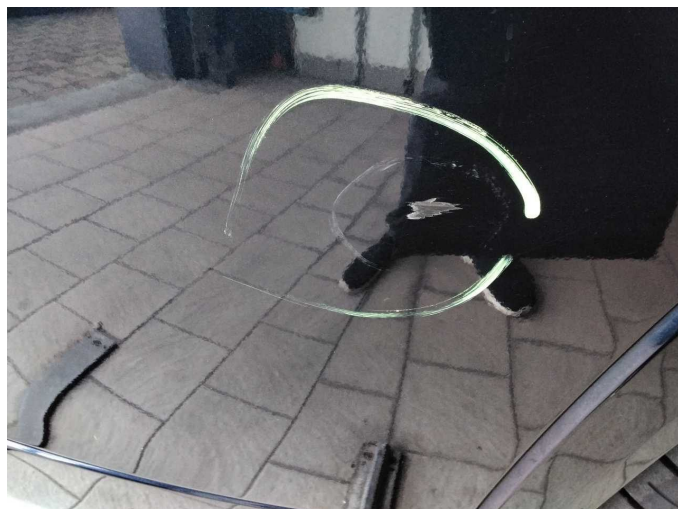
| No. | Component group | Description |
|---|---|---|
| 9 | Rear bumper | Rear bumper - Dent / paintcoat damage - Repair and paint |

**Damage 9:** Rear bumper: Rear bumper - Dent / paintcoat damage - Repair and paint

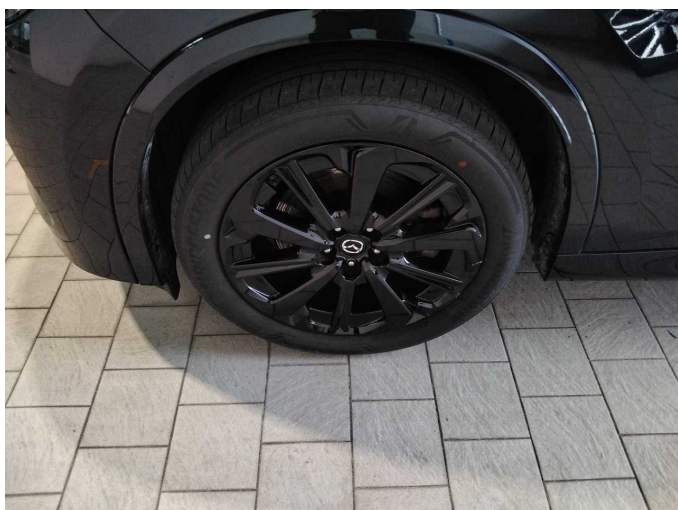
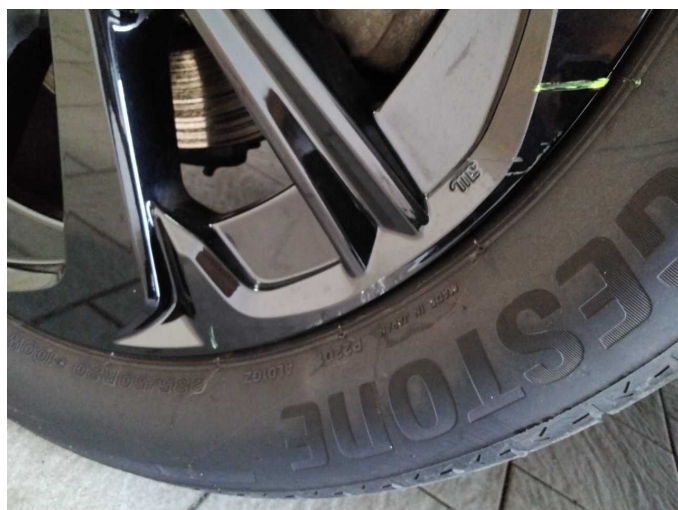
| No. | Component group | Description |
|---|---|---|
| 10 | Wheel / tyres | Alloy rim - front left side - Scratch(es) - Replace |

**Damage 10:** Wheel / tyres: Alloy rim - front left side - Scratch(es) - Replace

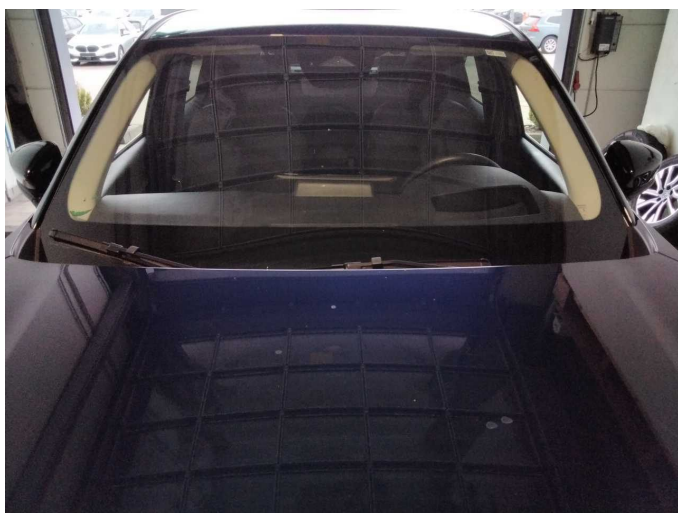
| No. | Component group | Description |
|---|---|---|
| 1 | Vehicle glazing | Windscreen - Stone chips - No deduction |

**Wear and tear 1:** Vehicle glazing: Windscreen - Stone chips - No deduction

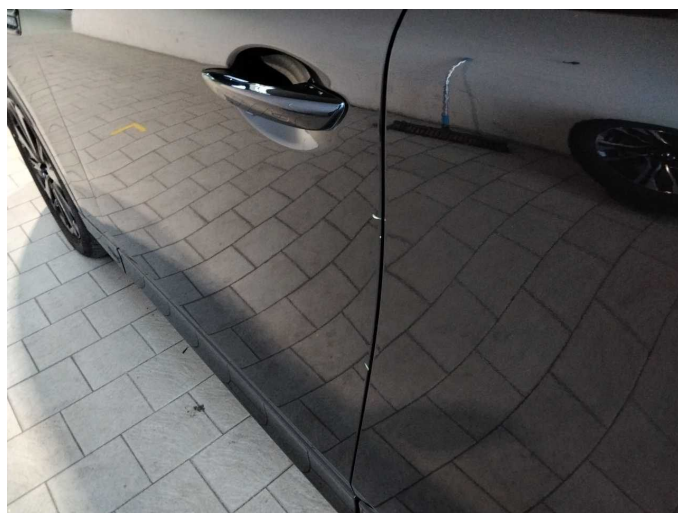
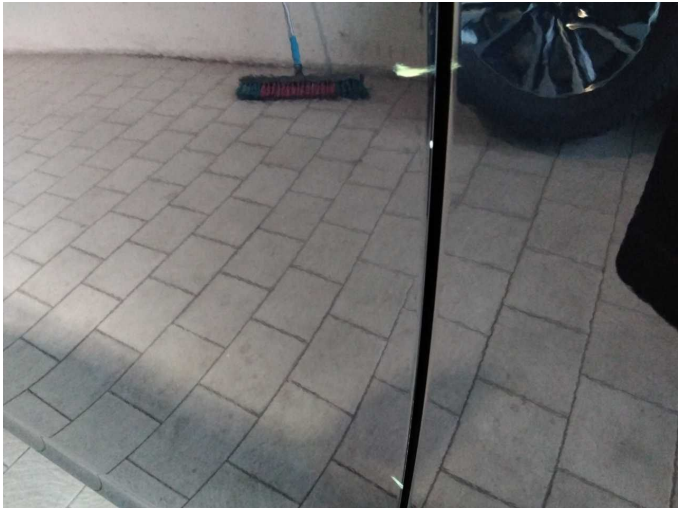
| No. | Component group | Description |
|---|---|---|
| 3 | Door - front left side | Door edge - Scratch(es) - No deduction |

**Wear and tear 3:** Door - front left side: Door edge - Scratch(es) - No deduction

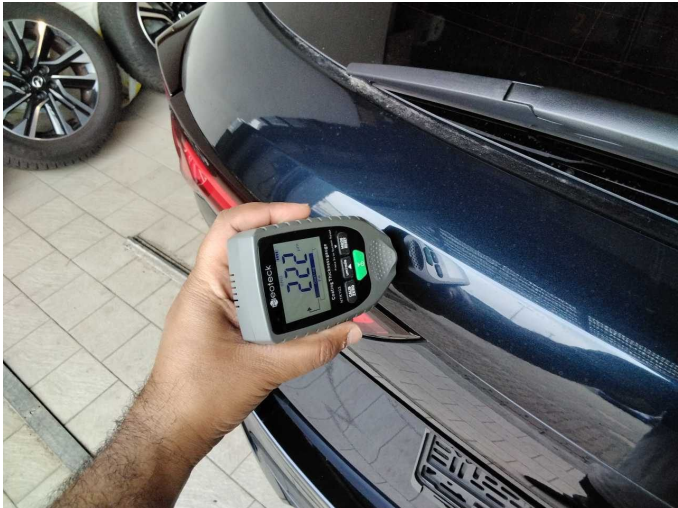
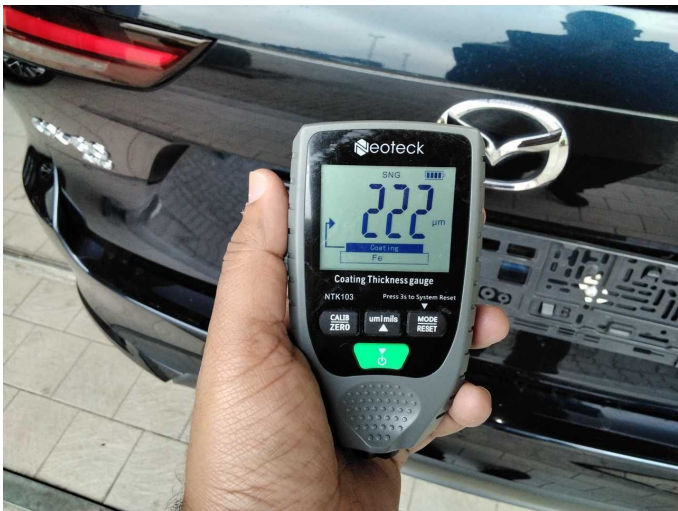
Boot lid / rear door 222 µm |

**Boot lid / rear door:** 222 µm
