Expertise

Protocol number: 46713623  
Order No. / Reference: 26462110  
Inspection date: 16 Jul 2026

Manufacturer: Mazda

Model: 2 SKYACTIV G 90 M HYBRID Homura

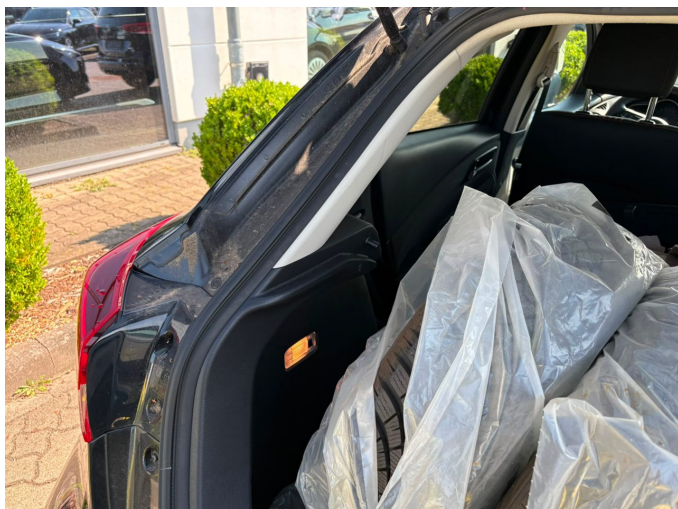
| No. | Component group | Description |
|---|---|---|
| 2 | Trim / covers | Cargo area - lining -left side - Broken / torn - Replace |

**Damage 2:** Trim / covers: Cargo area - lining -left side - Broken / torn - Replace

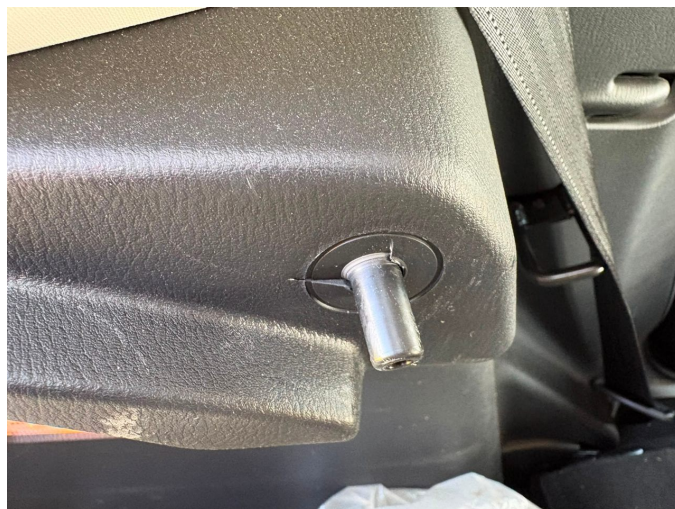
**Damage 2:** Trim / covers: Cargo area - lining -left side - Broken / torn - Replace

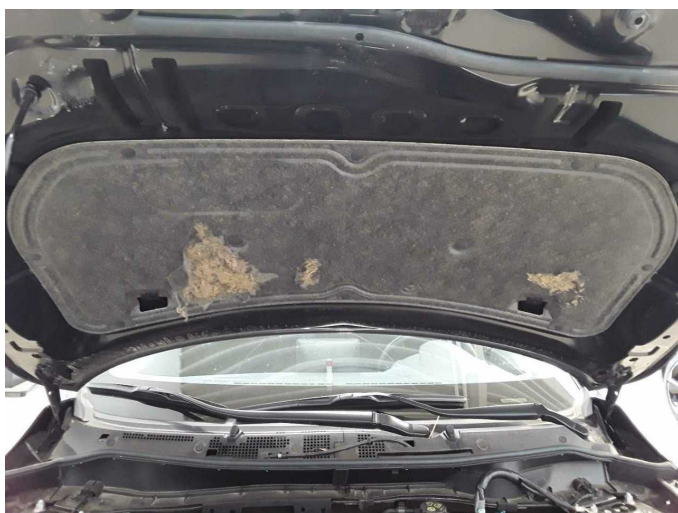
| No. | Component group | Description |
|---|---|---|
| 3 | Bonnet | Insulation lining - Damage caused by marten / rodent - Replace |

**Damage 3:** Bonnet: Insulation lining - Damage caused by marten / rodent - Replace

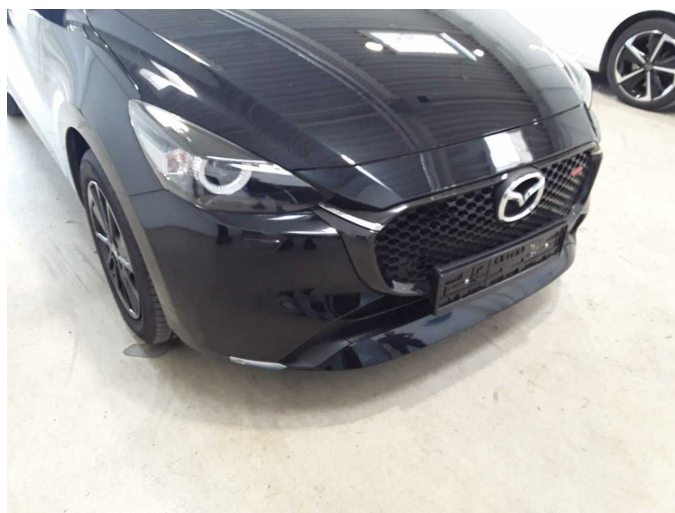
| No. | Component group | Description |
|---|---|---|
| 4 | Front bumper | Front bumper - Scratch(es) - Paint |

**Damage 4:** Front bumper: Front bumper - Scratch(es) - Paint

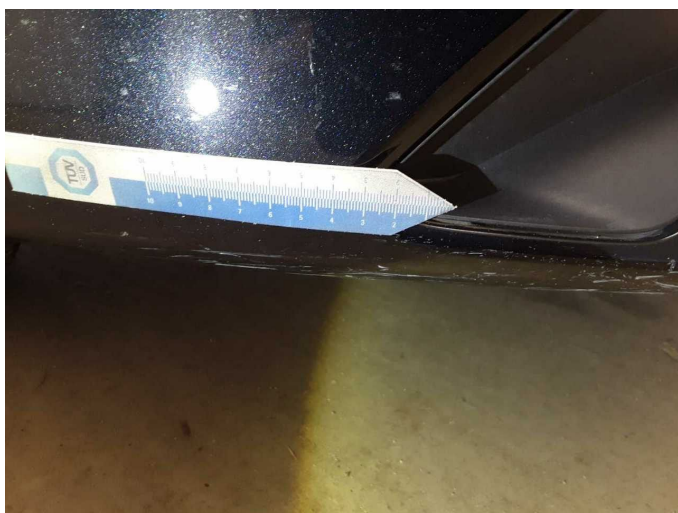
**Damage 4:** Front bumper: Front bumper - Scratch(es) - Paint

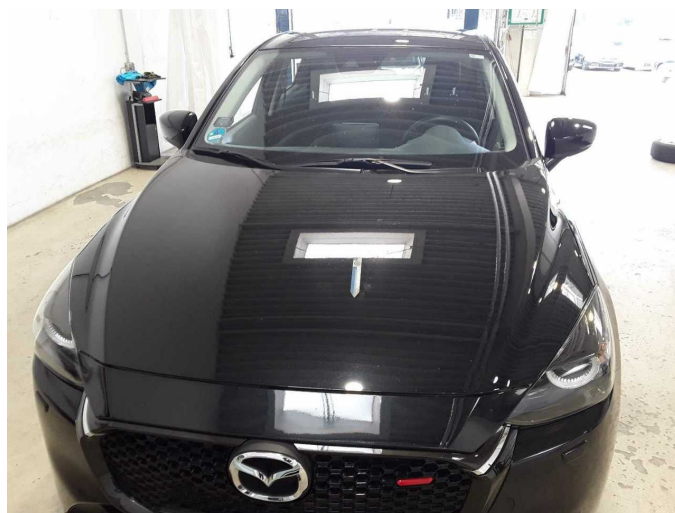
| No. | Component group | Description |
|---|---|---|
| 5 | Bonnet | Bonnet (Anätzung) - Paint defect - Repair and paint |

**Damage 5:** Bonnet: Bonnet (Anätzung) - Paint defect - Repair and paint

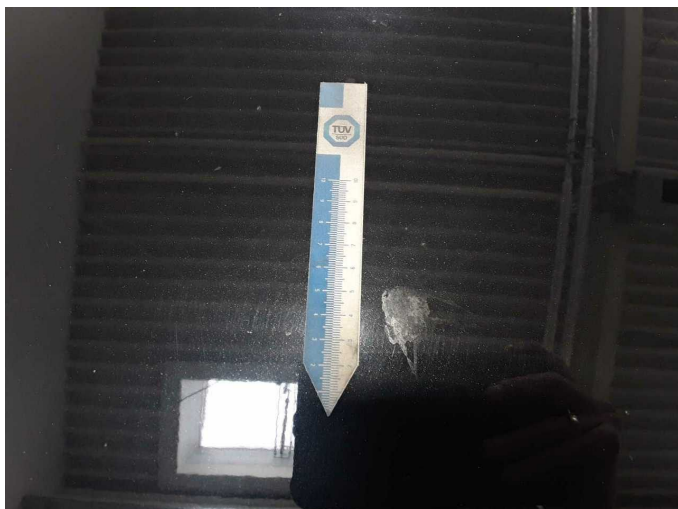
**Damage 5:** Bonnet: Bonnet (Anätzung) - Paint defect - Repair and paint
