## Expertise

Protocol number: 45916531  
Order No. / Reference: 26393432  
Inspection date: 9 Jun 2026

Manufacturer: Volkswagen

Model: Touran 2.0 TDI SCR DSG Comfortline

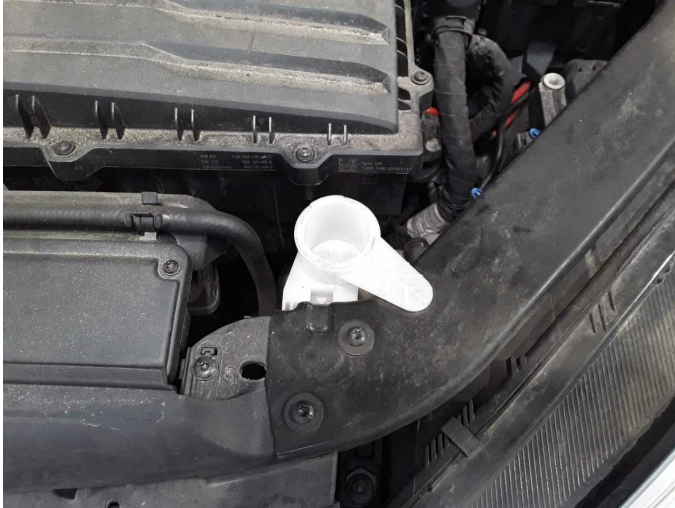
**Damage 1:** Screen cleaning: Wiper blades - rear (Deckel fehlt) - Differs from the original configuration - Replace

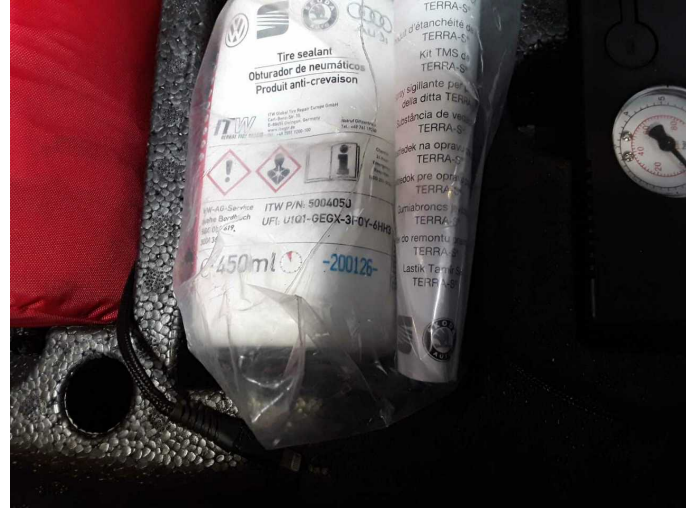
**Damage 2:** Equipment: Tirefit filler - Expired - Replace

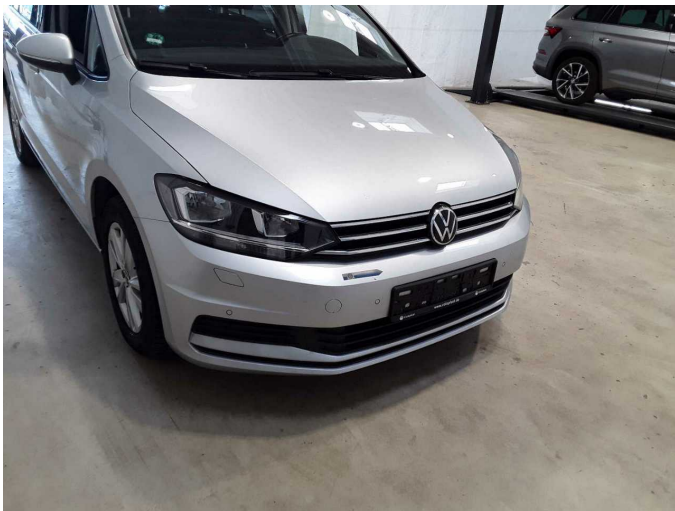
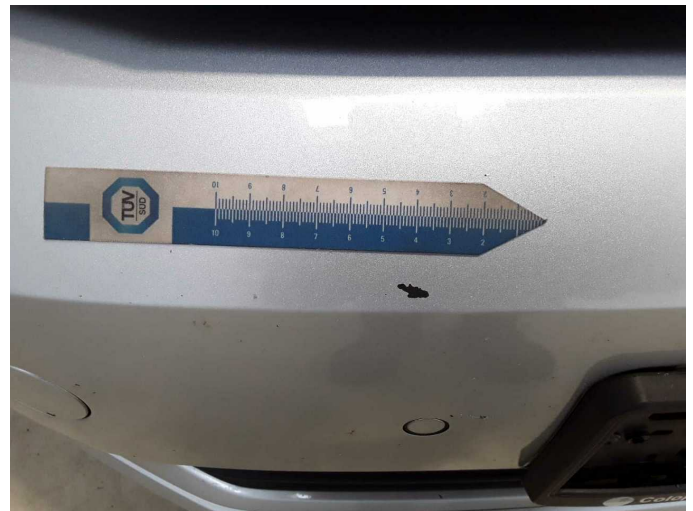
**Damage 3:** Front bumper: Front bumper - Scratch(es) - Smart repair

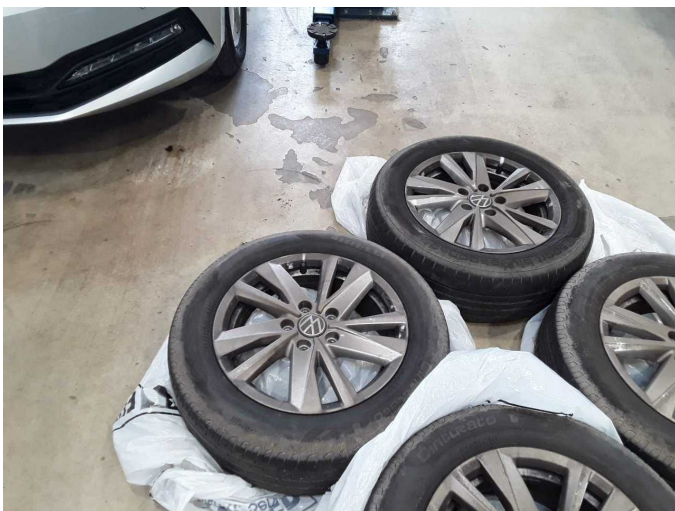
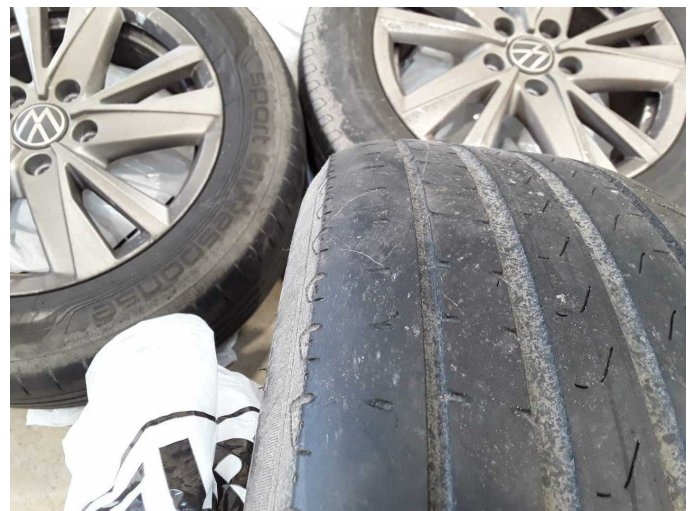
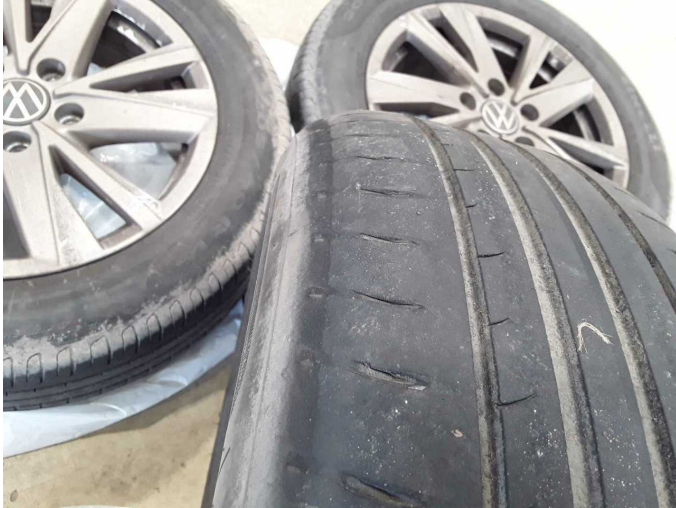
**Damage 4:** 2nd wheel set: 2 tyres (Innen abgefahren) - Worn - Replace

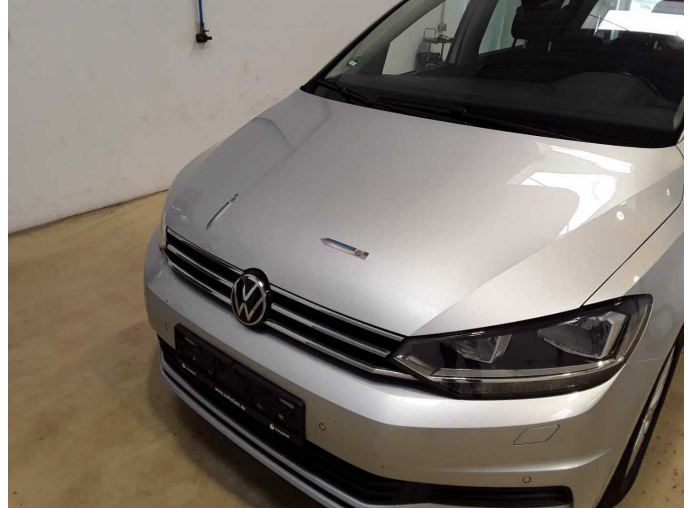
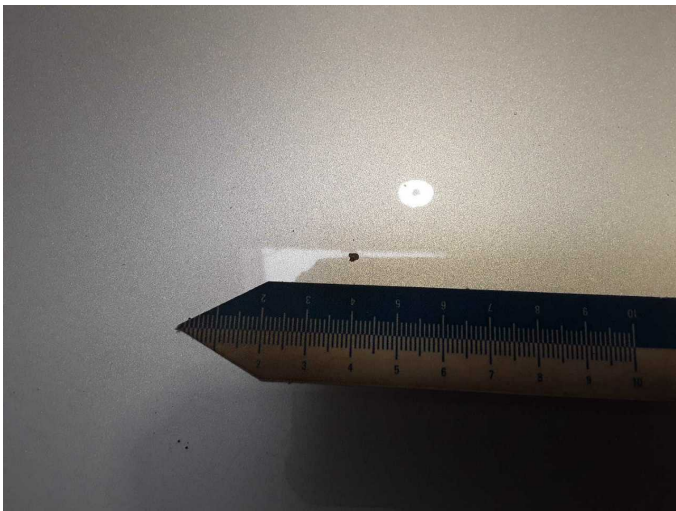
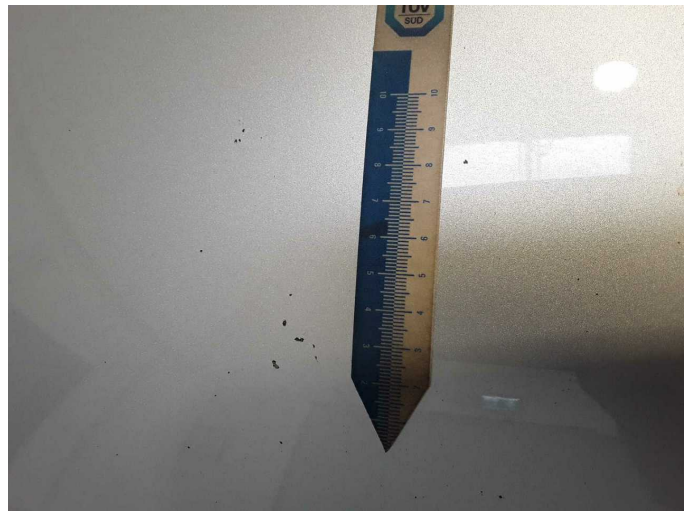
**Damage 5:** Bonnet: Bonnet - Stone chips - Paint
