## Expertise

Protocol number: 46182730  
Order No. / Reference: 26544007  
Inspection date: 23 Jun 2026

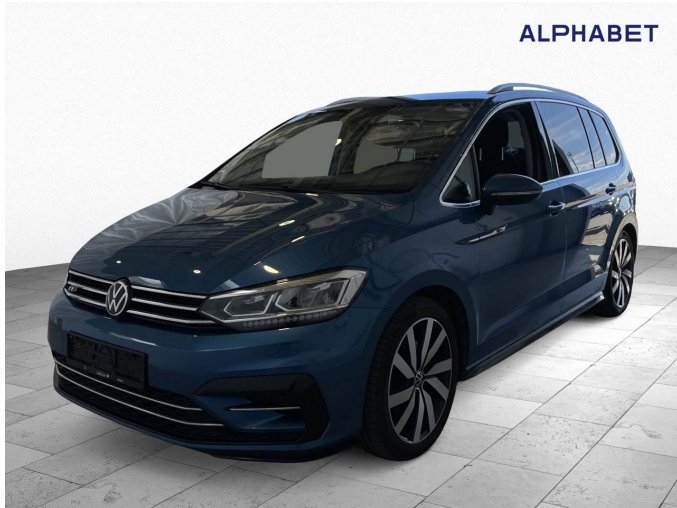
Figure 1: Diagonal front (left)

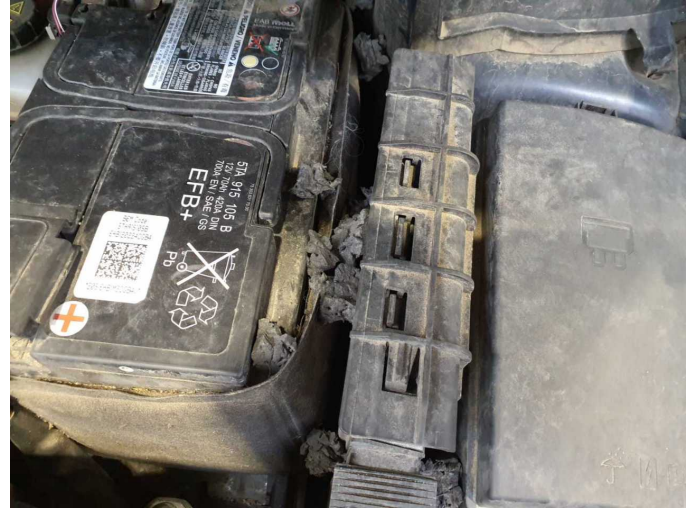
Damage 1: Cab: Insulation lining - Broken / torn - Replace

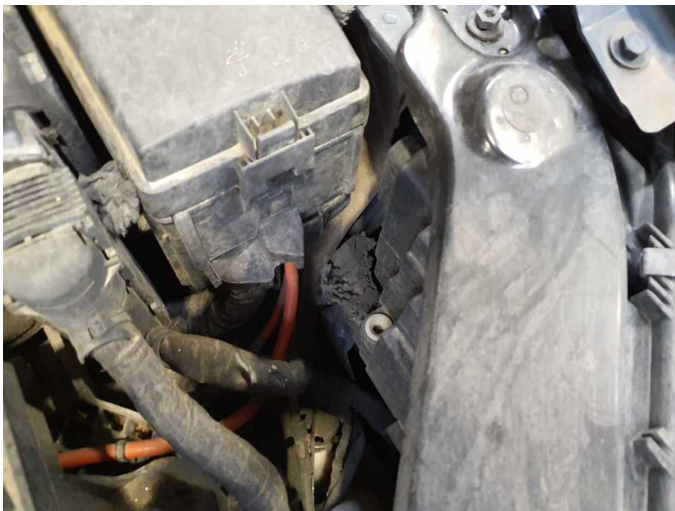
Damage 1: Cab: Insulation lining - Broken / torn - Replace

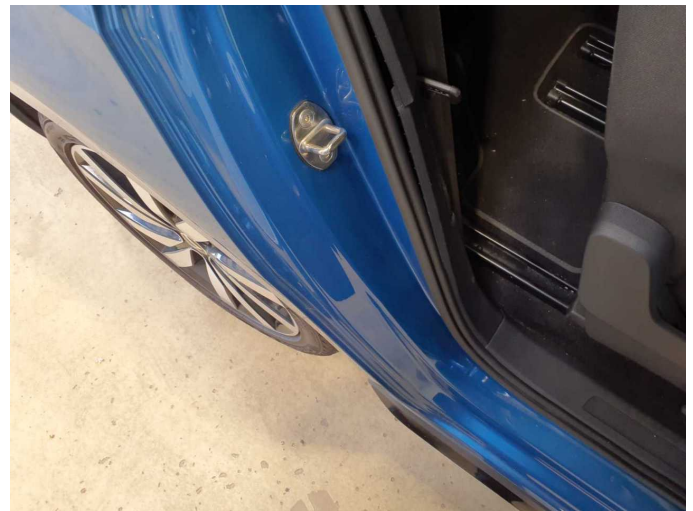
Damage 2: Side panel - rear right side: Sill - dent(s) - Smooth repair work

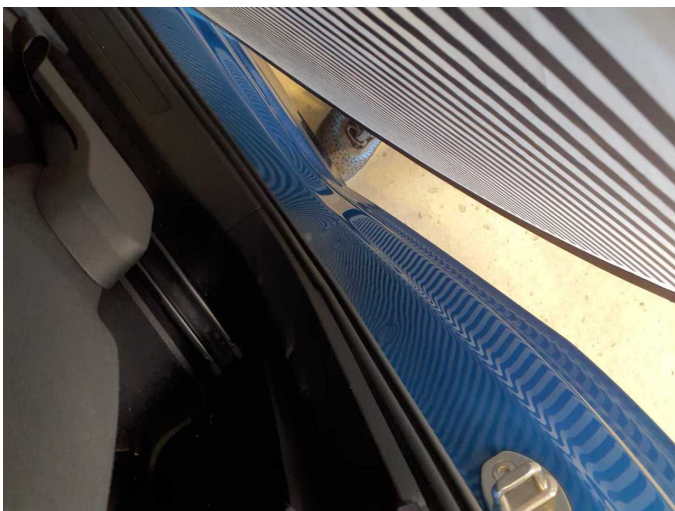
Damage 2: Side panel - rear right side: Sill - dent(s) - Smooth repair work

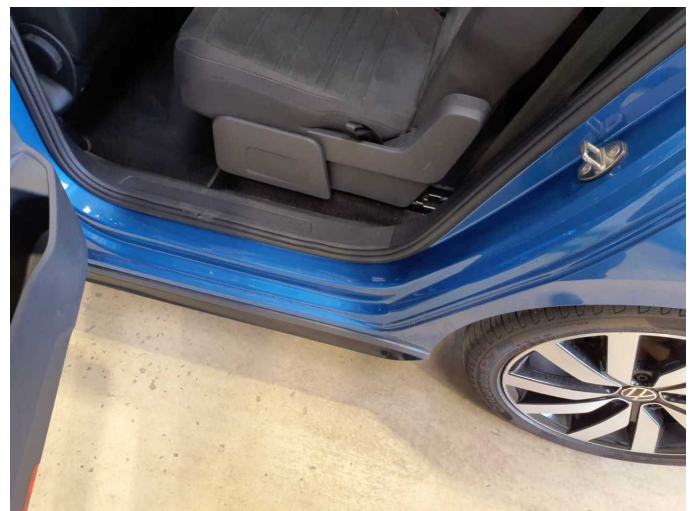
Damage 3: Side panel - rear left side: Sill - Dent / paintcoat damage - Smart repair

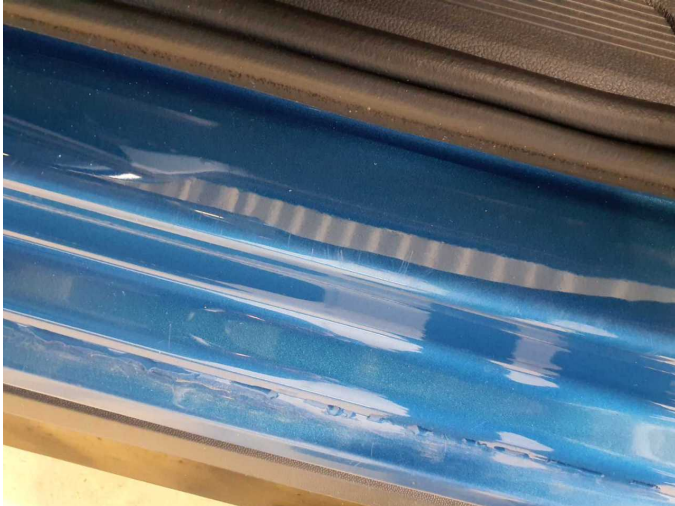
**Damage 3:** Side panel - rear left side: Sill - Dent / paintcoat damage - Smart repair

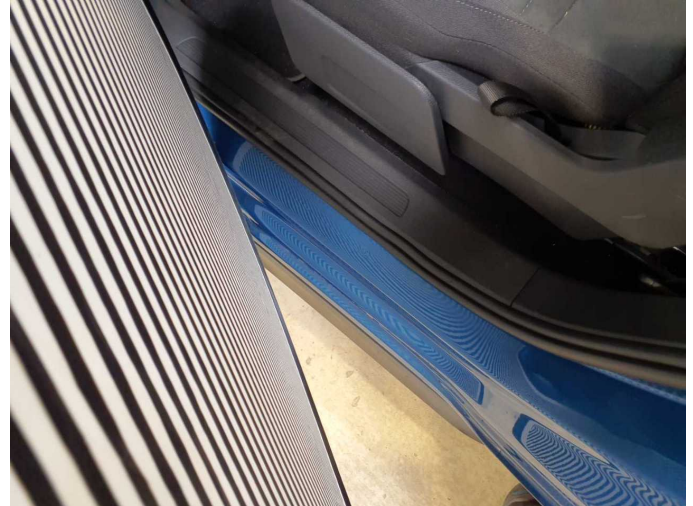
**Damage 3:** Side panel - rear left side: Sill - Dent / paintcoat damage - Smart repair

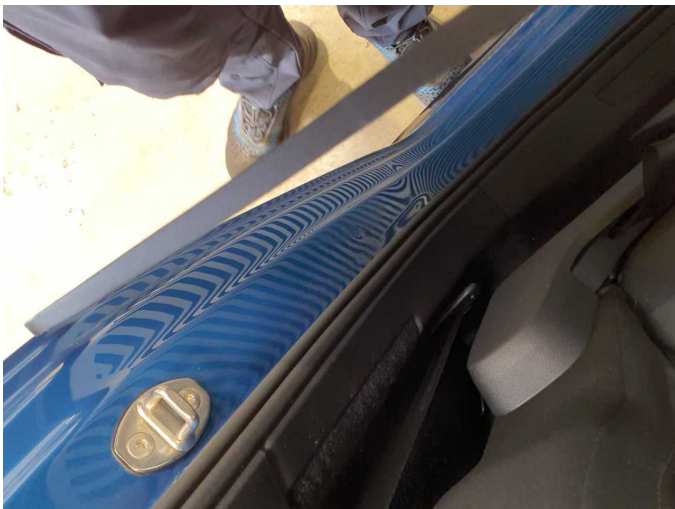
**Damage 3:** Side panel - rear left side: Sill - Dent / paintcoat damage - Smart repair

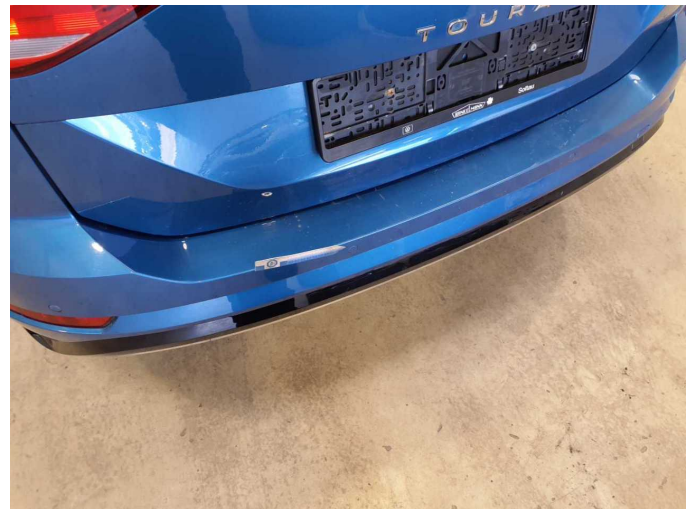
**Damage 4:** Rear bumper: Rear bumper - Scratch(es) - Smart repair

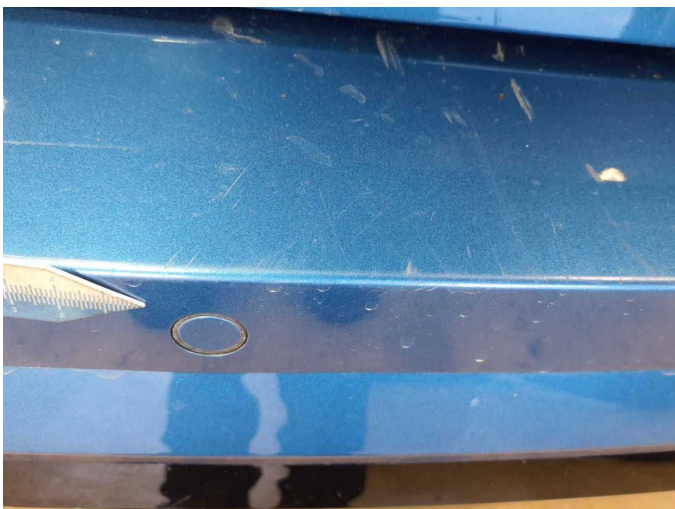
**Damage 4:** Rear bumper: Rear bumper - Scratch(es) - Smart repair

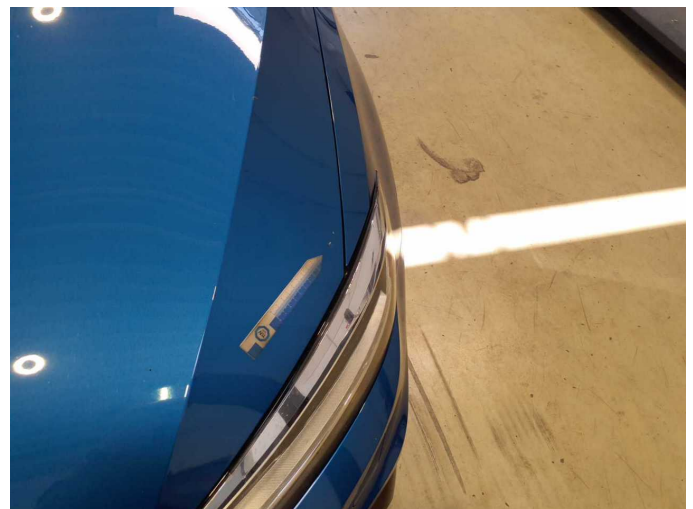
**Damage 5:** Bonnet: Bonnet - Stone chips - Smart repair

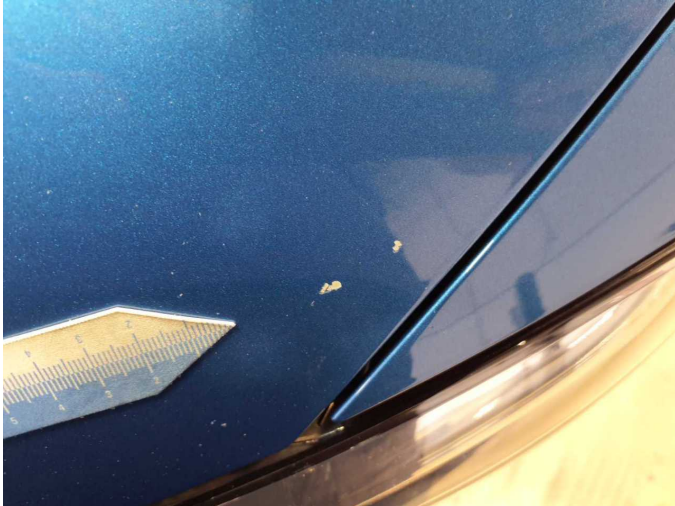
**Damage 5:** Bonnet: Bonnet - Stone chips - Smart repair

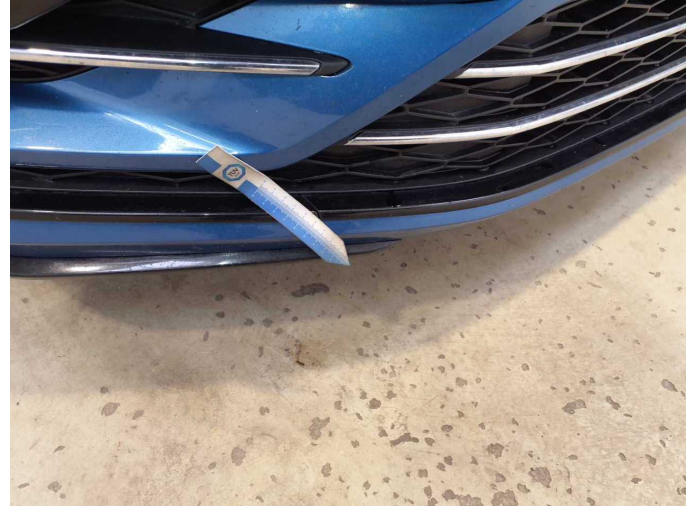
**Damage 6:** Front bumper: Front bumper - Scratch(es) - Smart repair

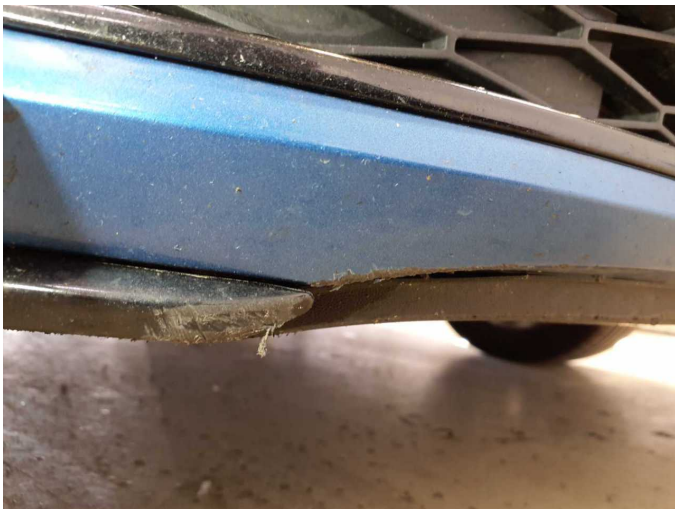
**Damage 6:** Front bumper: Front bumper - Scratch(es) - Smart repair

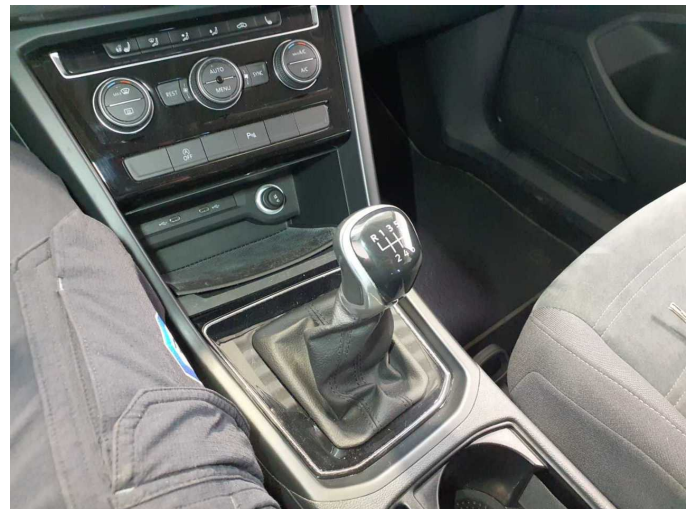
**Damage 7:** Gearbox: Selector lever - Broken / torn - Replace

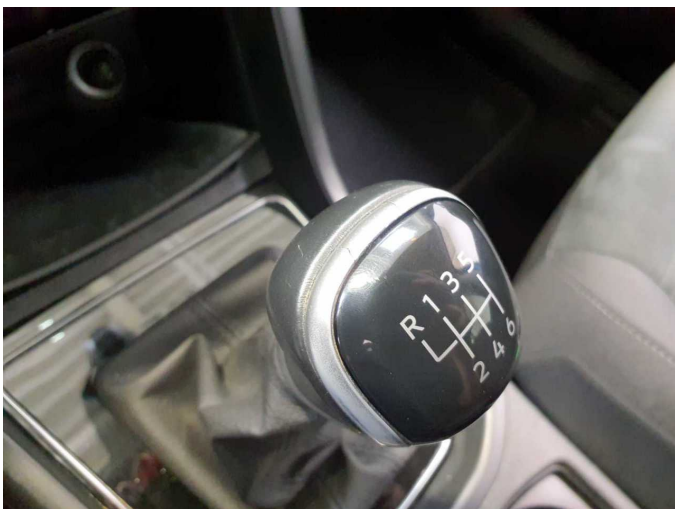
**Damage 7:** Gearbox: Selector lever - Broken / torn - Replace

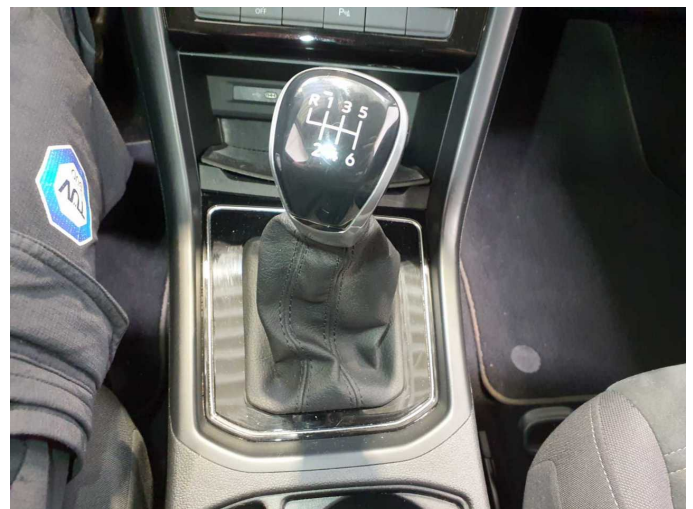
**Damage 7:** Gearbox: Selector lever - Broken / torn - Replace

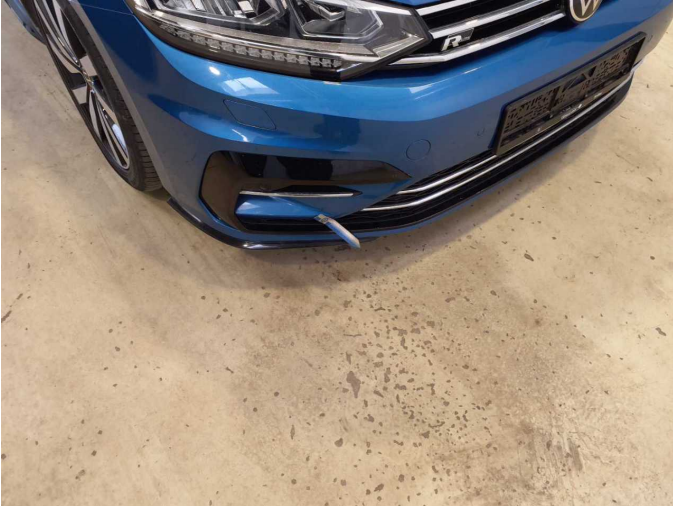
**Damage 8:** Front bumper: Spoiler - Scratch(es) - Loss in value

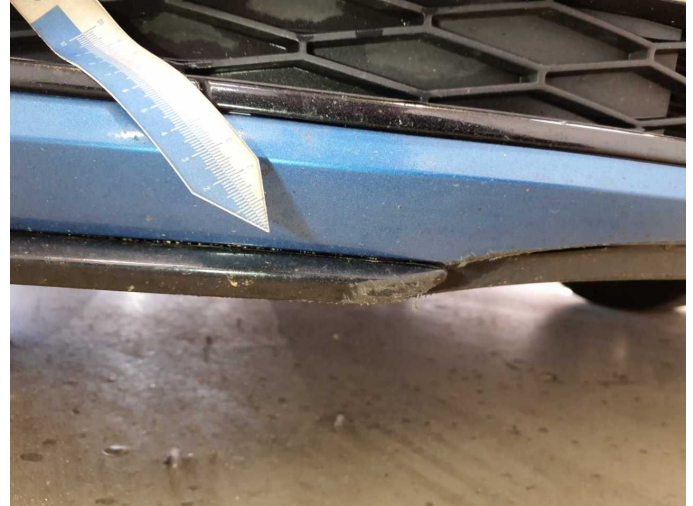
**Damage 8:** Front bumper: Spoiler - Scratch(es) - Loss in value

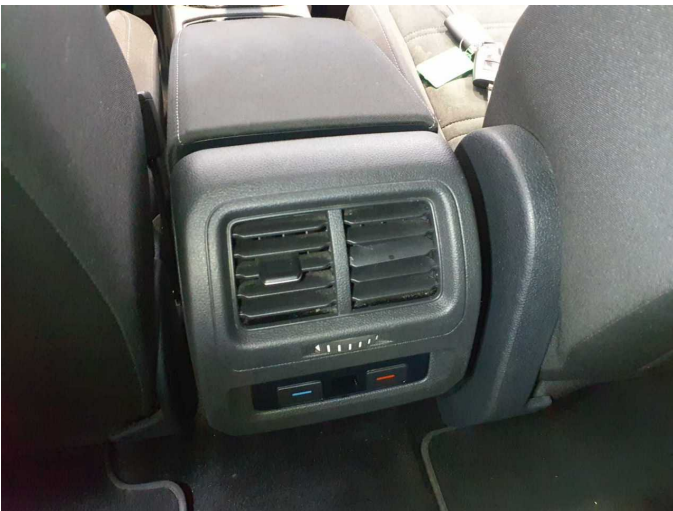
**Damage 9:** Instrument panel: Air nozzle - centre (Hinten) - Broken / torn - Replace

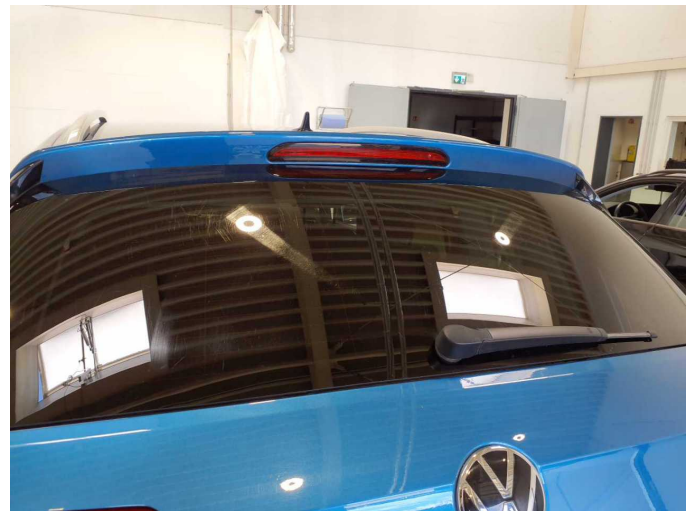
**Damage 10:** Vehicle glazing: Rear window - Scratch(es) - Loss in value

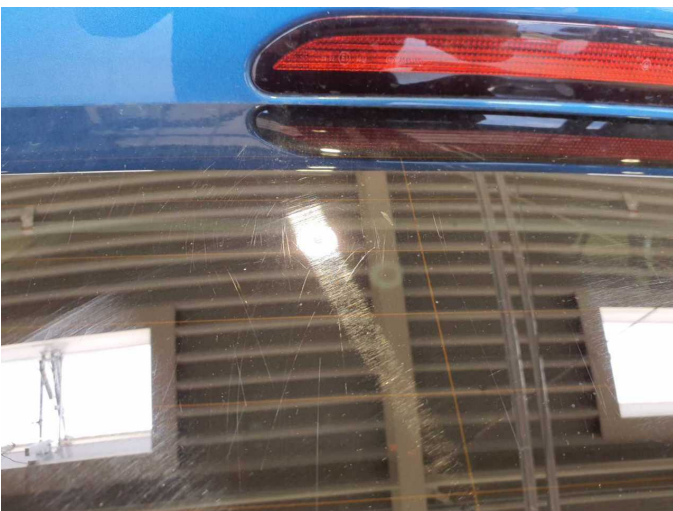
**Damage 10:** Vehicle glazing: Rear window - Scratch(es) - Loss in value

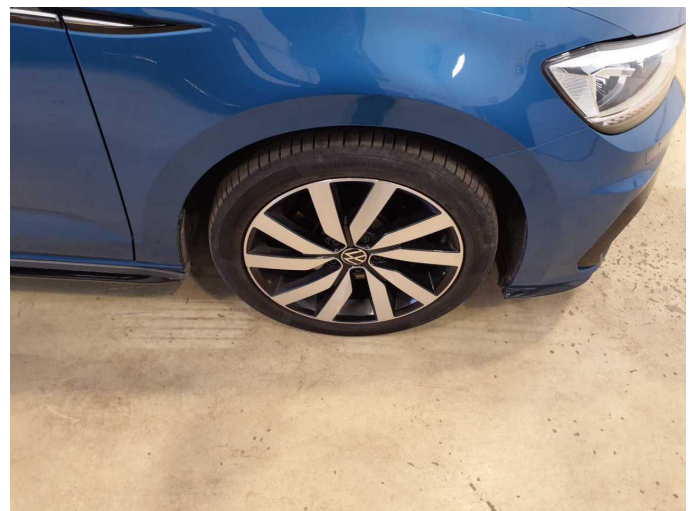
**Damage 11:** Wheel / tyres: Alloy rim - front right side - Scratch(es) - Loss in value

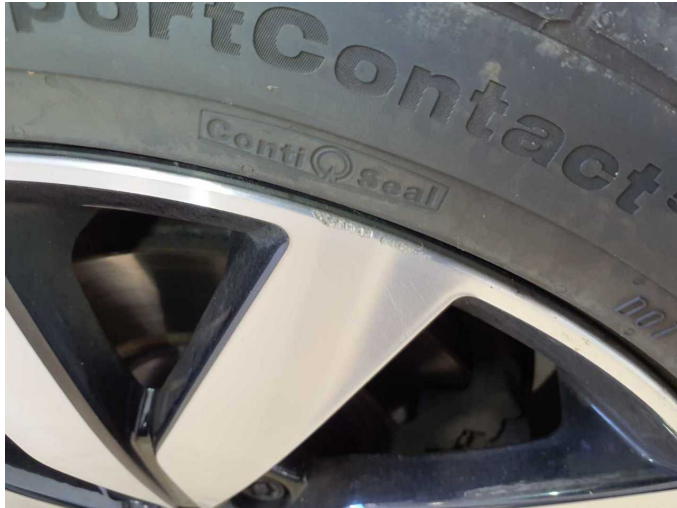
**Damage 11:** Wheel / tyres: Alloy rim - front right side - Scratch(es) - Loss in value

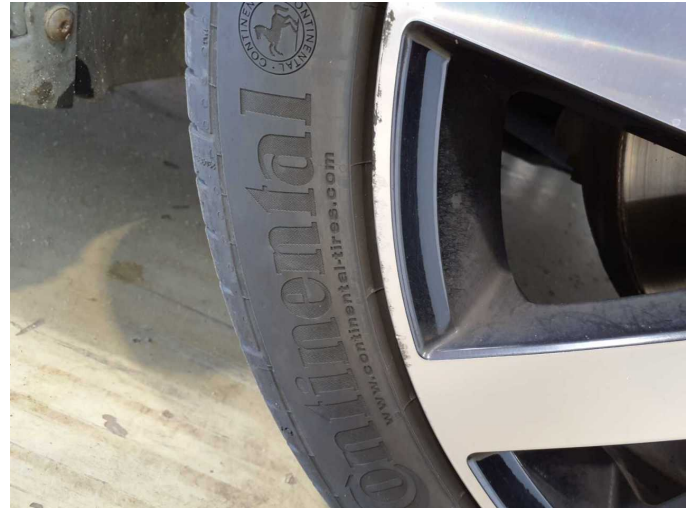
**Damage 11:** Wheel / tyres: Alloy rim - front right side - Scratch(es) - Loss in value

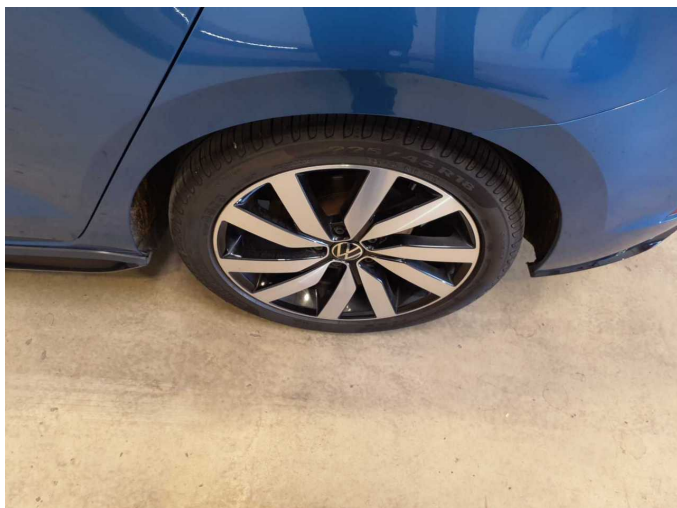
**Damage 12:** Wheel / tyres: Alloy rim - rear left side - Scratch(es) - Loss in value

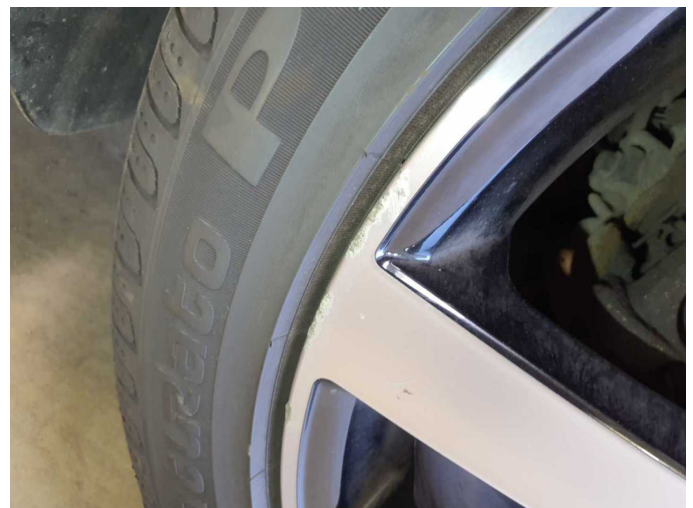
**Damage 12:** Wheel / tyres: Alloy rim - rear left side - Scratch(es) - Loss in value

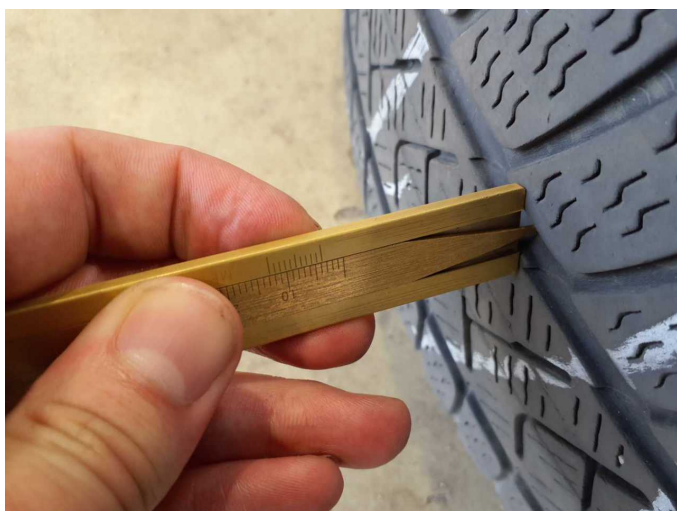
**Damage 13:** 2nd wheel set: Tyres - complete set - does not meet manufacturer specifications - Replace

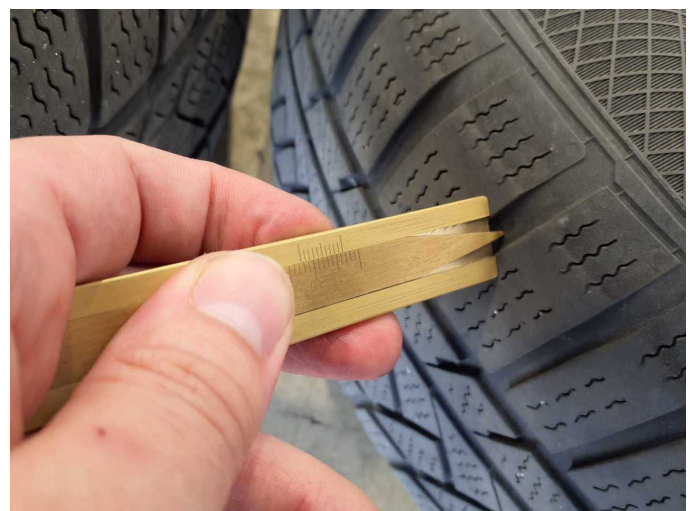
**Damage 13:** 2nd wheel set: Tyres - complete set - does not meet manufacturer specifications - Replace

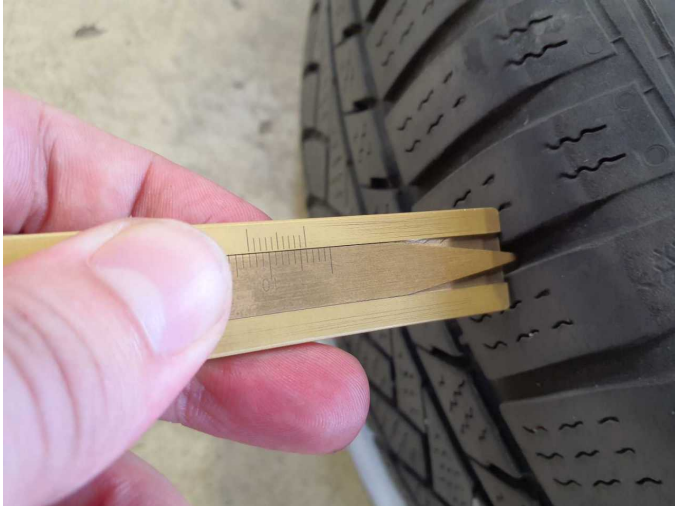
**Damage 13:** 2nd wheel set: Tyres - complete set - does not meet manufacturer specifications - Replace

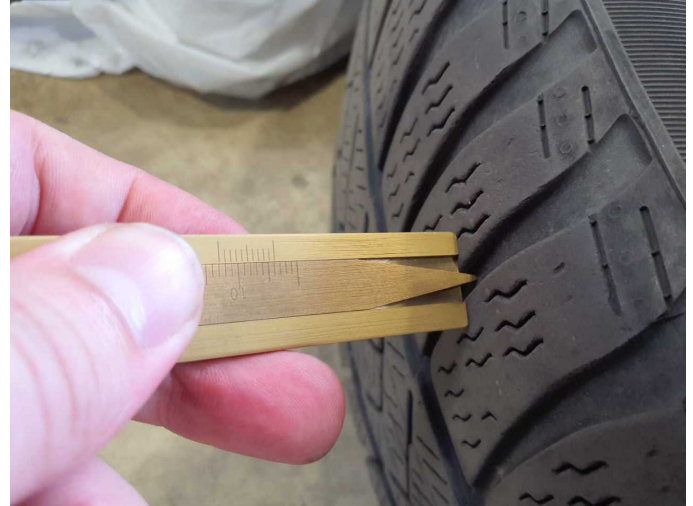
**Damage 13:** 2nd wheel set: Tyres - complete set - does not meet manufacturer specifications - Replace

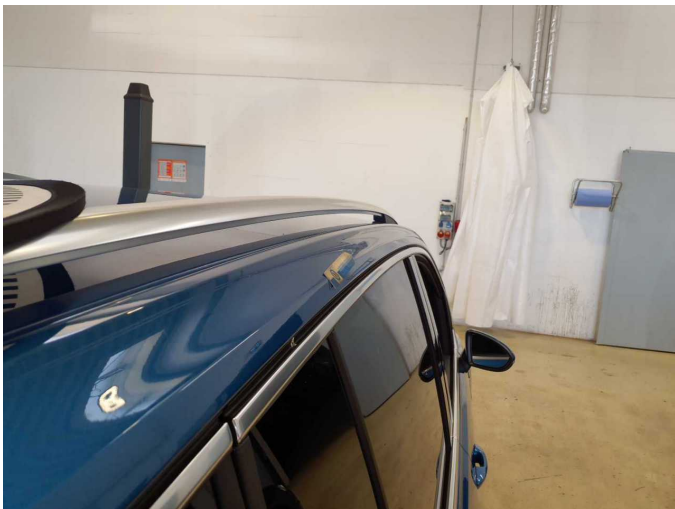
**Damage 14:** Roof: Roof rail - right side (Wellig) - Unprofessionally repaired - Paint

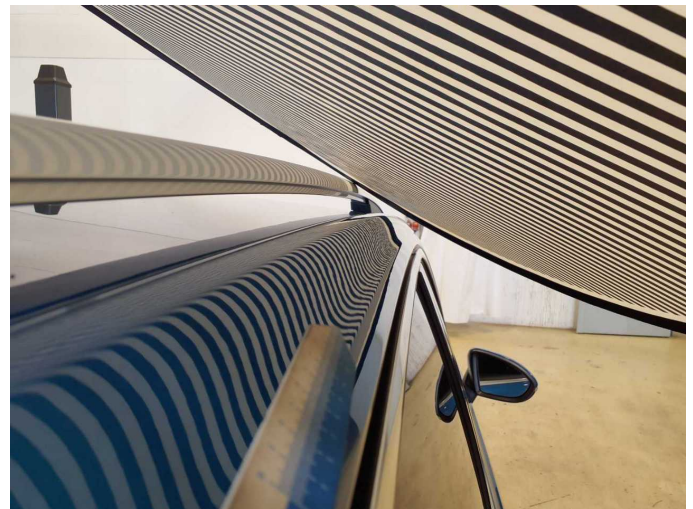
**Damage 14:** Roof: Roof rail - right side (Wellig) - Unprofessionally repaired - Paint

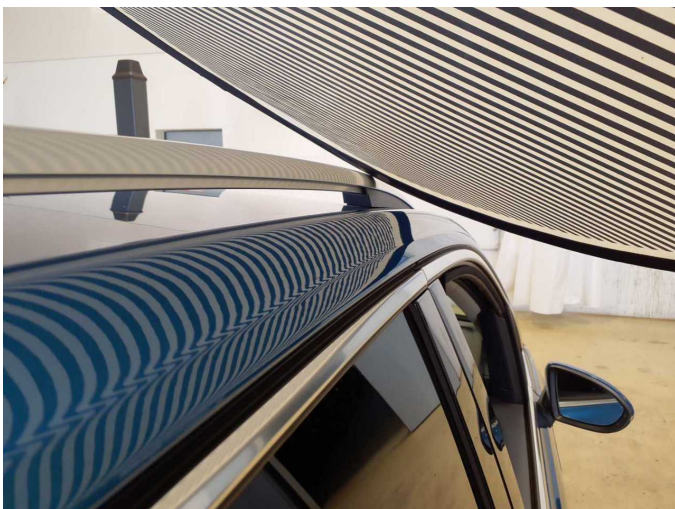
**Damage 14:** Roof: Roof rail - right side (Wellig) - Unprofessionally repaired - Paint

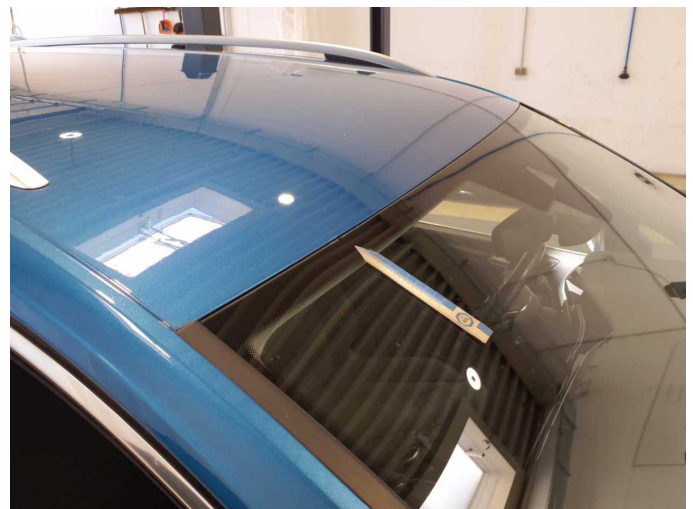
**Damage 15:** Vehicle glazing: Windscreen - Broken / torn - Replace

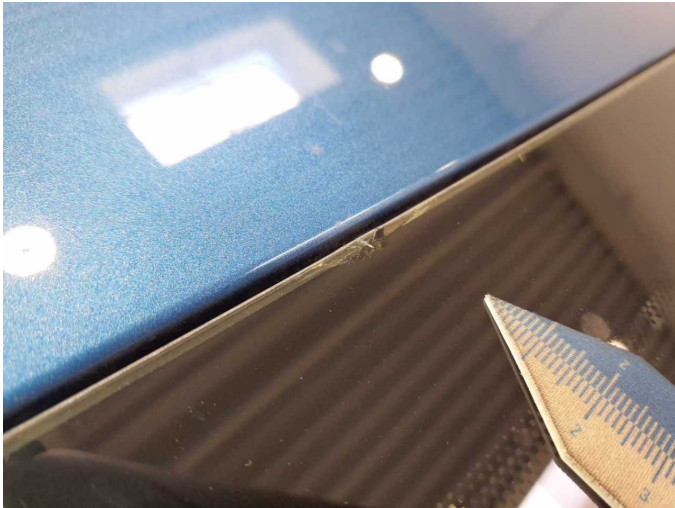
**Damage 15:** Vehicle glazing: Windscreen - Broken / torn - Replace

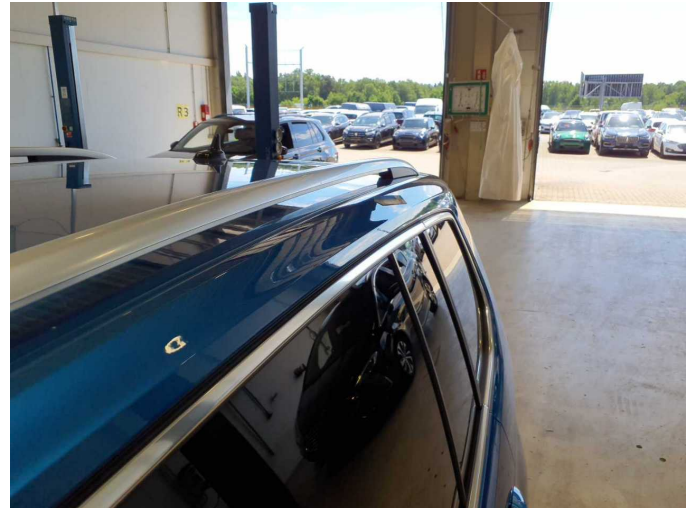
**Wear and tear 5:** Roof: Roof rail - left side - dent(s) - No deduction

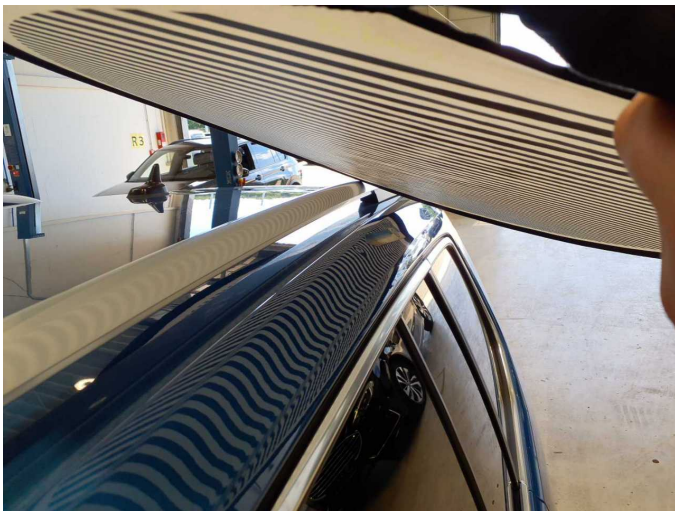
**Wear and tear 5:** Roof: Roof rail - left side - dent(s) - No deduction

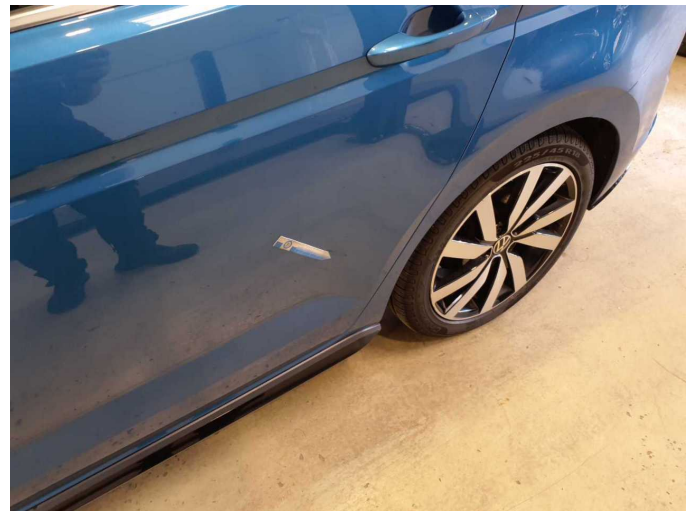
**Wear and tear 6:** Door - rear left side: Door - dent(s) - No deduction

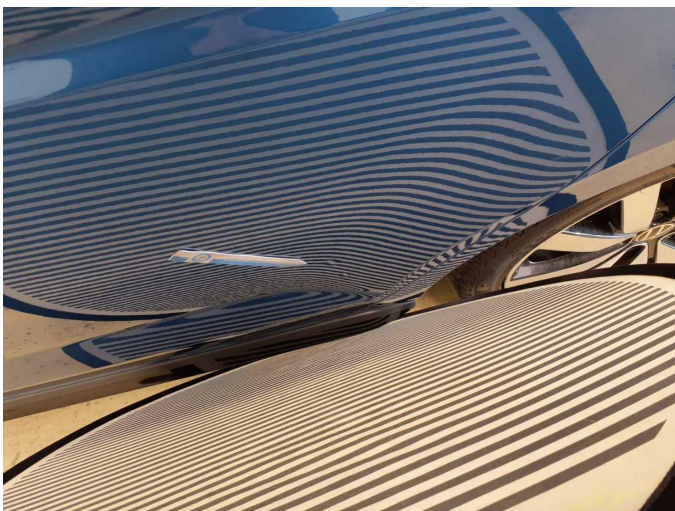
**Wear and tear 6:** Door - rear left side: Door - dent(s) - No deduction

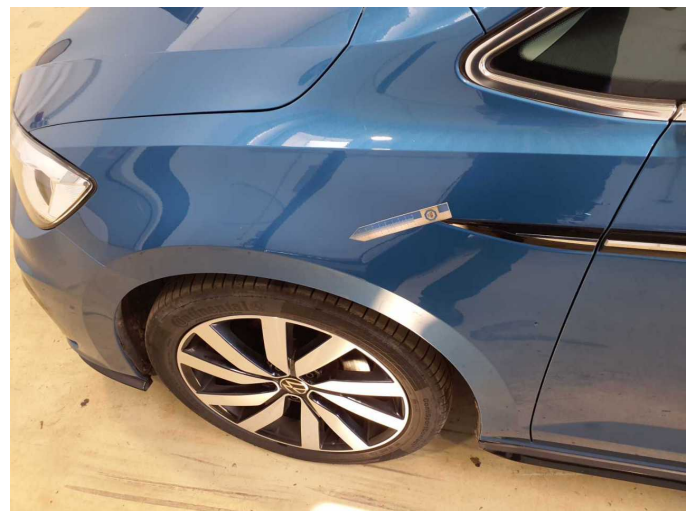
**Wear and tear 8:** Mudguard - left side: Mudguard - left side - dent(s) - No deduction

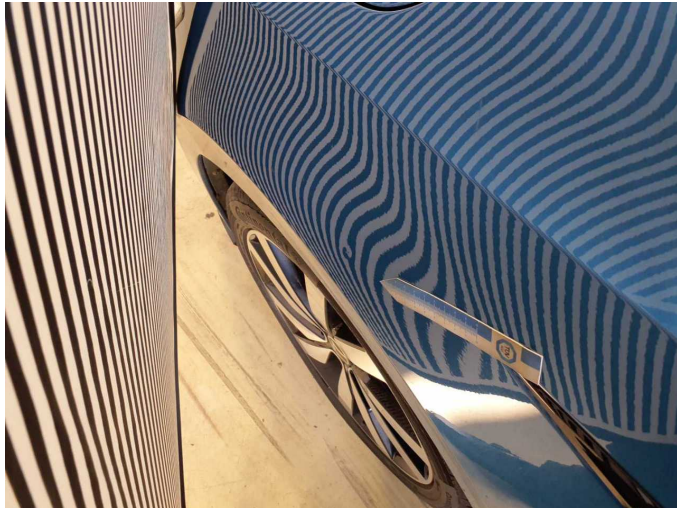
**Wear and tear 8:** Mudguard - left side: Mudguard - left side - dent(s) - No deduction

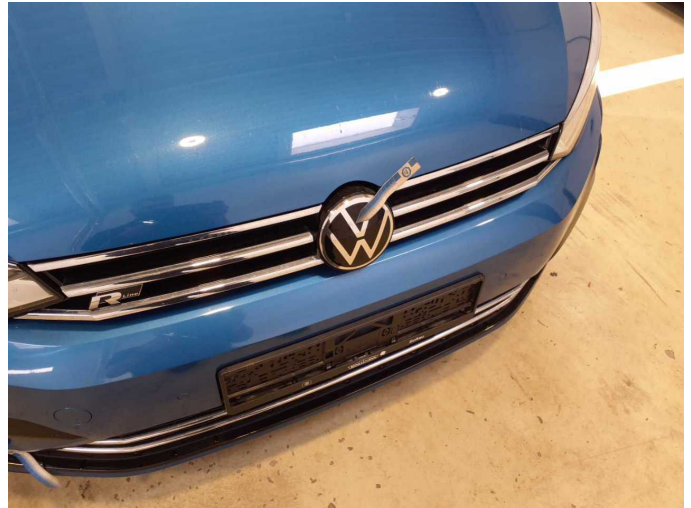
**Wear and tear 9:** Front structure: Emblem - Stone chips - No deduction

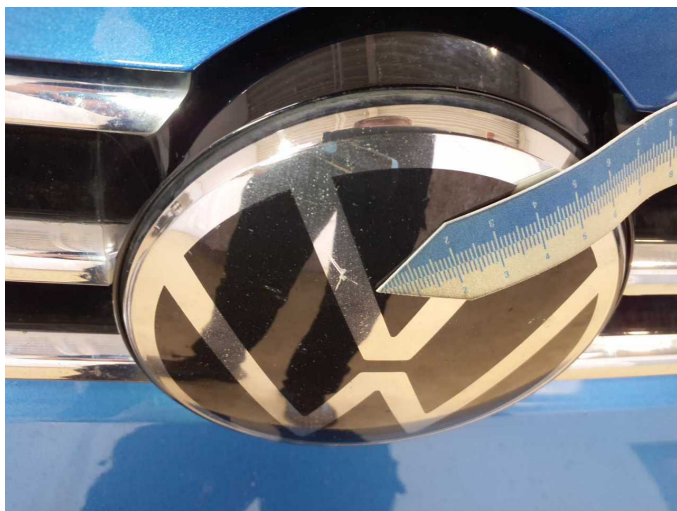
**Wear and tear 9:** Front structure: Emblem - Stone chips - No deduction

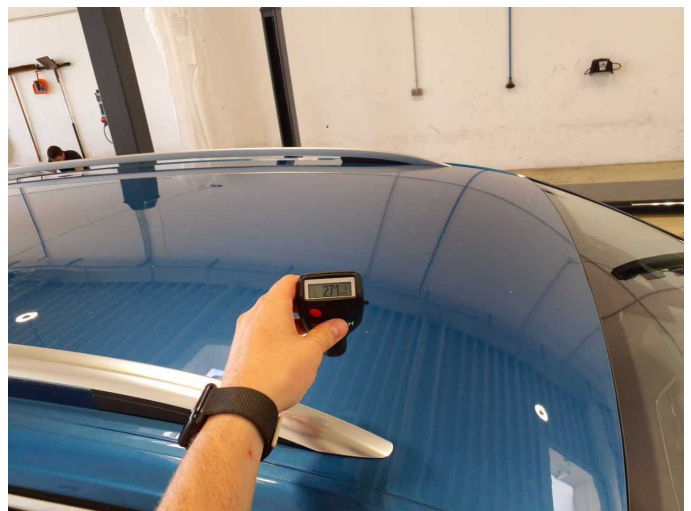
**Repainting 1:** Roof
