## Expertise

Protocol number: 45926602  
Order No. / Reference: 26490045  
Inspection date: 11 Jun 2026

Manufacturer: Opel

Model: Vivaro 1.5 D L

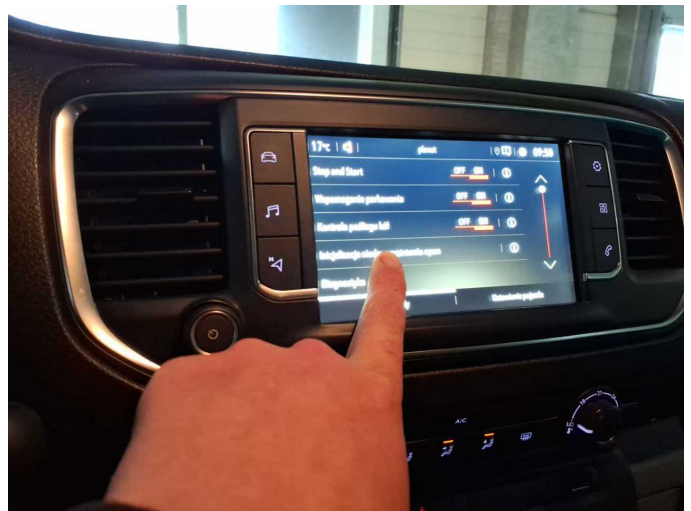
Damage 1: Multimedia system: Radio (Touch) - Non-operational - Perform diagnosis

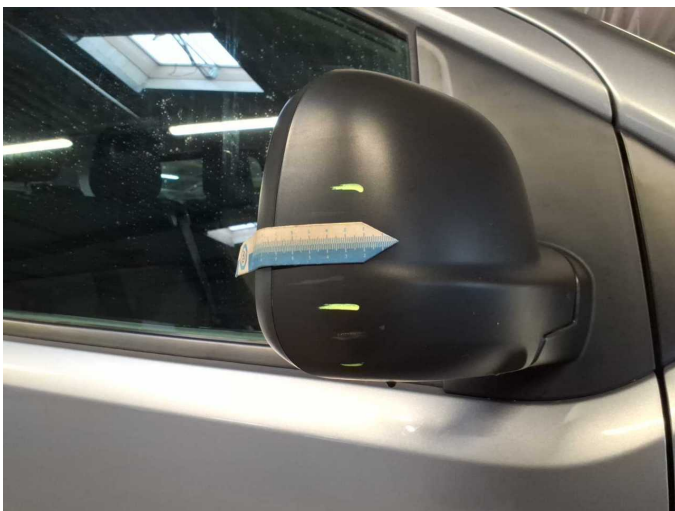
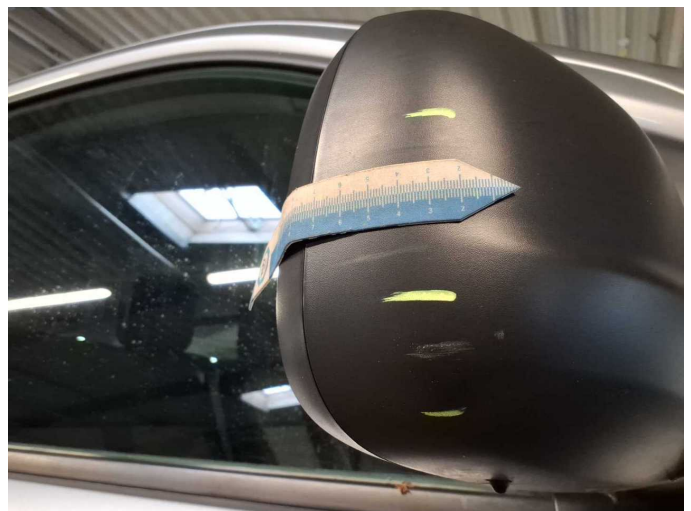
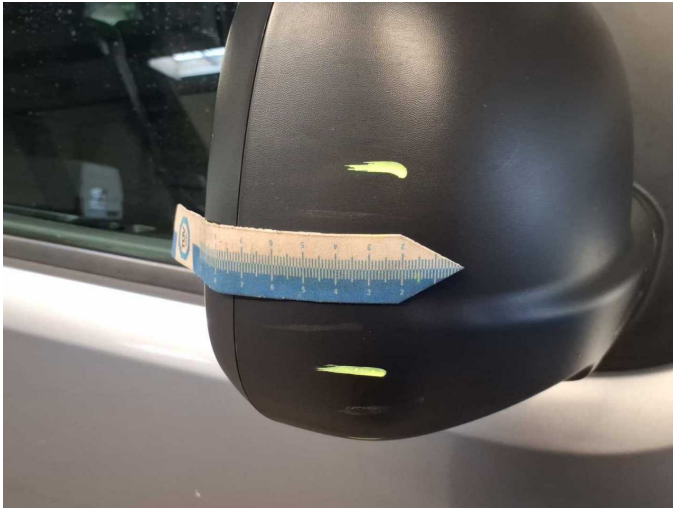
Damage 2: Wing mirror - right side: Cap - Scratch(es) - Smart repair

**Damage 2:** Wing mirror - right side: Cap - Scratch(es) - Smart repair

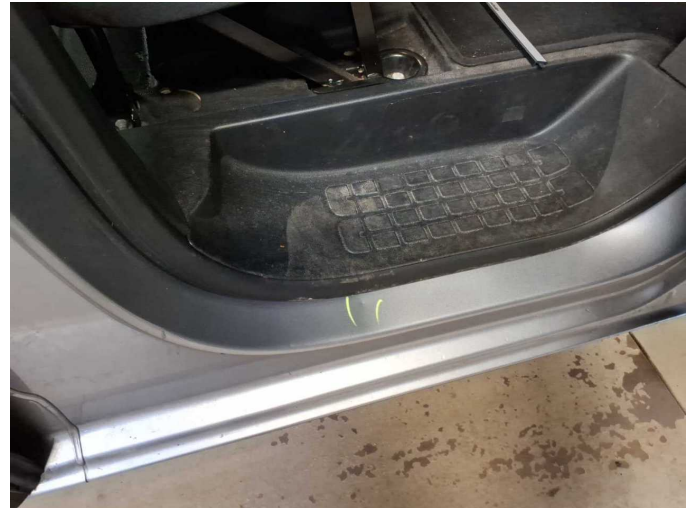
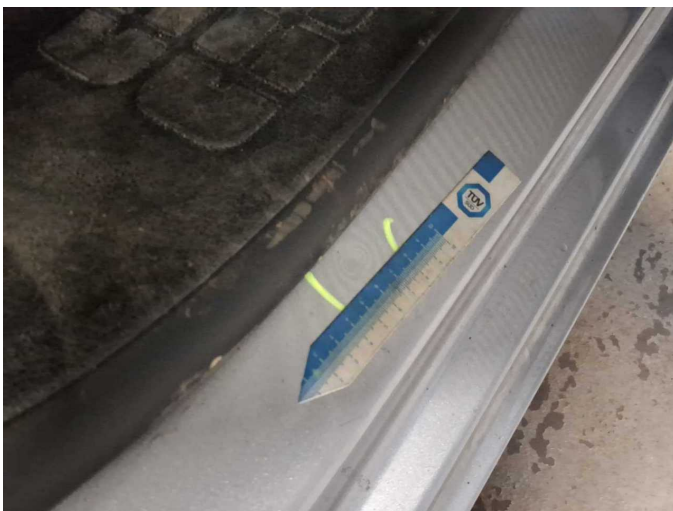
**Damage 3:** Sill - right side: Sill - dent(s) - Smooth repair work

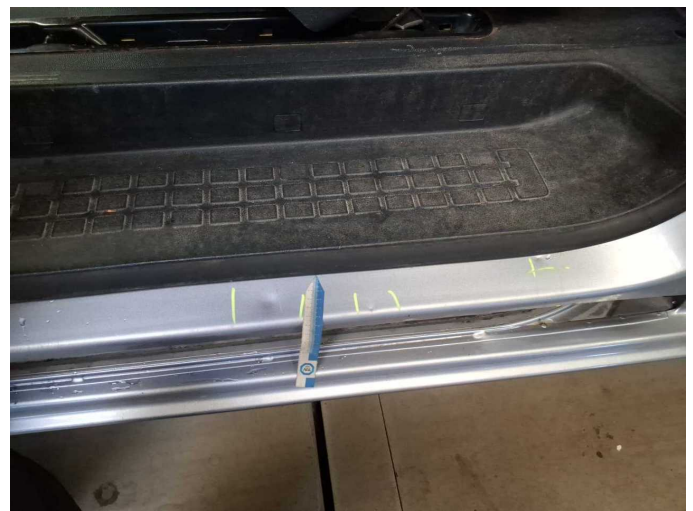
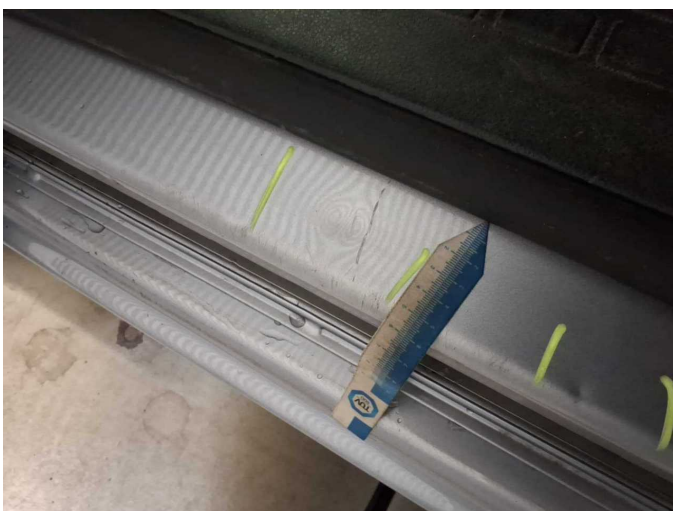
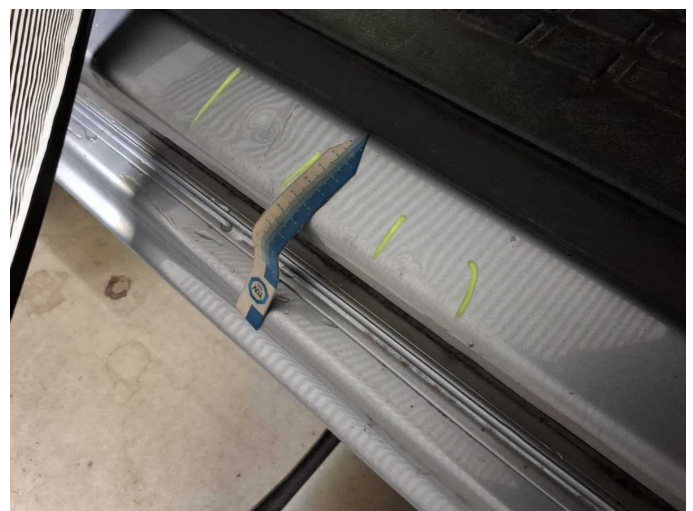
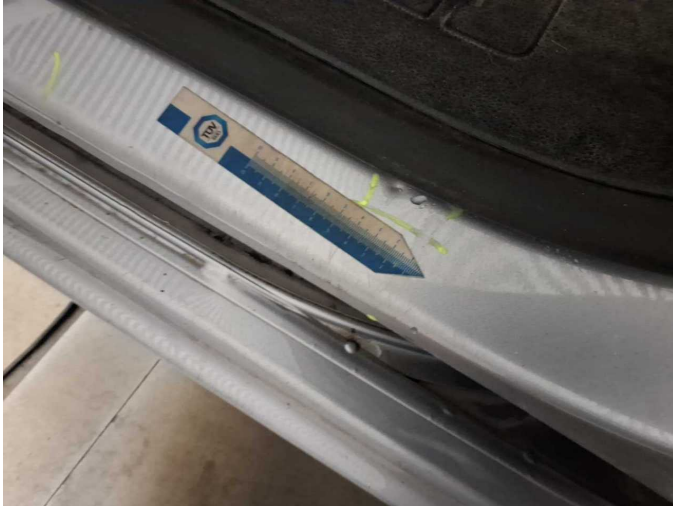
**Damage 4:** Side panel - rear right side: Side panel - dent(s) - Smooth repair work

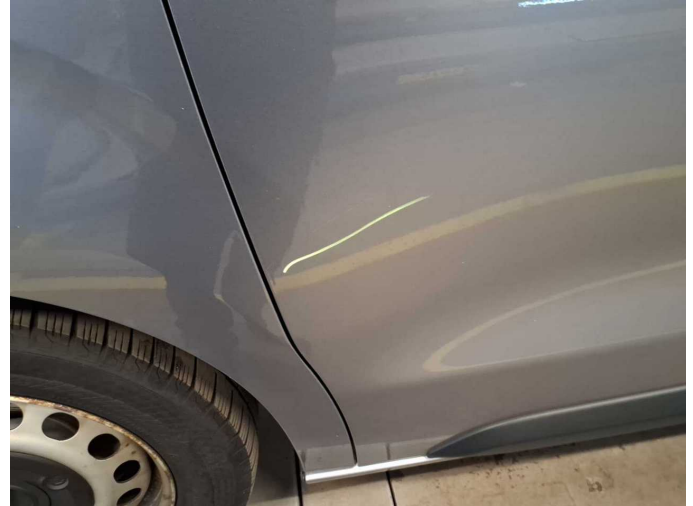
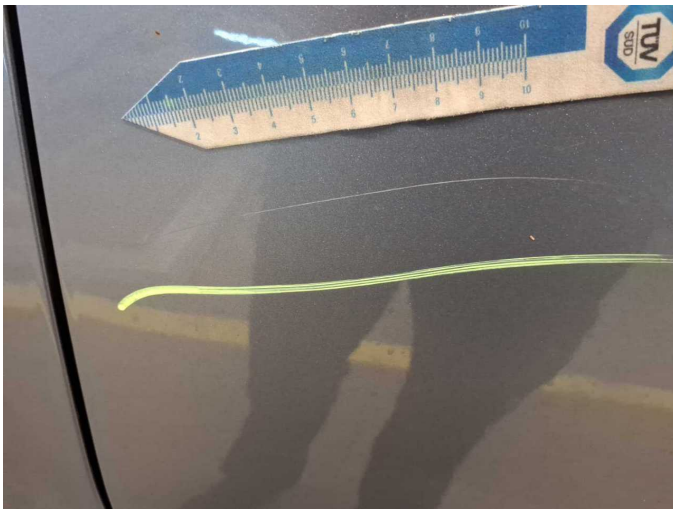
**Damage 5:** Door - front left side: Door - Scratch(es) - Smart repair

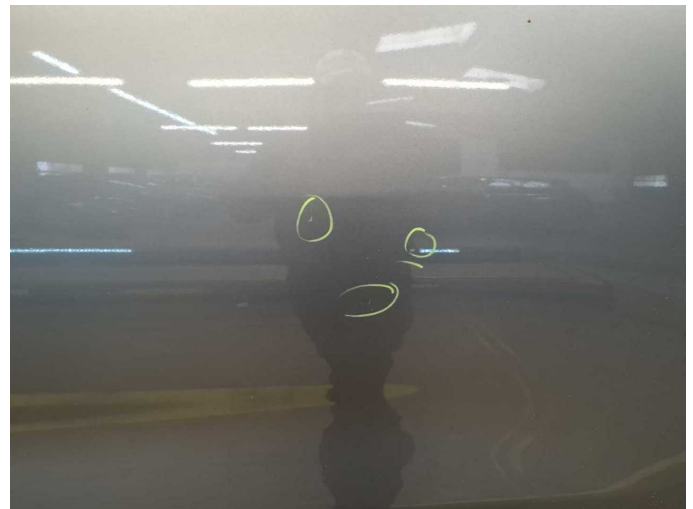
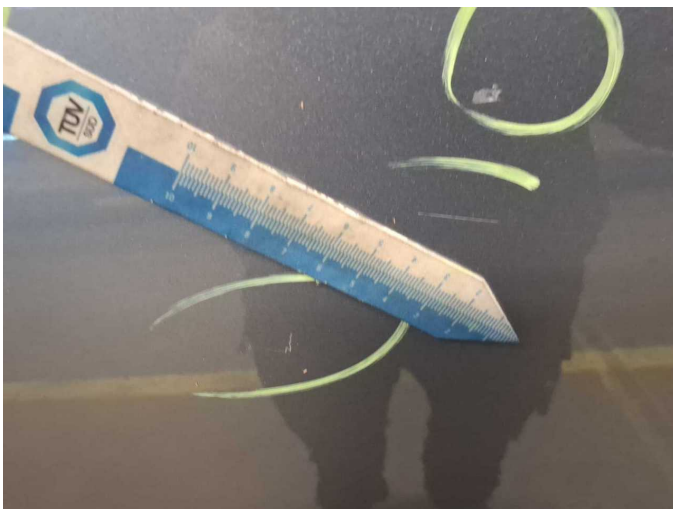
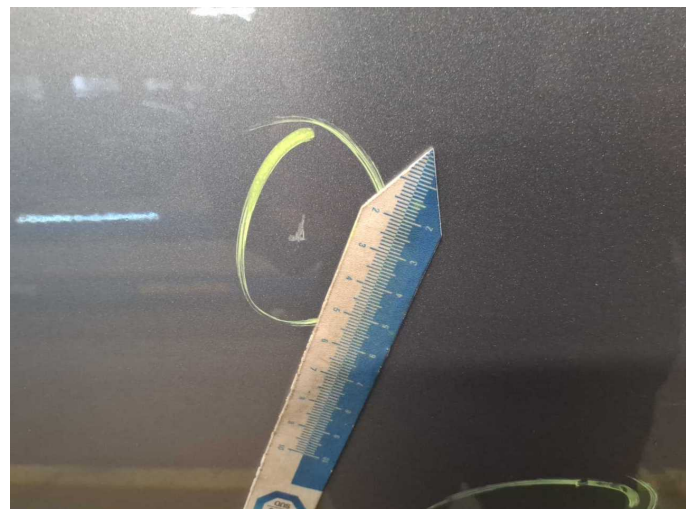
**Damage 6:** Side panel - rear left side: Side panel - Scratch(es) - Smart repair

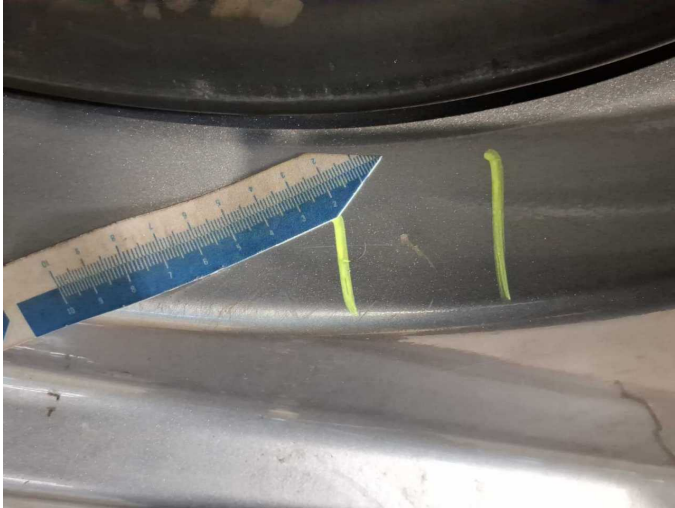
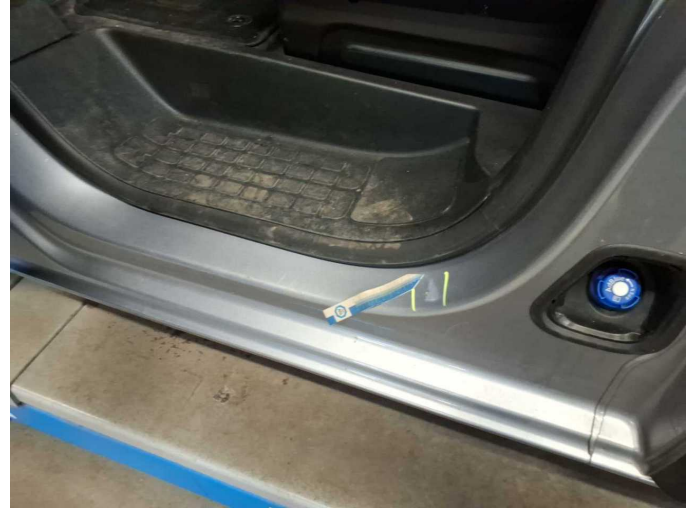
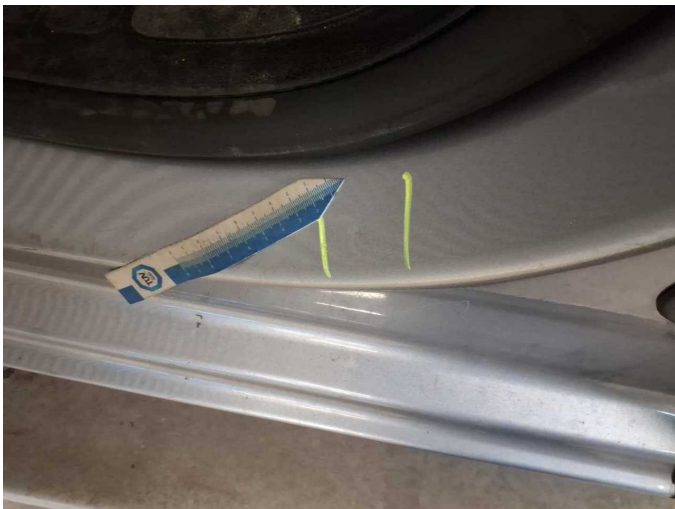
**Damage 7:** Sill - left side: Sill - Dent / paintcoat damage - Smart repair

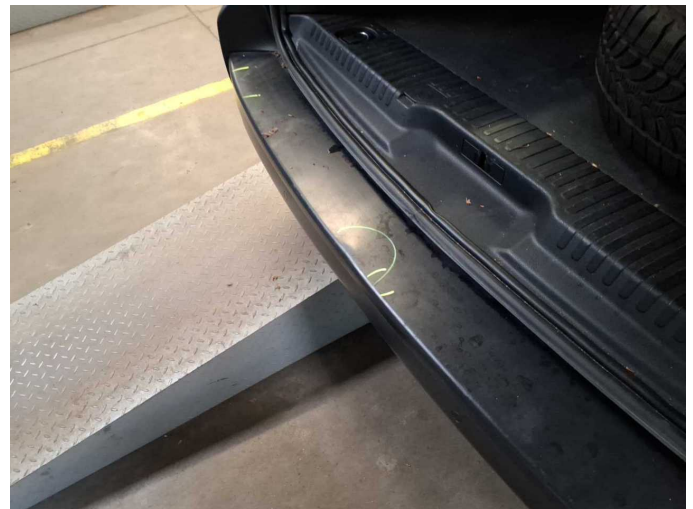
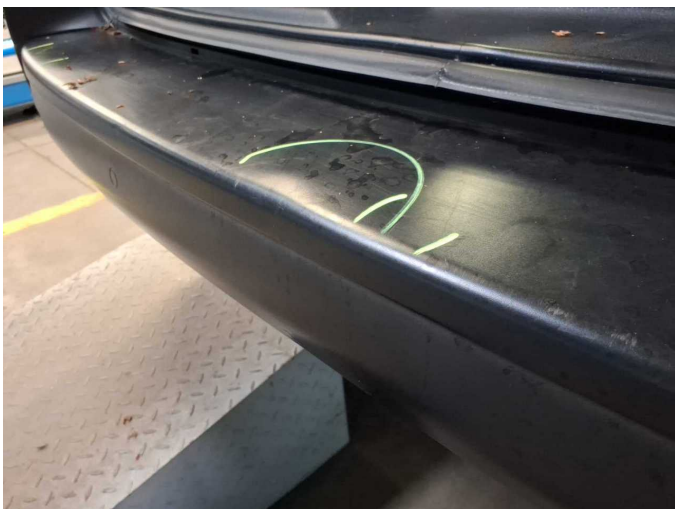
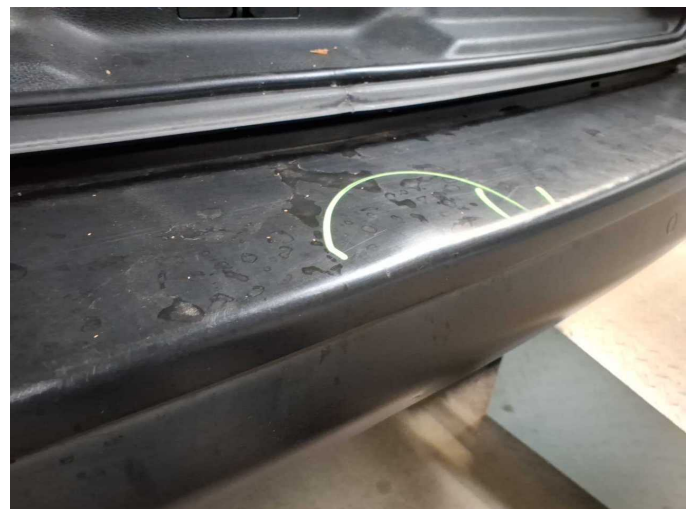
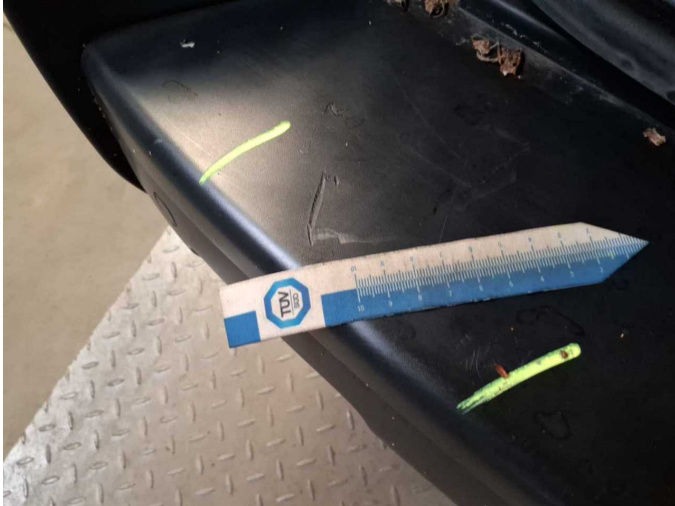
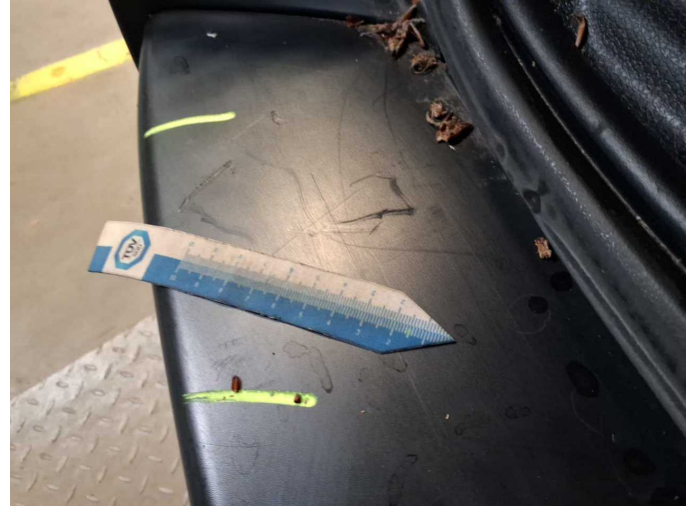
**Damage 8:** Rear bumper: Rear bumper (unpainted) - Deformed - Loss in value

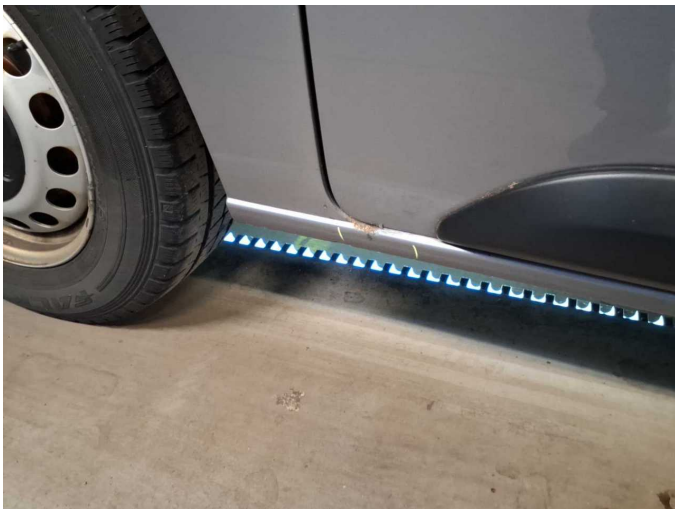
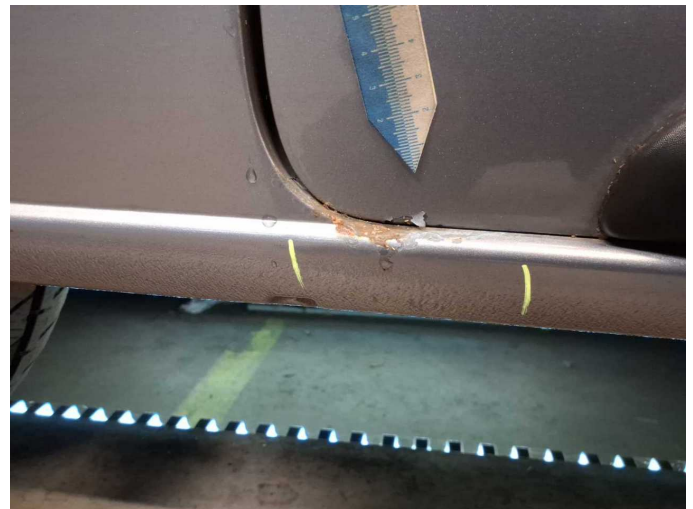
**Damage 9:** Sill - right side: Sill - Corrosion - Paint

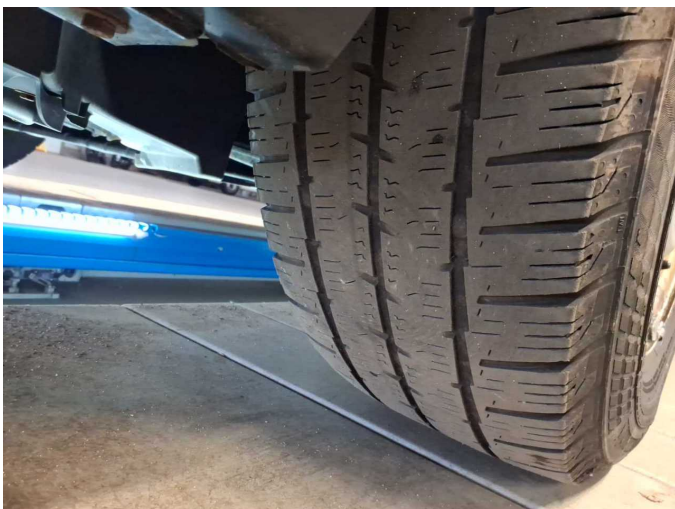
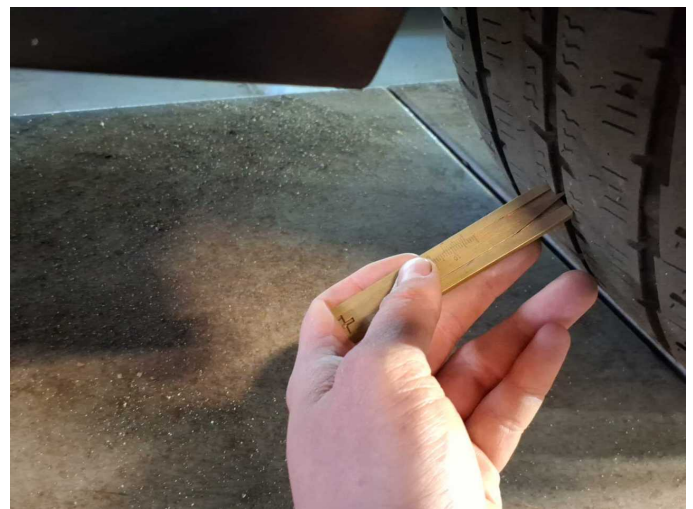
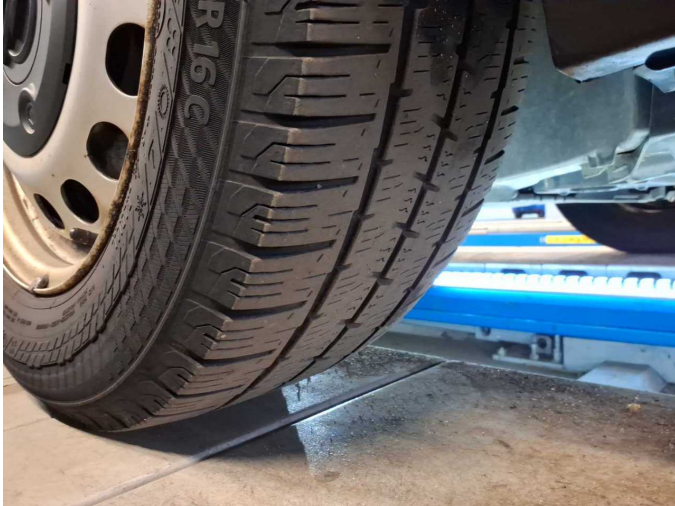
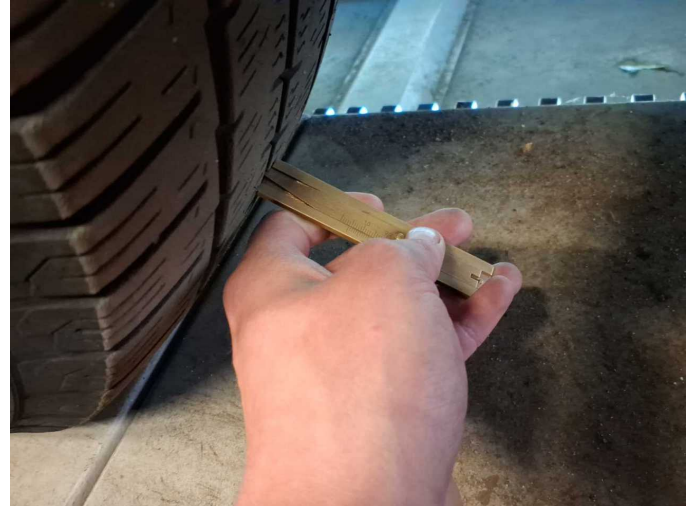
**Damage 10:** Wheel / tyres: Tyre - front - Does not meet the leasing specifications - Replace

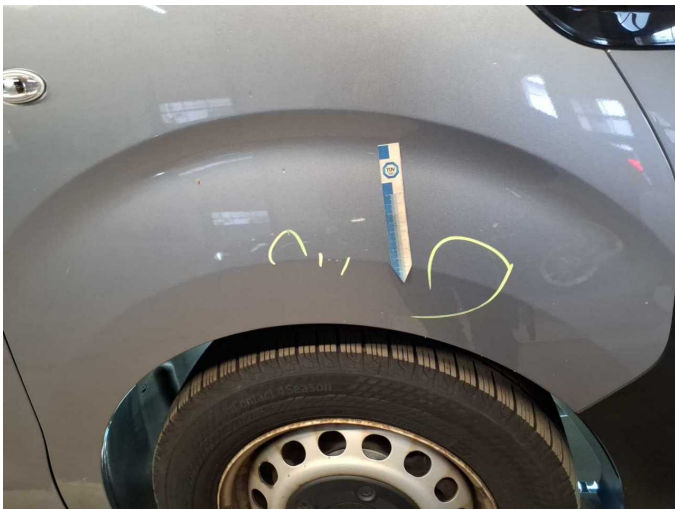
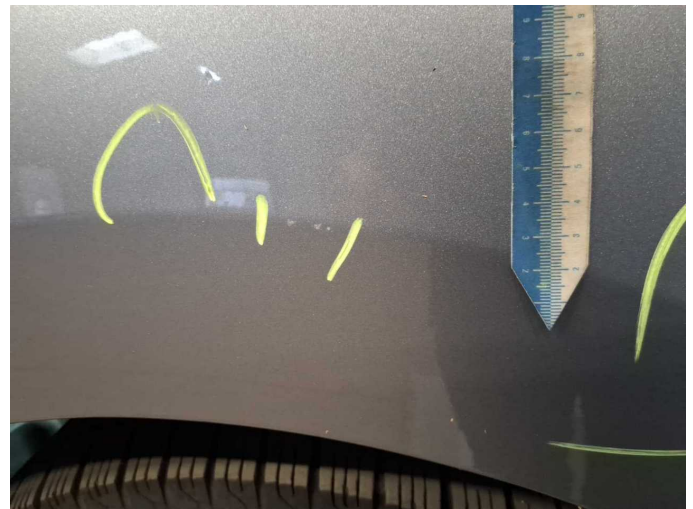
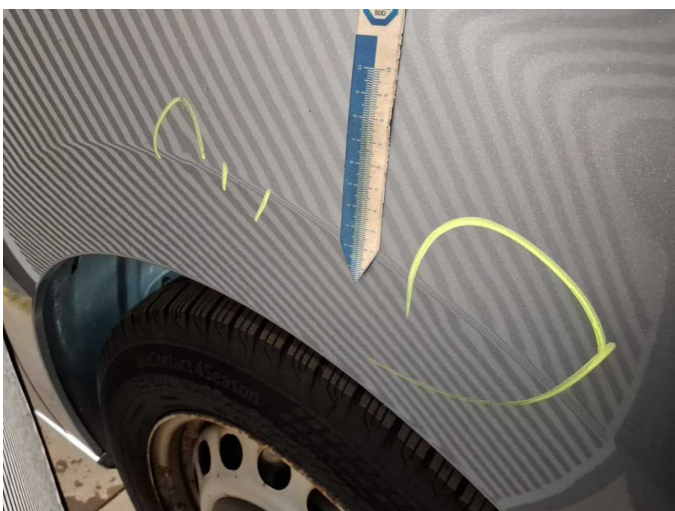
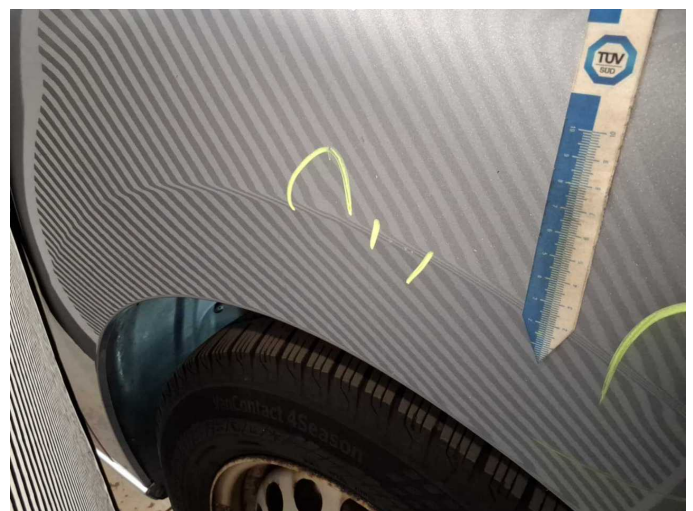
**Damage 11:** Mudguard - right side: Mudguard - right side - Dent / paintcoat damage - Repair and paint

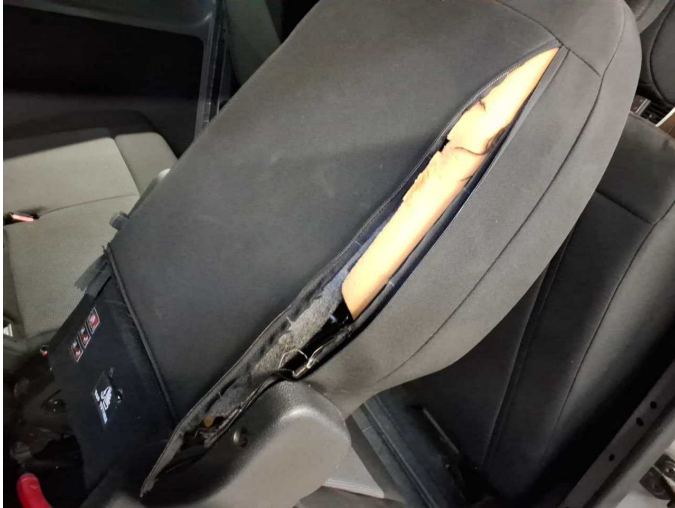
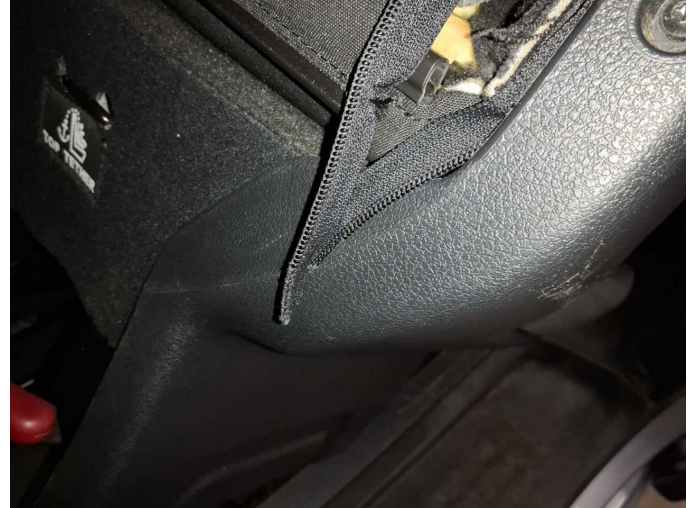
**Damage 12:** Seat - rear: Seat cover - 2nd row (Lehnenbezug) - Damaged - Replace

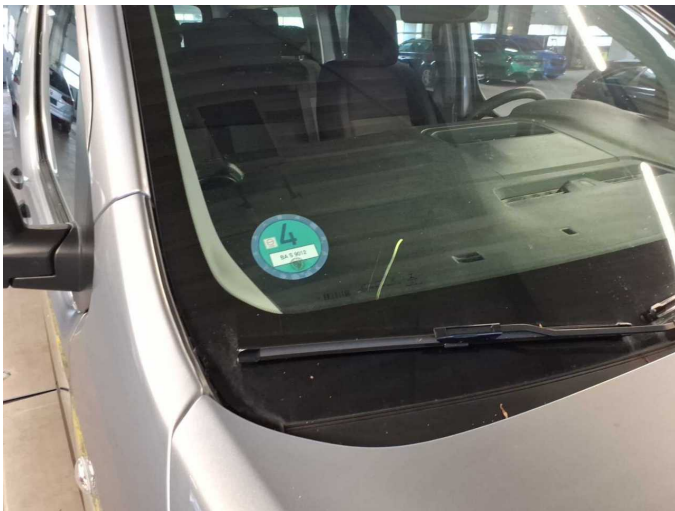
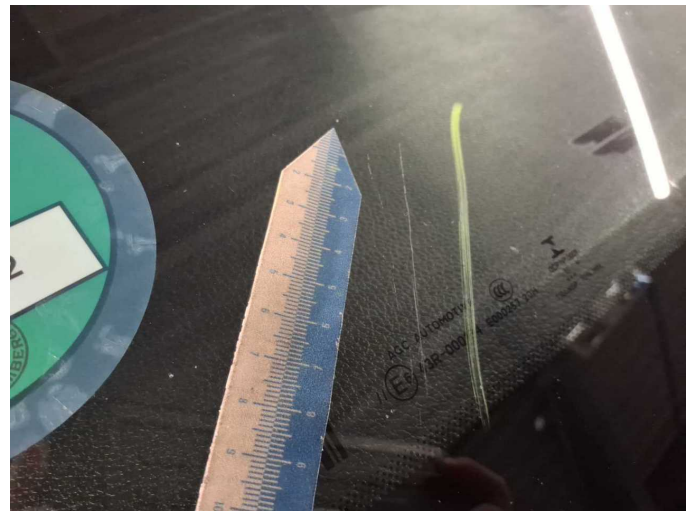
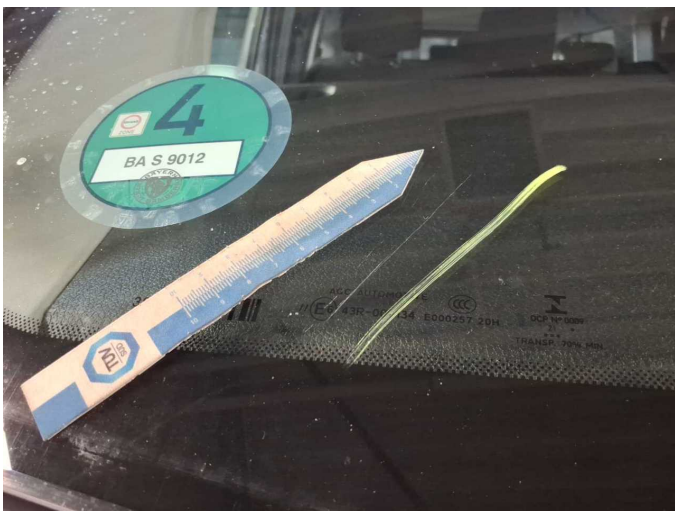
**Damage 13:** Vehicle glazing: Windscreen - Scratch(es) - Replace

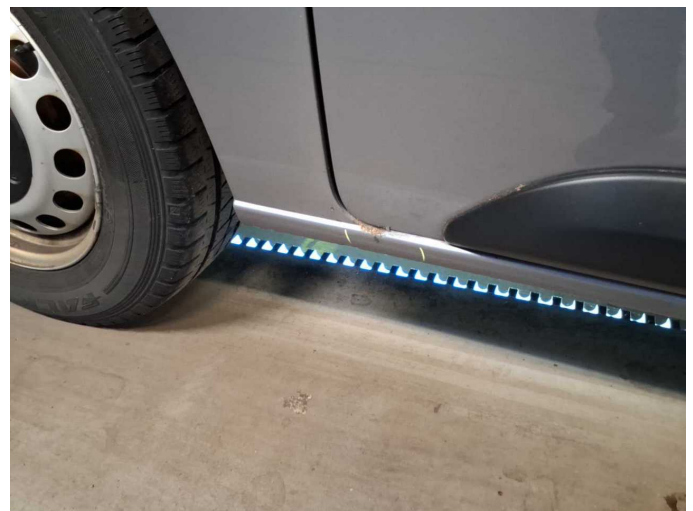
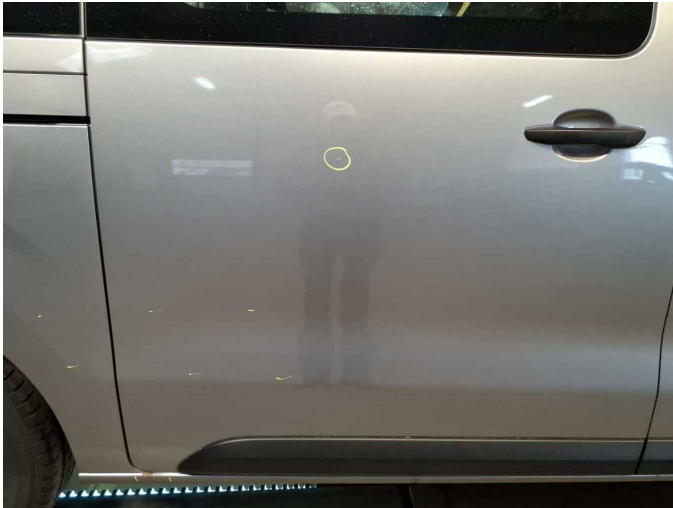
**Damage 14:** Sliding door, right: Sliding door (+Kratzer) - Corrosion - Paint

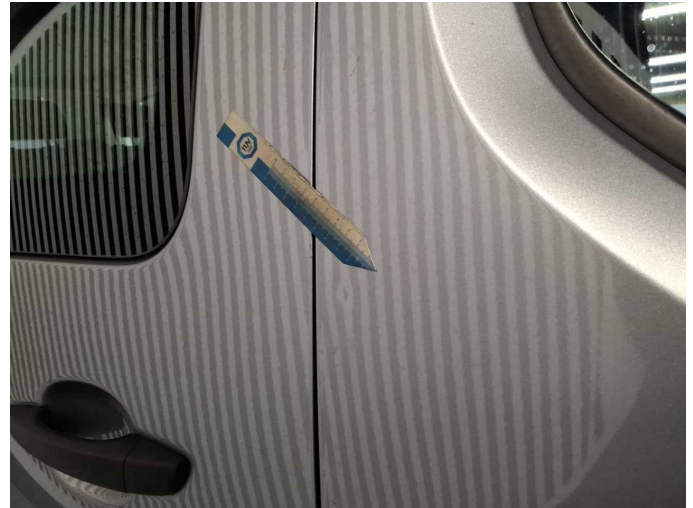
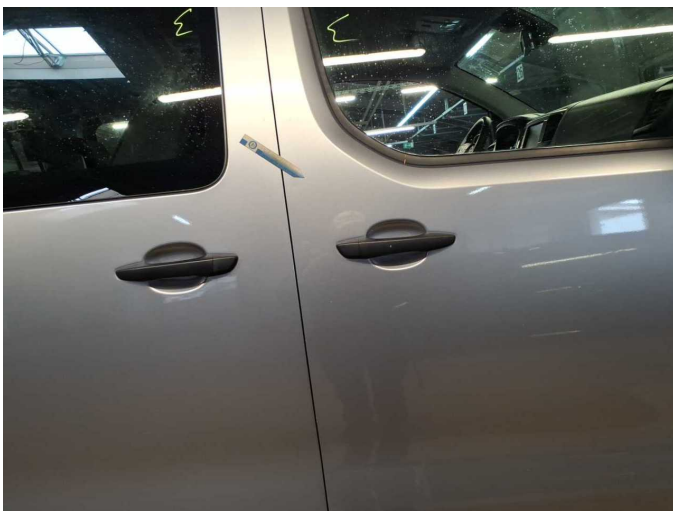
**Damage 15:** Door - front right side: Door - Dent / paintcoat damage - Repair and paint

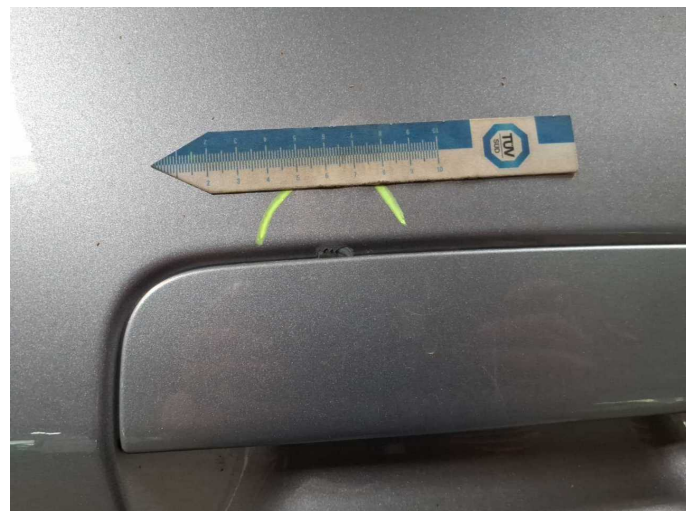
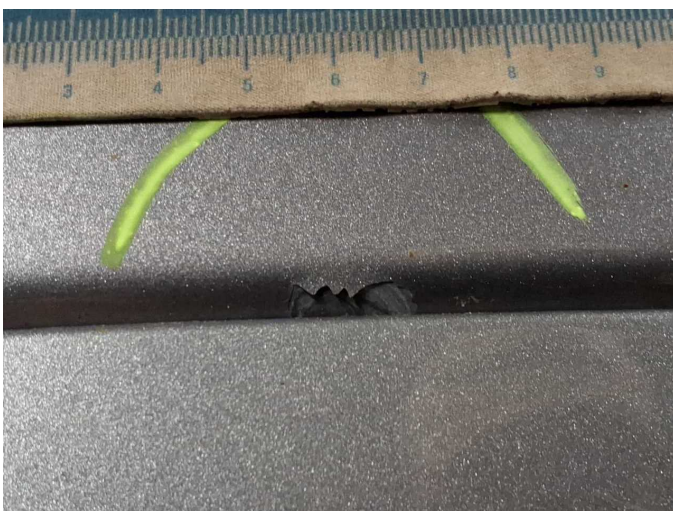
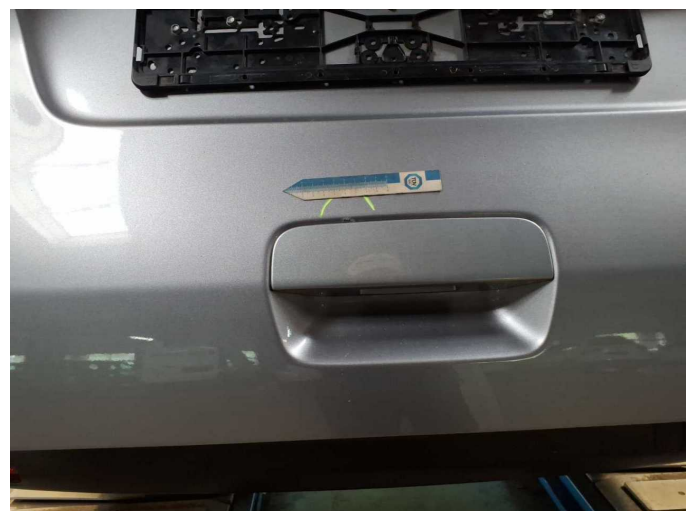
**Damage 16:** Boot lid / rear door: Boot lid - Dent / paintcoat damage - Paint

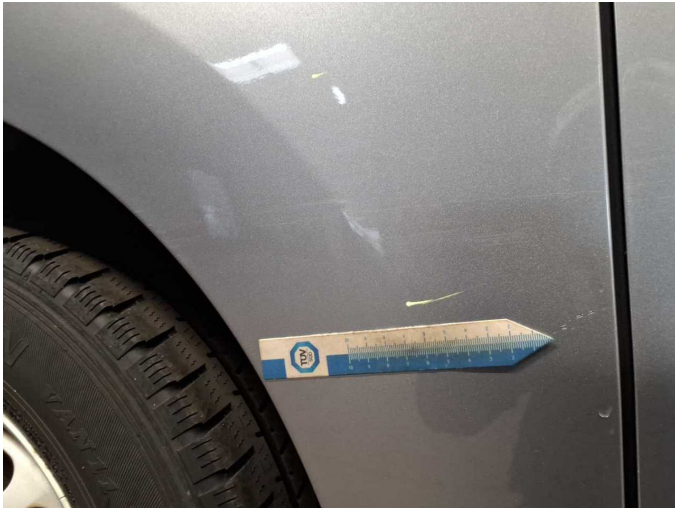
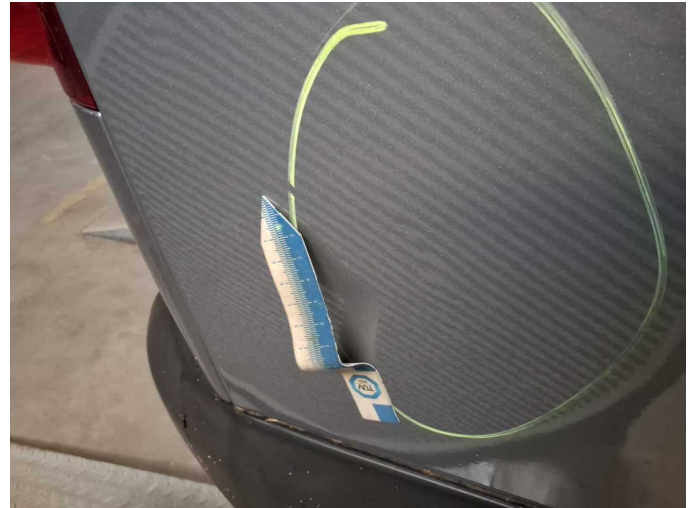
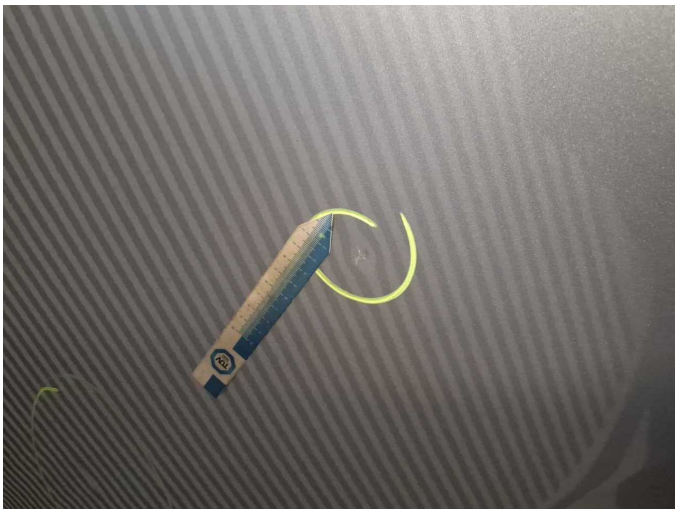
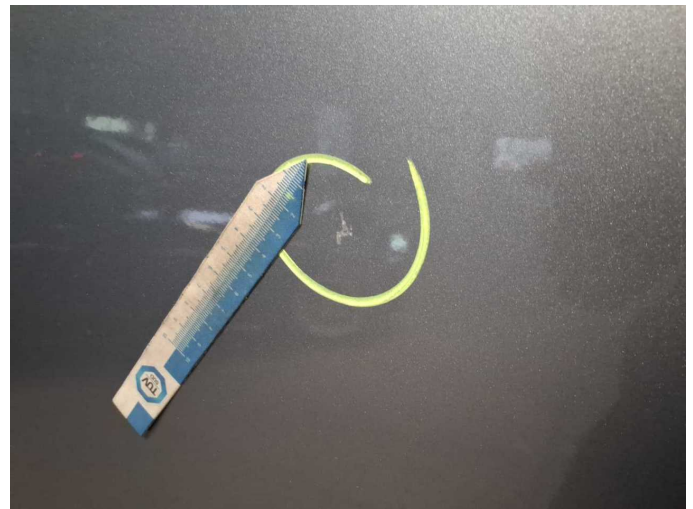
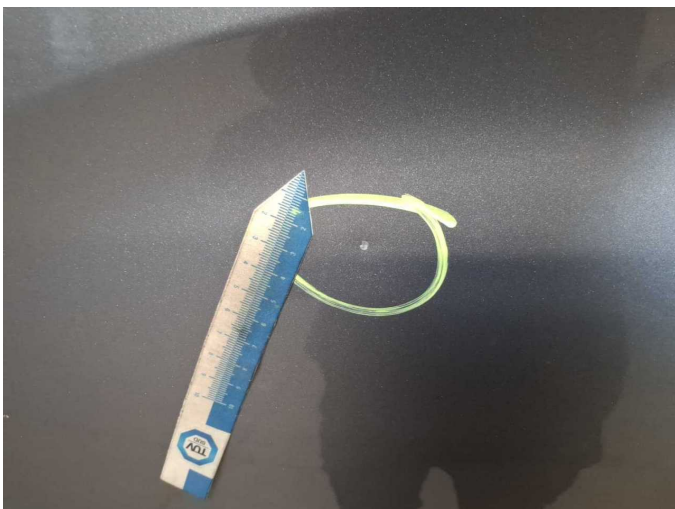
**Damage 17:** Side panel - rear right side: Side panel - Dent / paintcoat damage - Repair and paint

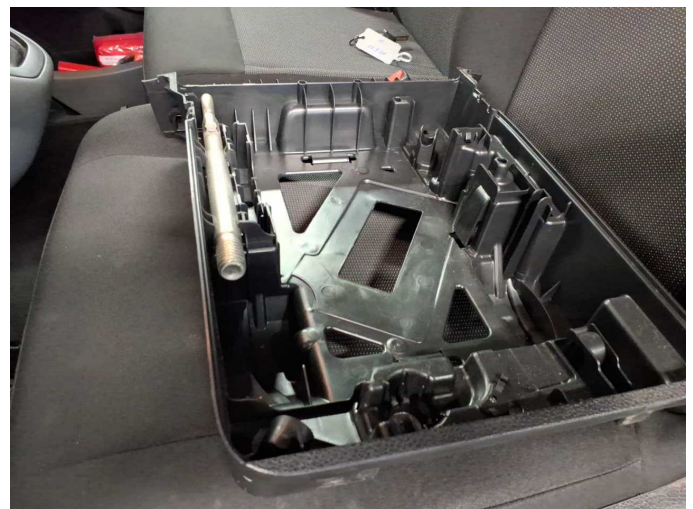
**Missing part 1:** Equipment: Tirefit complete - Missing - Replace

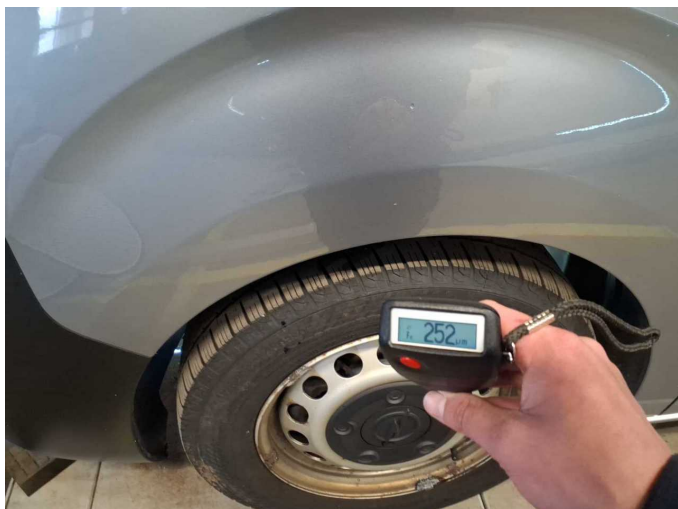
Mudguard - left side 252 µm |

Repainting 1: Mudguard - left side
