Expertise

Protocol number: 47180050  
Order No. / Reference: 26913223  
Inspection date: 19 Aug 2026

Manufacturer: Volkswagen

Model: Golf Variant 2.0 TDI SCR DSG Life

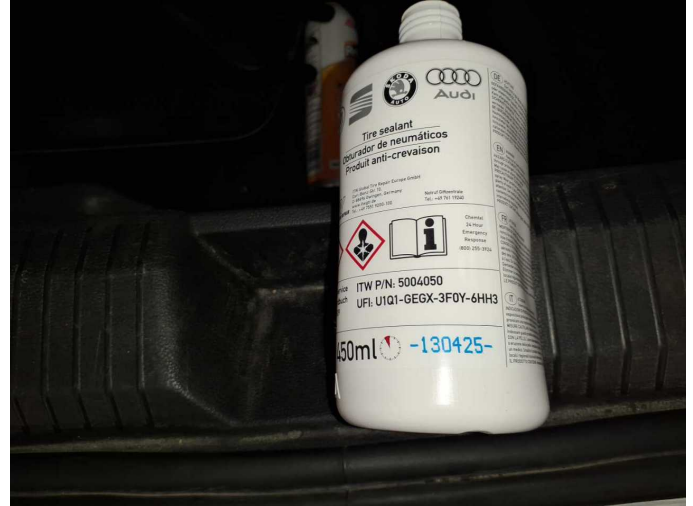
| No. | Component group | Description |
|---|---|---|
| 1 | Equipment | Tirefit filler - Expired - Replace |

**Damage 1:** Equipment: Tirefit filler - Expired - Replace

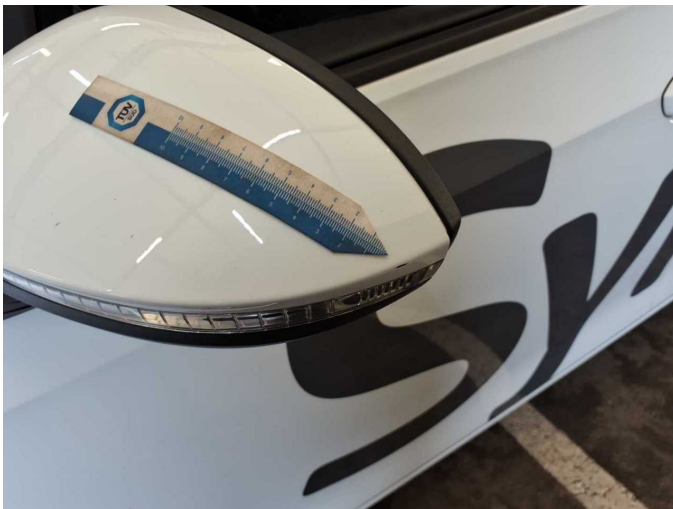
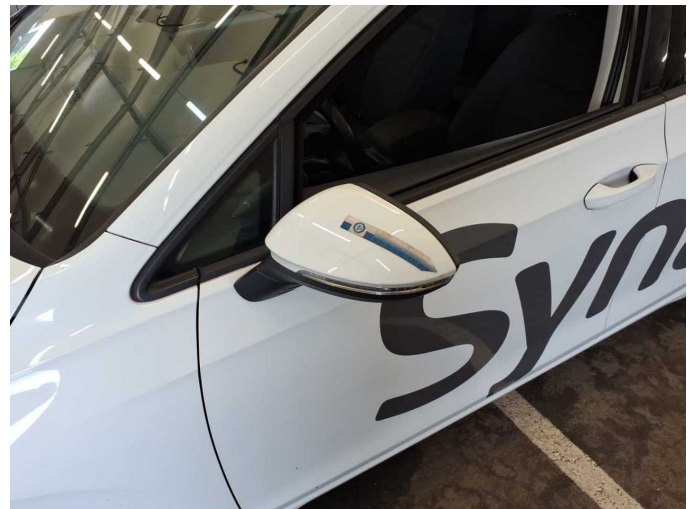
| No. | Component group | Description |
|---|---|---|
| 2 | Wing mirror - left side | Cap - Scratch(es) - Smart repair |

**Damage 2:** Wing mirror - left side: Cap - Scratch(es) - Smart repair

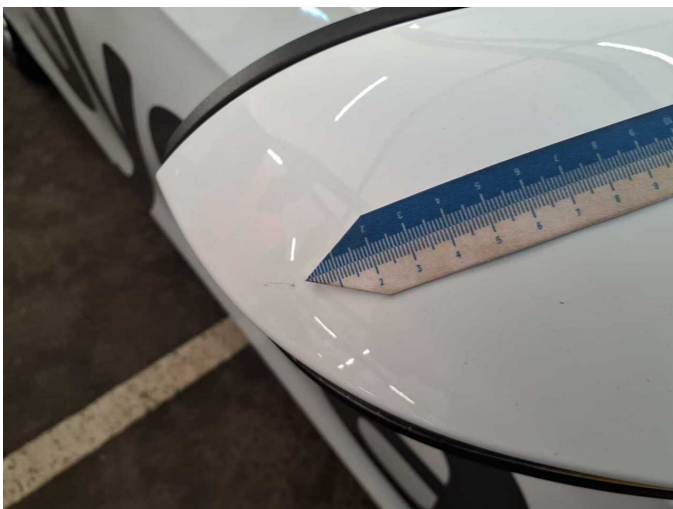
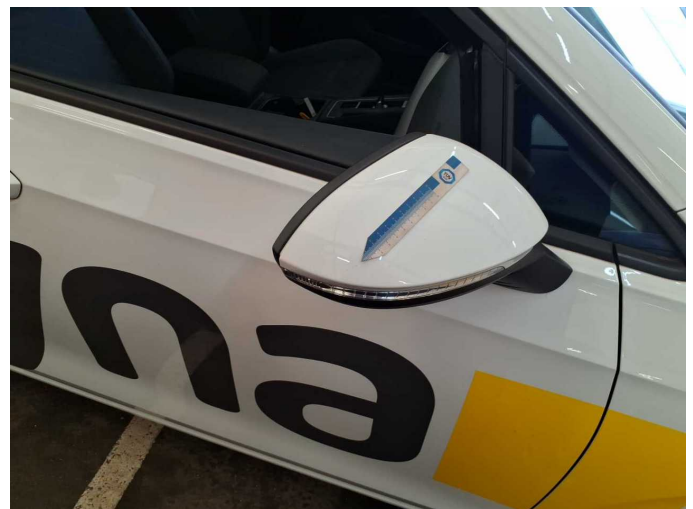
| No. | Component group | Description |
|---|---|---|
| 3 | Wing mirror - right side | Cap - Scratch(es) - Smart repair |

**Damage 3:** Wing mirror - right side: Cap - Scratch(es) - Smart repair

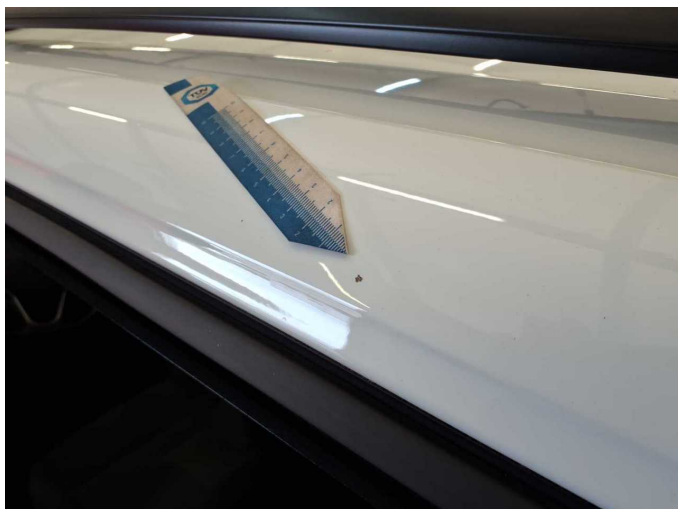
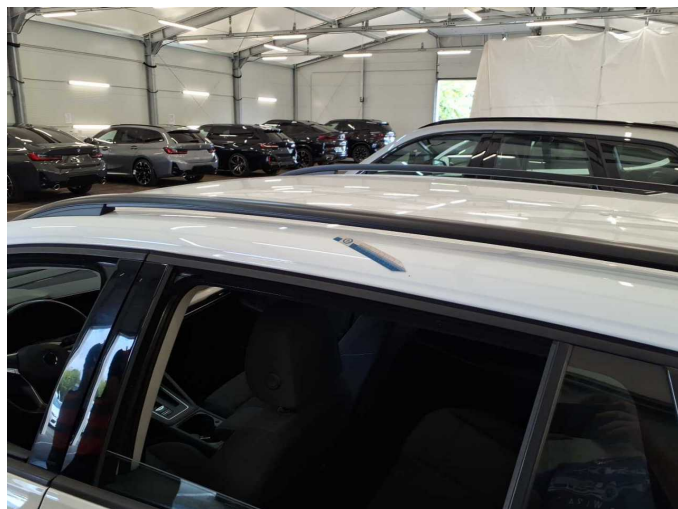
| No. | Component group | Description |
|---|---|---|
| 4 | Roof | Roof rail - left side - Scratch(es) - Smart repair |

**Damage 4:** Roof: Roof rail - left side - Scratch(es) - Smart repair

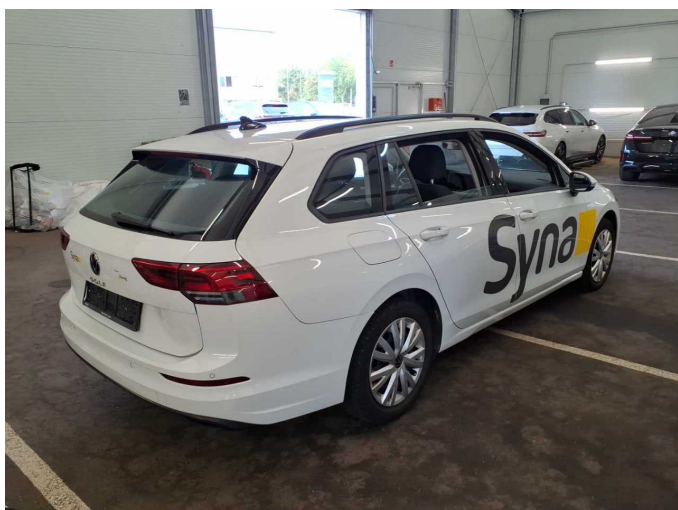
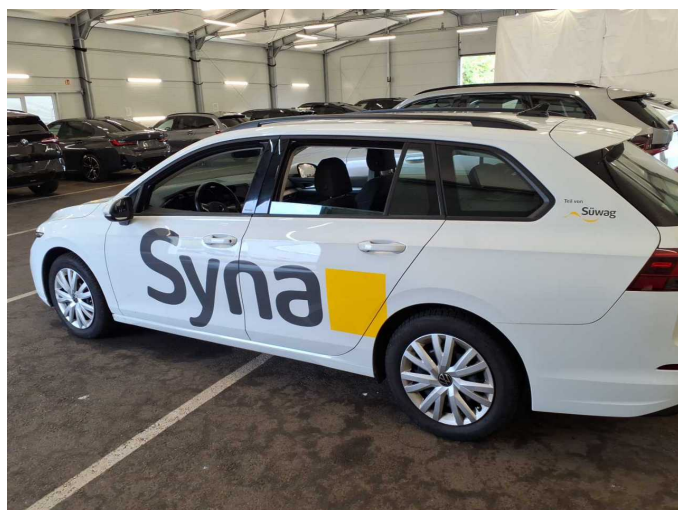
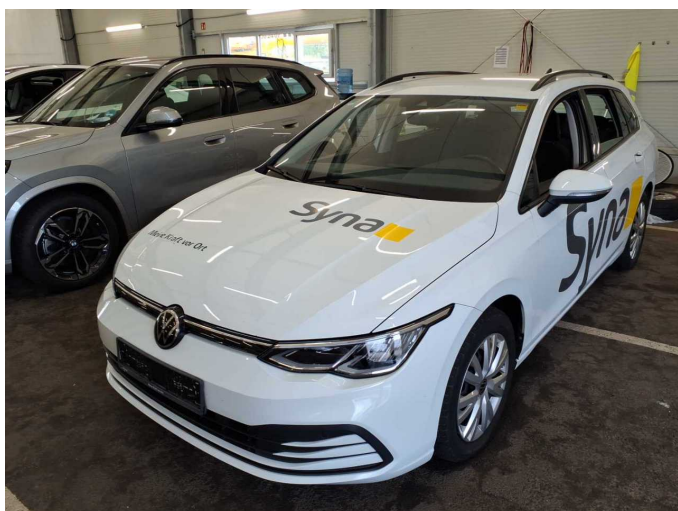
| No. | Component group | Description |
|---|---|---|
| 5 | Body | Body - Glued / labelled - De-glue / neutralise |

**Damage 5:** Body: Body - Glued / labelled - De-glue / neutralise

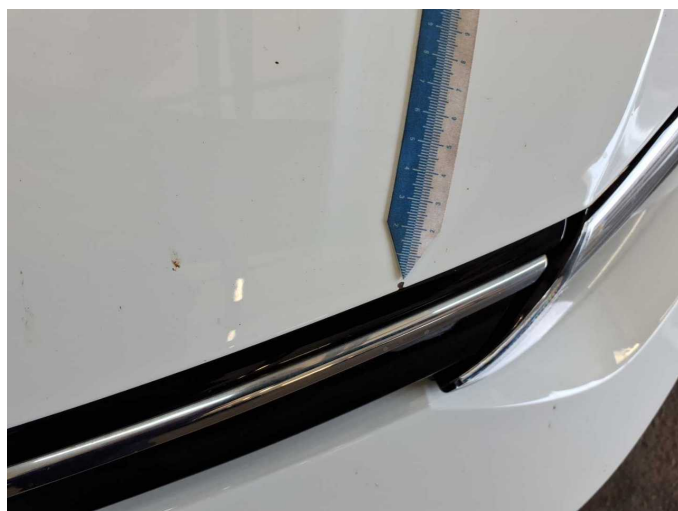
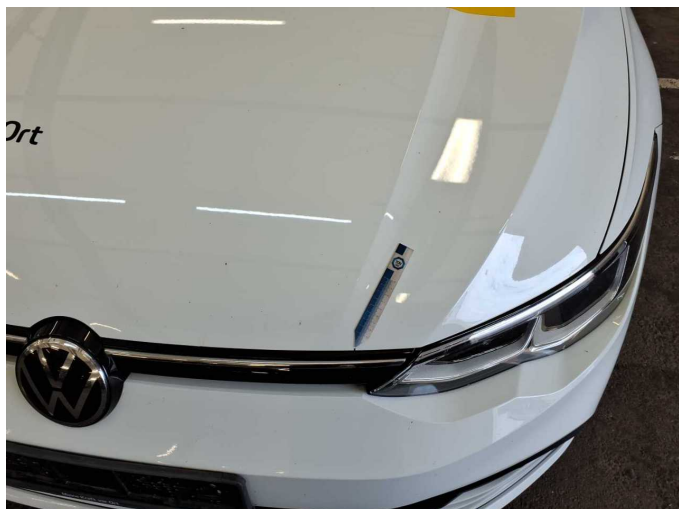
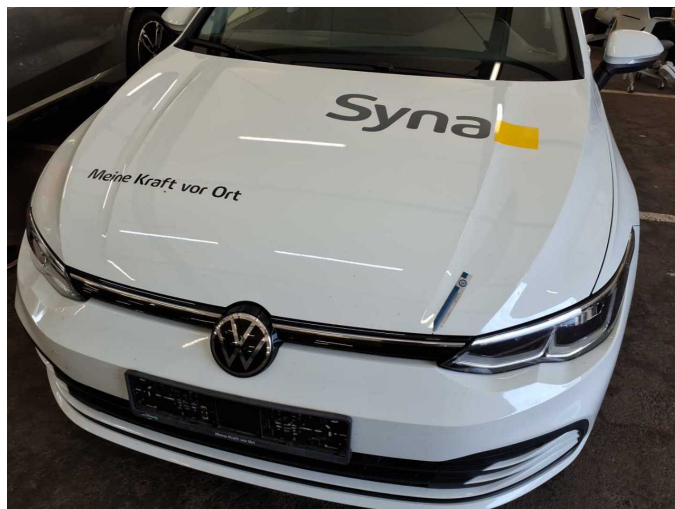
| No. | Component group | Description |
|---|---|---|
| 6 | Bonnet | Bonnet - Corrosion - Paint |

**Damage 6:** Bonnet: Bonnet - Corrosion - Paint

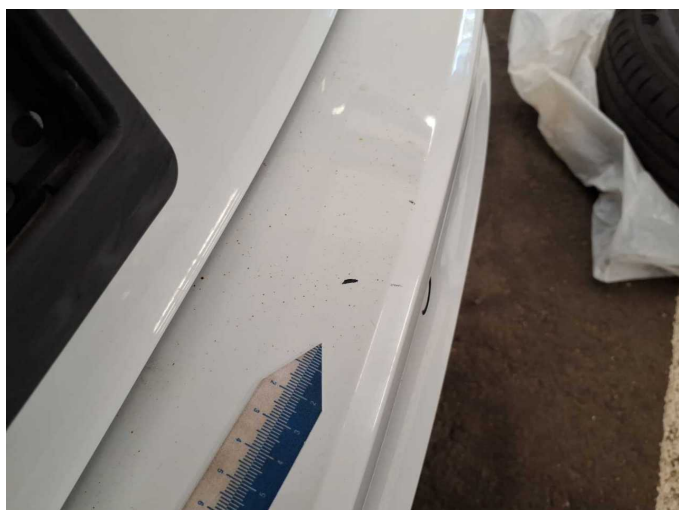
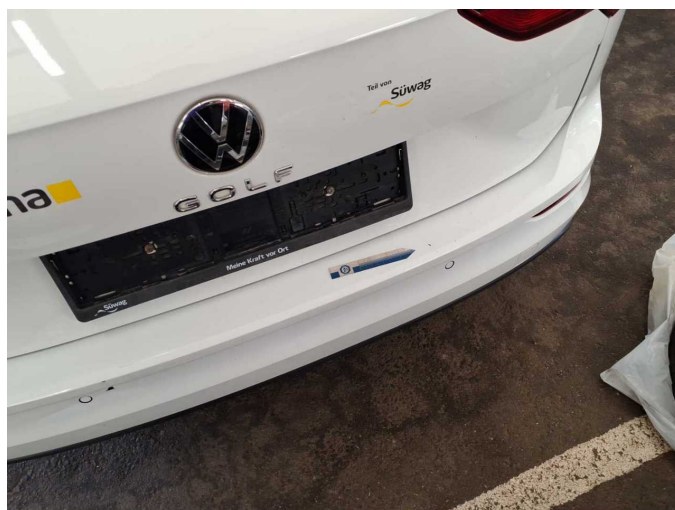
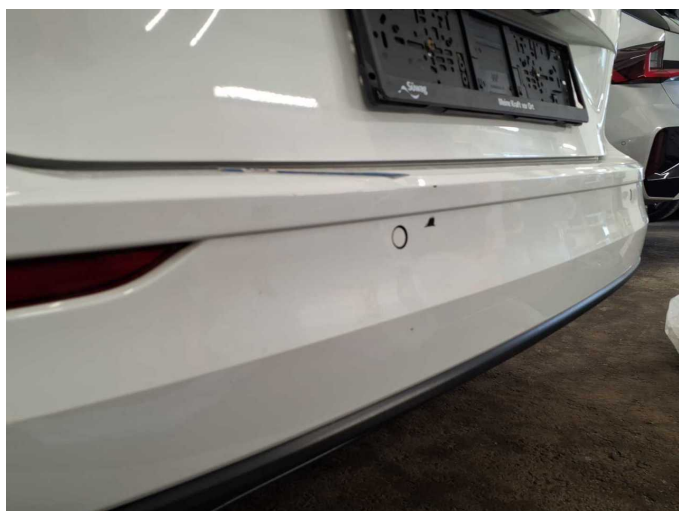
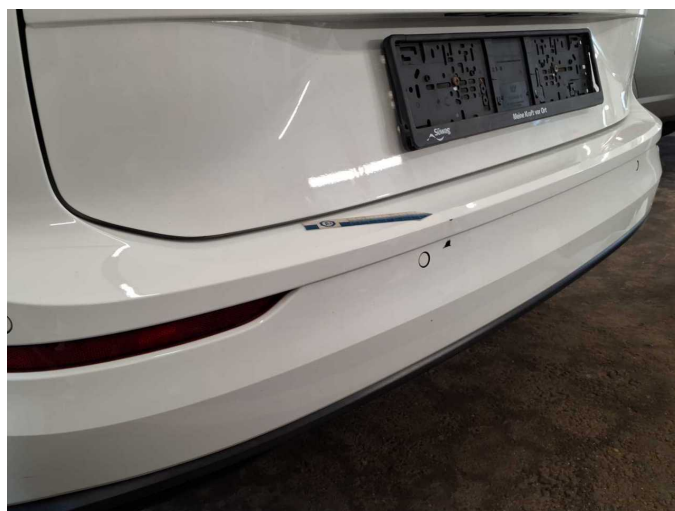
| No. | Component group | Description |
|---|---|---|
| 7 | Rear bumper | Rear bumper - Scratched - Paint |

**Damage 7:** Rear bumper: Rear bumper - Scratched - Paint

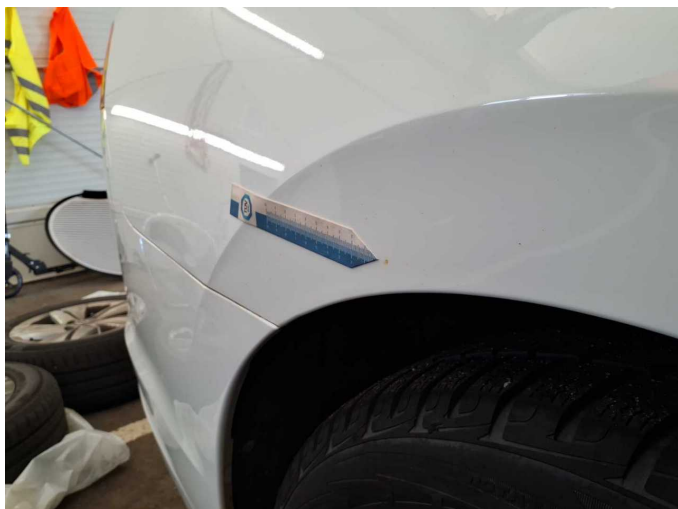
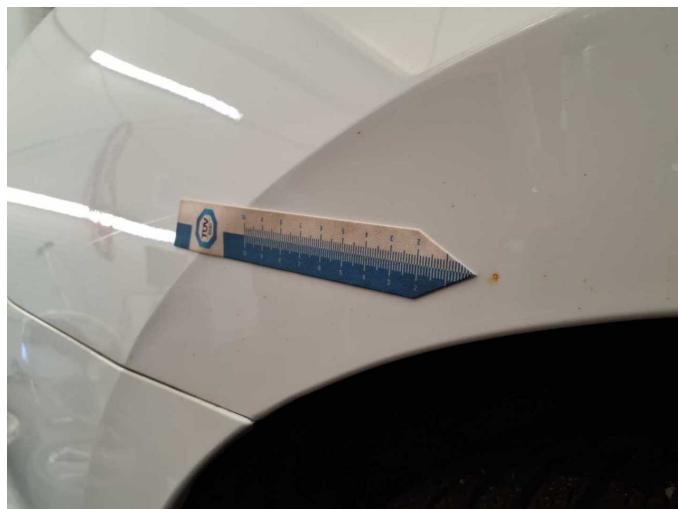
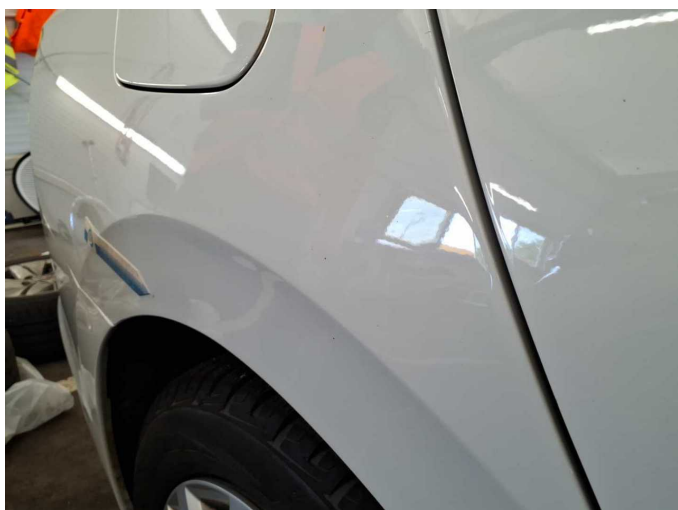
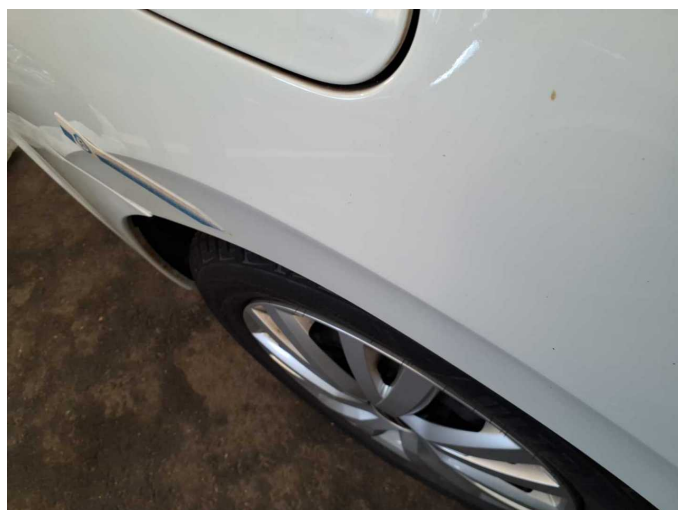
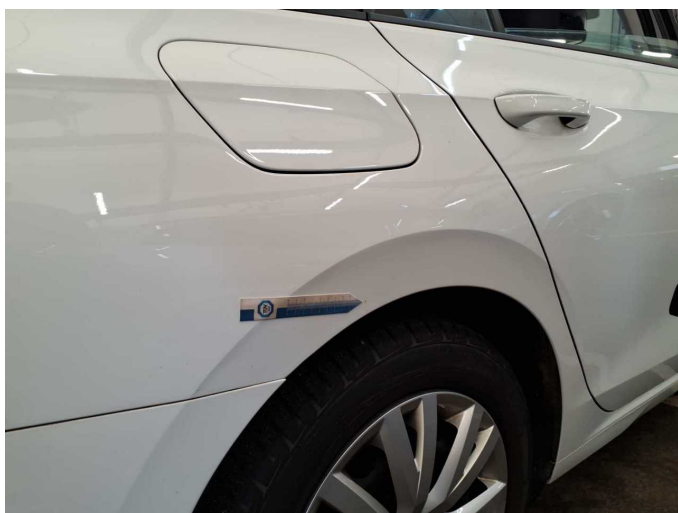
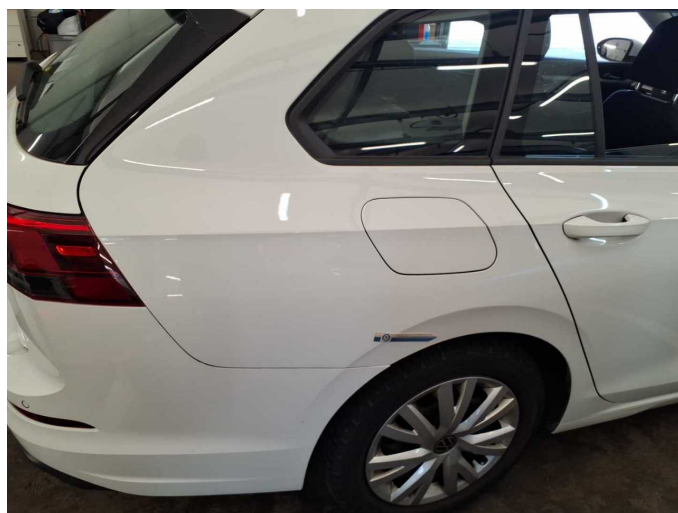
| No. | Component group | Description |
|---|---|---|
| 8 | Side panel - rear right side | Side panel (Löcher in Instandgesetzter Fläche) - Paint defect - Repair and paint |

**Damage 8:** Side panel - rear right side: Side panel (Löcher in Instandgesetzter Fläche) - Paint defect - Repair and paint

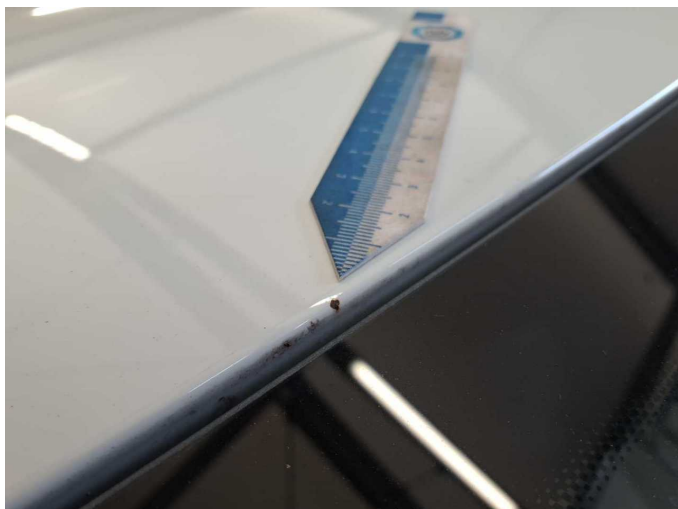
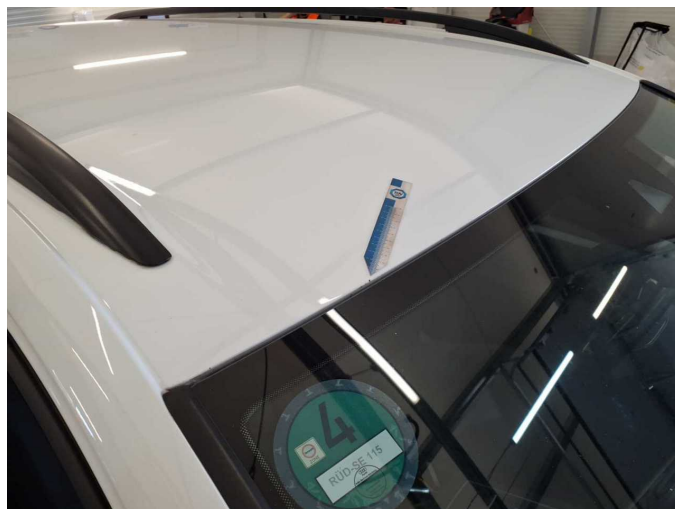
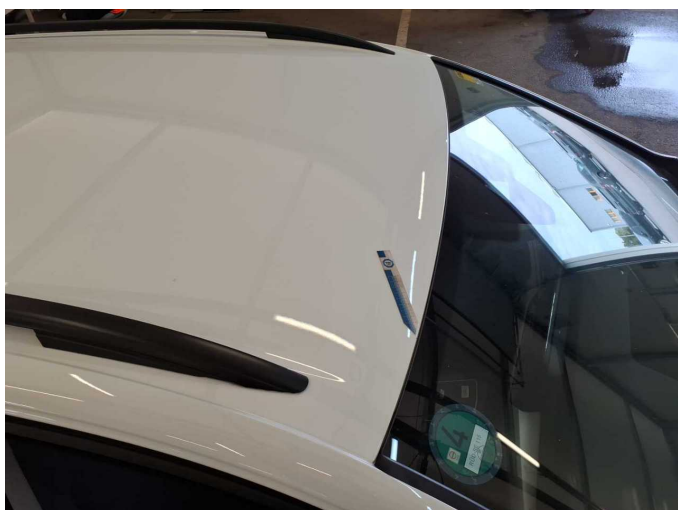
| No. | Component group | Description |
|---|---|---|
| 9 | Roof | Roof (Steinschlag mit Korrosion) - Corrosion - Repair and paint |

**Damage 9:** Roof: Roof (Steinschlag mit Korrosion) - Corrosion - Repair and paint

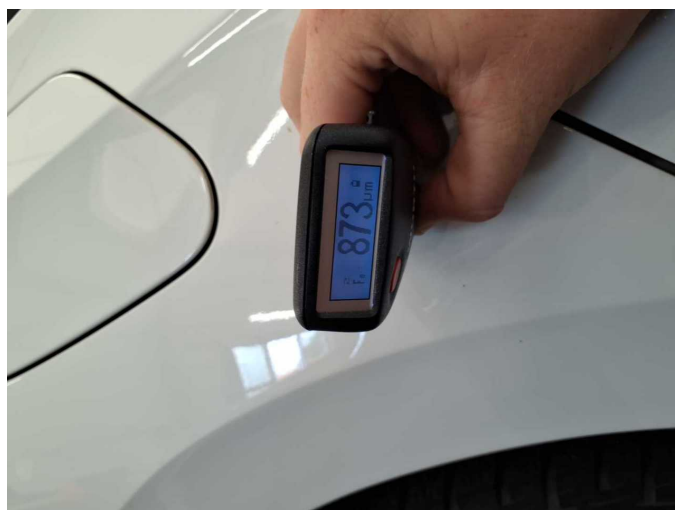
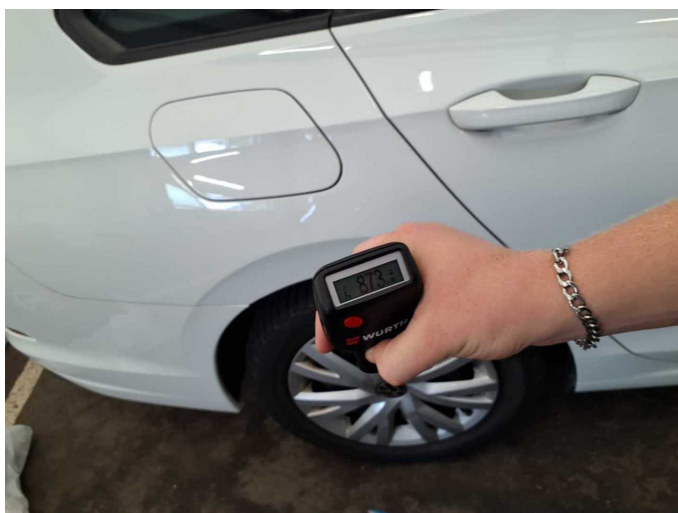
**Repainting 1:** Side panel - rear right side

| No. | Repainting |
|---|---|
| 1 | Side panel - rear right side, Unprofessionally carried out, Invoice of repair done Non-existent |

| Side panel - rear right side | 873 $\mu\text{m}$ |
