Expertise

Protocol number: 45990630
Order No. / Reference: 26506994
Inspection date: 17 Jun 2026

Manufacturer: Opel

Model: Astra Sports Tourer 1.5 D Automatik Business Elegance

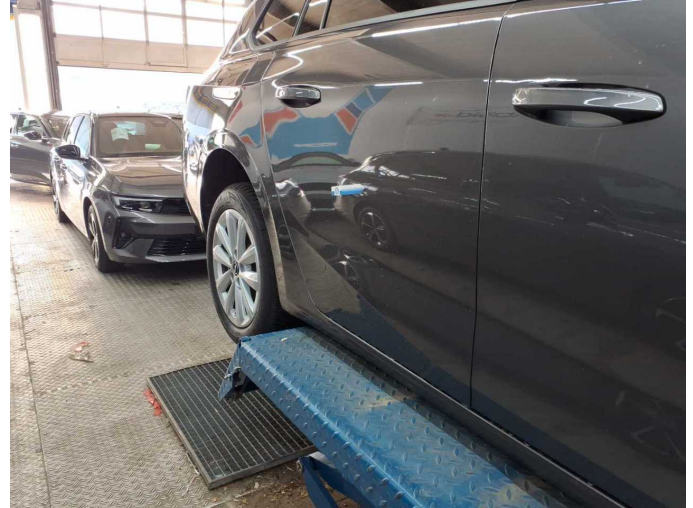
No.	Component group	Description
1	Door - rear right side	Door (Ein leichter knick zusehen) - dent(s) - Smooth repair work
2	Door - front left side	Door - dent(s) - Smooth repair work

Damage 1: Door - rear right side: Door (Ein leichter knick zusehen) - dent(s) - Smooth repair work

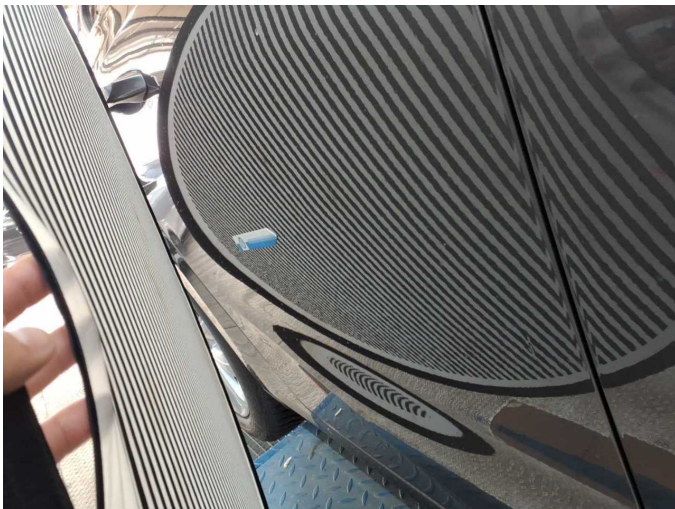
Damage 1: Door - rear right side: Door (Ein leichter knick zusehen) - dent(s) - Smooth repair work

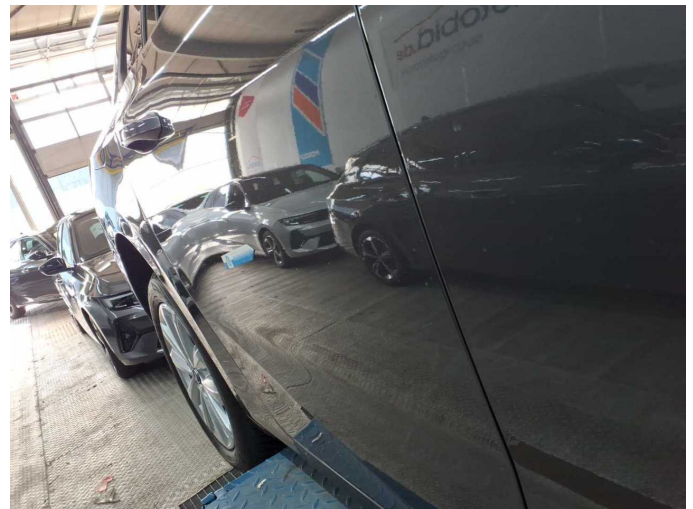
Damage 1: Door - rear right side: Door (Ein leichter knick zusehen) - dent(s) - Smooth repair work

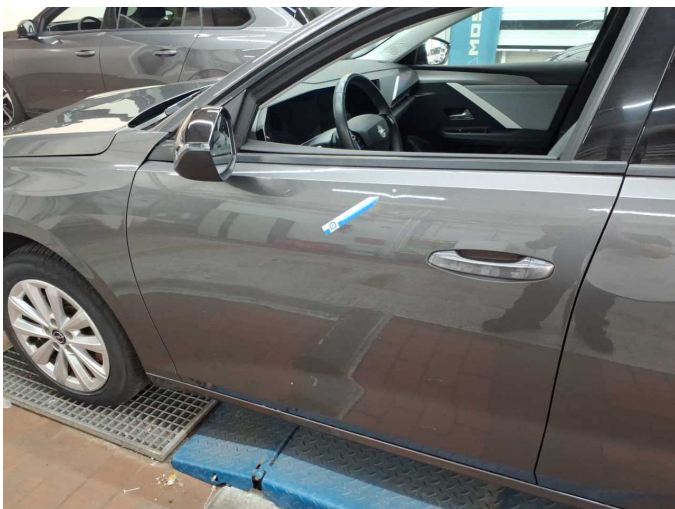
Damage 2: Door - front left side: Door - dent(s) - Smooth repair work

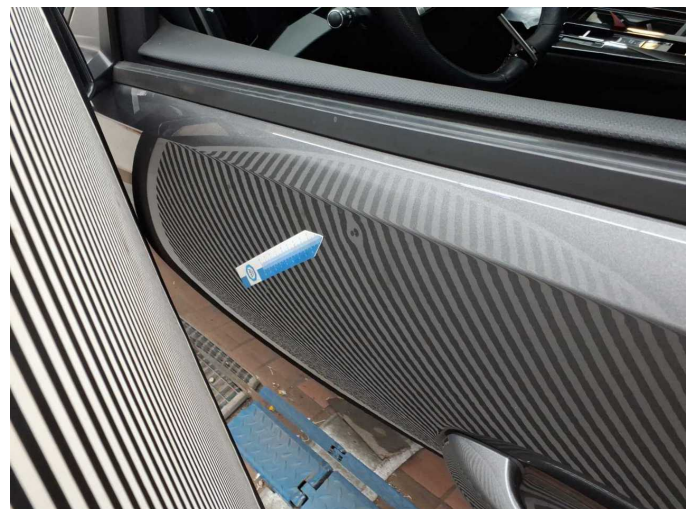
Damage 2: Door - front left side: Door - dent(s) - Smooth repair work

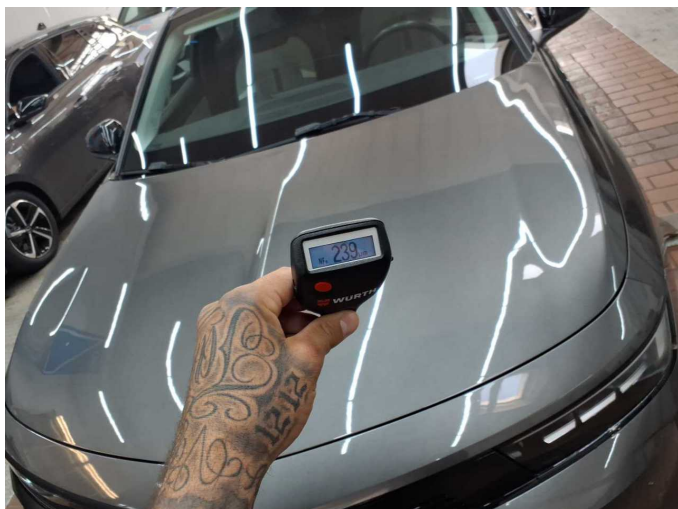
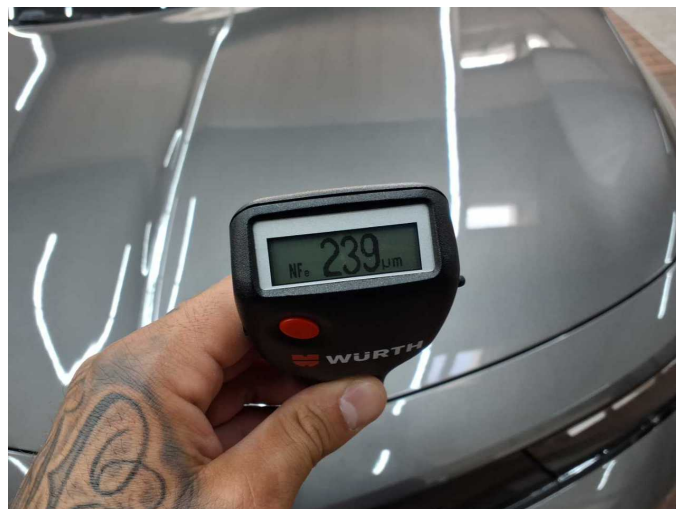
Repainting 1: Bonnet

No.	Repainting
1	Bonnet, Professionally carried out

Bonnet	239 µm
--------	--------
