Expertise

Protocol number: 46173283  
Order No. / Reference: 26588433  
Inspection date: 24 Jun 2026

| Manufacturer: Volvo | Model: XC90 T8 AWD Recharge Core |
| VIN: YV1LFH5V2P1979534 | |

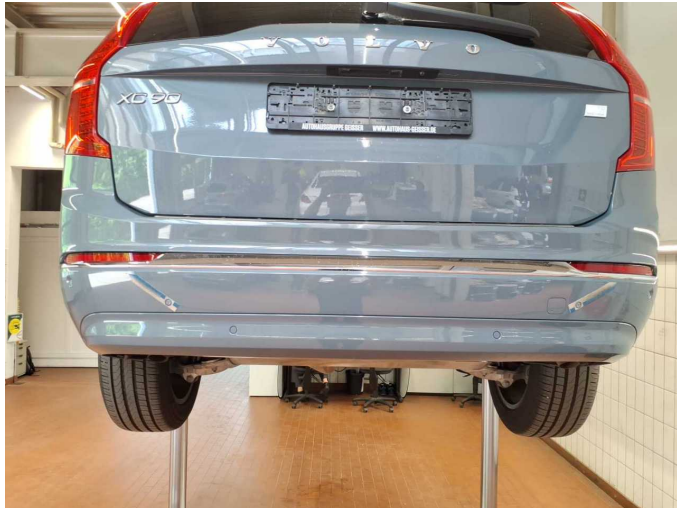
| No. | Component group | Description |
|---|---|---|
| 1 | Rear bumper | Rear bumper (Unterteil) - Scratch(es) - Smart repair |

**Damage 1:** Rear bumper: Rear bumper (Unterteil) - Scratch(es) - Smart repair

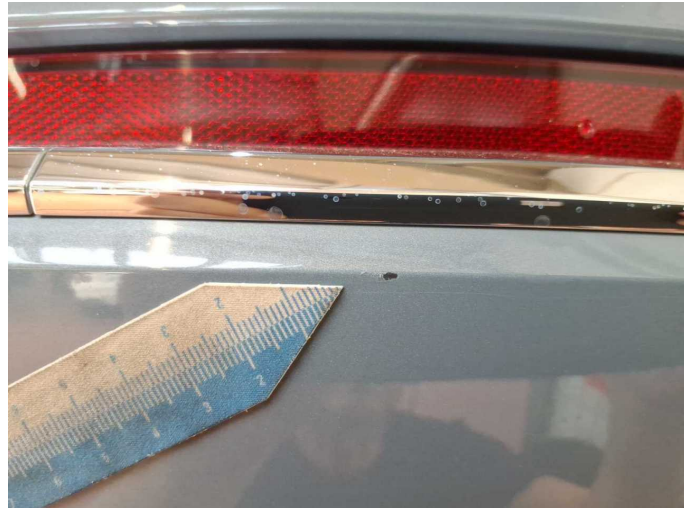
**Damage 1:** Rear bumper: Rear bumper (Unterteil) - Scratch(es) - Smart repair

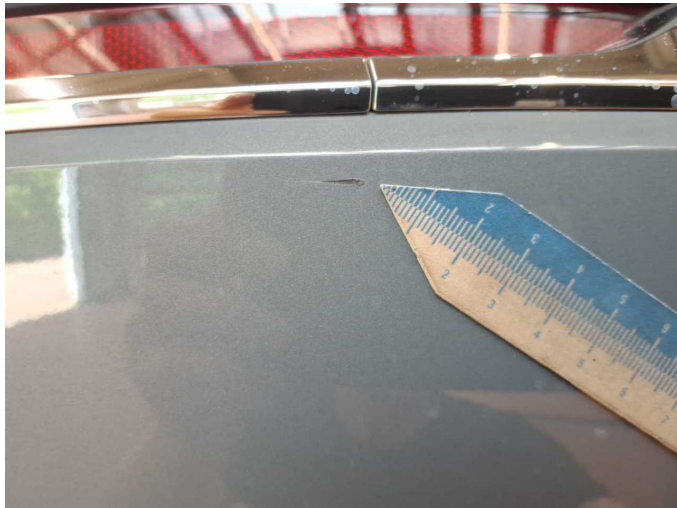
**Damage 1:** Rear bumper: Rear bumper (Unterteil) - Scratch(es) - Smart repair

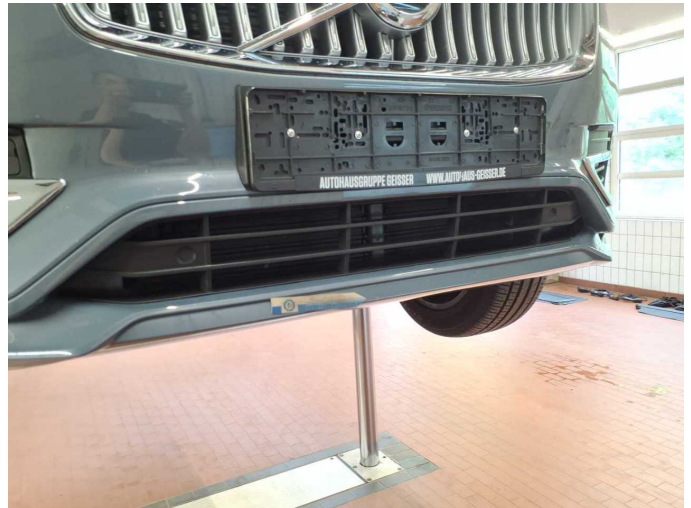
| No. | Component group | Description |
|---|---|---|
| 2 | Front bumper | Spoiler - dent(s) - Smart repair |

**Damage 2:** Front bumper: Spoiler - dent(s) - Smart repair

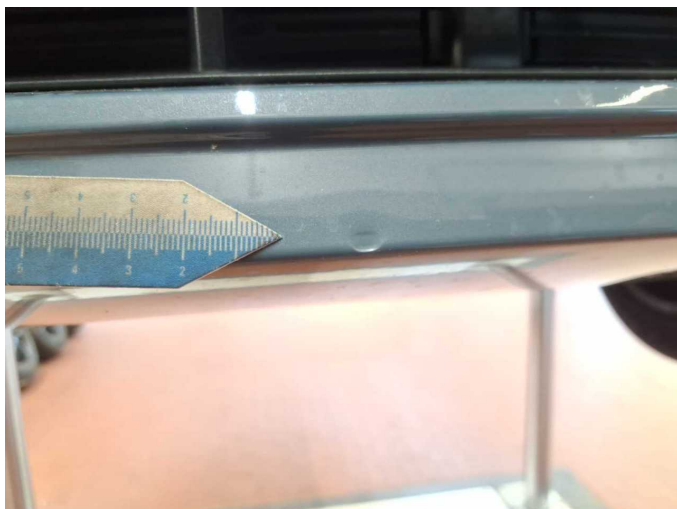
**Damage 2:** Front bumper: Spoiler - dent(s) - Smart repair

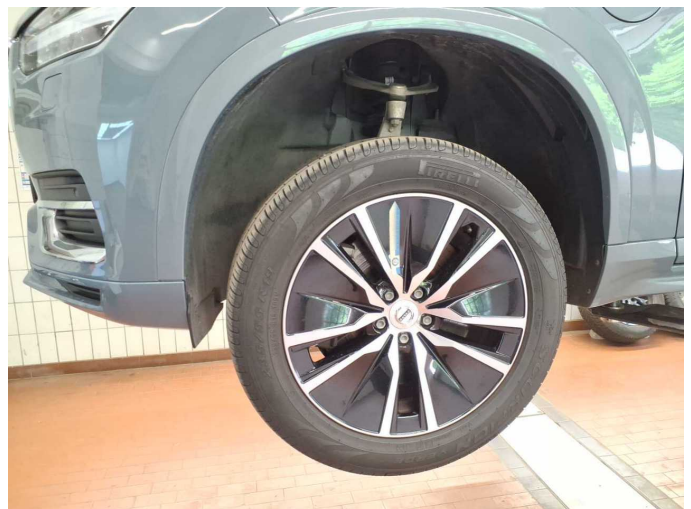
| No. | Component group | Description |
|---|---|---|
| 3 | Wheel / tyres | Alloy rim - front left side - Scratched - Loss in value |

**Damage 3:** Wheel / tyres: Alloy rim - front left side - Scratched - Loss in value

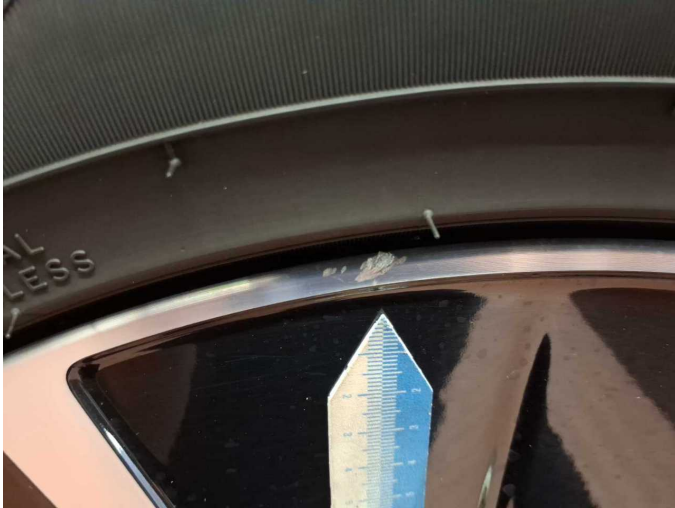
**Damage 3:** Wheel / tyres: Alloy rim - front left side - Scratched - Loss in value

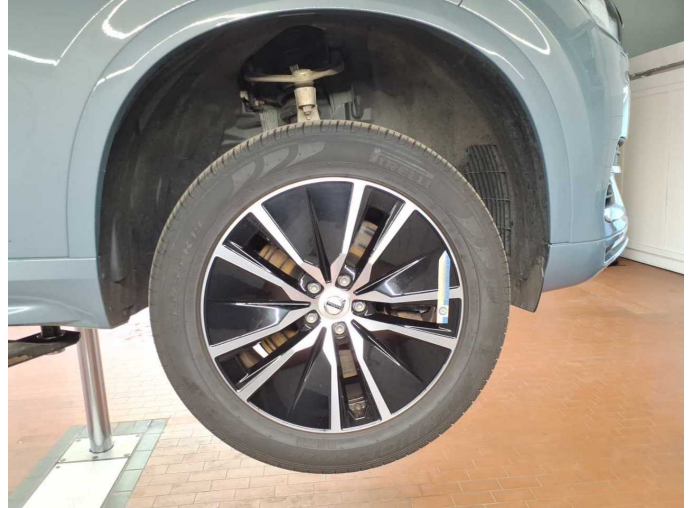
| No. | Component group | Description |
|---|---|---|
| 4 | Wheel / tyres | Alloy rim - front right side - Scratched - Loss in value |

**Damage 4:** Wheel / tyres: Alloy rim - front right side - Scratched - Loss in value

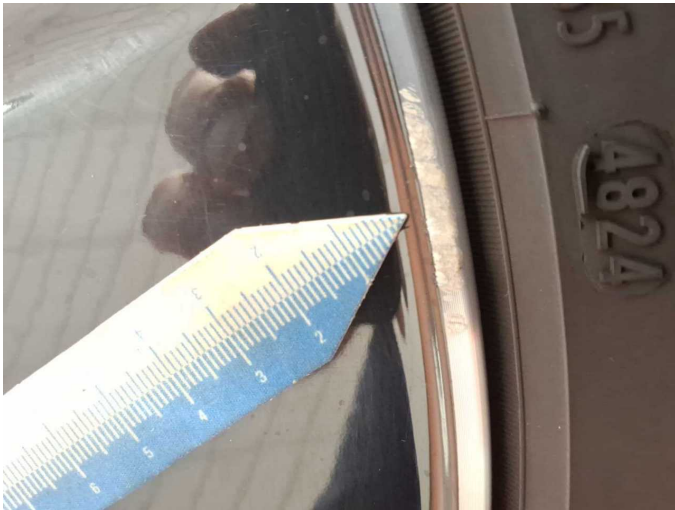
**Damage 4:** Wheel / tyres: Alloy rim - front right side - Scratched - Loss in value

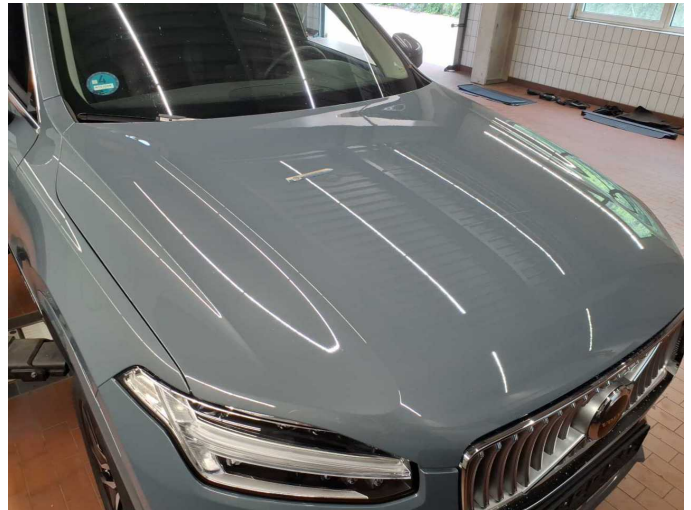
| No. | Component group | Description |
|---|---|---|
| 5 | Bonnet | Bonnet (teilweise lackieren) - dent(s) - Paint |

**Damage 5:** Bonnet: Bonnet (teilweise lackieren) - dent(s) - Paint

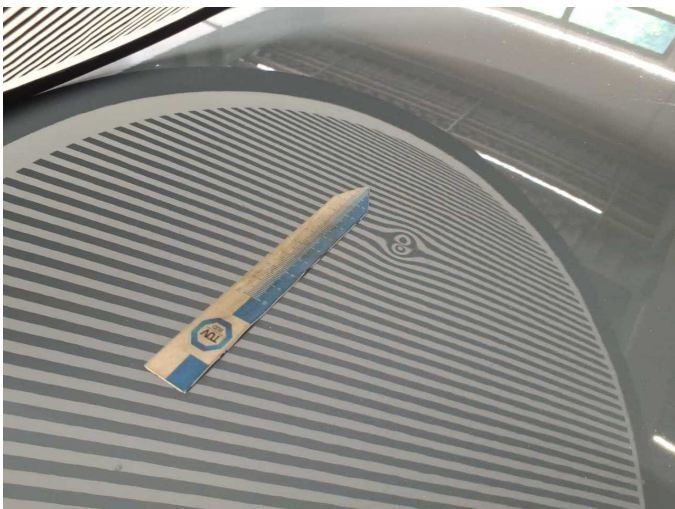
**Damage 5:** Bonnet: Bonnet (teilweise lackieren) - dent(s) - Paint

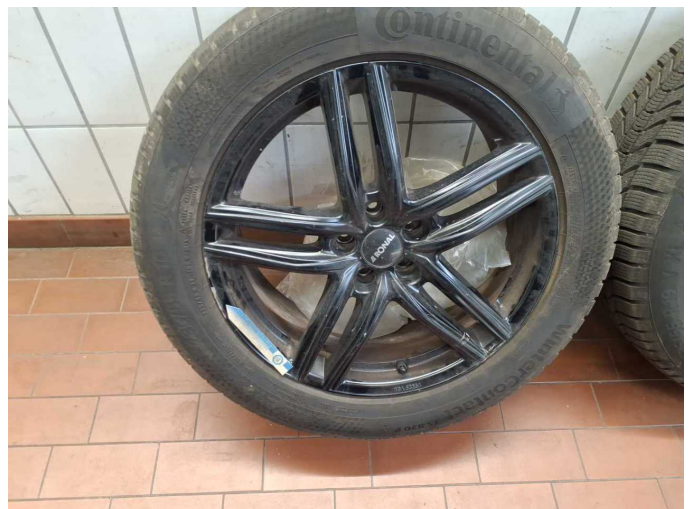
| No. | Component group | Description |
|---|---|---|
| 1 | 2nd wheel set | 1 alloy rim (Kein Teil der Ausstattung) - Scratched - No deduction |

**Wear and tear 1:** 2nd wheel set: 1 alloy rim (Kein Teil der Ausstattung) - Scratched - No deduction

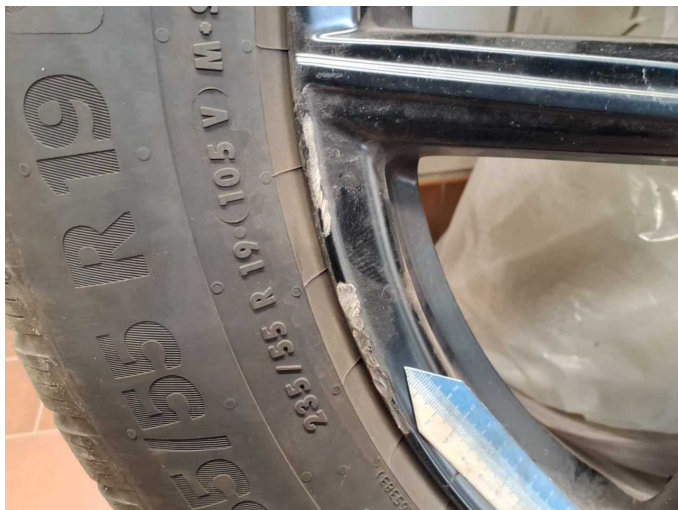
**Wear and tear 1:** 2nd wheel set: 1 alloy rim (Kein Teil der Ausstattung) - Scratched - No deduction

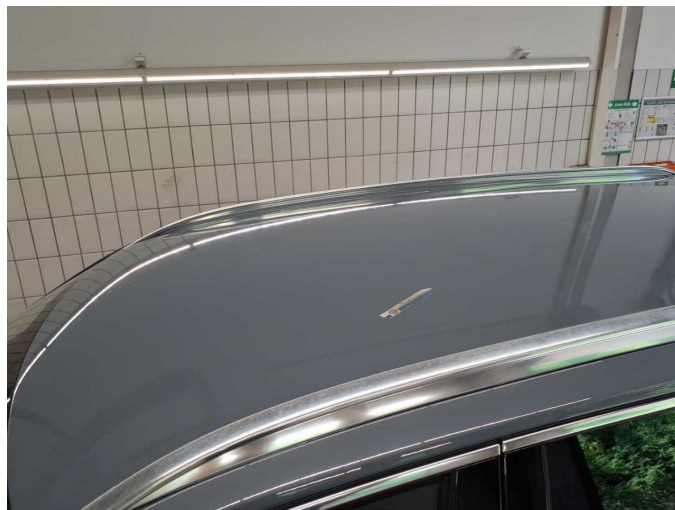
| No. | Component group | Description |
|---|---|---|
| 5 | Roof | Roof - dent(s) - No deduction |

**Wear and tear 5:** Roof: Roof - dent(s) - No deduction

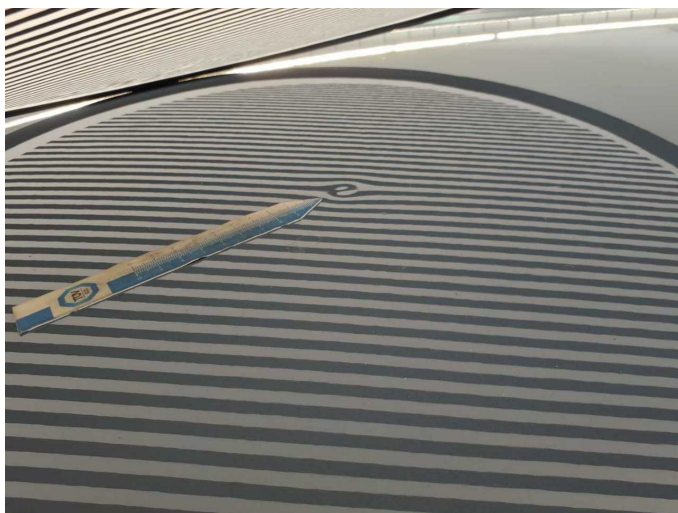
**Wear and tear 5:** Roof: Roof - dent(s) - No deduction
