Expertise

Protocol number: 46315606
Order No. / Reference: 26527816
Inspection date: 3 Jul 2026

Manufacturer: Opel

Model: Astra 1.2 Turbo Automatik Business Elegance

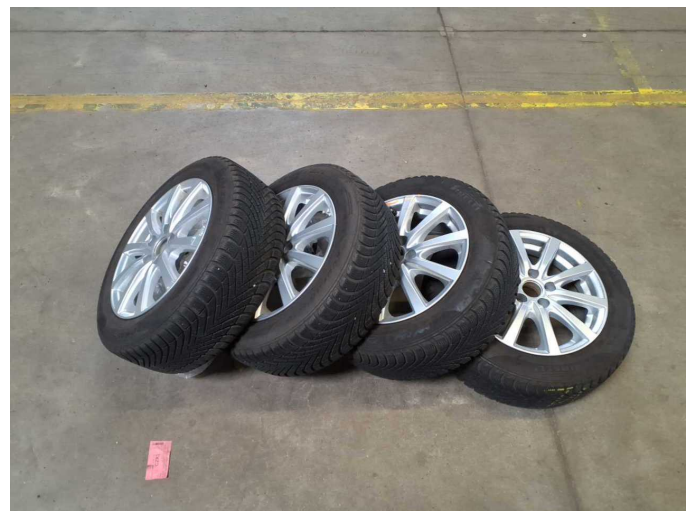
Figure 16: Additional tyres

Der beiliegende Radsatz ist nicht Bestandteil der vorliegenden Fahrzeugausstattung.

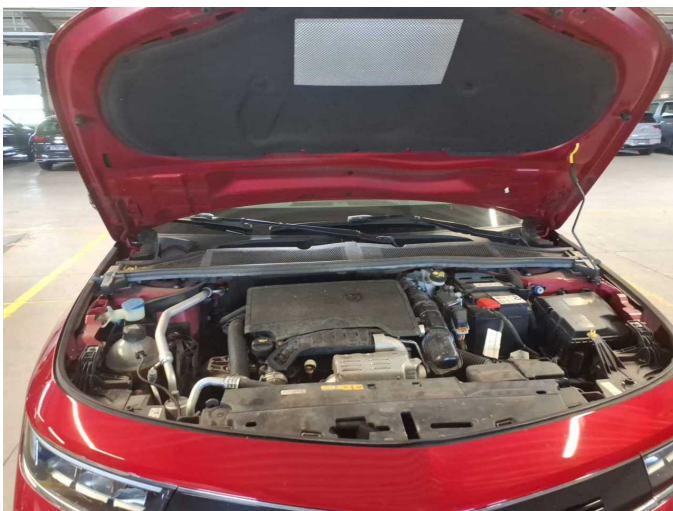
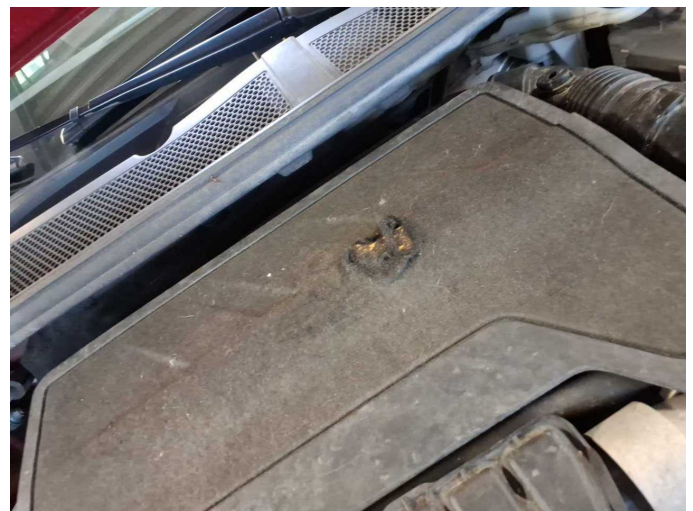
Damage 3: Engine: Engine cover - Damaged - Replace

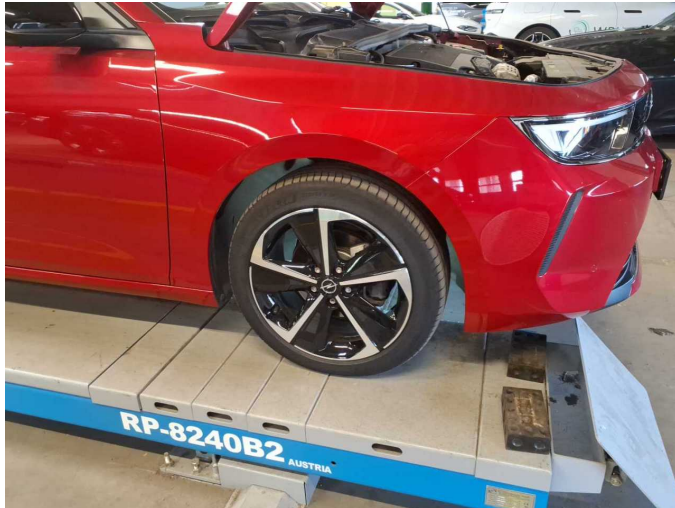
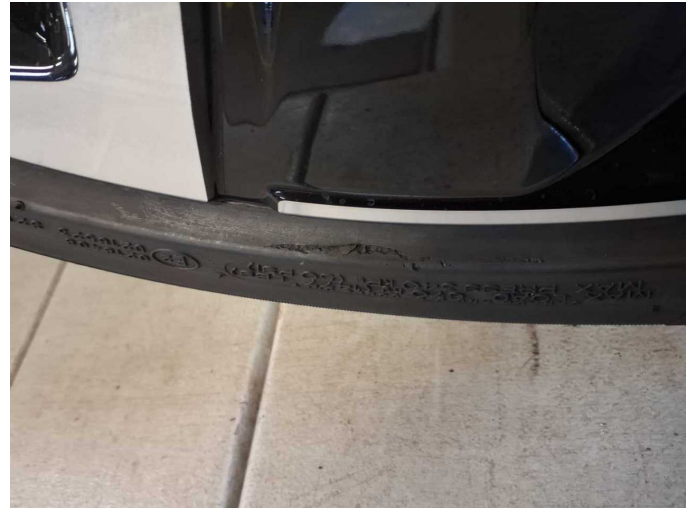
Damage 4: Wheel / tyres: Tyre - front right side (Flanke) - Damaged - Replace

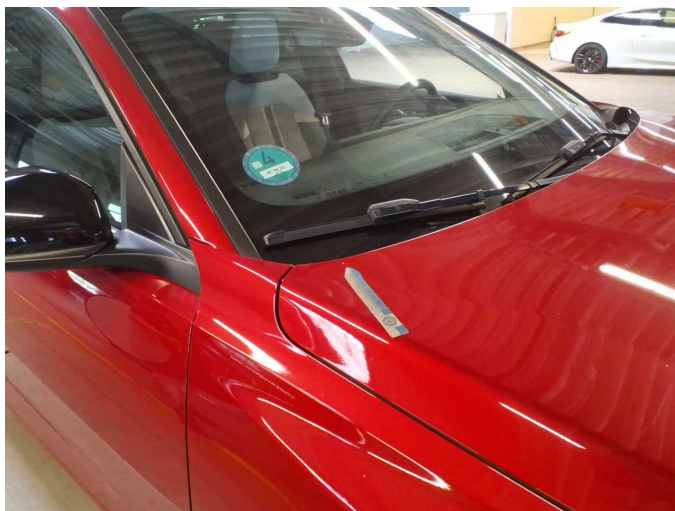
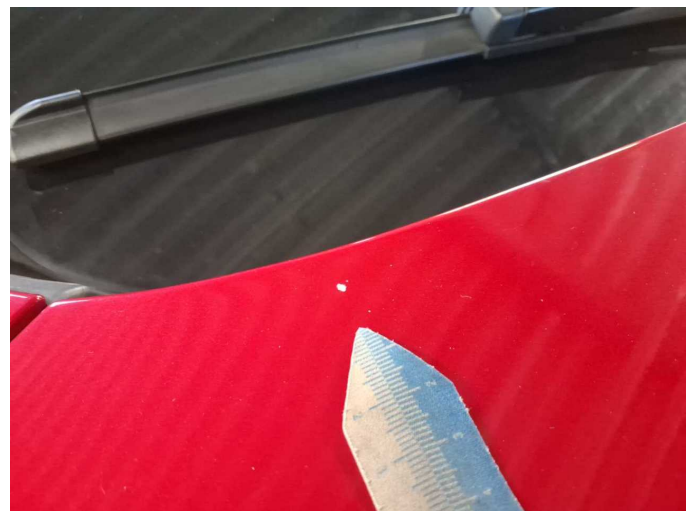
Wear and tear 1: Bonnet: Bonnet - Stone chips - No deduction

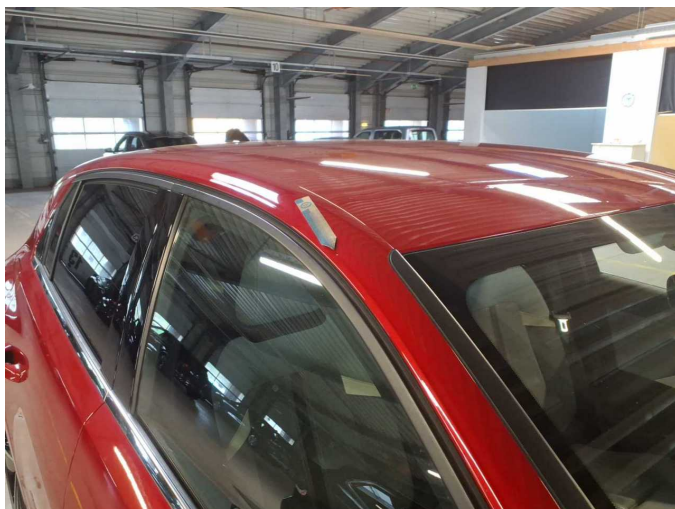
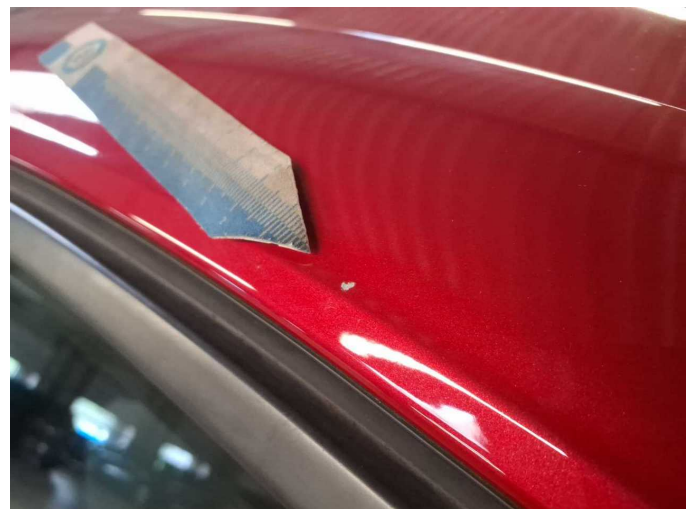
Wear and tear 2: Body: A-pillar - right side - Stone chips - No deduction
