MACDAM

Mercedes-Benz EQC '19 BEV

Vehicle information

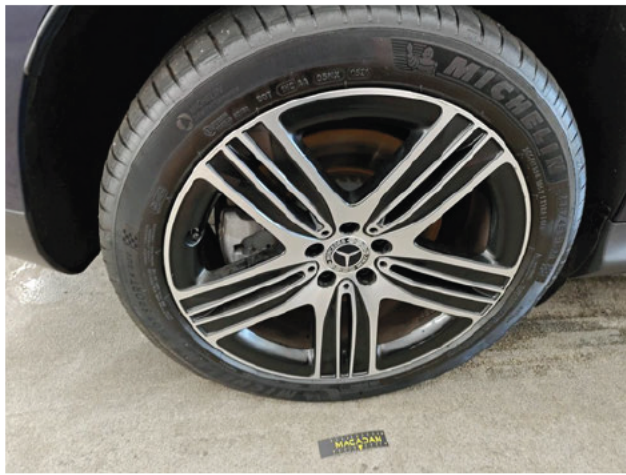
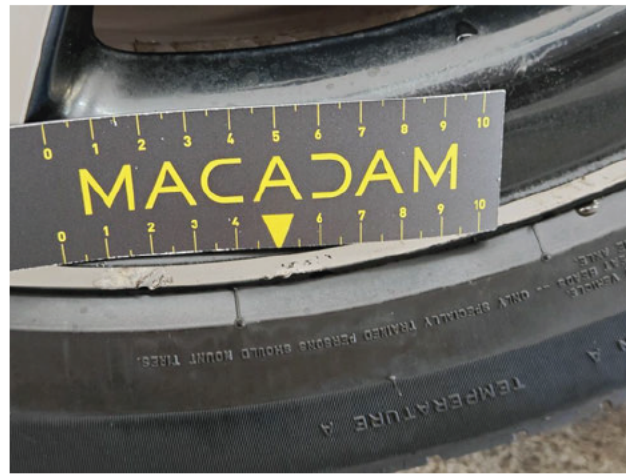
**Alloy rim RR**  
Scratch(es)  
Repair and paint (complete)  
Right

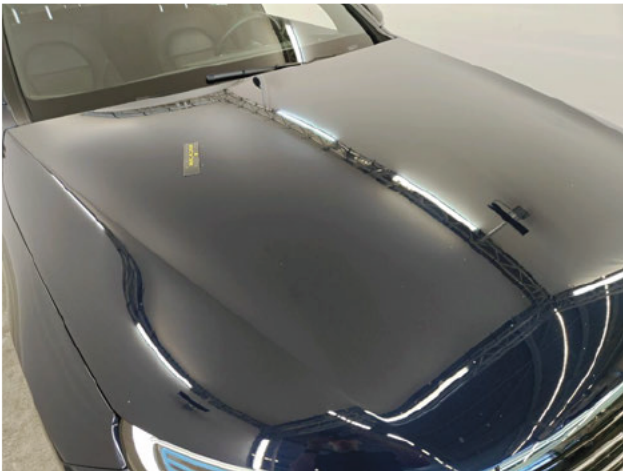
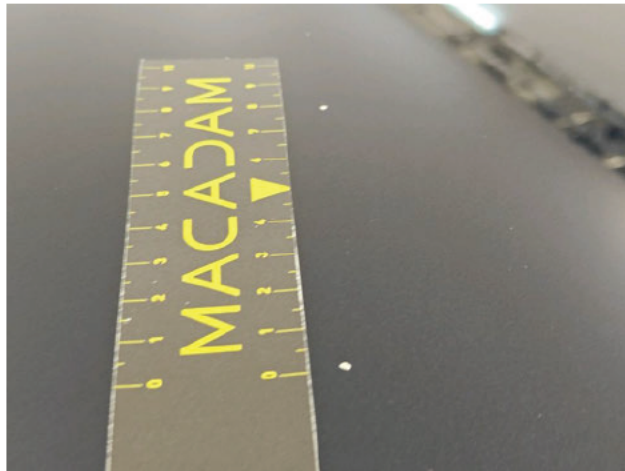
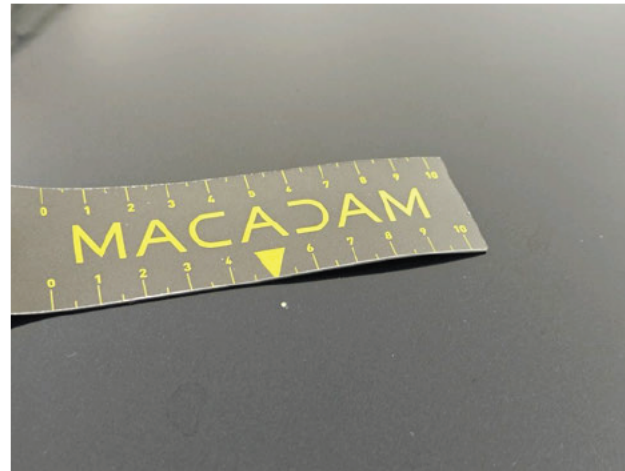
**Bonnet**  
Stone chip(s)  
Repair and paint (complete)  
Front

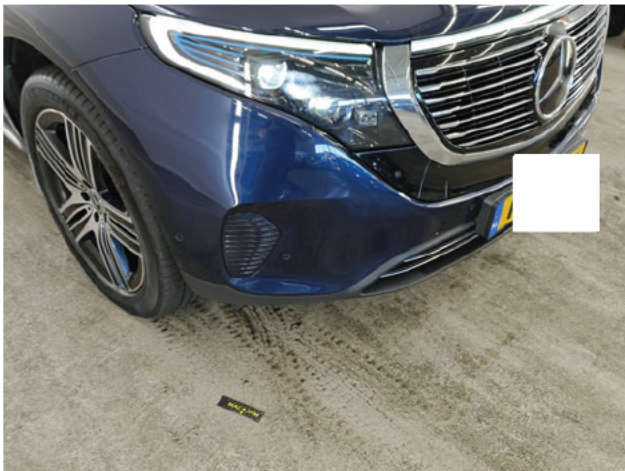
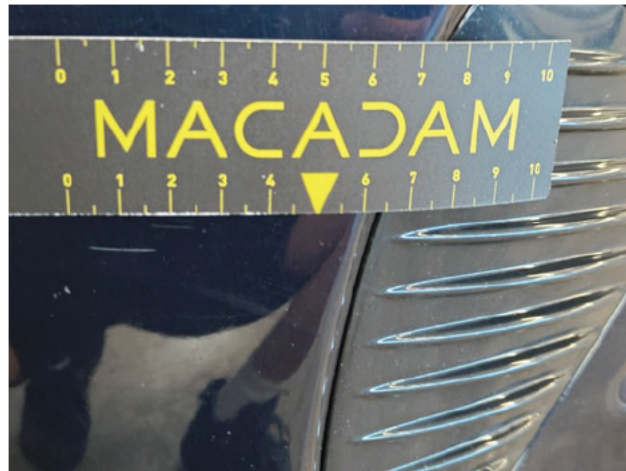
**Bumper F**  
Scratch(es)  
Repair and paint (partial)  
Front

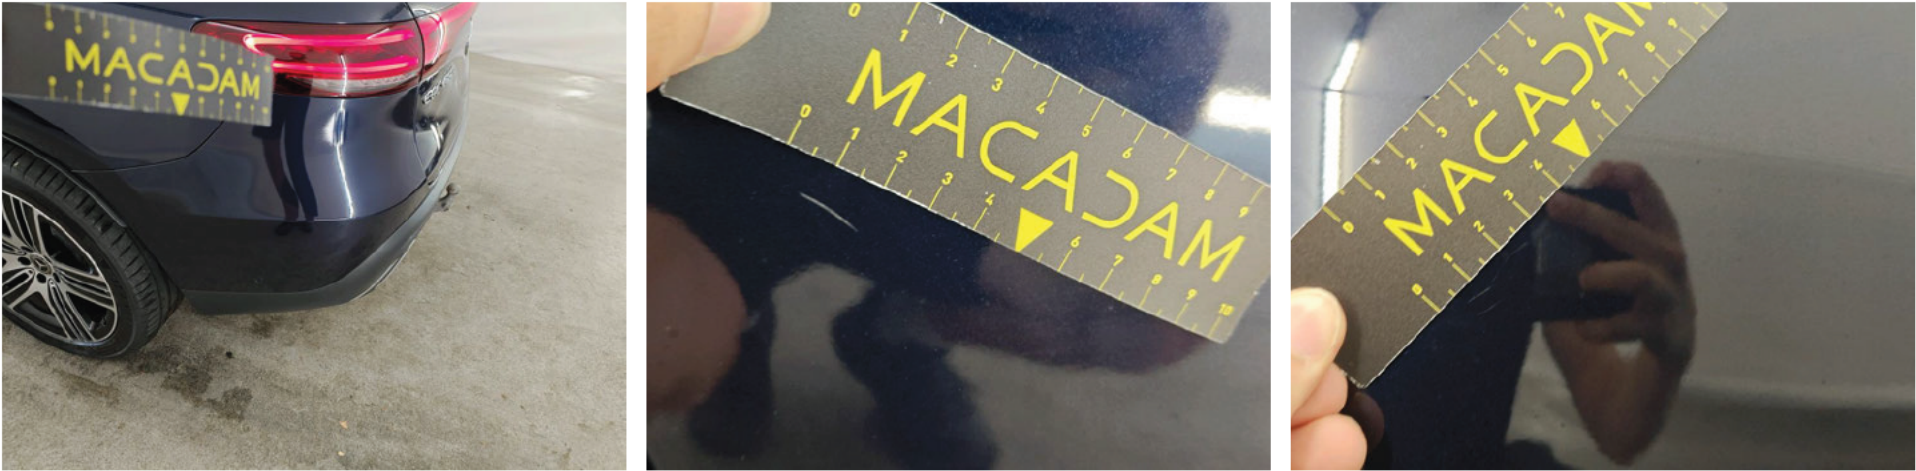
**Bumper R**  
Scratch(es)  
Repair and paint (complete)  
Rear

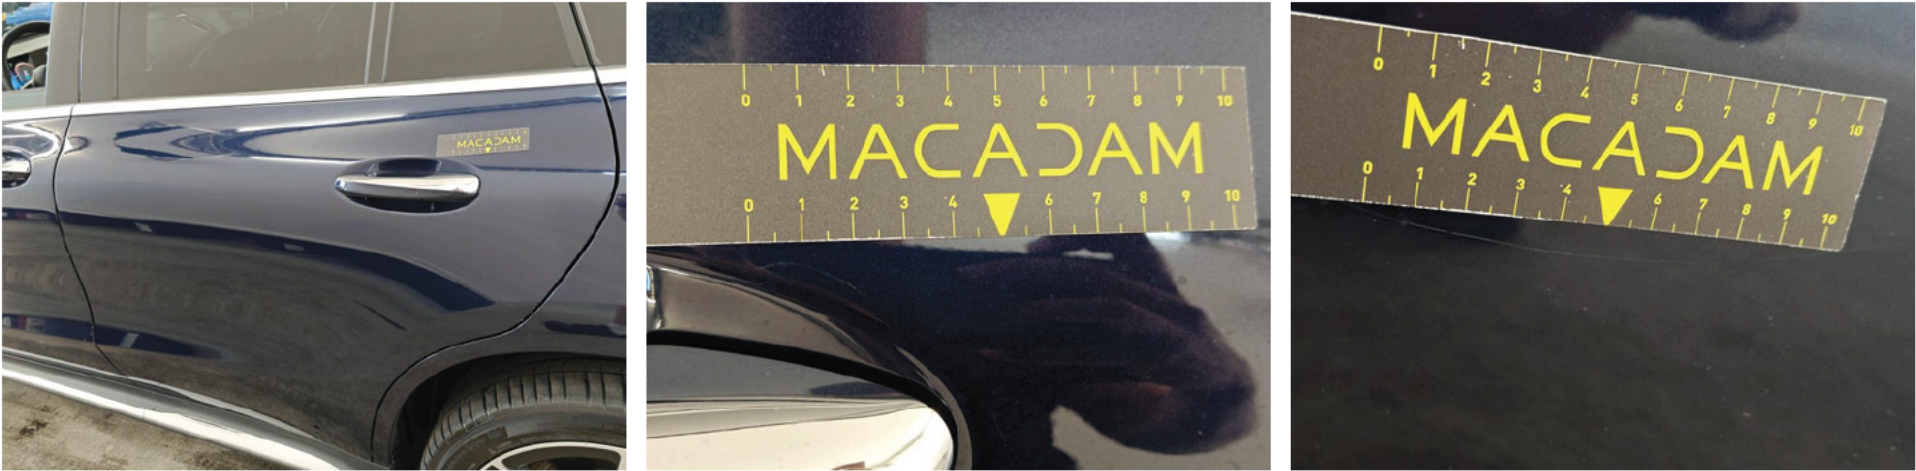
**Door RL**  
Scratch(es)  
Repair and paint (partial)  
Left

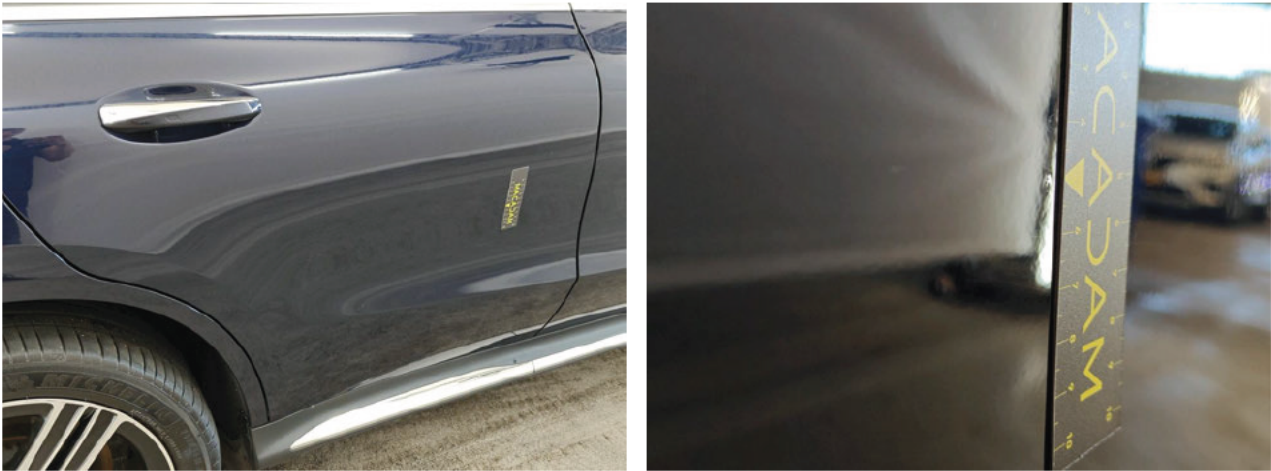
**Door RR**  
Bad repair  
Repair and paint (complete)  
Right

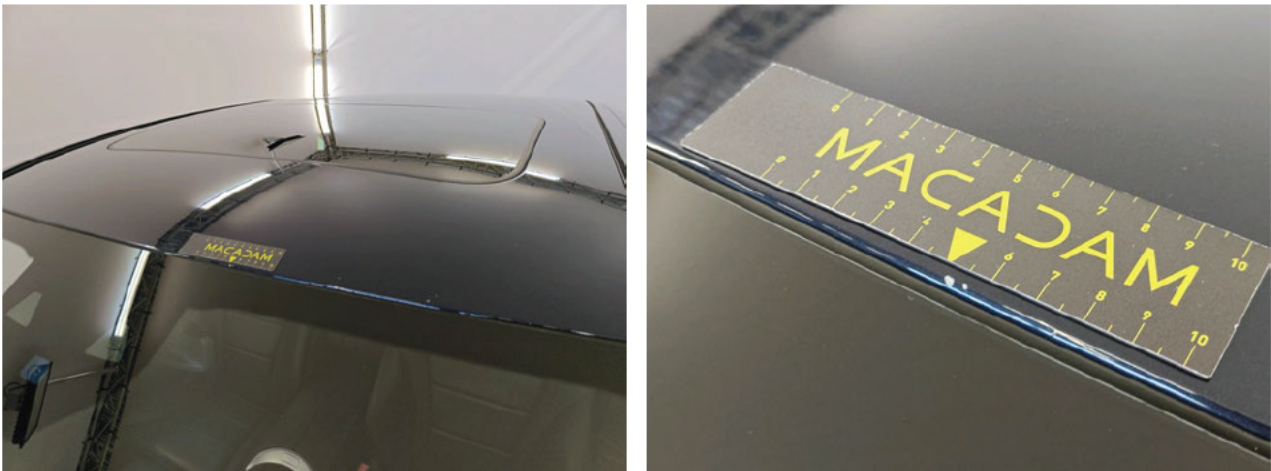
**Roof**  
Stone chip(s)  
Repair and paint (complete)  
Roof & others

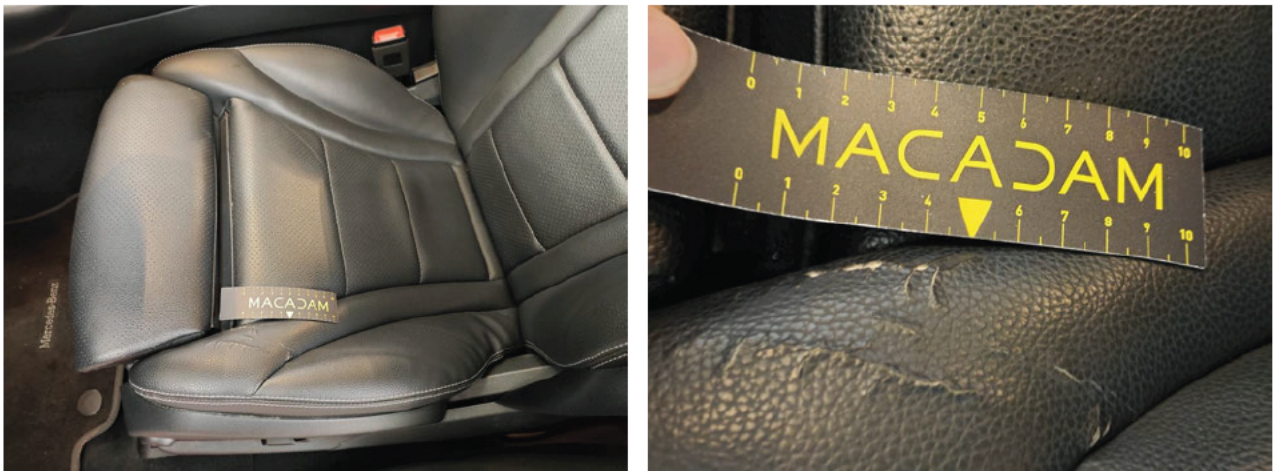
**Seat cover FL**  
Worn  
Replace  
Interior

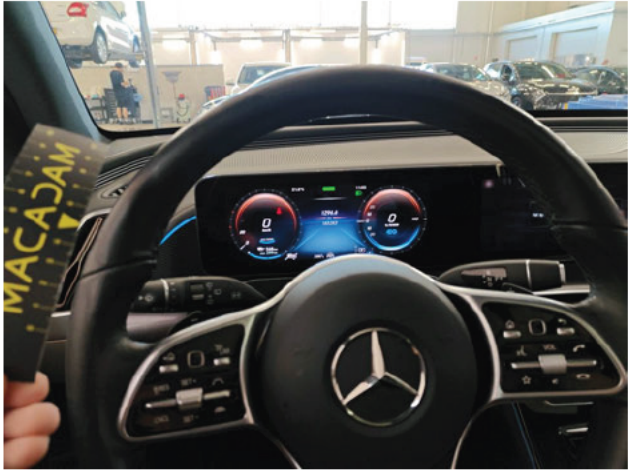
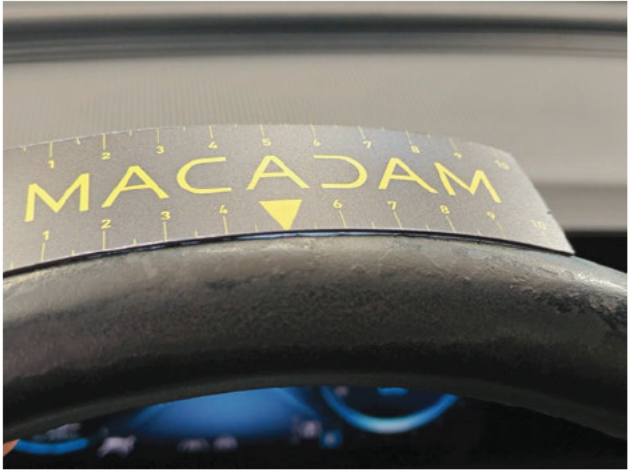
**Steering wheel**  
Worn  
Replace  
Interior

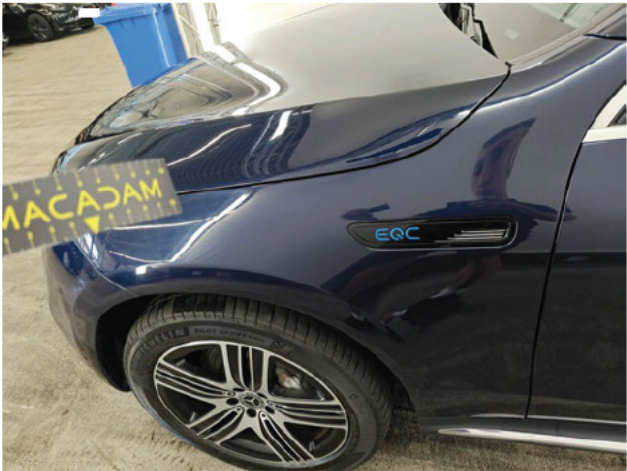
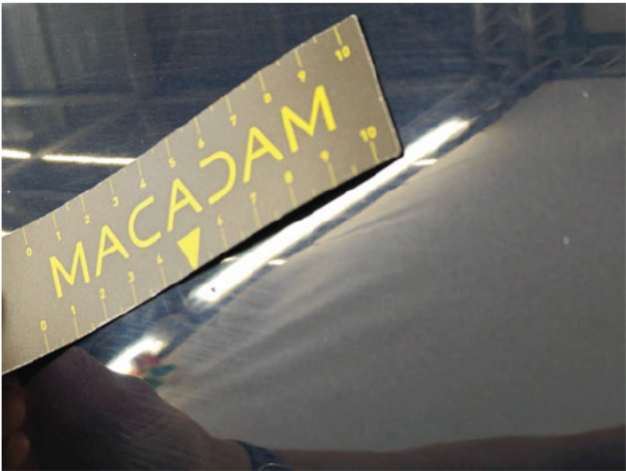
**Wing FL**  
Bad repair  
Repair and paint (complete)  
Left

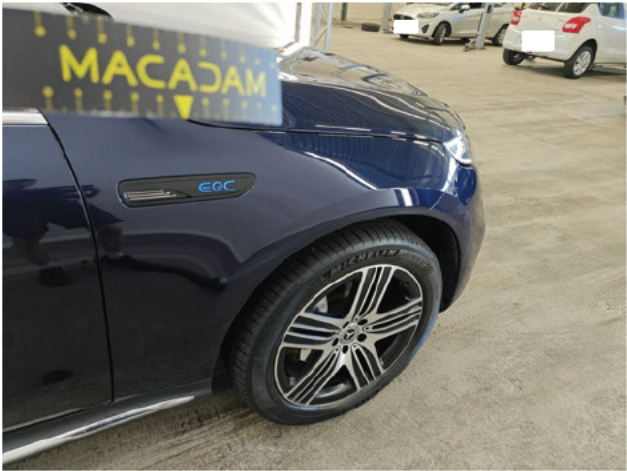
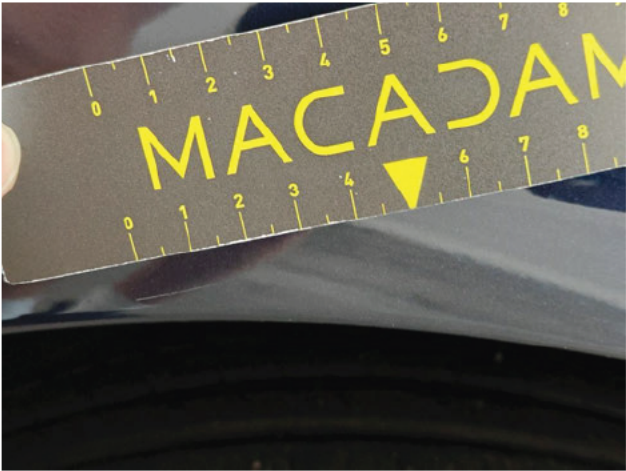
**Wing FR**  
Scratch(es)  
Repair and paint (complete)  
Right

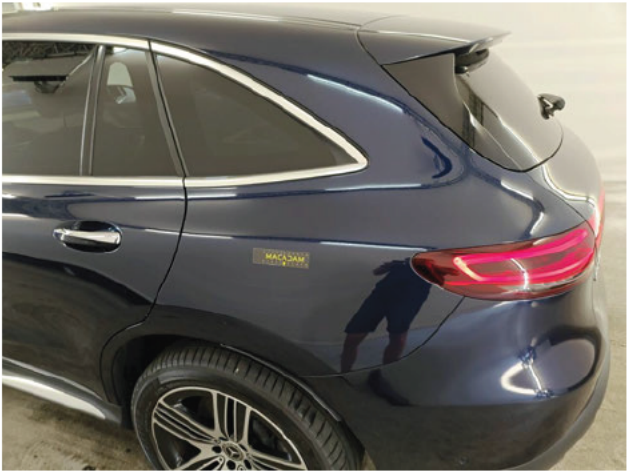
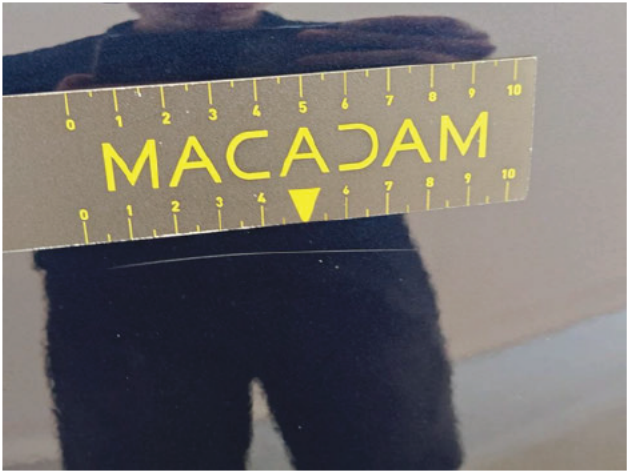
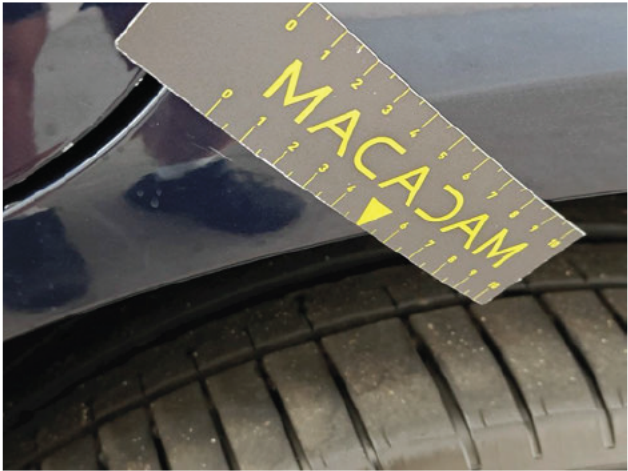
**Wing RL**  
Scratch(es)  
Repair and paint (complete)  
Left
