Expertise

Protocol number: 46495109  
Order No. / Reference: 26694886  
Inspection date: 13 Jul 2026

| Manufacturer: Volkswagen | Model: ID. Buzz Pro |
| VIN: WV2ZZZEB9PH017632 | |

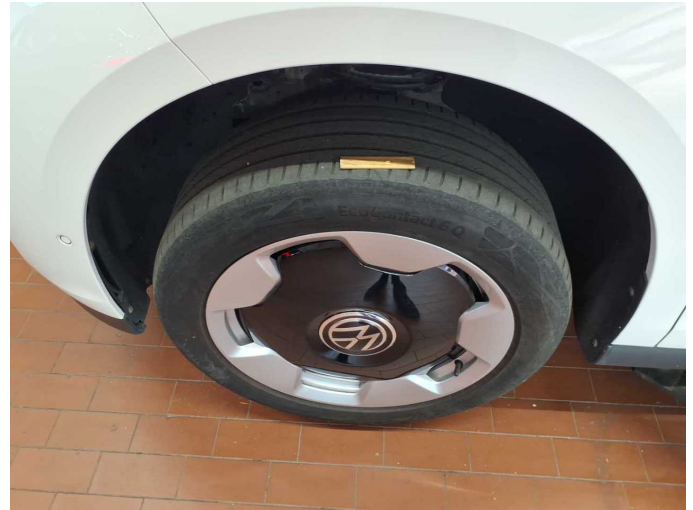
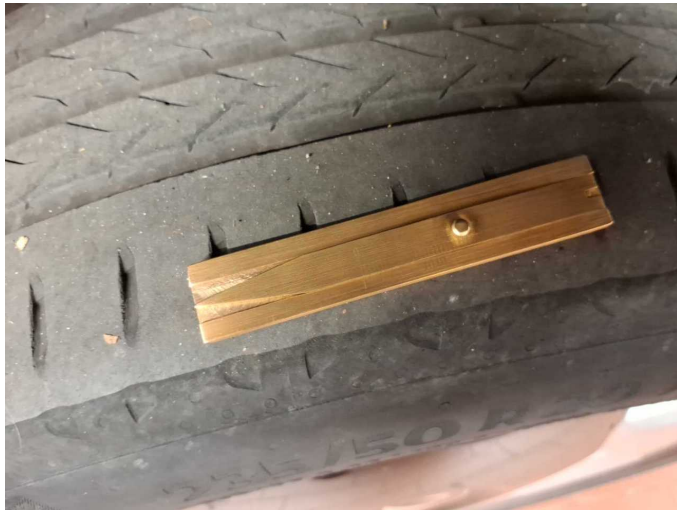
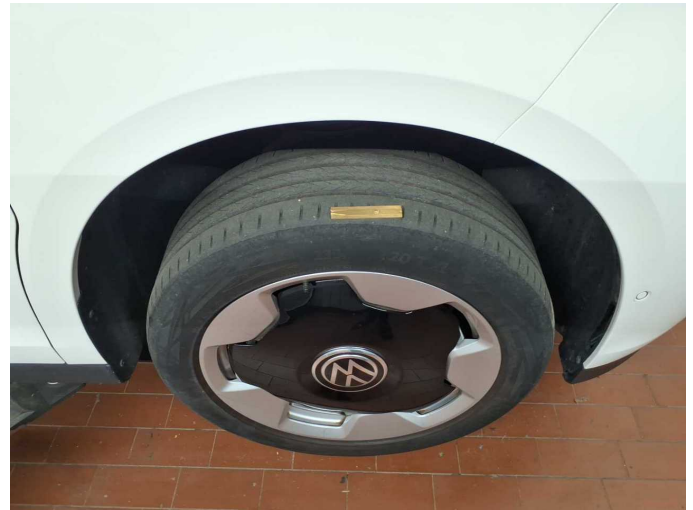
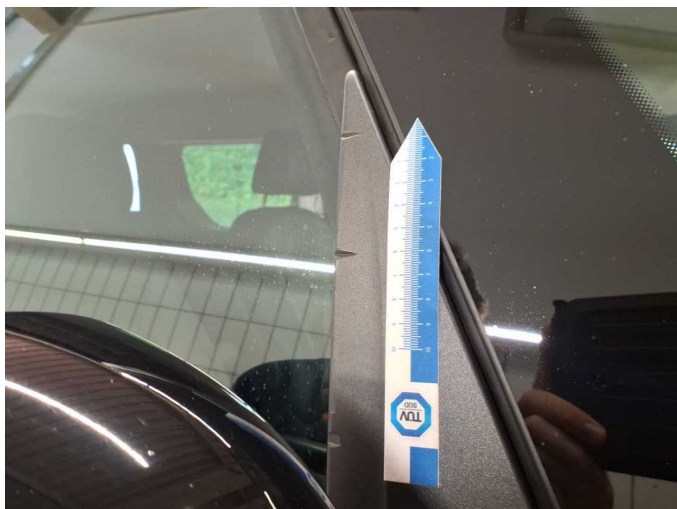
| # | Tyre size | Type of tyre | Manufacturer | Tread depth |
|---|---|---|---|---|
| 1) | 235/50 R20 104T | Summer tyres (with run-flat tyres) on Light alloy | Continental | 0mm / 0mm |

| No. | Component group | Description |
|---|---|---|
| 2 | Wheel / tyres | Tyre - front (Einseitig abgefahren) - Worn - Replace |

**Damage 2:** Wheel / tyres: Tyre - front (Einseitig abgefahren) - Worn - Replace

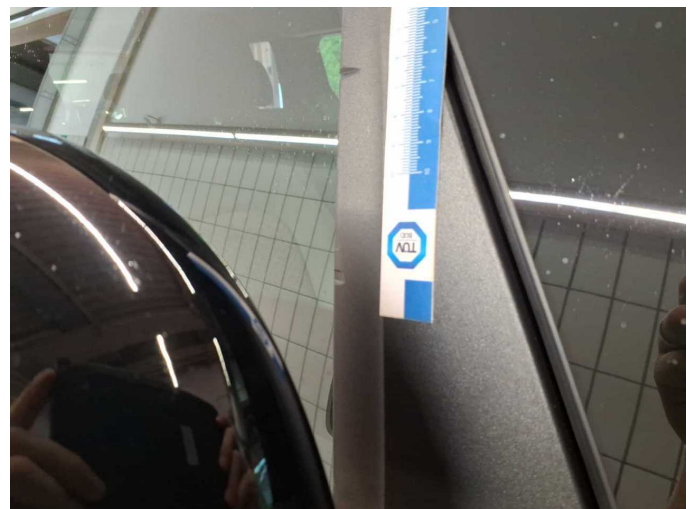
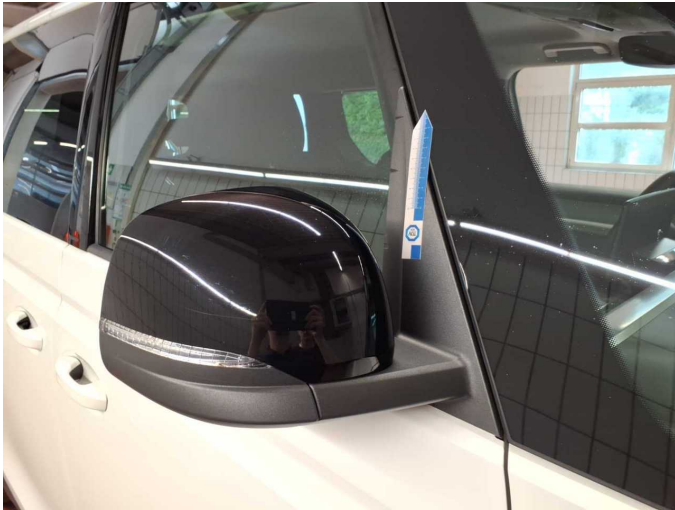
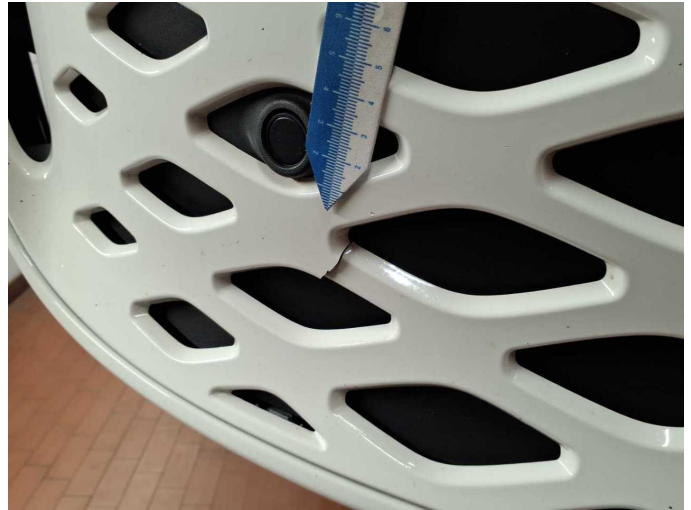
| No. | Component group | Description |
|---|---|---|
| 3 | Wing mirror - right side | Mirror housing - Scratched - Replace |

**Damage 3:** Wing mirror - right side: Mirror housing - Scratched - Replace

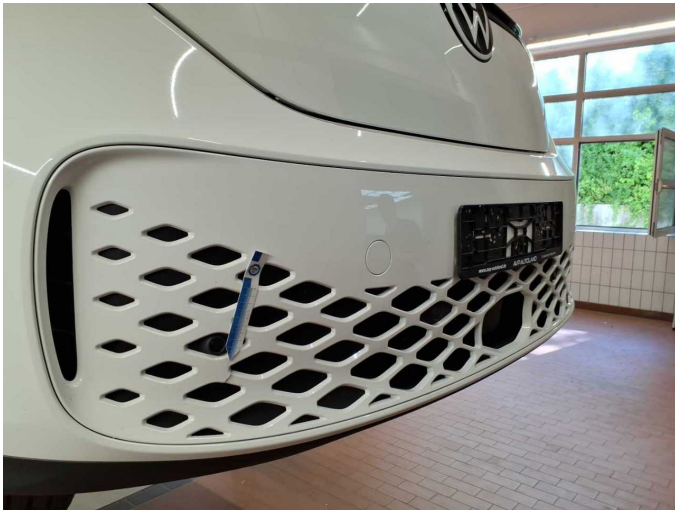
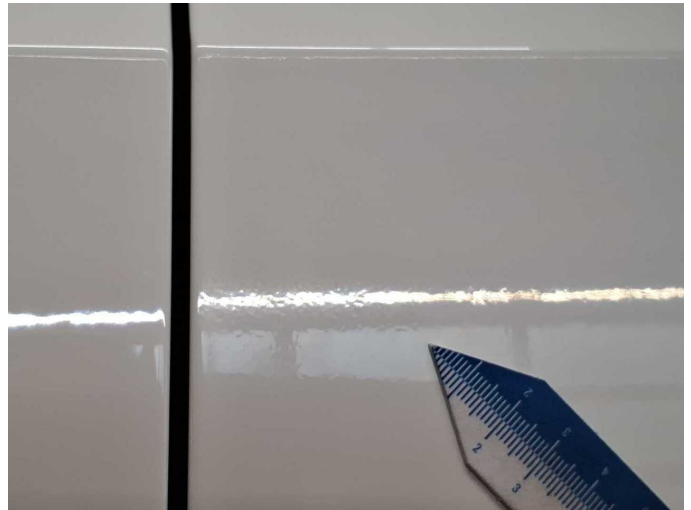
| No. | Component group | Description |
|---|---|---|
| 4 | Front bumper | Grille - Broken / torn - Replace |

**Damage 4:** Front bumper: Grille - Broken / torn - Replace

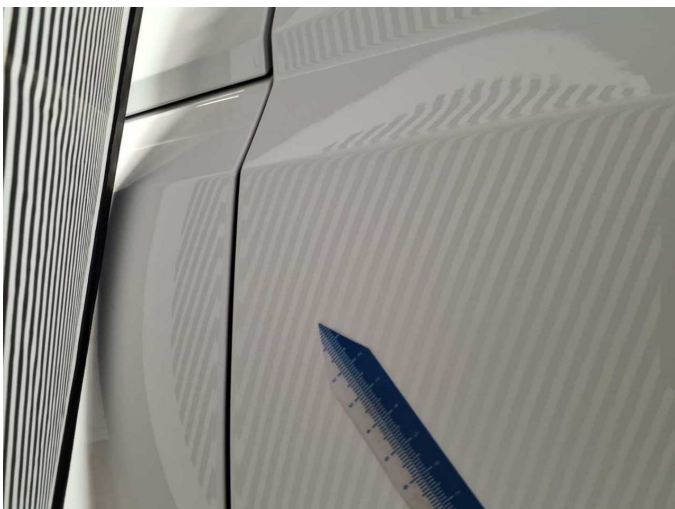
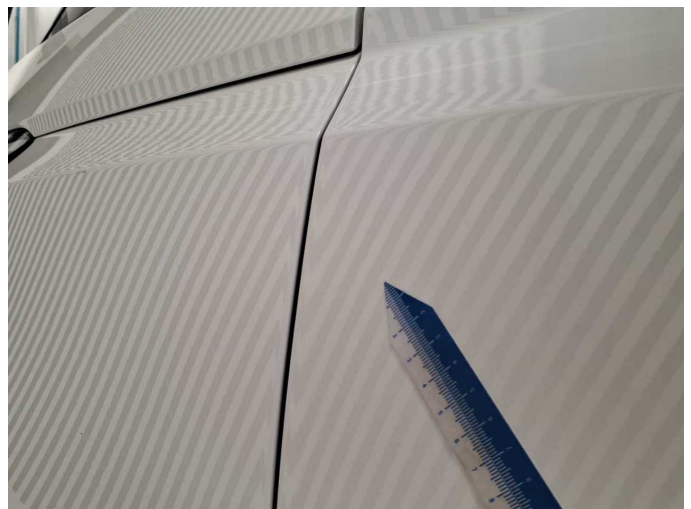
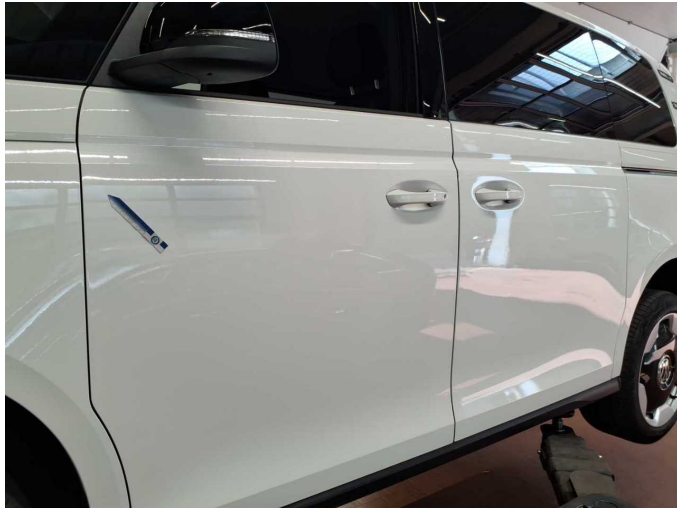
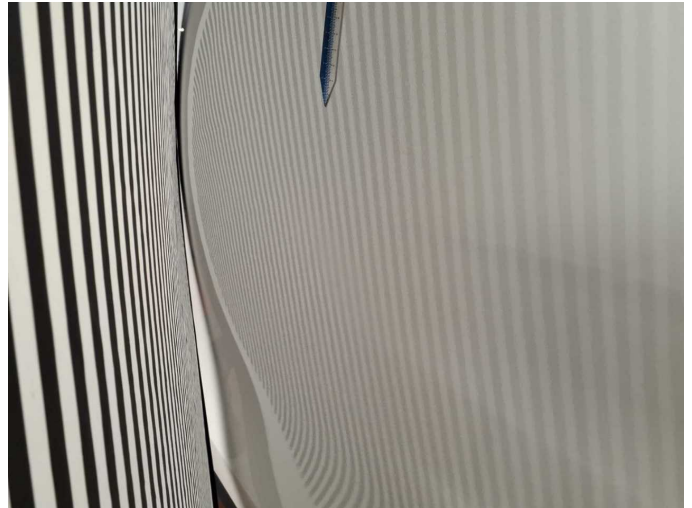
| No. | Component group | Description |
|---|---|---|
| 5 | Door - front left side | Door - Unprofessionally repaired - Paint |

**Damage 5:** Door - front left side: Door - Unprofessionally repaired - Paint

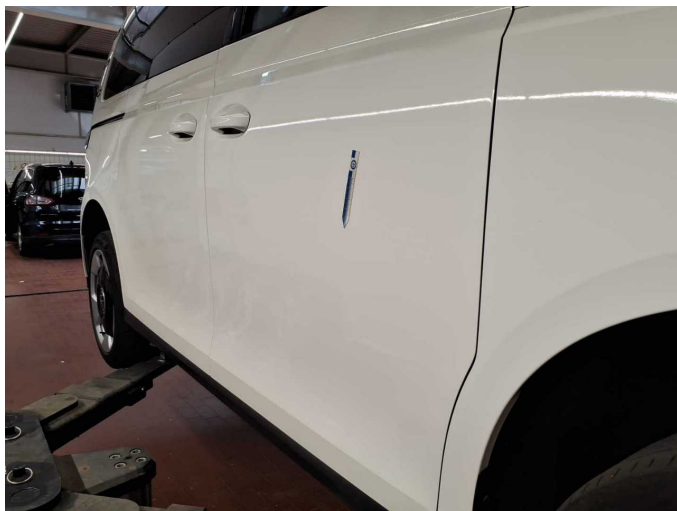
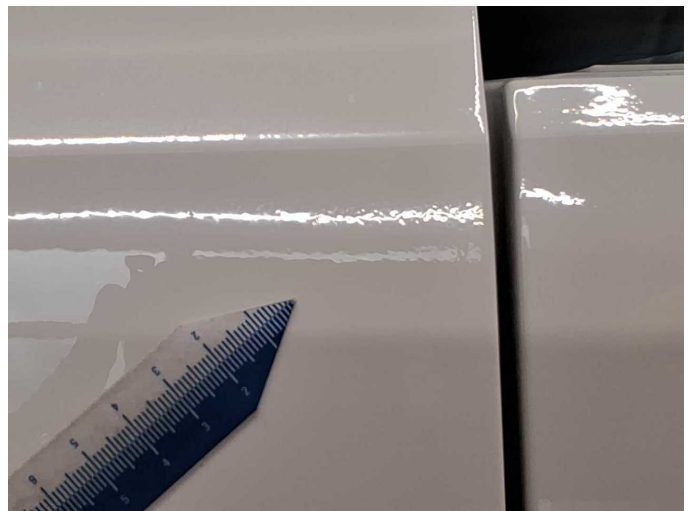
| No. | Component group | Description |
|---|---|---|
| 6 | Door - front right side | Door (Orangenhaut) - Unprofessionally repaired - Paint |

**Damage 6:** Door - front right side: Door (Orangenhaut) - Unprofessionally repaired - Paint

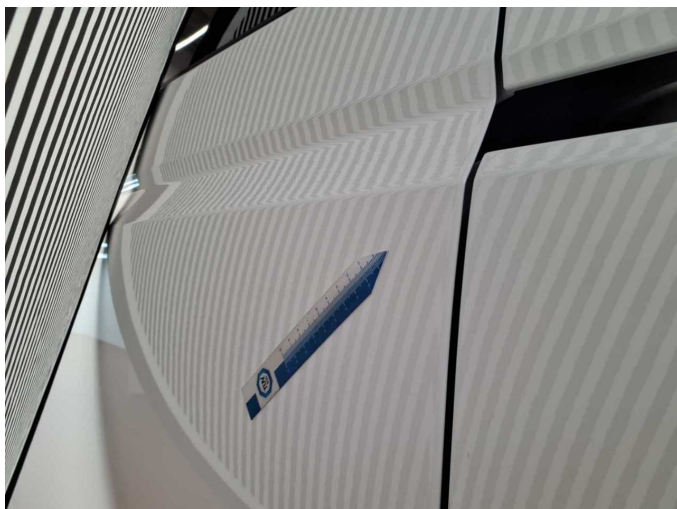
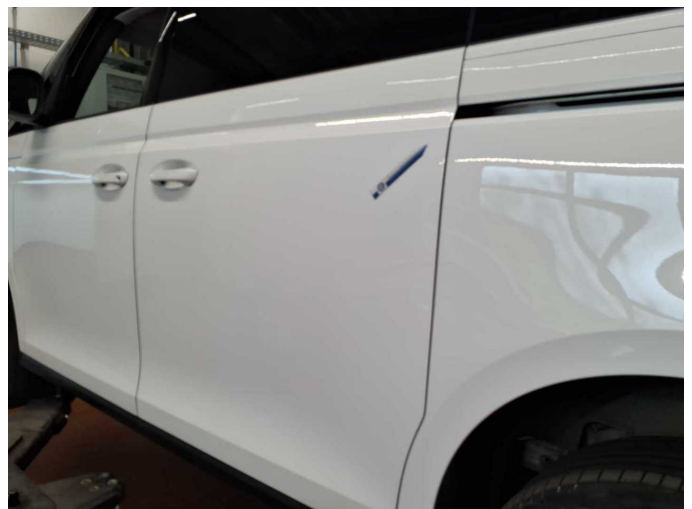
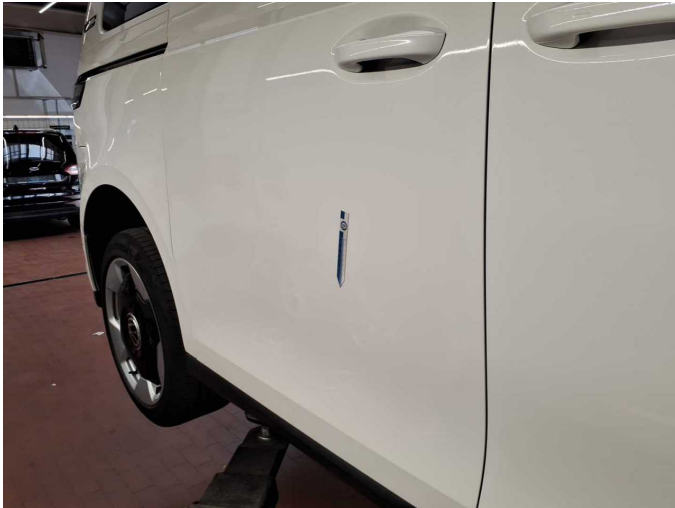
| No. | Component group | Description |
|---|---|---|
| 7 | Sliding door - left side | Sliding door with glass panel - Unprofessionally repaired - Paint |

**Damage 7:** Sliding door - left side: Sliding door with glass panel - Unprofessionally repaired - Paint

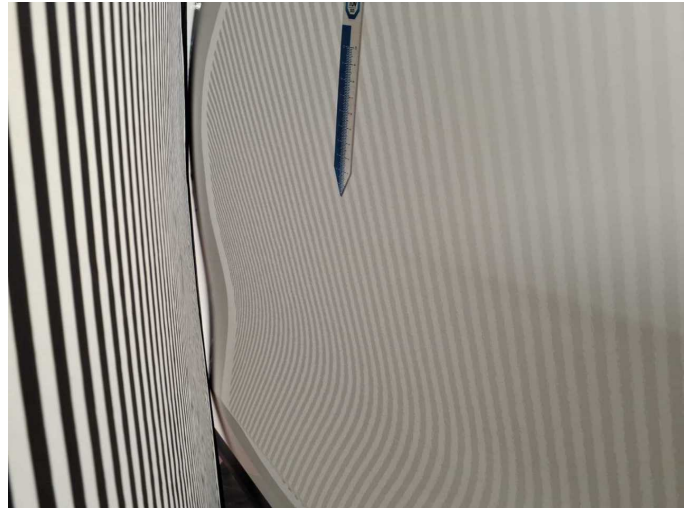
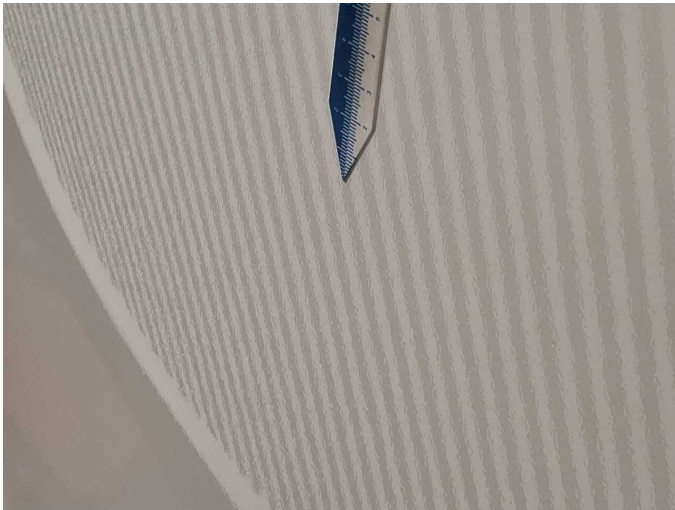
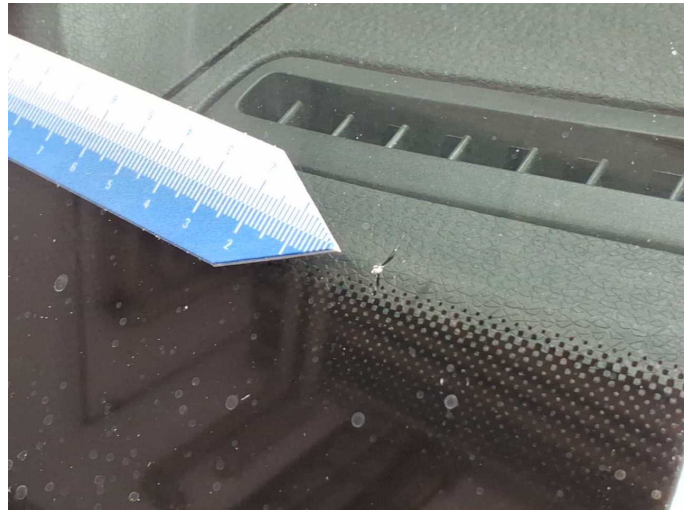
| No. | Component group | Description |
|---|---|---|
| 8 | Sliding door, right | Sliding door with glass panel - Unprofessionally repaired - Paint |

**Damage 8:** Sliding door, right: Sliding door with glass panel - Unprofessionally repaired - Paint

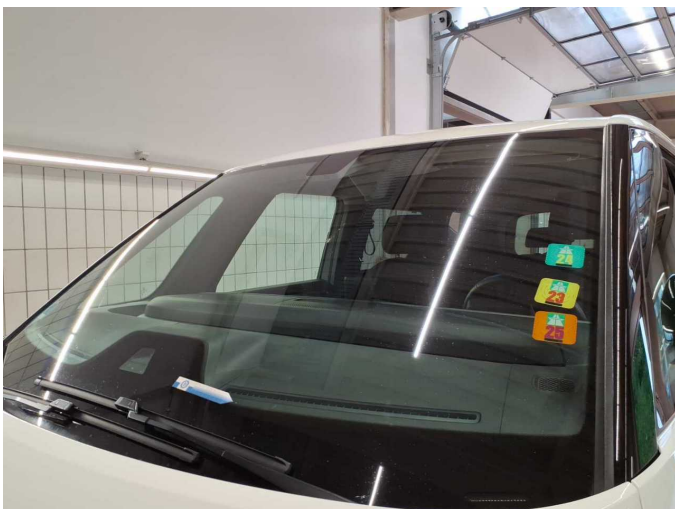
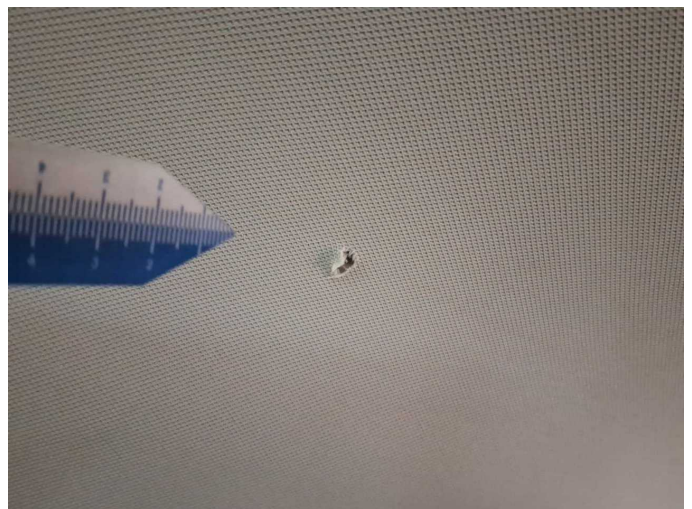
| No. | Component group | Description |
|---|---|---|
| 9 | Vehicle glazing | Windscreen - Stone chips - Replace |

**Damage 9:** Vehicle glazing: Windscreen - Stone chips - Replace

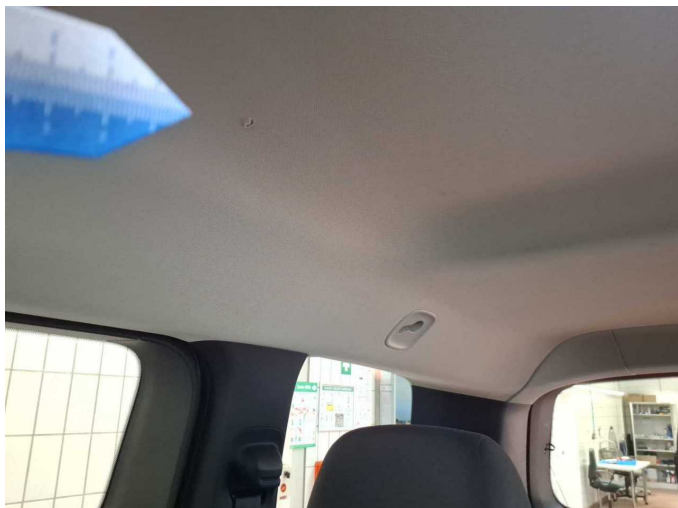
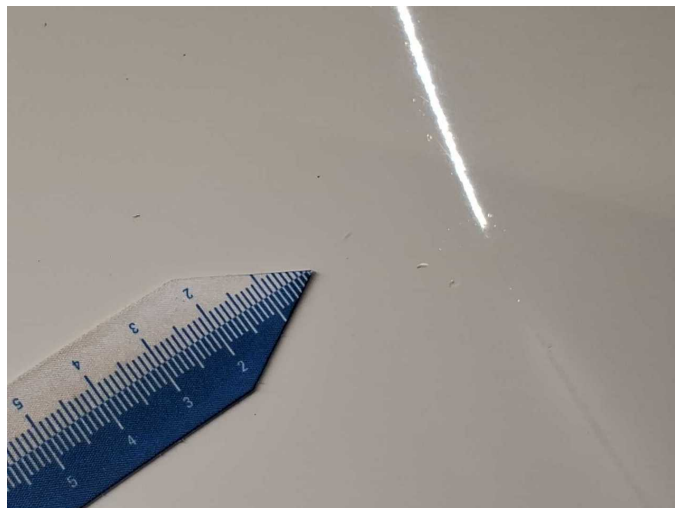
| No. | Component group | Description |
|---|---|---|
| 10 | Trim / covers | Roof lining - Broken / torn - Replace |

**Damage 10:** Trim / covers: Roof lining - Broken / torn - Replace

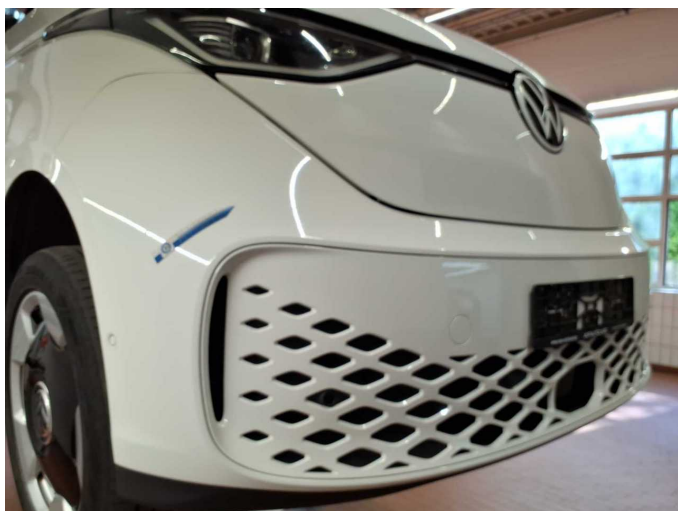
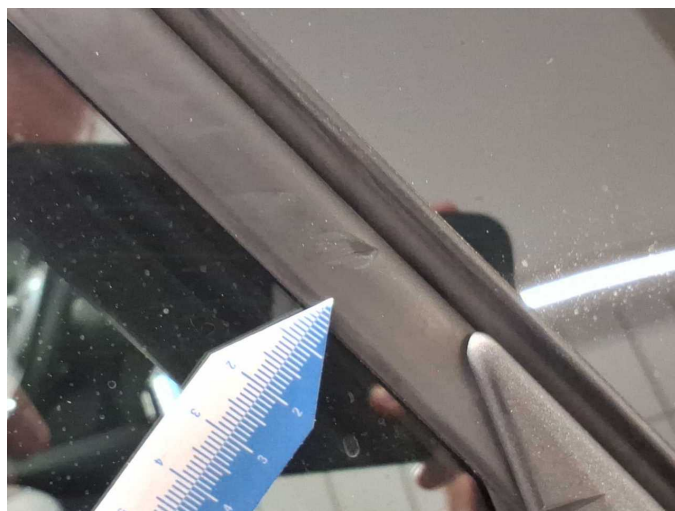
| No. | Component group | Description |
|---|---|---|
| 1 | Front bumper | Front bumper - Stone chips - No deduction |

**Wear and tear 1:** Front bumper: Front bumper - Stone chips - No deduction

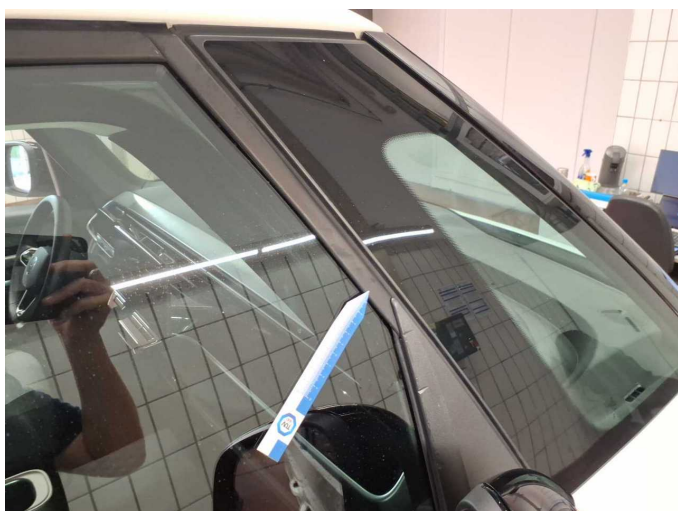
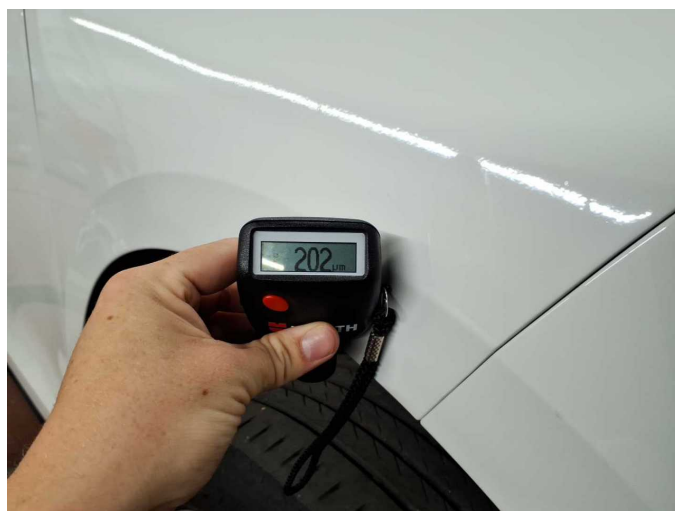
| No. | Component group | Description |
|---|---|---|
| 2 | Door - front right side | Window guide - Scratch(es) - No deduction |

**Wear and tear 2:** Door - front right side: Window guide - Scratch(es) - No deduction

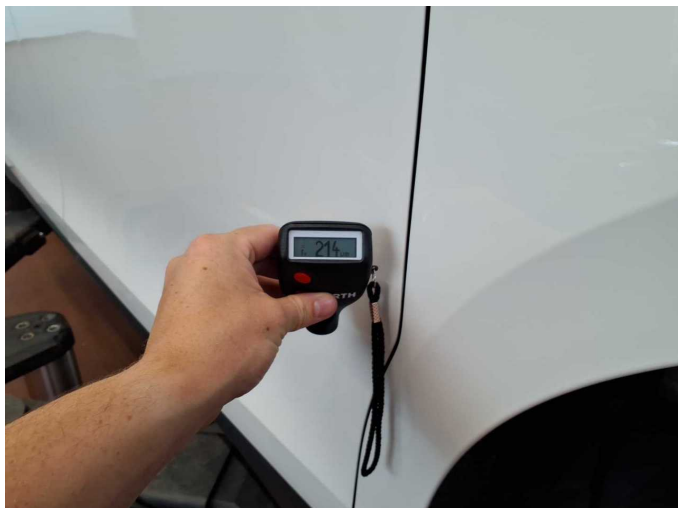
**Repainting 1:** Mudguard - right side

| Mudguard - right side | 202 µm | Door - rear left side | 214 µm |

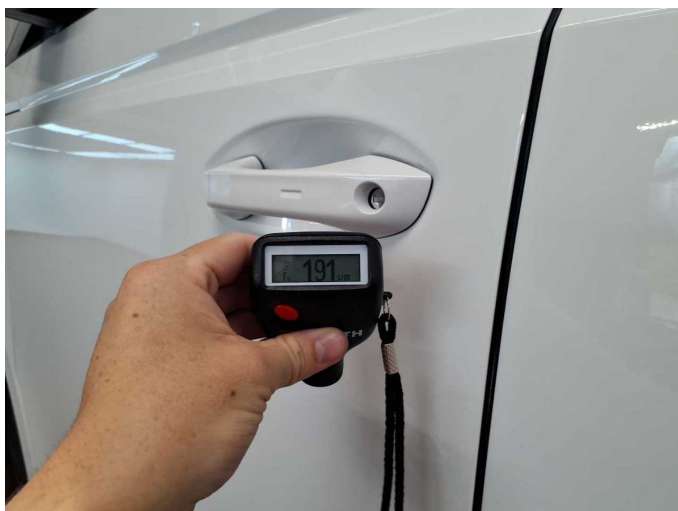
**Repainting 3:** Door - rear right side

| Door - rear right side | 190 µm | Door - front left side | 191 µm |
