Expertise

Protocol number: 46145875
Order No. / Reference: 26518192
Inspection date: 17 Jun 2026

Model: Transit Connect 230 L2 S&S Trend

VIN: WF07XXWPG7NY73116

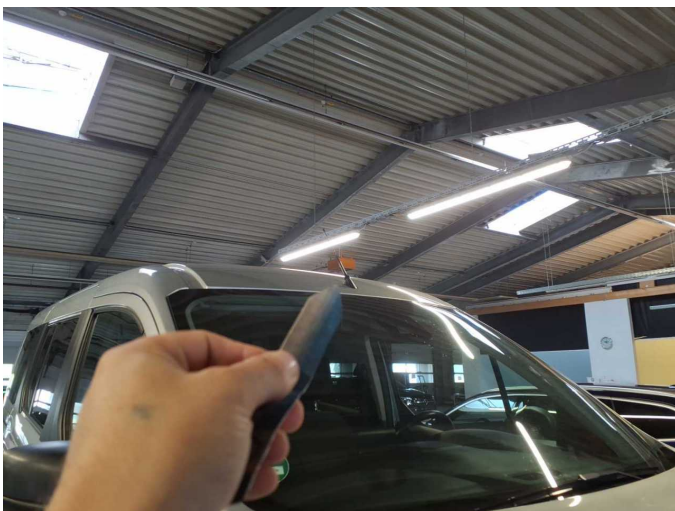
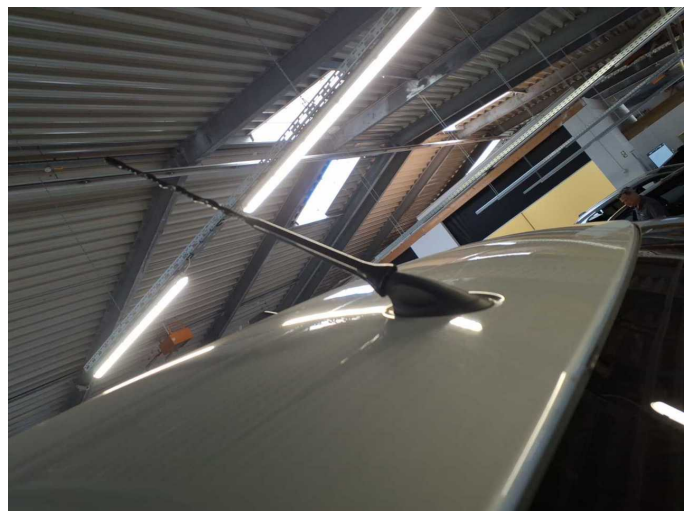
Damage 1: Roof: Stub aerial (Nicht original) - Differs from the original configuration - Replace

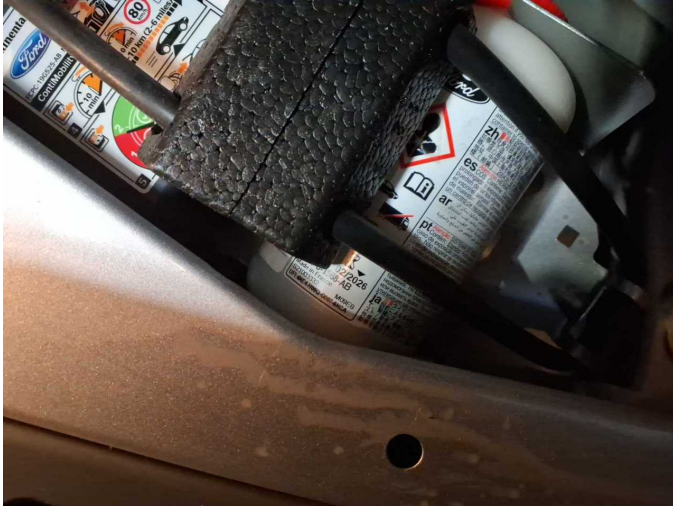
Damage 2: Equipment: Tirefit filler - Expired - Replace

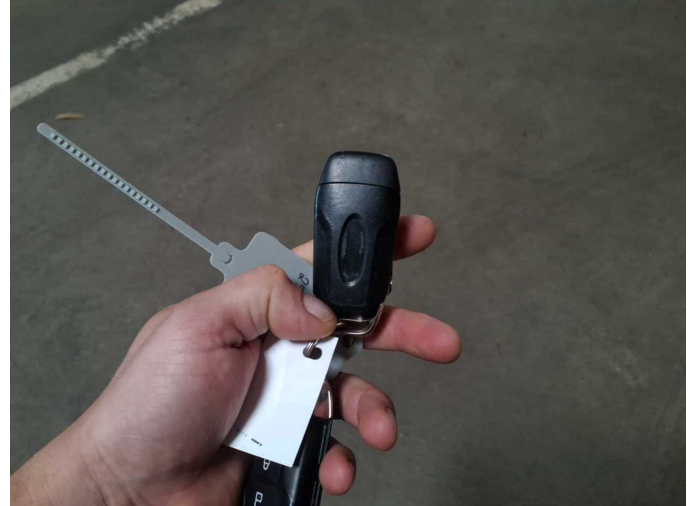
Damage 3: Equipment: Vehicle key with remote control - Damaged - Loss in value

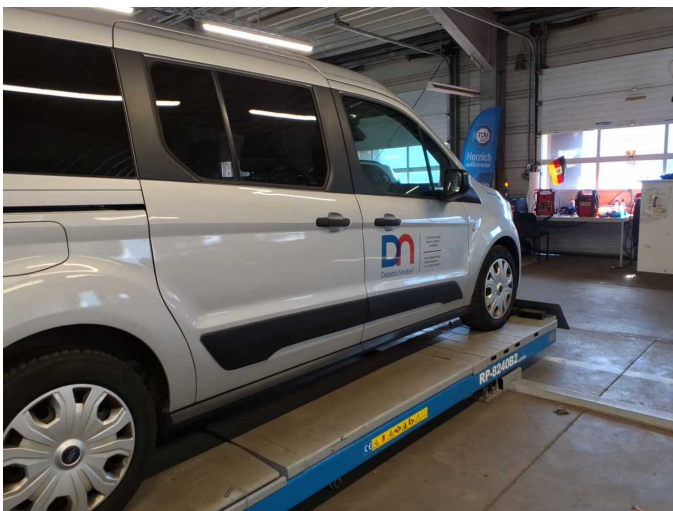
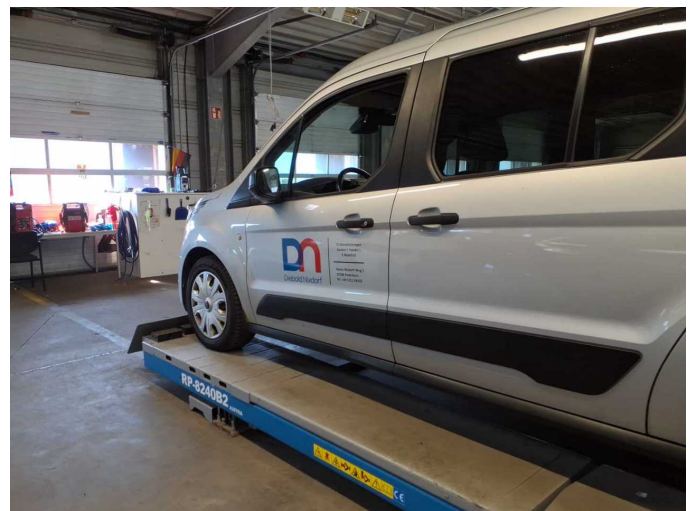
Damage 4: Body: Body - Glued / labelled - De-glove / neutralise

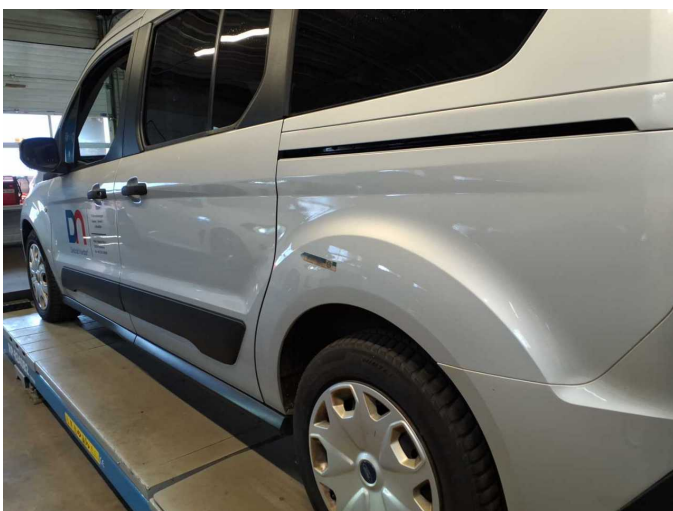
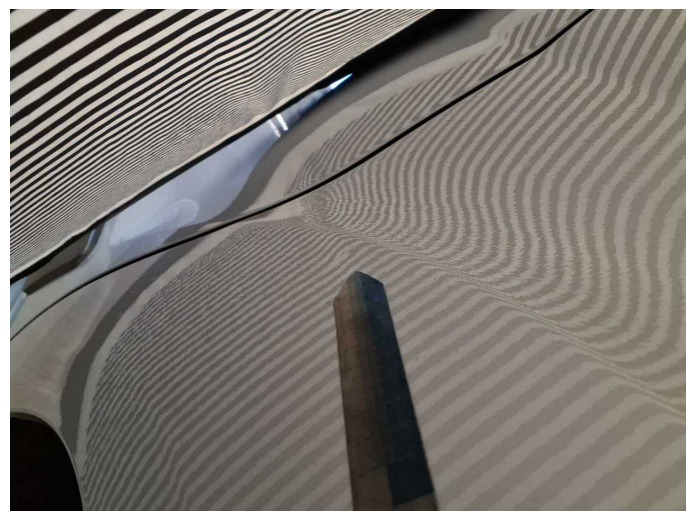
Damage 5: Side panel - rear left side: Side panel - dent(s) - Smooth repair work

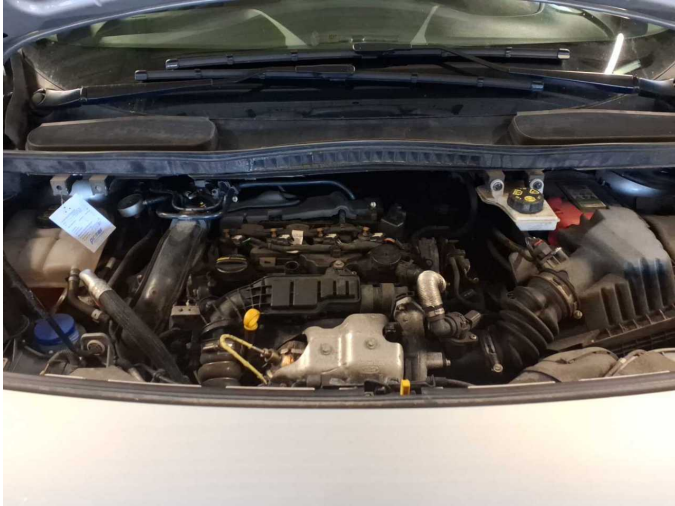
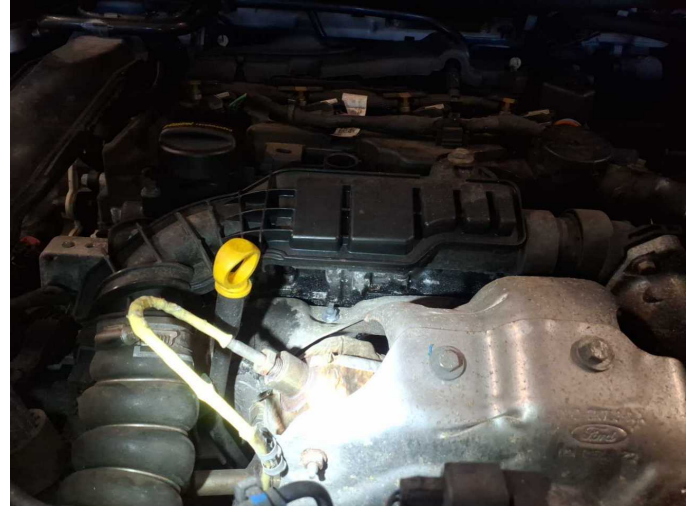
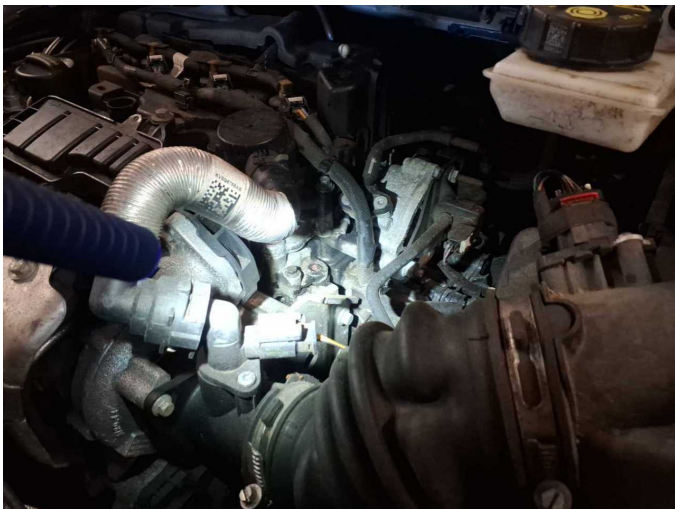
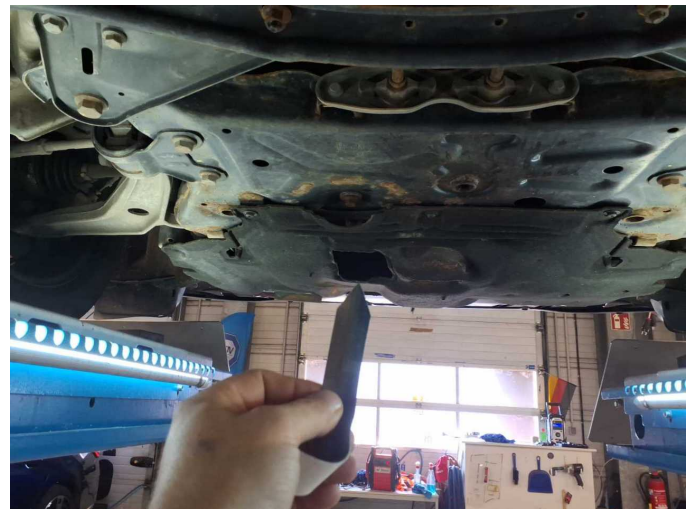
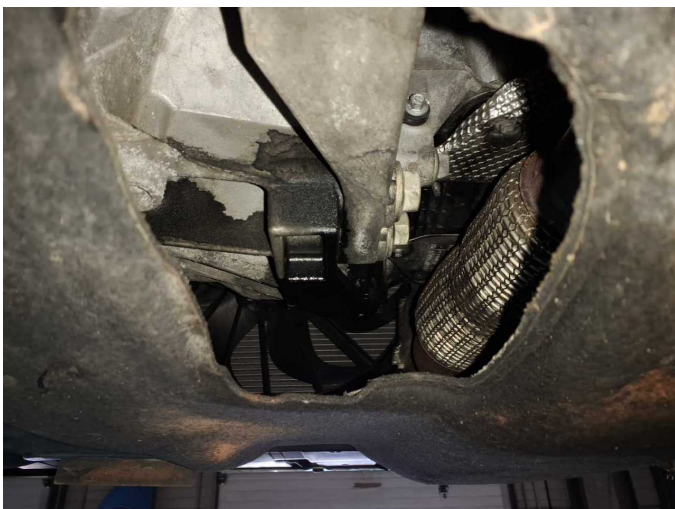
Damage 6: Engine: Engine (Ölfeucht) - Leaking - Perform diagnosis

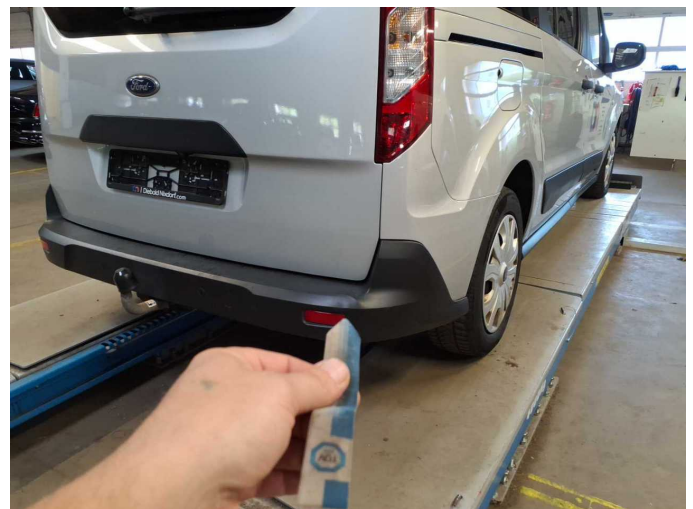
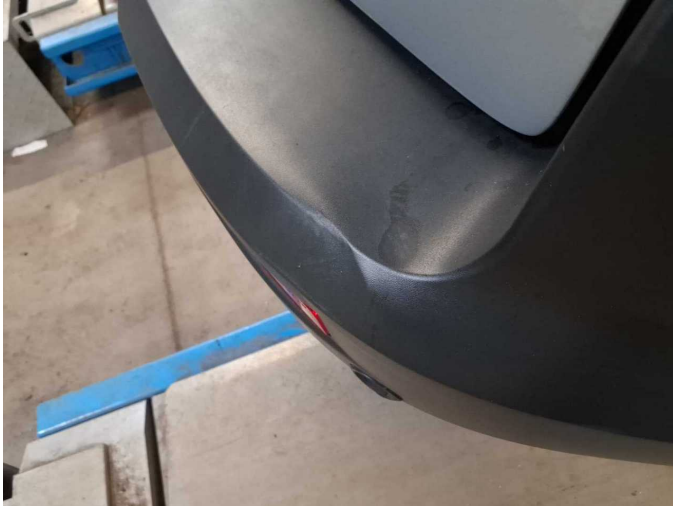
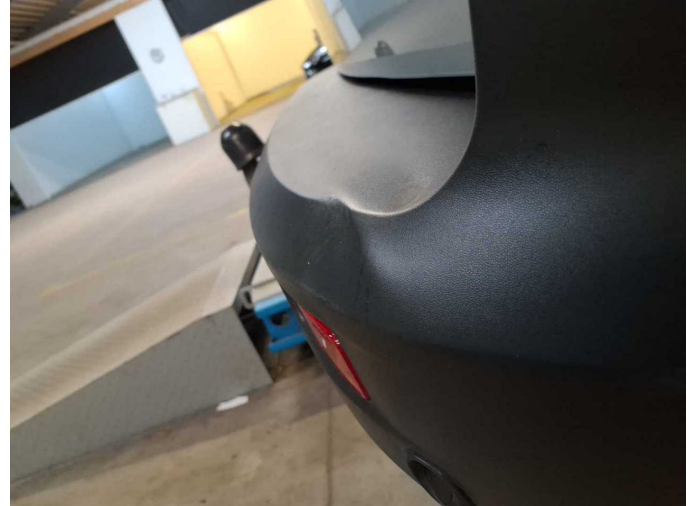
Damage 8: Rear bumper: Rear bumper - Deformed - Replace

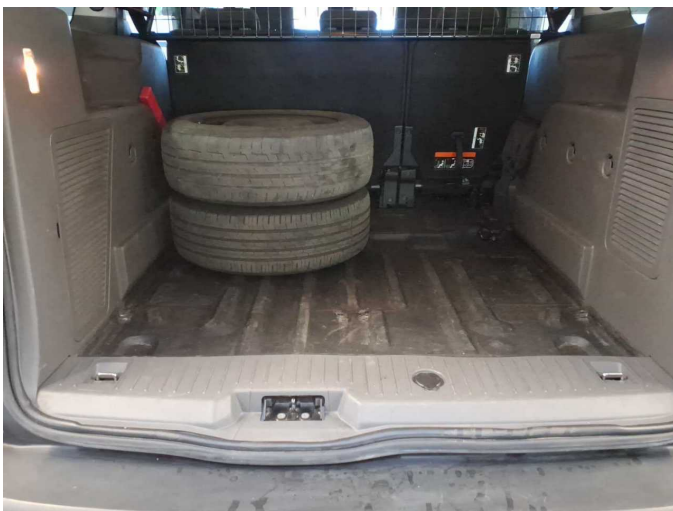
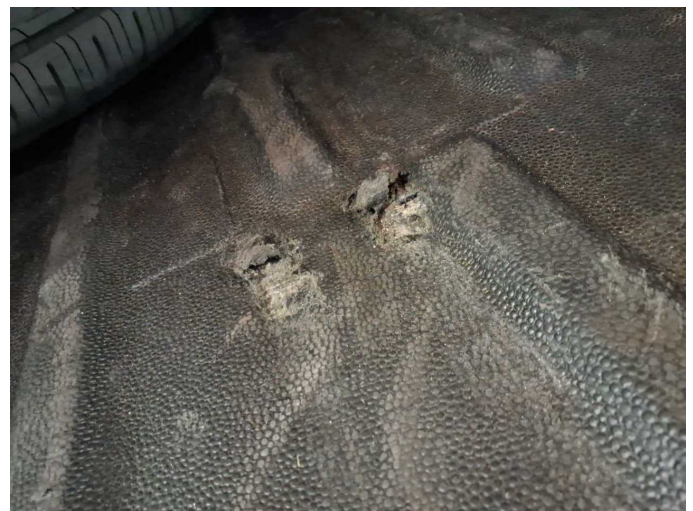
Damage 9: Interior: Cargo area floor - Broken / torn - Replace

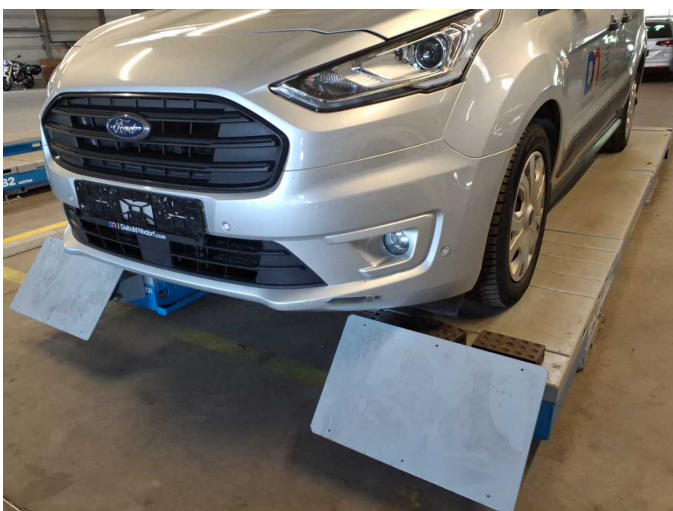
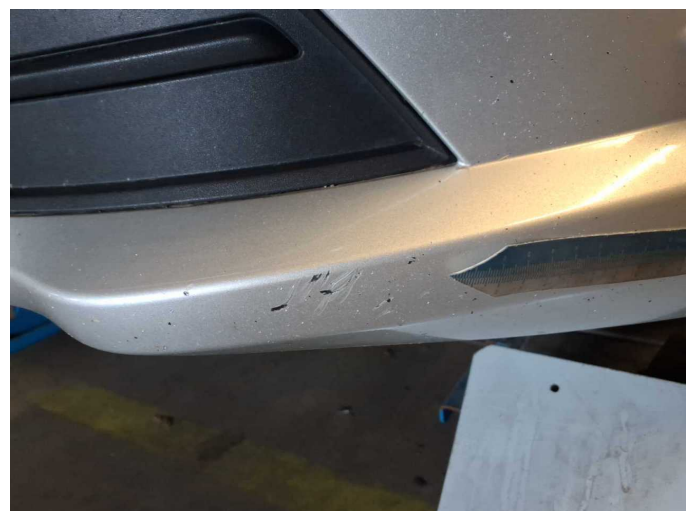
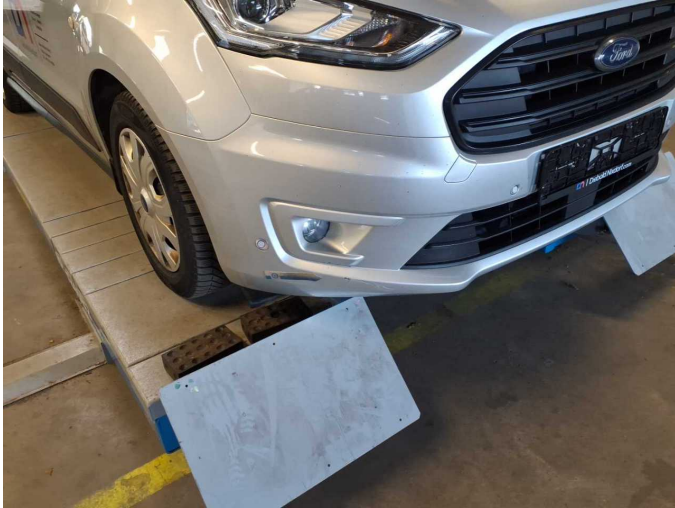
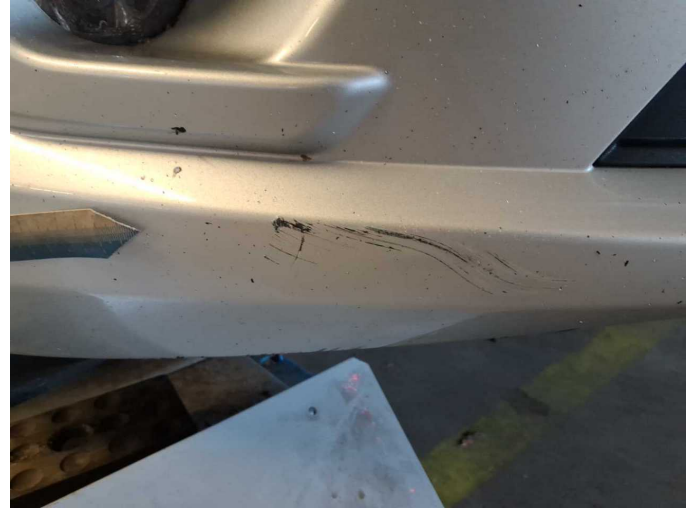
Damage 10: Front bumper: Front bumper - Scratched - Paint

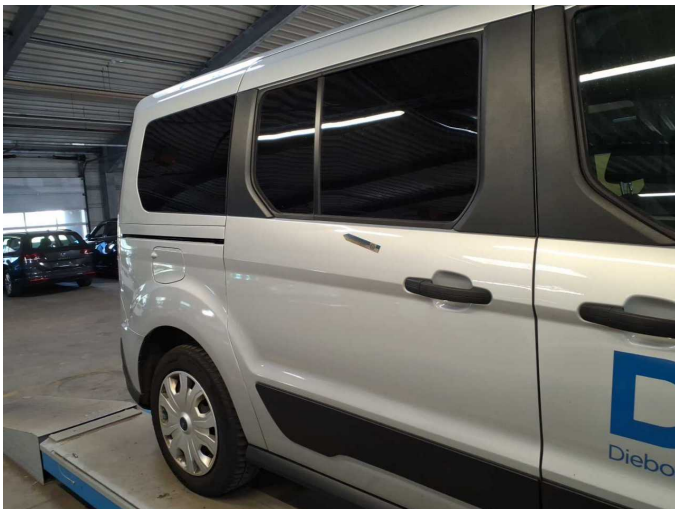
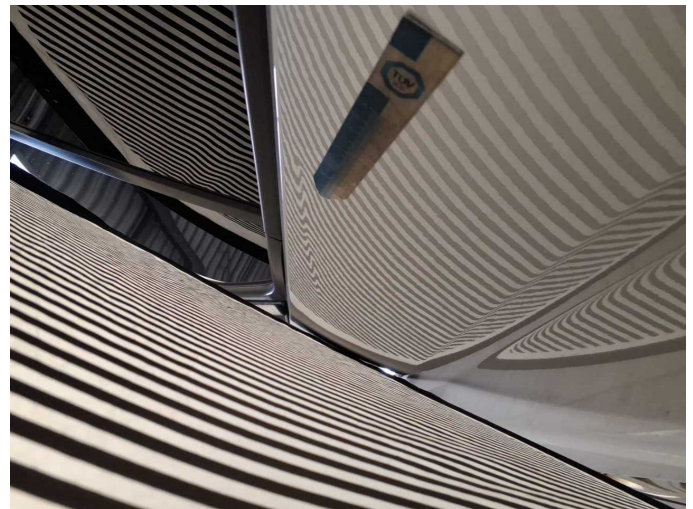
Damage 11: Sliding door, right: Sliding door with glass panel - Deformed - Repair and paint
