## Expertise

Protocol number: 45470390  
Order No. / Reference: 26227747  
Inspection date: 15 May 2026

Model: 5008 BlueHDi 130 EAT8 GT

VIN: VF3MCYHZUNS162160

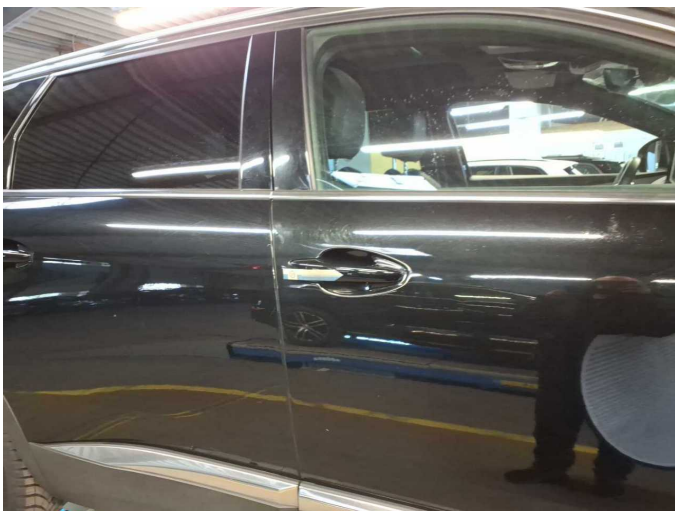
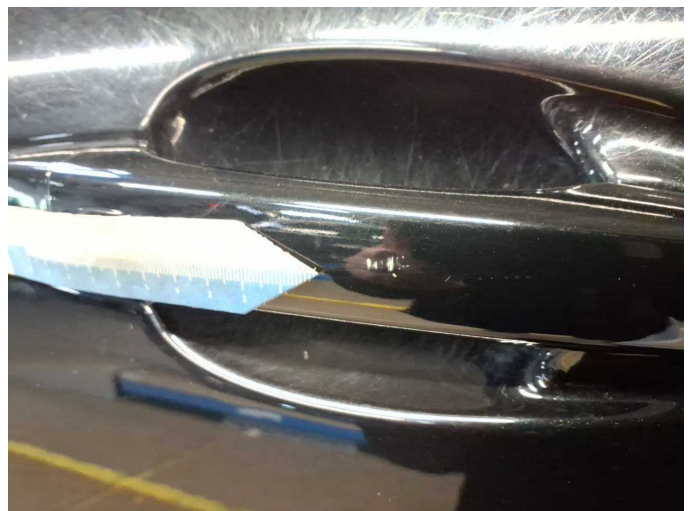
**Damage 1:** Door - front right side: Door handle - outside - Scratch(es) - Smart repair

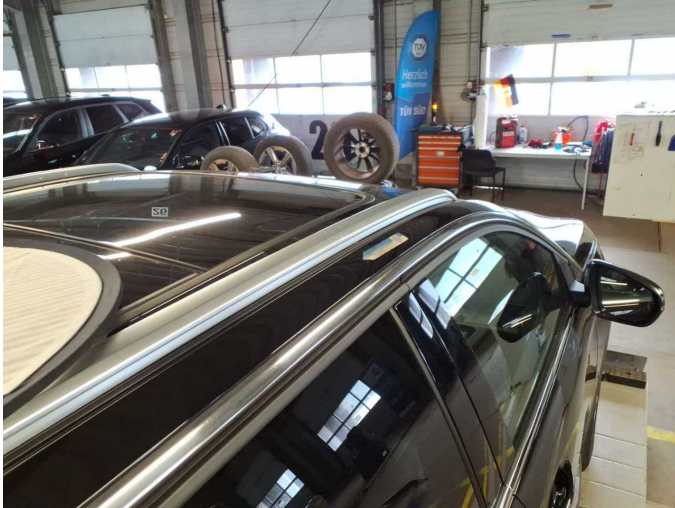
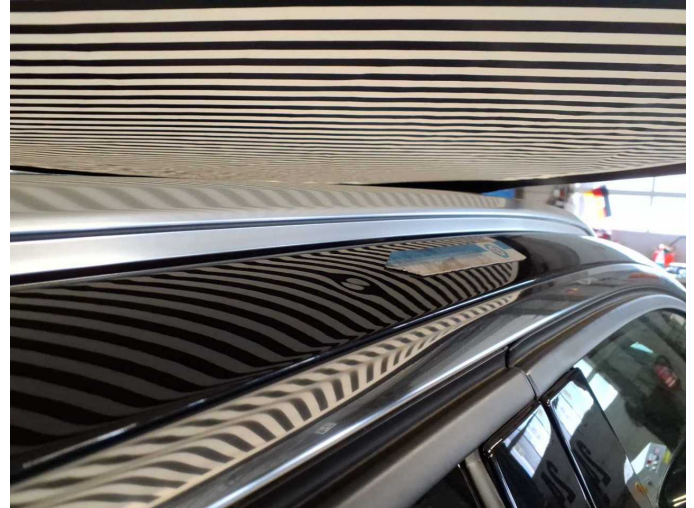
**Damage 2:** Roof: Roof rail - right side - dent(s) - Smooth repair work

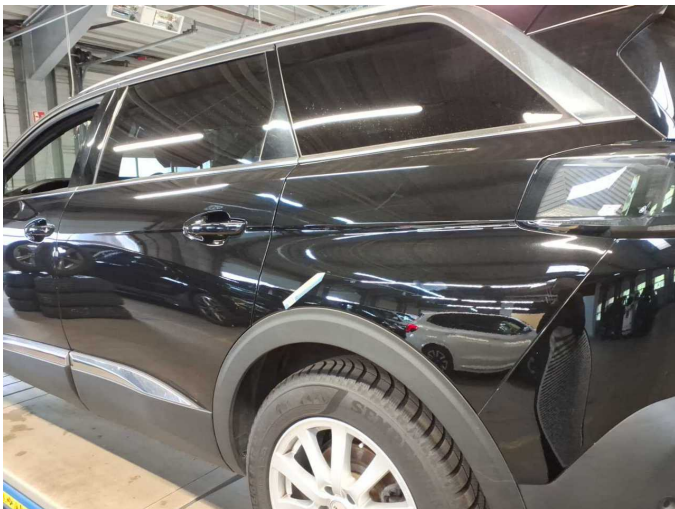
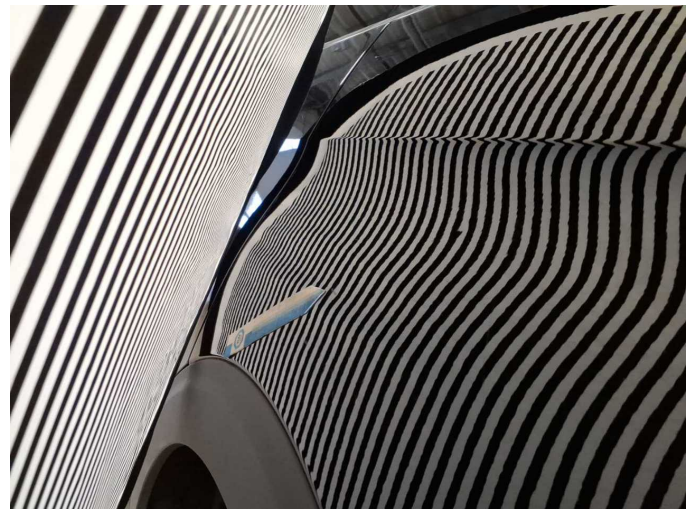
**Damage 3:** Side panel - rear left side: Side panel - dent(s) - Smooth repair work

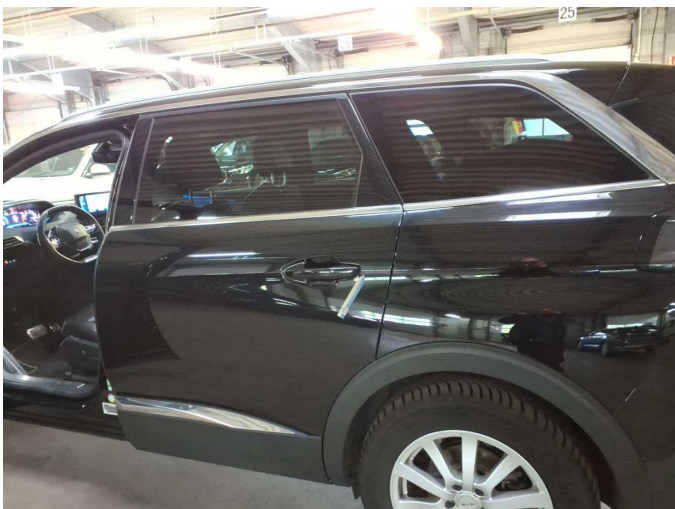
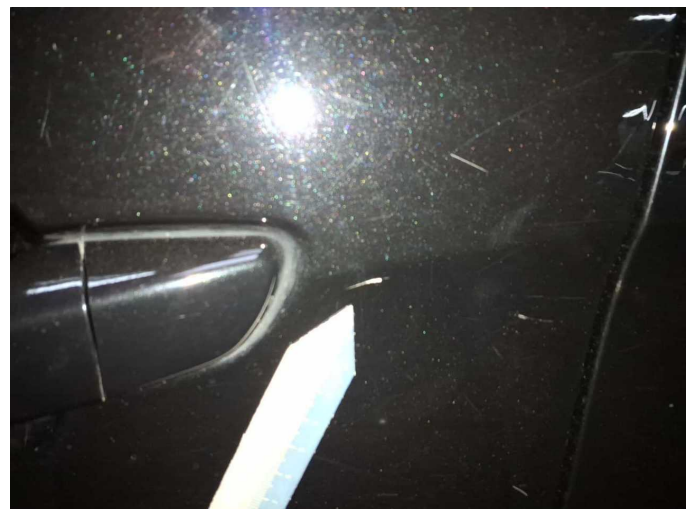
**Damage 4:** Door - rear left side: Door - Scratch(es) - Smart repair

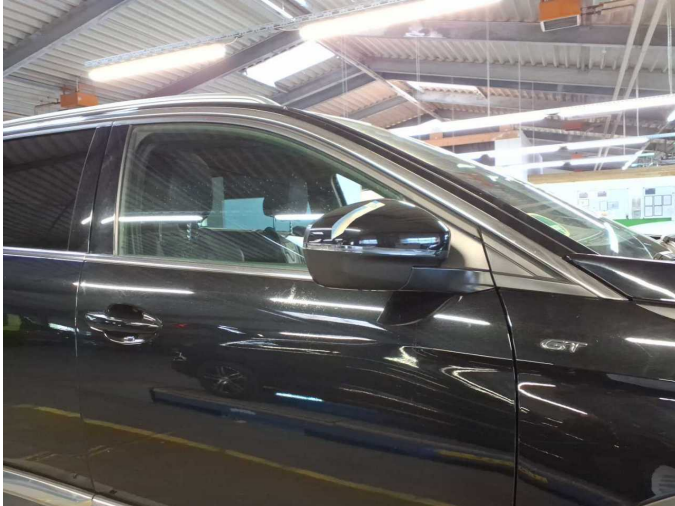
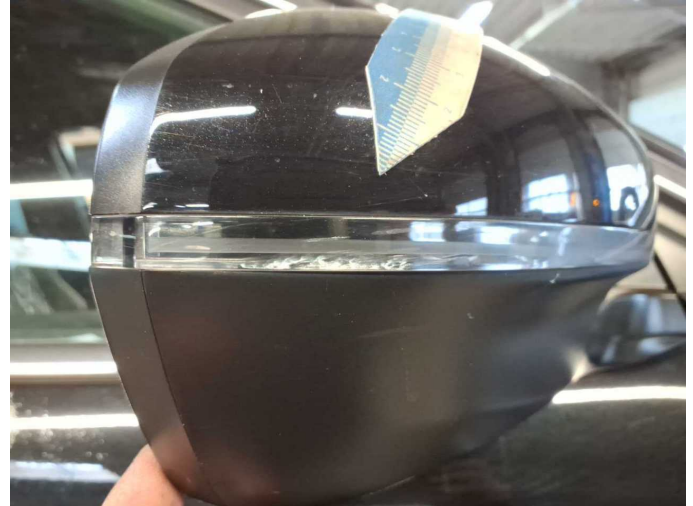
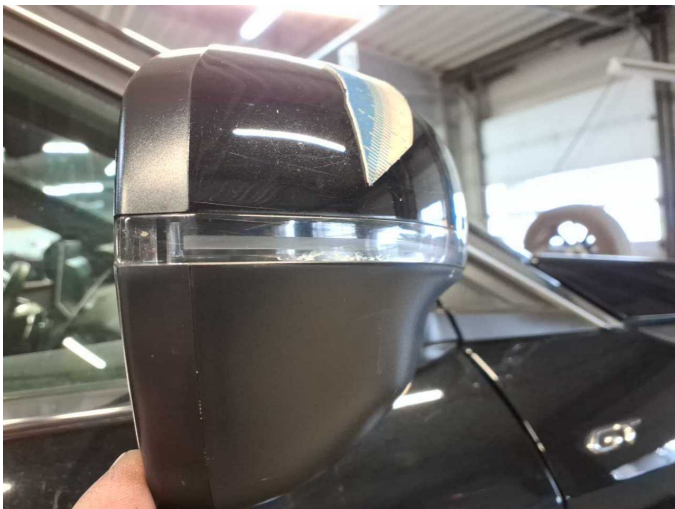
**Damage 5:** Indicator - front: Mirror - right side - Scratched - Replace

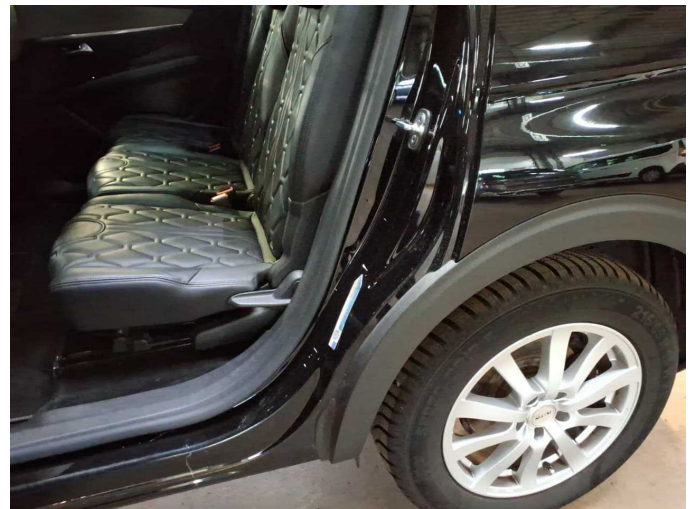
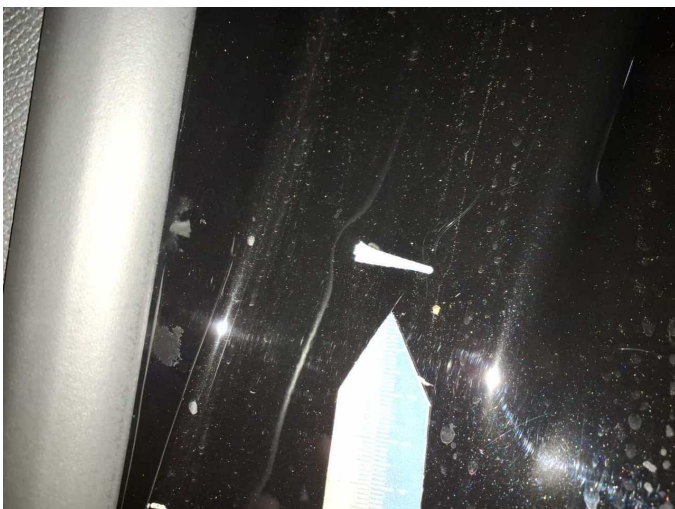
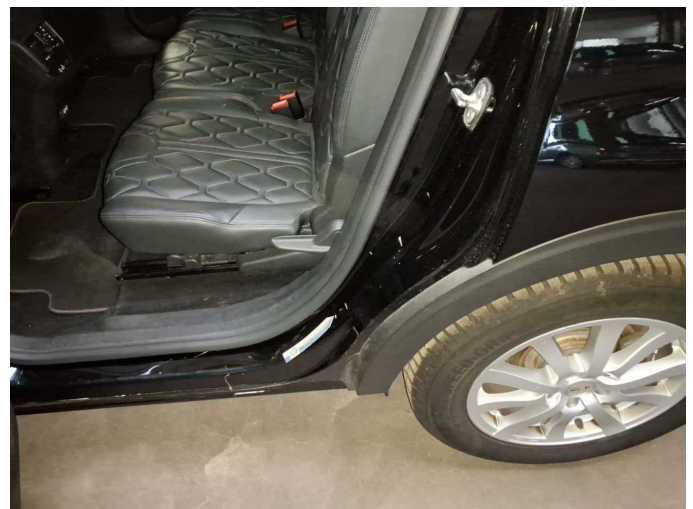
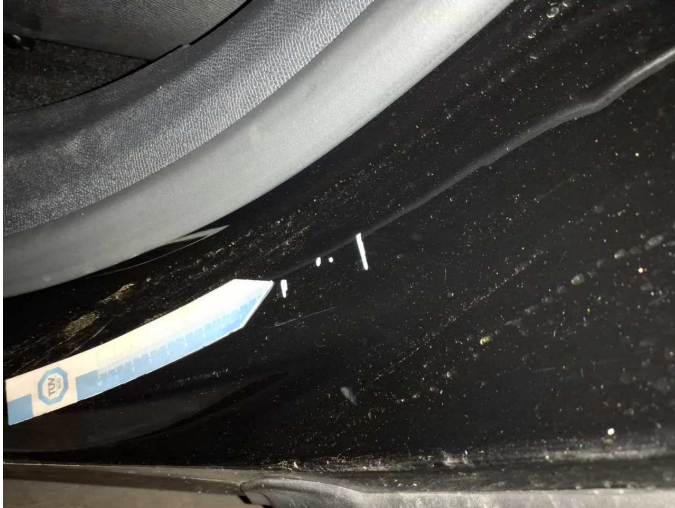
**Damage 6:** Side panel - rear left side: Sill - Dent / paintcoat damage - Smart repair

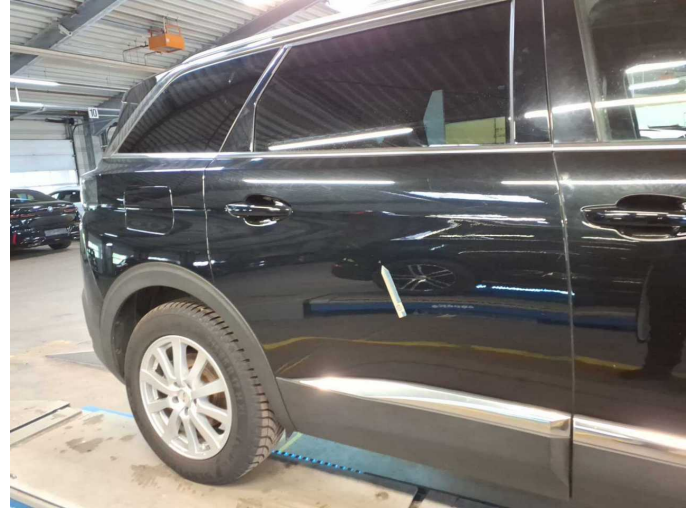
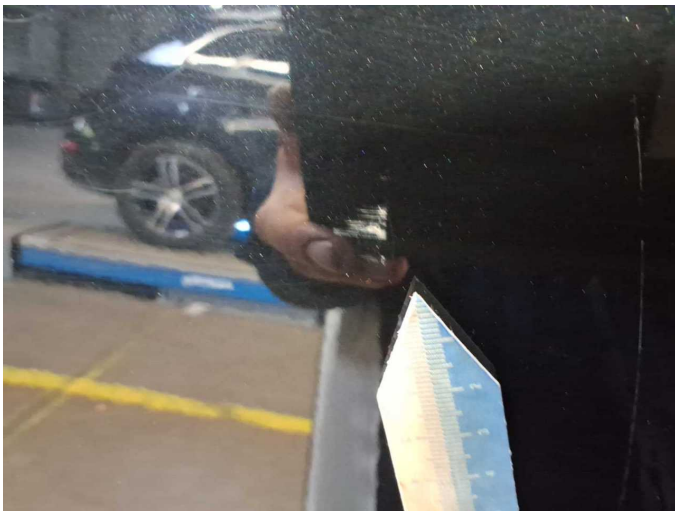
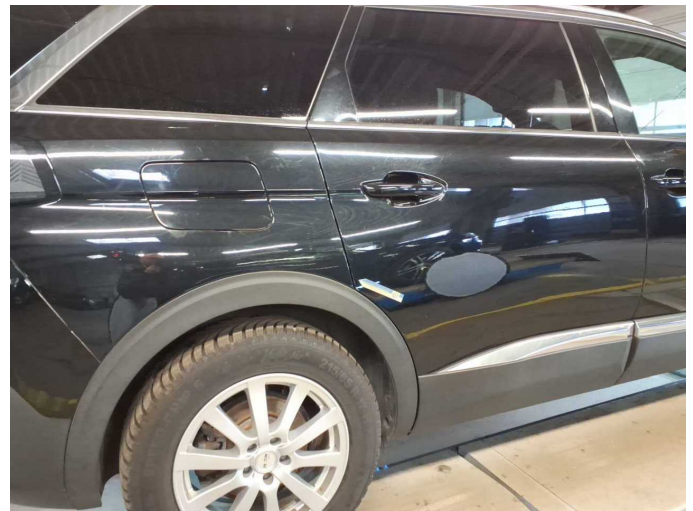
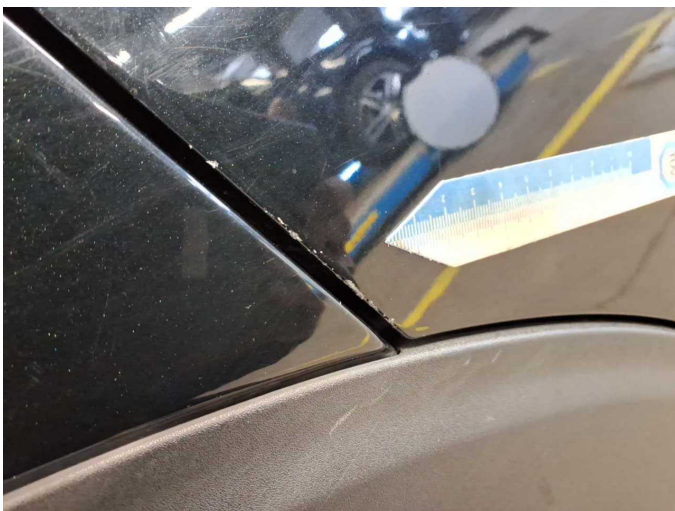
**Damage 7:** Door - rear right side: Door - Scratch(es) - Paint

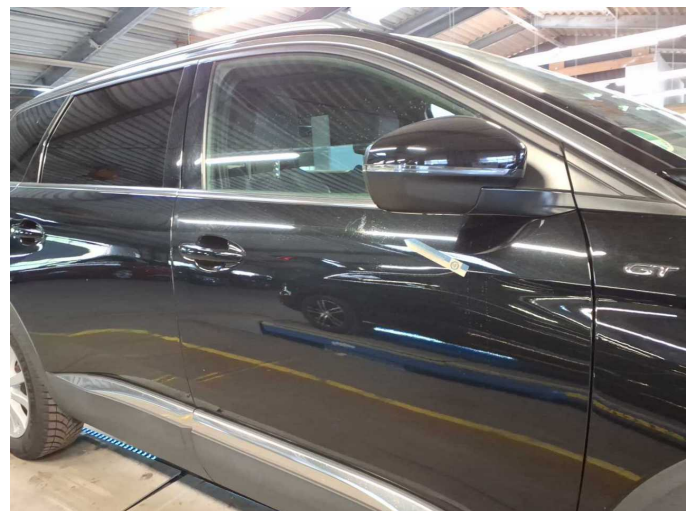
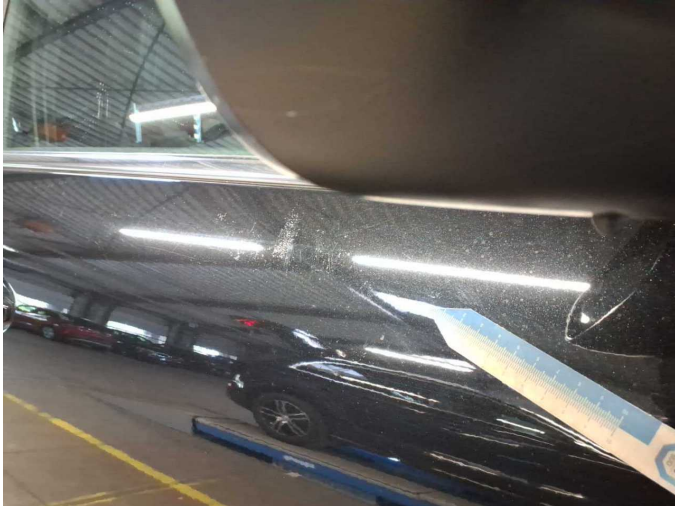
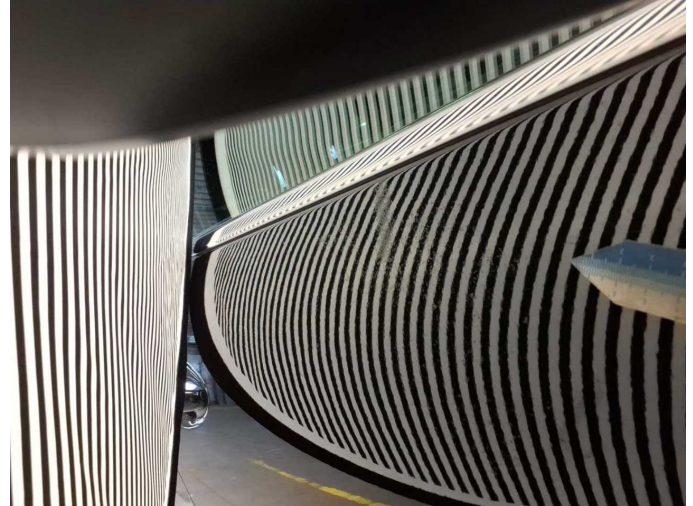
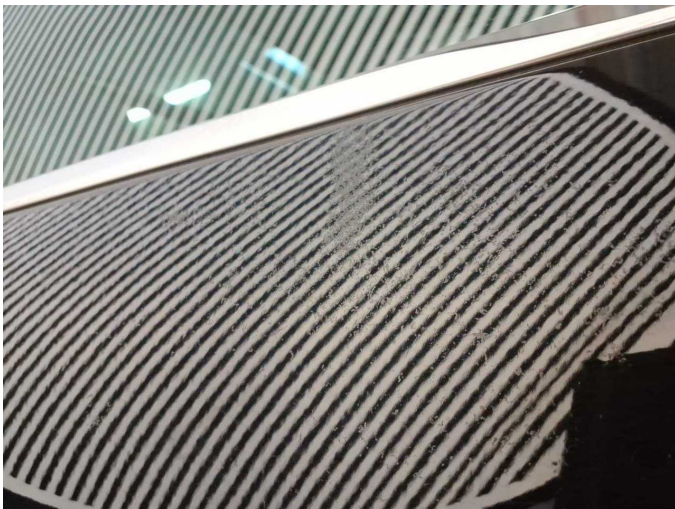
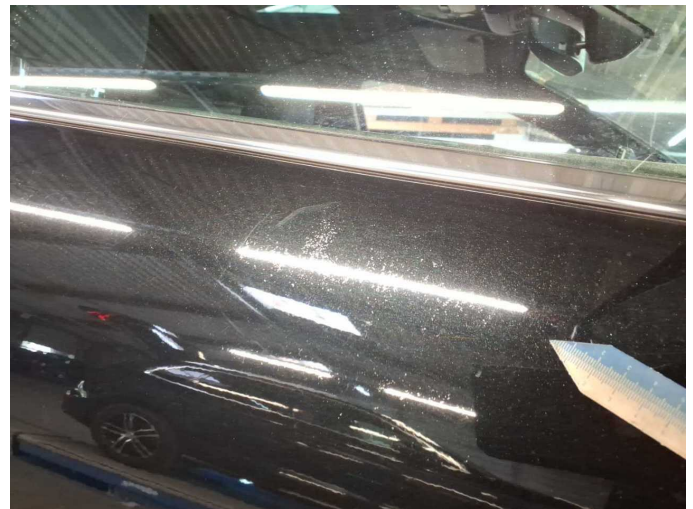
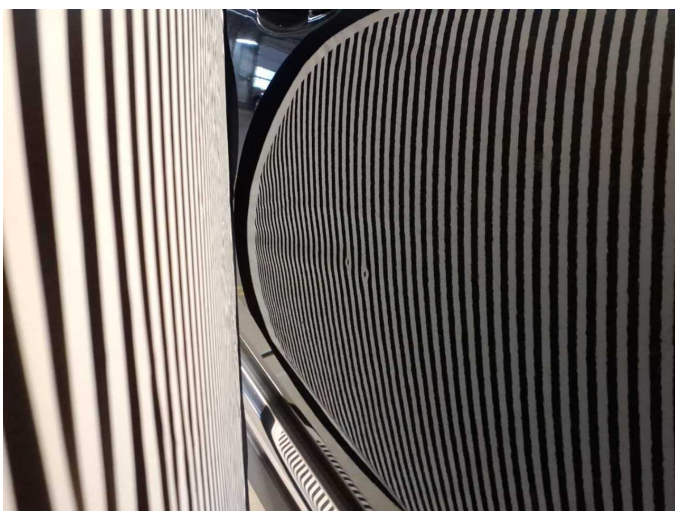
**Damage 8:** Door - front right side: Door (Einschlüsse, dellen) - Unprofessionally repaired - Repair and paint

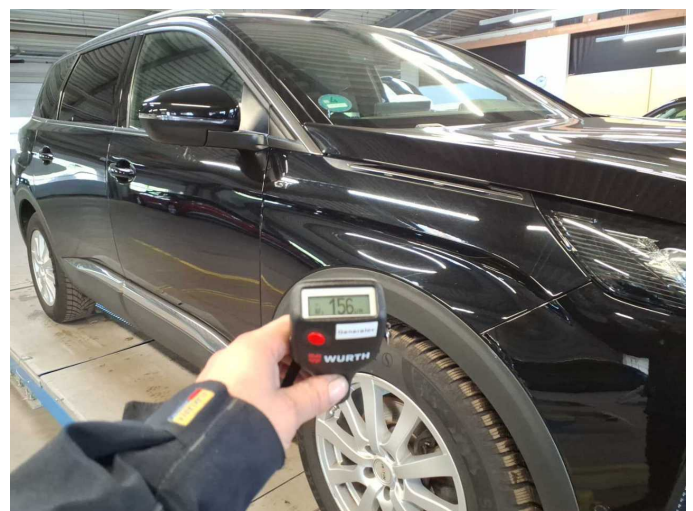
**Repainting 1:** Mudguard - right side

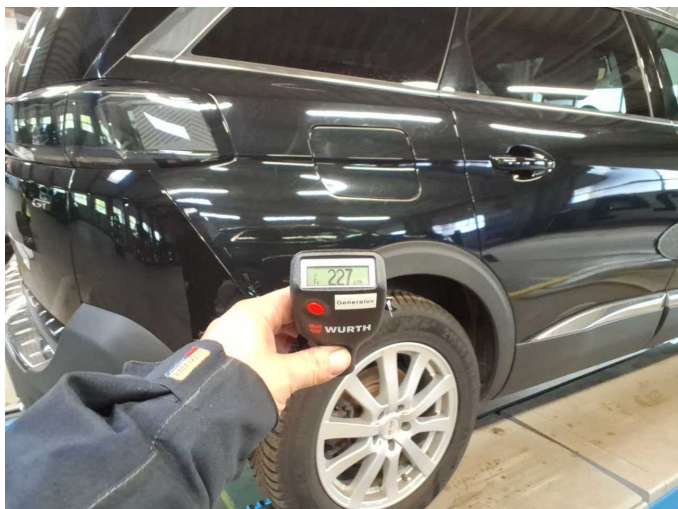
**Repainting 2:** Side panel - rear right side

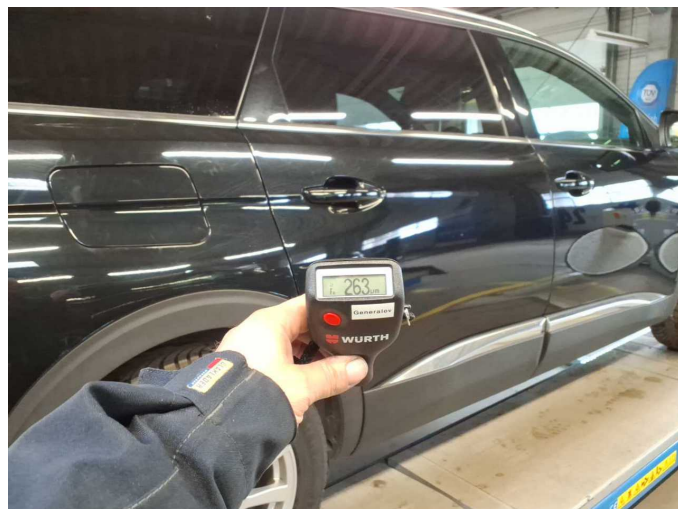
**Repainting 3:** Door - rear right side

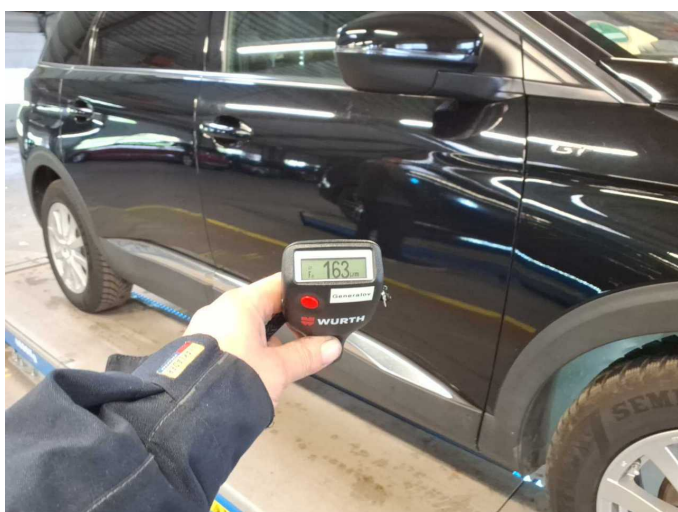
**Repainting 4:** Door - front right side
