Expertise

Protocol number: 46475184  
Order No. / Reference: 25812374  
Inspection date: 9 Jul 2026

Manufacturer: Mercedes-Benz  
VIN: W1V3KCFZ0TP857759

Model: 317 CDI Sprinter Lang HA PRO Kasten

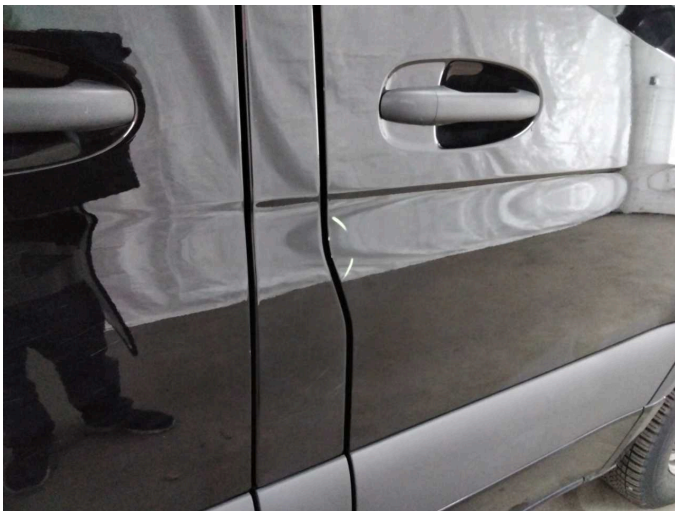
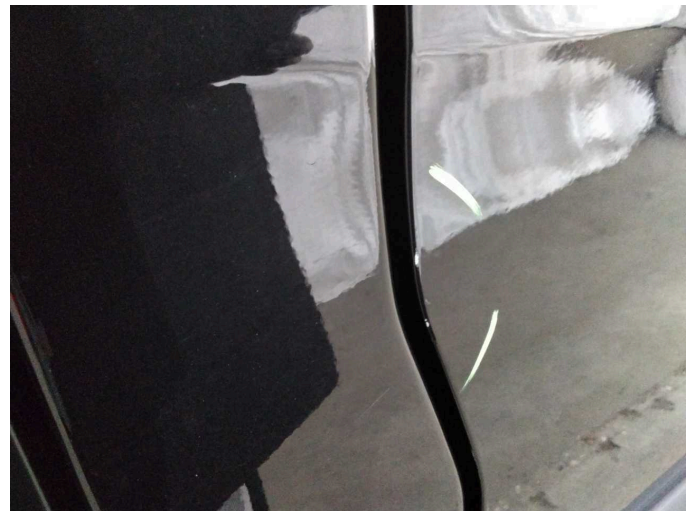
| No. | Component group | Description |
|---|---|---|
| 1 | Door - front right side | Door edge - Scratch(es) - Smart repair |

**Damage 1:** Door - front right side: Door edge - Scratch(es) - Smart repair

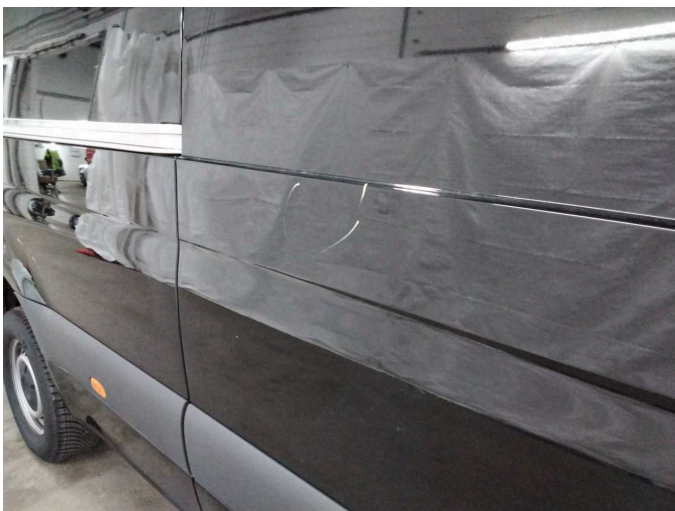
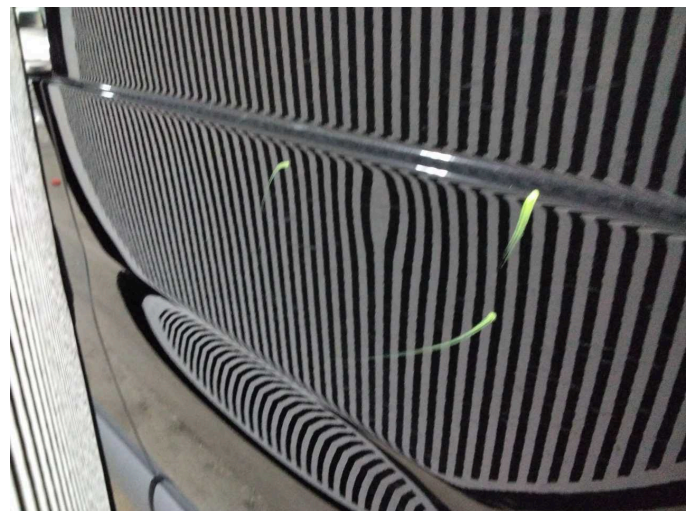
| No. | Component group | Description |
|---|---|---|
| 2 | Sliding door, right | Sliding door - dent(s) - Smooth repair work |

**Damage 2:** Sliding door, right: Sliding door - dent(s) - Smooth repair work

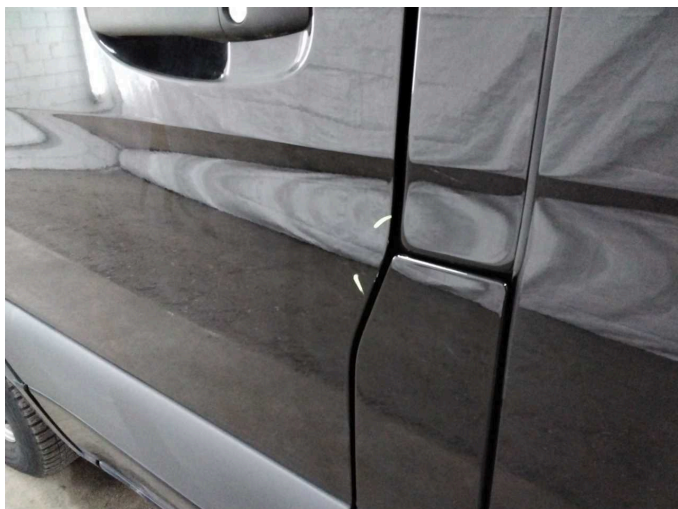
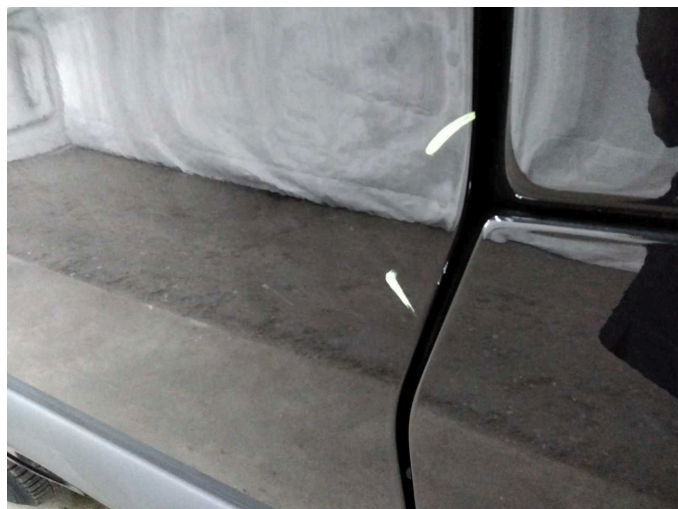
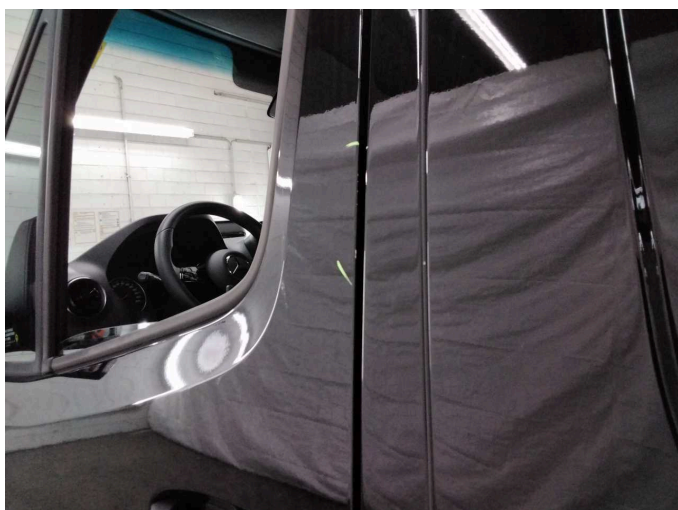
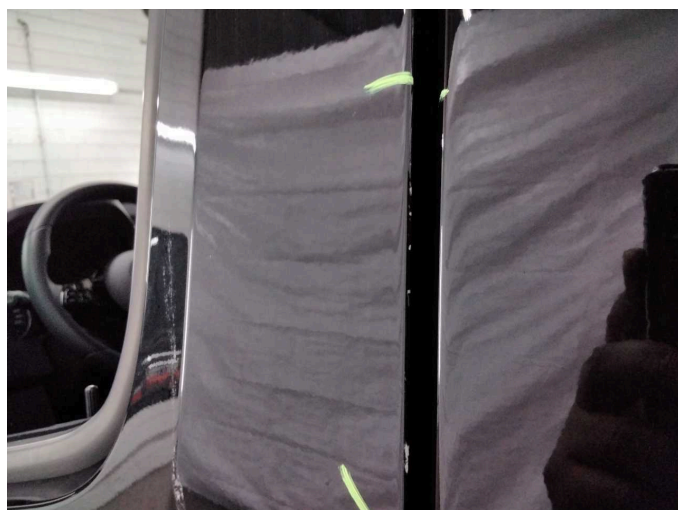
| No. | Component group | Description |
|---|---|---|
| 3 | Door - front left side | Door edge - Scratch(es) - Smart repair |

**Damage 3:** Door - front left side: Door edge - Scratch(es) - Smart repair

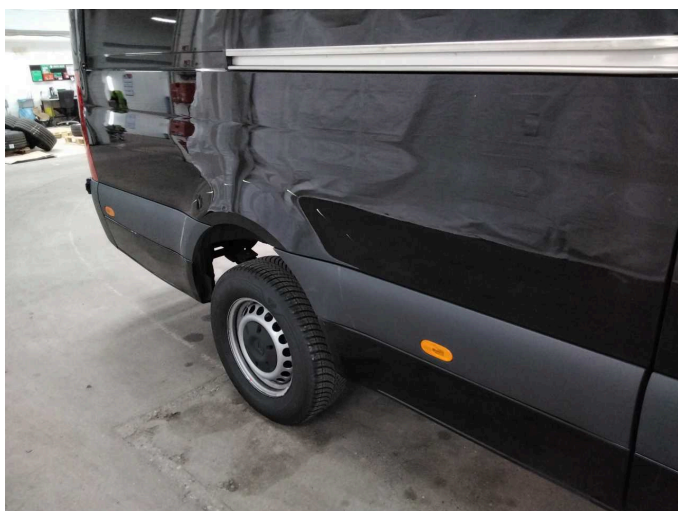
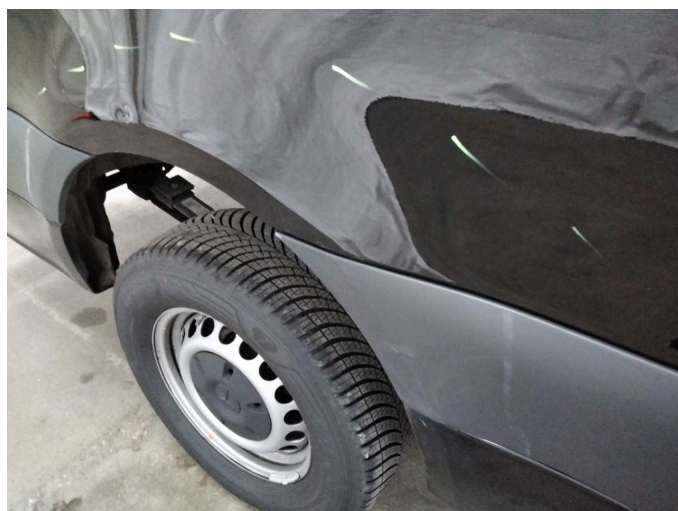
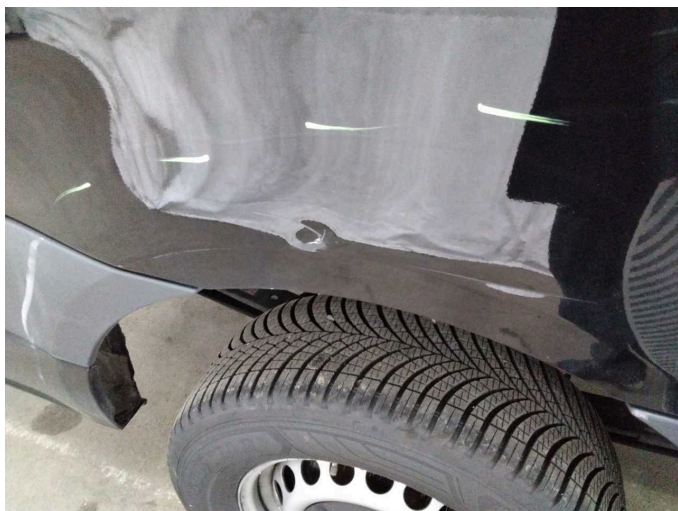
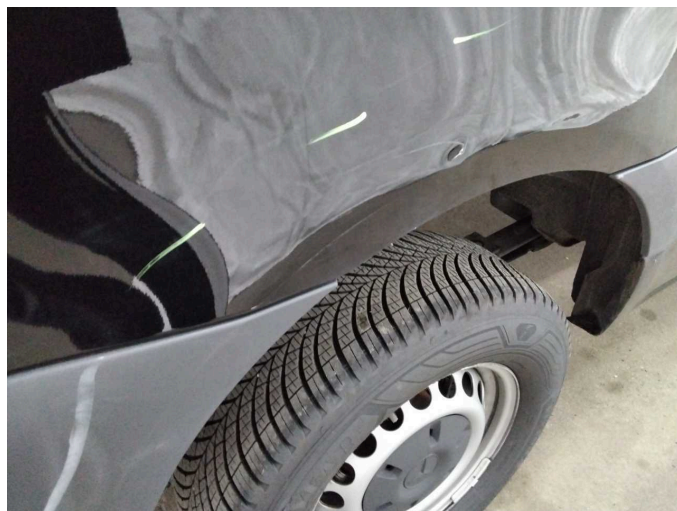
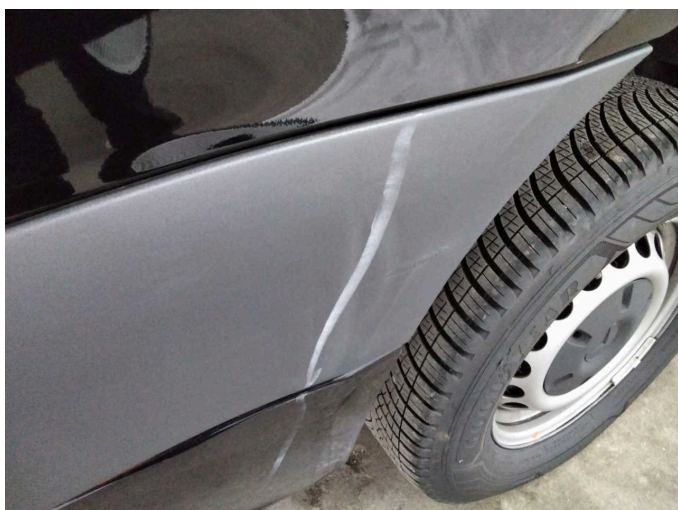
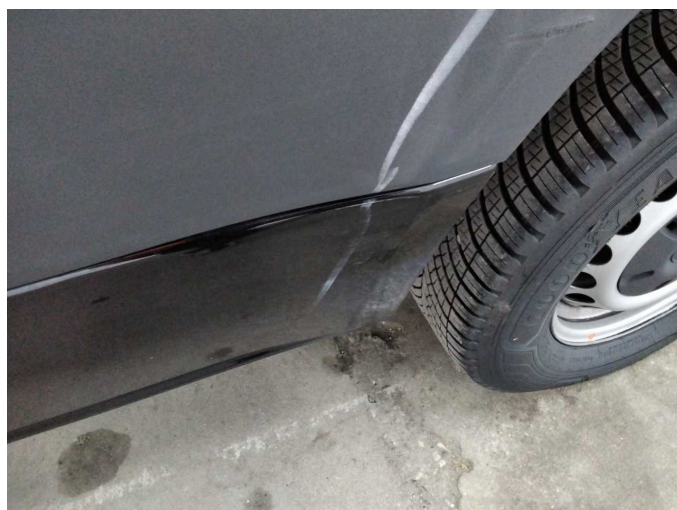
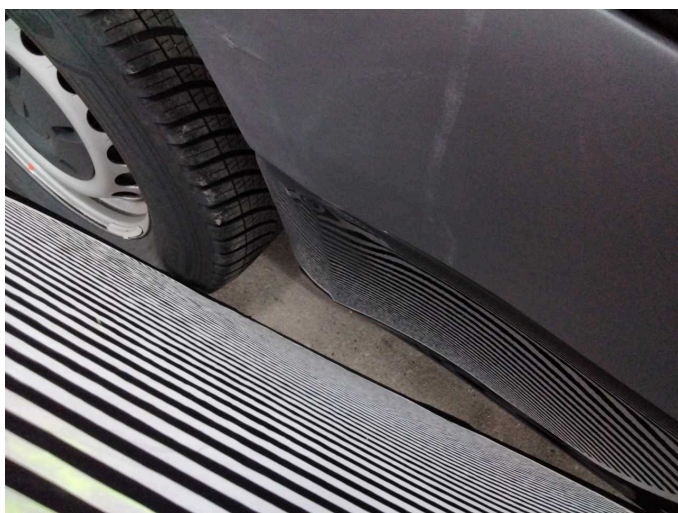
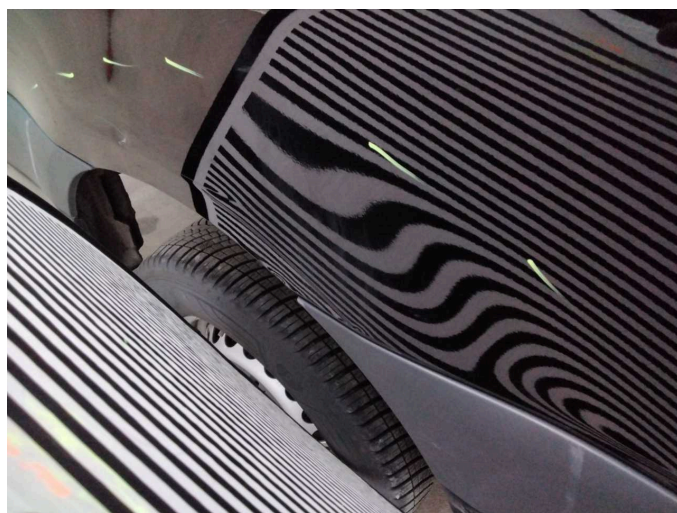
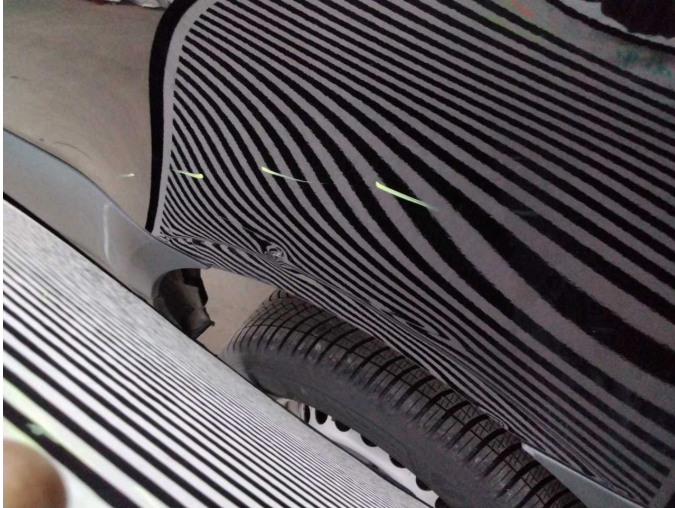
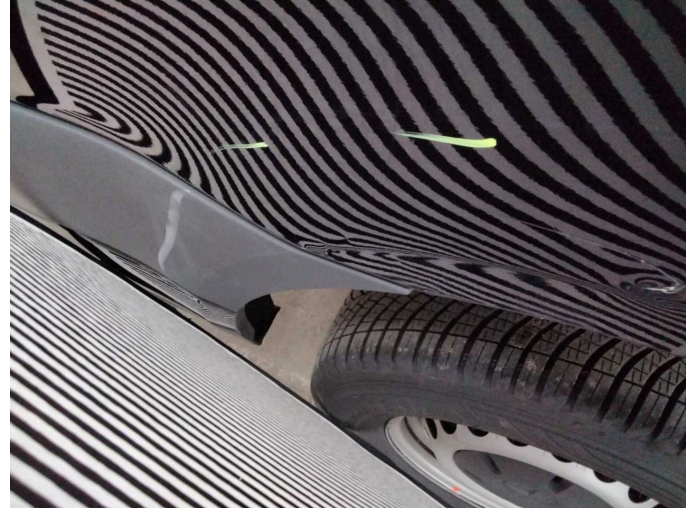
1 Side right

Non-repaired previous damages were found at the vehicle. The necessary repair costs are listed in the expert report or if necessary, are listed in detail in a separately enclosed repair cost calculation.

**Accident 1:** Side right

**Accident 1: Side right**
