Expertise

Protocol number: 46150641
Order No. / Reference: 26497104
Inspection date: 16 Jun 2026

Model: 3008 BlueHDi 130 Stop & Start EAT8 Active Business-Paket

VIN: VF3MCYHZRLS191689

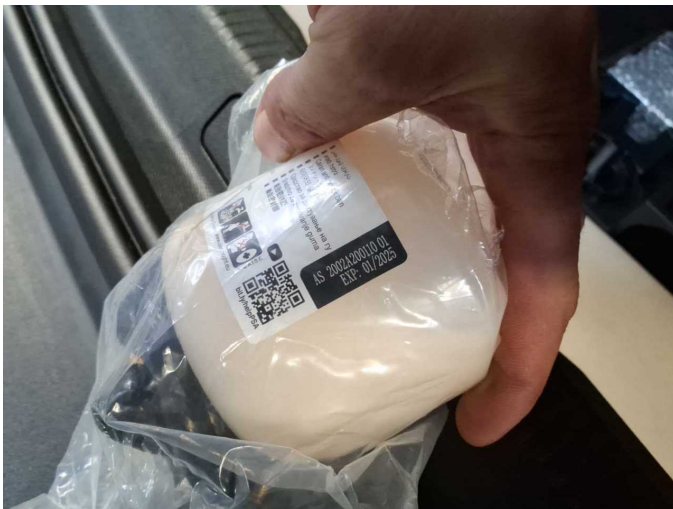
Damage 1: Equipment: Tirefit filler - Expired - Replace

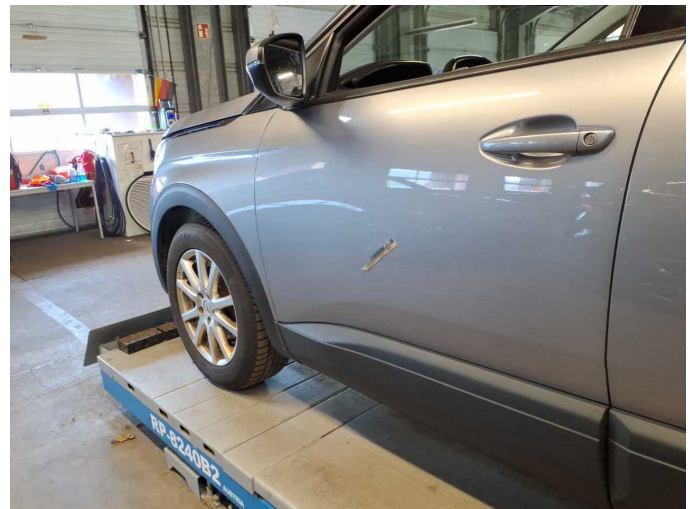
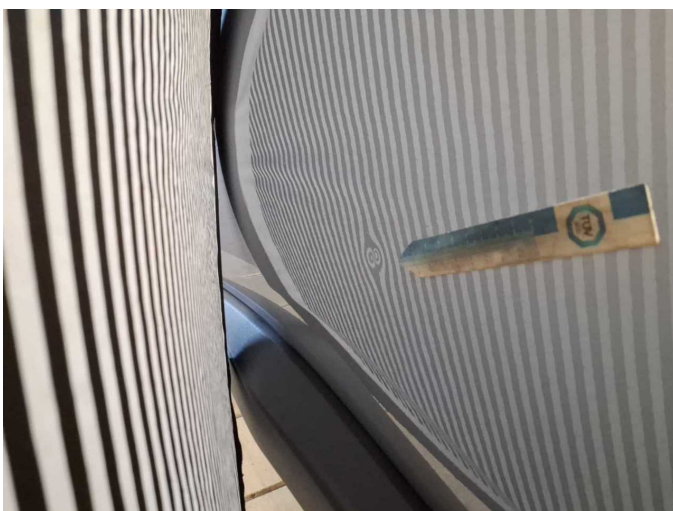
Damage 2: Door - front left side: Door - dent(s) - Smooth repair work

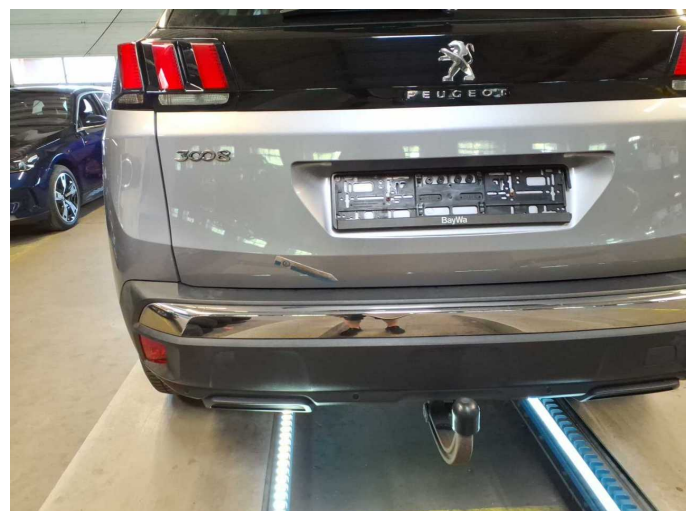
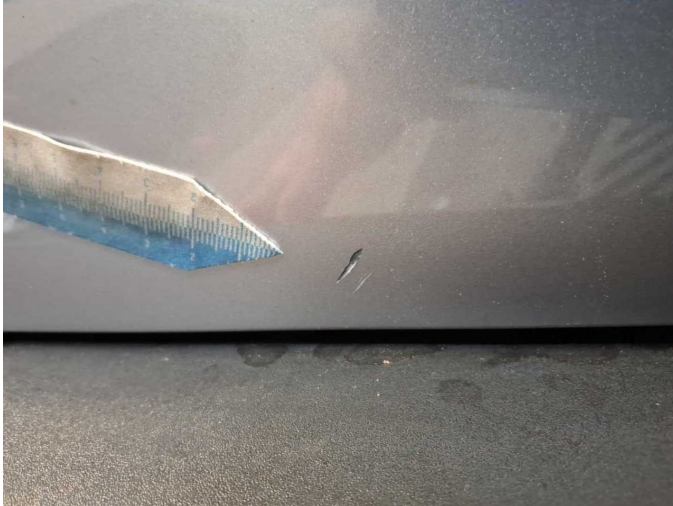
Damage 3: Boot lid / rear door: Boot lid - Scratch(es) - Smart repair

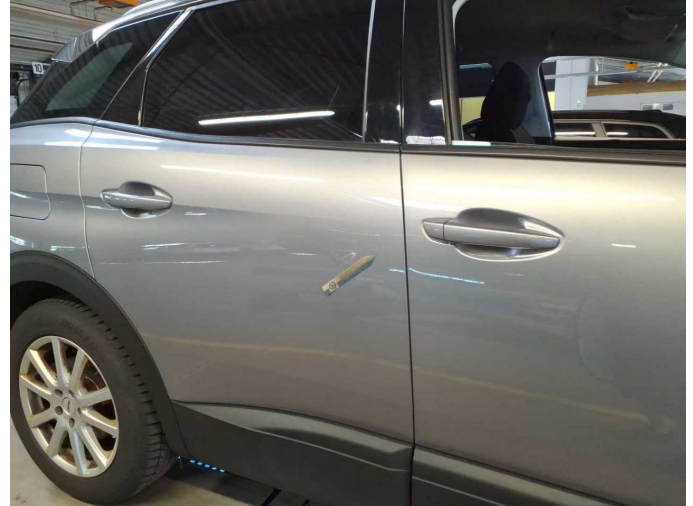
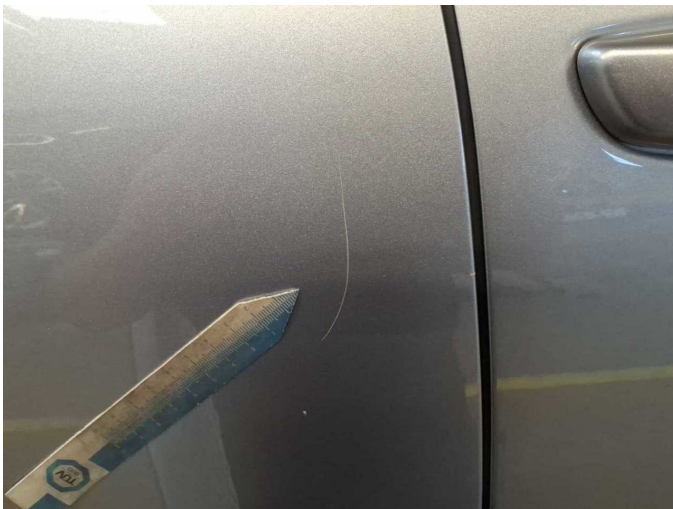
Damage 4: Door - rear right side: Door - Scratch(es) - Smart repair

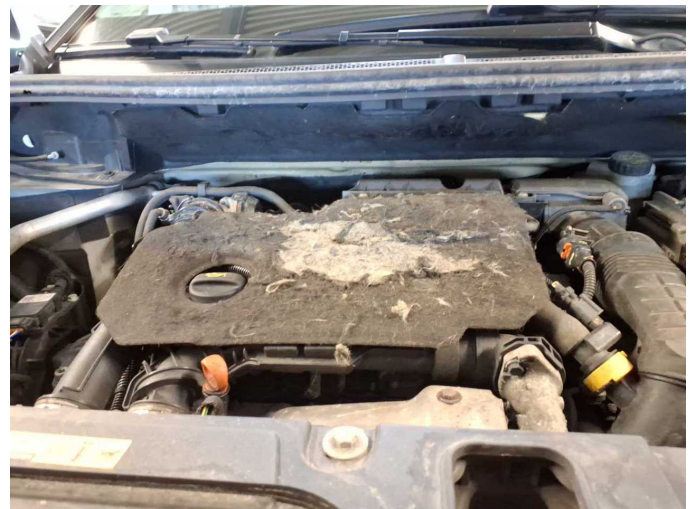
Damage 5: Engine: Engine cover (Evtl Mehrkosten) - Damage caused by marten / rodent - Replace

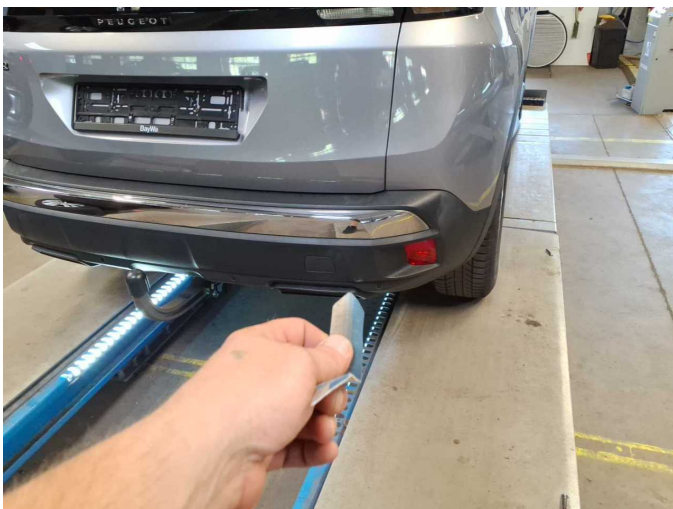
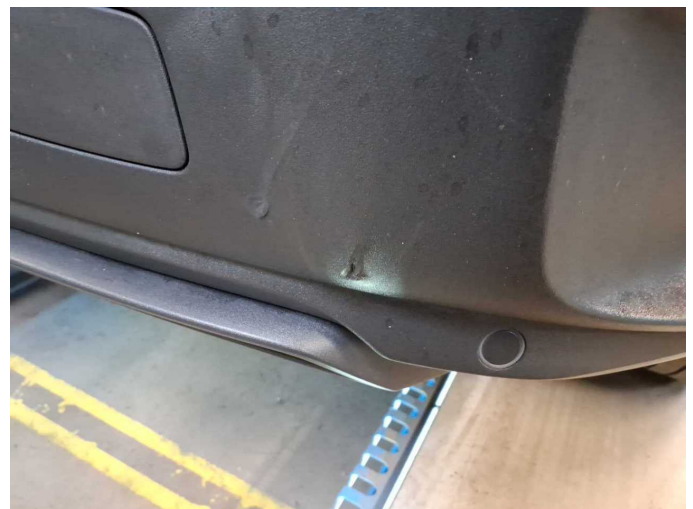
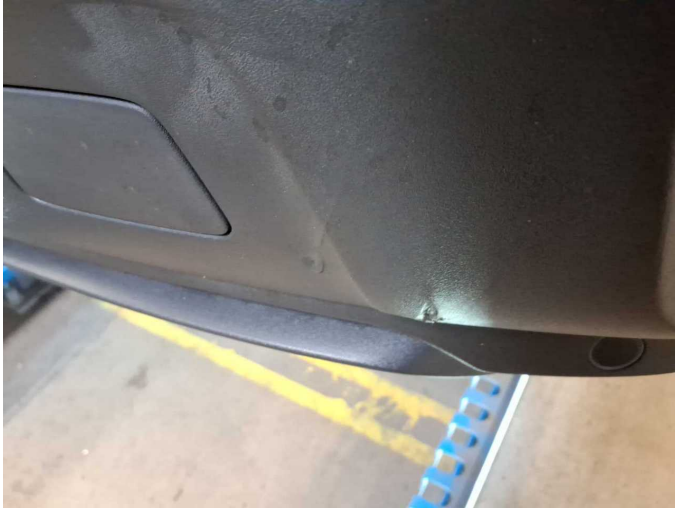
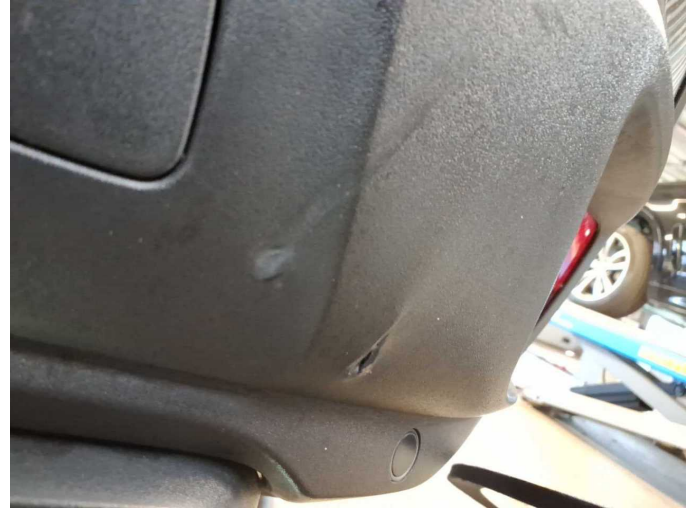
Damage 6: Rear bumper: Rear bumper (unpainted) - Broken / torn - Replace

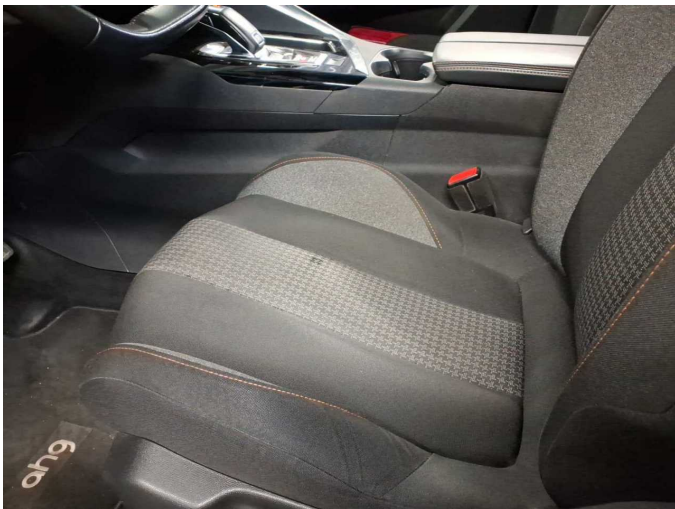
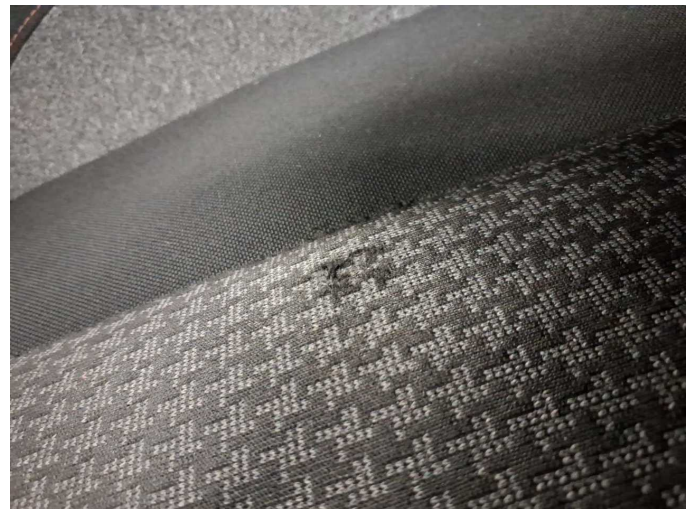
Wear and tear 2: Seat - front: Seat cover - left side - Abrasion - No deduction

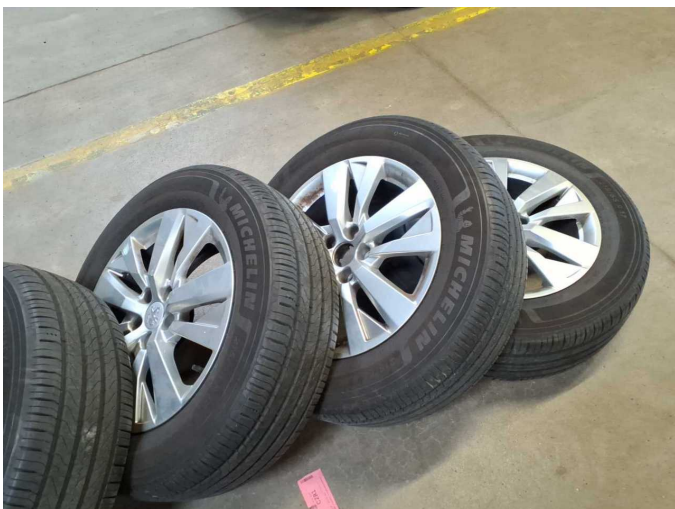
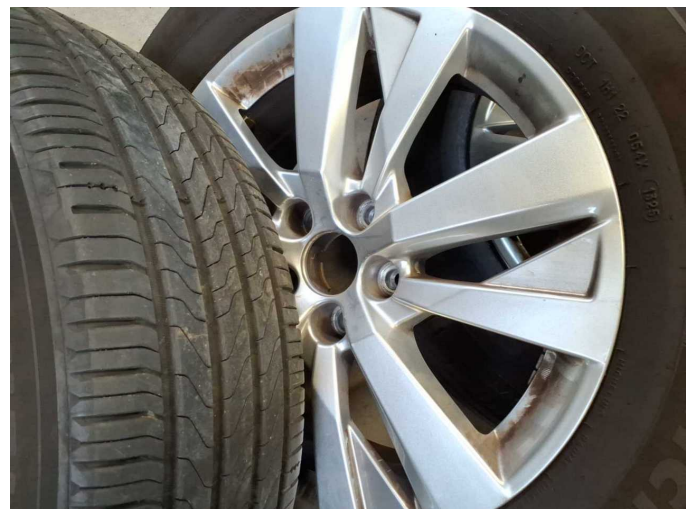
Missing part 1: 2nd wheel set: 1 wheel cover (Nabendeckel) - Missing - Replace

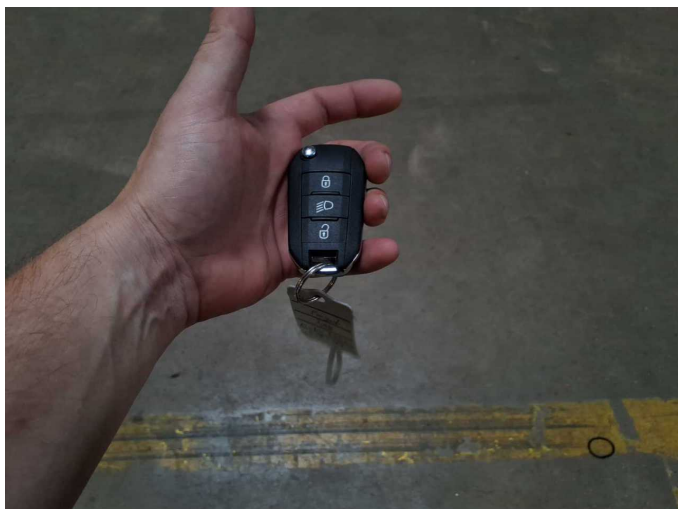
Missing part 2: Equipment: Vehicle key with remote control - Missing - Replace
