Expertise

Protocol number: 46104543  
Order No. / Reference: 26121552  
Inspection date: 23 Jun 2026

Manufacturer: Opel

Model: Astra 1.5 D Start/Stop Sports Tourer Business Edition

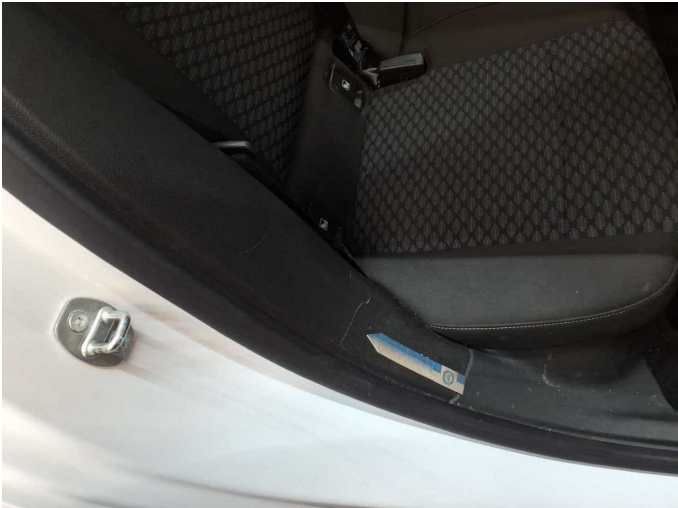
| No. | Component group | Description |
|---|---|---|
| 1 | Side panel - rear right side | Interior trim - Scratch(es) - Loss in value |

Damage 1: Side panel - rear right side: Interior trim - Scratch(es) - Loss in value

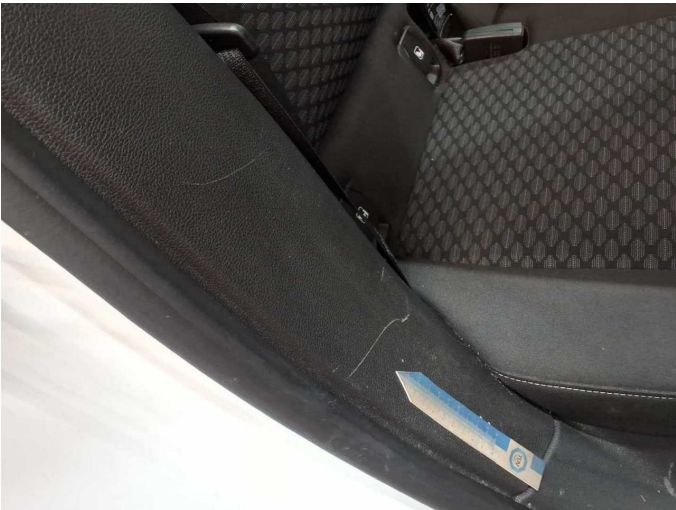
Damage 1: Side panel - rear right side: Interior trim - Scratch(es) - Loss in value

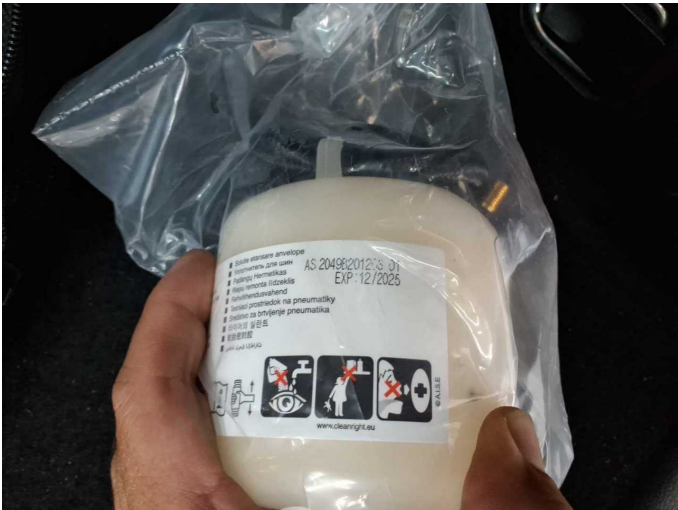
| No. | Component group | Description |
|---|---|---|
| 2 | Equipment | Tirefit filler - Expired - Replace |

Damage 2: Equipment: Tirefit filler - Expired - Replace

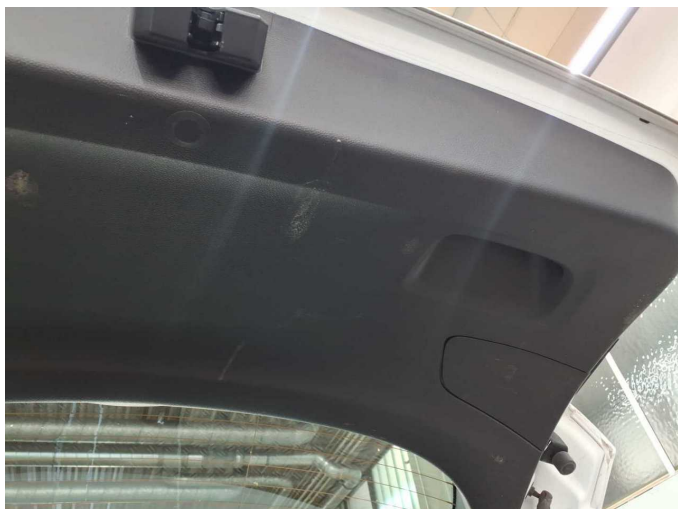
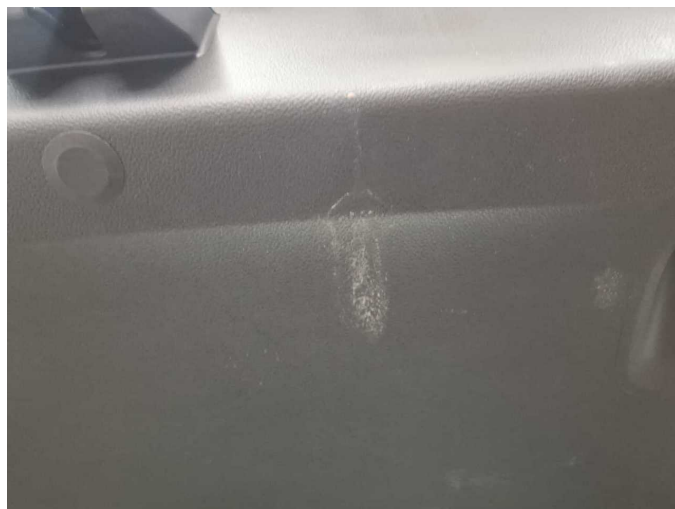
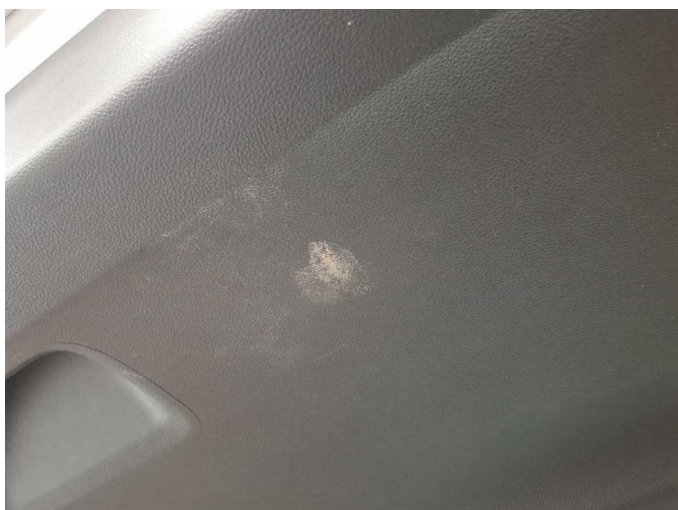
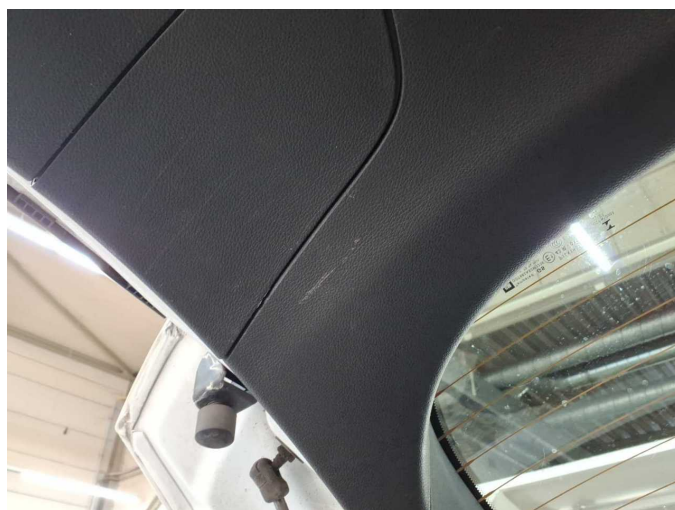
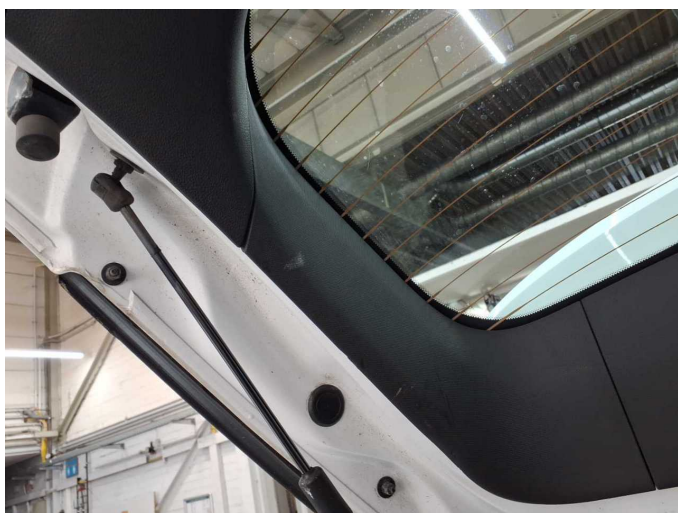
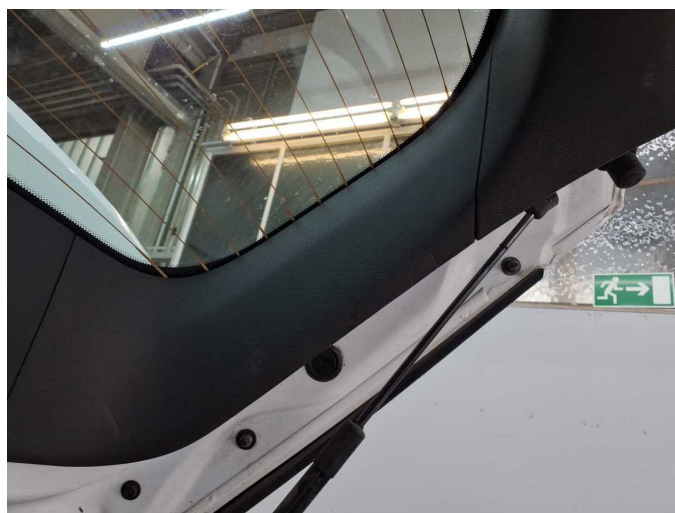
| No. | Component group | Description |
|---|---|---|
| 3 | Trim / covers | Boot lid - interior trim - Scratch(es) - Loss in value |

**Damage 3:** Trim / covers: Boot lid - interior trim - Scratch(es) - Loss in value

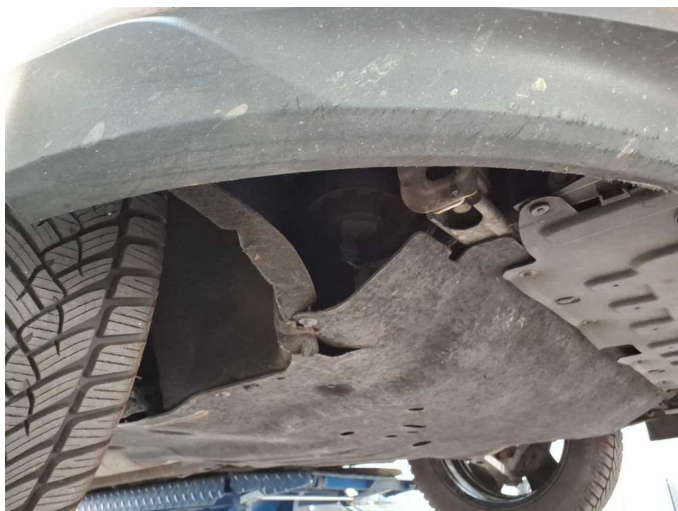
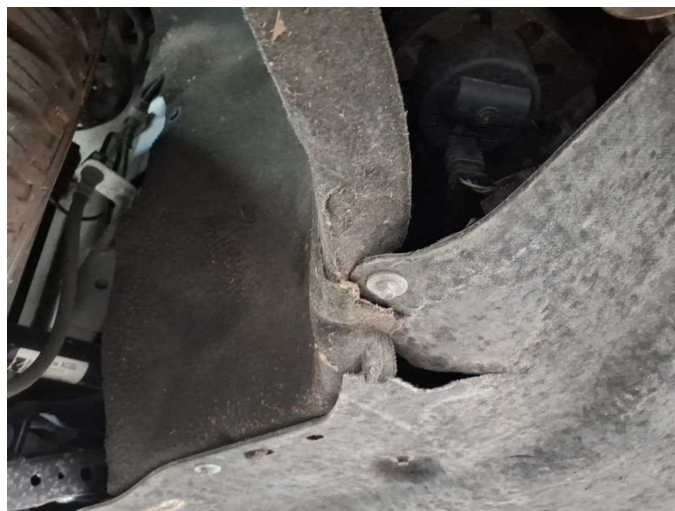
| No. | Component group | Description |
|---|---|---|
| 4 | Side panel - rear right side | Wheel arch (Radhausschale) - Broken / torn - Replace |

**Damage 4:** Side panel - rear right side: Wheel arch (Radhausschale) - Broken / torn - Replace

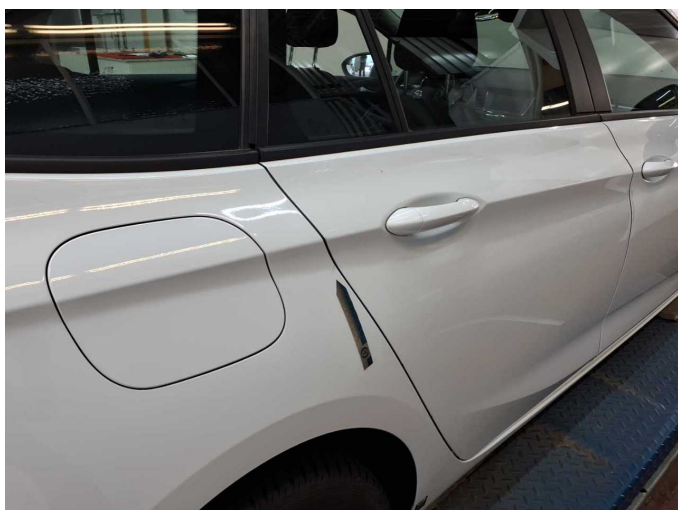
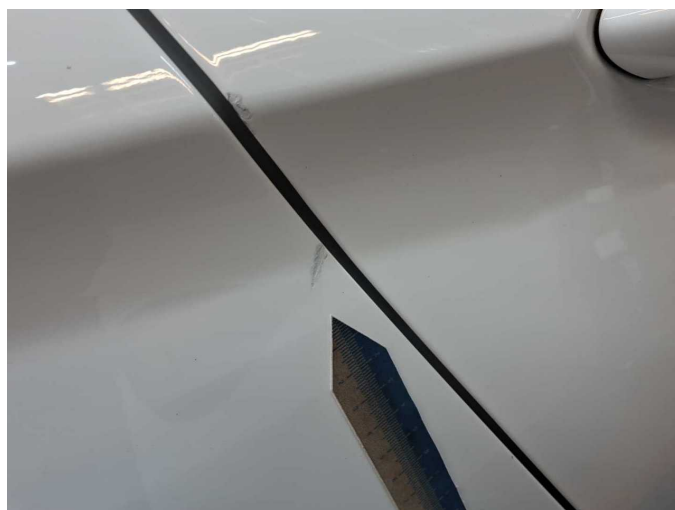
| No. | Component group | Description |
|---|---|---|
| 5 | Side panel - rear right side | Side panel - Scratch(es) - Smart repair |

**Damage 5:** Side panel - rear right side: Side panel - Scratch(es) - Smart repair

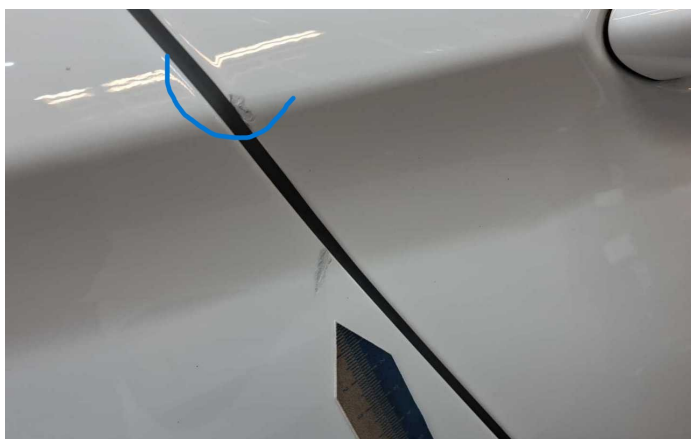
| No. | Component group | Description |
|---|---|---|
| 6 | Door - rear right side | Door - Scratch(es) - Smart repair |

**Damage 6:** Door - rear right side: Door - Scratch(es) - Smart repair

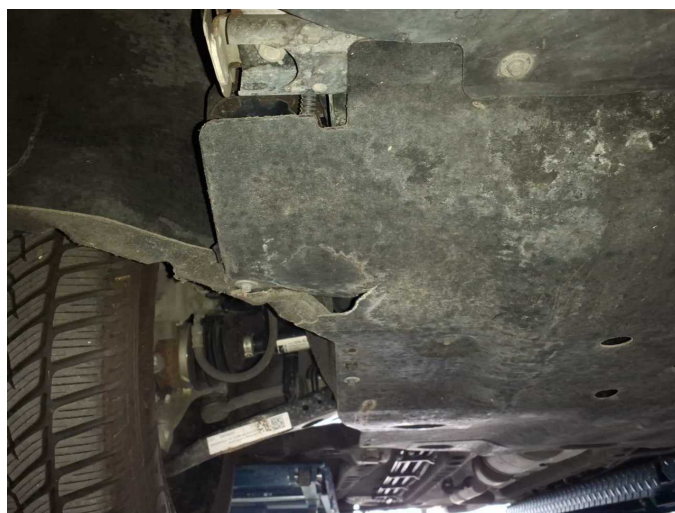
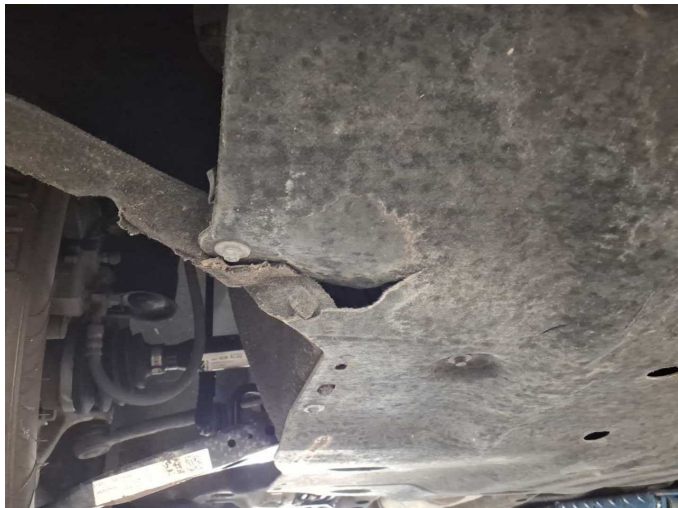
| No. | Component group | Description |
|---|---|---|
| 7 | Body | Underbody panelling - Broken / torn - Replace |

**Damage 7:** Body: Underbody panelling - Broken / torn - Replace

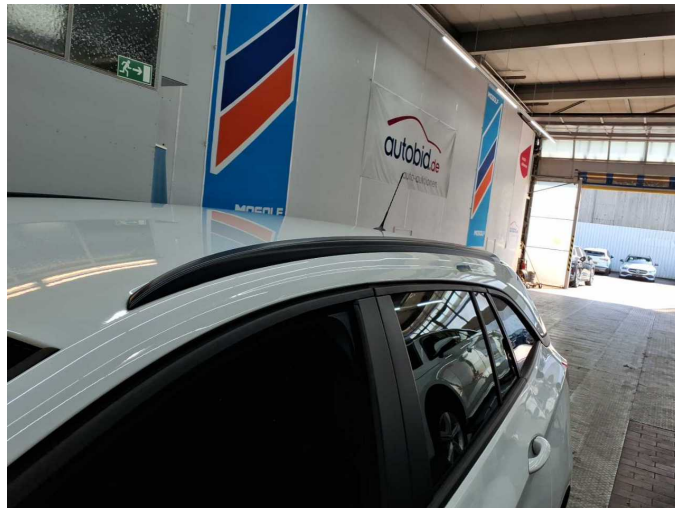
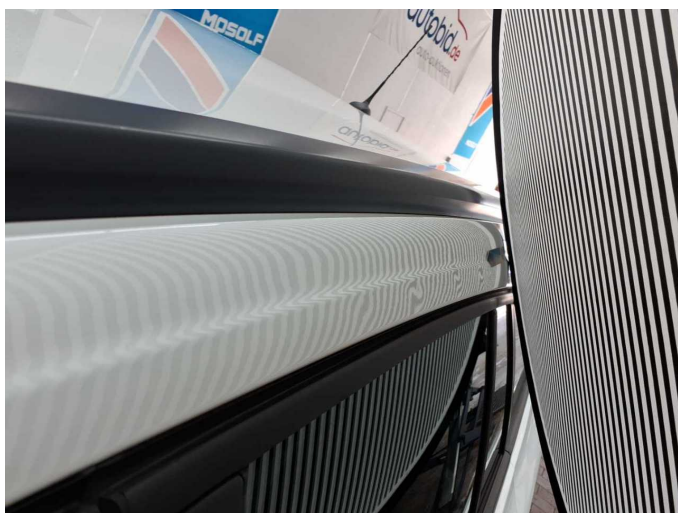
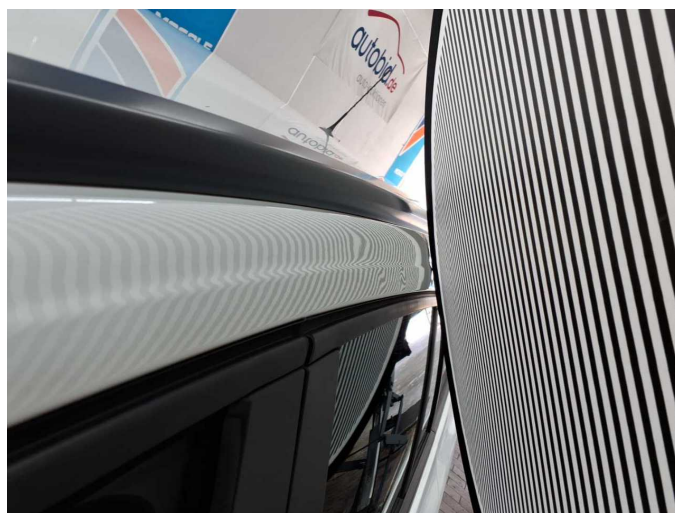
| No. | Component group | Description |
|---|---|---|
| 8 | Roof | Roof rail - left side - dent(s) - Smooth repair work |

**Damage 8:** Roof: Roof rail - left side - dent(s) - Smooth repair work

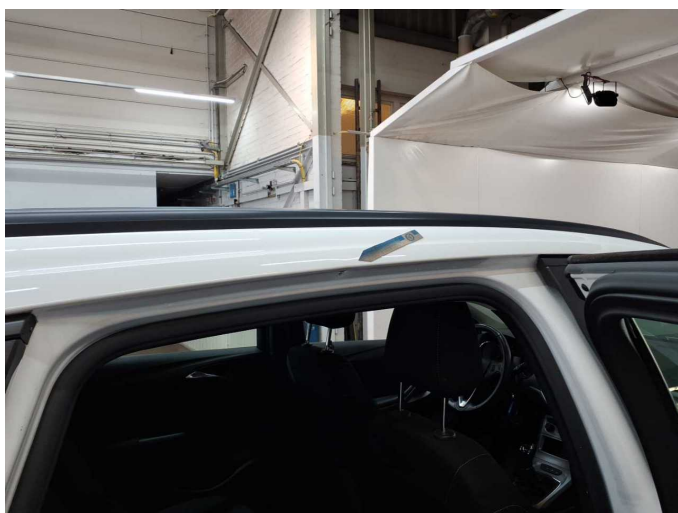
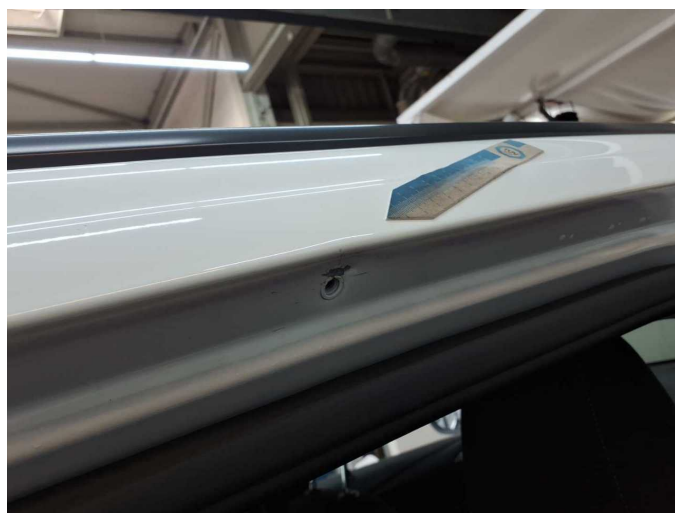
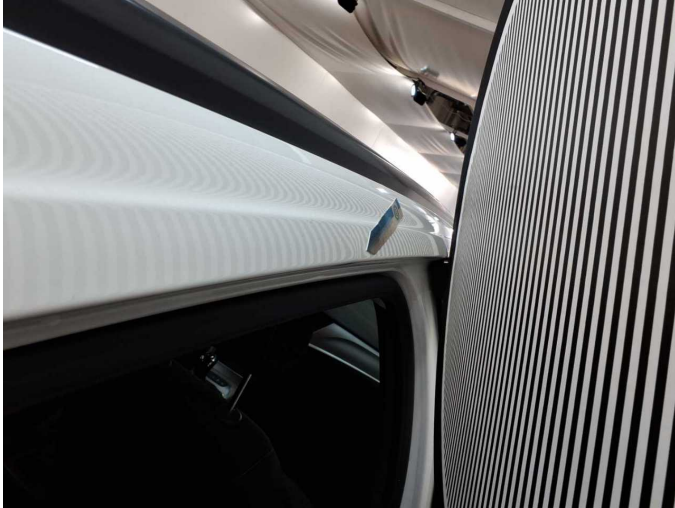
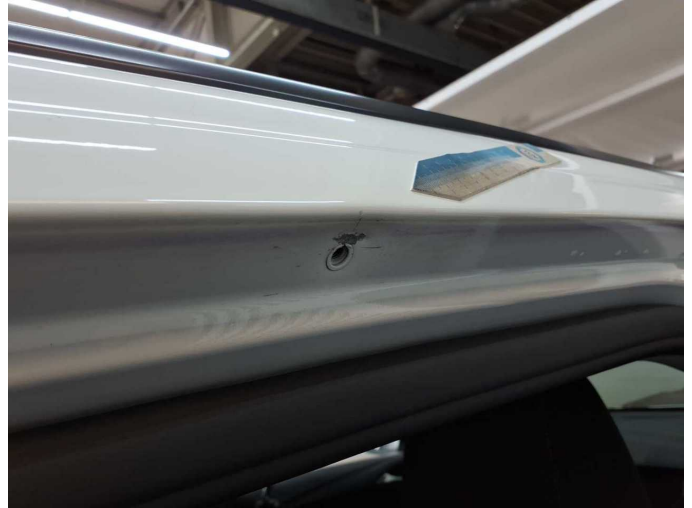
| No. | Component group | Description |
|---|---|---|
| 9 | Roof | Roof rail - right side - Dent / paintcoat damage - Repair and paint |

**Damage 9:** Roof: Roof rail - right side - Dent / paintcoat damage - Repair and paint
