Expertise

Protocol number: 46574827  
Order No. / Reference: 26664006  
Inspection date: 17 Jul 2026

Manufacturer: Ford

Model: Transit Custom 320 L2H1 VA Trend

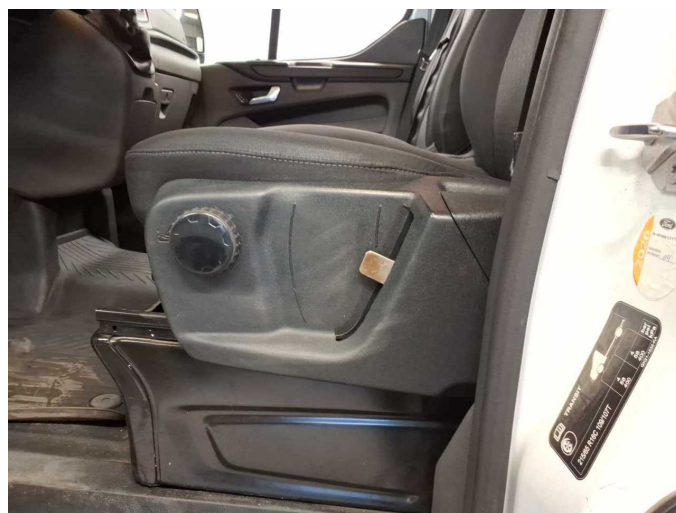
| No. | Component group | Description |
|---|---|---|
| 1 | Seat - front | Lever seat adjustment - Missing - Replace |

**Damage 1:** Seat - front: Lever seat adjustment - Missing - Replace

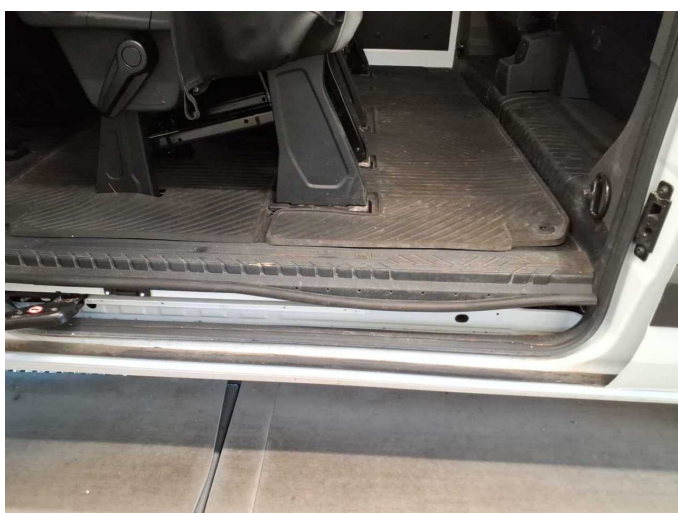
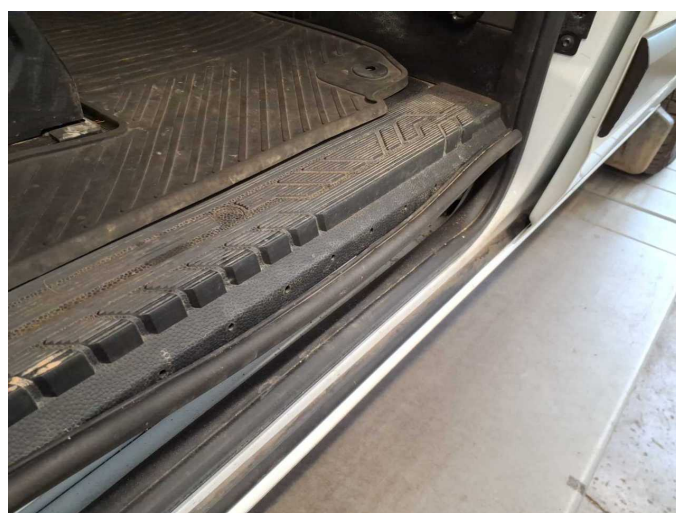
| No. | Component group | Description |
|---|---|---|
| 2 | Sliding door, right | Door seal - Loose - Repair |

**Damage 2:** Sliding door, right: Door seal - Loose - Repair

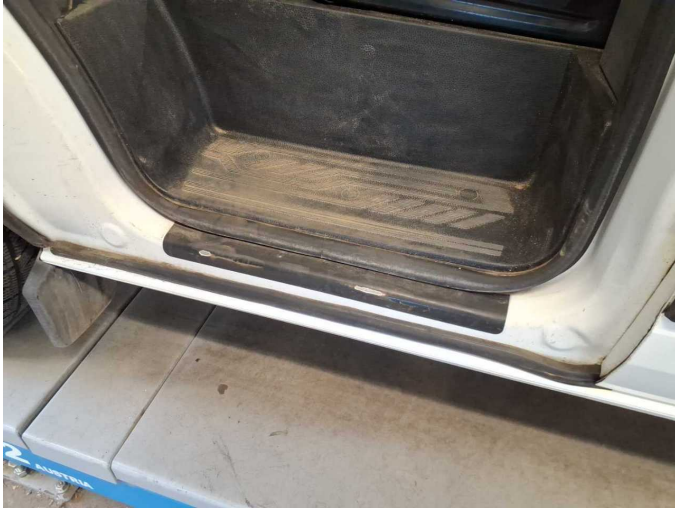
| No. | Component group | Description |
|---|---|---|
| 3 | Sill - left side | Sill - Scratch(es) - Smart repair |

**Damage 3:** Sill - left side: Sill - Scratch(es) - Smart repair

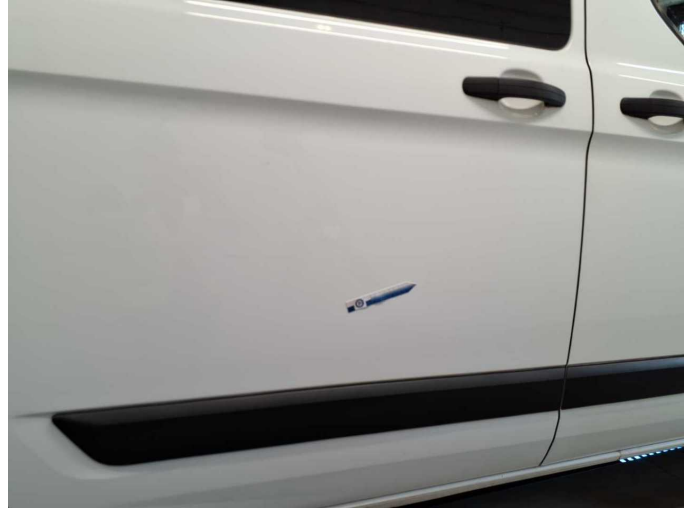
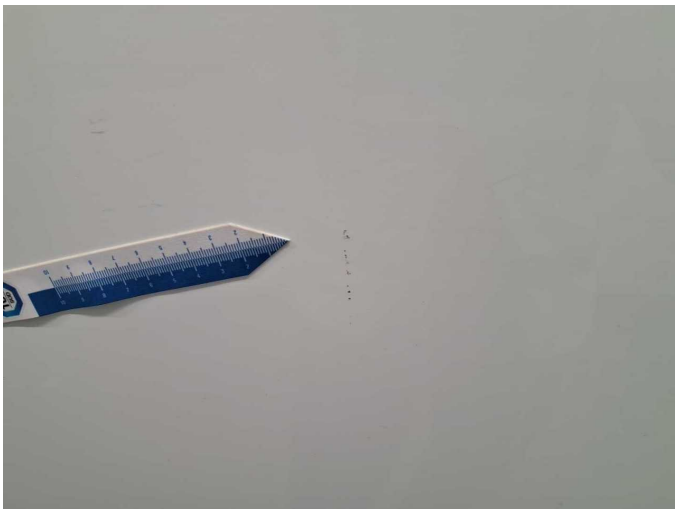
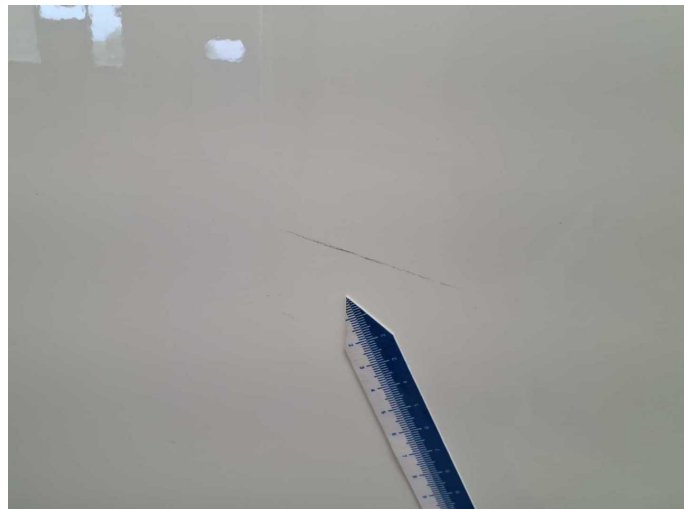
| No. | Component group | Description |
|---|---|---|
| 4 | Sliding door, right | Sliding door with glass panel (Mehrkosten möglich) - Scratch(es) - Conditioning |

**Damage 4:** Sliding door, right: Sliding door with glass panel (Mehrkosten möglich) - Scratch(es) - Conditioning

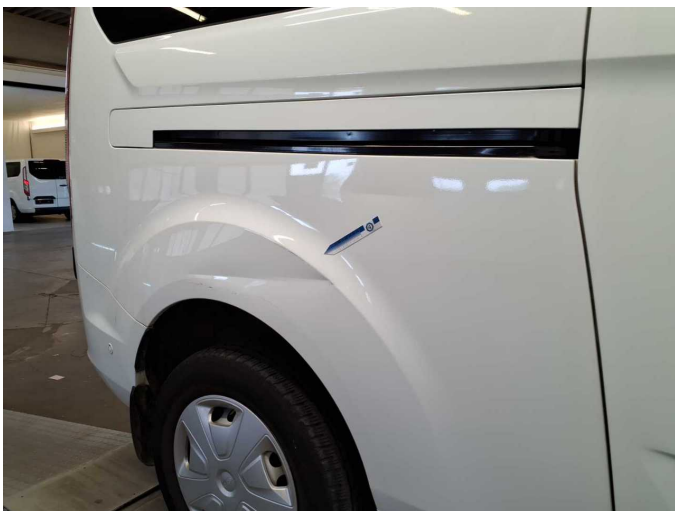
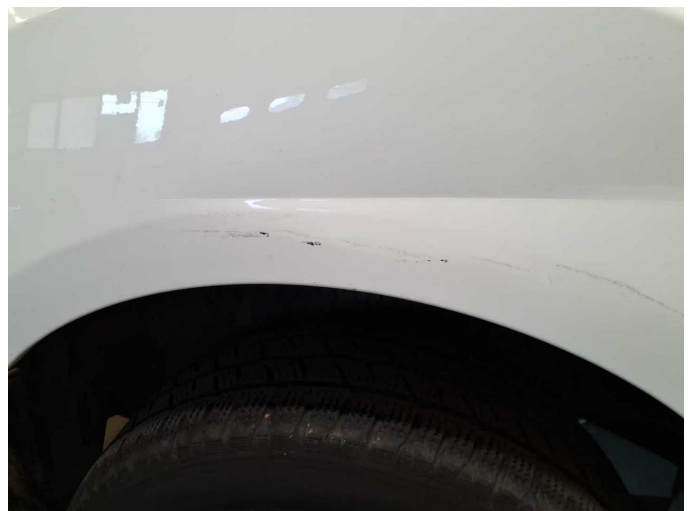
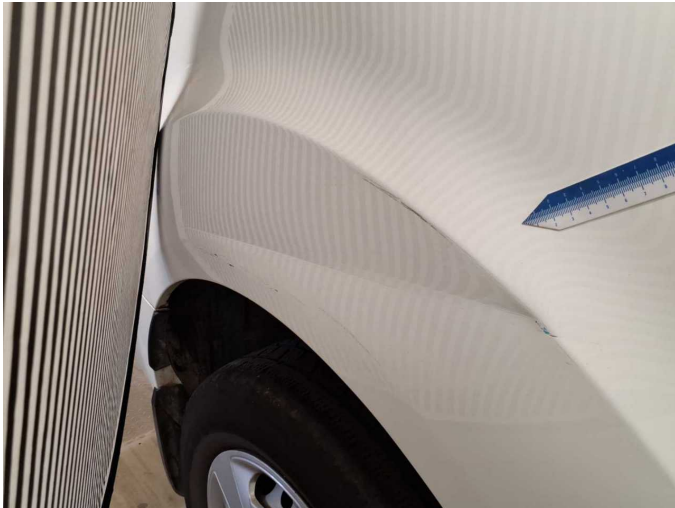
| No. | Component group | Description |
|---|---|---|
| 5 | Side panel - rear right side | Side panel (Unterhalb) - Dent / paintcoat damage - Repair and paint |

**Damage 5:** Side panel - rear right side: Side panel (Unterhalb) - Dent / paintcoat damage - Repair and paint

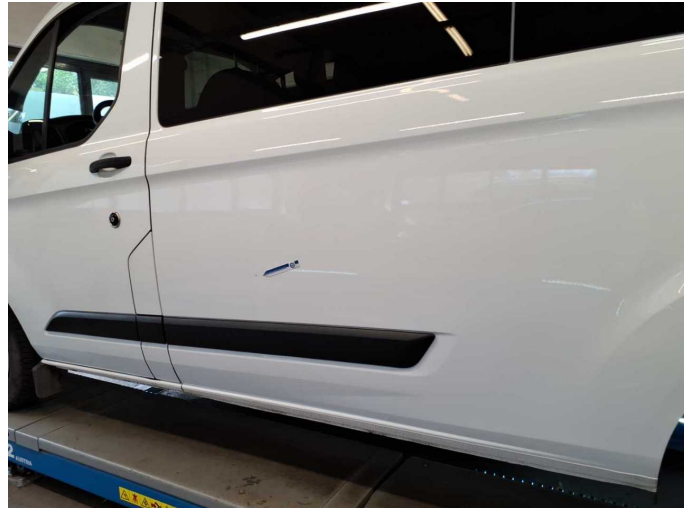
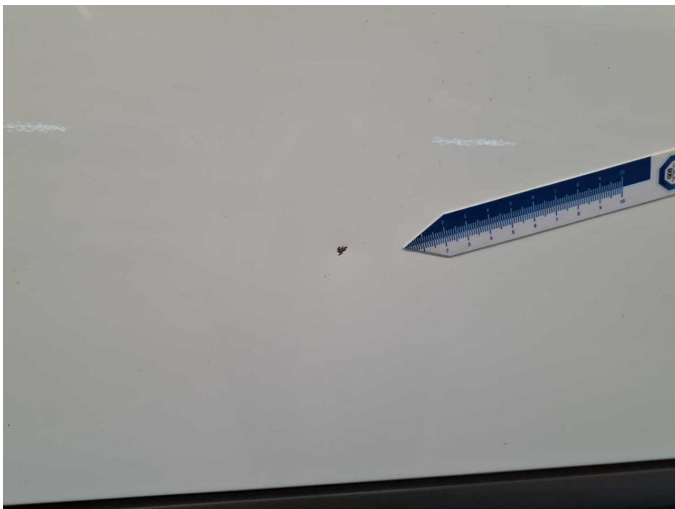
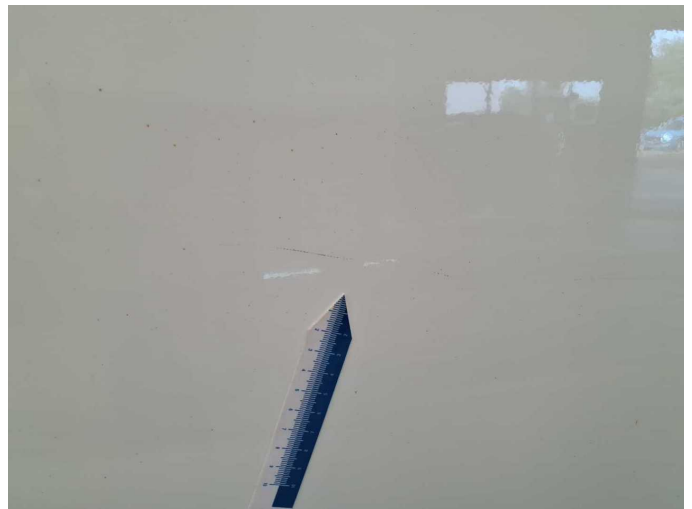
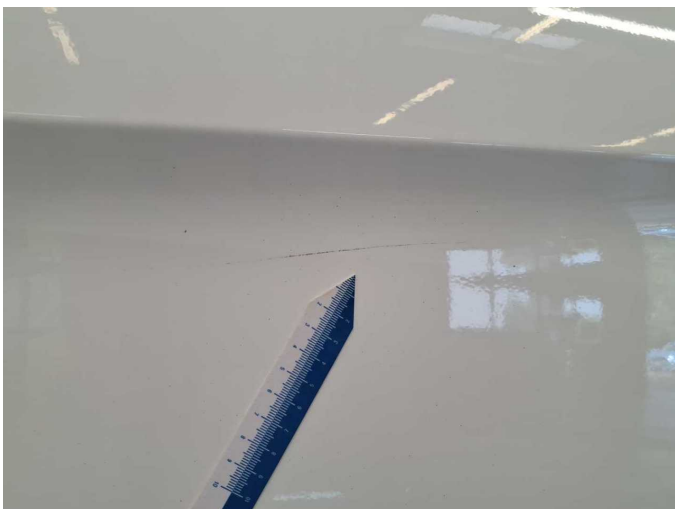
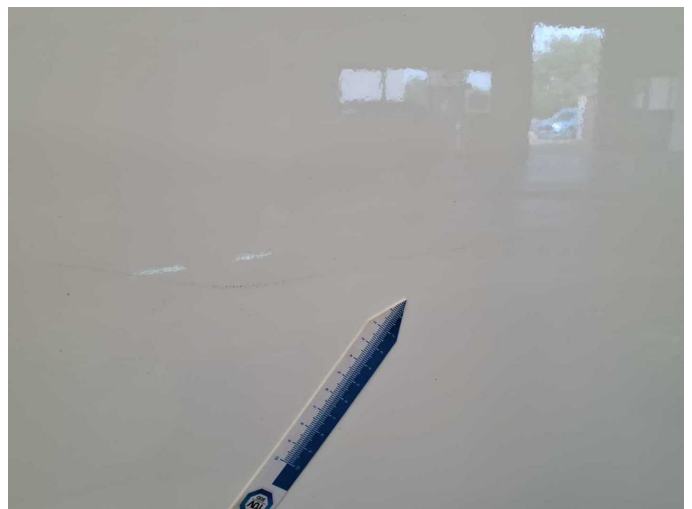
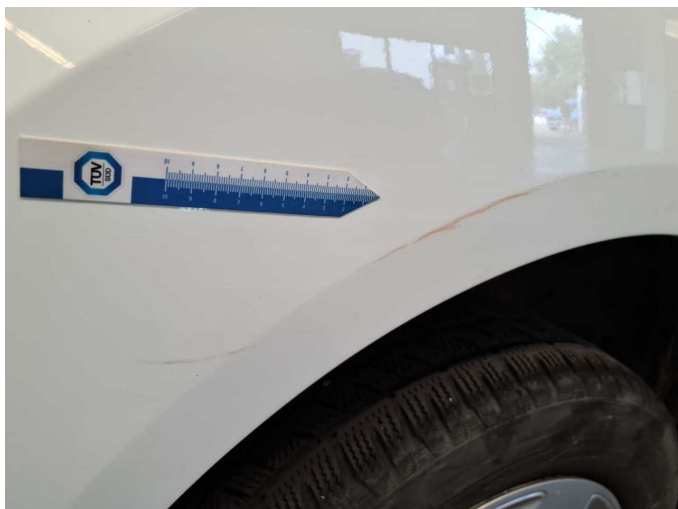
| No. | Component group | Description |
|---|---|---|
| 6 | Side panel - rear left side | Side panel - Scratch(es) - repair according to calculation |

**Damage 6:** Side panel - rear left side: Side panel - Scratch(es) - repair according to calculation

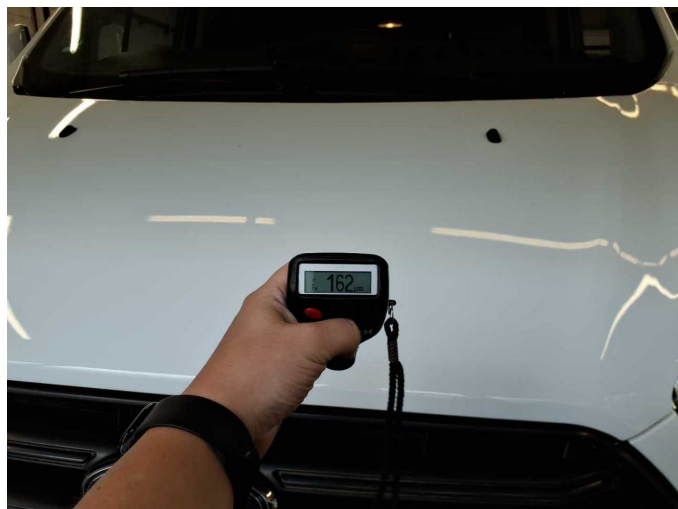
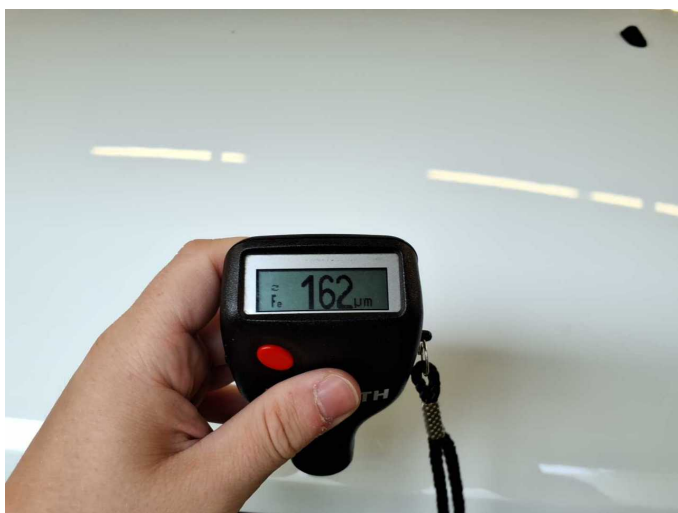
| No. | Repainting |
|---|---|
| 1 | Bonnet, Professionally carried out, Invoice of repair done Non-existent |

| Bonnet | 162 µm |

**Repainting 1:** Bonnet
